# **NDE Reliability Issues for the Examination of CASS Components**

The relatively low cost and corrosion resistance of cast austenitic stainless steel (CASS) materials resulted in their extensive use for piping systems in nuclear power plants (NPPs). However, CASS component welds are among the most challenging volumetric examinations required to be performed for detection of potential service degradation. Effective and reliable inspection methods for CASS materials are essential to achieving the objectives of defense-in-depth. A complicating issue is the presence of thermal aging embrittlement, a known degradation mechanism that occurs in CASS NPP materials. Further, while not as yet reported in CASS, many unforeseen instances of cracking in safety-related piping system welds have been experienced in other austenitic materials. Currently, a performance-based method to qualify NDE in CASS is not available.

The primary objectives of the report are to assess the overall feasibility for advanced NDE methods to reliably and effectively examine field CASS piping components and to determine if techniques similar to those described in existing standards could be applied to develop perfo

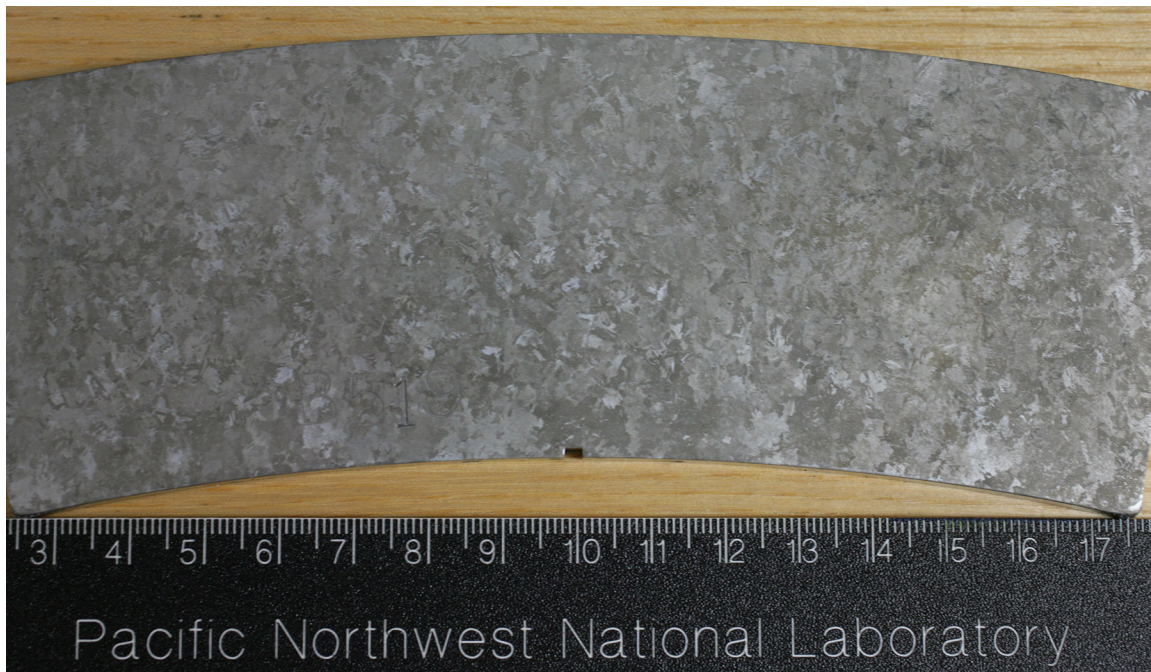
**Figure 2-5 Portion of Later Vintage CCSS Piping Segment Showing Slightly More Refined Equiaxed Grains Throughout**

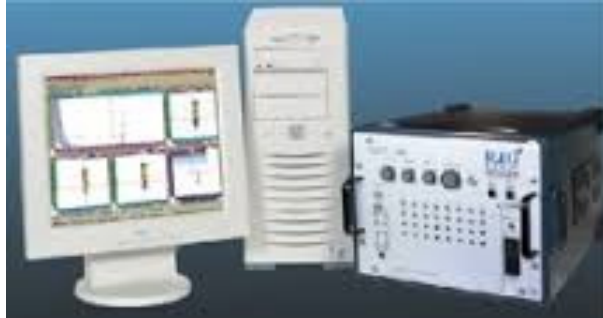
**Figure 6-5 Modified Tomoscan III with Typical Acquisition Data Station**

The first PA system at PNNL consisted of a Tomoscan III (Figure 6-5) produced by R/D Tech. This was a standard piece of equipment used for PA applications in several industrial sectors. This type of system was being used by General Electric to inspect reactor internals and at the EPRI NDE Center for a variety of applications, including far-side inspection procedure development and initial true-state characterization of the industry's Performance Demonstration

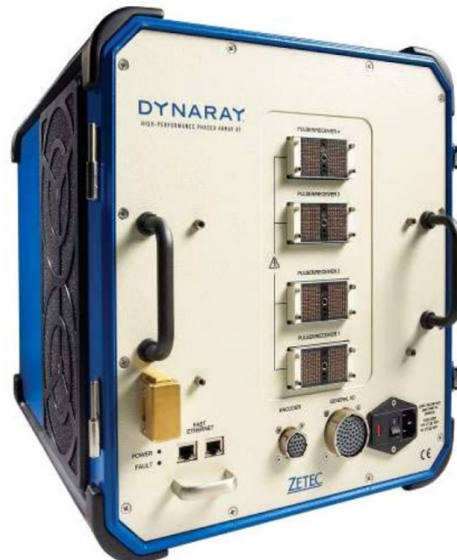
**Figure 6-6 Zetec DYNARAY Off-the-Shelf Phased Array Instrument with Low-Frequency Capabilities**

Initiative specimens. The instrument was programmable (by development of focal laws in software) to control up to 32 channels for transmission and reception of ultrasonic signals at a typical frequency range of 1–5 MHz. For the early LF work, R/D Tech modified a Tomoscan III to operate at 500 kHz. Instruments with extended frequency ranges can now be routinely ordered, such as the Zetec DYNARAY class of PA equipment (Figure 6-6).

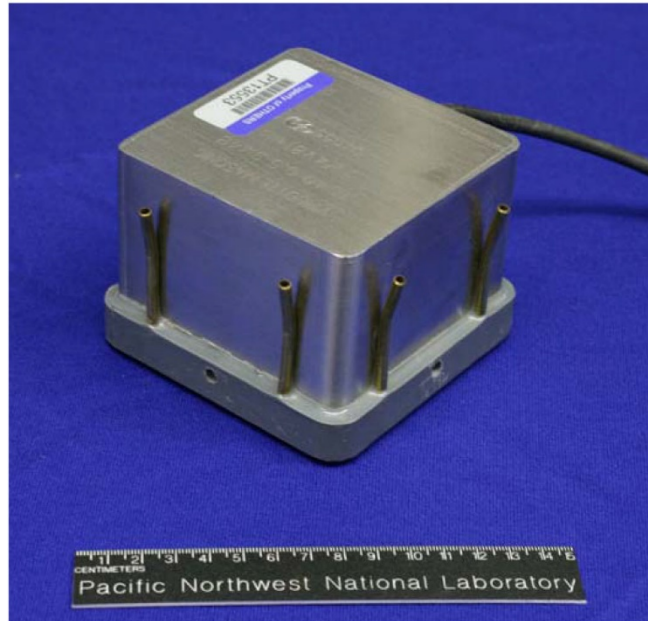
**Figure 6-13 Improved Design of 500 kHz Phased Array Probe**

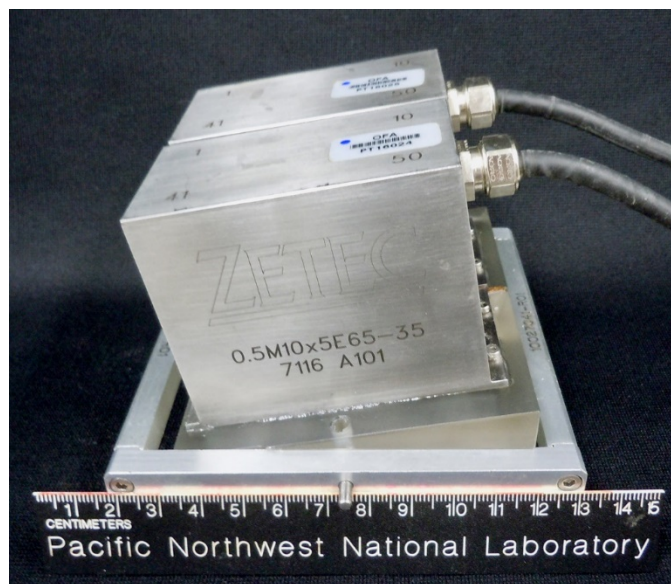
**Figure 6-14 Current (latest) Generation of 500 kHz PA Probe**

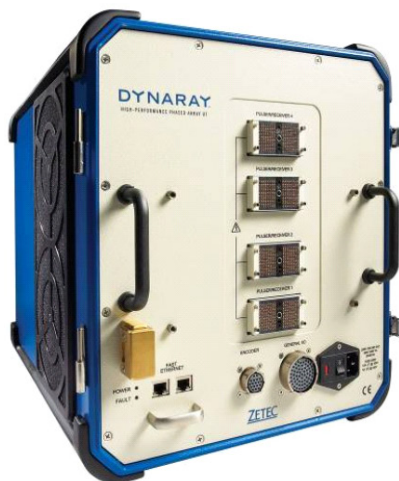
**Figure 7-6 Data Acquisition System and Laboratory Workstation.** *Left:* DYNARAY PA data acquisition system (courtesy of Zetec). *Right:* Laboratory workstation for both data acquisition and data analysis, with the DYNARAY system on the lower shelf.

An ATCO scanner was interfaced to a Zetec DYNARAY controller via a Zetec motor control drive unit MCDU-02 (see Figure 7-6). These are off-the-shelf devices and are commercially available. All data acquisition parameters were accessed through UltraVision 3.6R5. Probes were driven by a 200 V square pulse of width equal to one-half the wave period. For example, the 800 kHz probe was driven with a pulse width of 625 ns.

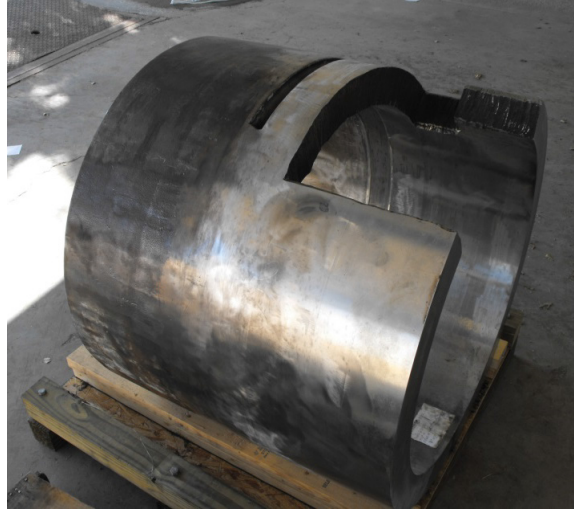
**Figure 7-13 DMW Mockup as Received by PNNL**

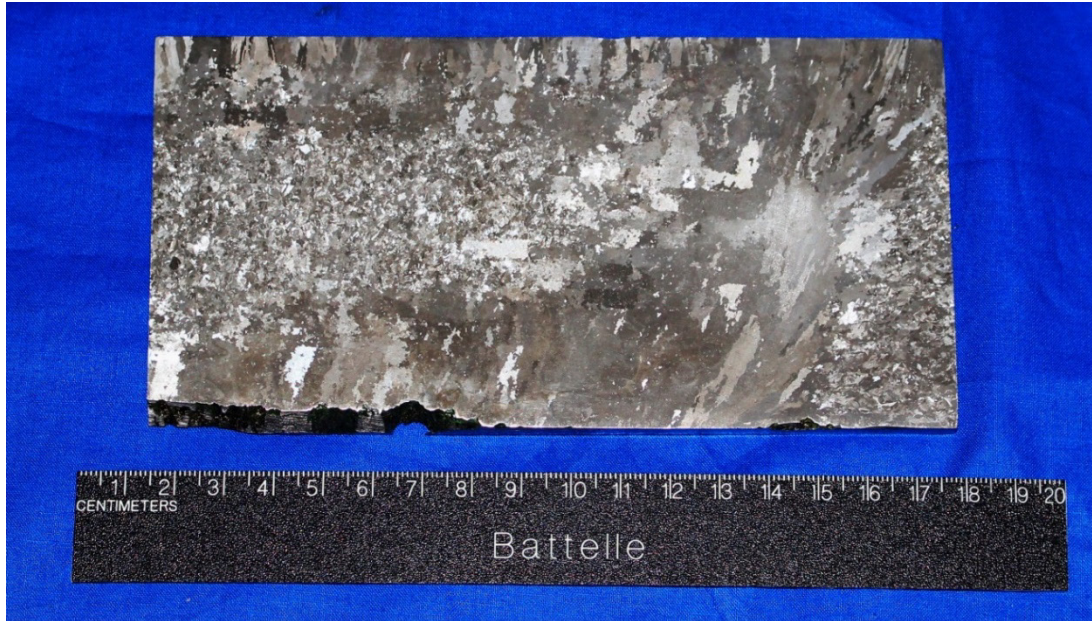
**Figure 7-20 The Polished and Etched Circumferential Section.** This figure shows the circumferential grain structure of the removed section, revealing considerable heterogeneity in grain structure type, size, and distribution. The OD is at the top of the figure.

Photographs of the grain structure of this CASS material were taken from polished and etched pieces cut from the specimen. Figure 7-17 shows the portion of CASS material that was removed, as indicated by the red line drawn on the mockup. Thin slices (~6 mm or ~0.25 in.) were cut from both the axial and circumferential faces for polishing and etching. Figure 7-18 illustrates the respective orientations of each slice. Figure 7-19 and Figure 7-20 are detail photographs showing axial and circumferential views of the grain structure, respectively. The grains appear to be columnar near the OD and somewhat columnar near the ID, with relatively larger grains near the ID. Equiaxed grains are present in the mid-wall region with a wide range of grain sizes. Figure 7-20 shows a particularly striking heterogeneity in grain structure, size, and distribution toward the right side of the section. Note that the grain structures in Figure 7-19 and Figure 7-20 may appear slightly different from those in Figure 7-18; this is due to the different ways that the grain faces reflect light in the different photographs.

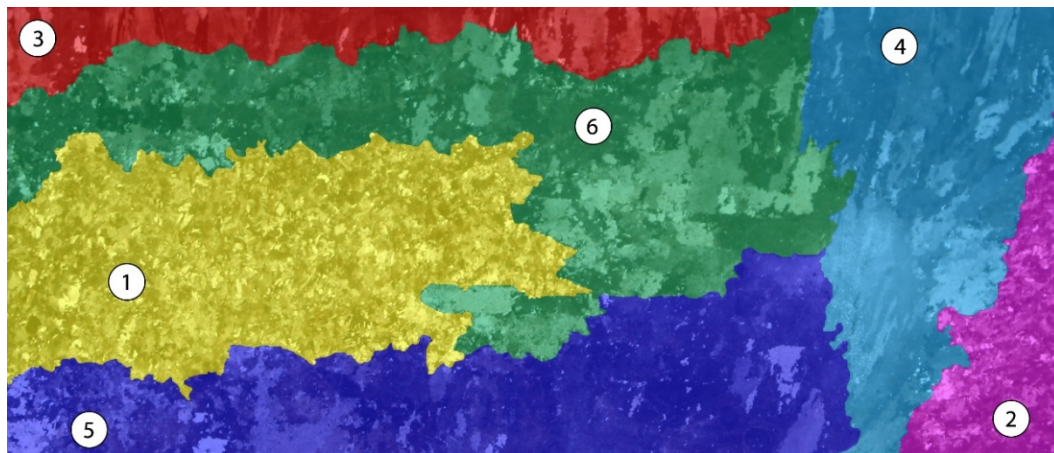
**Figure 7-21 False Color Image of the Different Grain Regions Identified in the Axial Section**

Regions with predominantly similar grain geometries were delineated so that the average grain size and orientation could be measured in each region. This was done using a linear intercept method described in Anderson et al. (2007). Figure 7-21 and Figure 7-22 show the different regions that were delineated and categorized (color coding was added to aid in visualization).

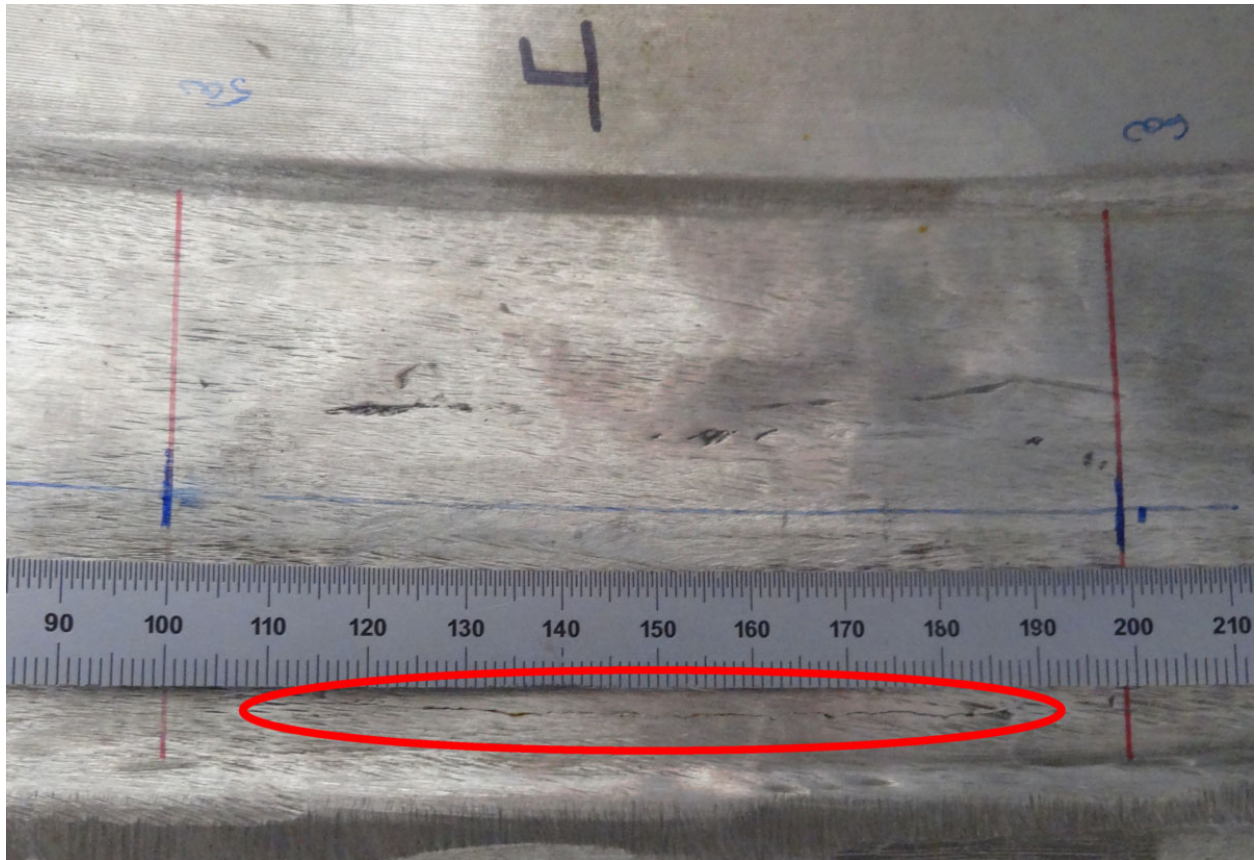
**Figure 7-27** Photograph of Flaw 4 (16% circ). This flaw is in the butter region on the carbon steel side of the weld. It is visible below the ruler within the red oval and spans from approximately 110–190 mm on the ruler. The CASS end is upward. Some grind marks are visible above the ruler.

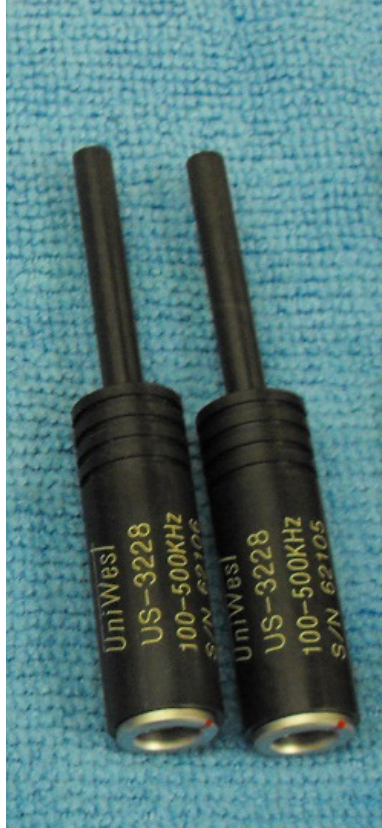
**Figure 7-29 UniWest US-3228 Pencil Probe**

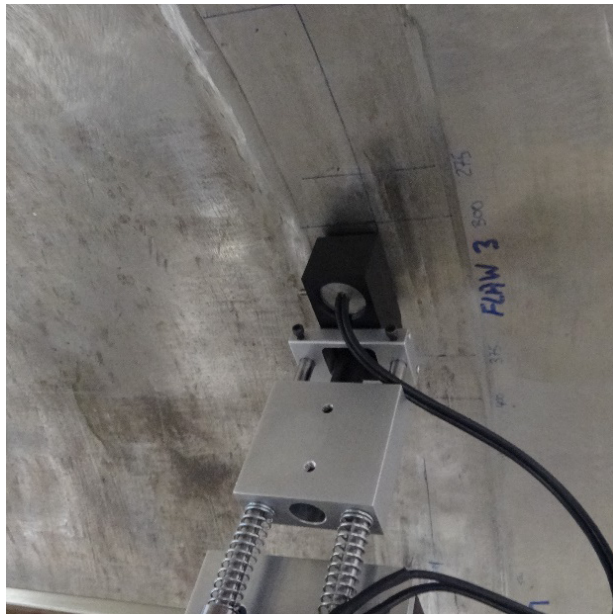
**Figure 7-32 Data Acquisition Using the Zetec Spot Probe**

Polytetrafluoroethylene (or PTFE) tape with a thickness of 0.094 mm (0.0037 in.) was placed over the scan region of each flaw for the pencil probe examinations, as shown in Figure 7-31. The tape provided a consistent liftoff (offset from the specimen surface) and also protected the wear-face of the probe. The spot probe was placed in a machined Delrin fixture, shown in Figure 7-32, such that the probe face was 0.13 mm (0.005 in.) from the examination surface. This configuration provided a consistent liftoff throughout the examination and protected the probe wear-face.

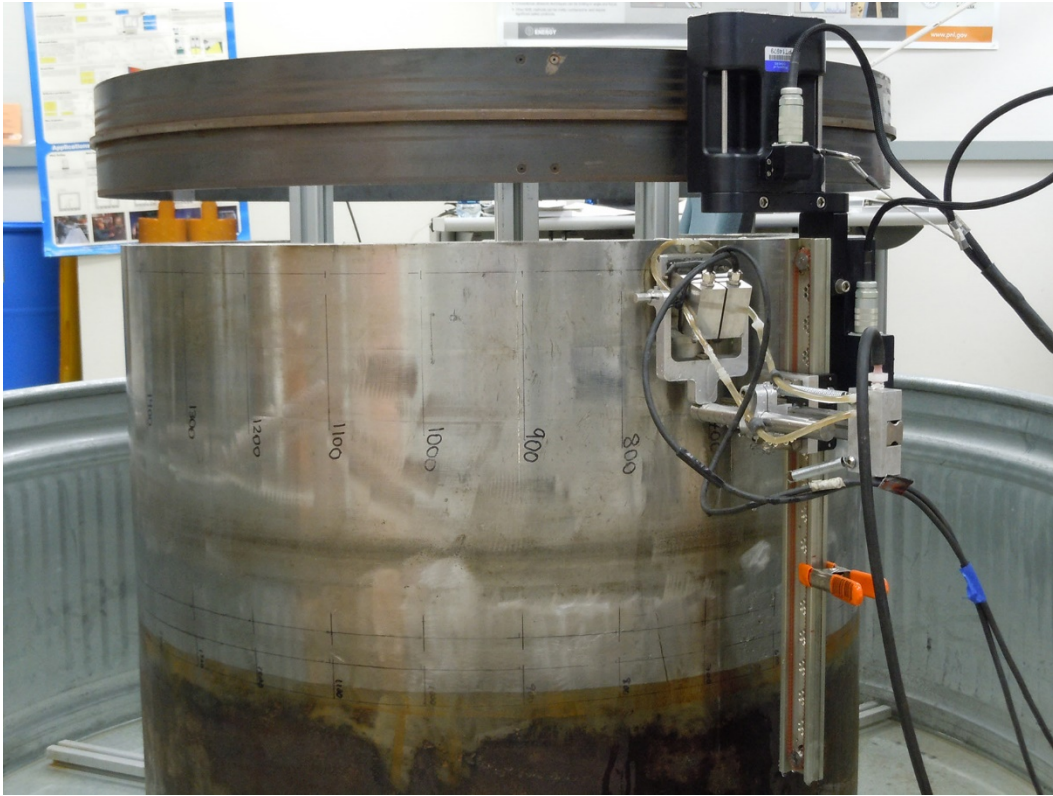
**Figure 7-38 Corner Scan on the Vertically Oriented Specimen. This scan is being done with the 800 kHz PA probe.**

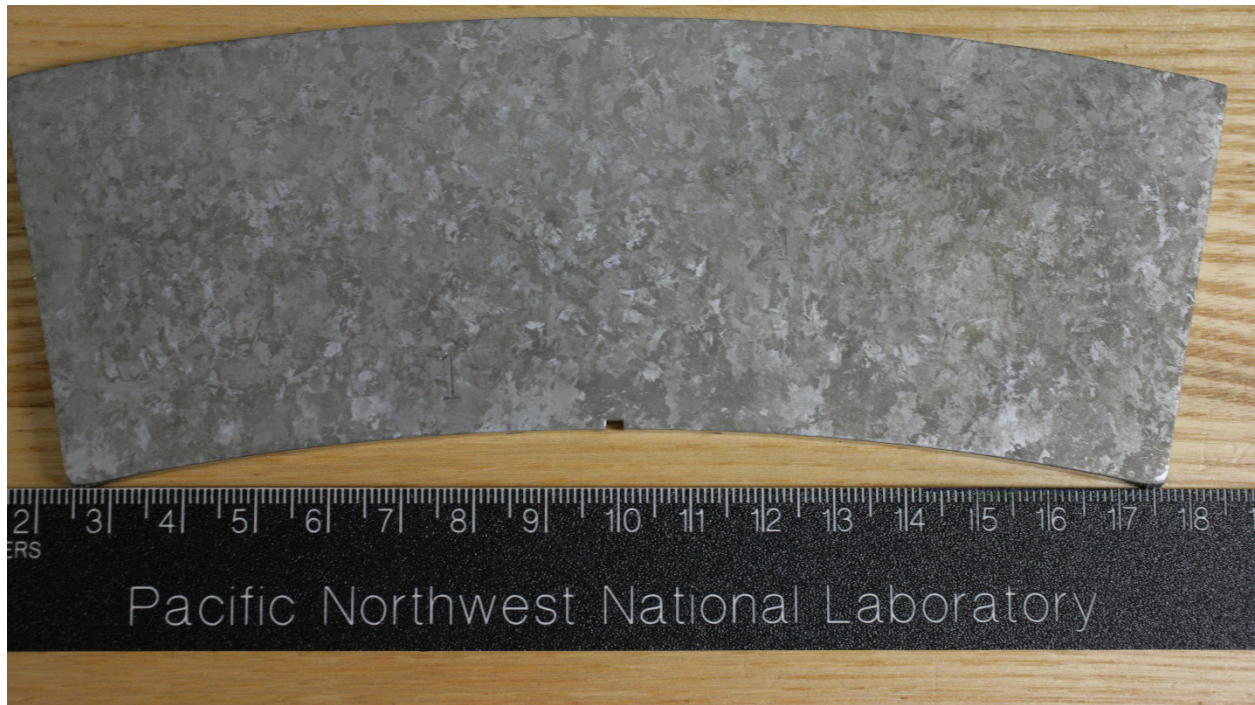
**Figure 8-2 Specimen B-519E.** This specimen from PNNL has a smaller-to-medium grain equiaxed microstructure. Figure adapted from PNNL-23393 (Crawford et al. 2014).

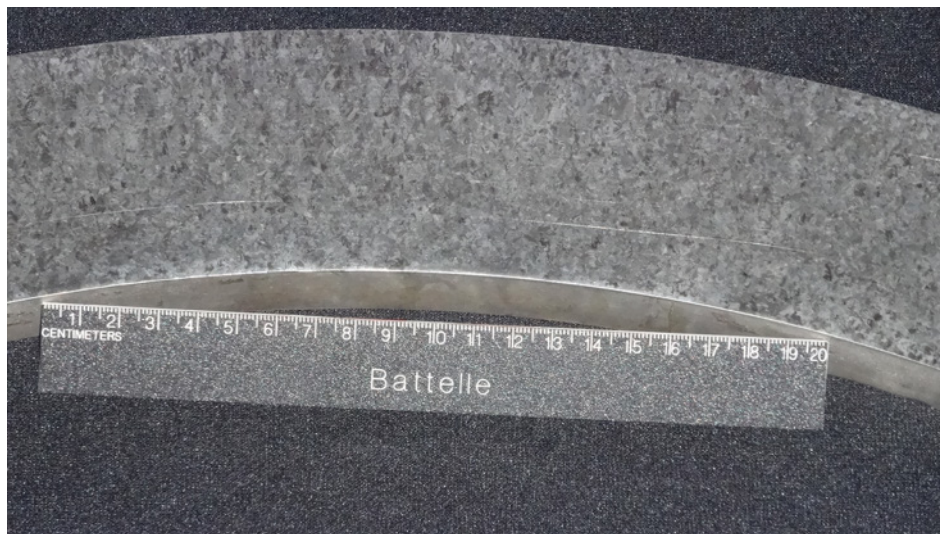
**Figure 8-3 Manoir Ring.** This pipe segment from the Manoir Foundry exhibits a small-grained equiaxed microstructure.

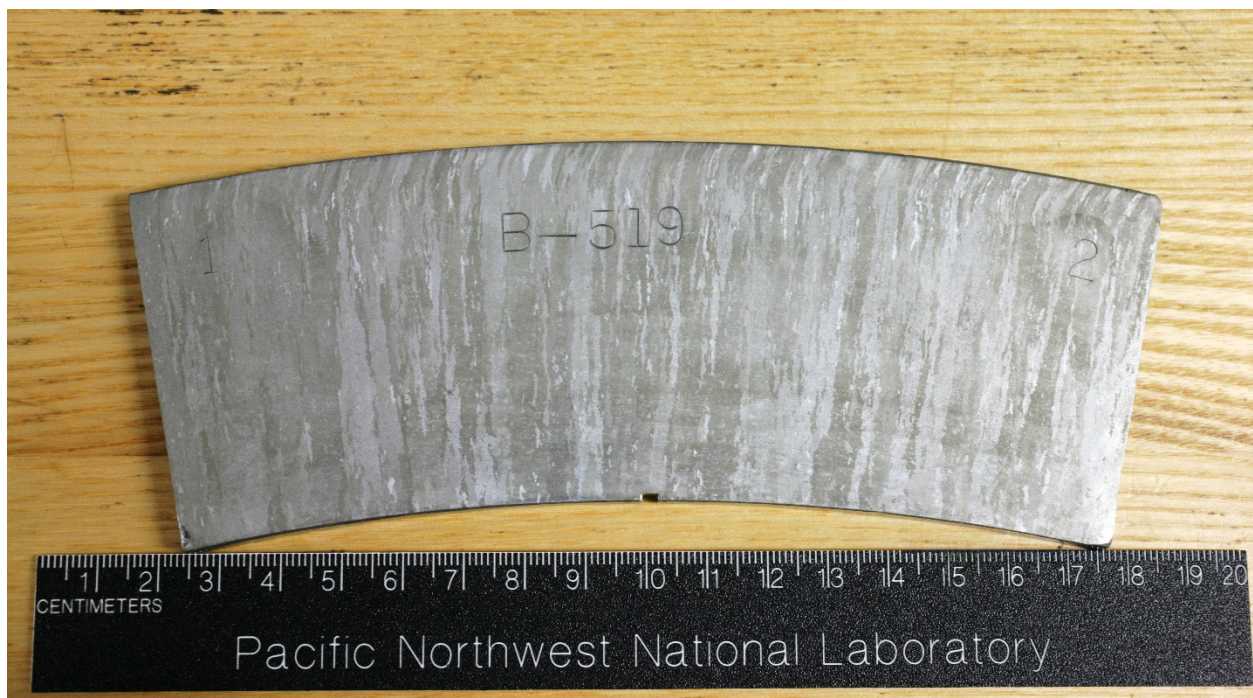
**Figure 8-5 Specimen B-519C.** This specimen from PNNL has a medium-grained, columnar microstructure with little or no banding. Figure adapted from PNNL-23393 (Crawford et al. 2014).
