Subject: U.S. Department of Energy Response to U.S. Nuclear Regulatory Commission Staff Review of the *Draft Long-Term Surveillance Plan for the Naturita, Colorado, Disposal Site*; and Submission of the Revised Preliminary Final *Long-Term Surveillance Plan for the Naturita, Colorado, Disposal Site* (NRC Docket No. WM-00066)

# Long-Term Surveillance Plan for the Naturita, Colorado, Disposal Site

September 2019

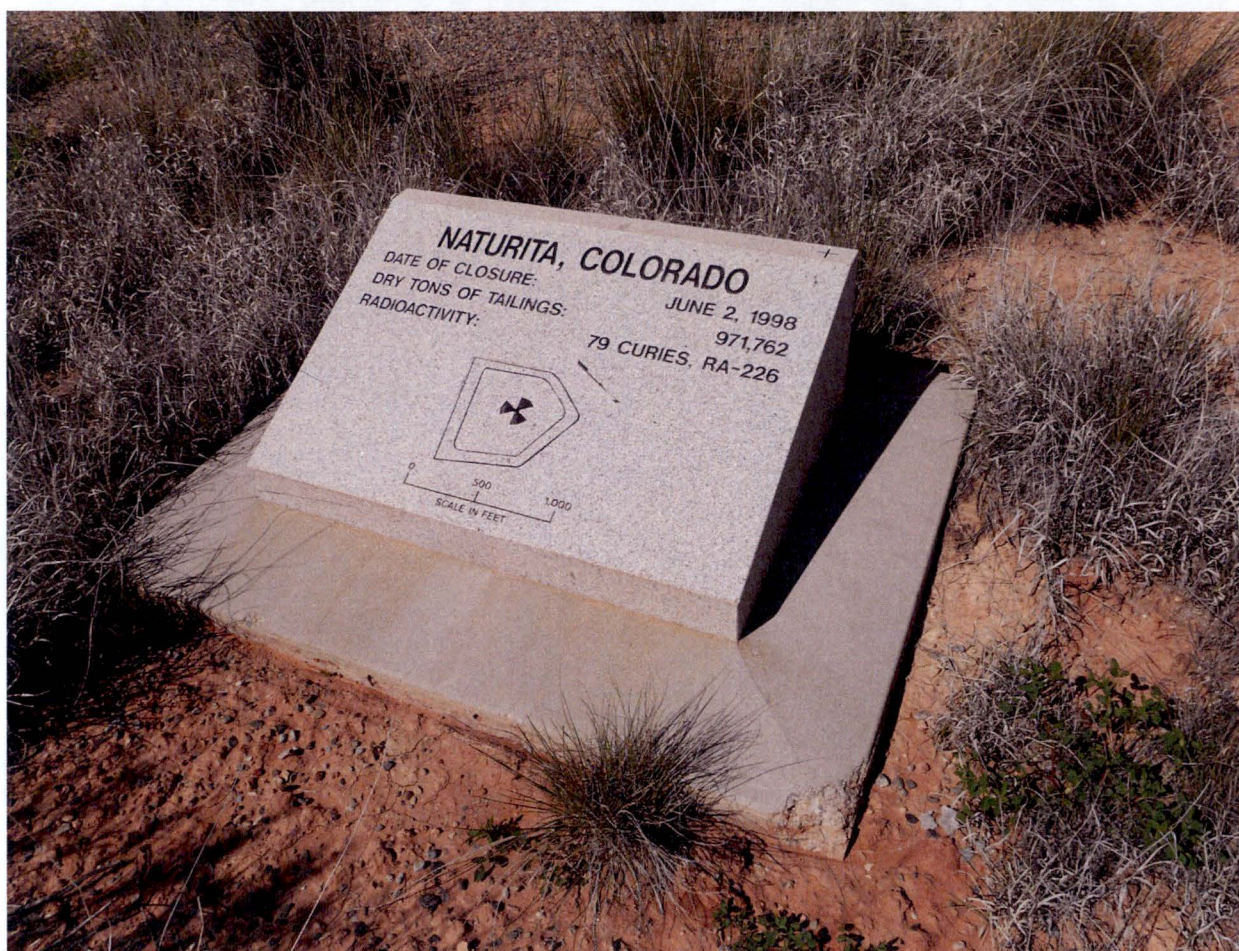
Figure 6. Site Marker SMK-1 by the Entrance Gate

**Site Markers:** There are two granite site markers (SMK-1 and SMK-2) at the site. SMK-1 is just inside the entrance gate and is set in reinforced concrete that extends 3 feet below the ground surface. SMK-2 is on top of the disposal cell and is set in reinforced concrete that extends to the top of the frost-protection layer. The markers identify the site, the general location of the disposal cell, the date of closure (June 2, 1998), the mass of residual radioactive materials (971,762 dry tons), and the radioactivity (79 curies  $^{226}\text{Ra}$ ). A photo of one of the markers is shown in Figure 6.

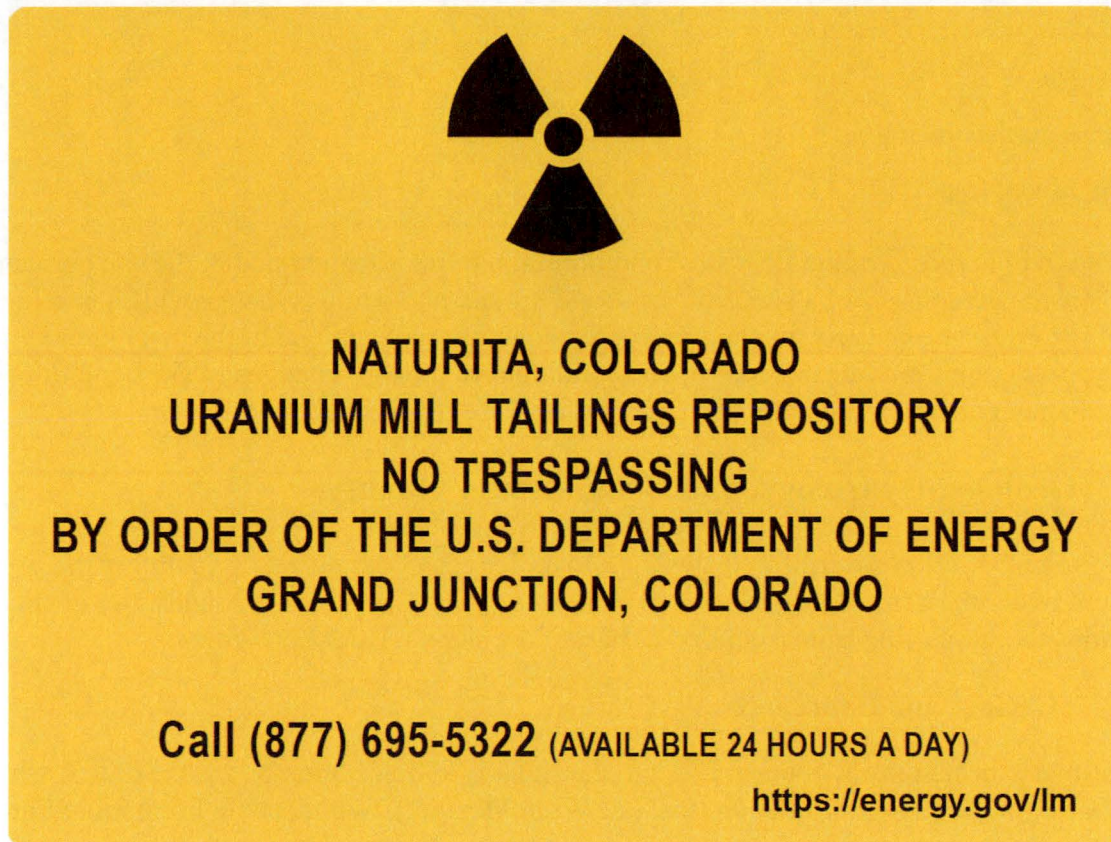
*Figure 7. Entrance Sign*

**Entrance and Perimeter Signs:** LM-posted warning signs (18 × 24 inches) indicate property use around the site boundary. The entrance sign is near the entrance gate and site marker SMK-1. In addition to the entrance sign, 25 perimeter signs (P1–P25) are located at approximately 200-foot intervals along the site boundary, offset 5 feet inside the perimeter fence. These signs display the international trefoil symbol indicating the presence of radioactive materials and state that trespassing is forbidden. The entrance sign (Figure 7) has the same information as the perimeter signs, plus the name of the site (Naturita Colorado Uranium Mill Tailings Repository), the 24-hour telephone number for LM in Grand Junction, Colorado ([877] 695-5322), and the LM website address. All sign posts are embedded in concrete to a depth of approximately 3 feet below ground surface.

- Updating the 24-hour telephone number in section 2.3.4 to reflect the new DOE 24-hour telephone number.
- Replacing Figure 7 with a graphic showing the new entrance sign with the new 24-hour telephone number.
- Updating the Inspection Checklist in Appendix C in anticipation of the future Uravan site transfer to read the "Uravan Title II Burbank Repository Disposal Cell" rather than "Umetco Uravan Title II disposal cell."
- Updating the Specific Site Surveillance Features in the Inspection Checklist in Appendix C to reflect recent updates to the perimeter signs whereby the signs no longer incorrectly identify the site. Removing "signs identify the site as the Uravan repository" to "Location as indicated on the site map."

- A condition is identified during the annual inspection (or other site visit) that requires personnel, perhaps with specific expertise, to return to the site to evaluate the condition.
- DOE is notified by a citizen or outside agency that conditions at the site are substantially changed. A 24-hour DOE contact telephone number is posted on the entrance sign and is intended for public use to request information or to report a problem at the site (Figure 7).
