SUBJECT: OBSERVATIONAL SITE VISIT AT MAYBELL WEST DISPOSAL SITE

Report No.: 040-09090/2019-001

Facility: Maybell West Disposal Site

## **NRC Observational Site Visit Report**

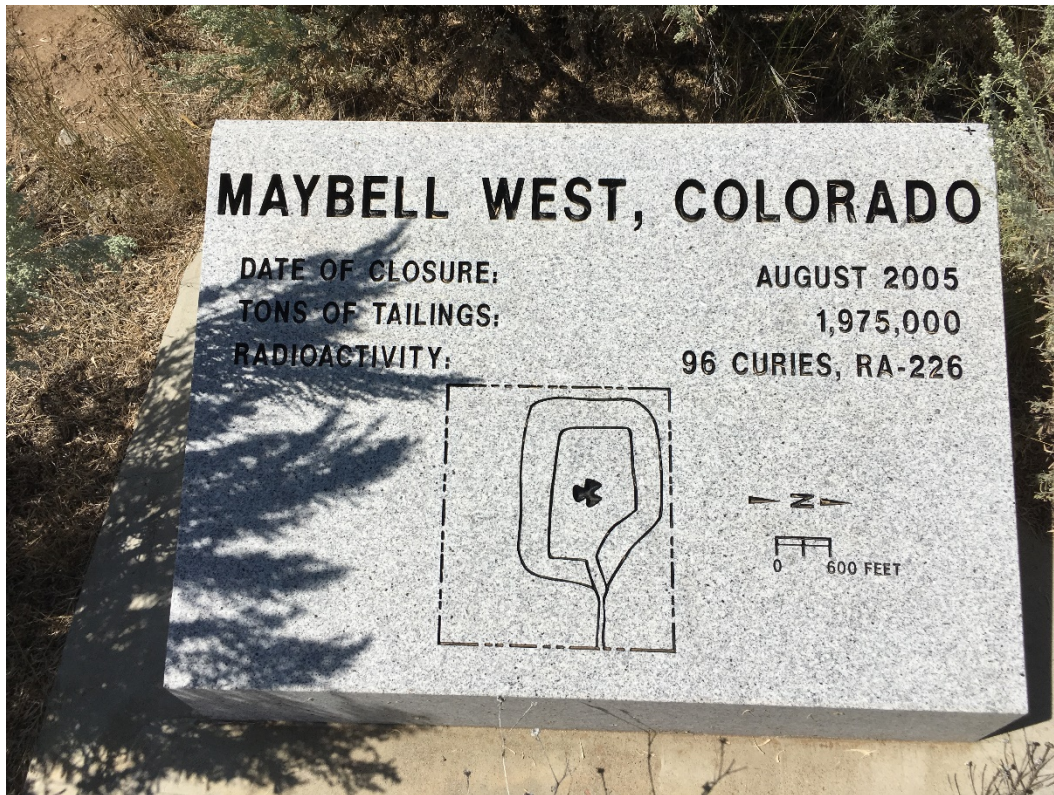
Figure 1: Maybell West disposal site marker at entrance to disposal cell

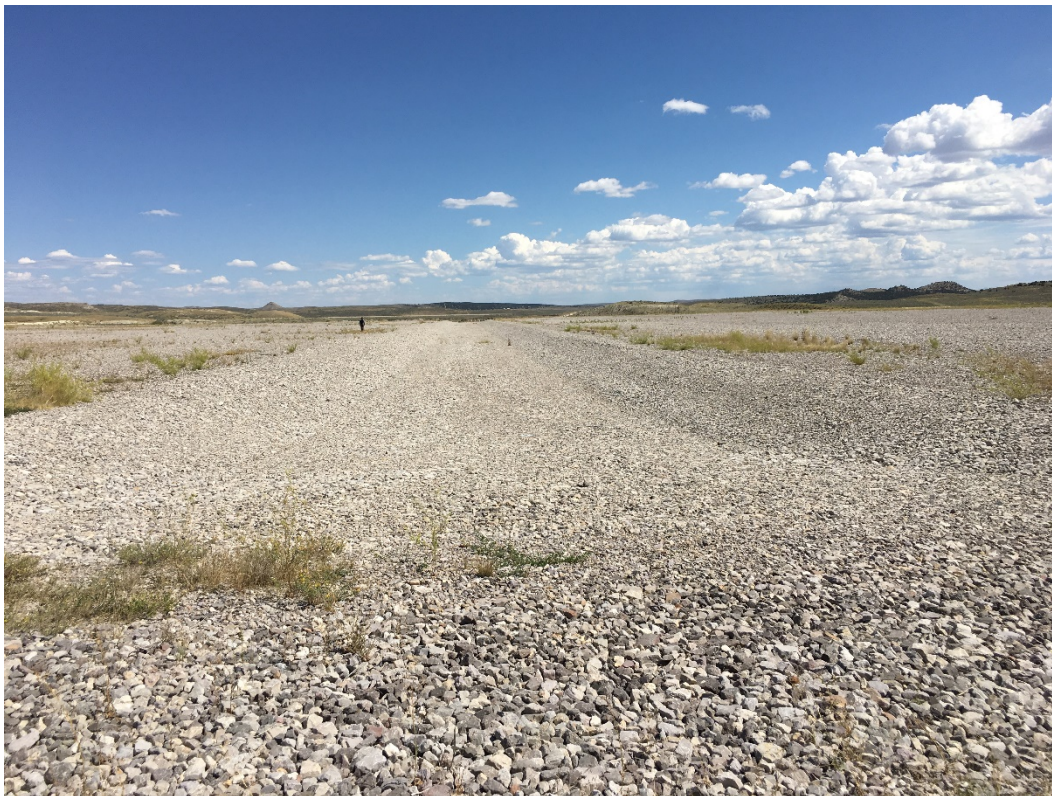
The DOE inspectors checked the two disposal cells for evidence of erosion, settlement, slumping, displacement, and any other feature that would require maintenance or repair. The rock surfaces on the top and side slopes were found to be in excellent condition, with several minor exceptions (Figures 2 and 4). On the ancillary disposal cell, the DOE inspectors noted a row of small depressions along the northern edge of the cell, where the top cover connects with the northern side slope. This was the first time that the DOE inspectors had observed these minor depressions.

Figure 2: Top of disposal cell, looking east along Diversion Channel No. 1

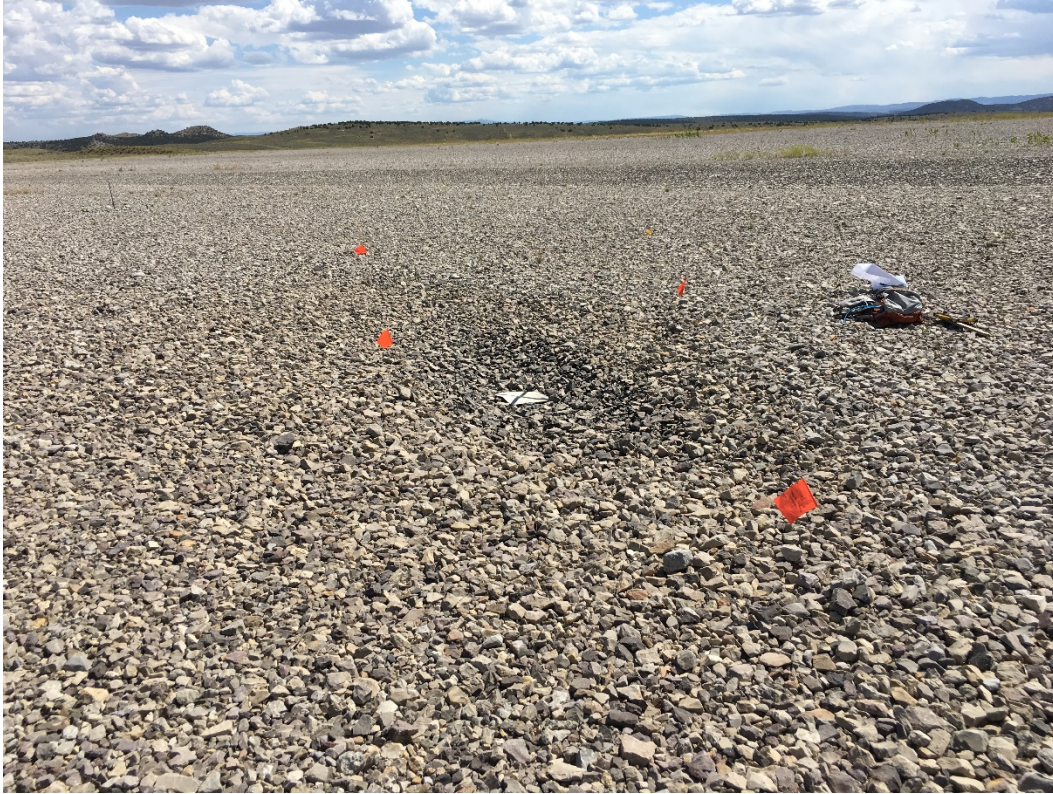
observed in 2018. The DOE inspectors physically measured the sizes of the three depressions during the inspection. The largest depression measured 26-feet long, 8-feet wide, and 1-foot deep (Figure 3). The second depression measured 14-feet long, 6-feet wide, and 4-inches deep. The third and smallest depression measured 1-foot long, 1-foot wide, and 5-inches deep. The DOE planned to continue to monitor these depressions into the future and will use the information gained in the 2019 inspection for comparison to depression sizes in future inspections.

Figure 3: Small depression on top of main disposal cell, looking southeast

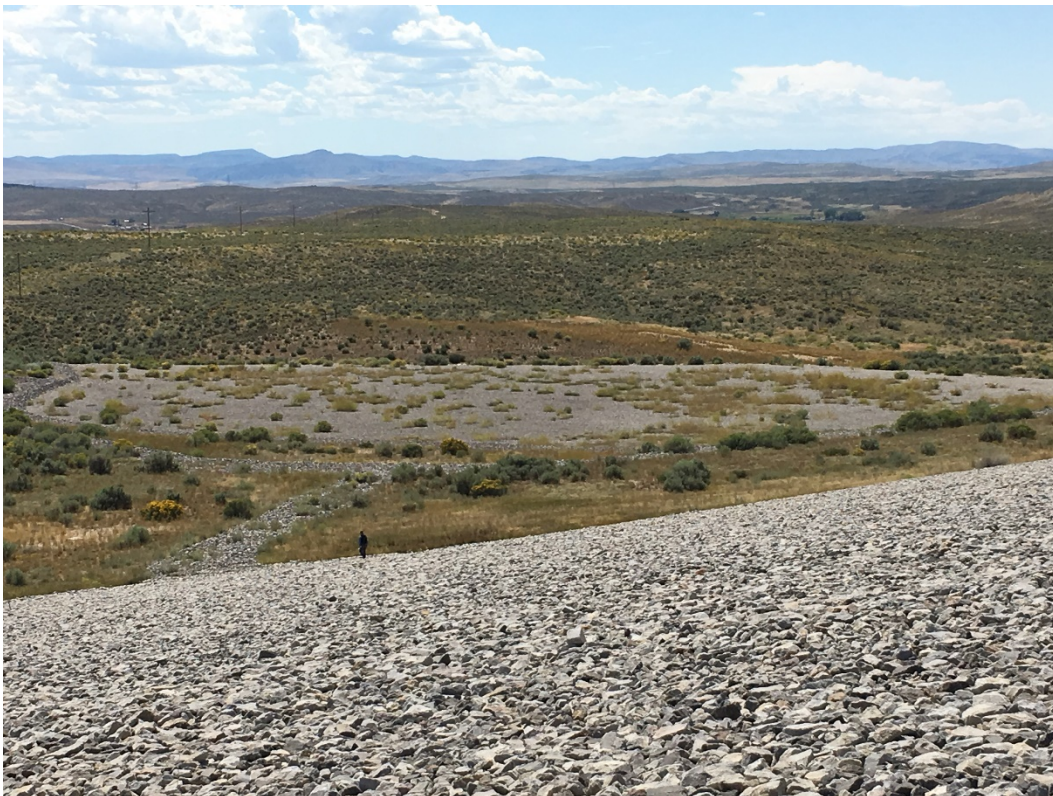
Figure 4: Ancillary disposal cell as seen from top of main disposal cell, looking southeast
