**From:** Strait, Kenneth A. <Kenneth.Strait@pseg.com>  
**Sent:** Monday, December 30, 2019 11:02 AM  
**To:** incidental.take@noaa.gov; EndangeredSpecies Resource  
**Cc:** jeanette.bowers@dep.nj.gov  
**Subject:** [External\_Sender] SALEM GENERATING STATION-INCIDENTAL TAKE OF ATLANTIC STURGEON  
**Attachments:** Sturgeon Incidental Take Report for 12-27-19 Specimen #1.pdf; Sturgeon Incidental Take Report for 12-27-19 Specimen #2.pdf

Attached are the Incidental Take Reports and Data Collection Forms for the two Atlantic sturgeon collected on 12/27/2019 at the Salem Generating Station cooling water intake. The one deceased specimen was processed and is being held under refrigeration pending further direction from NMFS GARFO. The live specimen was processed and released as quickly as possible. This incidental take is authorized under Biological Opinion NER-2010-6581.

Specimen #1

Specimen # 2

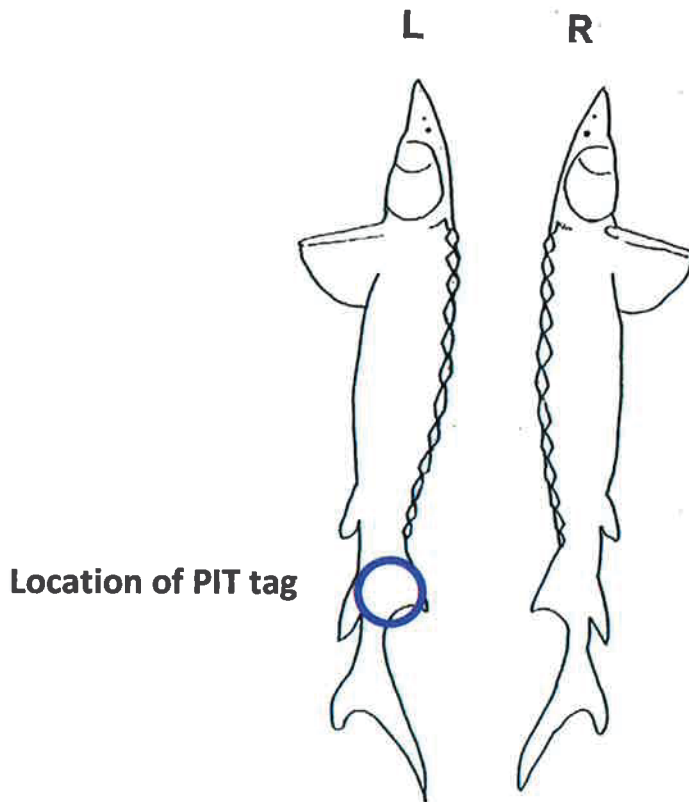
Draw wounds, abnormalities, tag locations on diagram and briefly describe below

Describe any wounds / abnormalities (note tar or oil, gear or debris entanglement, propeller damage, etc.). **Please note if no wounds / abnormalities are found. Specimen was alive at the time of collection and was found to be in overall good condition. No internal or external tags were indicated during processing, therefore PIT tagging was conducted, with placement of the tag on the left side, near the base of the dorsal fin (refer to illustration above). After processing, the specimen was released back to the Delaware River.**

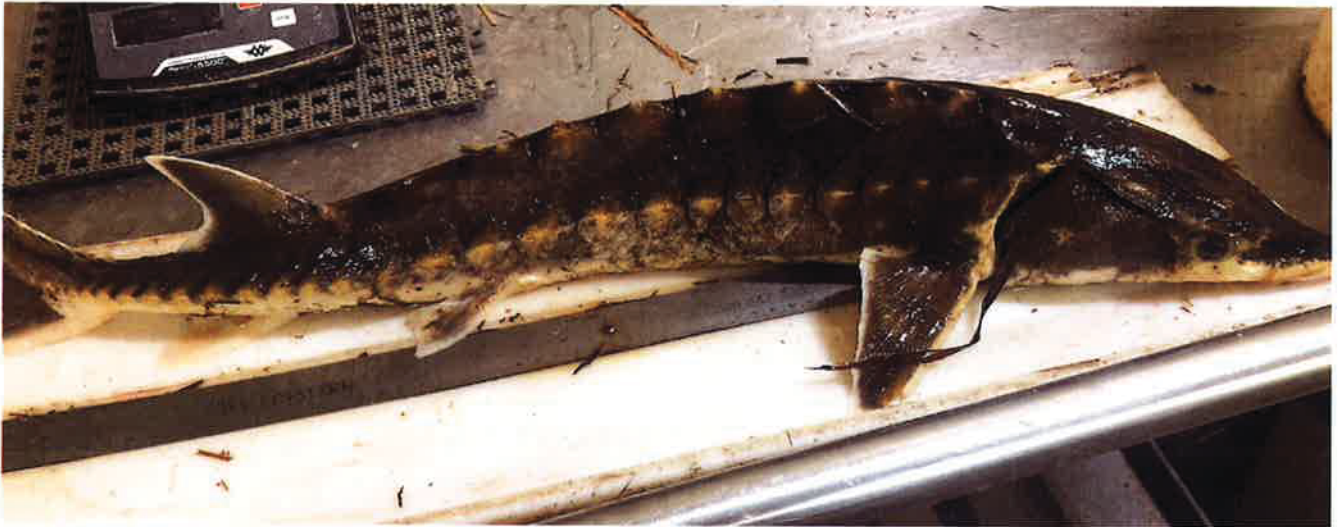
A dorsolateral view showing the size and condition of the live, Atlantic sturgeon (*Acipenser oxyrinchus*), retrieved at 10:50am on 12/27/19 from 22A circulator intake by Salem Yard Crew personnel during routine trash rack cleaning at Salem Nuclear Generating Station (12/27/2019).

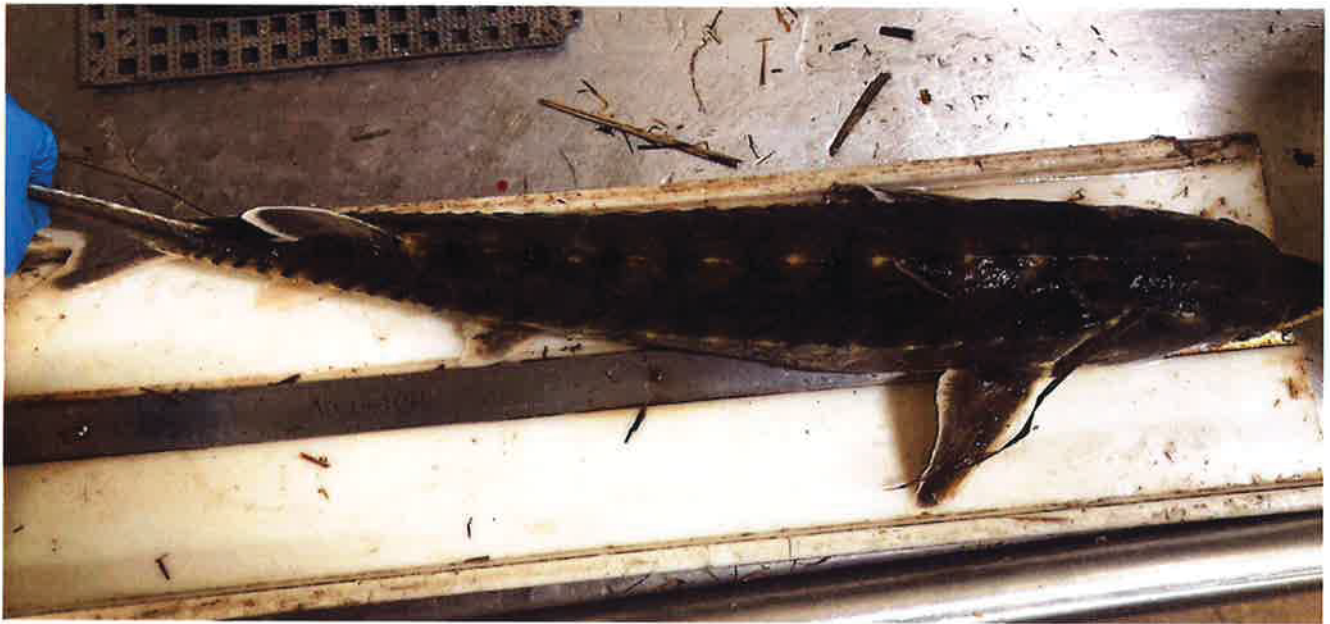
A dorsal view of the specimen. No injuries or other damage was observed at the time of collection 12/27/2019).

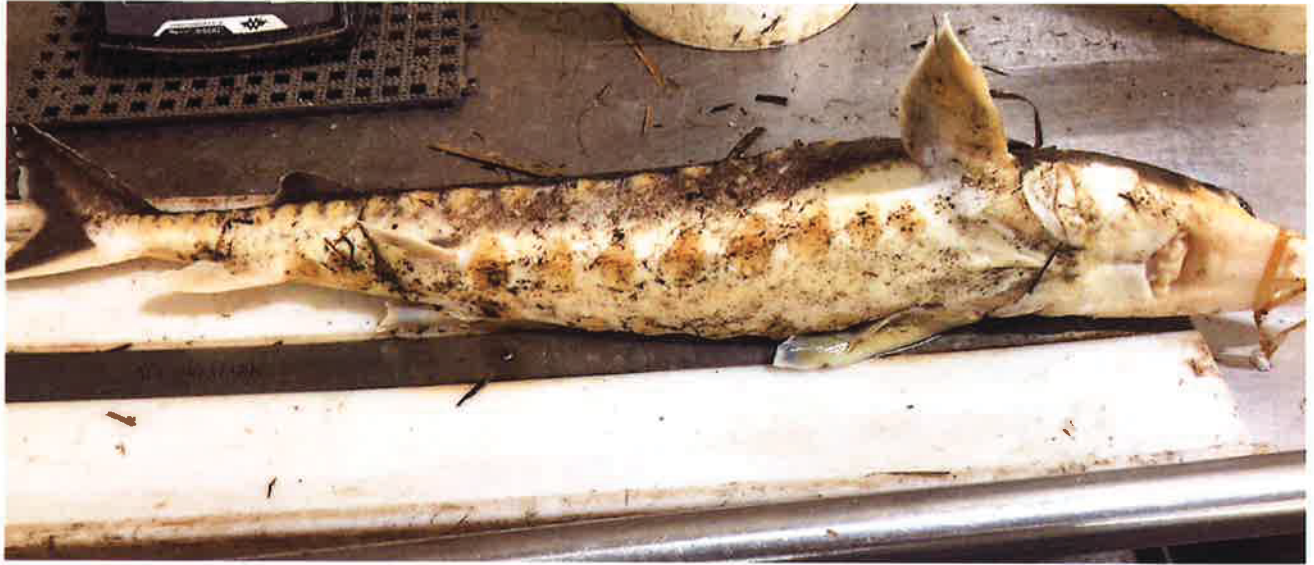
Ventral view of the specimen, showing the overall condition (12/27/2019).

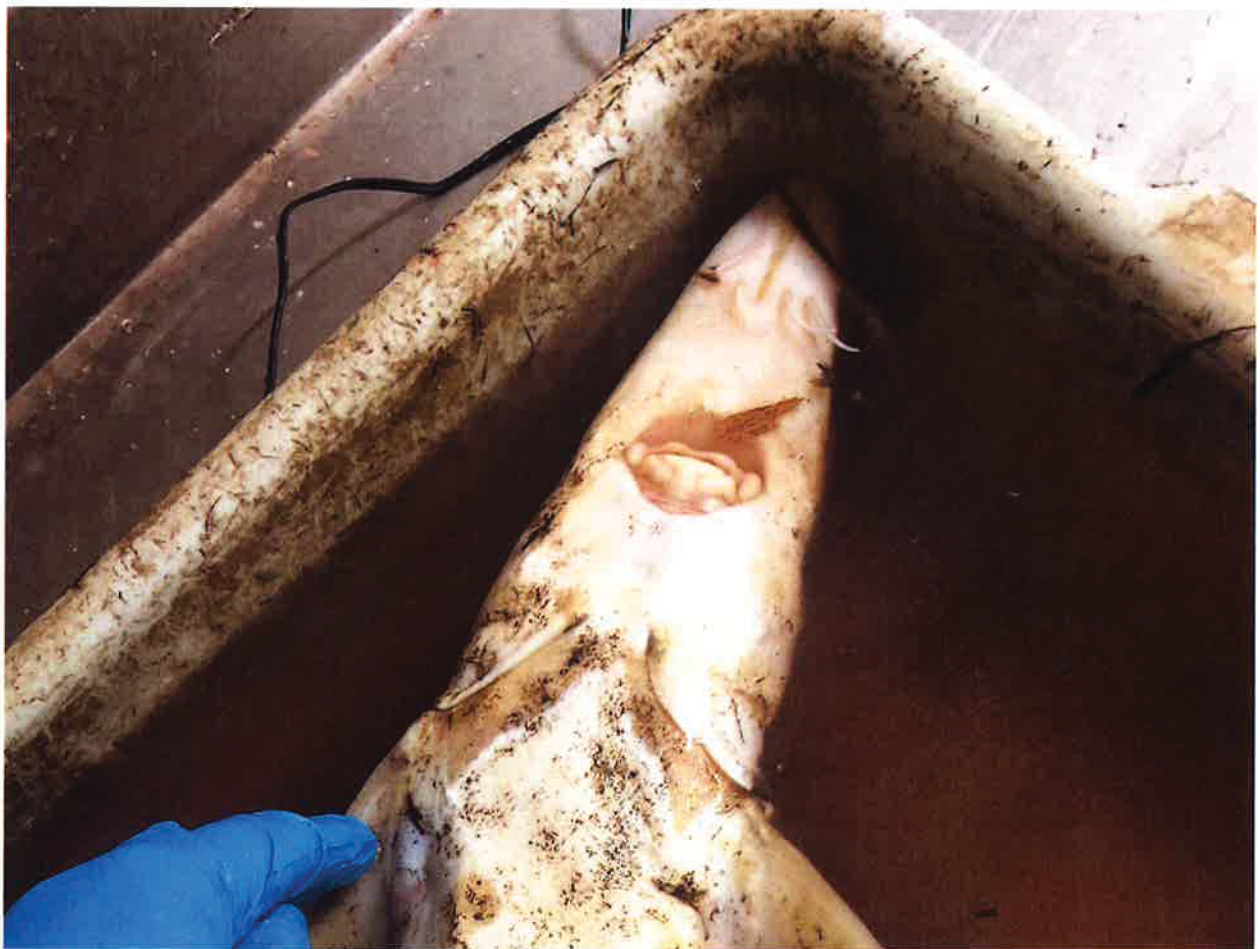
Ventral view of the head, showing the characteristic small mouth and elongated rostrum (12/27/2019).

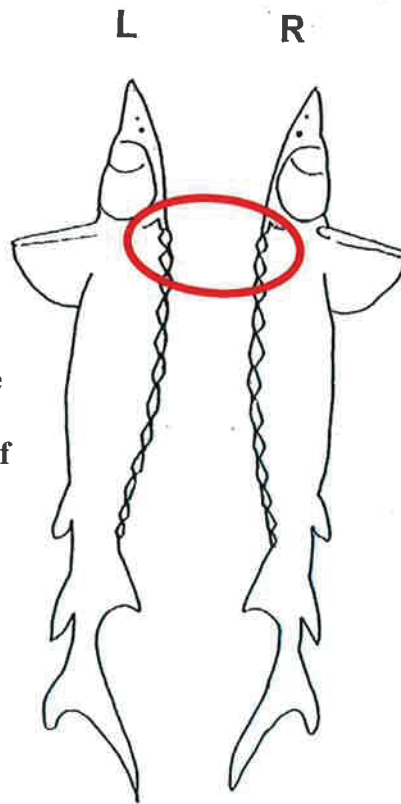
Draw wounds, abnormalities, tag locations on diagram and briefly describe below

**Existence of large laceration, located dorsally, immediately posterior to the gills and above the pectoral fins.**

**Minor bruising located at the bases of pectoral, pelvic, and anal fins, around the scutes of the torso, and ventrally on the rostrum.**

Describe any wounds / abnormalities (note tar or oil, gear or debris entanglement, propeller damage, etc.). **Please note if no wounds / abnormalities are found. Specimen was deceased at the time of collection but was observed to have a fresh wound, as indicated by the existence of blood. The specimen was complete, but a large laceration was located near the head, and minor bruising was observed on the fin bases, around the bases of scutes, and on the ventral portion of the rostrum (refer to diagram above).**

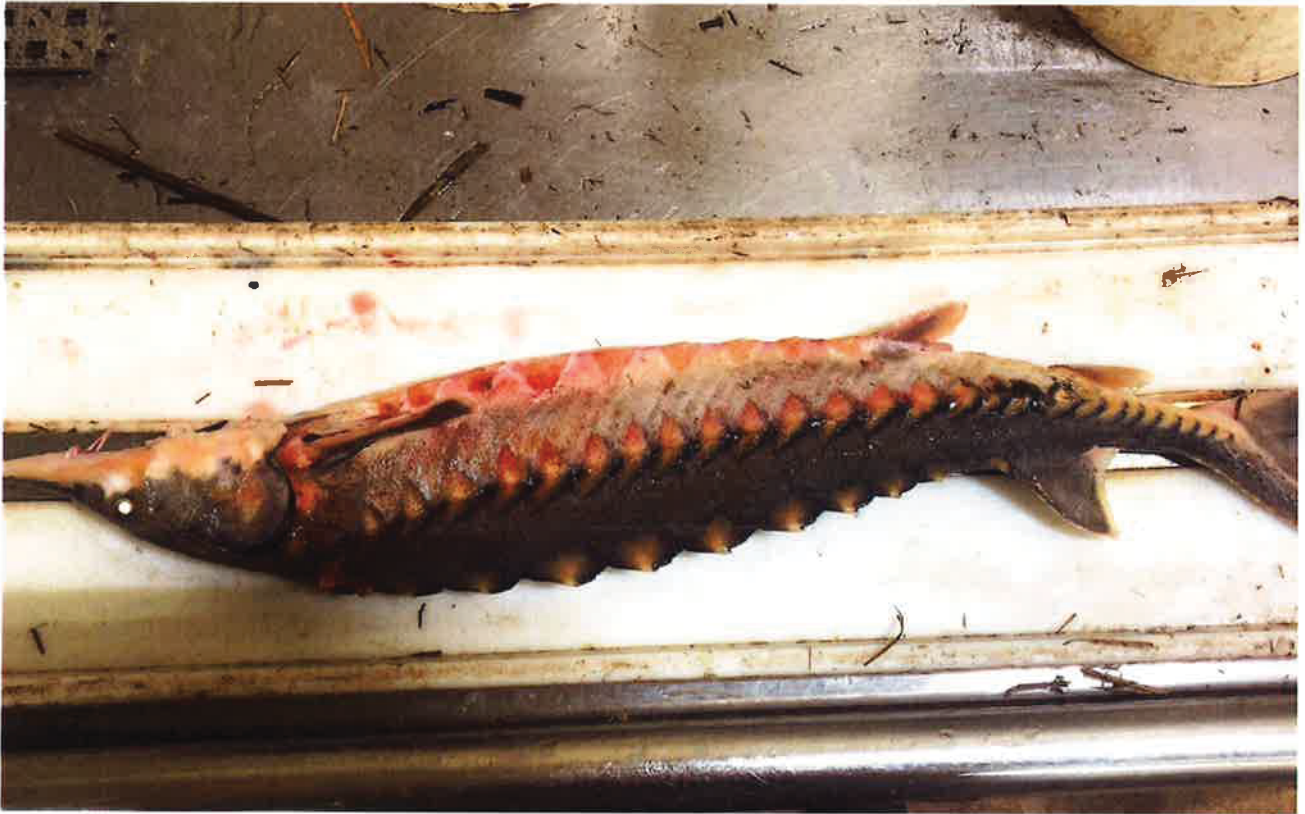
Dorsolateral view, showing the size and condition of the recently deceased Atlantic sturgeon (*Acipenser oxyrinchus*), retrieved at 11:00am on 12/27/19 from 22A circulator intake by Salem Yard Crew personnel during routine trash rack cleaning at Salem Nuclear Generating Station (12/27/2019).

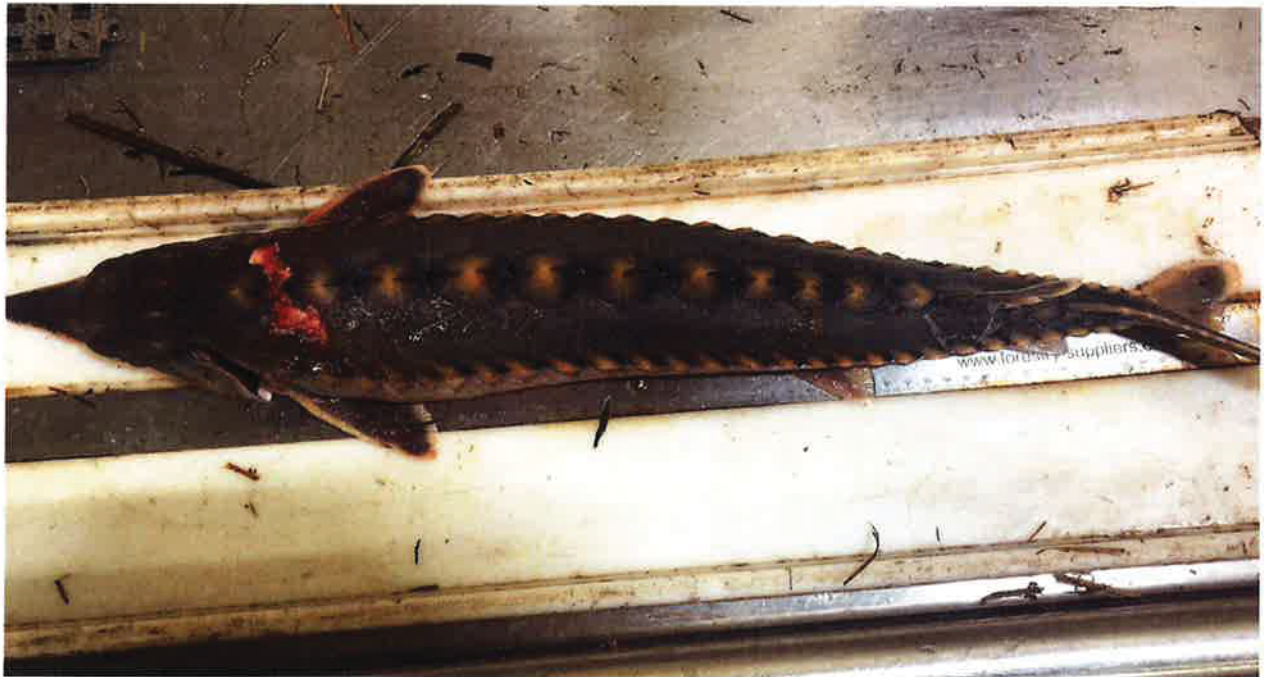
A dorsal view of the specimen, showing overall condition at the time of collection. A large laceration is shown near the head, posterior to the gill openings and above the pectoral fins (12/27/2019).

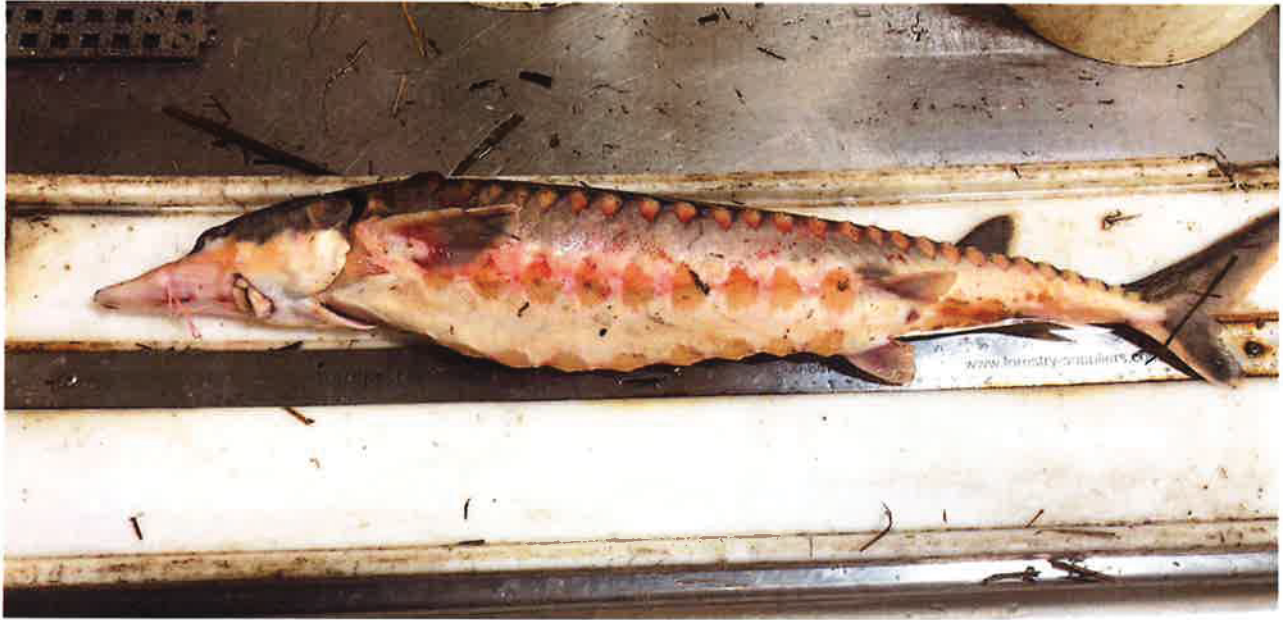
A ventral view of the specimen, showing existing minor bruising at the bases of the pectoral fins, around the scutes, and on the ventral portion of the rostrum (12/27/19).

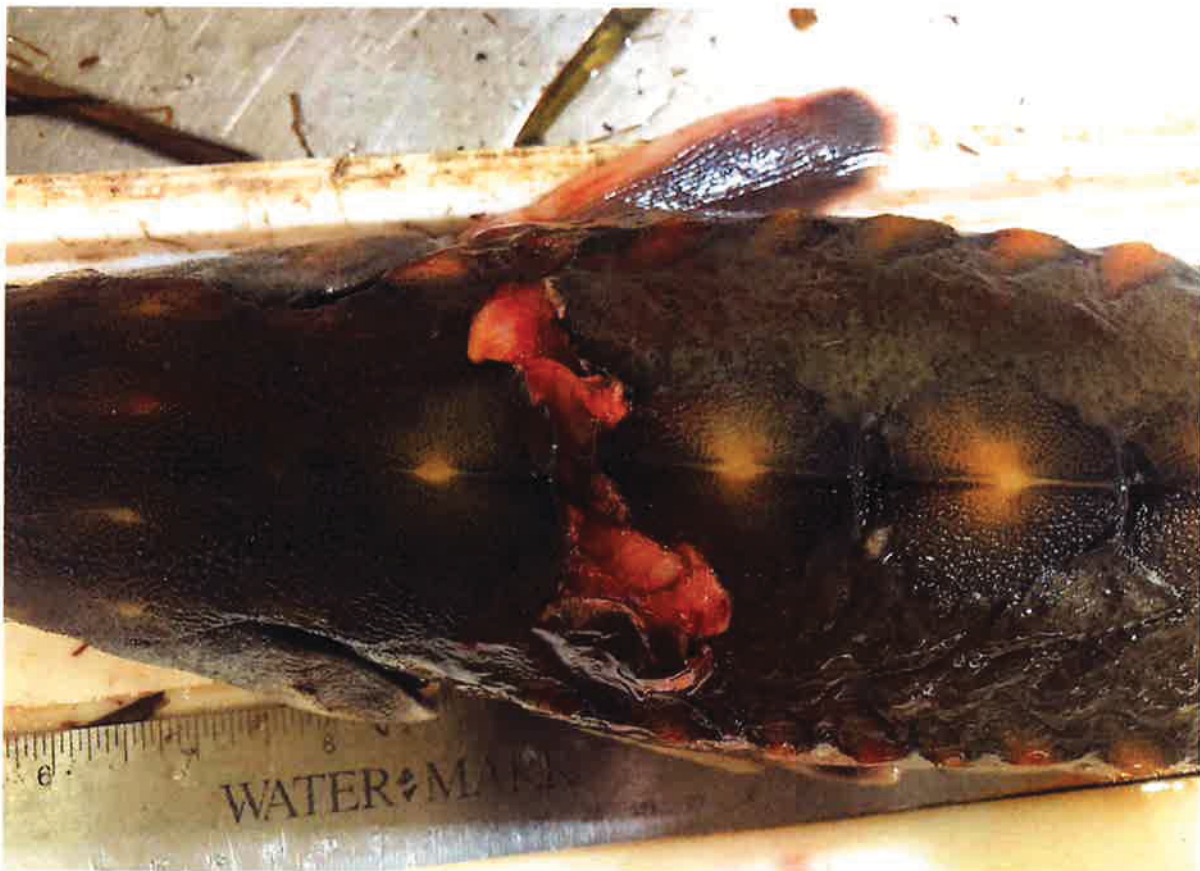
A close-up dorsal view of the head, showing detail of the large laceration (12/27/2019).

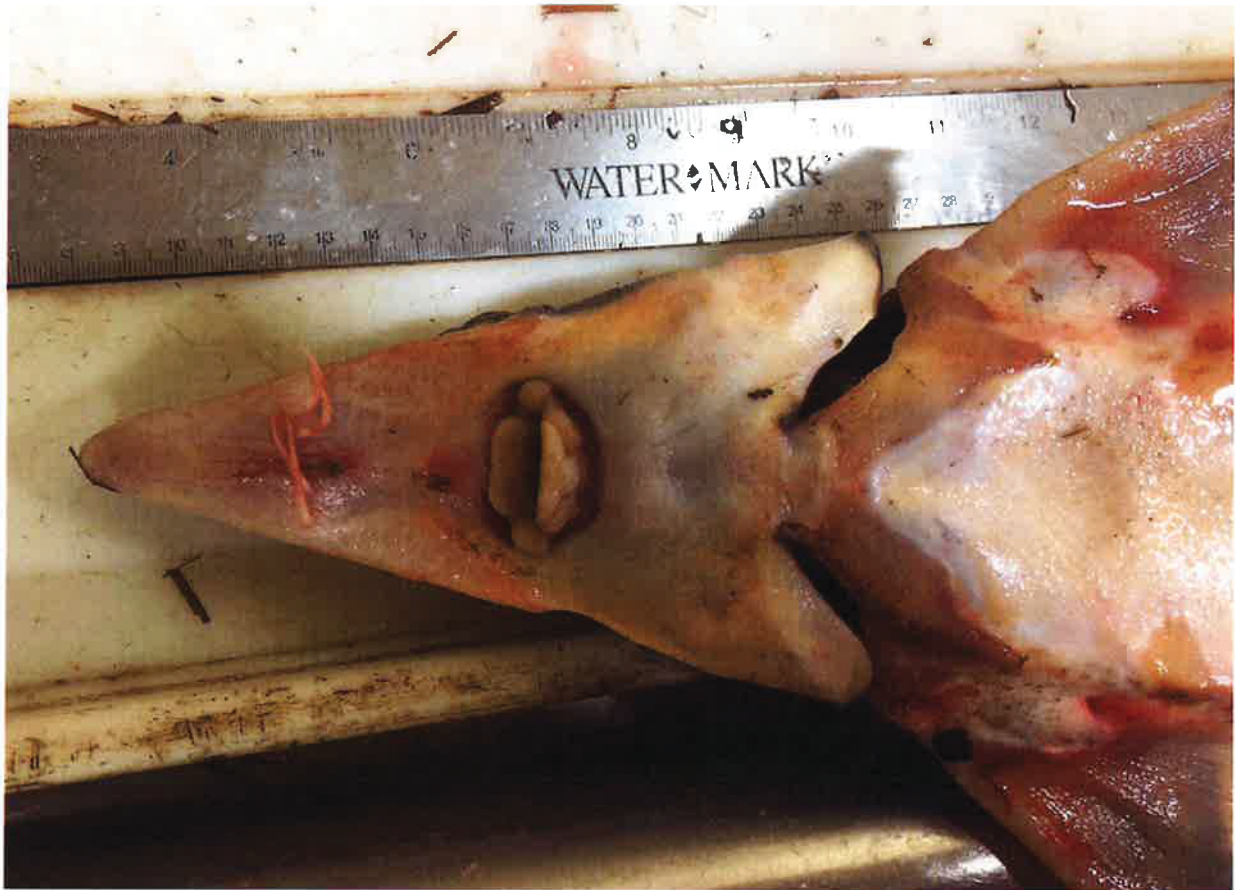
A ventral view of the head, showing a close-up of the characteristic elongated rostrum and small mouth (12/27/2019).
