From: Cary, Richard H. <Richard.Cary@pseg.com>
Sent: Monday, January 27, 2020 11:35 AM
To: incidental.take@noaa.gov; EndangeredSpecies Resource
Cc: jeanette.bowers@dep.nj.gov
Subject: [External_Sender] Salem Generating Station - Incidental Take of Atlantic Sturgeon 01/24/2020
Attachments: Sturgeon Incidental Take Report for 01-24-2020.pdf

Appendix C, Part 2A (Sturgeon)

STURGEON DATA COLLECTION FORM

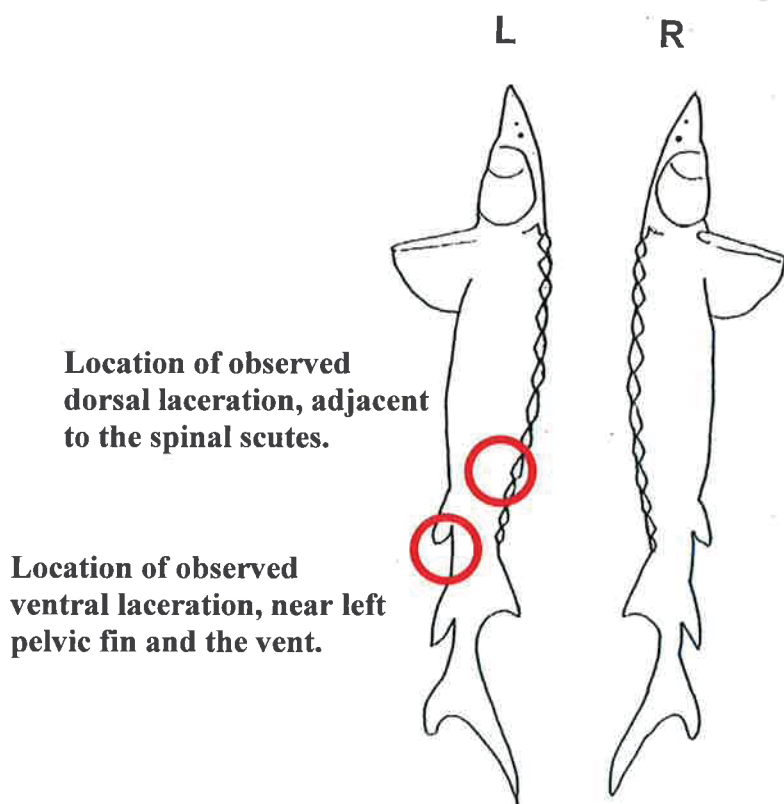
Draw wounds, abnormalities, tag locations on diagram and briefly describe below

Describe any wounds / abnormalities (note tar or oil, gear or debris entanglement, propeller damage, etc.). **Please note if no wounds / abnormalities are found. Specimen was deceased at the time of collection and was observed to have two large flesh wounds; one on its ventral side, near the left pelvic fin and vent, and a second wound dorsally, adjacent to the spinal scutes (refer to diagram above). Specimen exhibited no evidence of decomposition.**

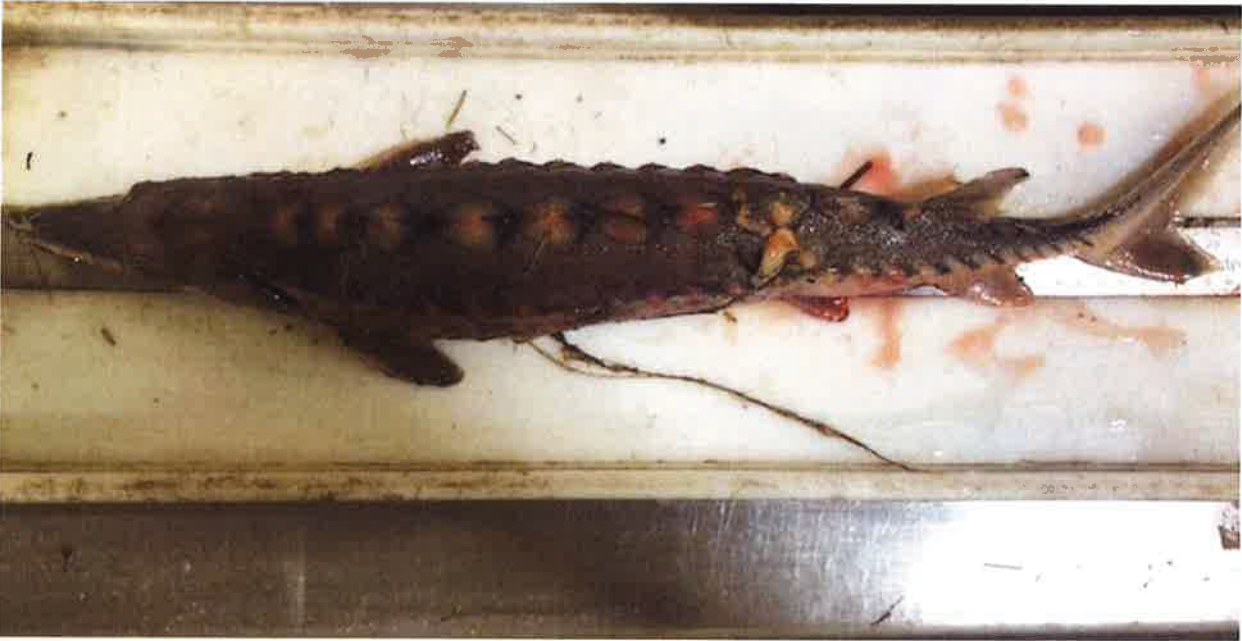
A dorsal view showing the size and condition of the deceased, Atlantic sturgeon (*Acipenser oxyrinchus*), retrieved at 11:15am on 01/24/2020 from the Unit 2 trash collection basket by Salem Yard Crew personnel during routine trash rack cleaning at Salem Nuclear Generating Station (01/24/2020).

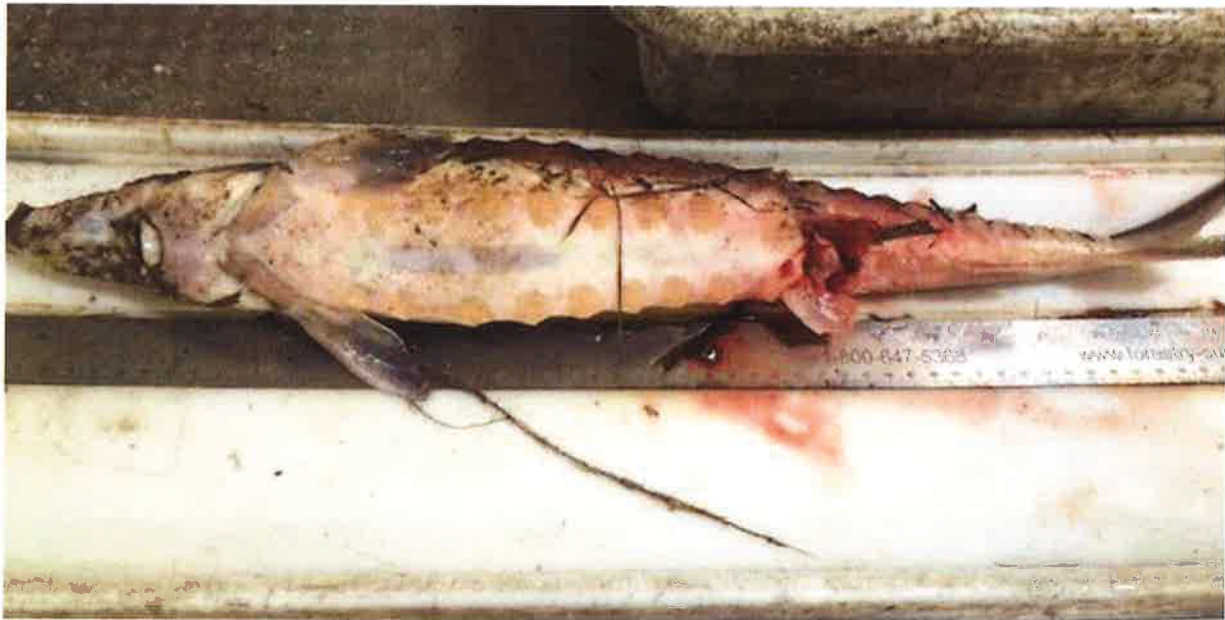
A ventral view of the specimen showing damage to the lower torso, attributed to a large laceration located near the left pelvic fin and vent (01/24/2020).

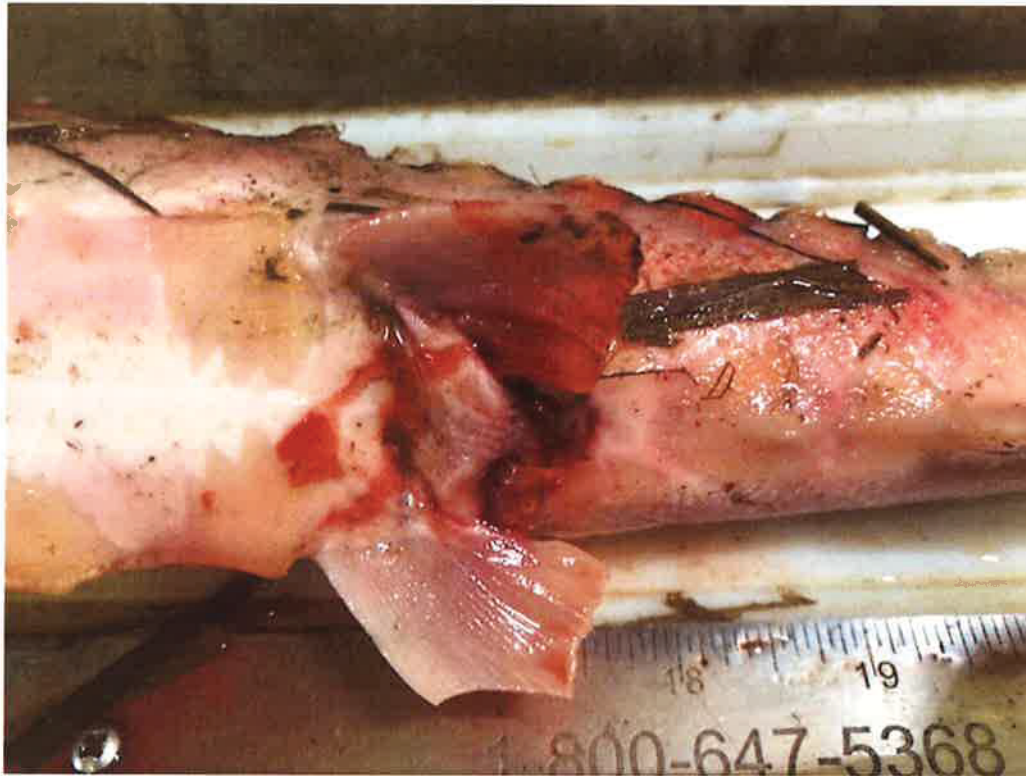
Ventral view of the specimen showing a close-up of the observed laceration located near the vent (01/24/2020).

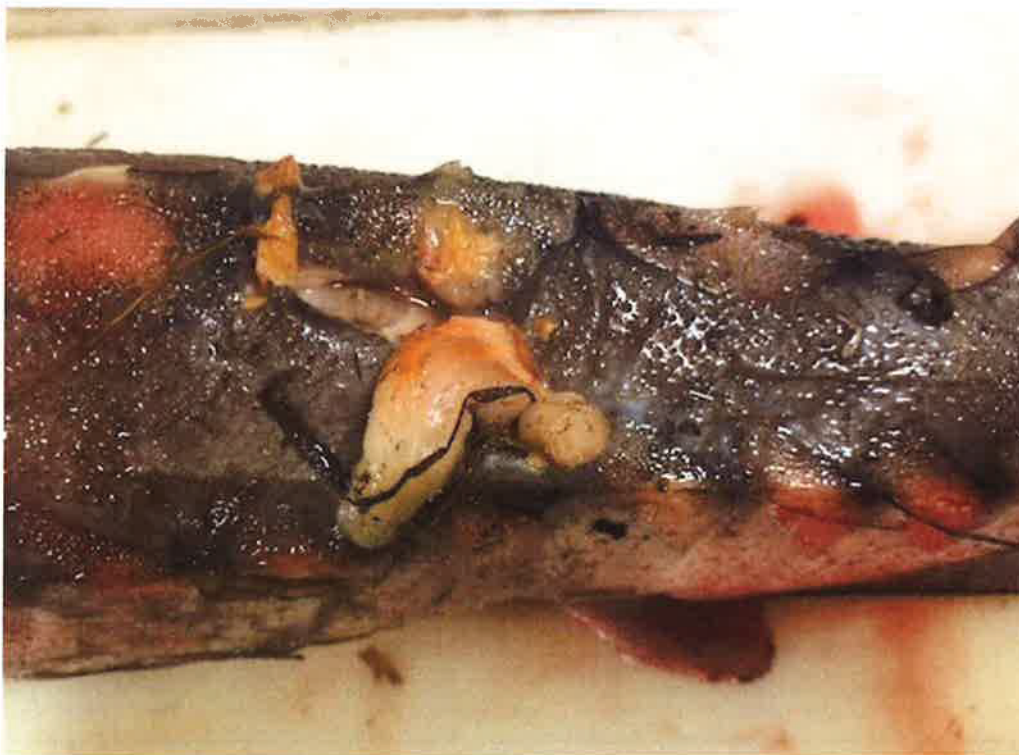
Dorsal view of the specimen showing additional damage to the lower torso, in the form of a second laceration located along the spinal scutes (01/24/2020).

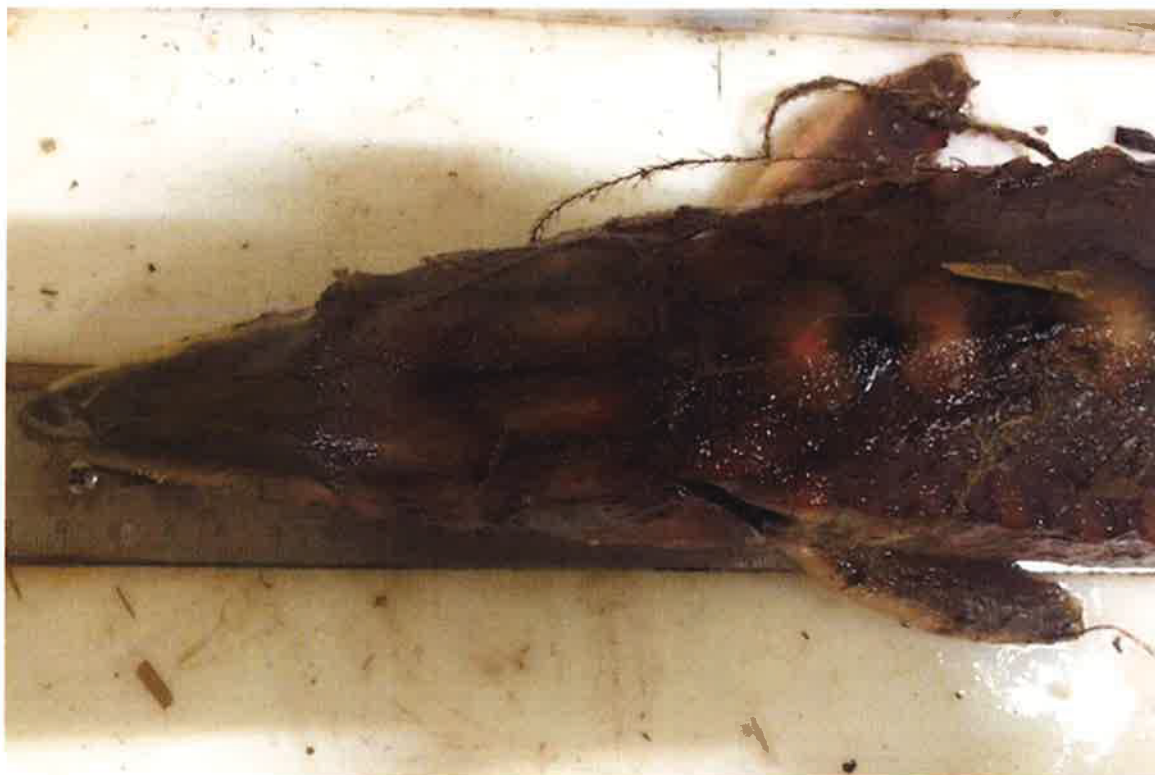
Dorsal view of the head, showing the characteristic elongated rostrum (01/24/2020).

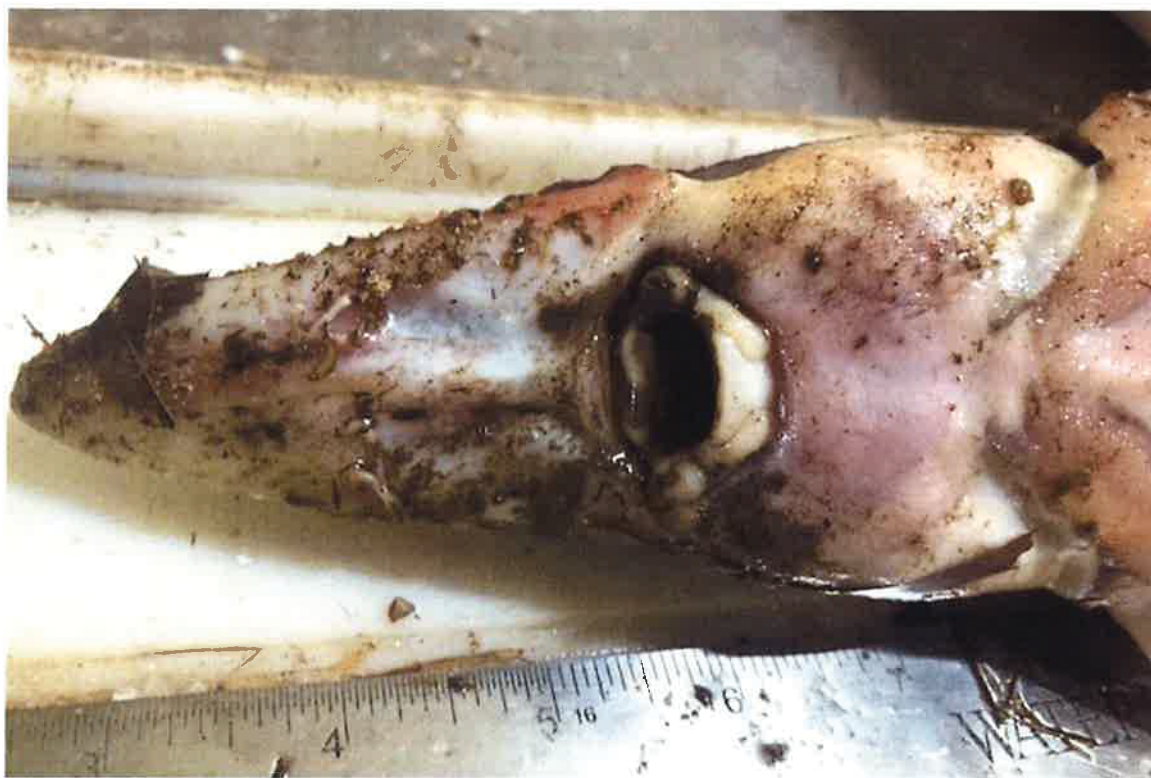
A ventral view of the head, showing the characteristic small mouth (01/24/2020).
