Nondestructive evaluation in advanced reactors

Advanced Non-Light Water Reactors – Materials and
Component Integrity Workshop

December 9-11, 2019
Rockville, MD

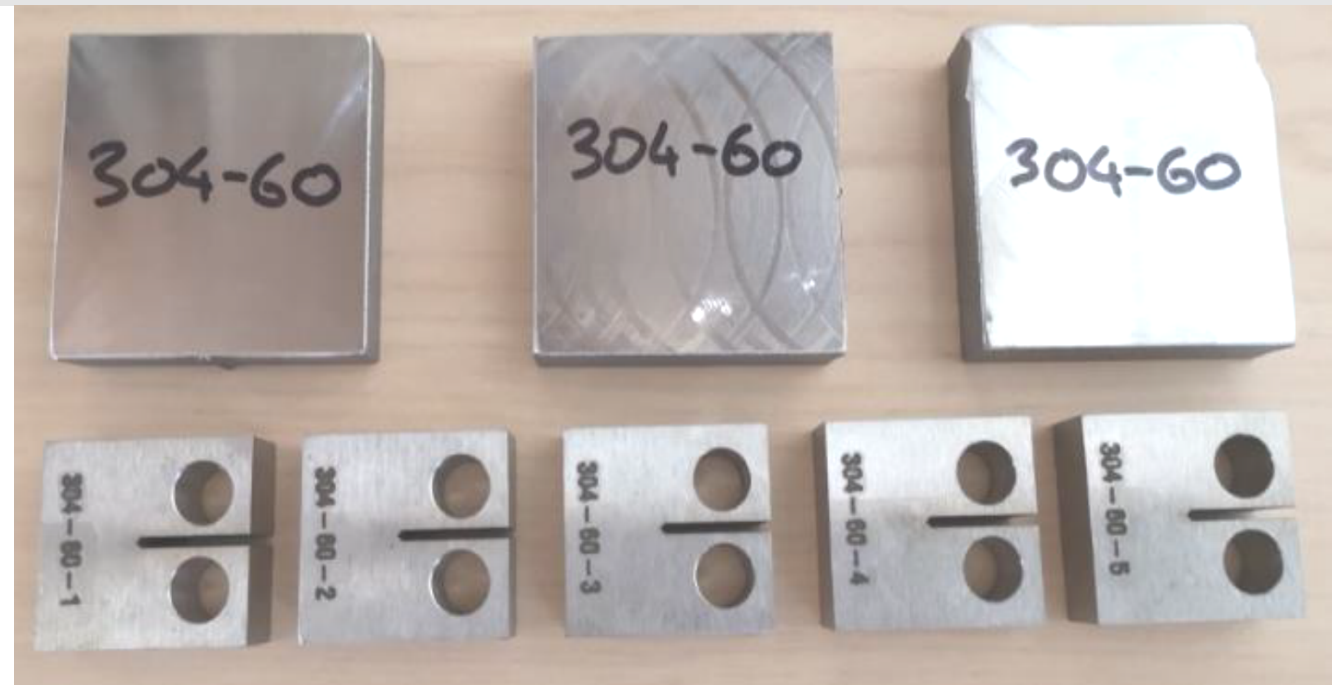
Test samples

- Compact CT: SS304, SS316, SS347, A286
- Cold work to simulate embrittlement
 - Cold work 0%, 20%, 40%, 60%, 80%

Techniques

- Linear UT (velocity, attenuation, absorption)
- Nonlinear UT
- Thermal Thermoelectric Power
- Instrumented Indentation System

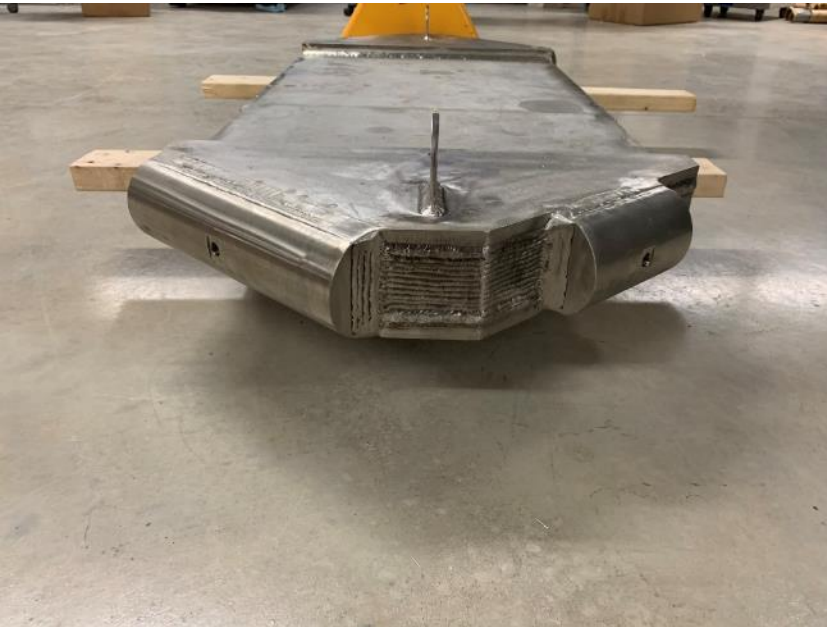
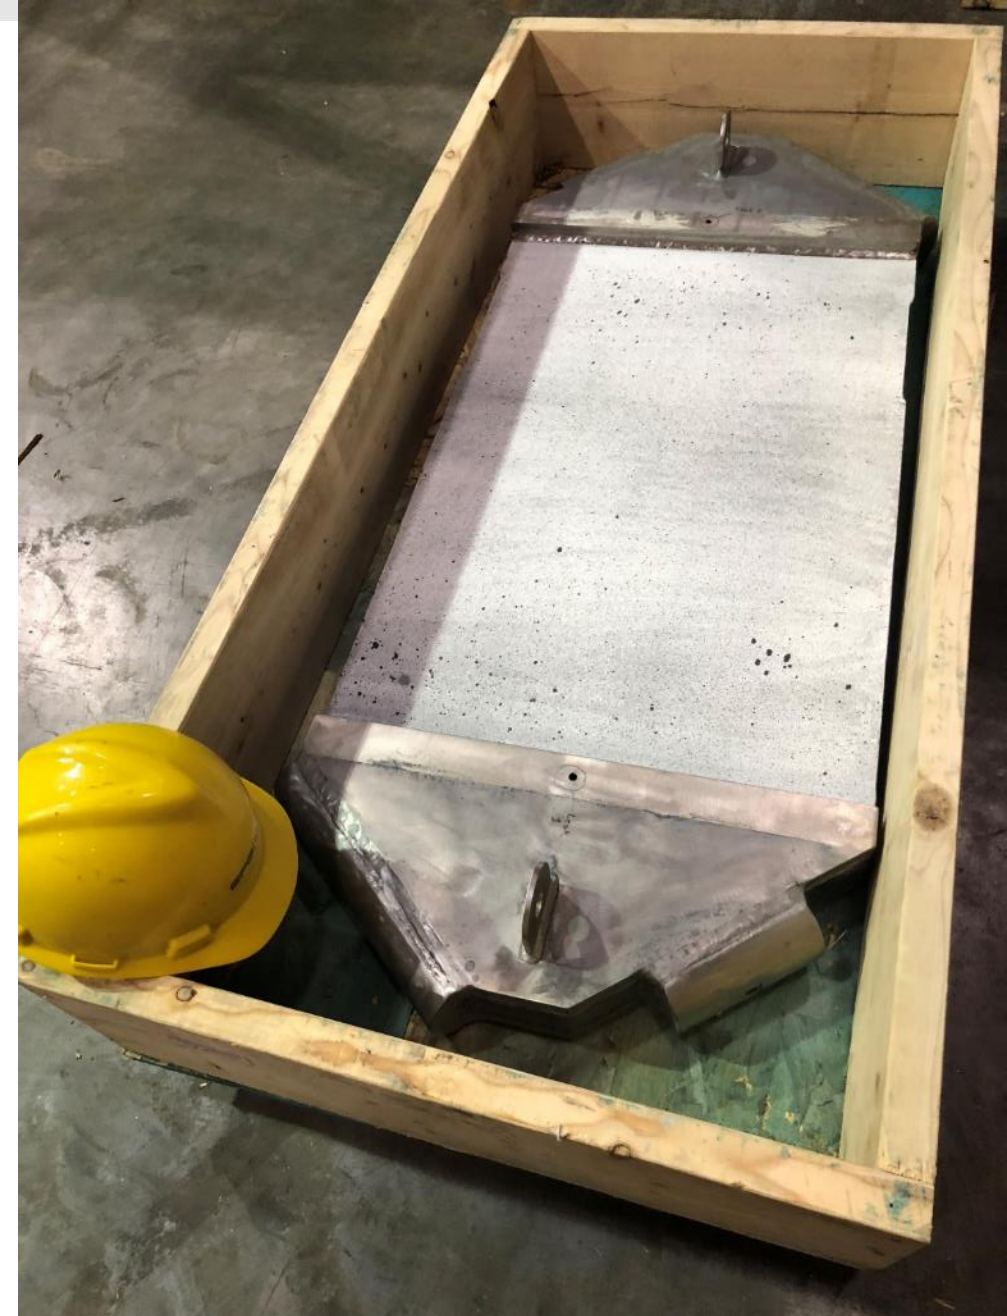
Comprex CHX

NDE results on a failed CHX provided by UW
