WCAP-13694

PRIMARY LOOP LEAK-BEFORE-BREAK
RECONCILIATION TO ACCOUNT FOR THE EFFECTS OF
STEAM GENERATOR REPLACEMENT/UPRATING

April 1993

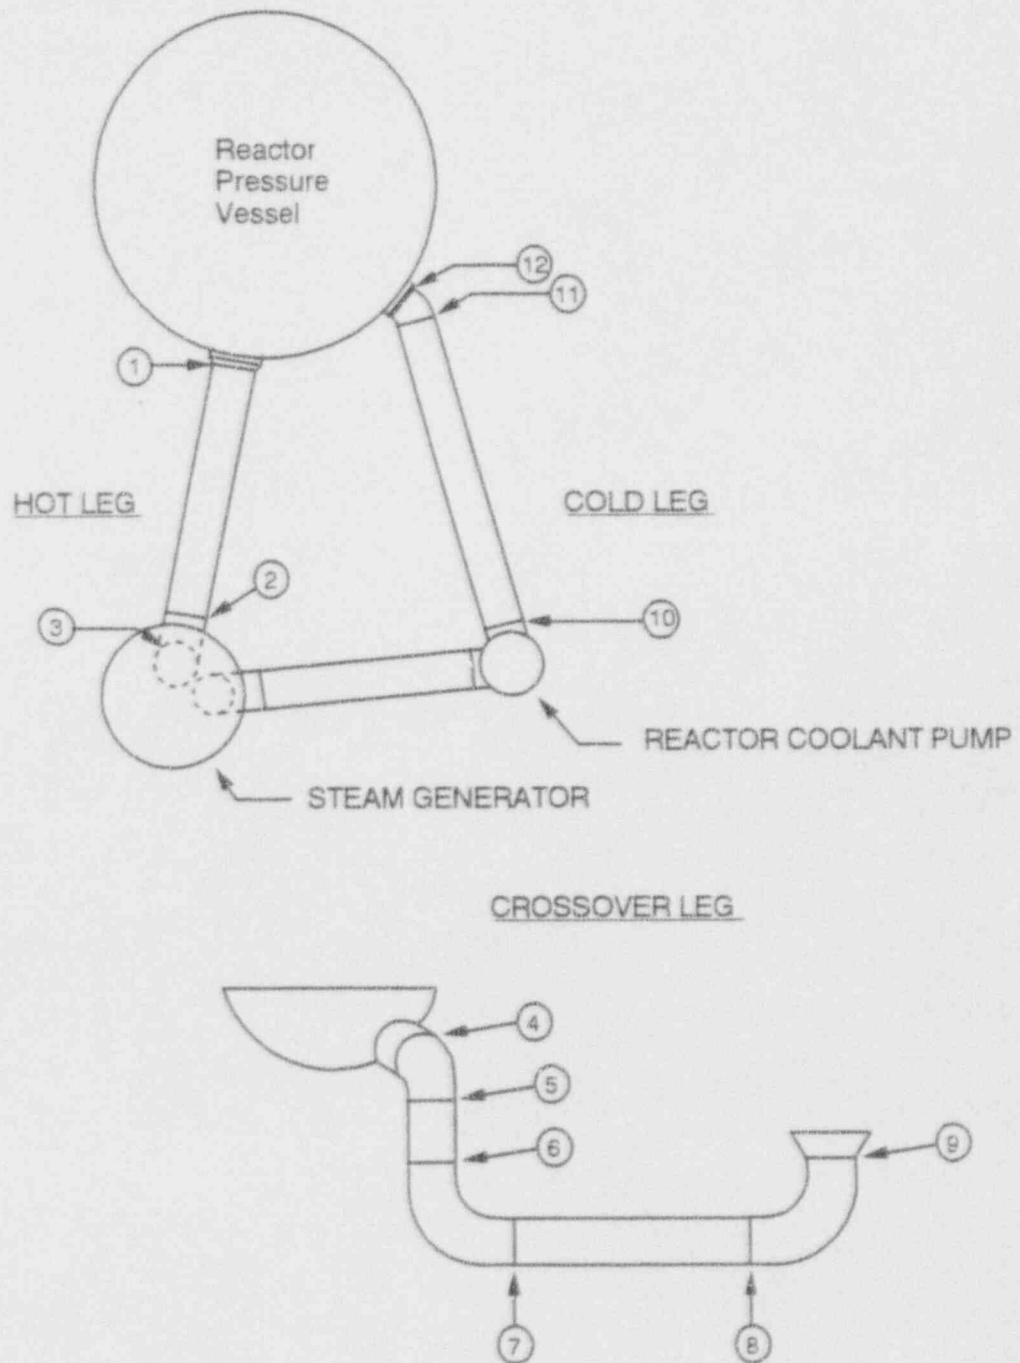
Figure 2-1

Schematic Diagram of Virgil C. Summer Primary Loop Showing Weld Locations

The normal operating loads and faulted condition loads used in WCAP-13206 (Reference 1) are provided in Tables 2-1 and 2-2 for ready reference. The corresponding loads resulting from the revised configuration are provided in Tables 2-3 and 2-4. Review of faulted loads in Table 2-4 shows that the highest stressed location is Location 3 (see Figure 2-1). Since this is an elbow, this location is the toughness critical location (refer to Section 3 of Reference 1 for an explanation of load and toughness critical locations). The highest stressed pipe location is Location 1, therefore it is the load critical location. Detailed fracture mechanics evaluations and leak rate calculations were performed at these locations.
