To	J. E. MATHESON, FUEL ENGINEERING, NPGD	
From	W. A. MCINTEER <i>WAM</i> G. M. BAIN <i>GMB</i> - IRRADIATED MATERIALS TECHNOLOGY, LRC	
Cust.	GPUN	File No. or Ref. RDD:83:5489:01
Subj.	TMI-1 RECOVERY — RNS RETAINER EXAMINATION	Date MAY 20, 1982

SUMMARY

As part of the TMI-1 recovery effort, a RNS retainer was examined at the LRC Hot Cell Facility. Although it was unirradiated, the retainer had been installed in-core since the EOC-4 outage in late 1978. Detailed testing of the retainer and its component parts included:

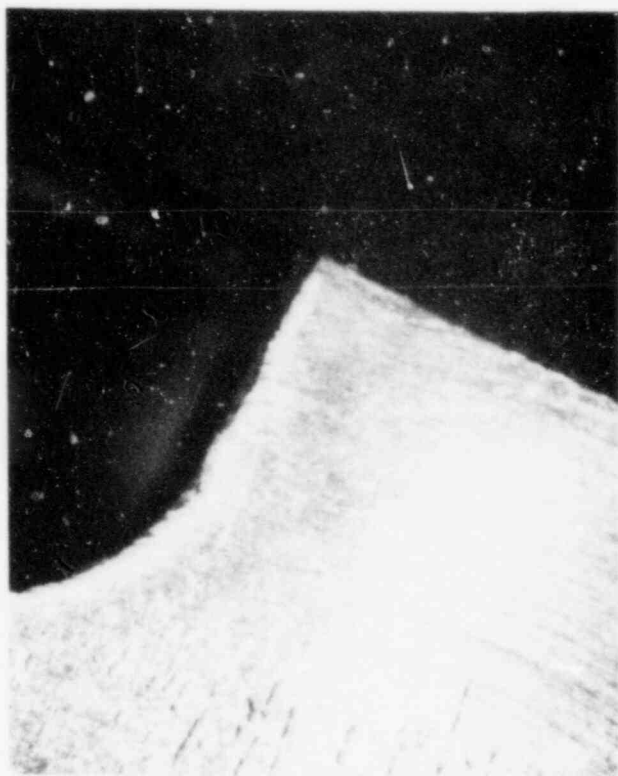
Weld Area

A visual inspection of the retainer, prior to disassembly, showed no cracks in the weld, knee, or foot regions of the retainer legs. A schematic view of a retainer identifying its various components is shown in Figure 1. Typical macrophotos of the leg weld, knee, and foot regions are shown in Figure 2. Virtually no crud was observed on the outside surface. Overall views of the retainer are shown in Figures 3 and 4.

Figure 2. Typical Macro
Appearance of
Retainer Leg

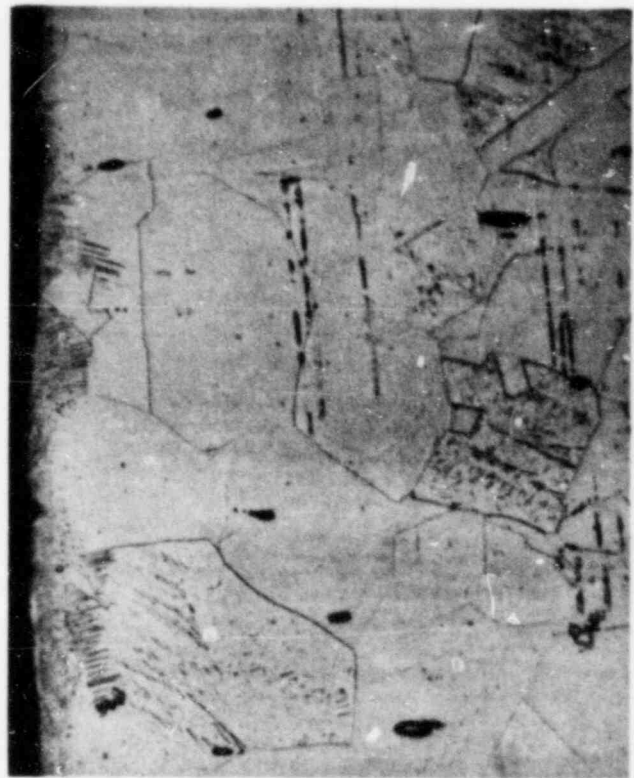
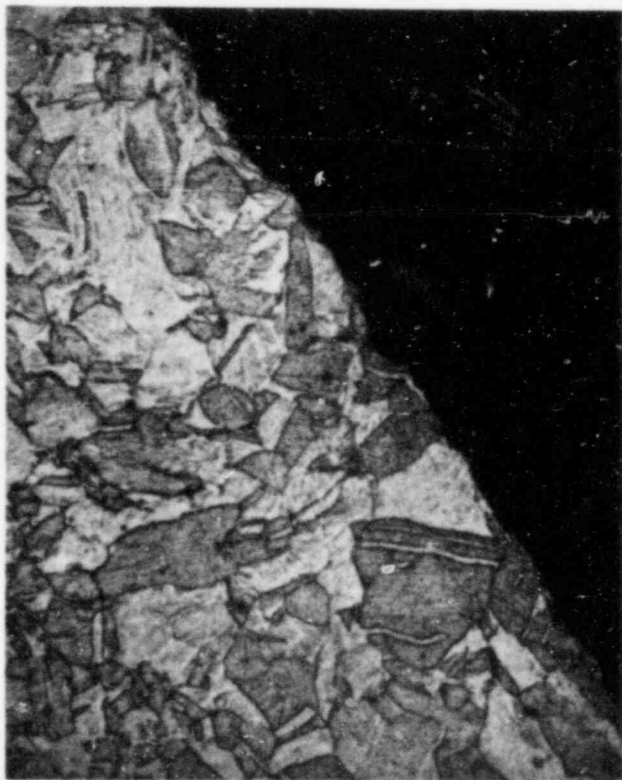
Figure 8. Typical Etched
Appearance of
Retainer Component
Microstructures (400X)

The microstructure of all the samples appeared normal and no evidence of intergranular attack was observed. Figure 8 shows typical etched microstructures of the 304 SS base metal, 308 SS weld metal, and X750 spring. The weld area and heat-affected zone are shown at 50X in Figure 9.

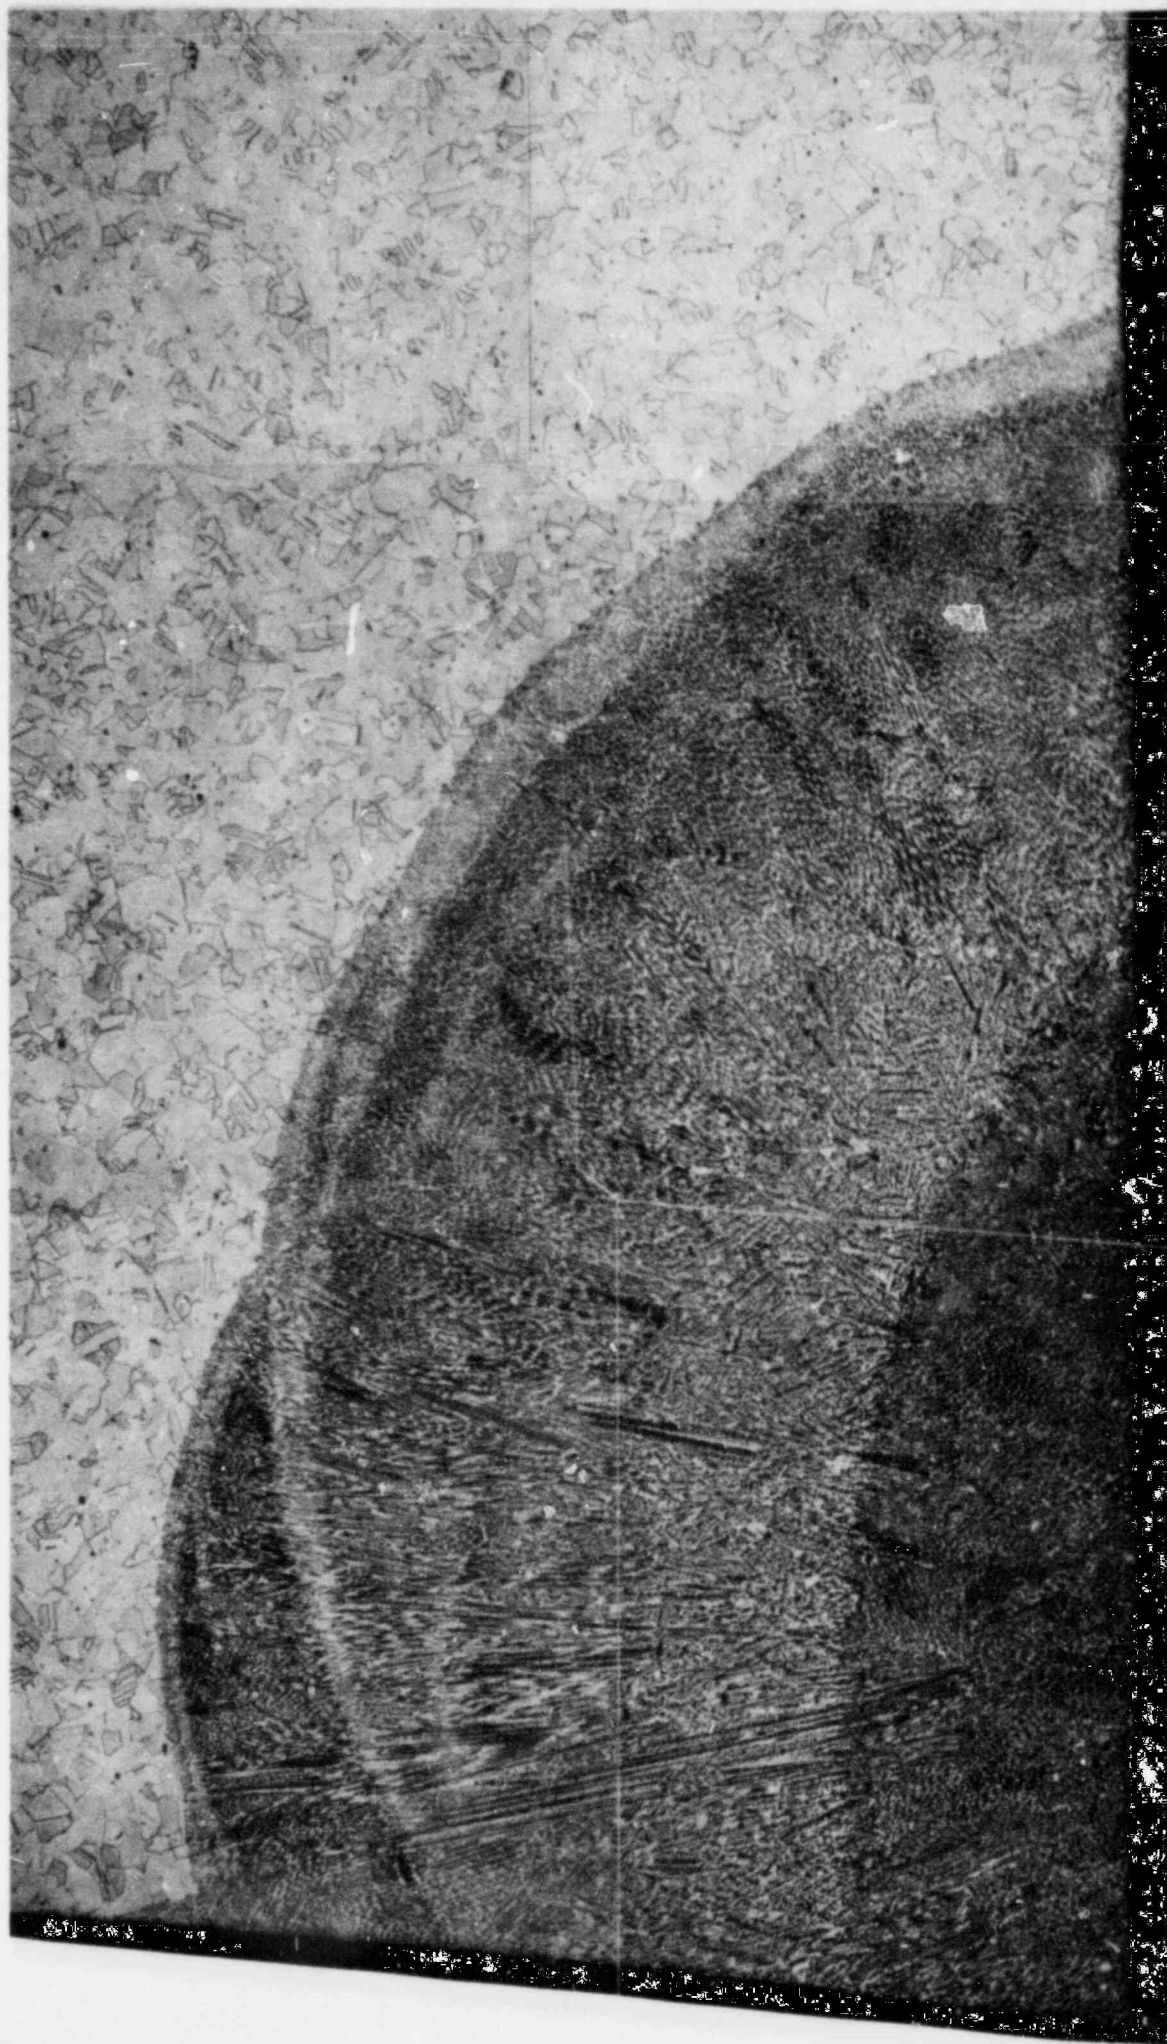
Figure 9. Retainer Leg Weld and Heat Affected Zone (50X)
