OVERVIEW OF PROGRESS  
IN THE TMI-1 TUBE CLEANING EXPERIMENT

G.P.U. NUCLEAR

January 31, 1983

R. H. Barnes, A. K. Wensky,  
and J. Lathouse

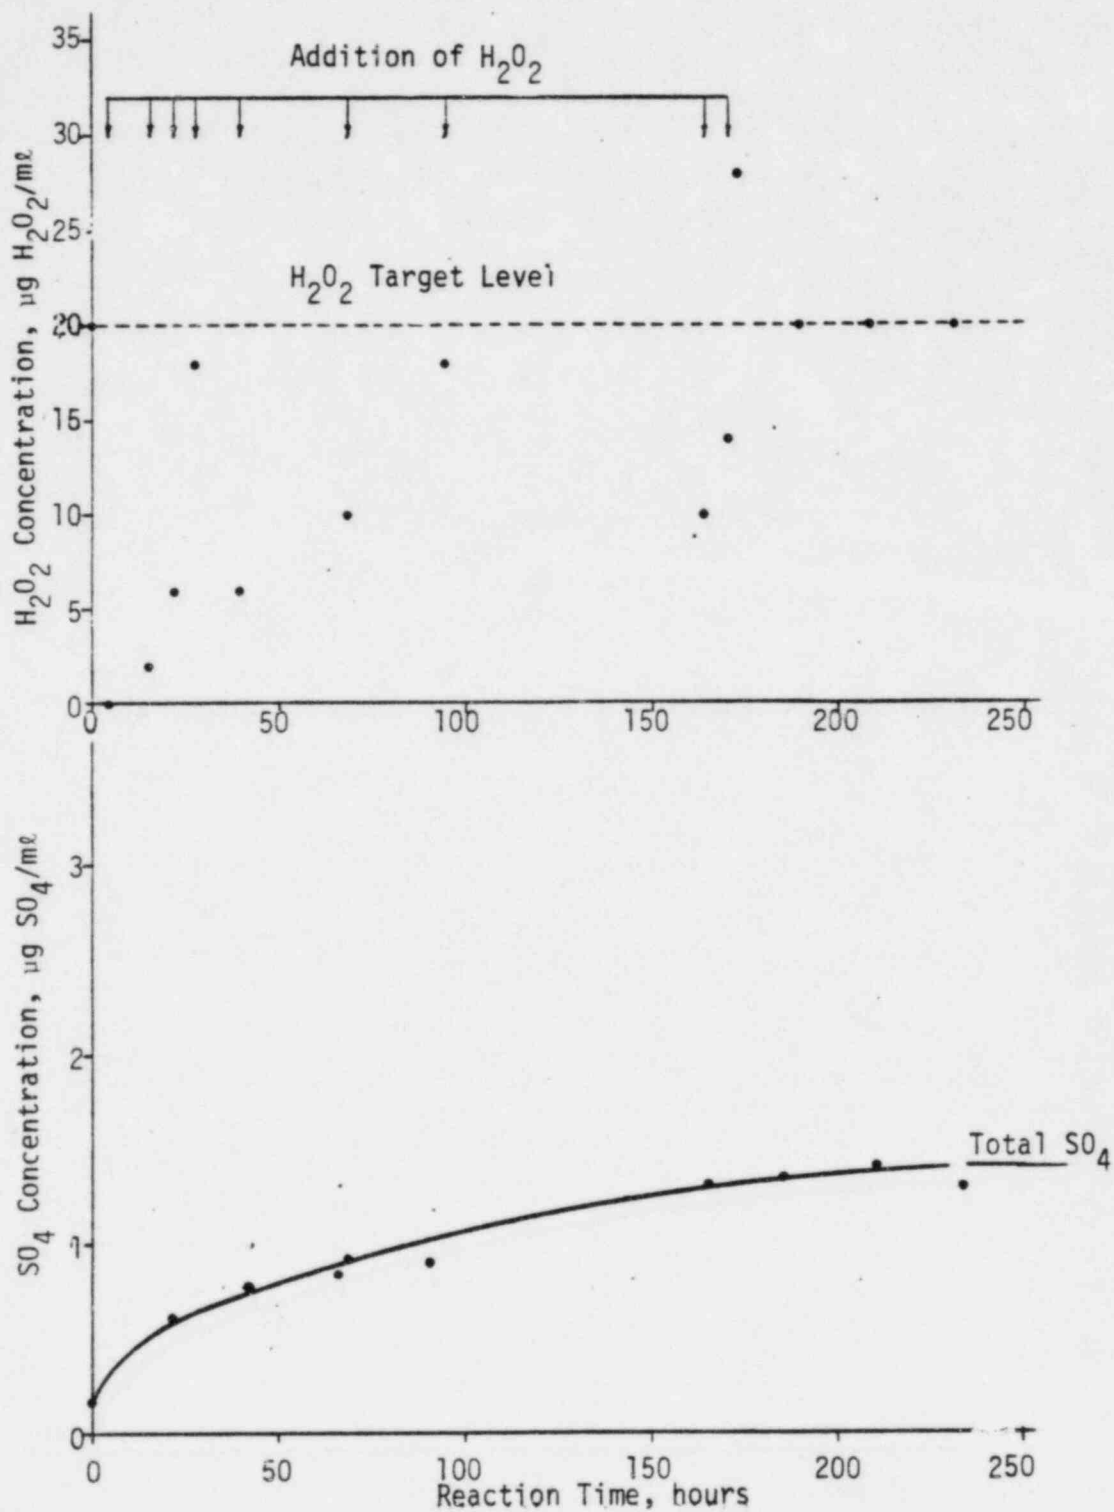
Figure 1. Hydrogen Peroxide and Sulfate Concentrations as a Function of Reaction Time for Tube Run-1 at pH 8 and 130°F.

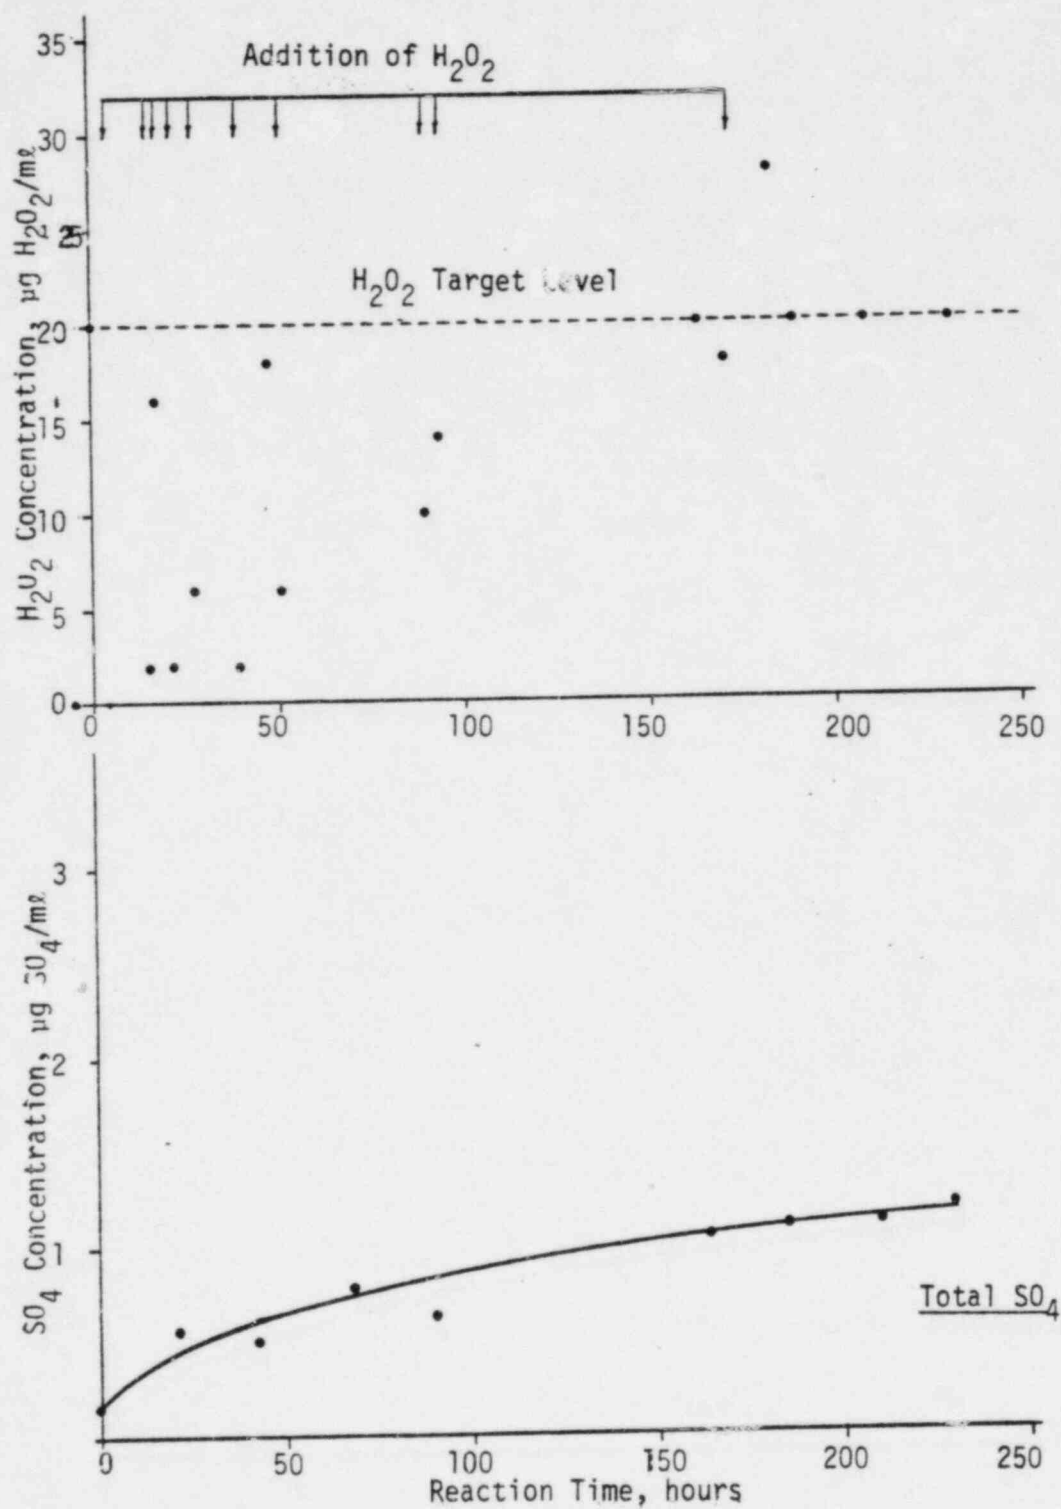
Figure 2. Hydrogen Peroxide and Sulfate Concentrations as a Function of Reaction Time for Tube Run-2 at pH 8 and 130°F.

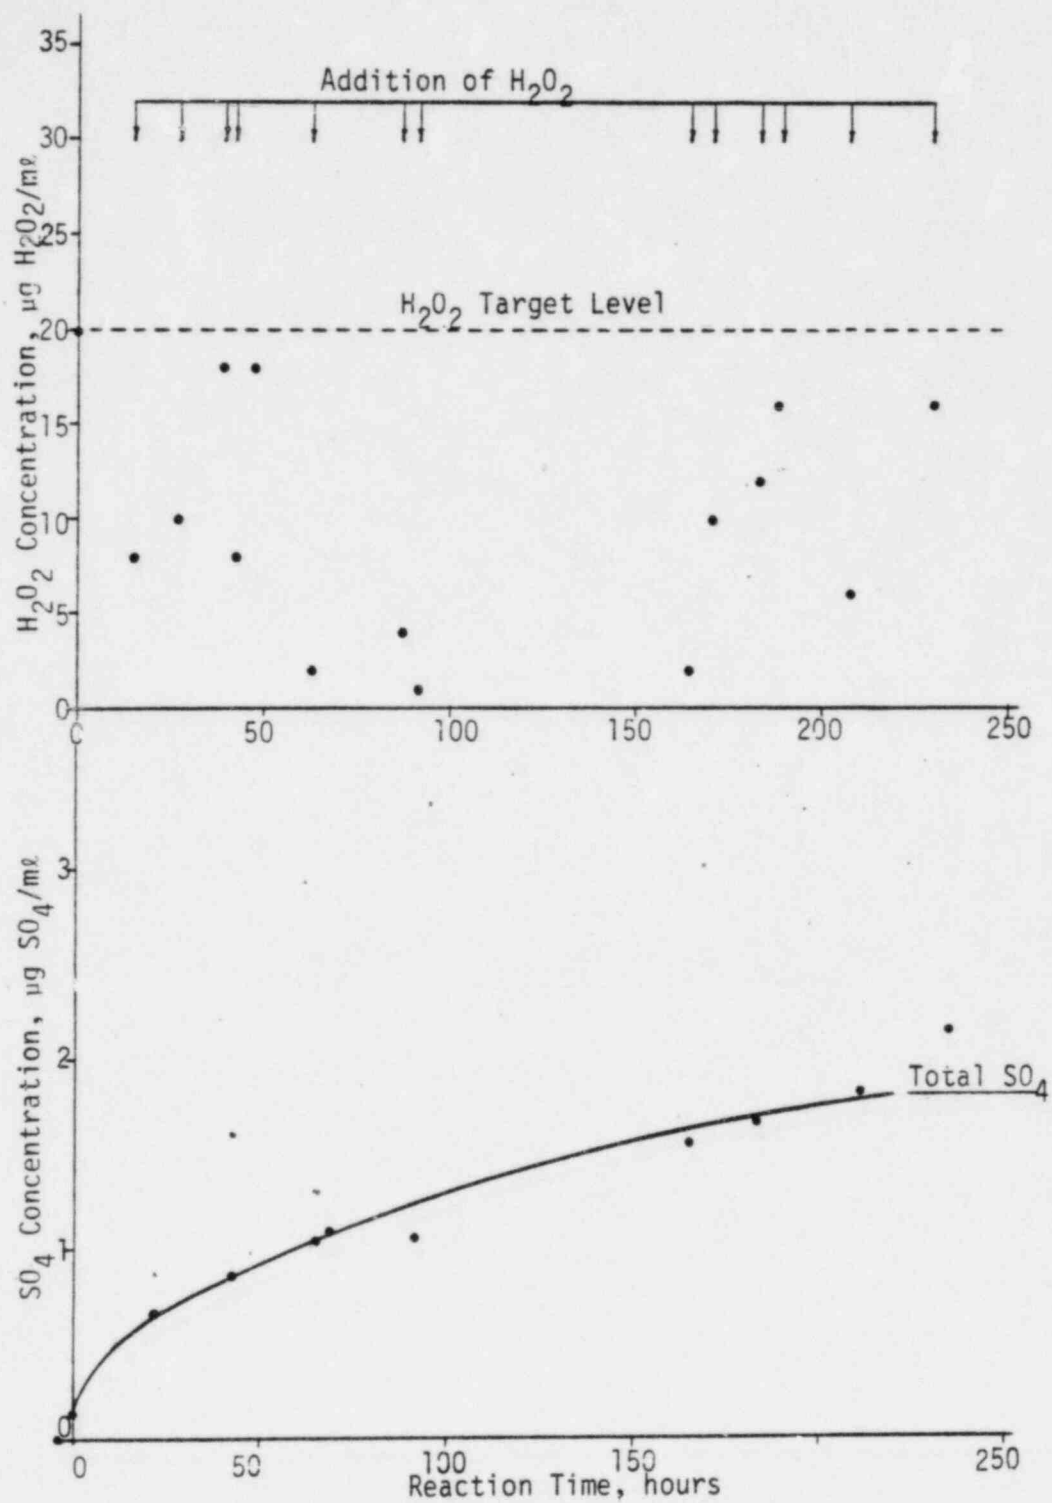
Figure 3. Hydrogen Peroxide and Sulfate Concentration as a Function of Reaction Time for Tube Run-3 at pH 10 and 130°F.

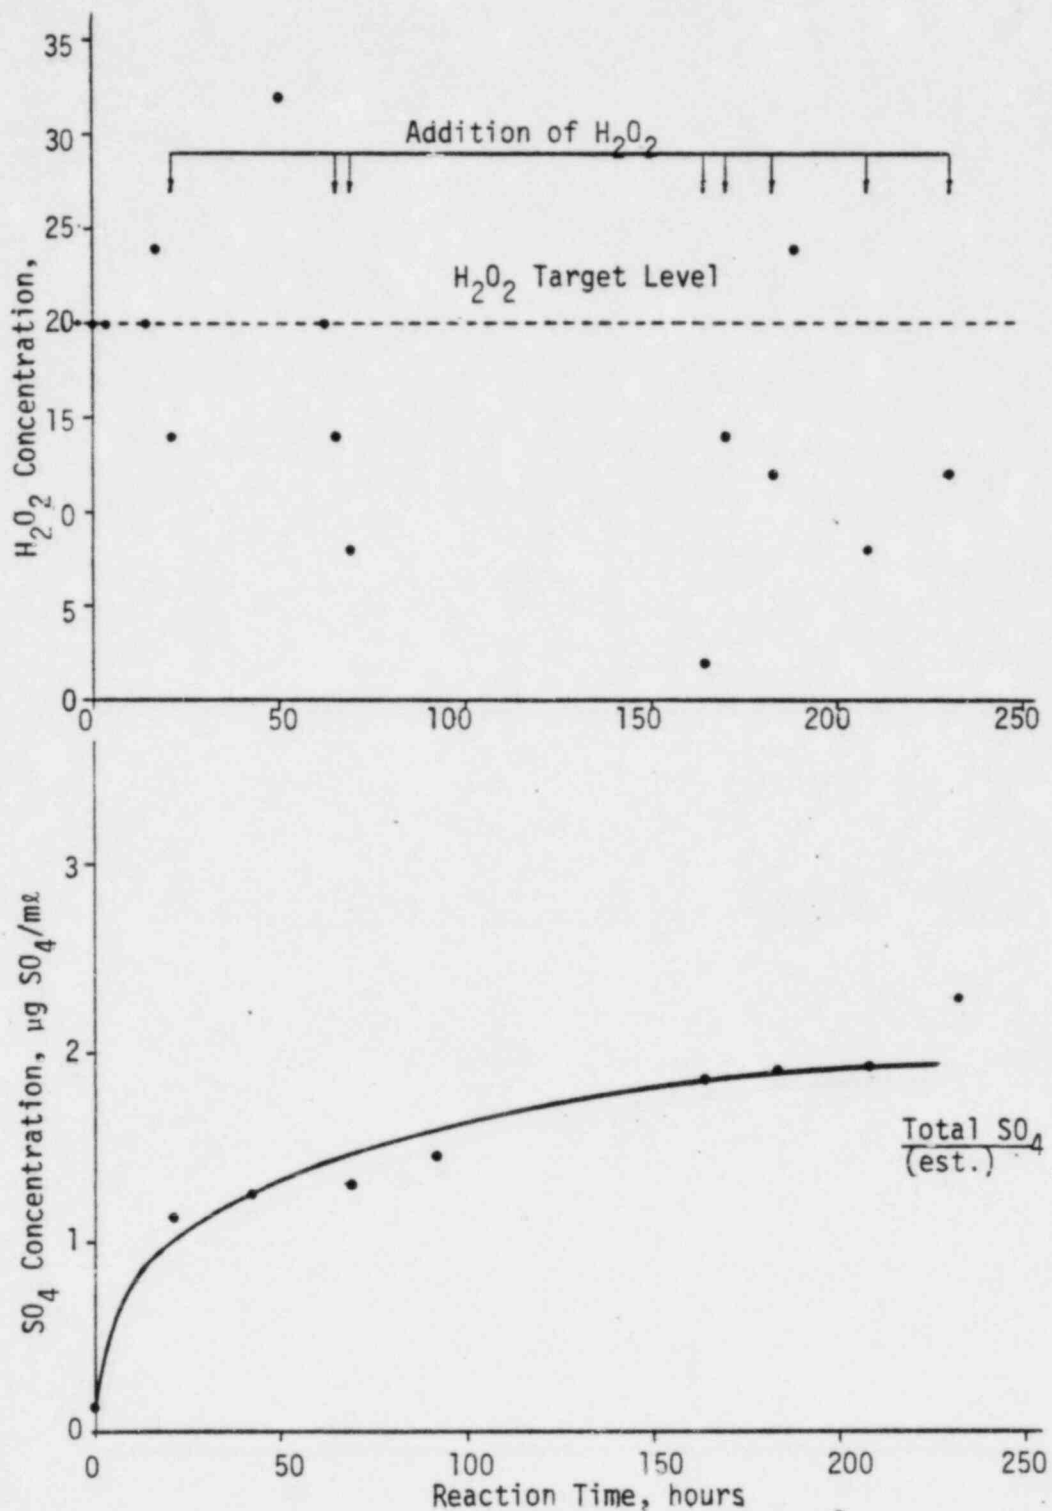
Figure 4. Hydrogen Peroxide and Sulfate Concentrations as a Function of Reaction Time for Tube Run-4 at pH 10 and 130°F.

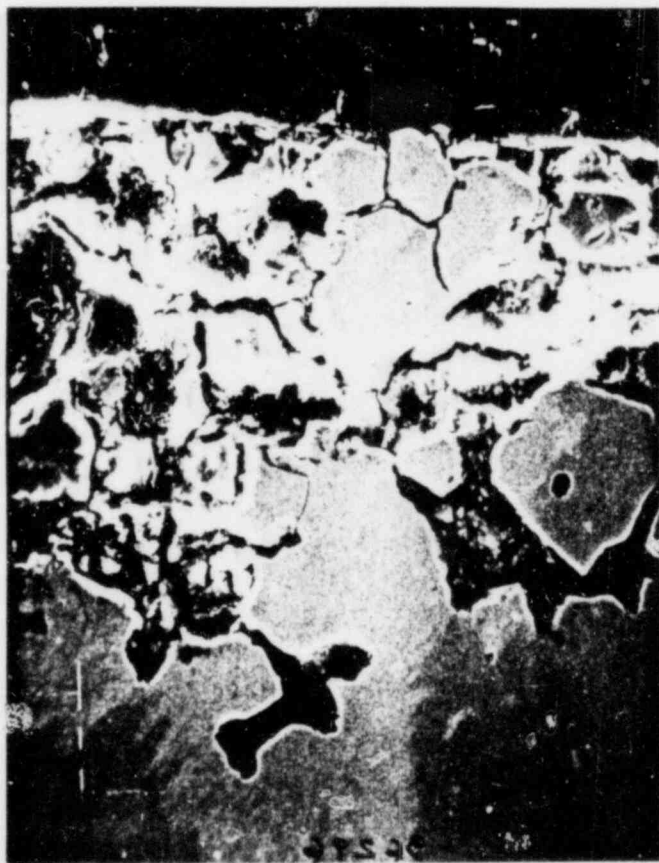
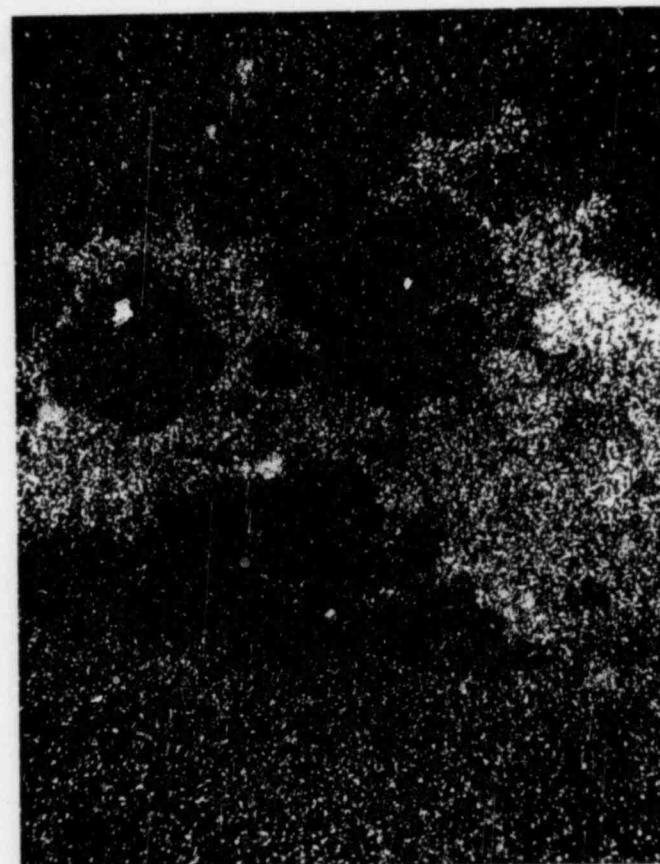
Figure 5. SEM Photomicrograph and X-Ray Map for Sulfur Contaminated Area in Cross Section of As-Received Inconel-600 Tube Sample.

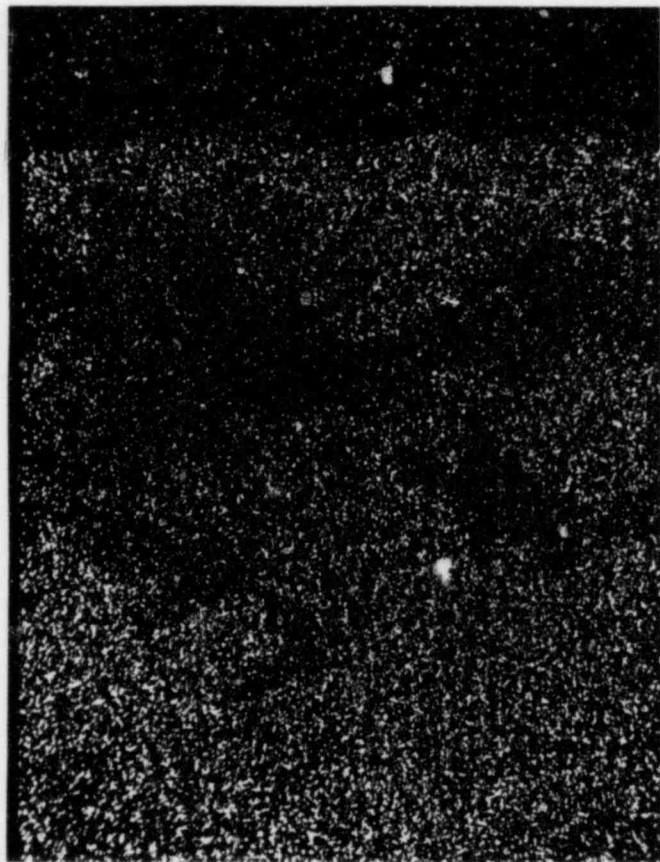
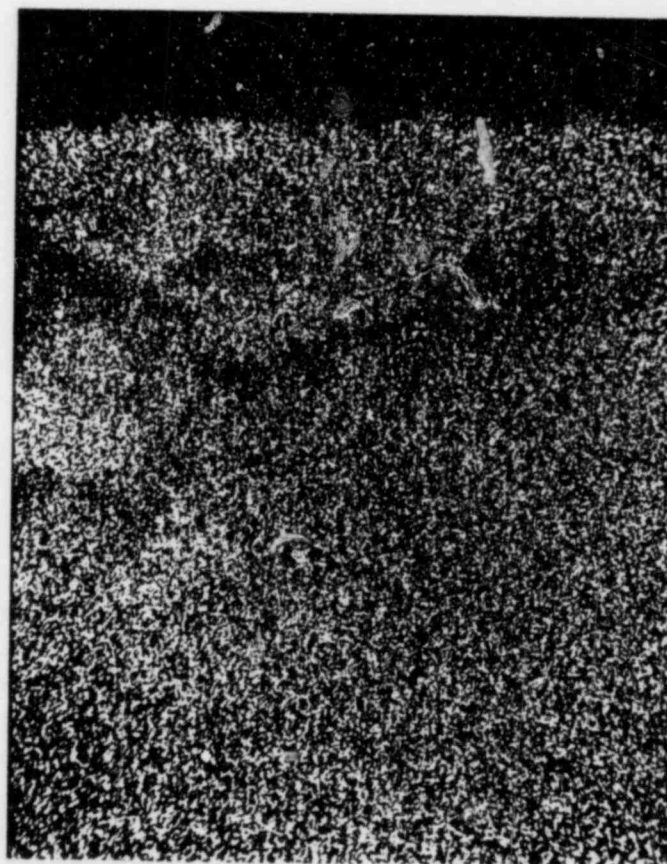
Figure 6. X-Ray Maps for Sulfur Contaminated Area in Cross Section of As-Received Inconel 600 Tube Sample.

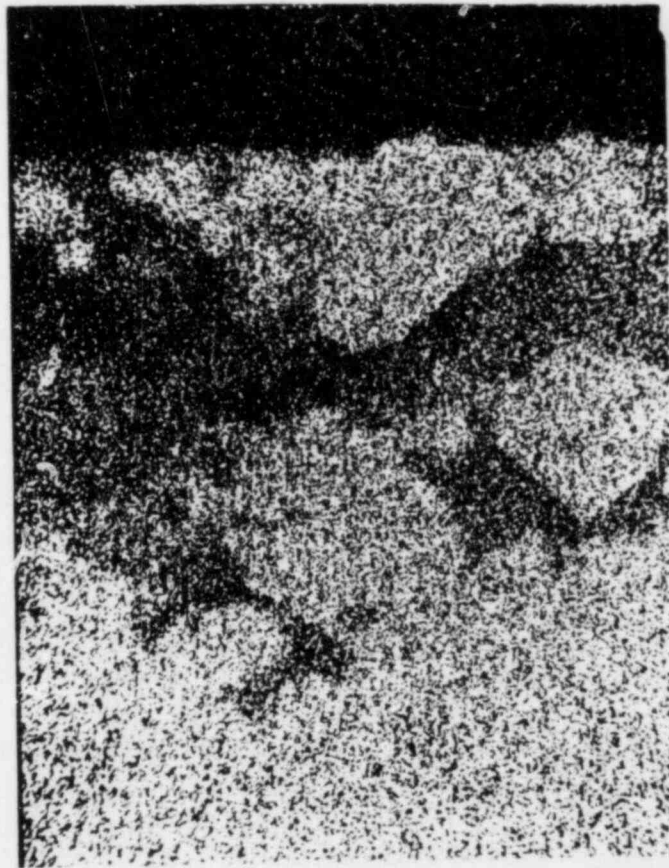
Figure 7. Nickel X-Ray Map for Sulfur Contaminated Area in Cross Section of As-Received Inconel-600 Tube Sample.

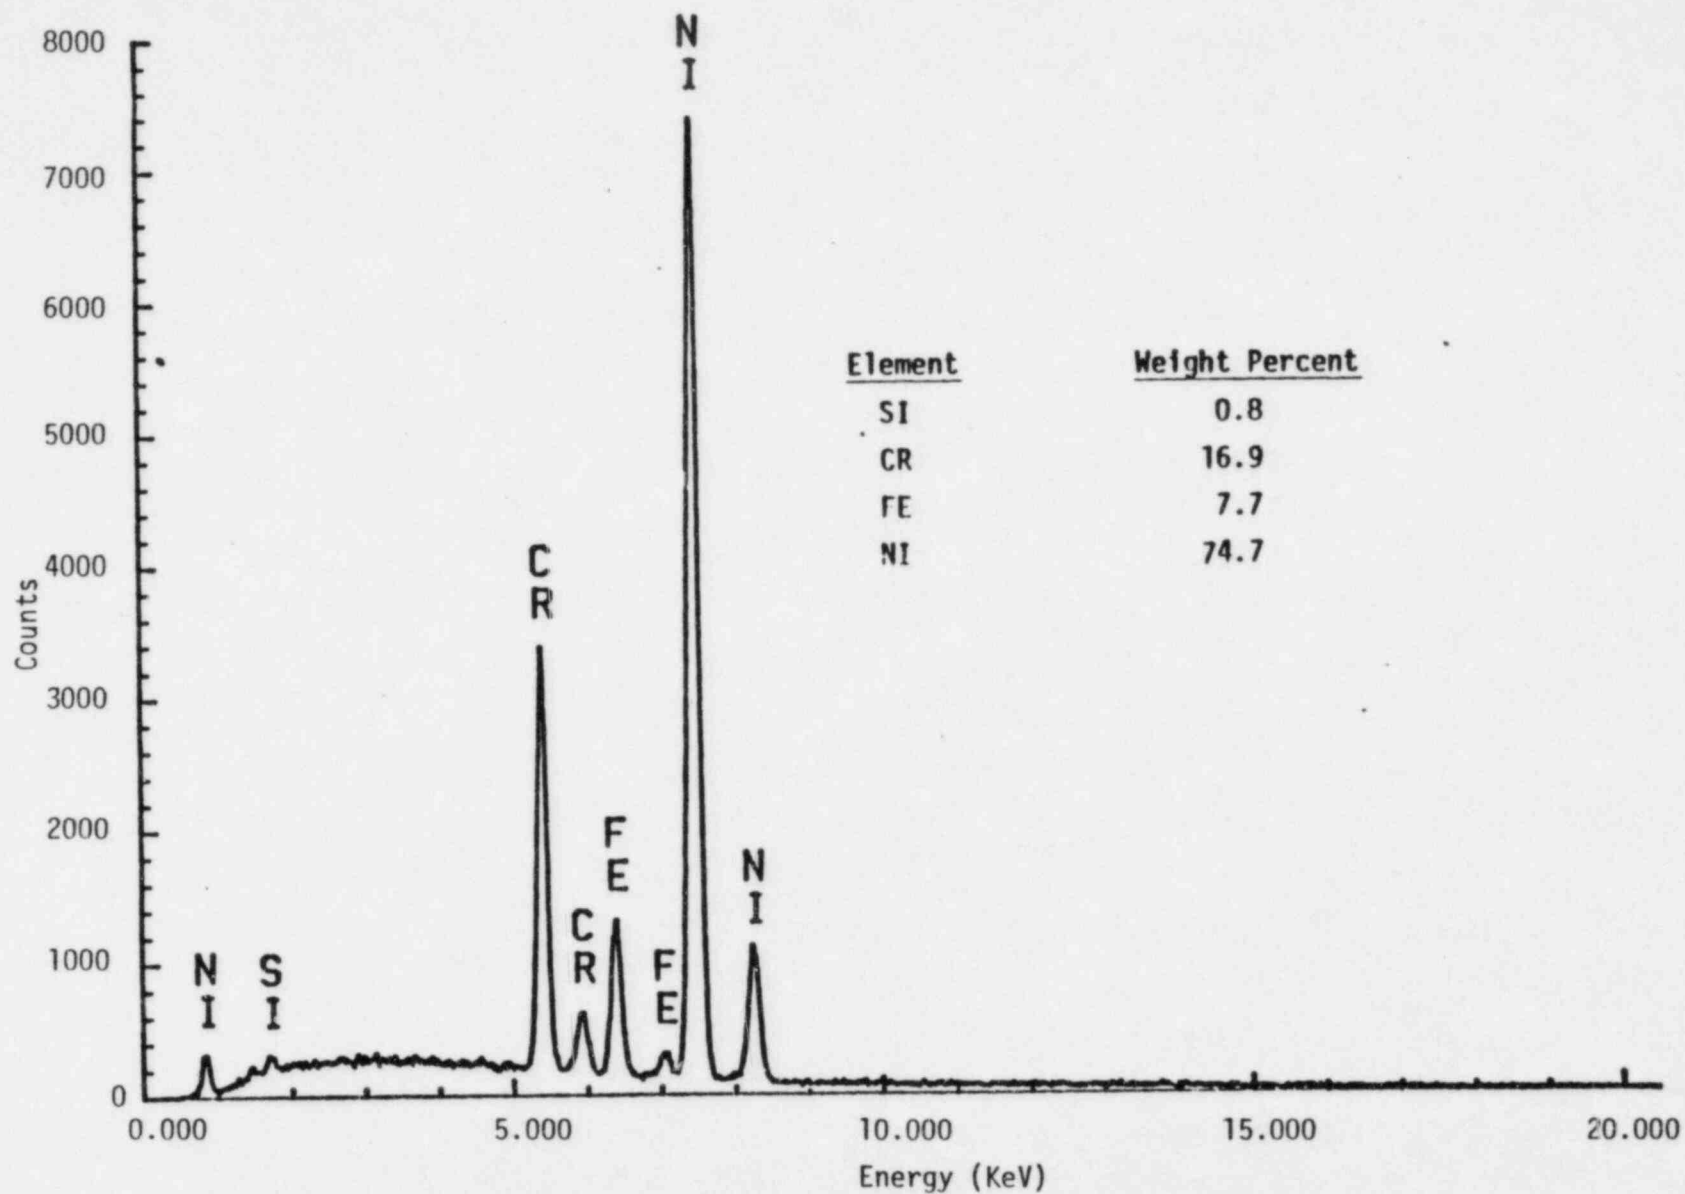
Figure 8. Energy Dispersive X-Ray Spectrum for Base Metal in As-Received Inconel-600 Tube.

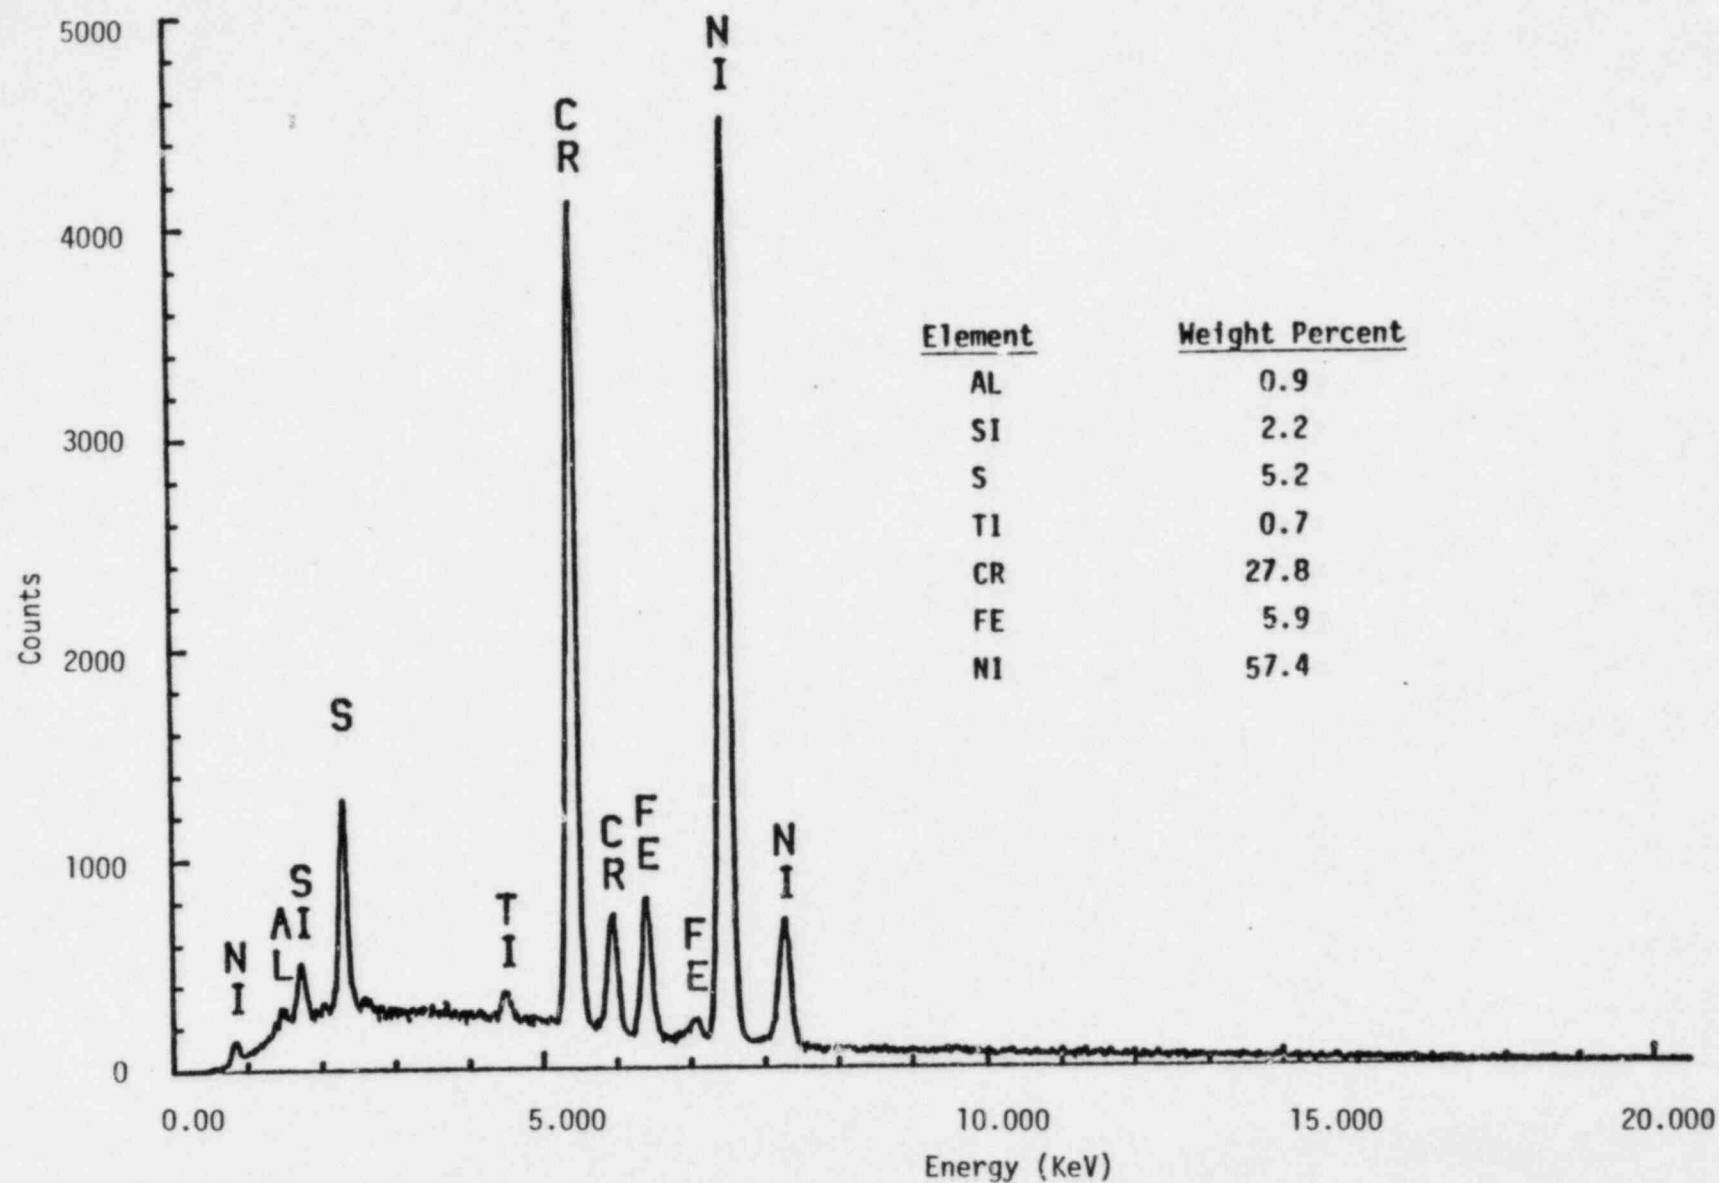
Figure 9. Energy Dispersive X-ray Spectrum for Sulfur Contaminant Area C) in Cross Section of As-Received Inconel-600 Tube.

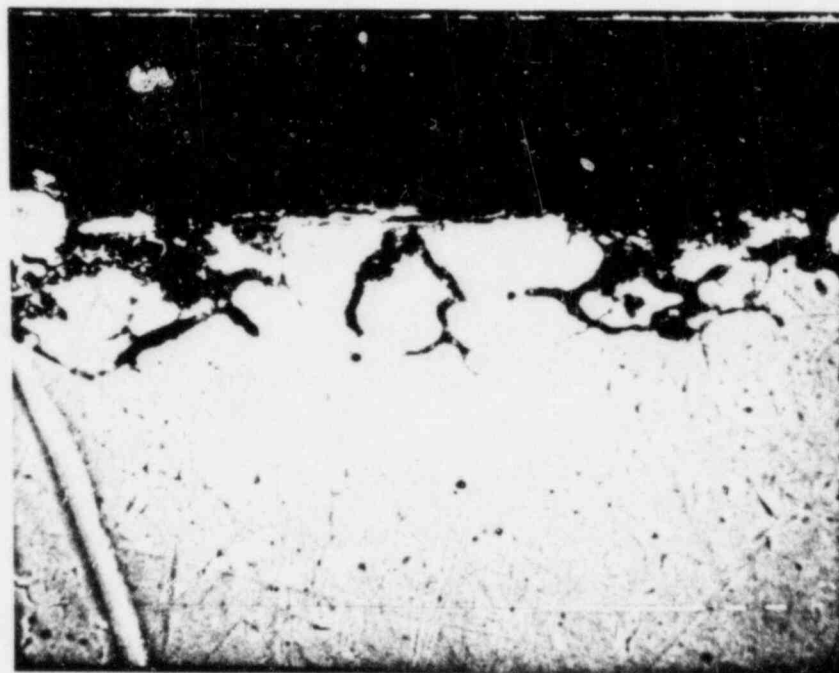
Figure 10. SEM Photomicrograph of Sulfur Contaminated Area in Cross Section of Inconel-600 Tube Sample after Cleaning with  $\text{H}_2\text{O}_2$  at pH 10.

SEM/EDAX examination of samples from Tube Run-1 and -3 showed no sulfur above the detection limit of 0.1 - 0.2 weight percent. Typical areas of sulfur attack in the sample from Tube No. 88-11 (Tube Run-3) after cleaning at pH 10 are shown in Figures 10 and 11. An EDAX spectrum obtained at Point 2 in Figure 11 is presented in Figure 12. Even at the extreme depths of attack, no residual sulfur was observed.

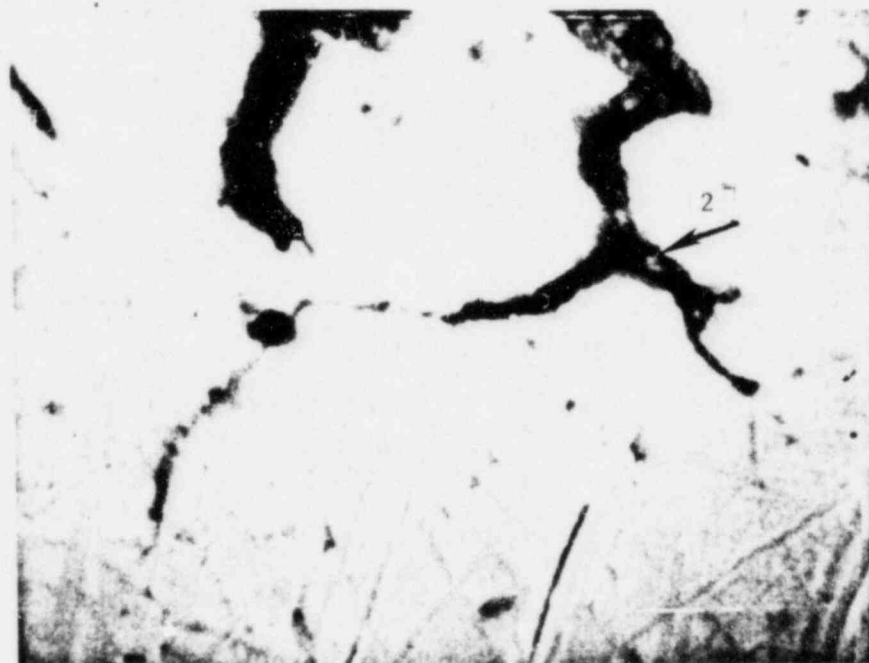
Figure 11. SEM Photomicrograph of Sulfur Contaminated Area in Cross Section of Inconel-600 Tube Sample after Cleaning with  $\text{H}_2\text{O}_2$  at pH 10.

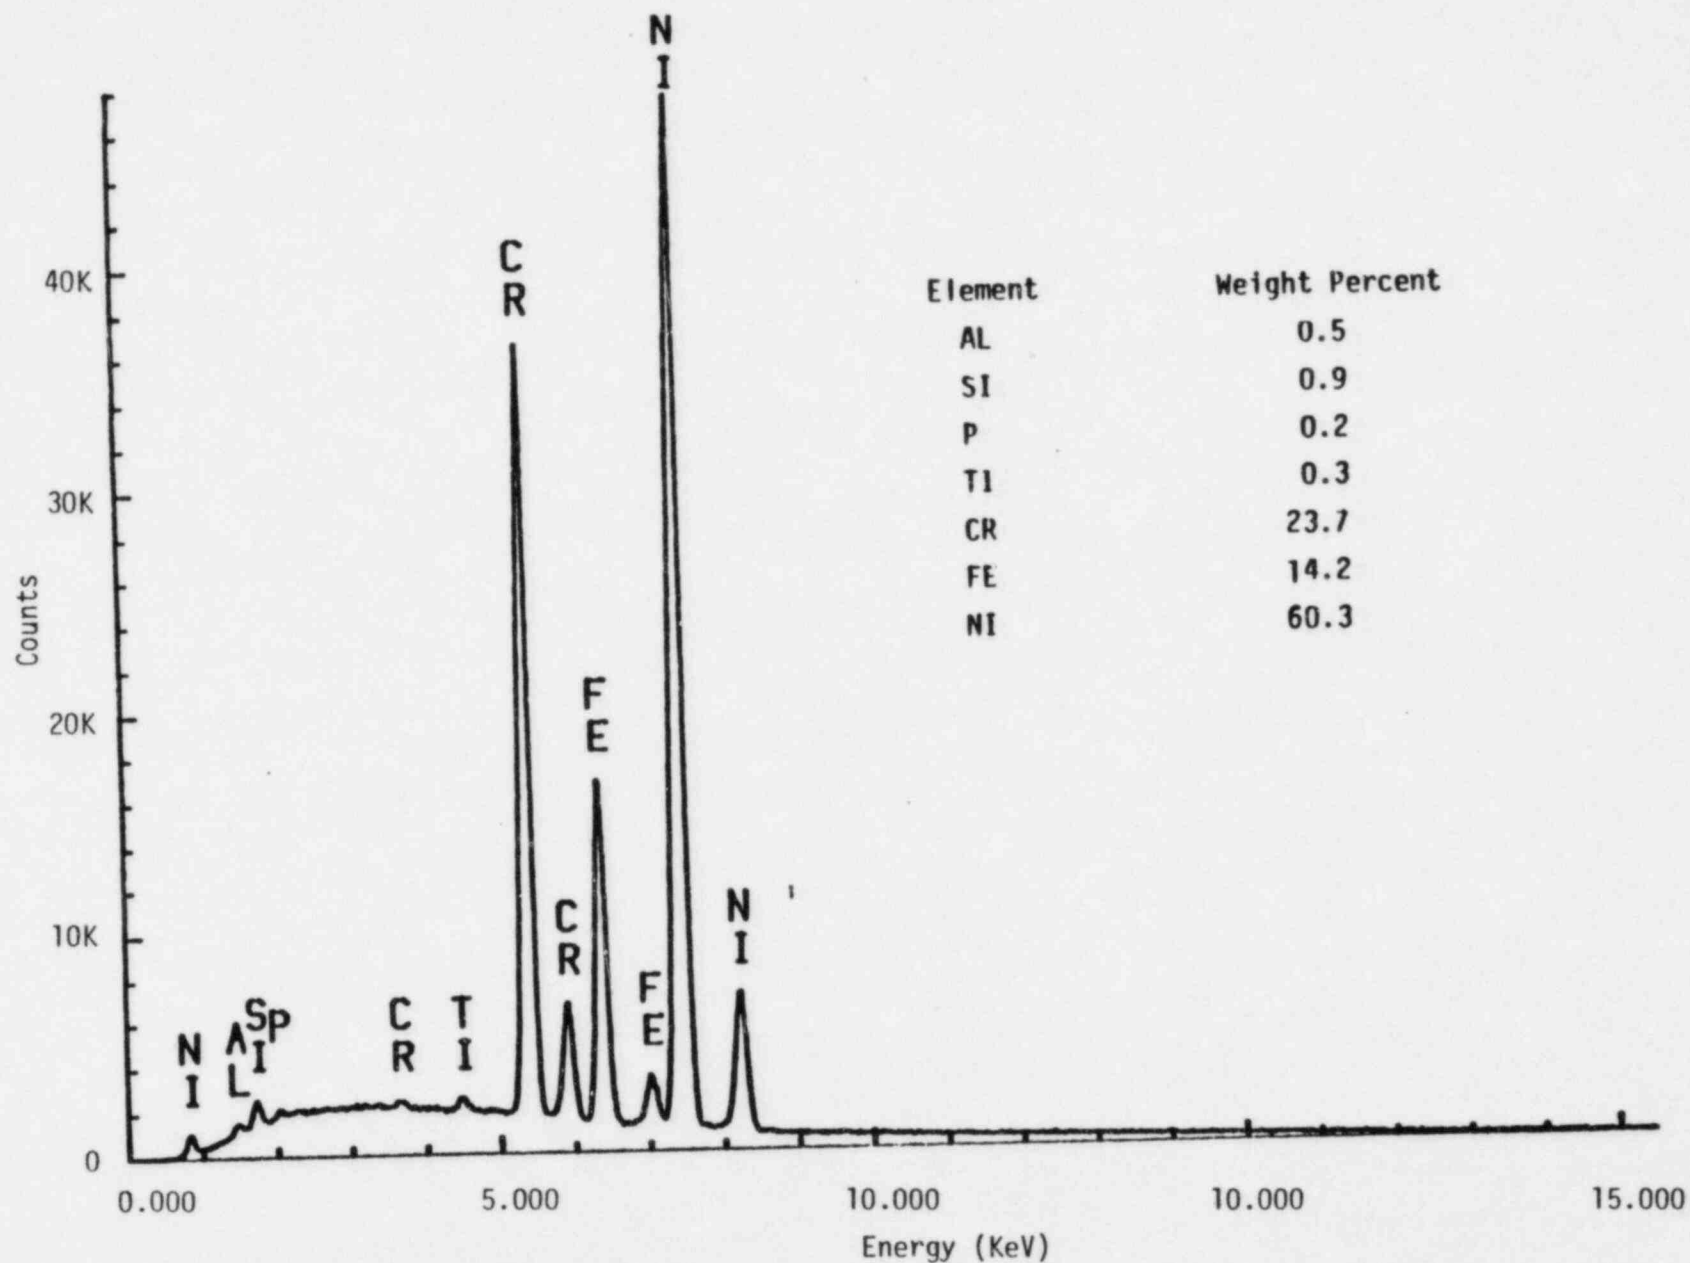
Figure 12. Energy Dispersive X-Ray Spectrum for Sulfur Contaminated Area (Area 2) in Cross Section of Inconel-600 Tube Sample After Cleaning with  $H_2O_2$  at pH<sub>8</sub>.

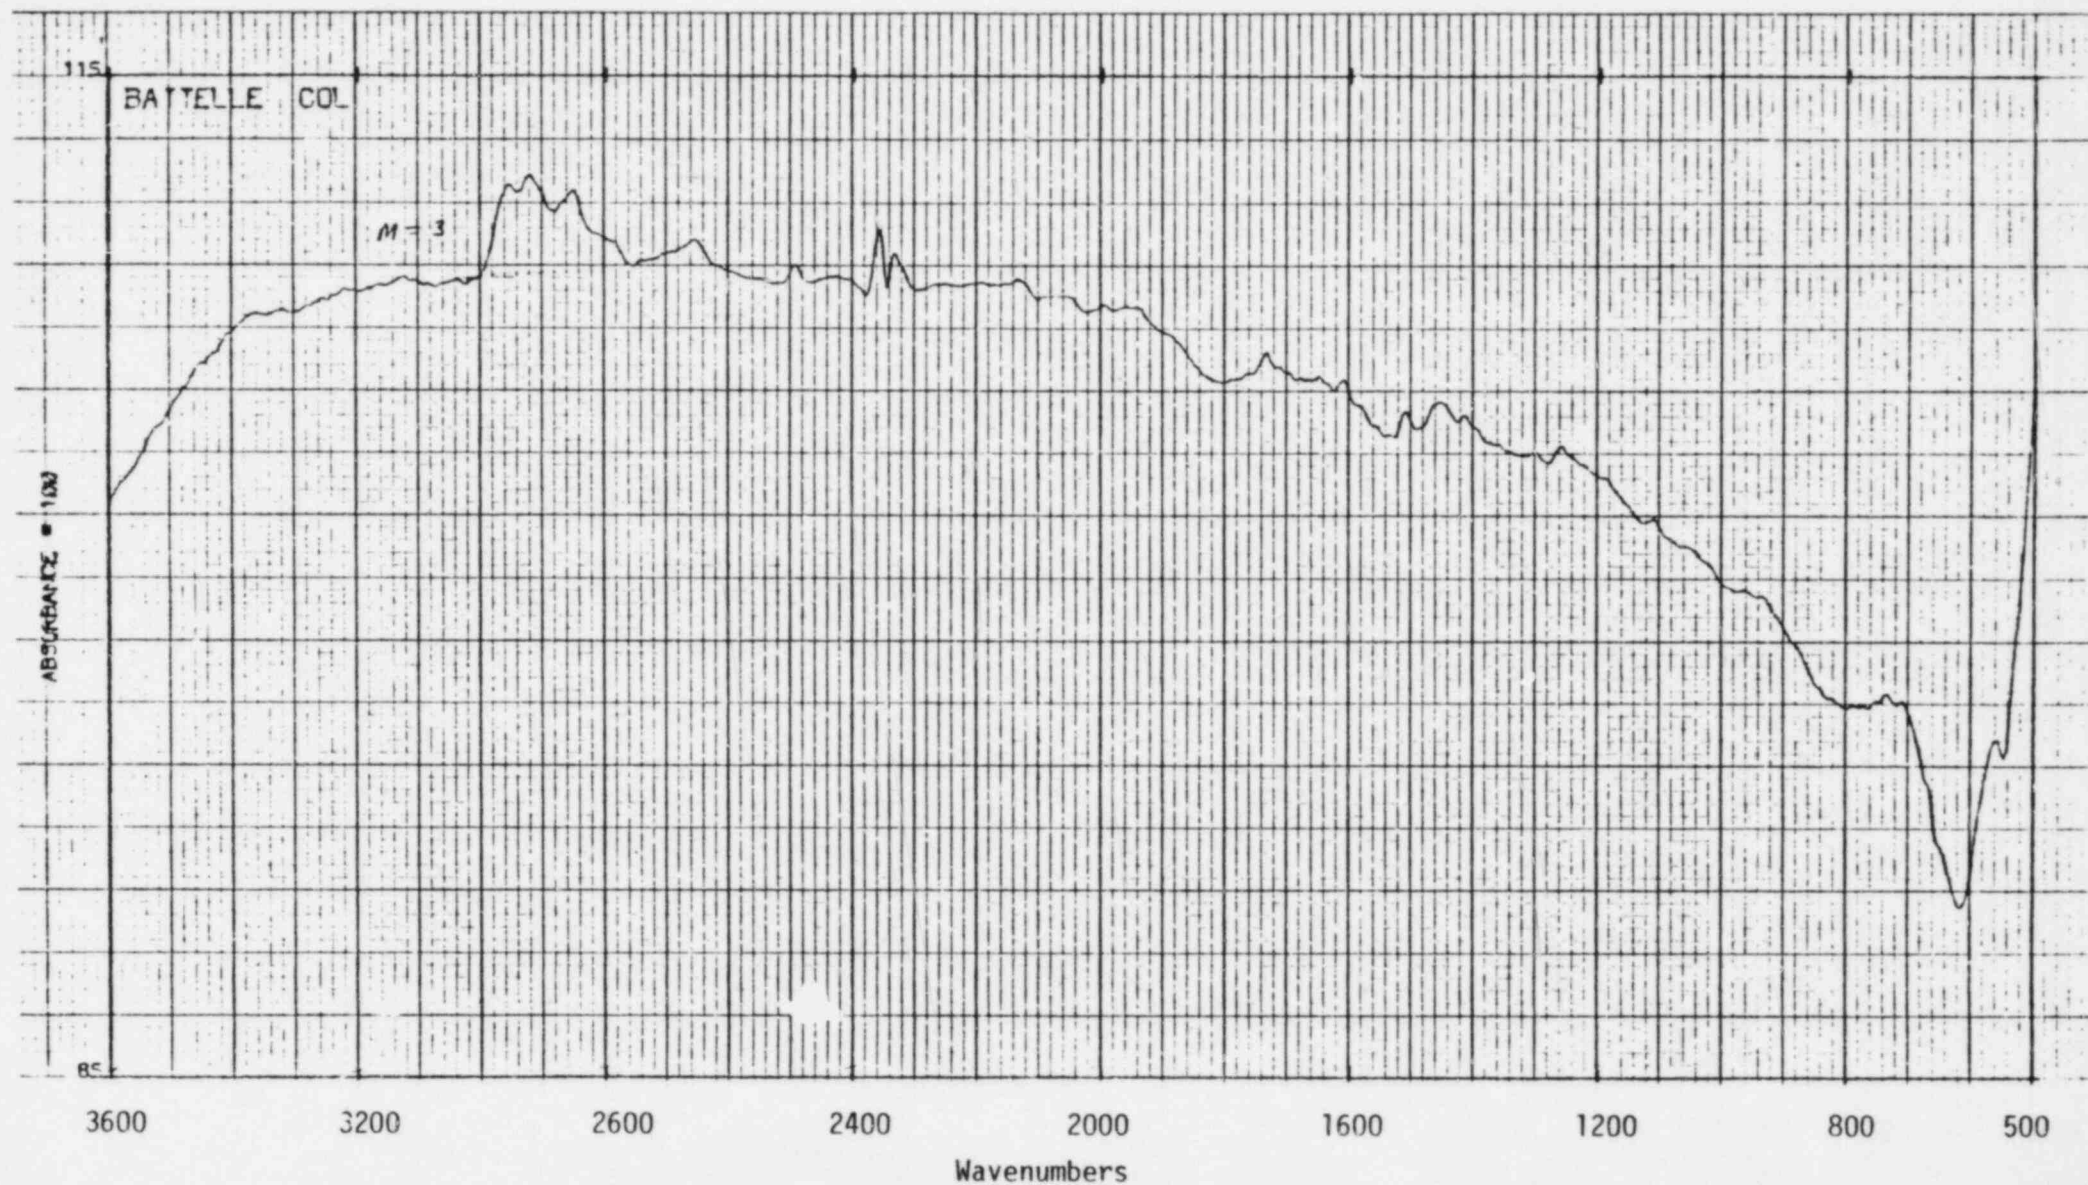
Figure 13. Infrared Diffuse Reflectance Spectrum for Dark Region on ID of Sample from Tube 146-6 (J Run 146A).

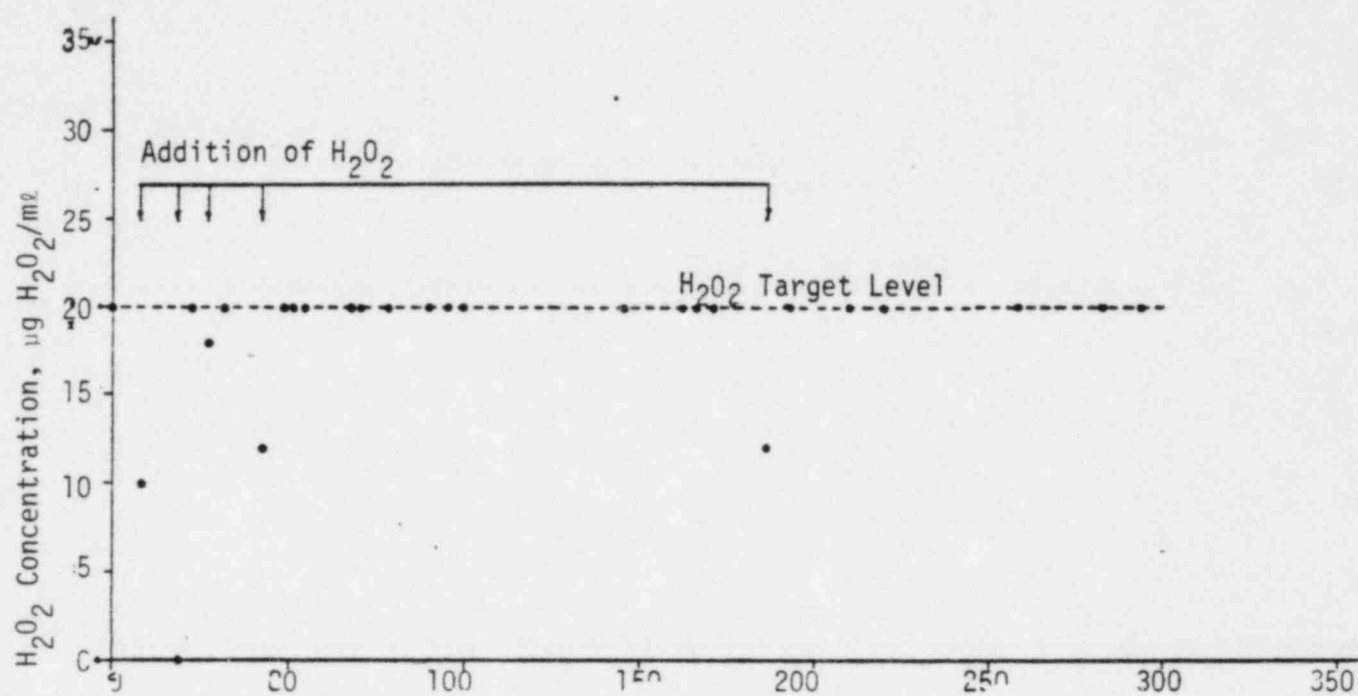
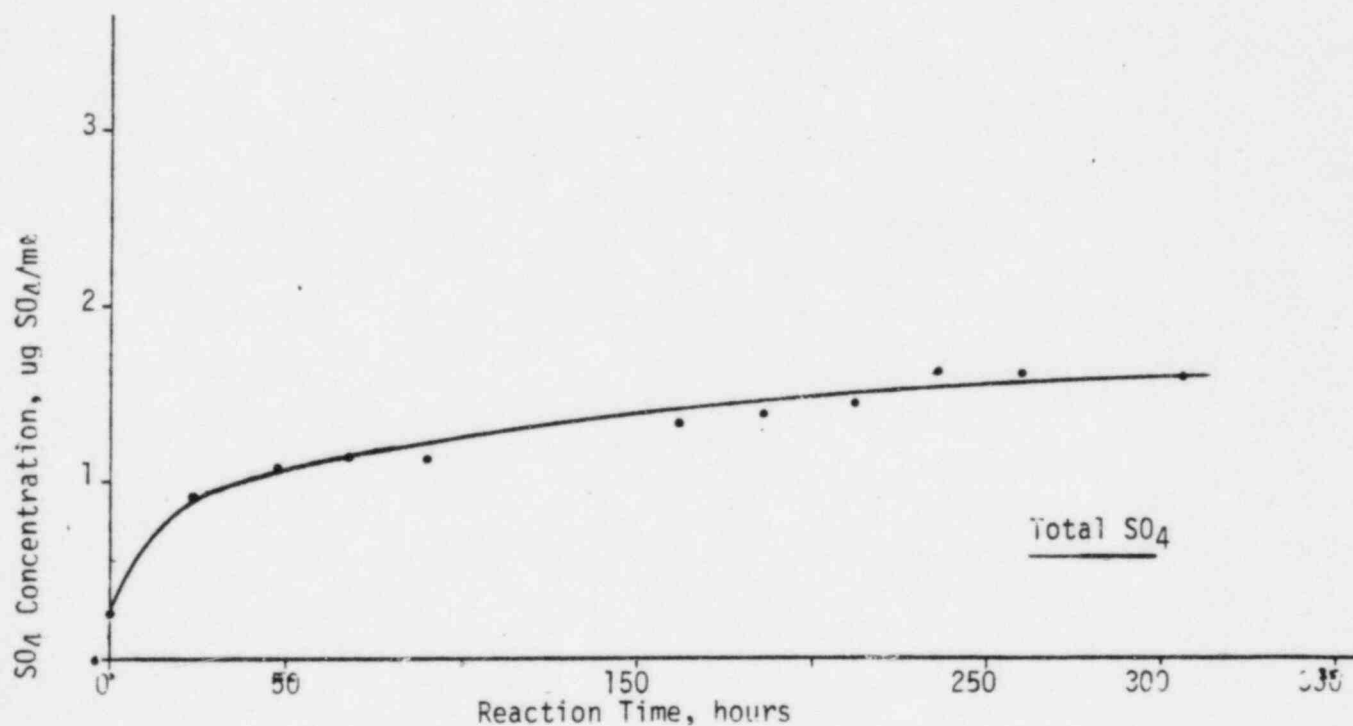
Figure 14. Hydrogen Peroxide and Sulfate Concentrations as a Function of Reaction Time for Immunol Run-1 at pH8 and 130°F (Immunol Treated Tube Sample).
