OVERVIEW OF PROGRESS  
IN THE TMI-1 TUBE CLEANING EXPERIMENT

G.P.U. NUCLEAR

January 31, 1983

R. H. Barnes, A. K. Wensky,  
and J. Lathouse

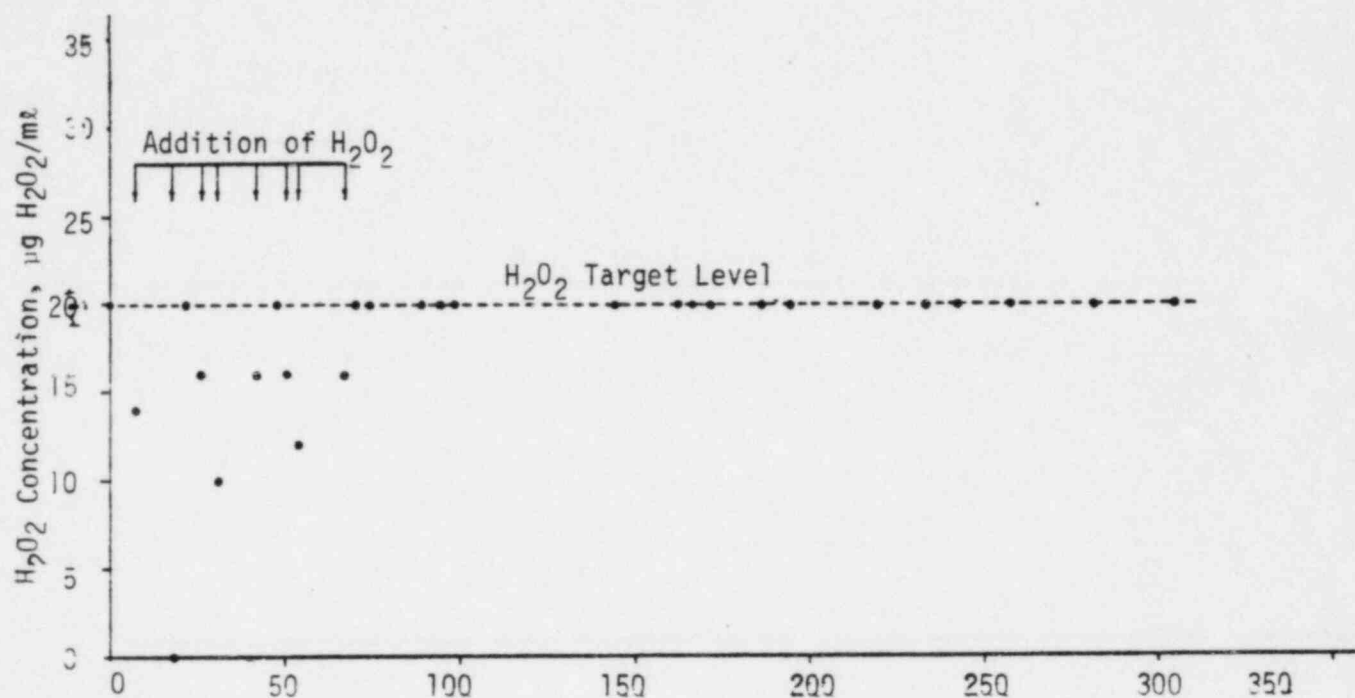
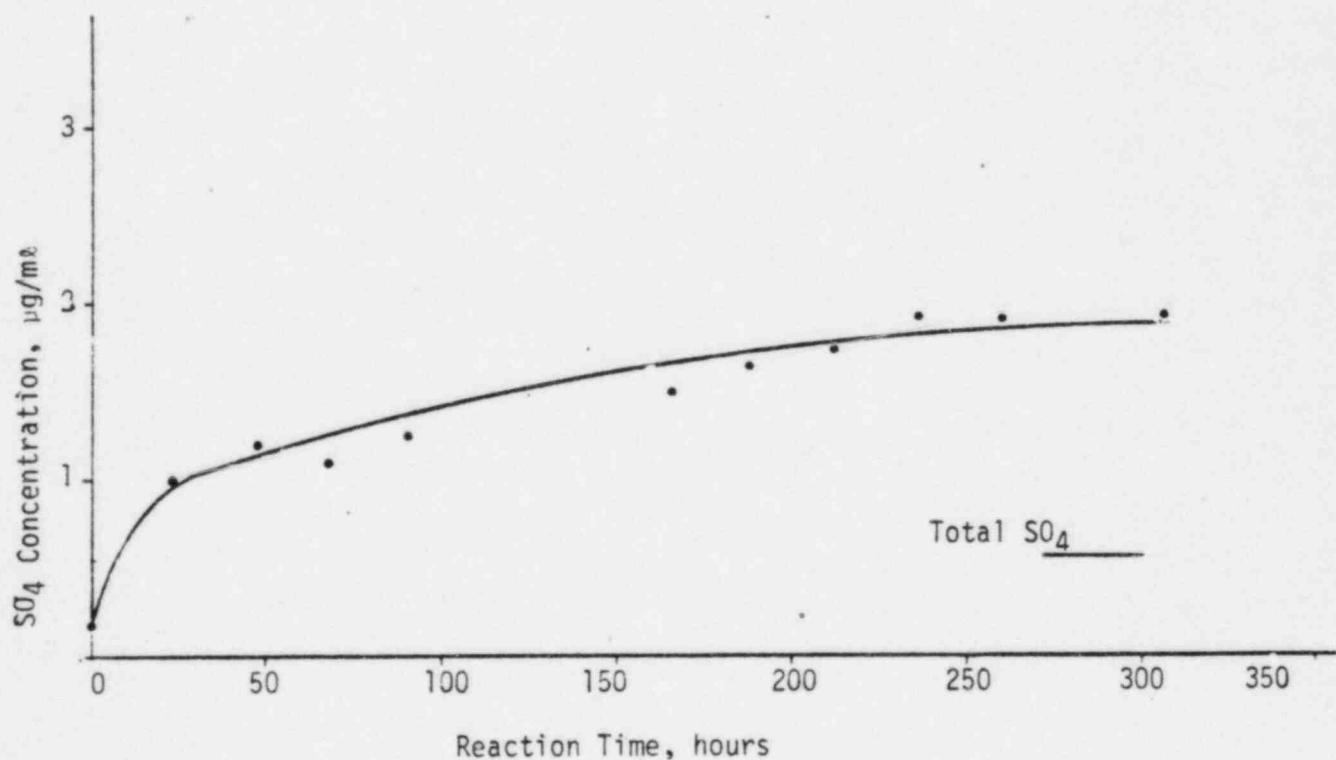
FIGURE 15. HYDROGEN PEROXIDE AND SULFATE CONCENTRATIONS AS A FUNCTION OF REACTION TIME FOR IMMUNOL RUN-2 OF pH 8 AND 130°F (IMMUNOL TREATED TUBE SAMPLE).

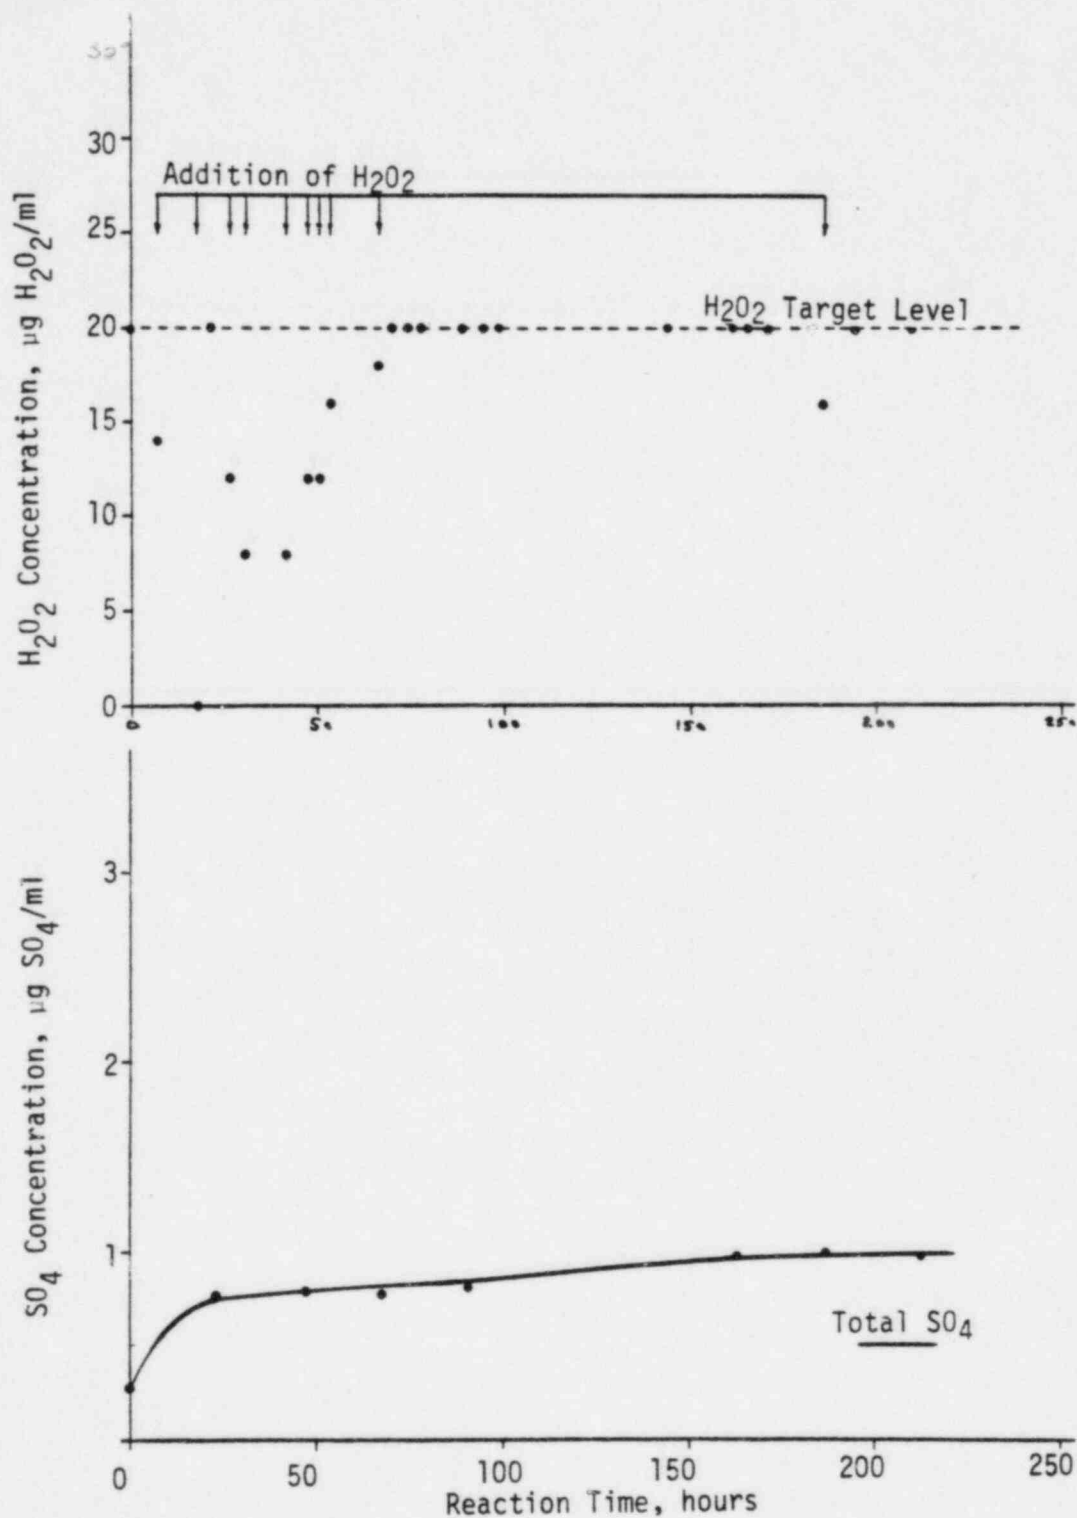
FIGURE 16. HYDROGEN PEROXIDE AND SULFATE CONCENTRATIONS AS A FUNCTION OF REACTION TIME FOR IMMUNOL RUN-3 AT pH 8 AND 130°F (IMMUNOL TREATED TUBE SAMPLE).

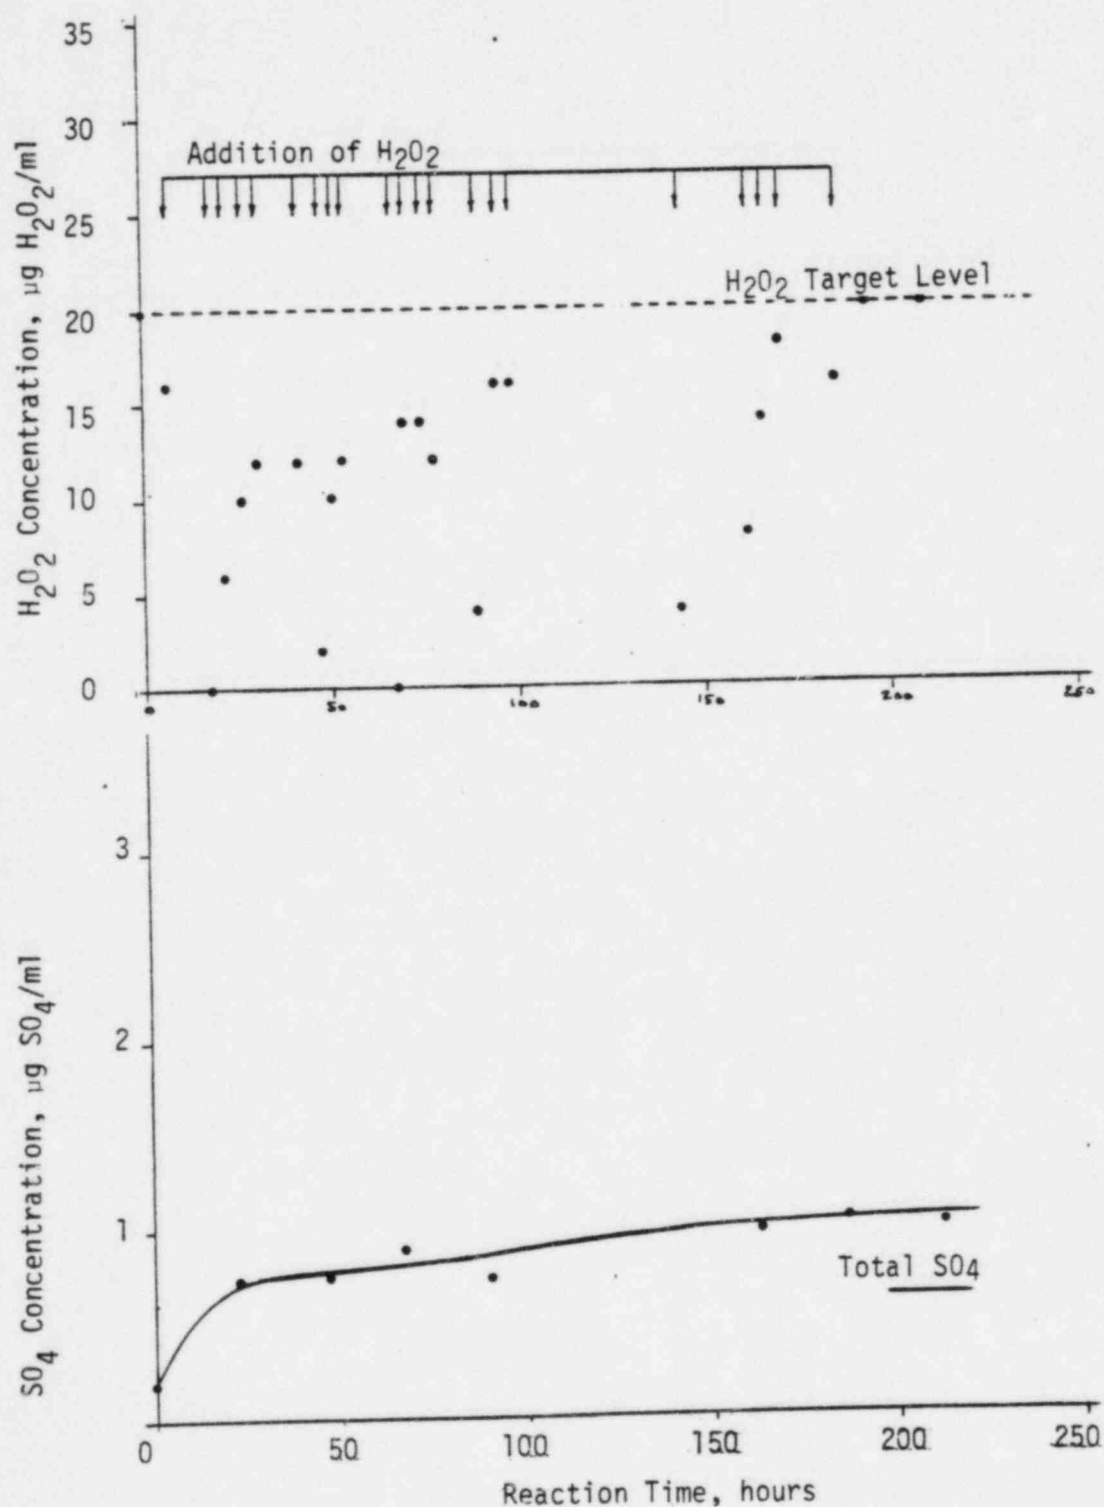
FIGURE 17. HYDROGEN PEROXIDE AND SULFATE CONCENTRATIONS AS A FUNCTION OF REACTION TIME FOR IMMUNOL RUN-4 AT pH8 AND 130°F (UNTREATED TUBE SAMPLE).

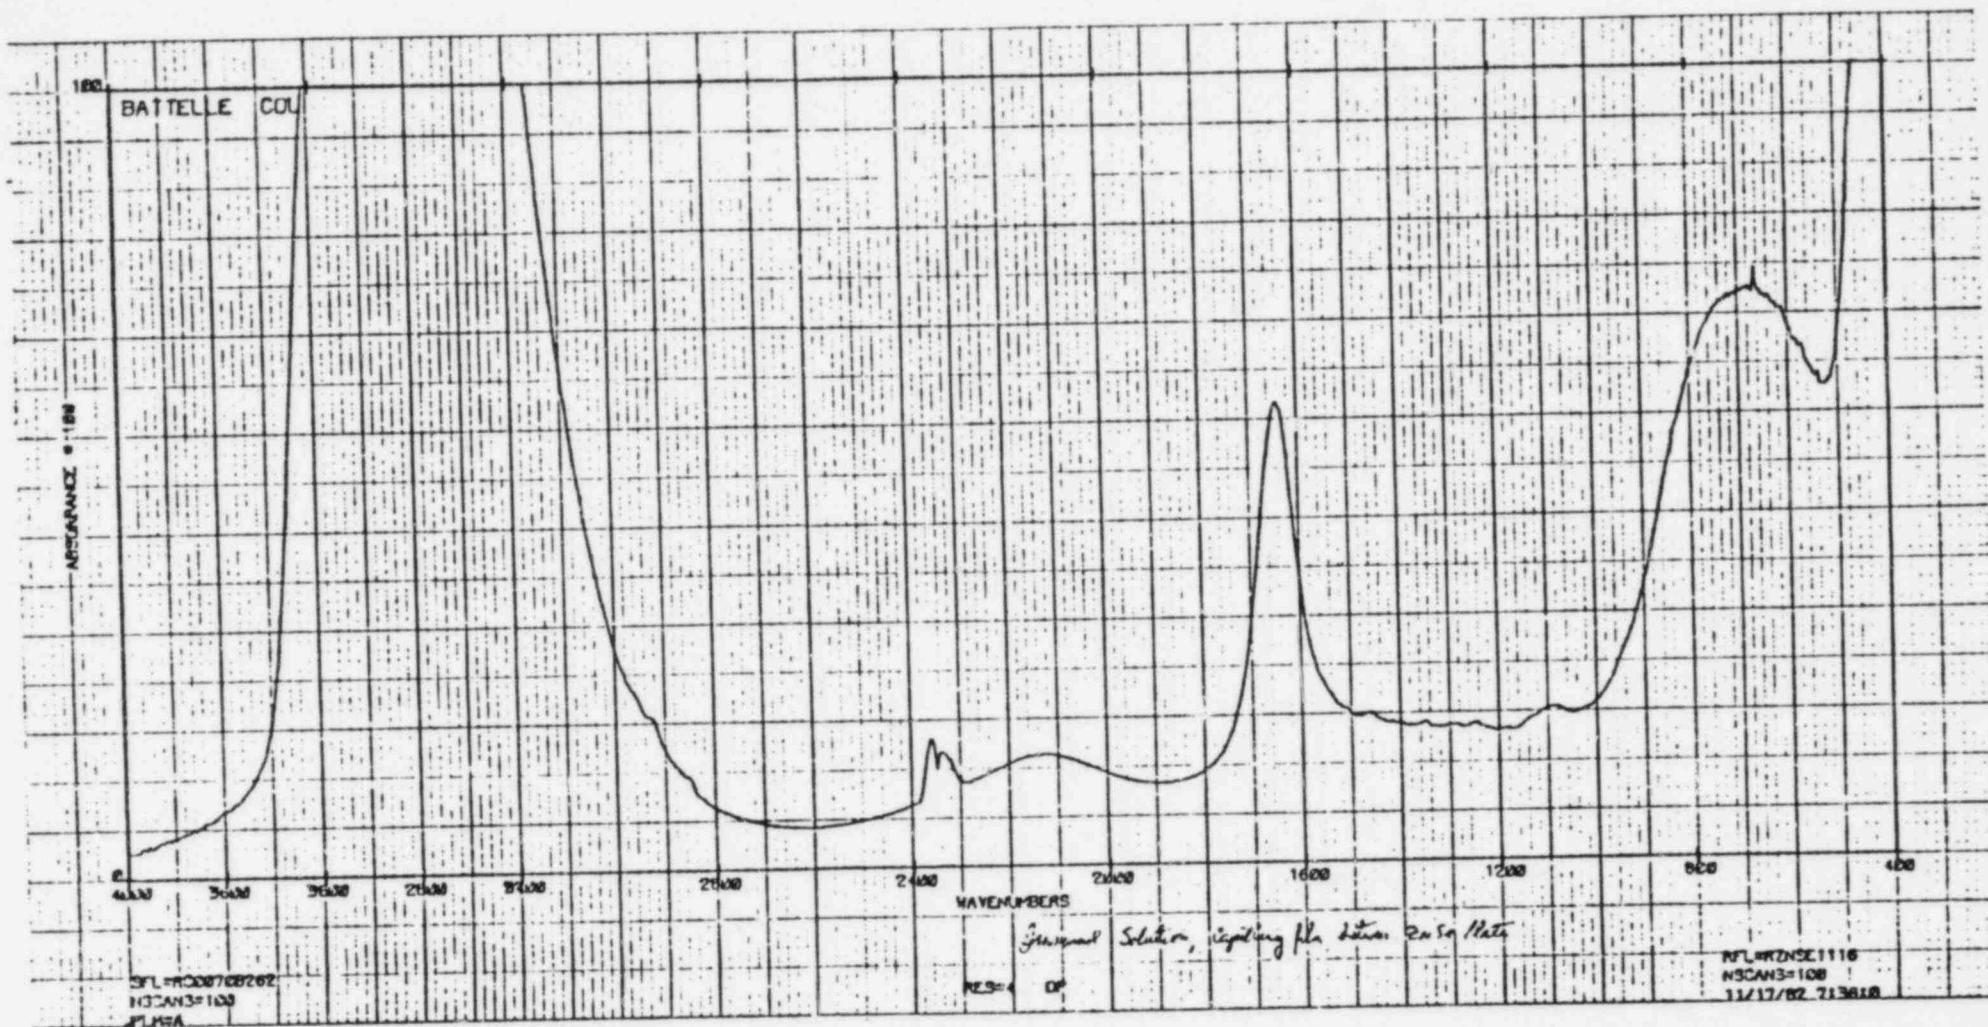
FIGURE 18. INFRARED TRANSMISSION SPECTRUM OF DYED IMMUNOL SOLUTION LOT B-2-62 (THIS MATERIAL USED TO PREPARE TUBE SAMPLES SUPPLIED TO BATTELLE BY B&W).

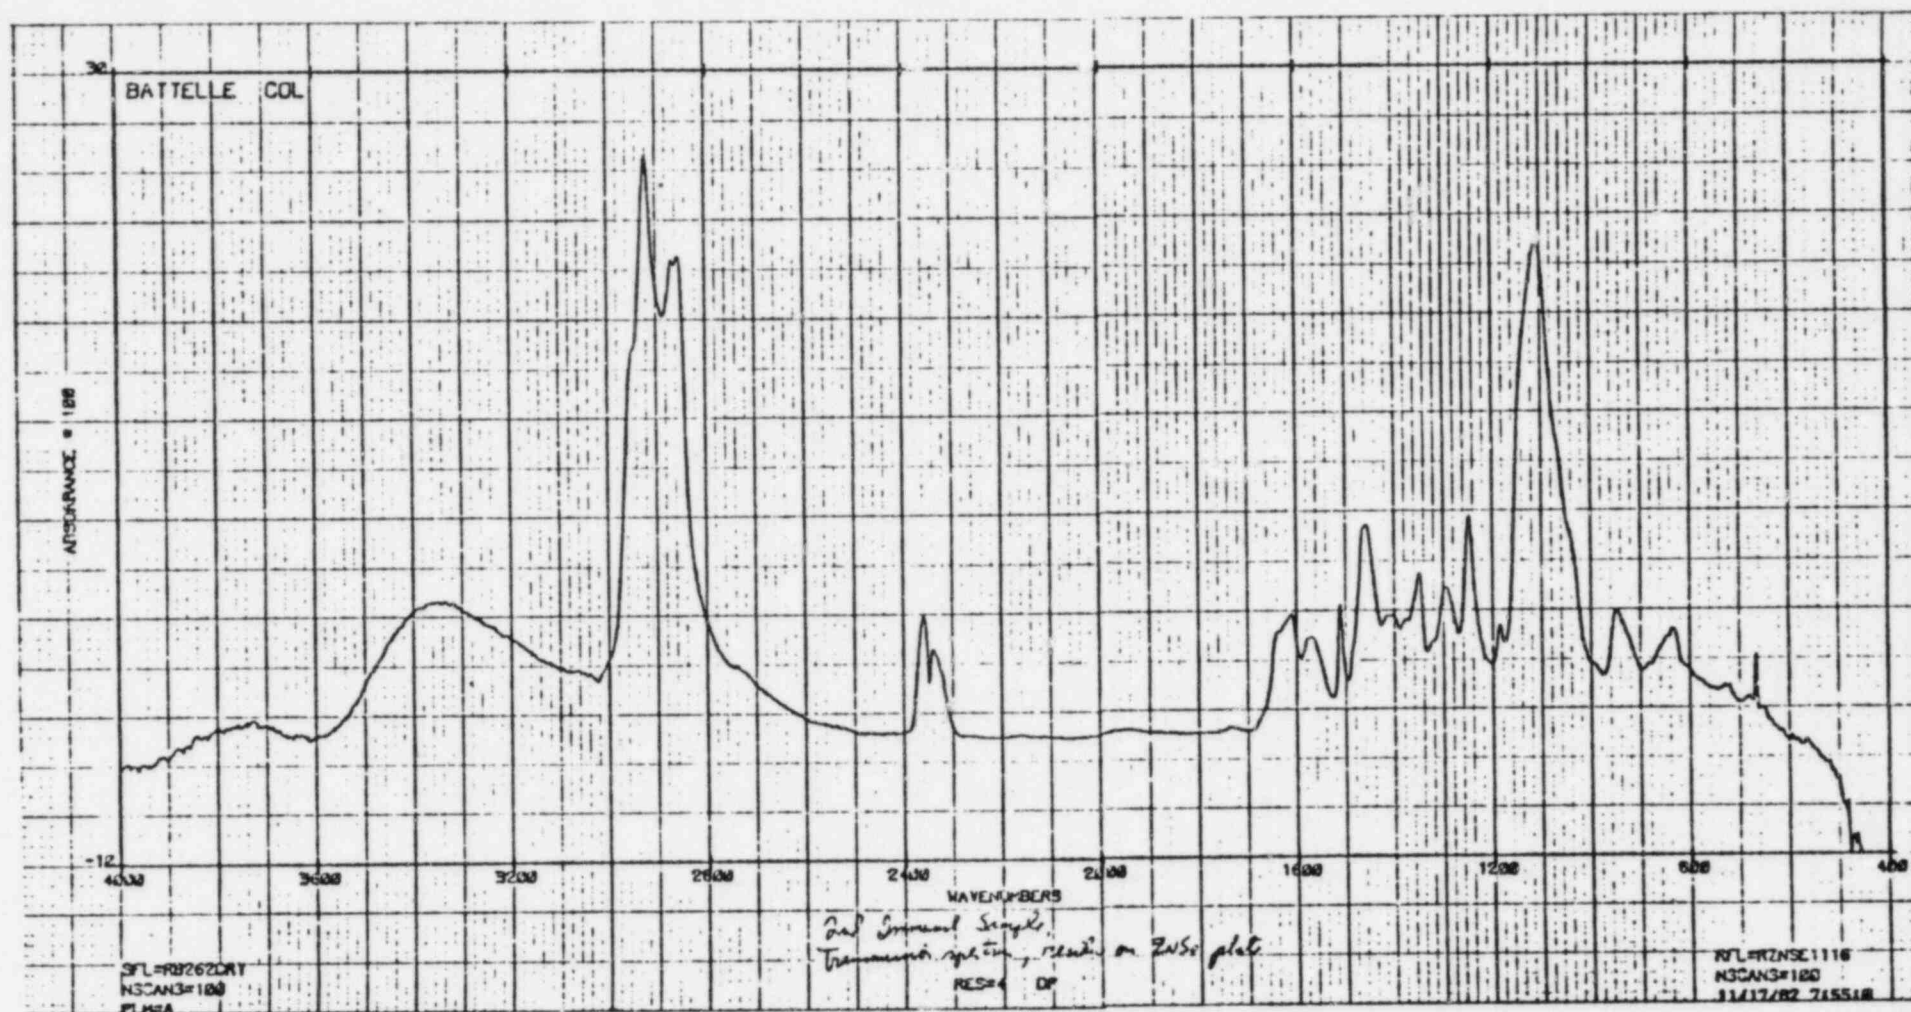
FIGURE 19. INFRARED TRANSMISSION SPECTRUM FOR RESIDUE FROM DYED IMMUNOL LOT NO. B-2-62. SAMPLES EVAPORATED ON ZeSe PLATE. (THIS MATERIAL USED TO PREPARE TUBE SAMPLES SUPPLIED TO BATTELLE BY B&W).

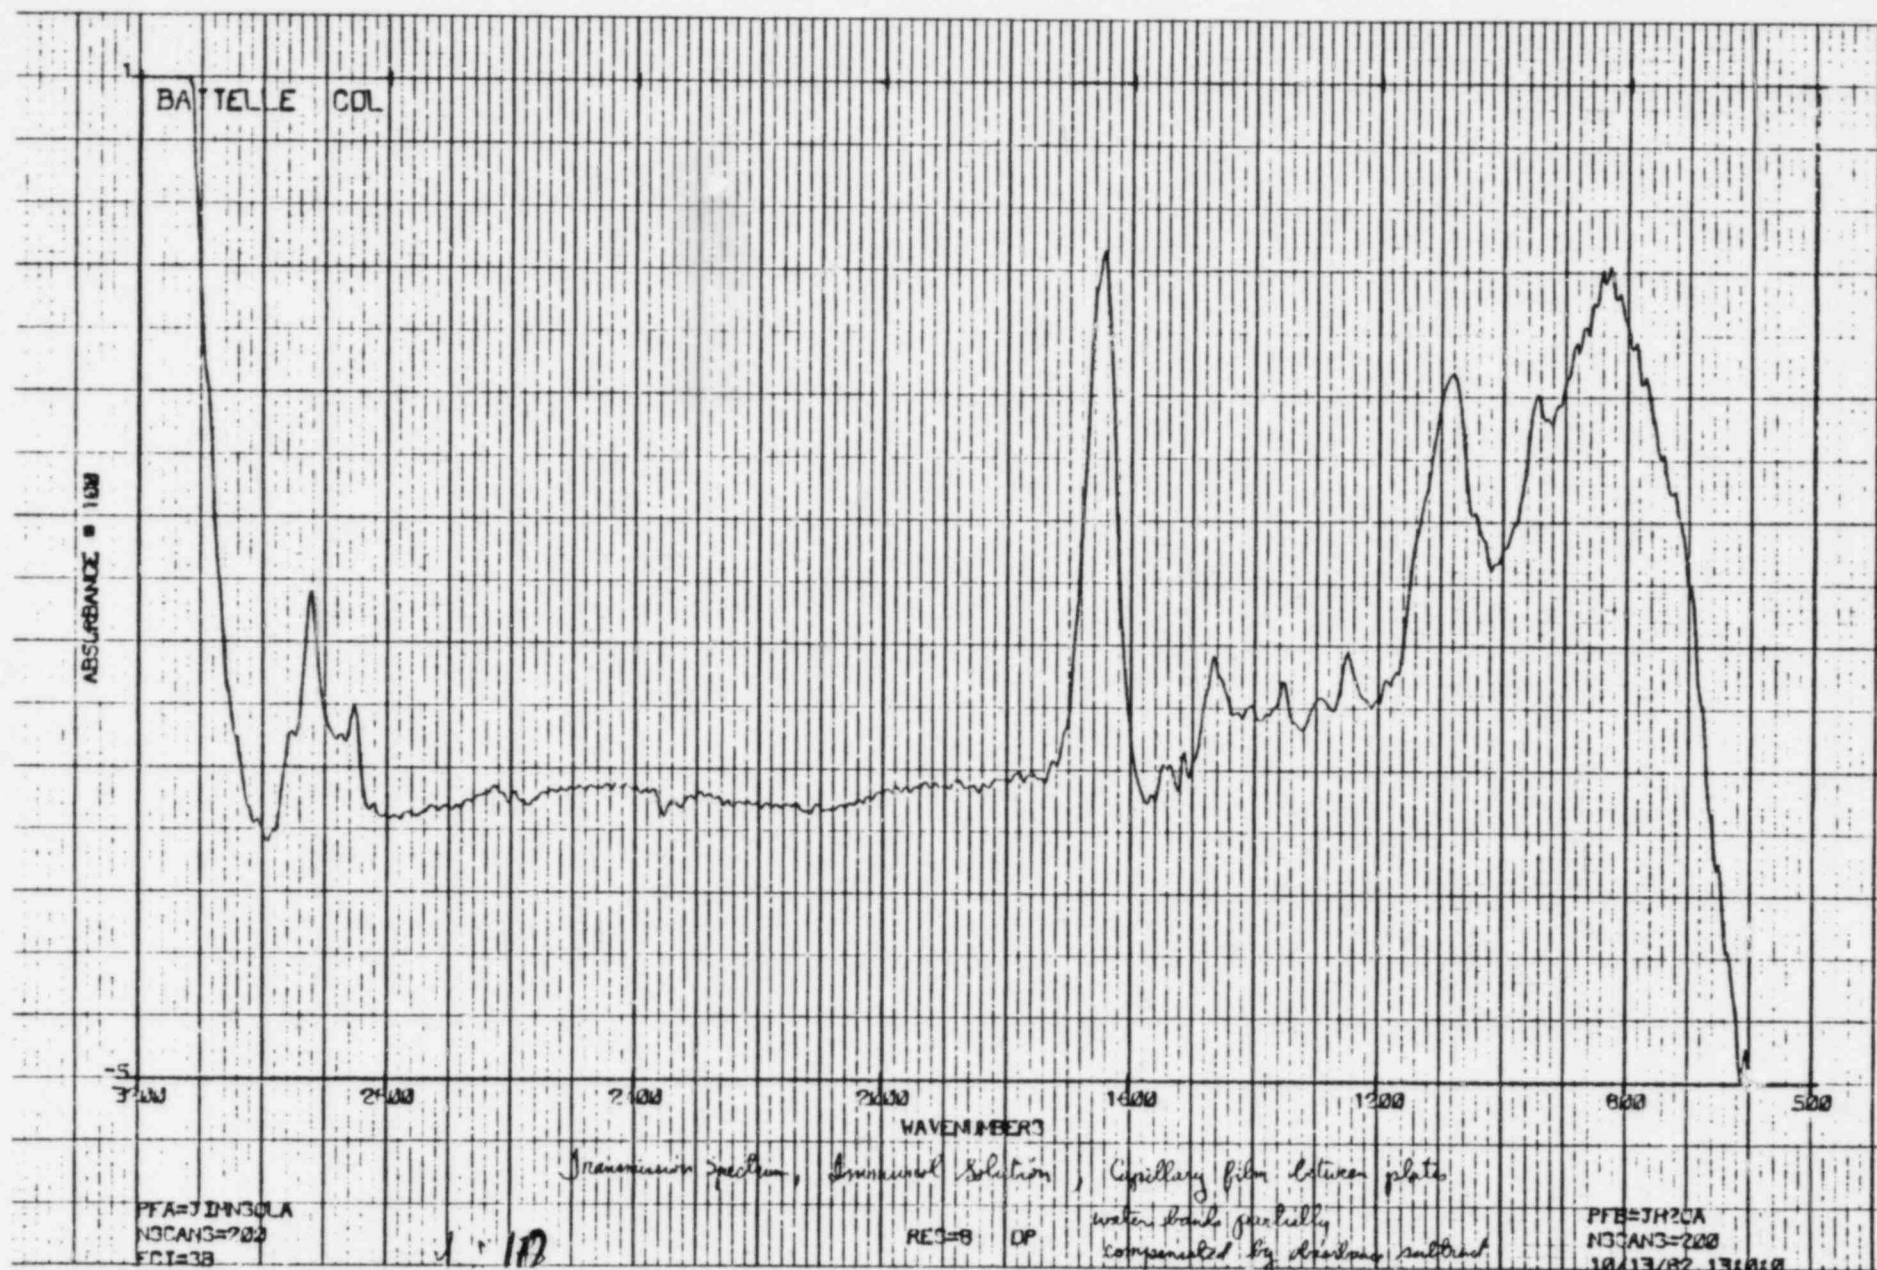
FIGURE 20. INFRARED TRANSMISSION SPECTRUM OF DYED IMMUNOL SOLUTION LOT NO. B-46-99 (THIS MATERIAL SUPPLIED TO BATTELLE BY SANDY POTTERTON OF B&W).

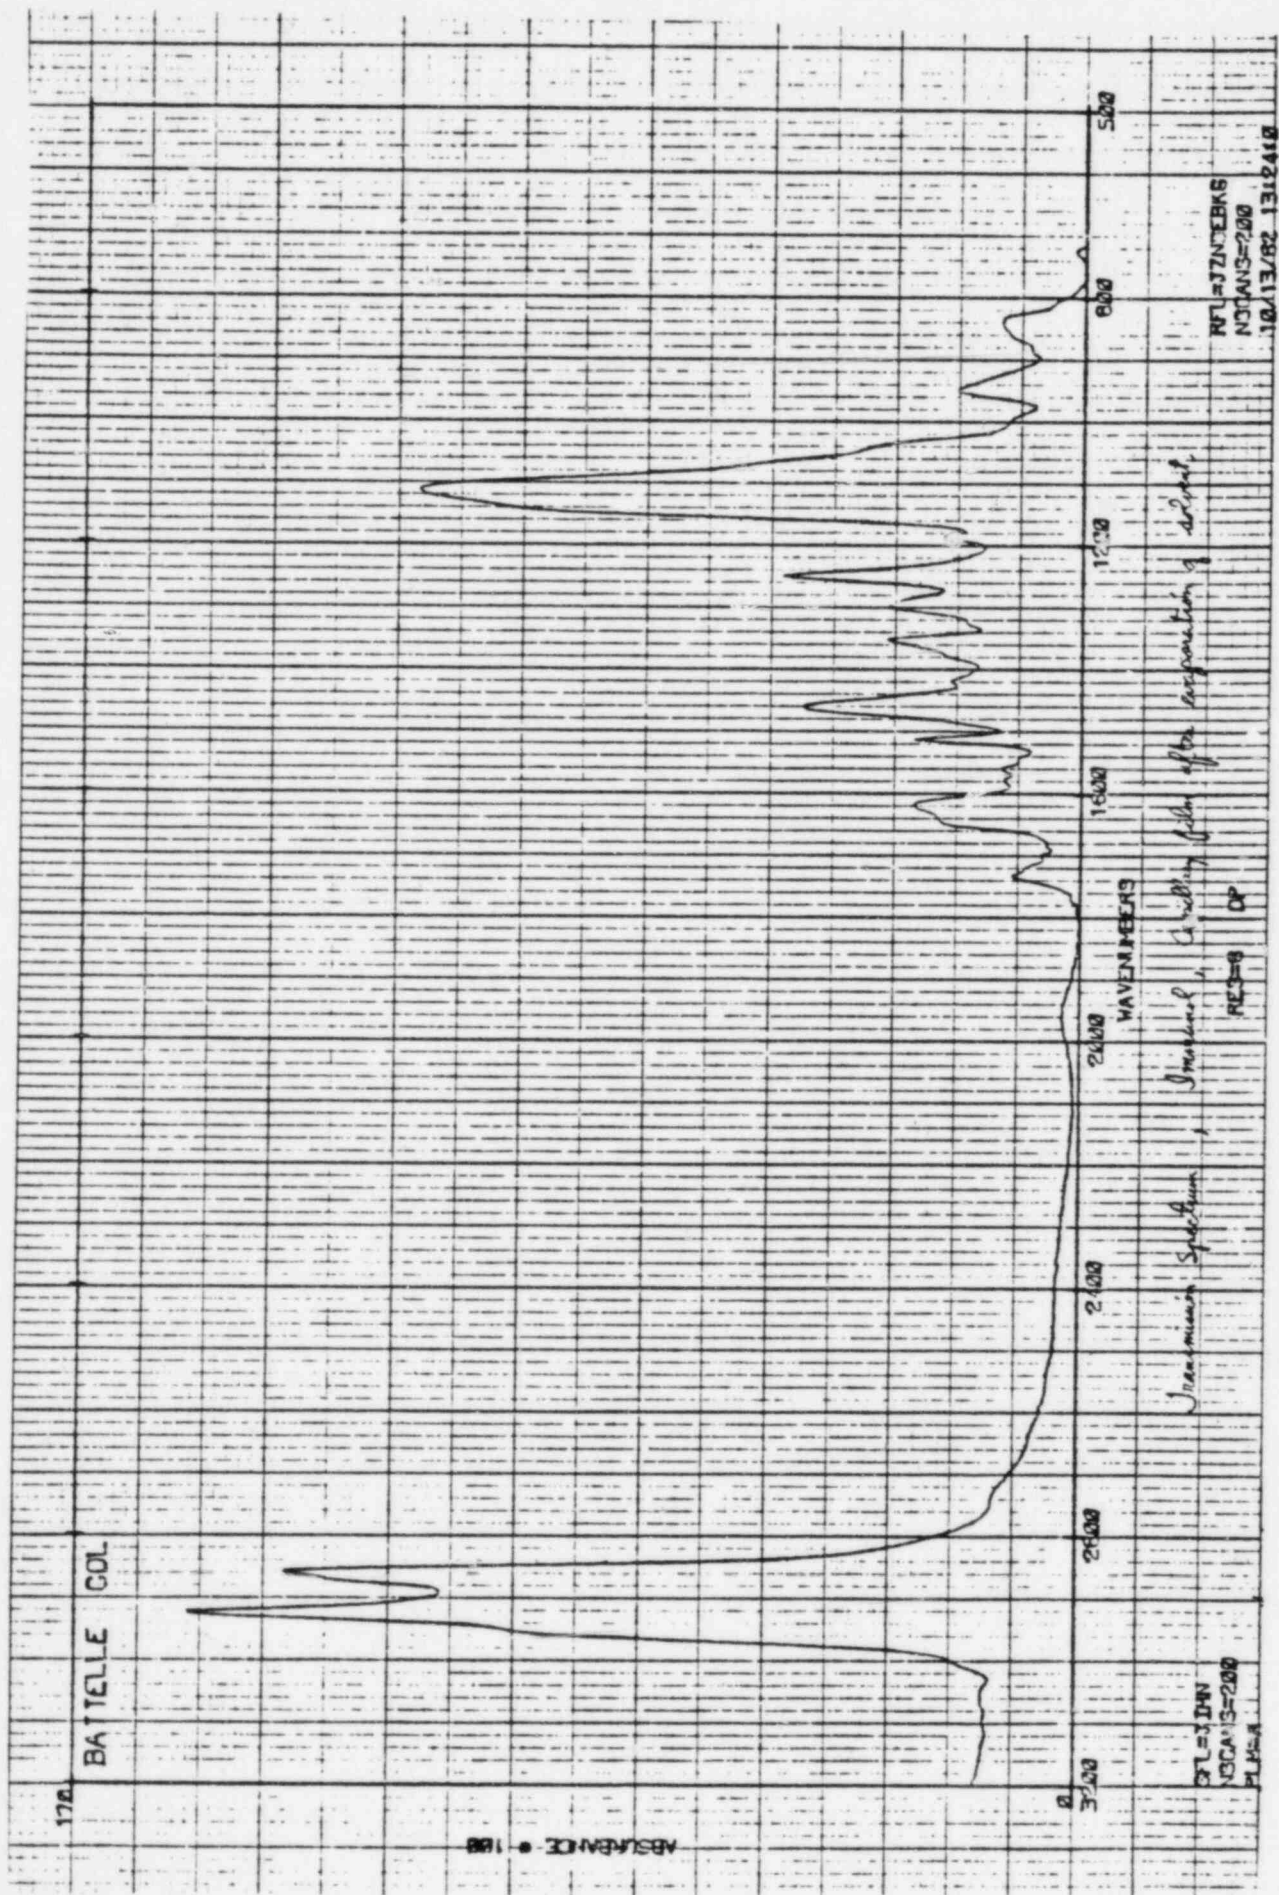
FIGURE 21. INFRARED TRANSMISSION SPECTRUM FOR RESIDUE FROM DYED IMMUNOL LOT NO. B-46-99. SAMPLE EVAPORATED ON ZeSe PLATE. (THIS MATERIAL SUPPLIED TO BATTELLE BY SANDY POTTERTON OF B&W).

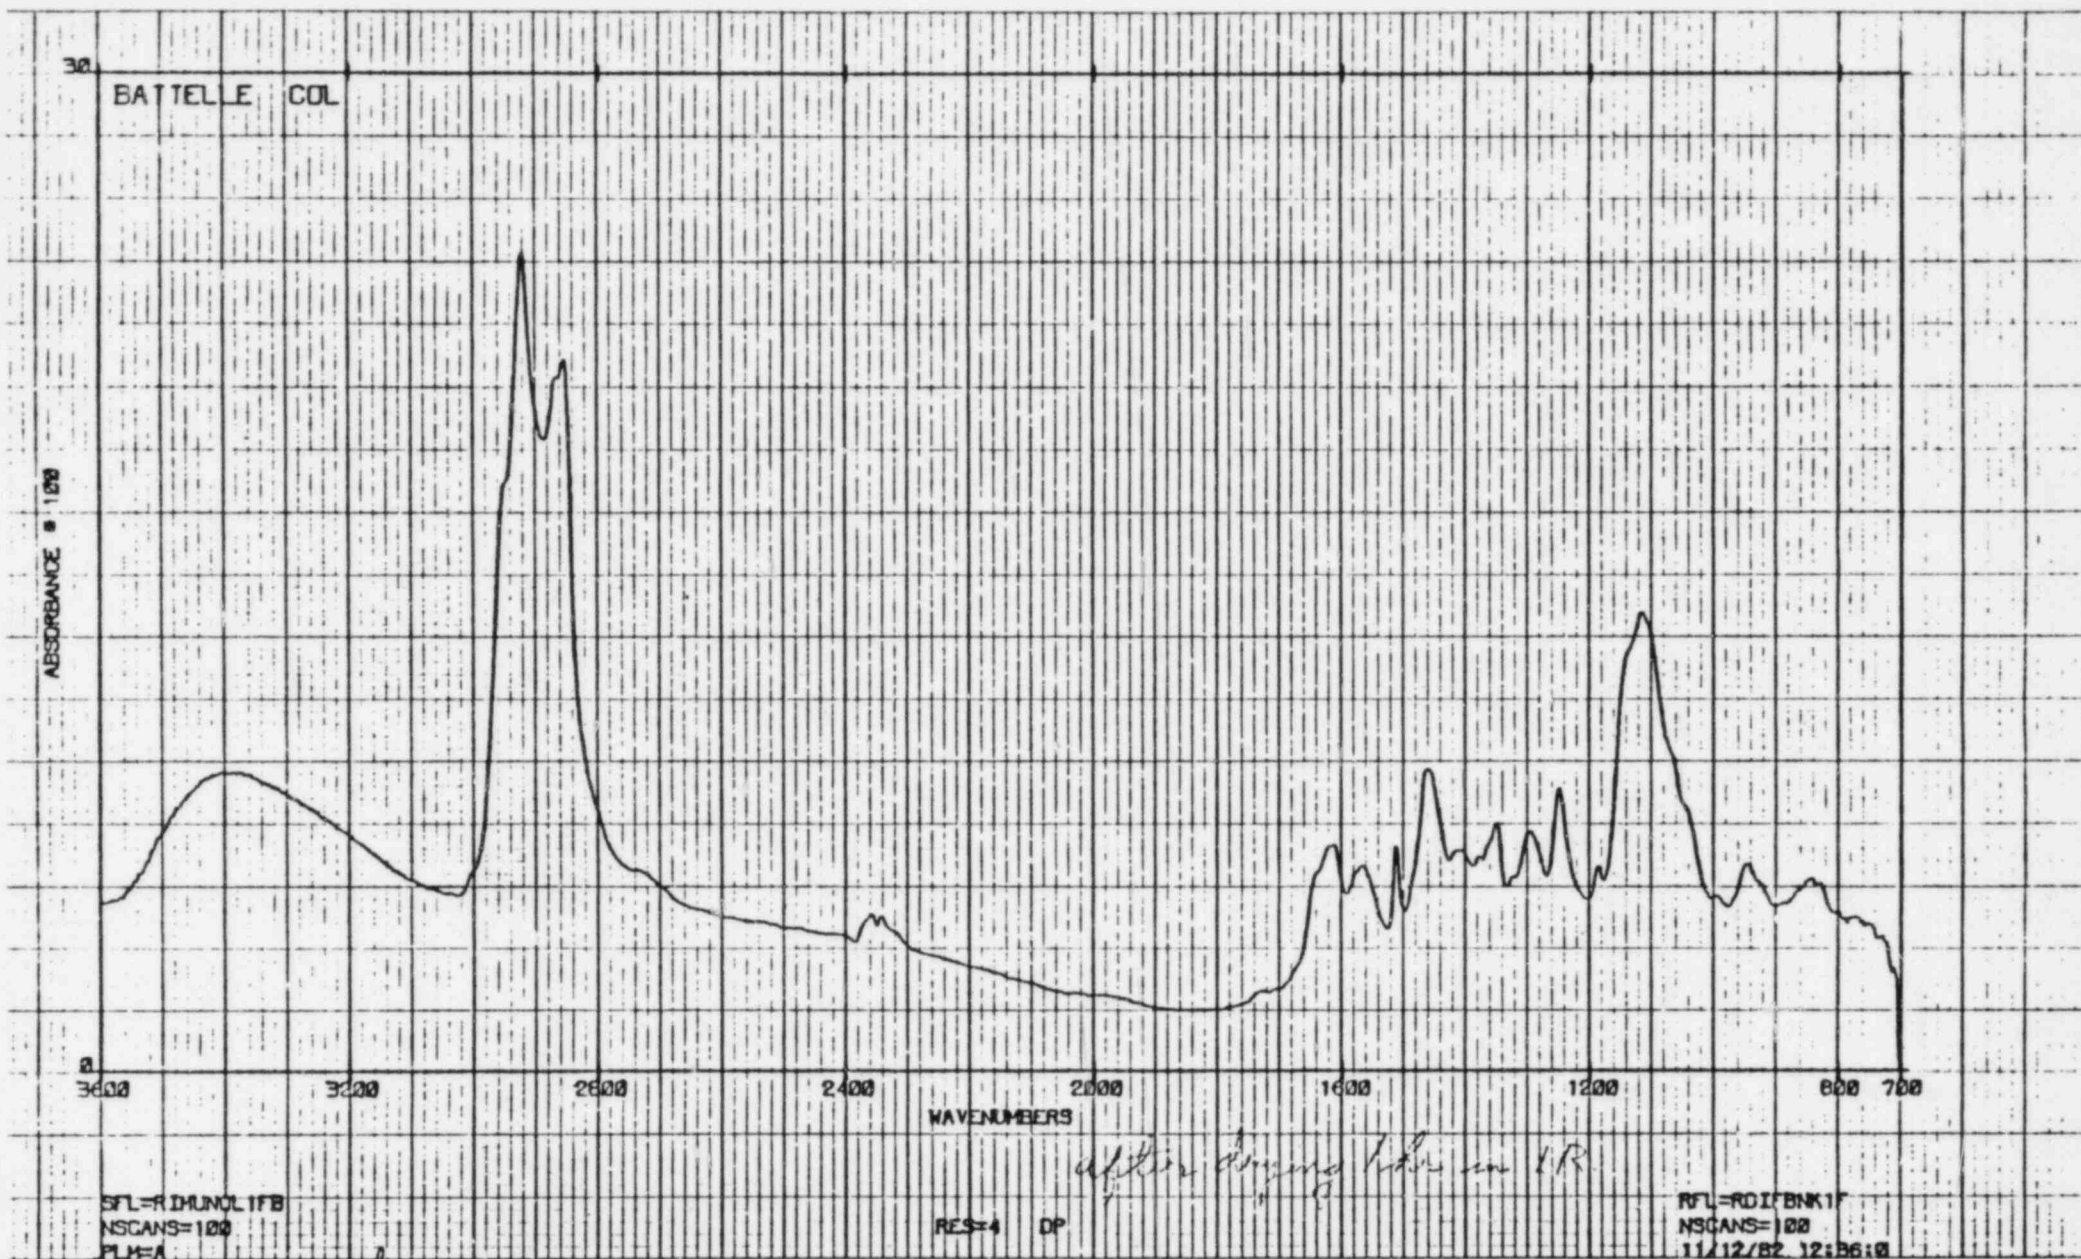
FIGURE 22. INFRARED DIFFUSE REFLECTANCE SPECTRUM FOR DYED IMMUNOL FILM (LOT NO. B-49-99) ON INCONEL-600 SURFACE AFTER DRYING FILM FOR 1 HOUR WITH INFRARED HEAT LAMP (THIS MATERIAL SUPPLIED TO BATTELLE BY SANDY POTTERTON OF B&W).

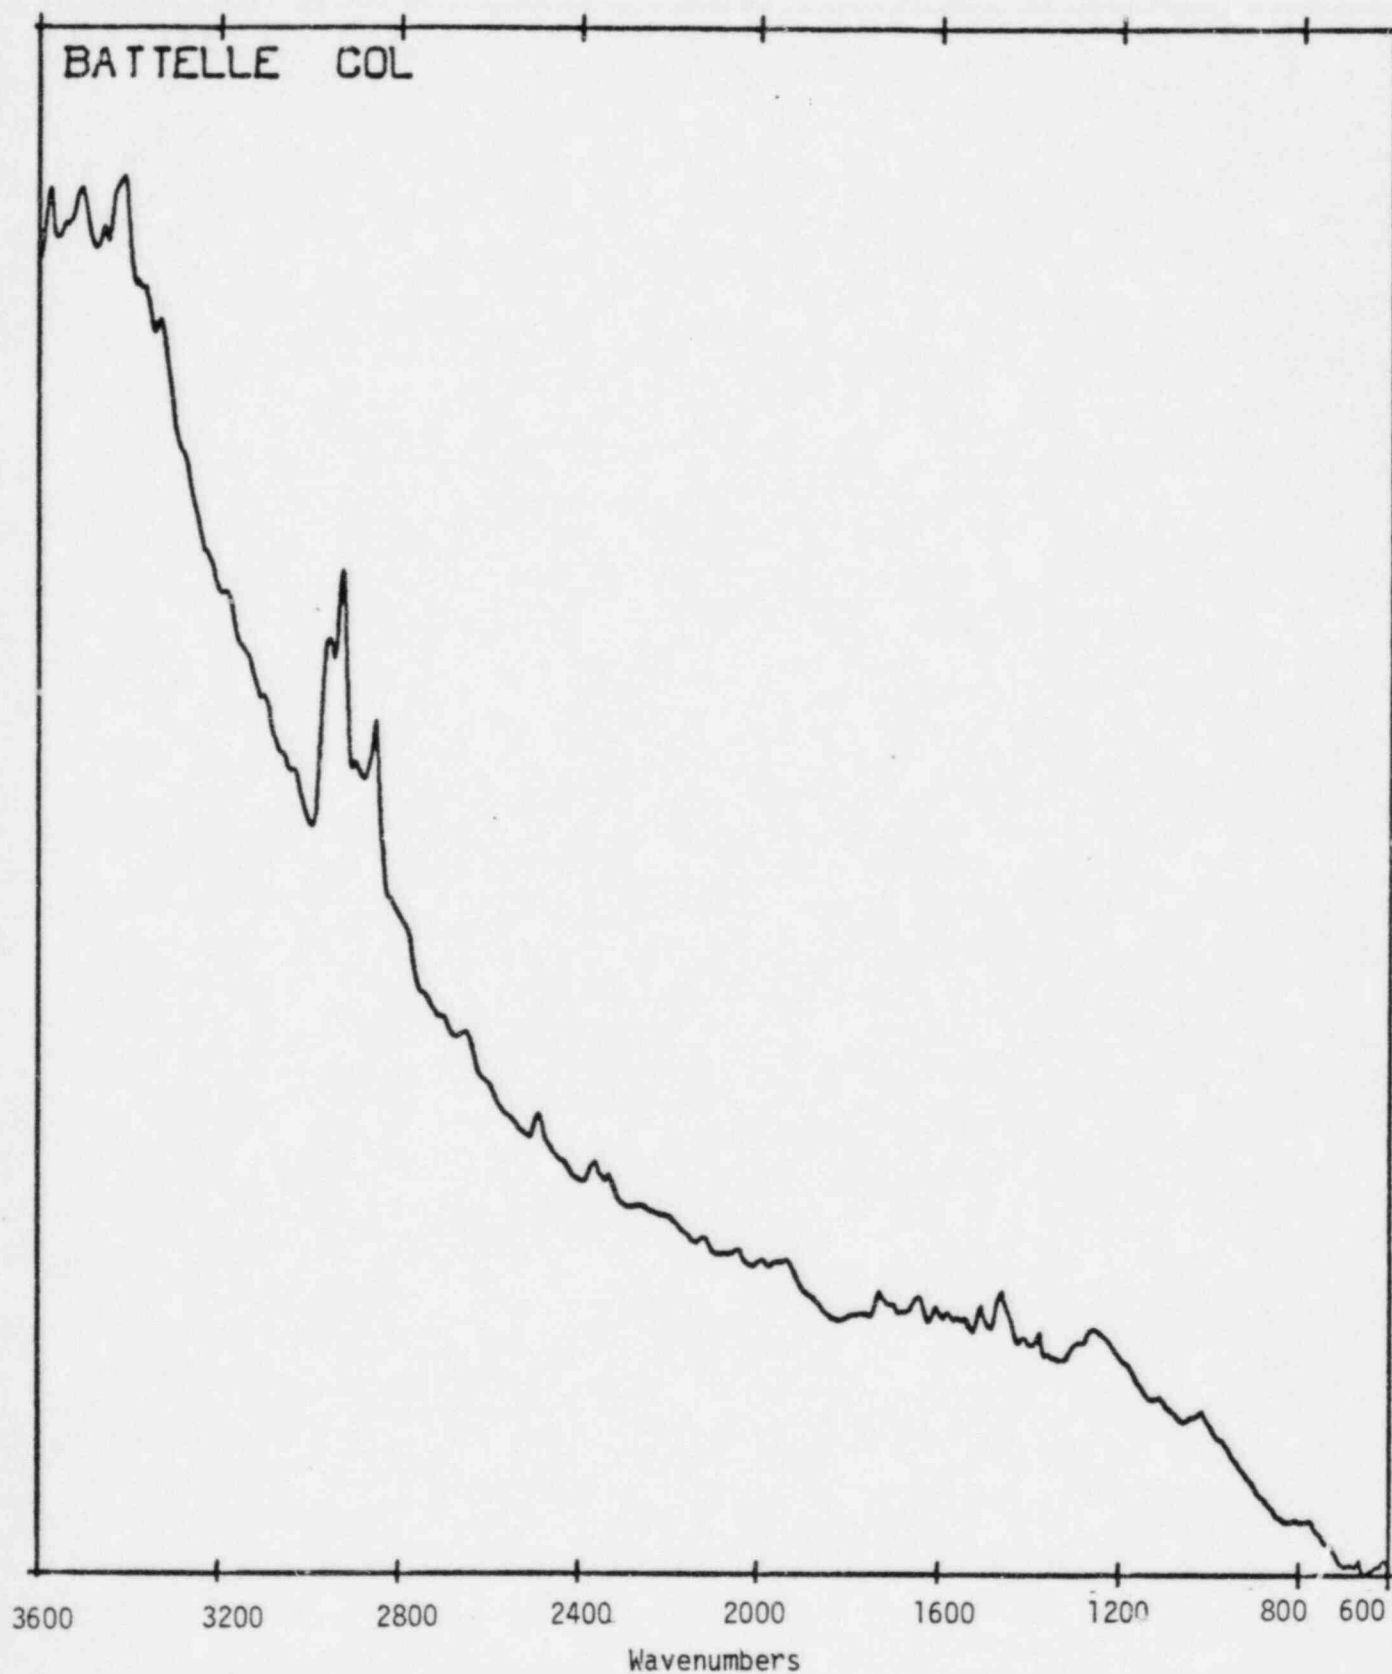
FIGURE 23. INFRARED DIFFUSE REFLECTANCE SPECTRUM FOR ID SURFACE OF TUBE SAMPLE 3-1 AFTER PEROXIDE CLEANING (IMMUNOL RUN-1).

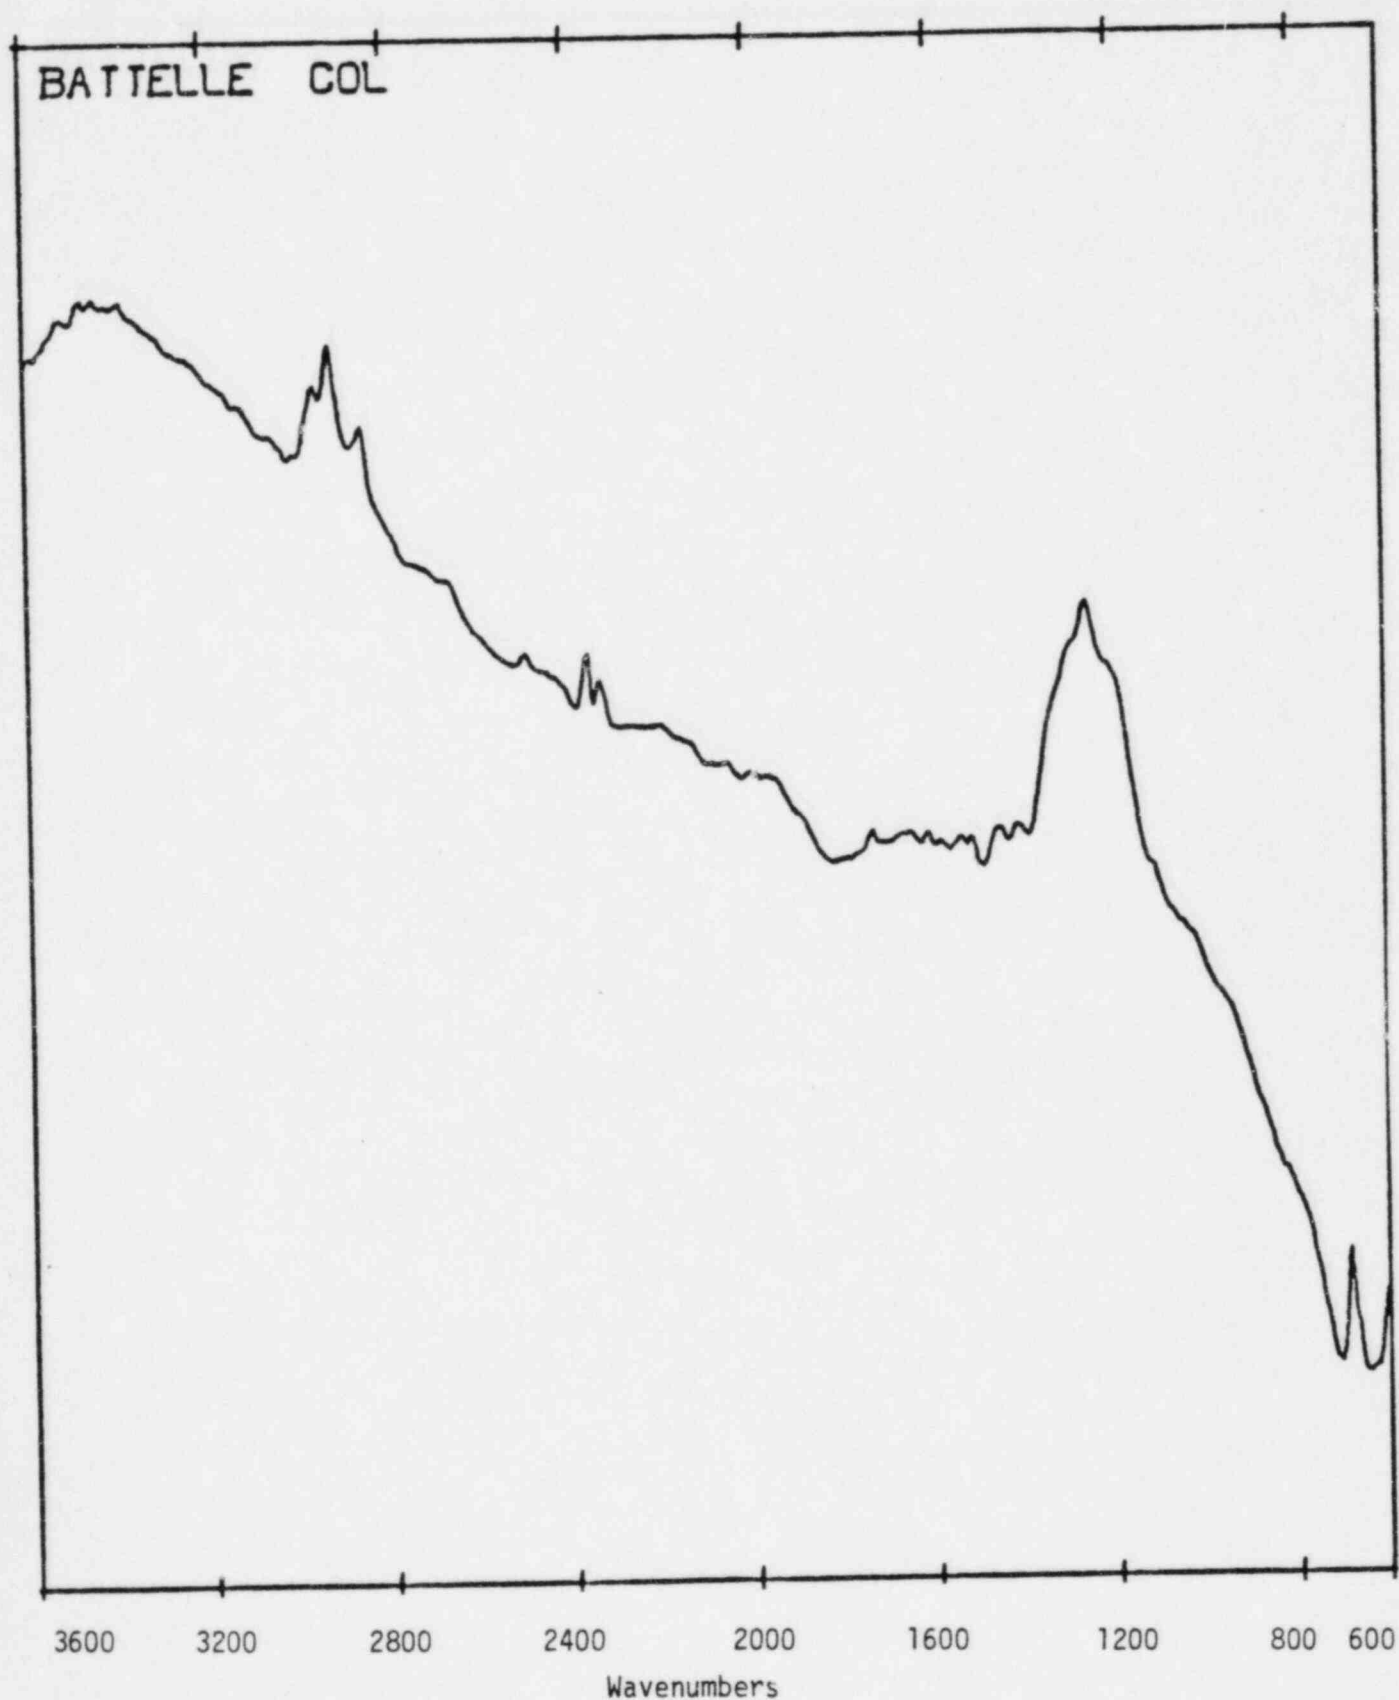
FIGURE 24. INFRARED DIFFUSE REFLECTANCE SPECTRUM FOR DARK SPOT ON ID SURFACE OF TUBE SAMPLE 3-3 AFTER PEROXIDE CLEANING (IMMUNOL RUN-1).

The only evidence for the presence of anything besides a hydrocarbon was observed on sample Number 3-3. In this case, the spectrometer beam was focused on a dark spot on the ID surface of the tube sample.
