OVERVIEW OF PROGRESS  
IN THE TMI-1 TUBE CLEANING EXPERIMENT

G.P.U. NUCLEAR

January 31, 1983

R. H. Barnes, A. K. Wensky,  
and J. Lathouse

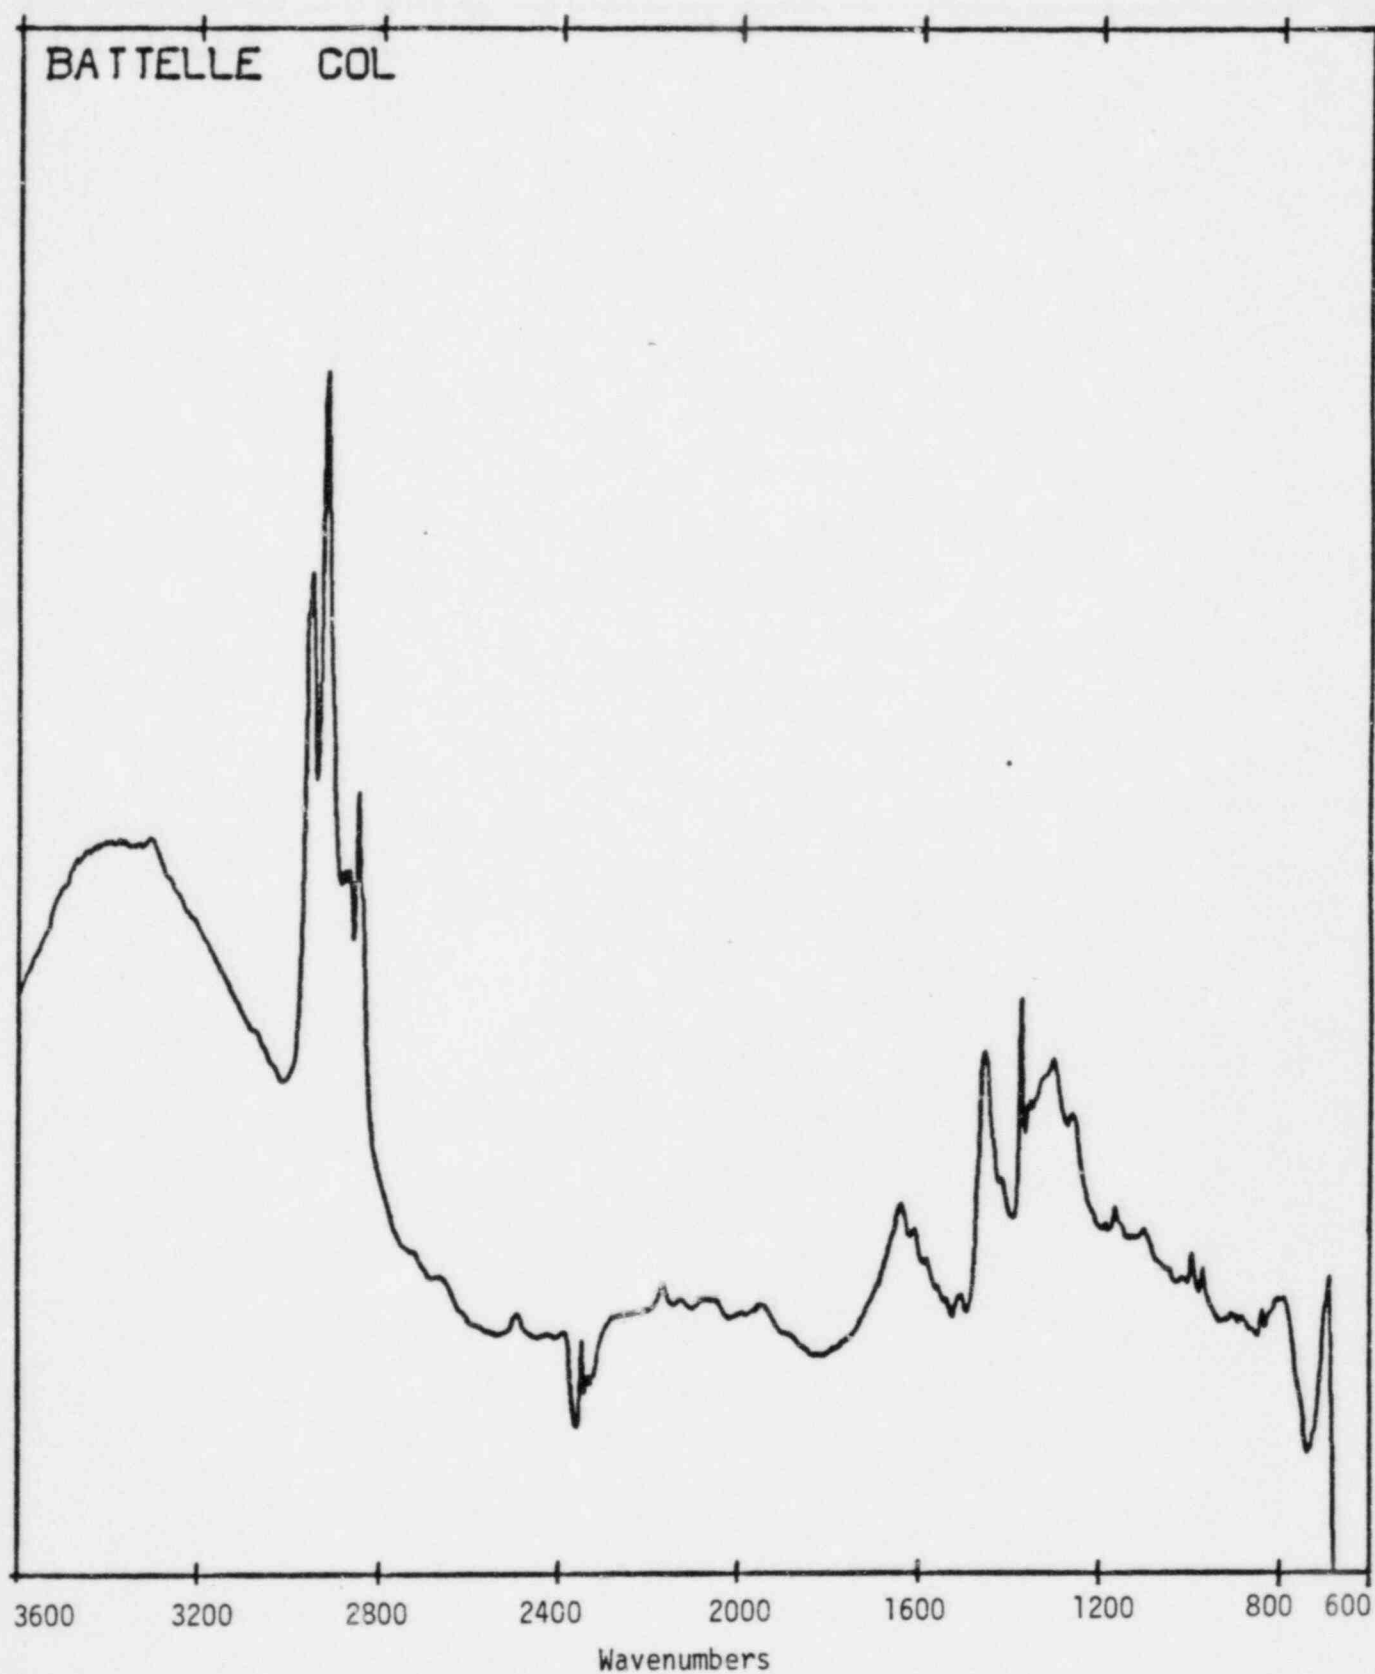
FIGURE 25a. INFRARED DIFFUSE REFLECTANCE SPECTRUM FOR UNCLEARED ID SURFACE OF SAMPLE FROM PIECE 4 OF TUBE NO. AS 111-13.

The infrared diffuse reflectance spectra for an uncleaned sample of tube piece 4 and the peroxide cleaned samples were essentially identical. A typical spectrum is given in Figure 25(a). The weak doublet near  $1000\text{ cm}^{-1}$  is characteristic of isotactic polypropylene (Figure 25(b)). Relative intensities of the bands around  $2900\text{ cm}^{-1}$  differ somewhat from those usually found in normal isotactic polypropylene films.

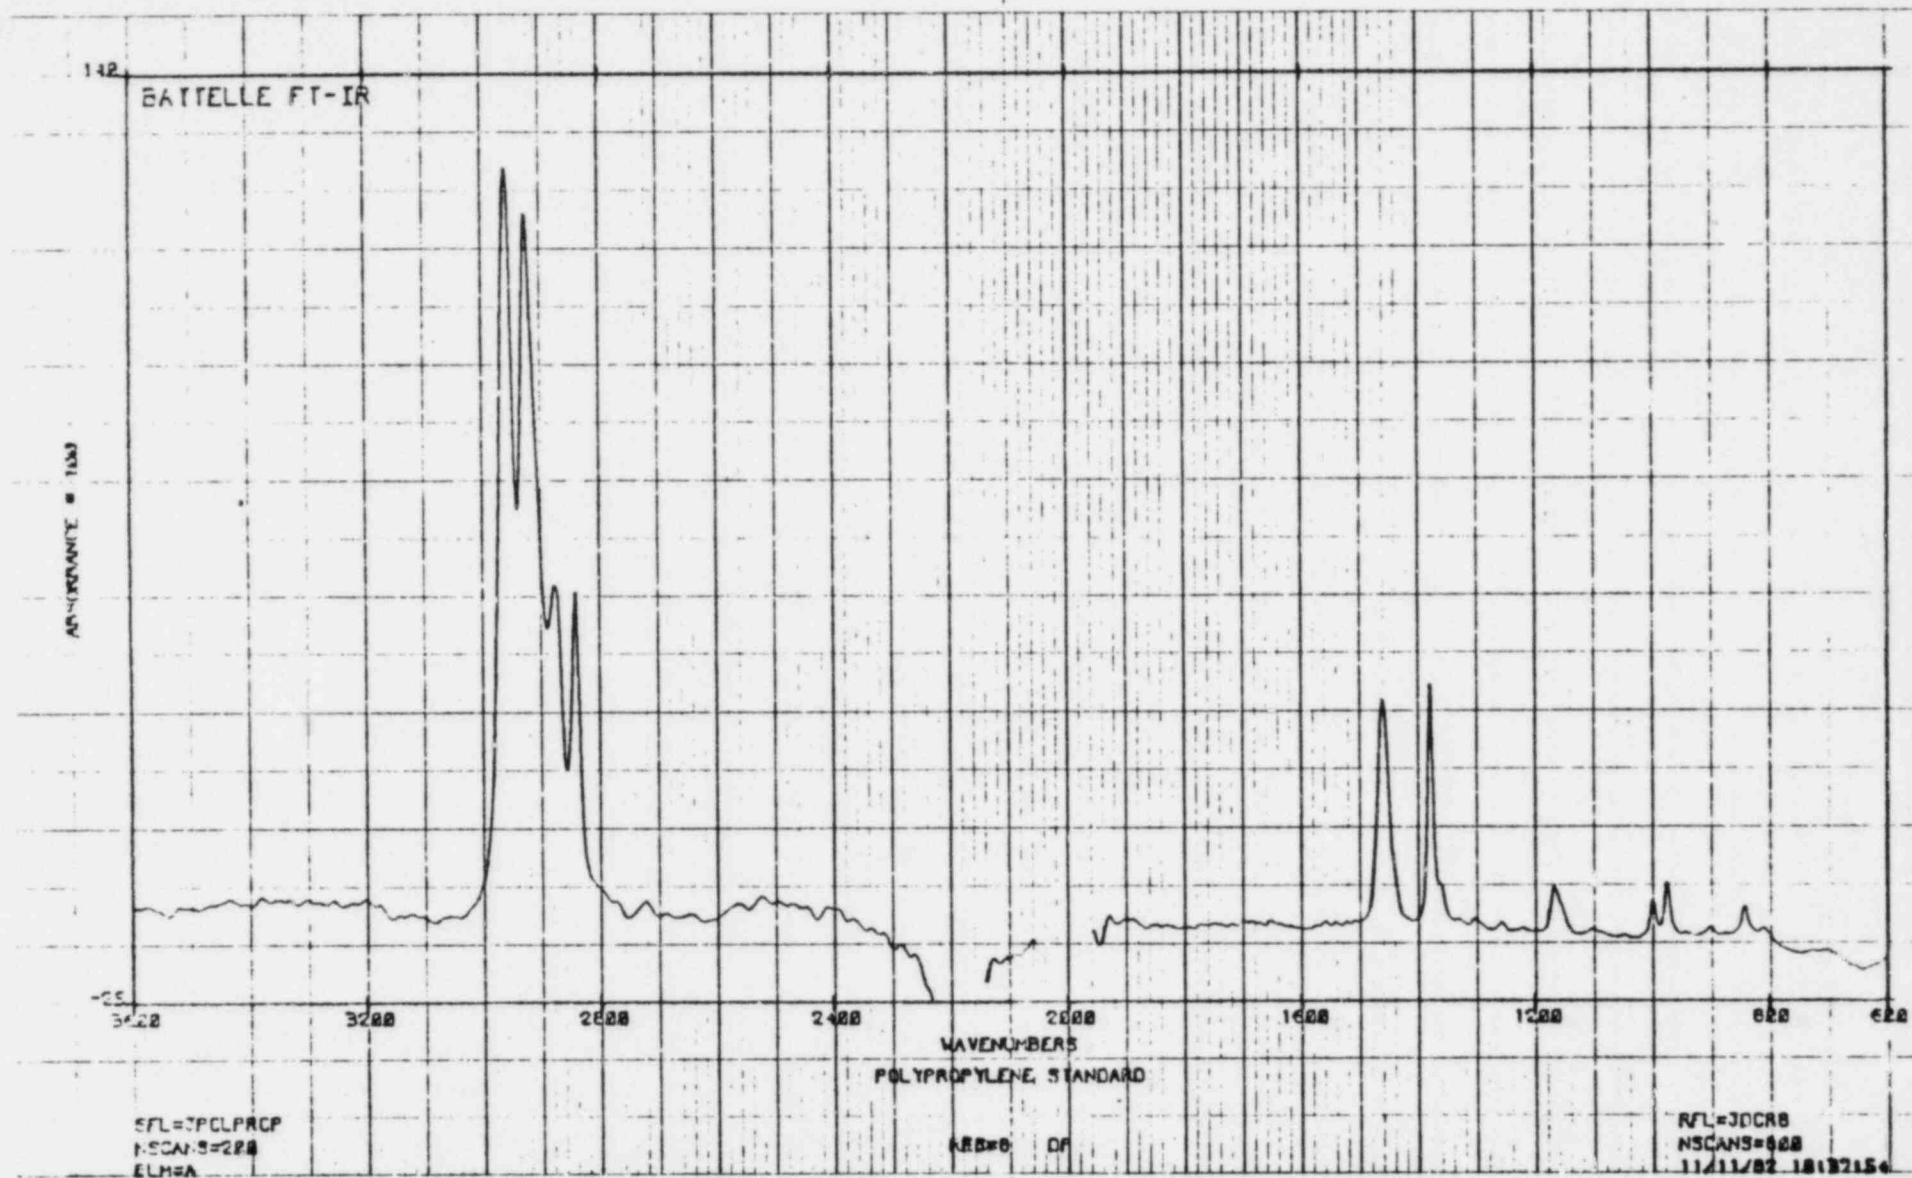
FIGURE 25b. INFRARED TRANSMISSION SPECTRUM FOR POLYPROPYLENE STANDARD

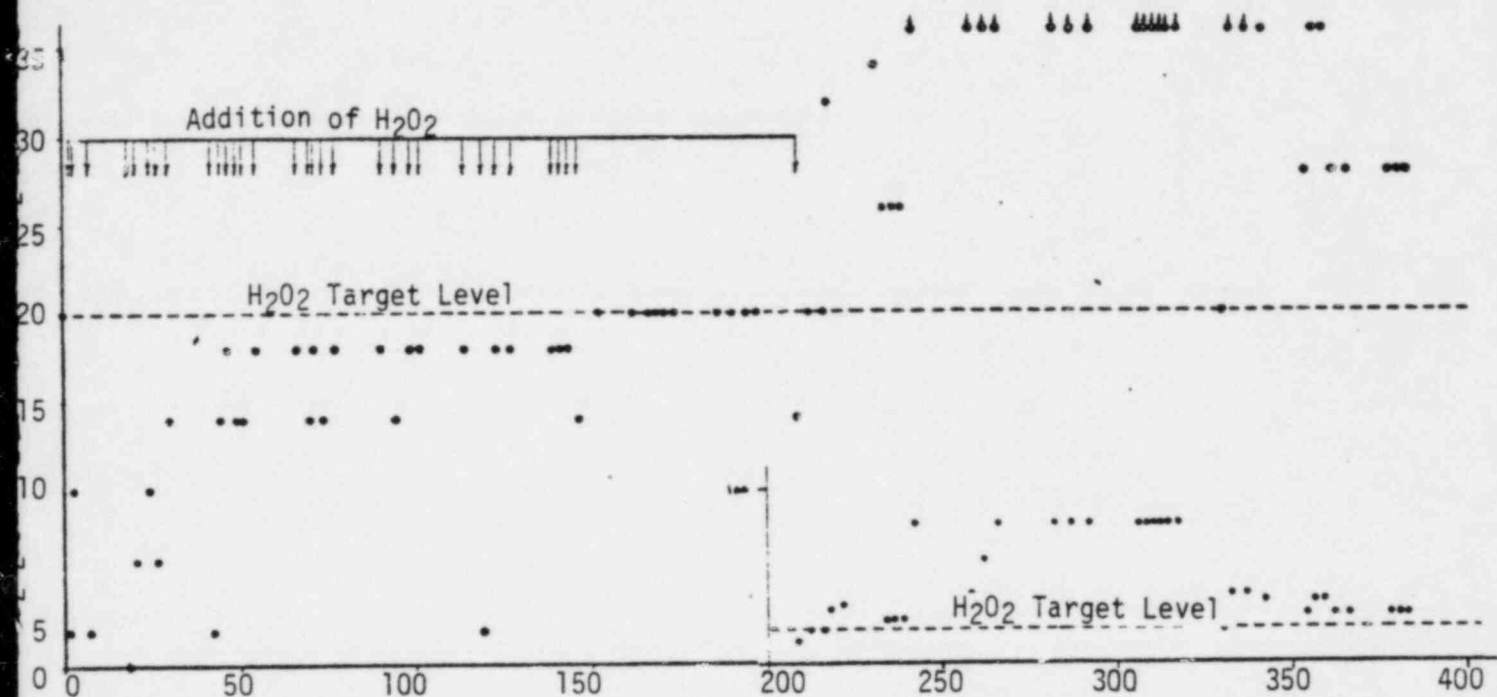
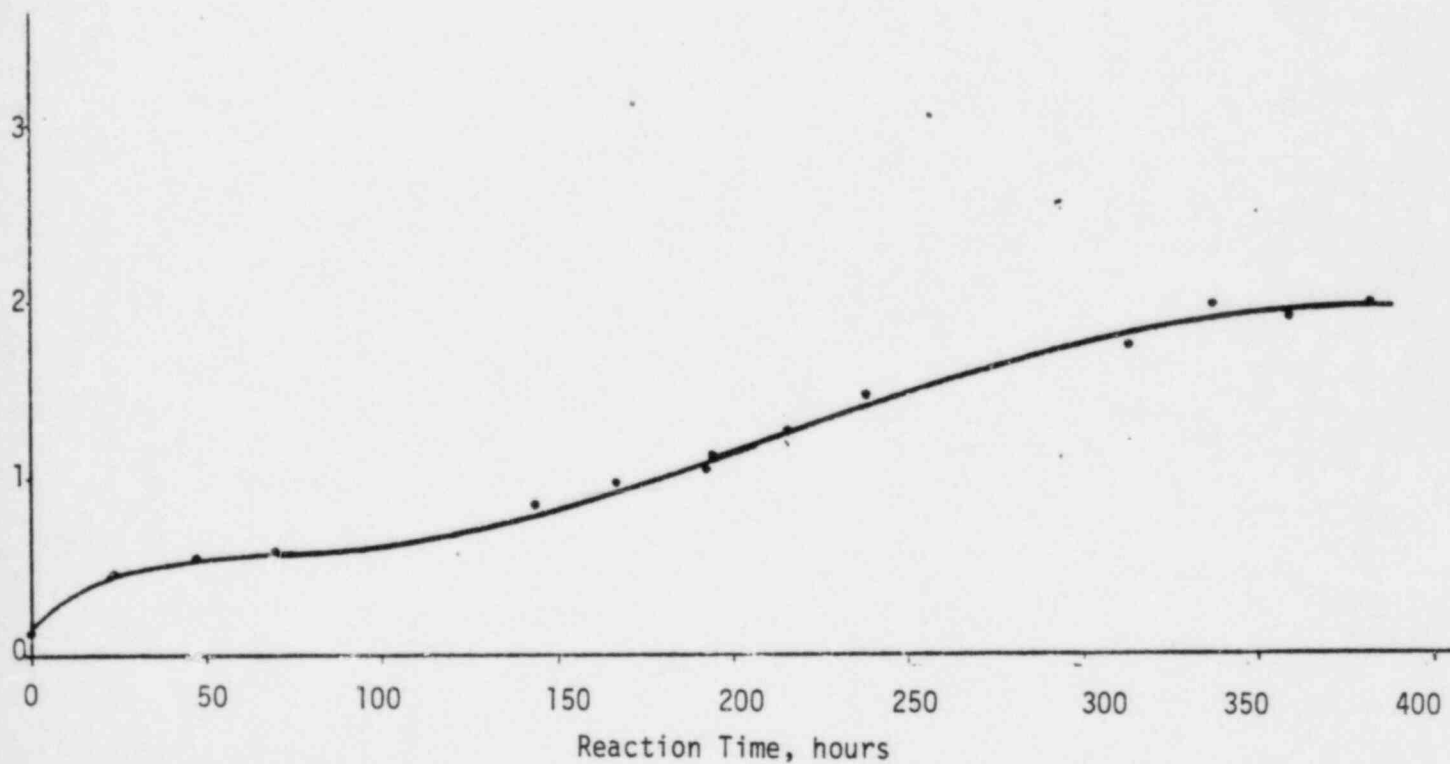
FIGURE 27. HYDROGEN PEROXIDE AND SULFATE CONCENTRATIONS AS A FUNCTION OF REACTION TIME FOR IMMUNOL EXPANSION RUN-1 AT pH8 AND 130°F (UNTREATED TUBE SAMPLE 14 in. FROM EXPANSION TRANSITION ZONE).

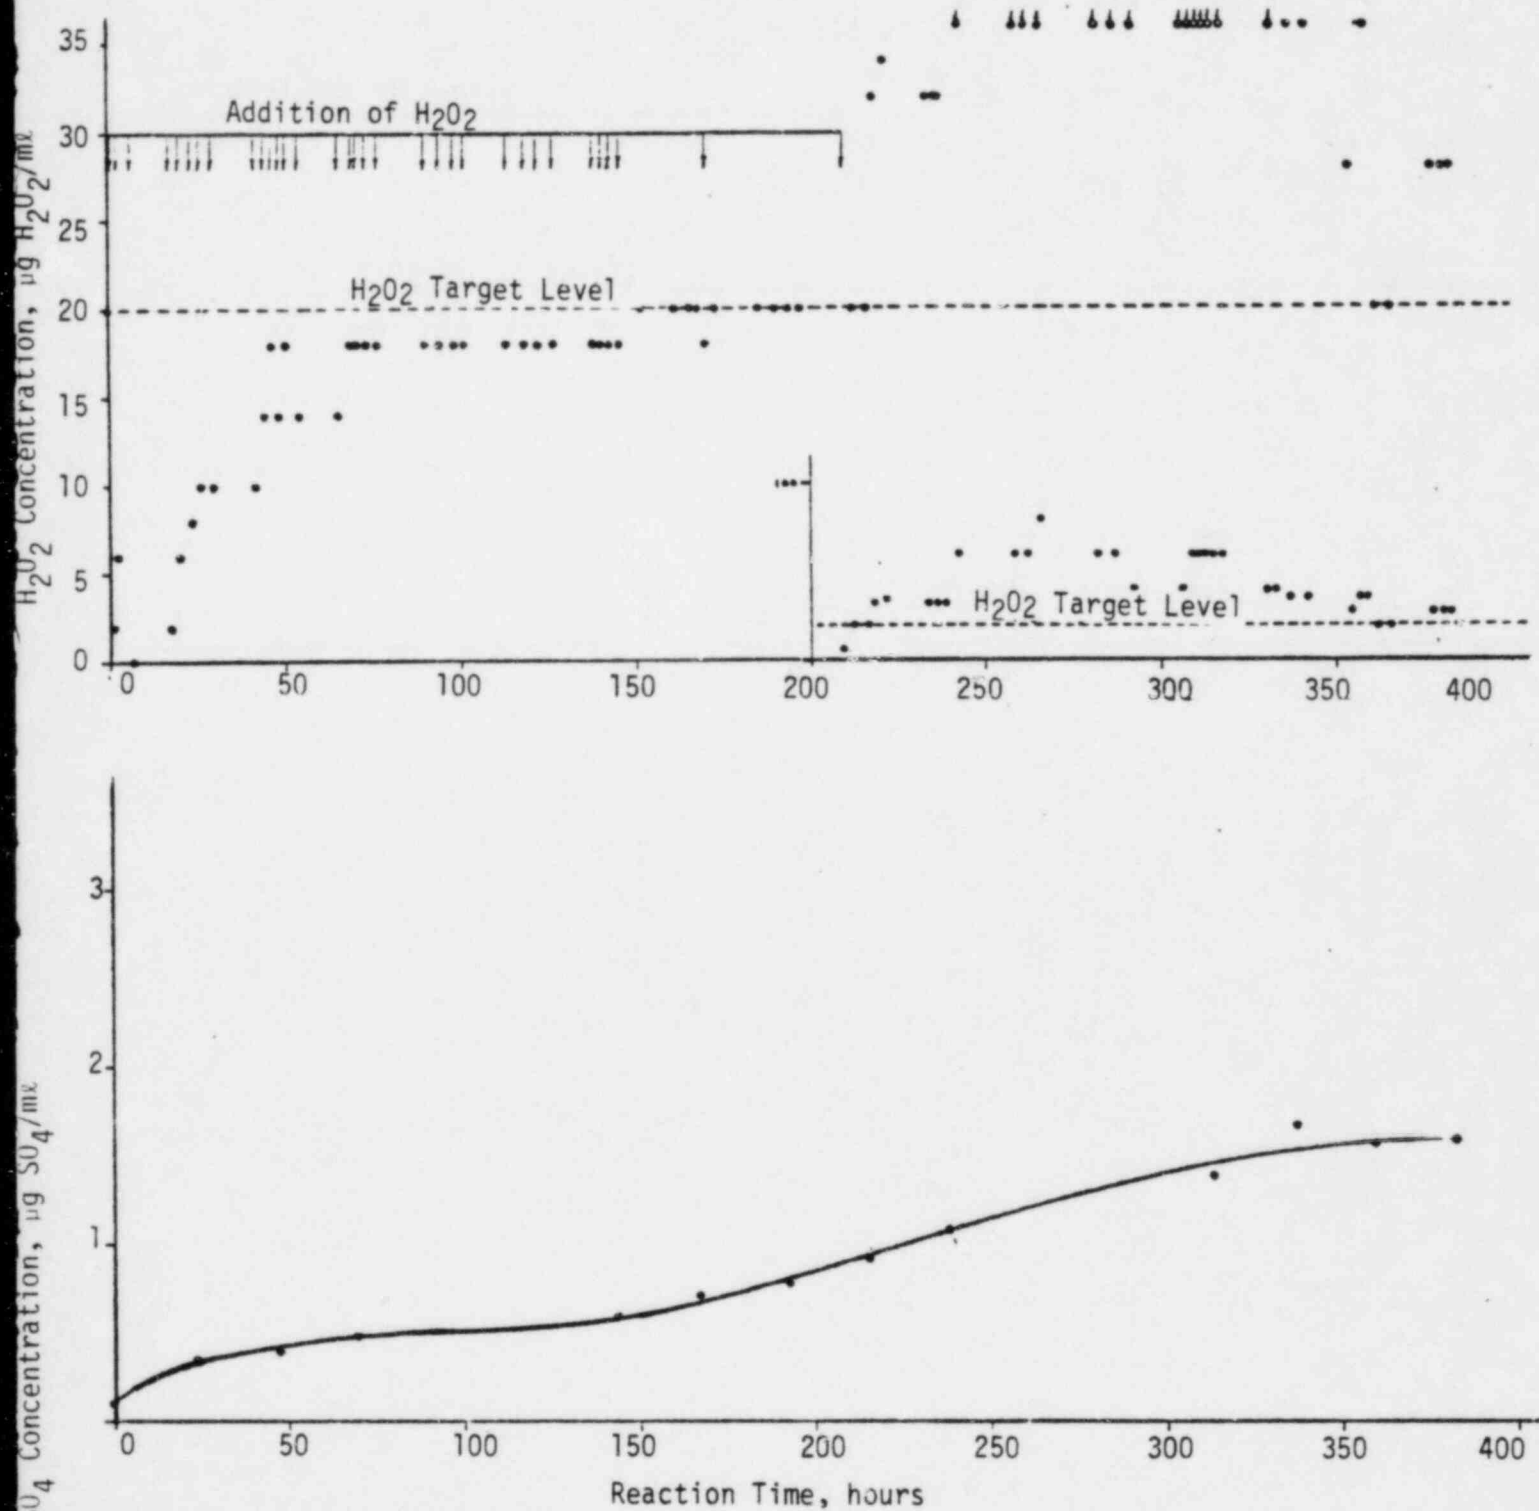
FIGURE 28. HYDROGEN PEROXIDE AND SULFATE CONCENTRATIONS AS A FUNCTION OF REACTION TIME FOR IMMUNOL EXPANSION RUN-2 AT pH8 AND 130°F (UNTREATED TUBE SAMPLE FROM EXPANSION TRANSITION ZONE).

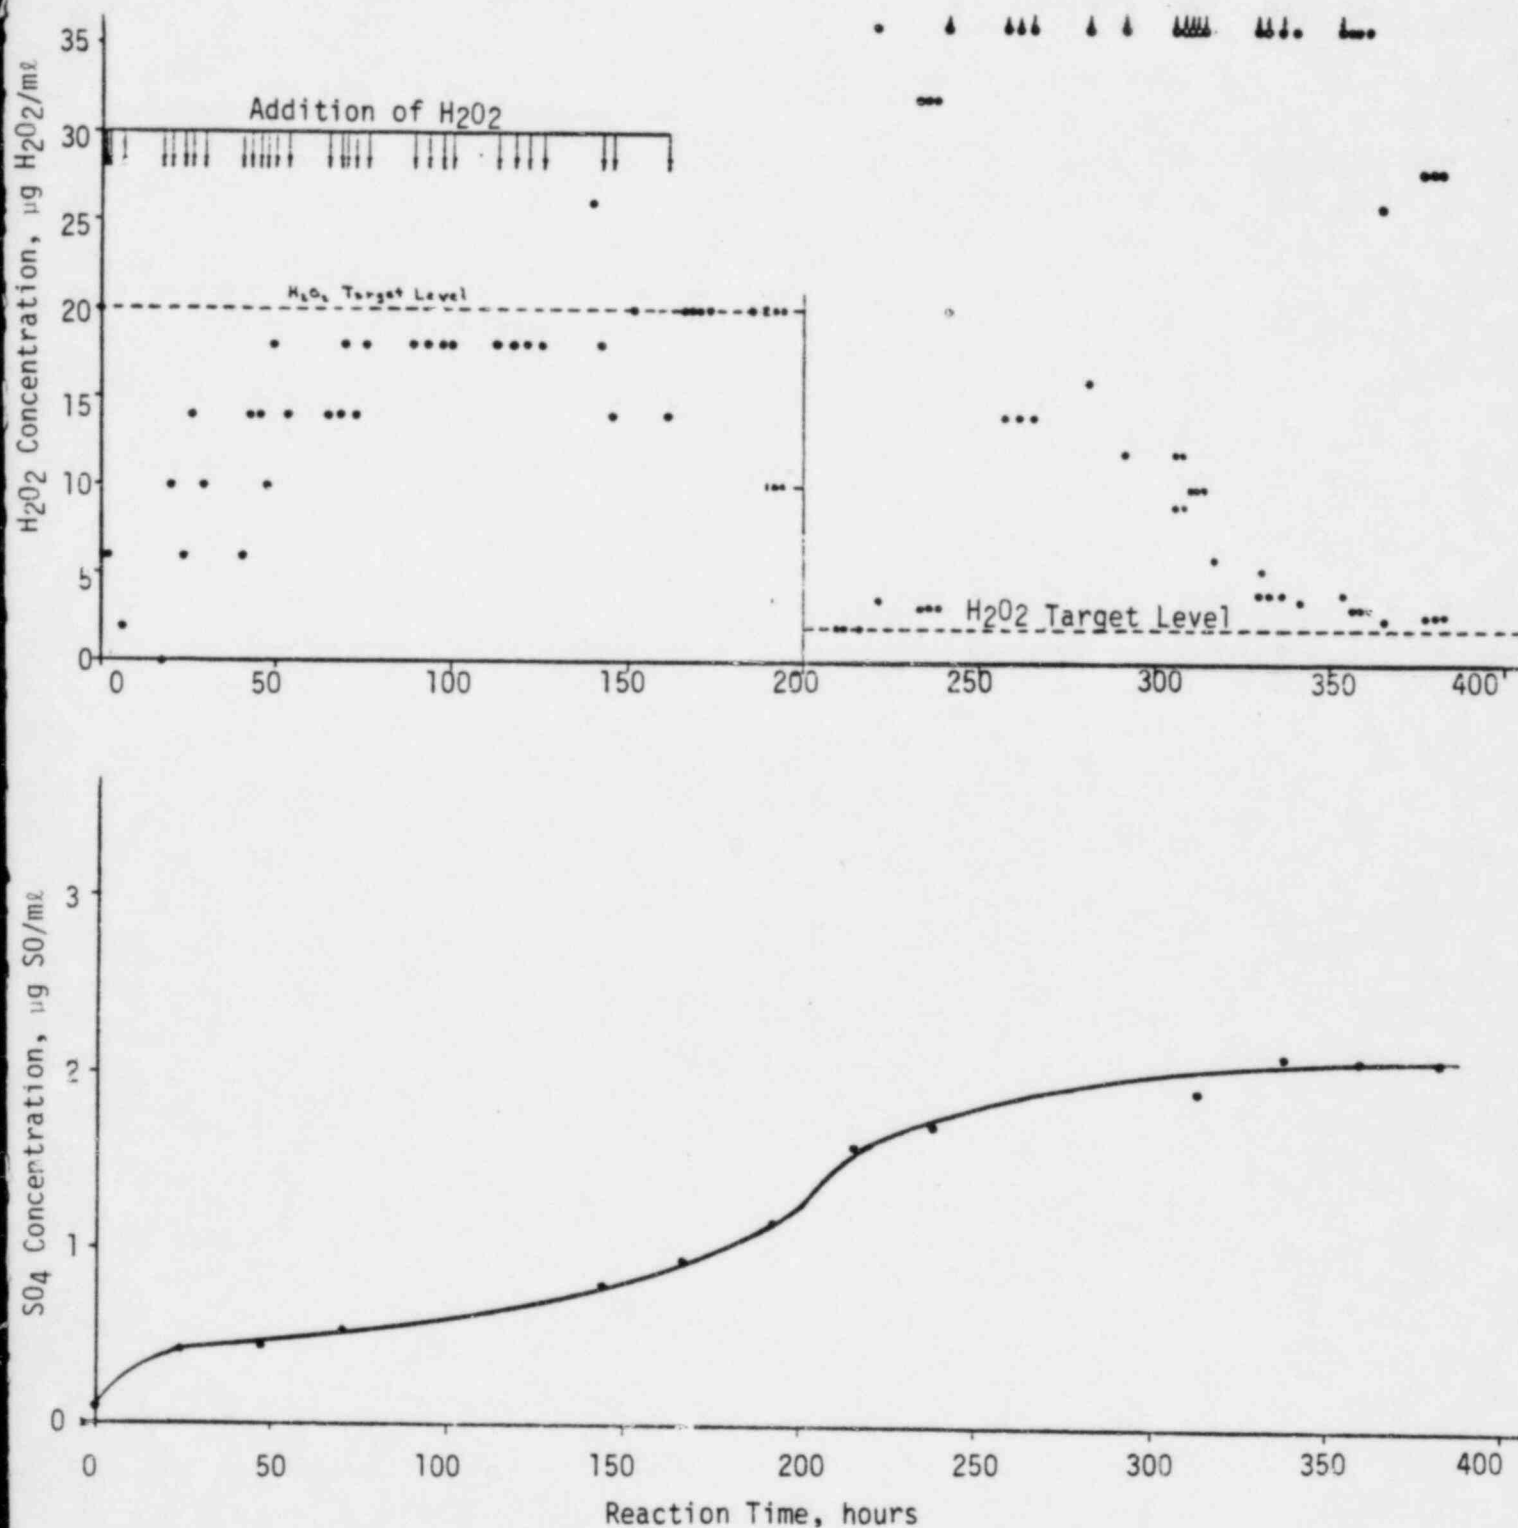
FIGURE 29. HYDROGEN PEROXIDE AND SULFATE CONCENTRATIONS AS A FUNCTION OF REACTION TIME FOR IMMUNOL EXPANSION RUN-3 AT pH8 AND 130°F (IMMUNOL TREATED TUBE SAMPLE 14 in. FROM EXPANSION TRANSITION ZONE).

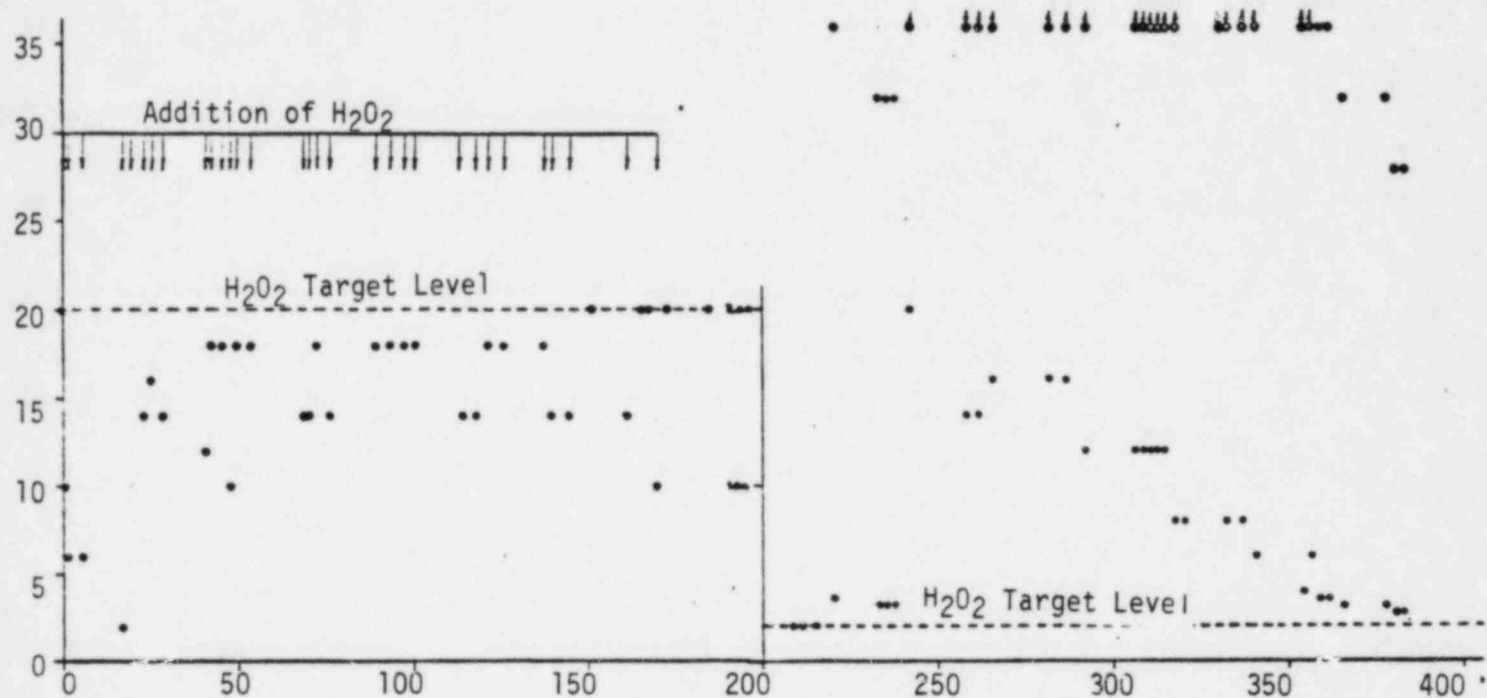
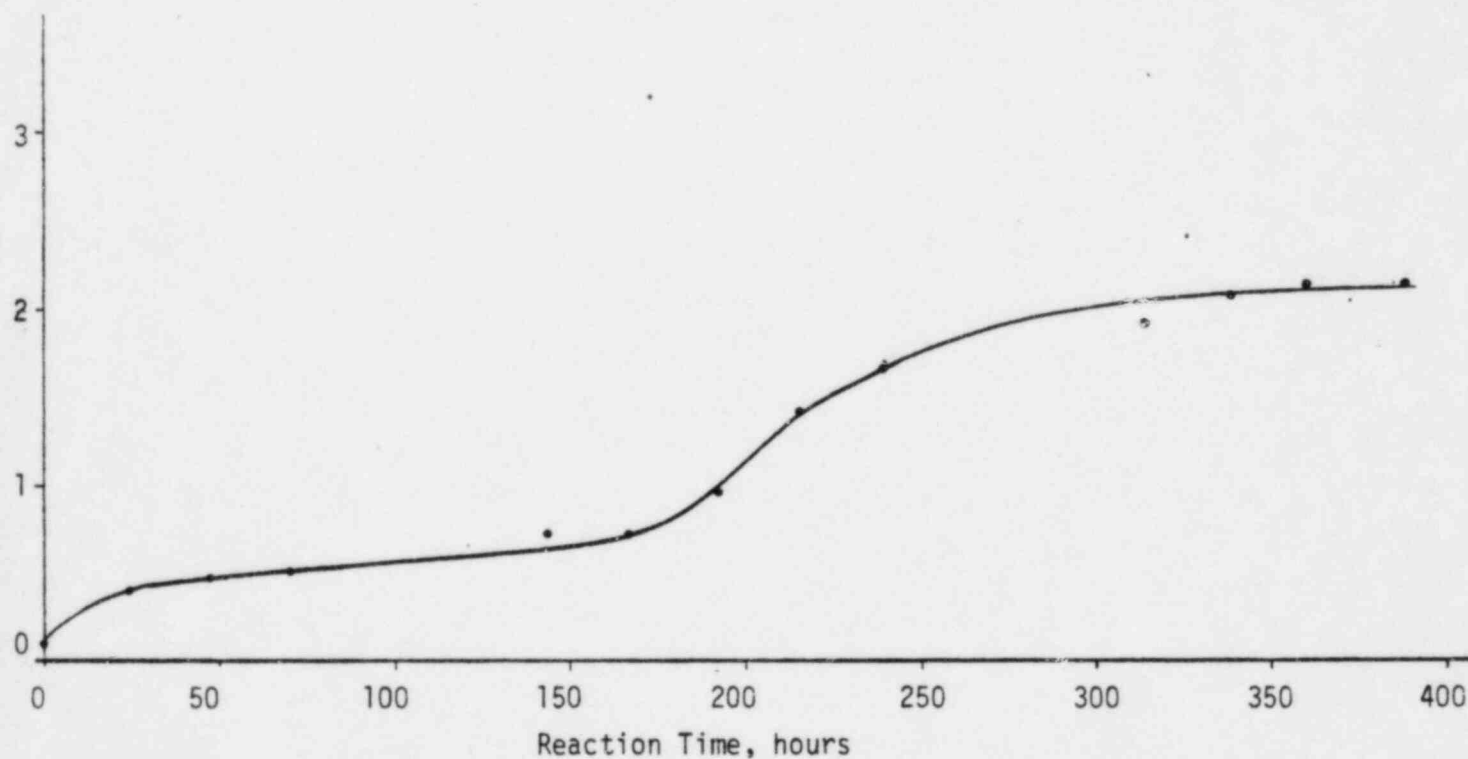
FIGURE 30. HYDROGEN PEROXIDE AND SULFATE CONCENTRATIONS AS A FUNCTION OF REACTION TIME FOR IMMUNOL EXPANSION RUN-4 AT pH8 and 130°F (IMMUNOL TREATED TUBE SAMPLE FROM EXPANSION TRANSITION ZONE).

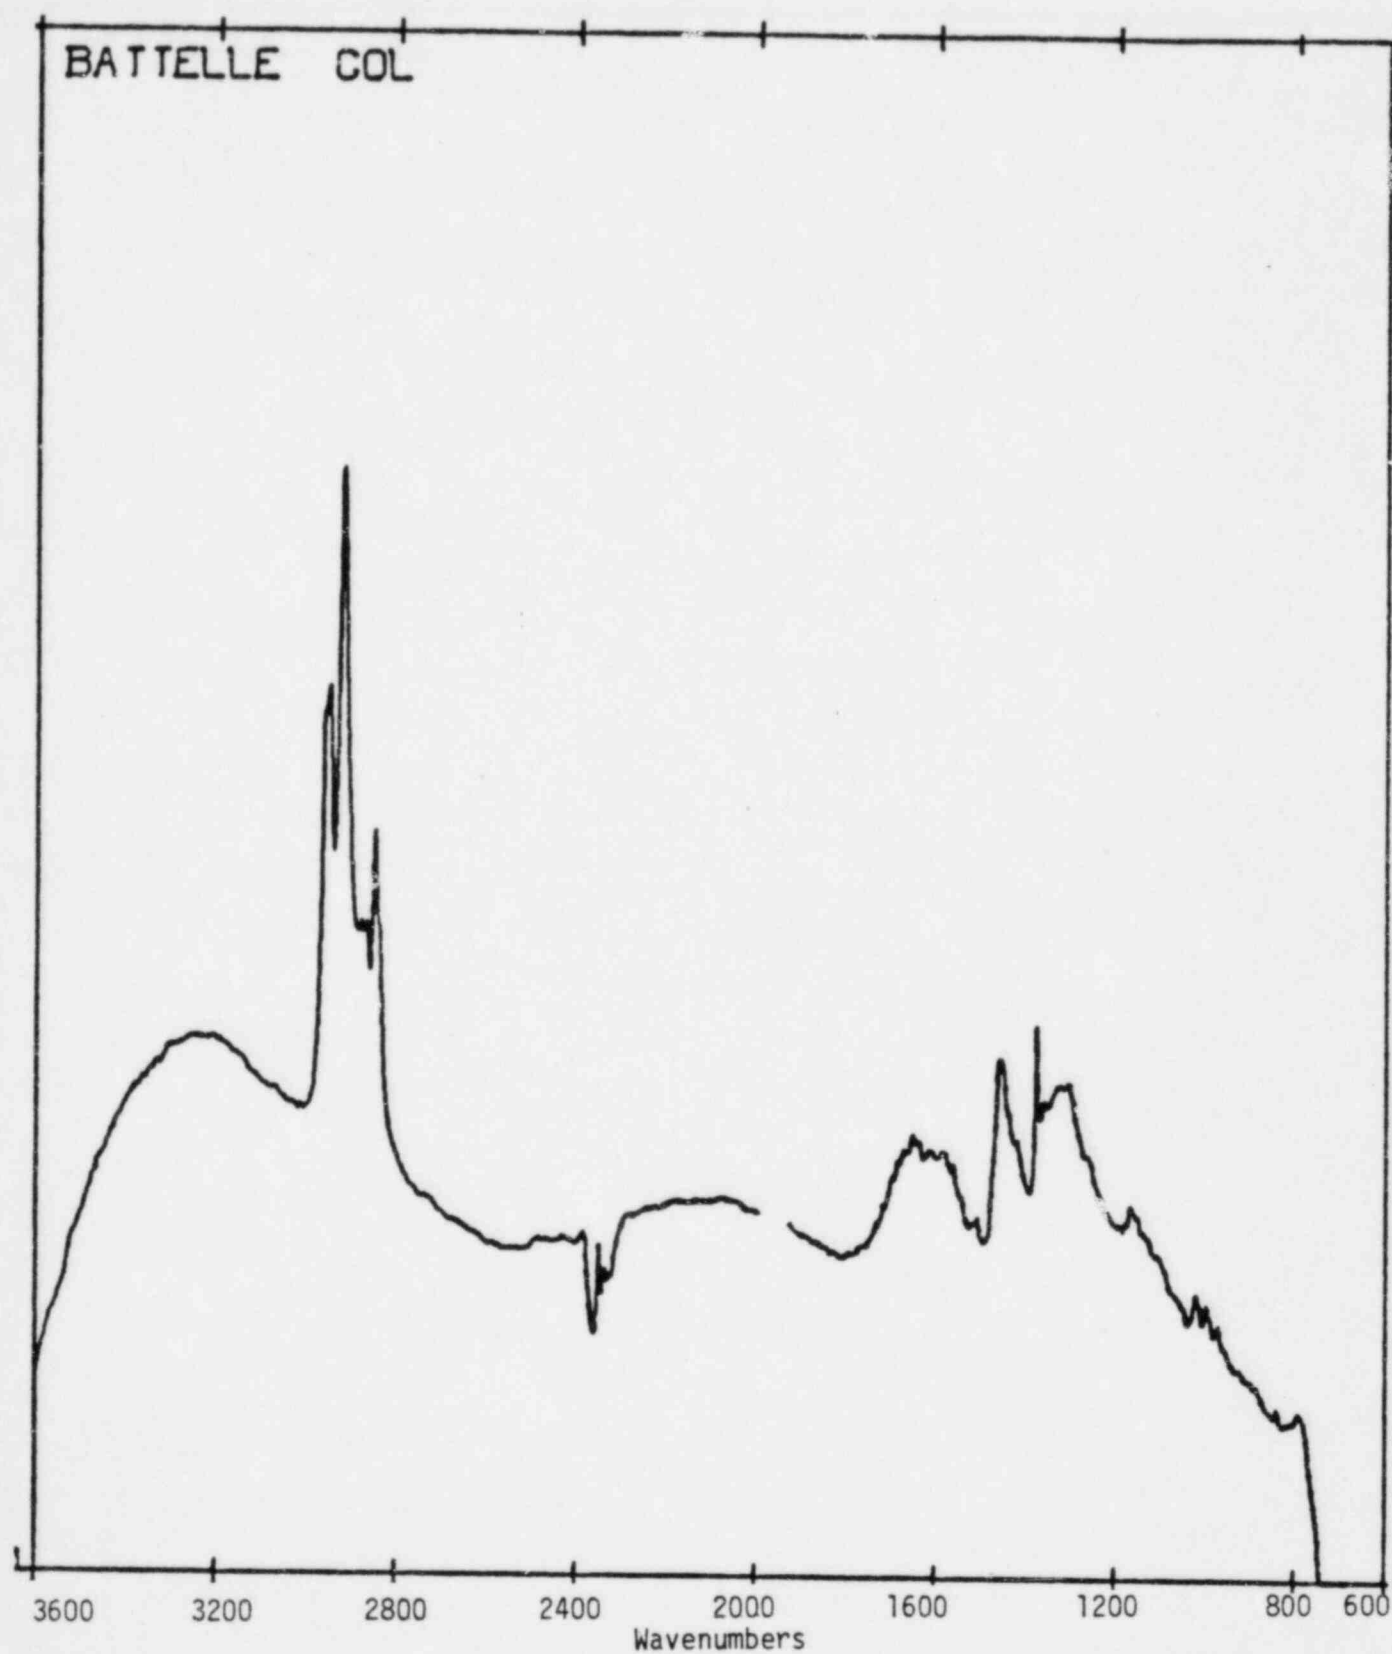
FIGURE 31. INFRARED DIFFUSE REFLECTANCE SPECTRUM FOR SAMPLE NO. 2-10 AFTER PEROXIDE CLEANING (IMMUNOL EXPANSION RUN-2).

The uncleaned sample Number 2-7 and the peroxide cleaned sample Number 2-10 both showed the same polypropylene material as observed with untreated samples from piece 4 of tube number A 111-13. A typical spectrum for sample number 2-10 after cleaning is presented in Figure 31. Presence of the Immunol prevents adherence of the polypropylene material. Once formed, the polypropylene is unaffected by the peroxide cleaning process. However, presence of the polypropylene does not appear to appreciably influence the rate of removal of sulfur by the hydrogen peroxide cleaning process. The absorption spectrum for sample Number 2-7, which was an uncleaned sample from about 5 inches from sample Number 2-10, was diminished in intensity indicating a lower density of polypropylene. These spectra differed significantly from those obtained for sample Number 2-2. The spectrum for sample Number 2-2 is given in Figure 32. The intensity of the absorption is considerably less than that observed with sample Numbers 2-7 and 2-10 with negligible absorption at  $2960\text{ cm}^{-1}$ . The spectrum for sample number 2-2 indicates that less material is present on the sample surface and that fewer methyl groups are present. The spectrum appears to show a contribution from polyethylene.

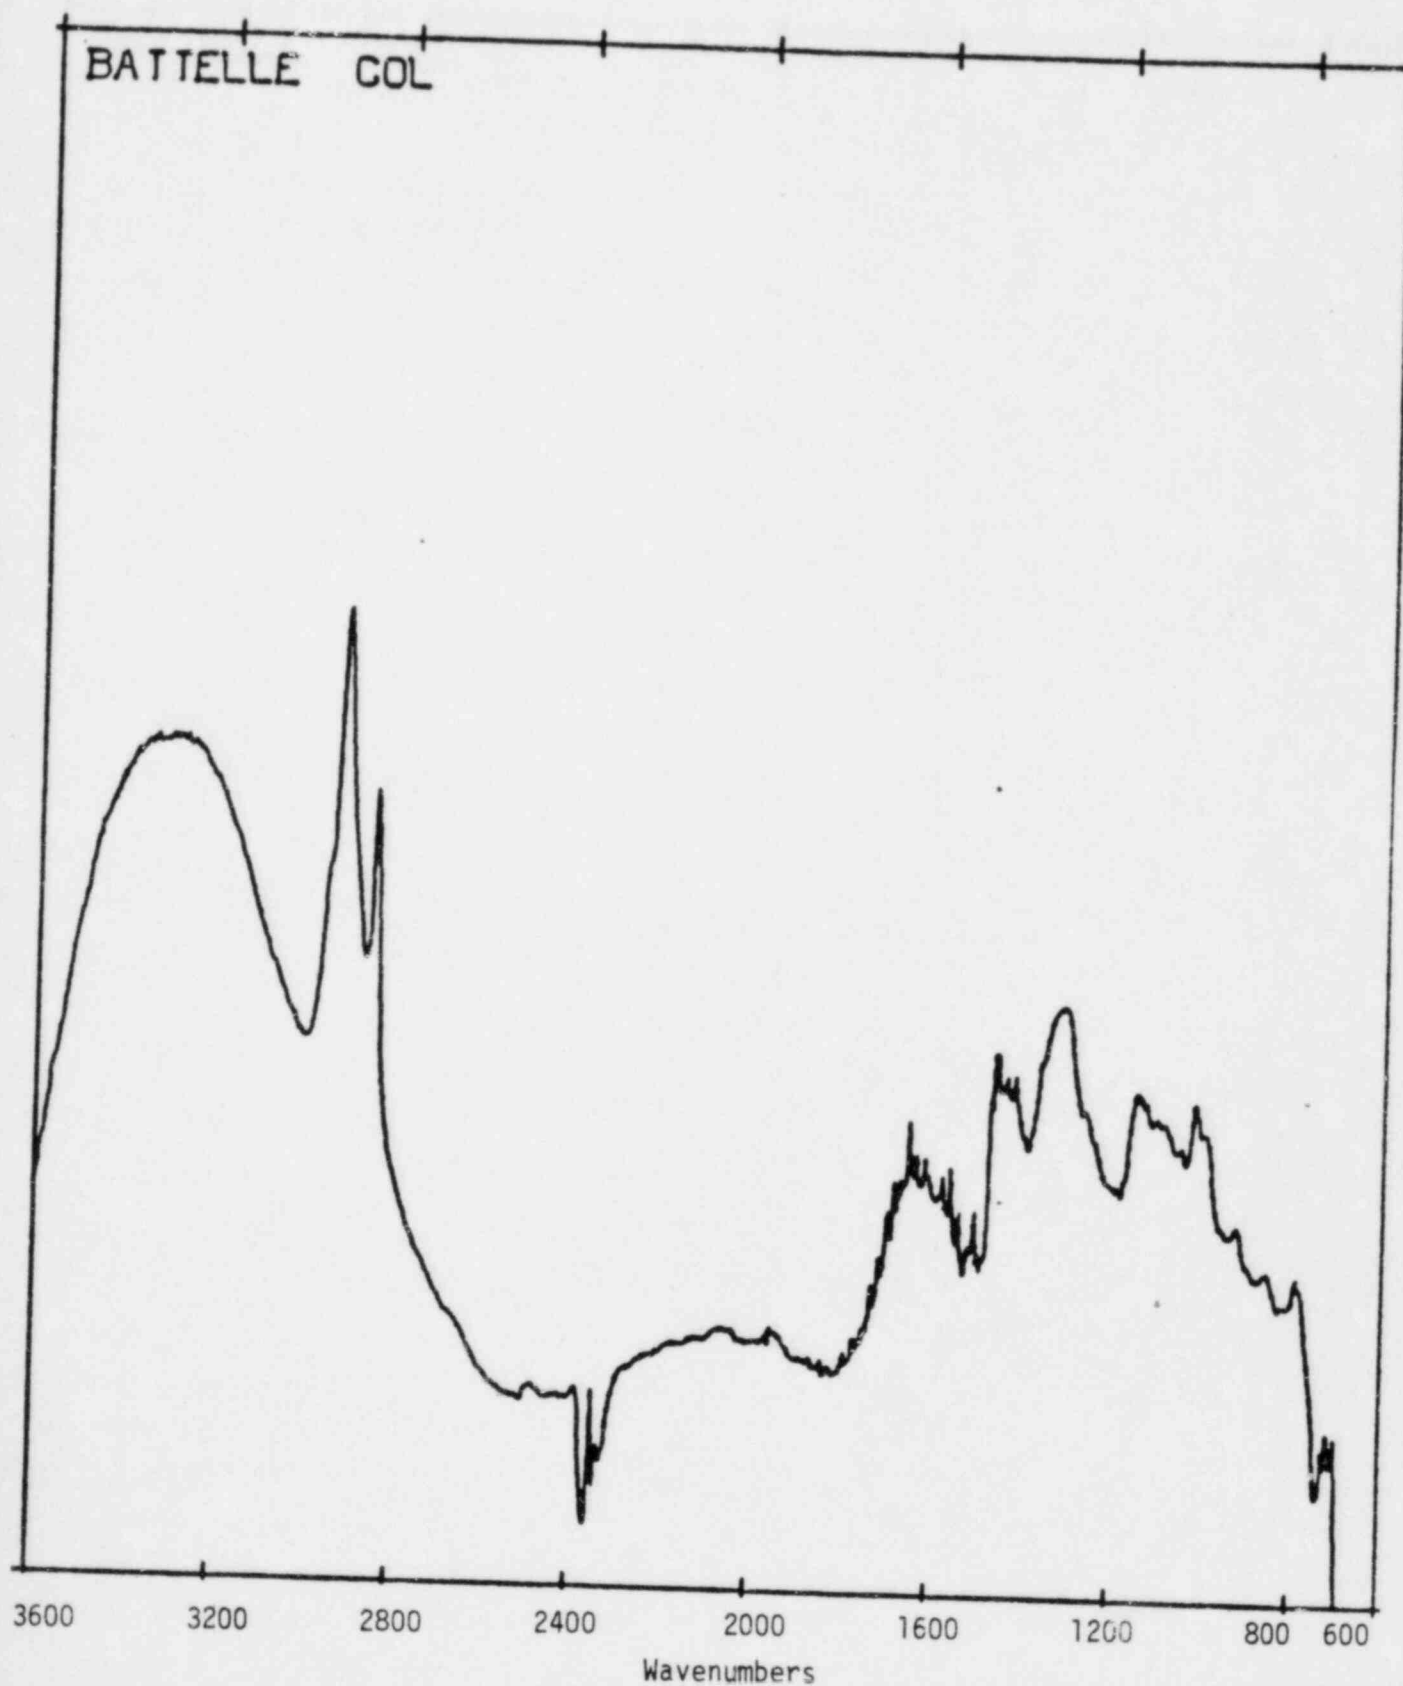
FIGURE 32. INFRARED DIFFUSE REFLECTANCE SPECTRUM FOR SAMPLE NO. 2-2 AFTER PEROXIDE CLEANING (IMMUNOL EXPANSION RUN-1).

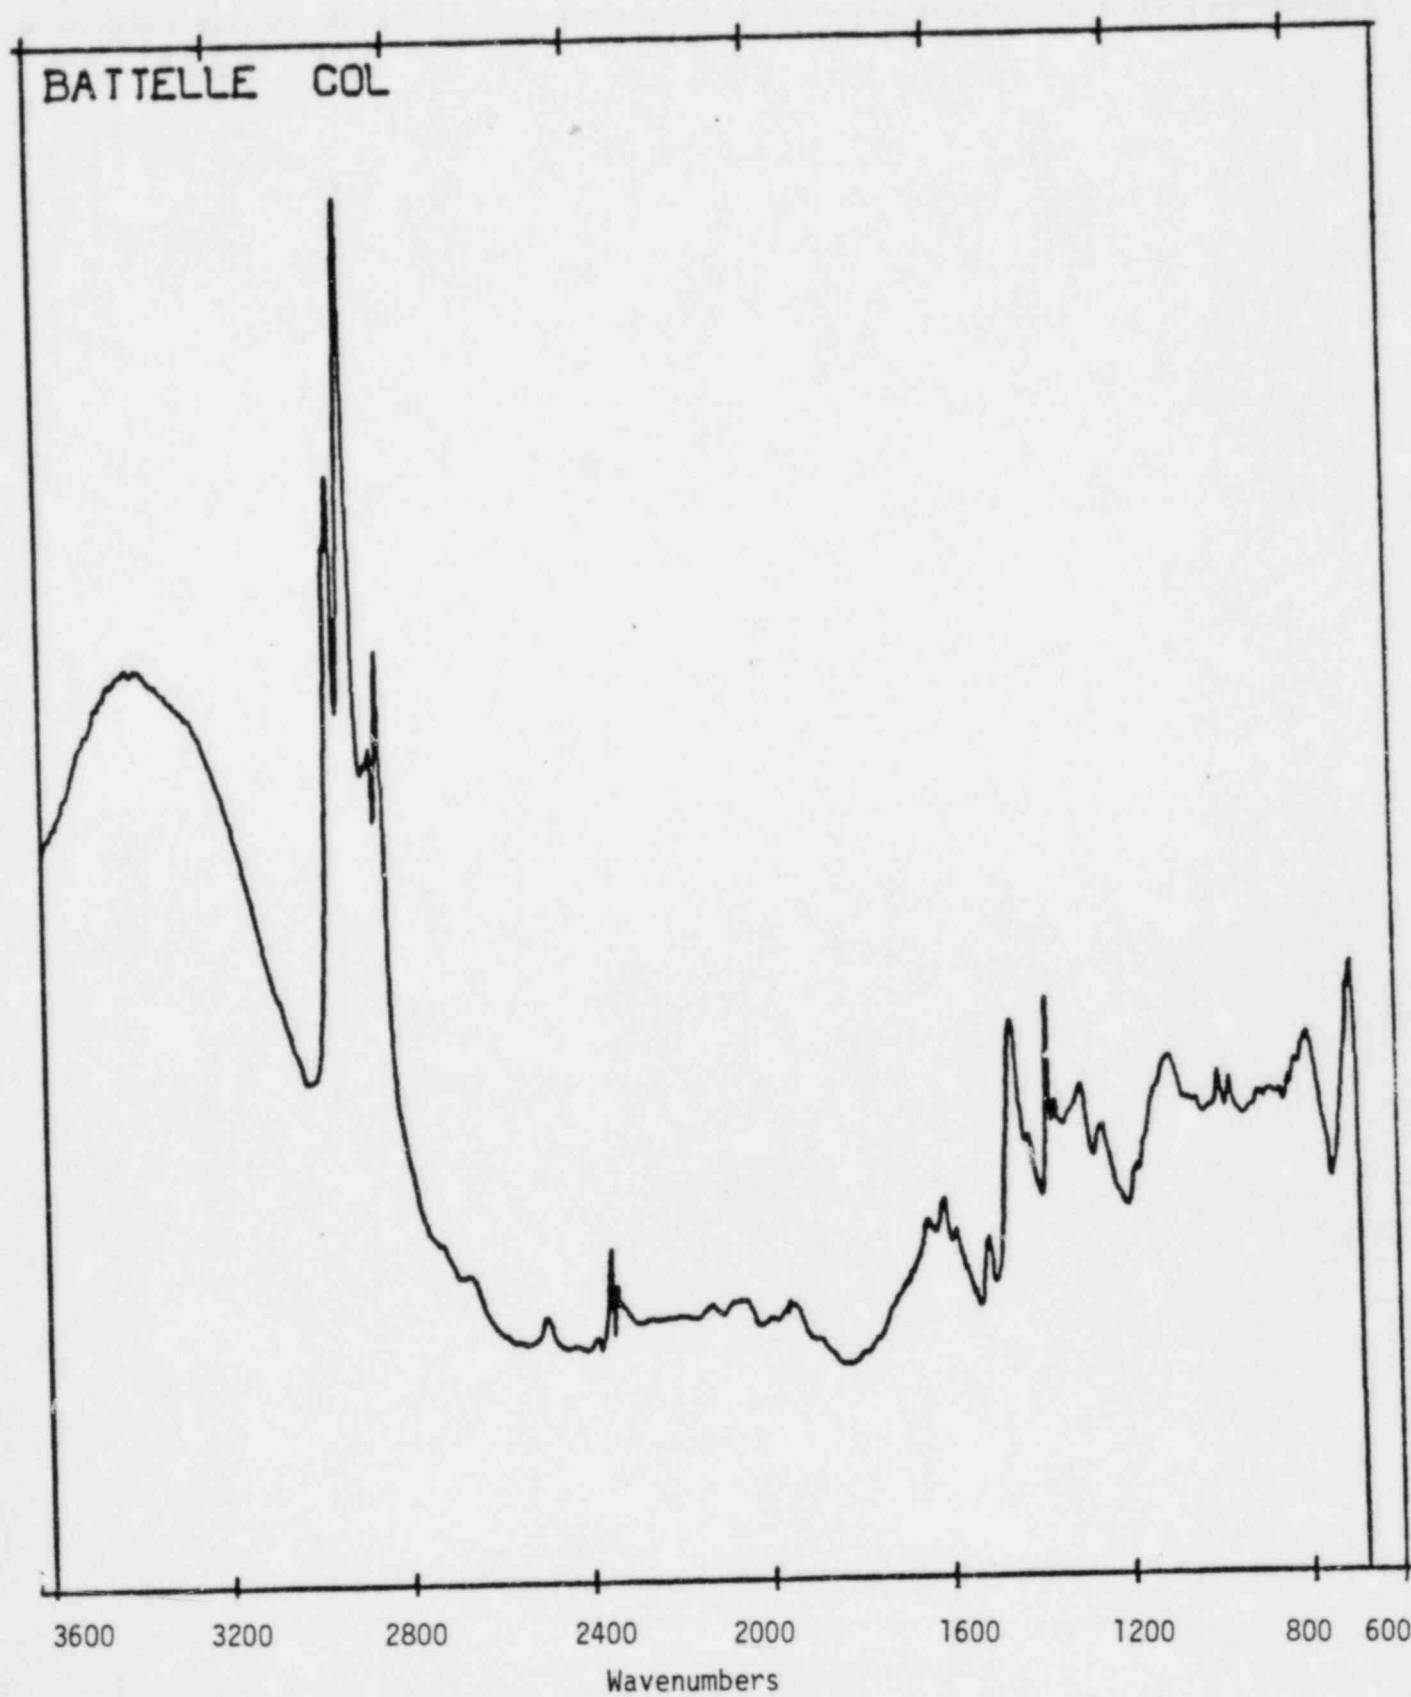
FIGURE 33. INFRARED DIFFUSE REFLECTANCE SPECTRUM FOR UNCLEARED SAMPLE NO. 5-7.

The spectrum for sample Number 5-7 is also quite similar to that observed with samples from piece 4. A diffuse reflectance spectrum for the uncleaned sample is shown in Figure 33. This spectrum also shows the presence of polypropylene. Particles removed from the ID surface of this sample were also identified as isotactic polypropylene.
