OVERVIEW OF PROGRESS  
IN THE TMI-1 TUBE CLEANING EXPERIMENT

G.P.U. NUCLEAR

January 31, 1983

R. H. Barnes, A. K. Wensky,  
and J. Lathouse

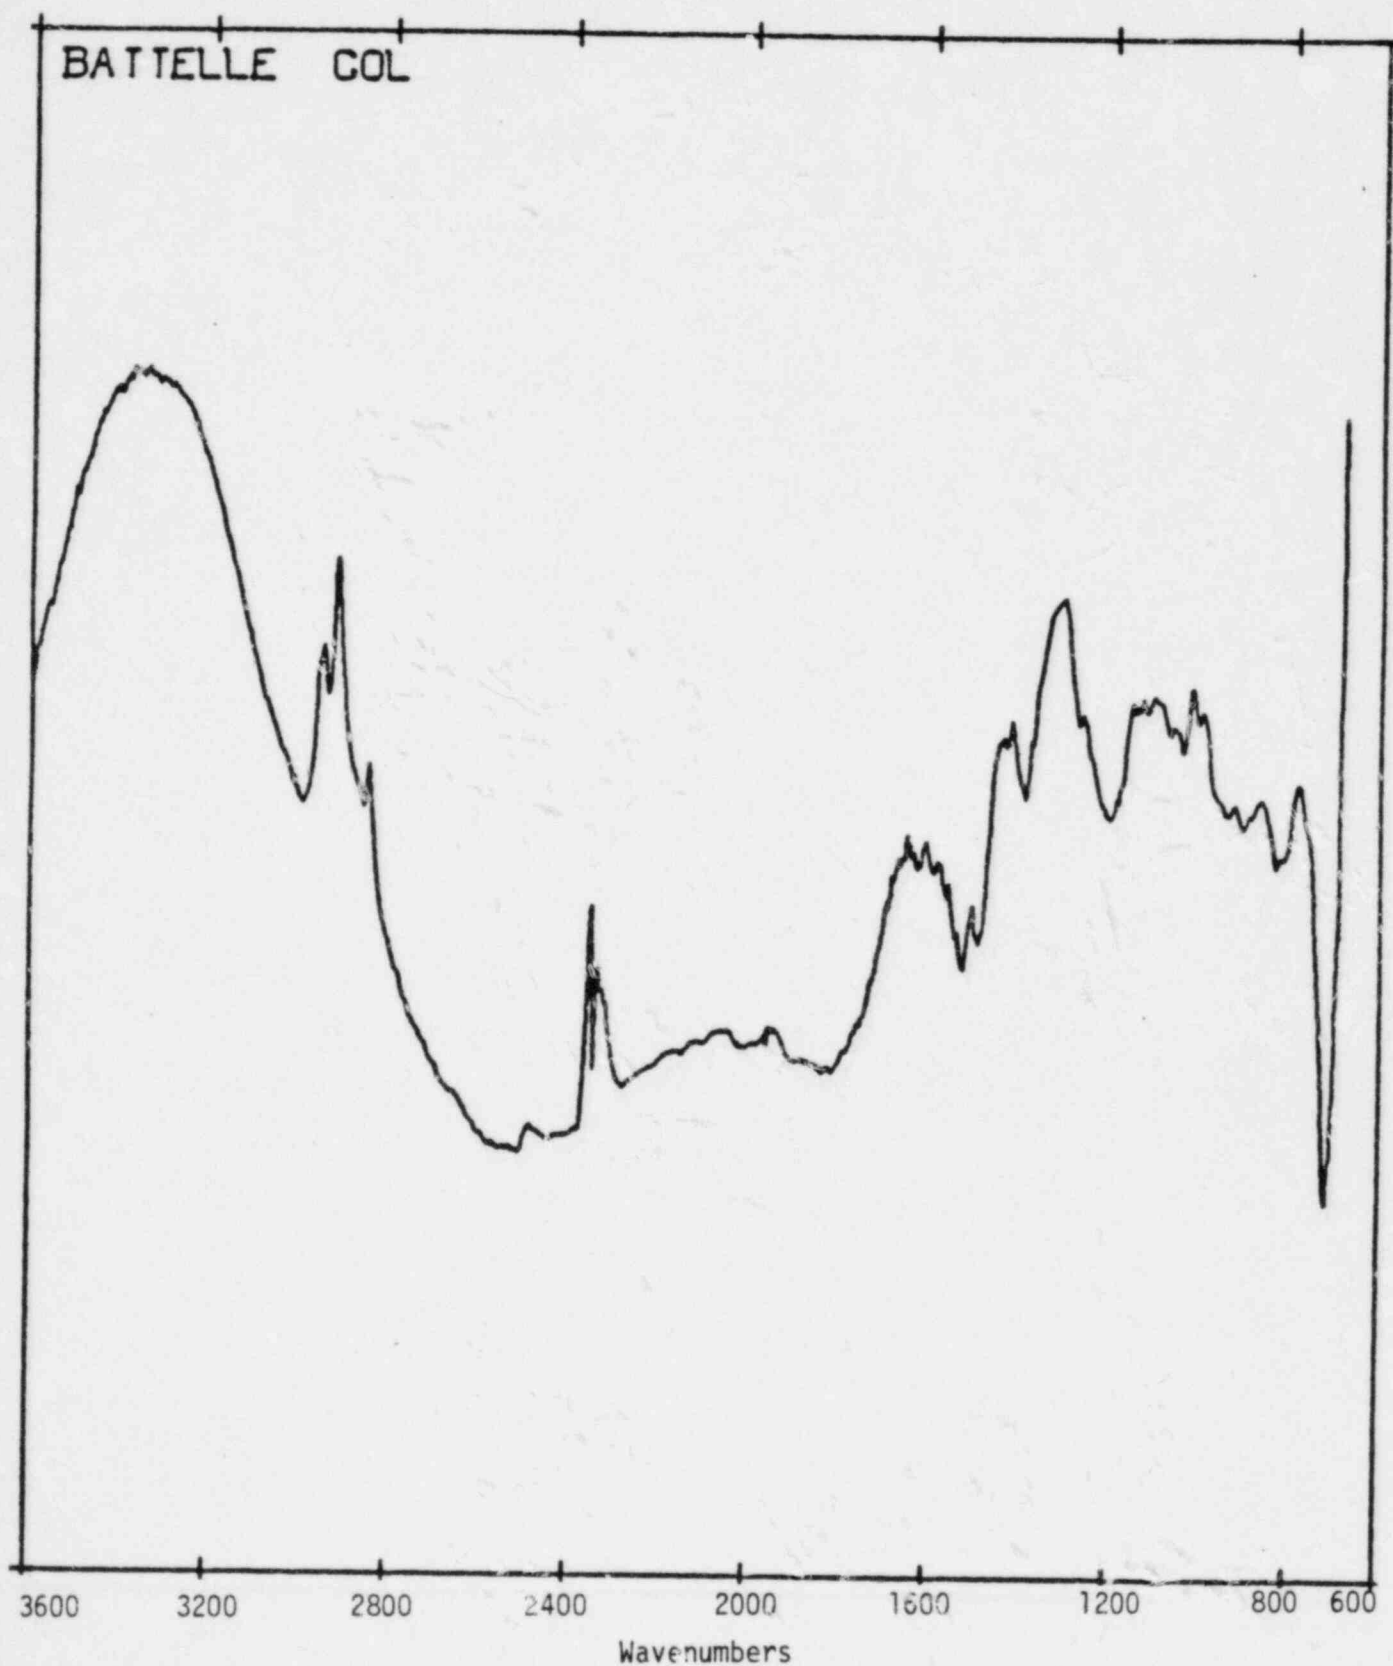
FIGURE 34. INFRARED DIFFUSE REFLECTANCE SPECTRUM FOR SAMPLE NO. 5-2 AFTER PEROXIDE CLEANING (IMMUNOL EXPANSION RUN-3).

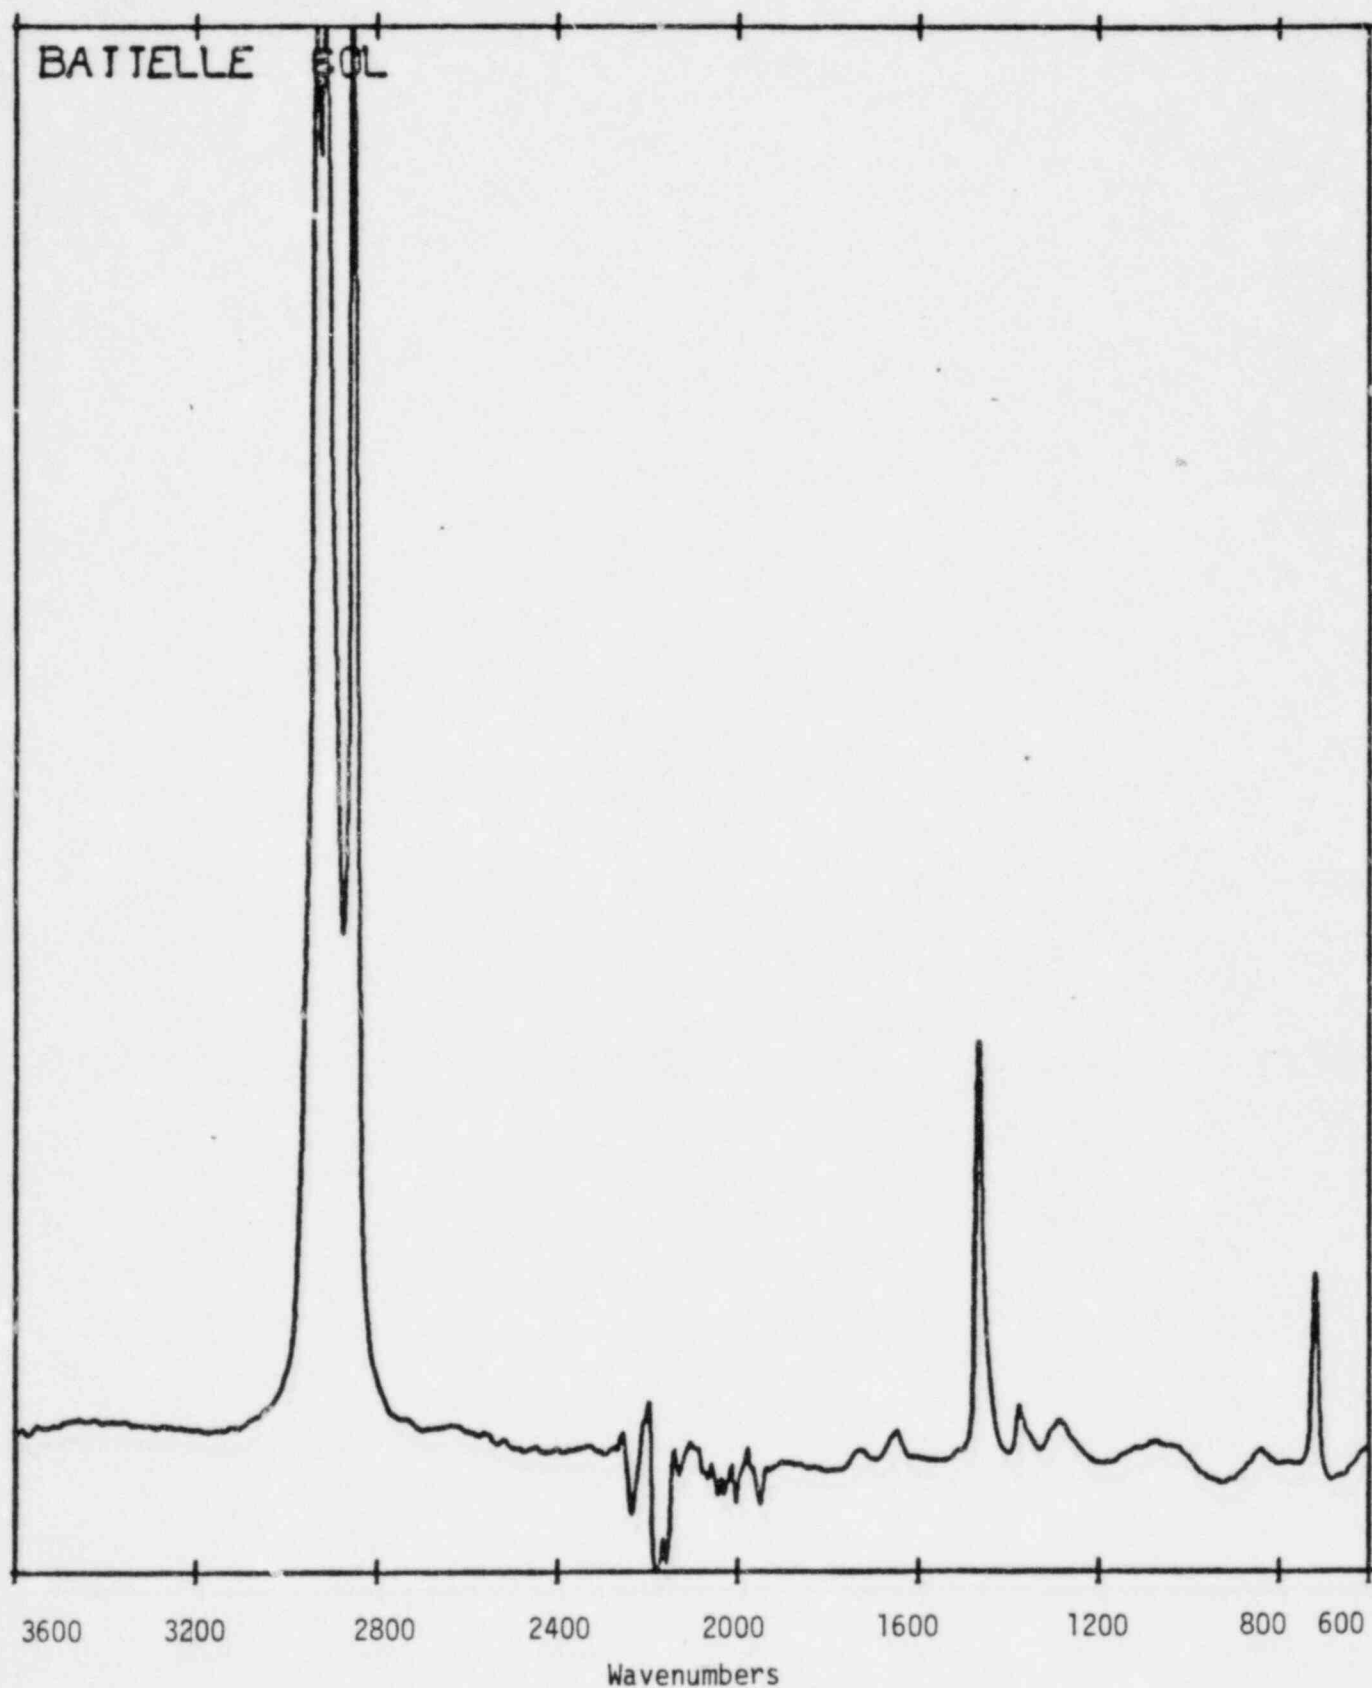
FIGURE 35. INFRARED TRANSMISSION SPECTRUM OF POLYETHYLENE PARTICLE REMOVED FROM ID SURFACE OF SAMPLE NO. 5-10 BEFORE CLEANING.

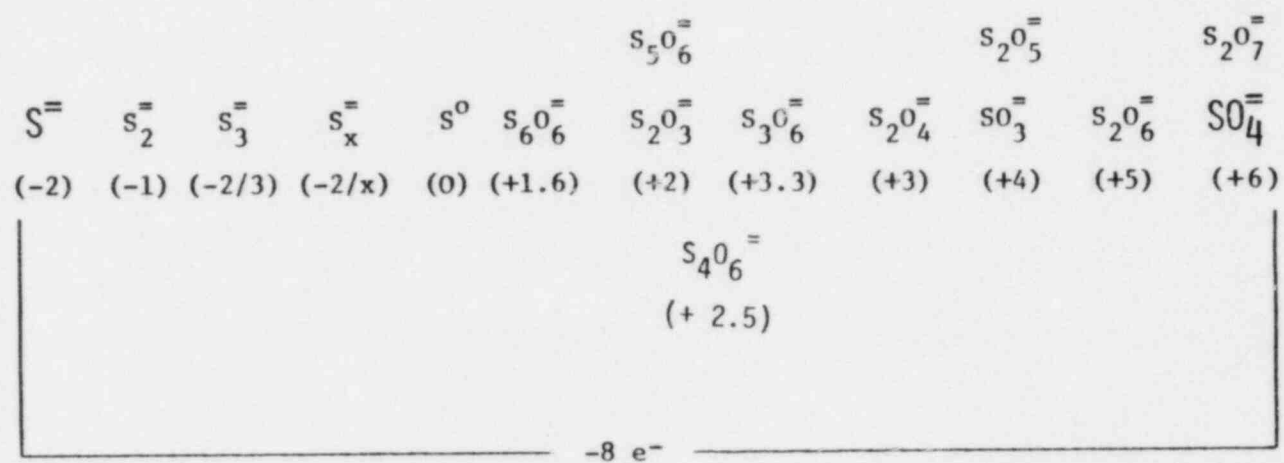
Figure 36. Reaction Intermediate, for Oxidation of Sulfide to Sulfate.

An important feature of future cleaning studies will be to direct more attention to the intermediate sulfur species that are formed. A number of the possible intermediates formed in the oxidation chain going from sulfide to sulfate are shown in Figure 36. The tetrathionate, thiosulfate, and possibly other species can severely attack Inconel. A better understanding of the concentrations of these intermediates and their influence on the cleaning process is advisable.

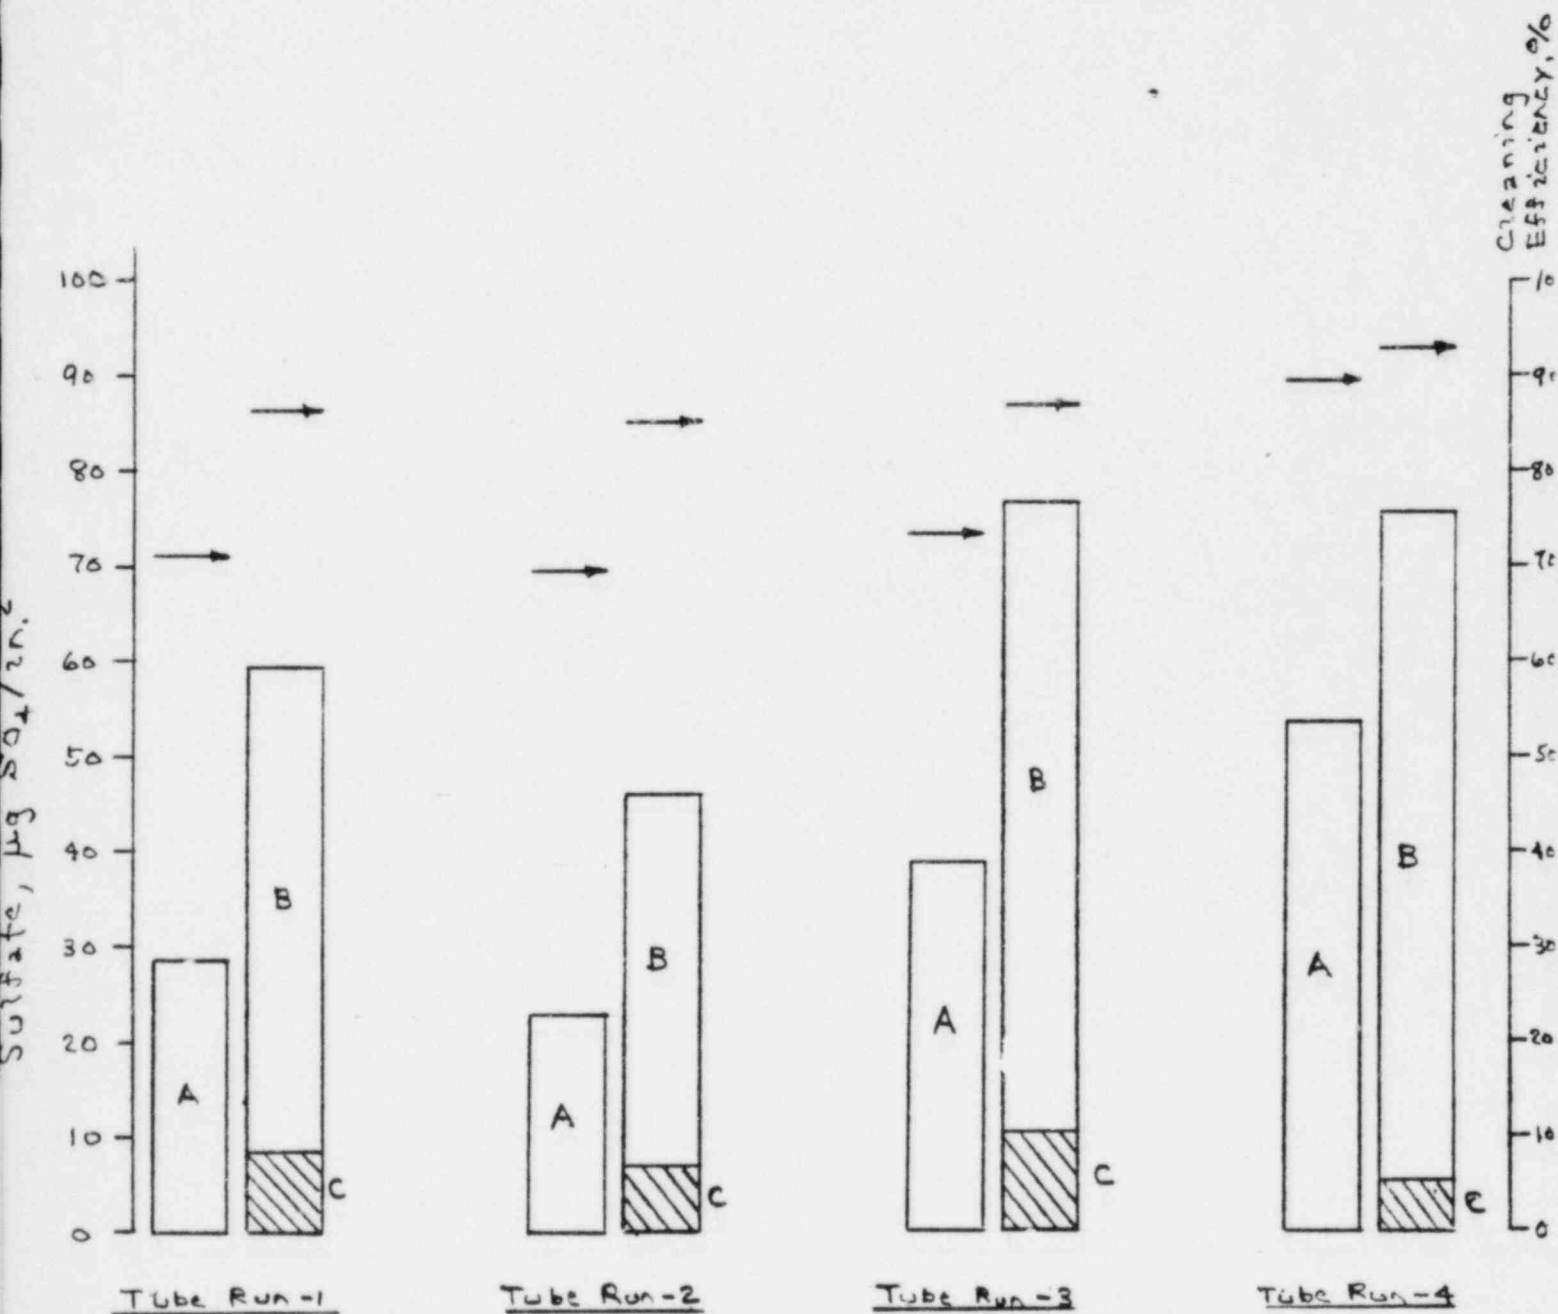
FIGURE A -1. SUMMARY OF SULFUR ANALYSES AND CLEANING EFFICIENCIES FOR BEAKER CLEANING SERIES 1

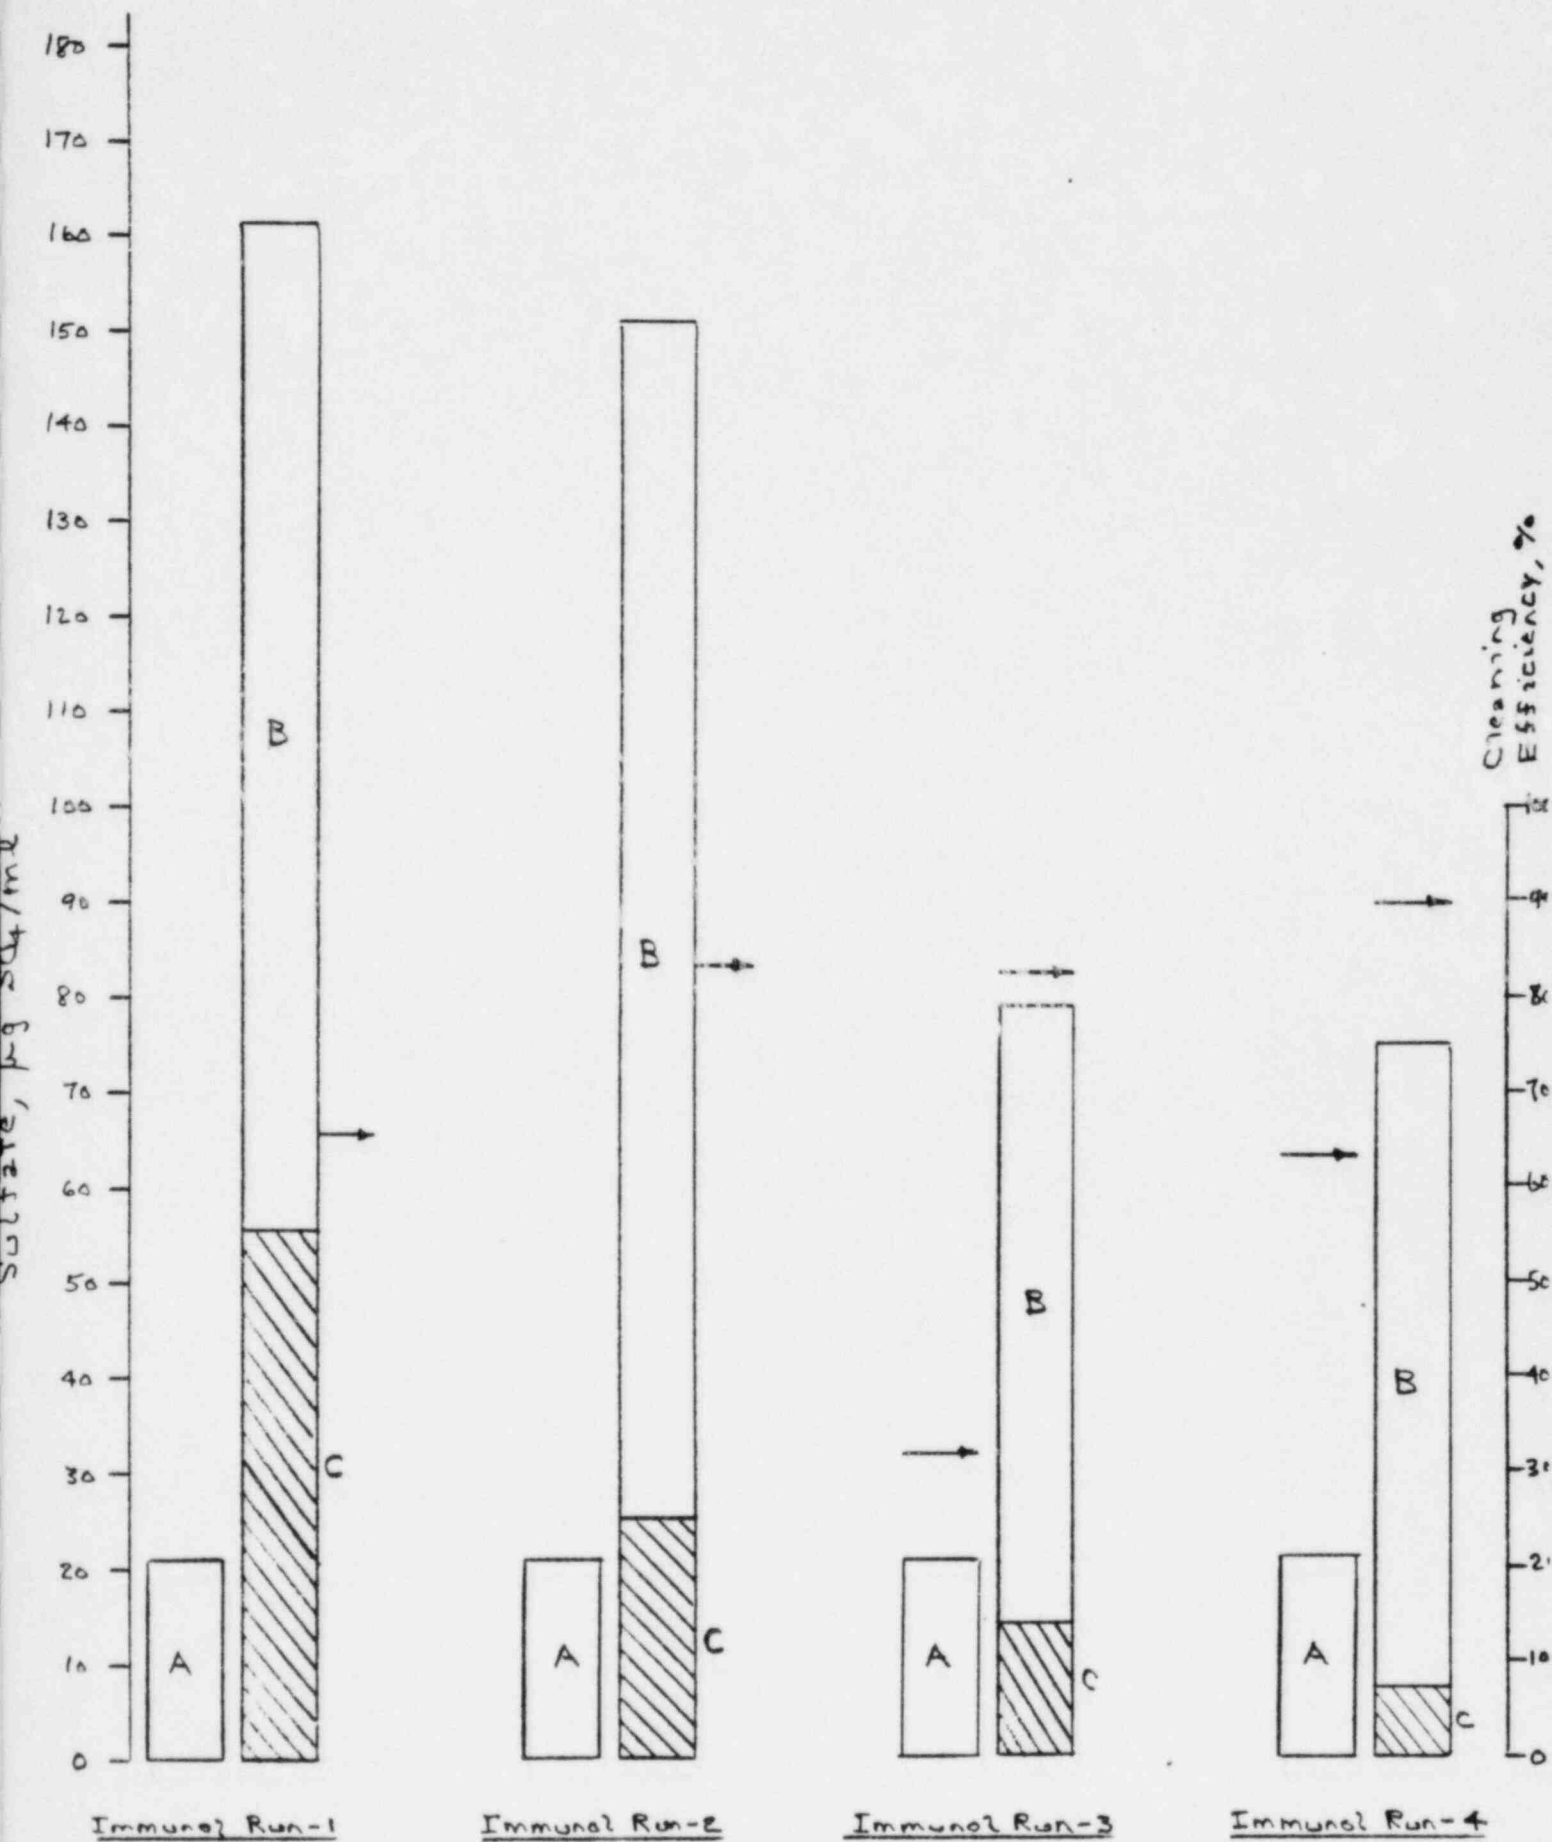
FIGURE A-2 SUMMARY OF SULFUR ANALYSES AND CLEANING EFFICIENCIES FOR BEAKER CLEANING SERIES 2

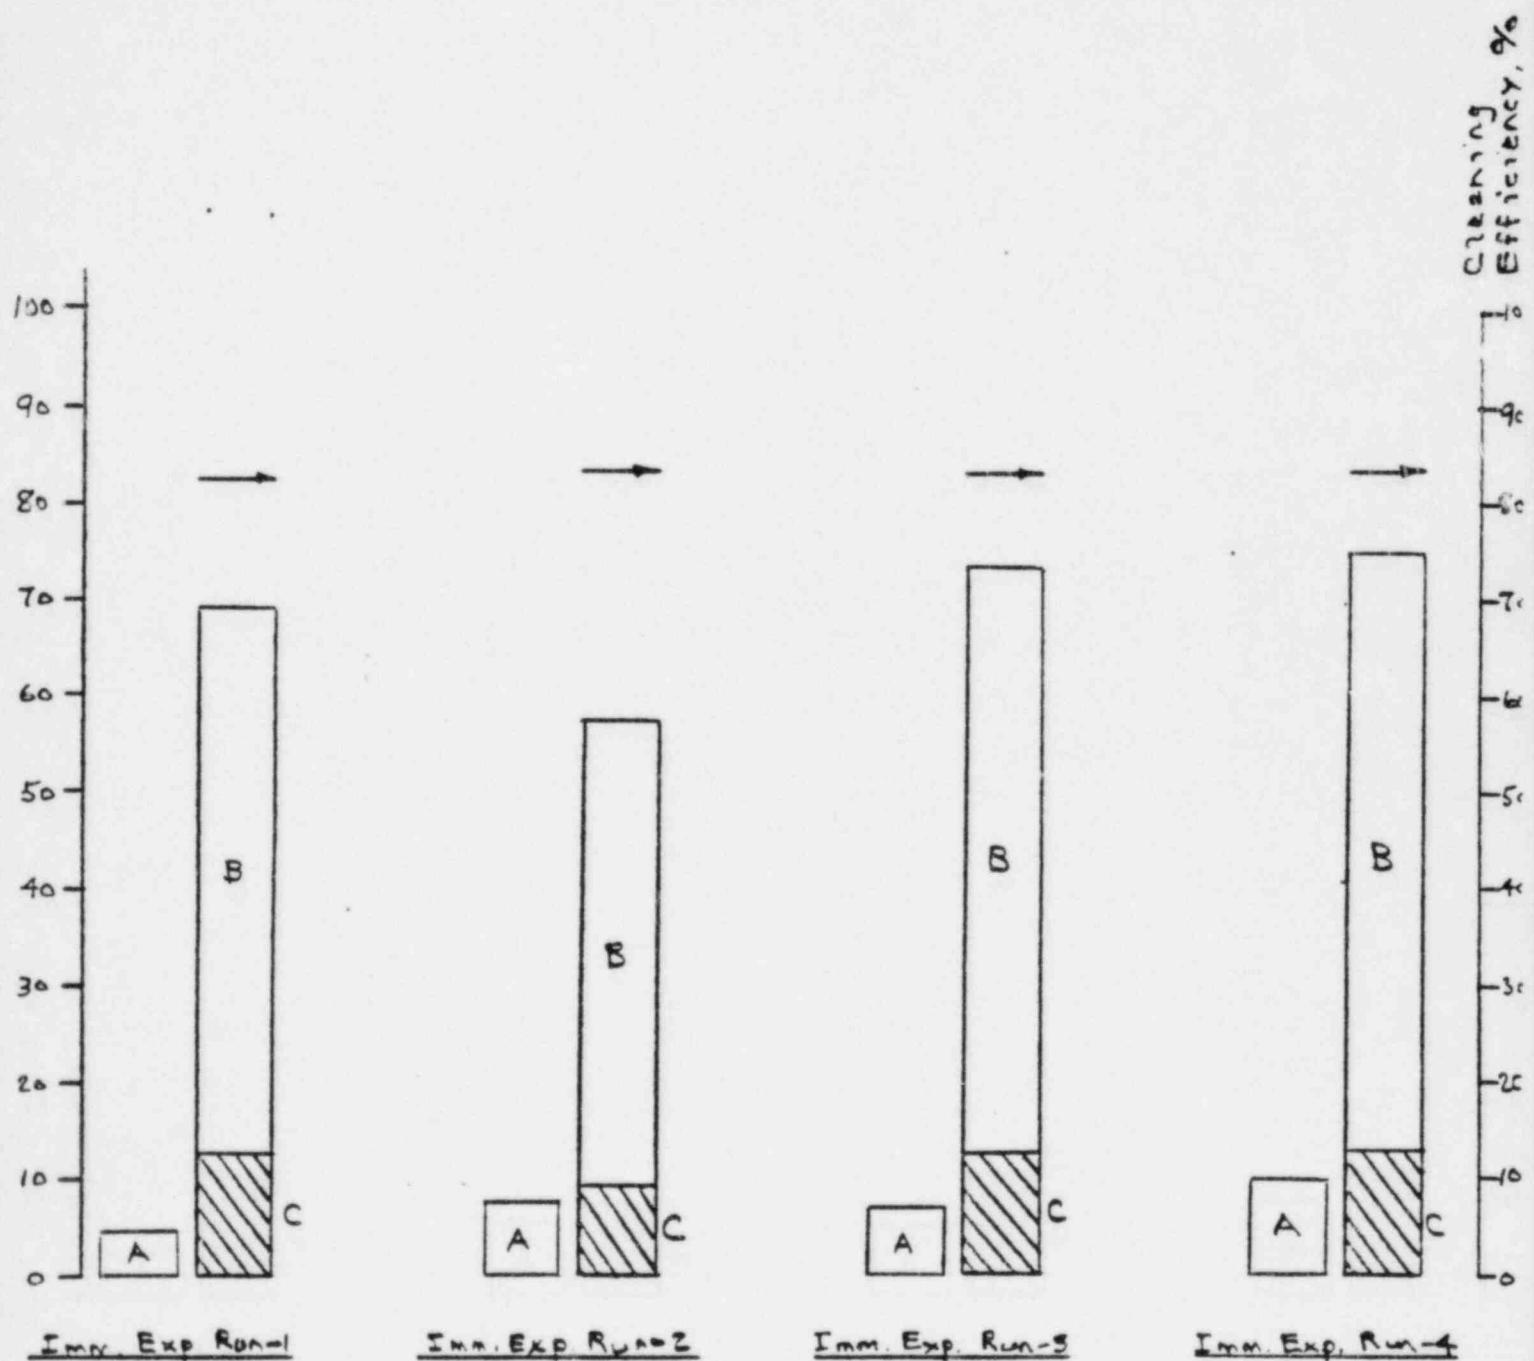
FIGURE A-3 SUMMARY OF SULFUR ANALYSES AND CLEANING EFFICIENCIES FOR BEAKER CLEANING SERIES 3
