REPORT  
of the  
OVERHEAD FLUID GROUTING  
TEST PROGRAM

Located at  
Consumers Power Company  
Midland Nuclear Power Plant  
Midland Units 1 & 2

July 15, 1983

OVERHEAD FLUID GROUTING TEST PROGRAM  
REMEDIAL UNDERPINNING  
MIDLAND UNITS 1 & 2

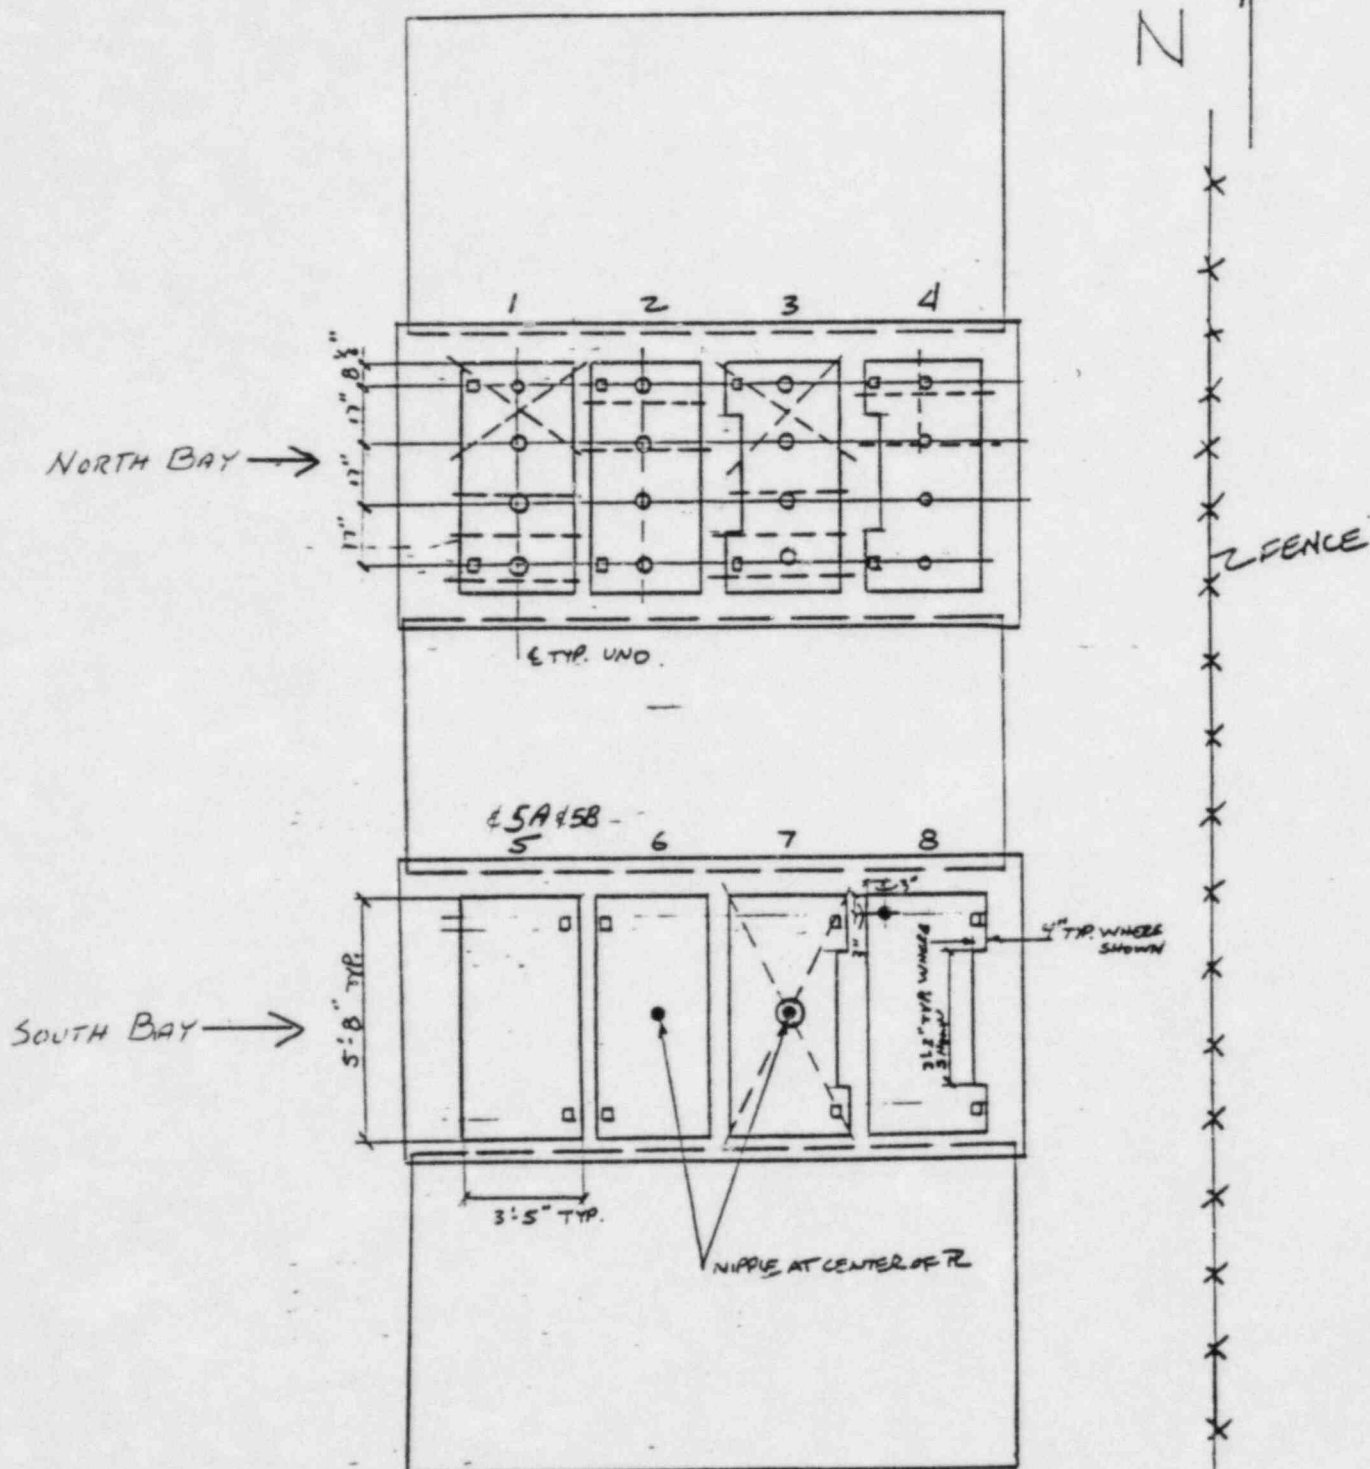
# PRESSURE GRouting PLAN ARRANGEMENT

- - 5/8"  $\phi$  NIPPLE WELDED TO PLATE
- - 3/4"  $\phi$  NIPPLE WELDED TO PLATE
- ⊙ - 1 1/2"  $\phi$  CORE HOLE 3" DEEP
- - 4"  $\phi$  HOLE IN PLATE
- GROOVE CUT IN SLAB FOR AIR PASSAGEWAY (DEPTH VARIES FROM 1 1/2" @ CENTER OF RATE TO 3/4" OUTSIDE THE RATE AREA)
- 1 - TEST RATE LOCATION NUMBER

Eight (8) test plates were laid out four (4) in each of the two simulation bays. The north simulation bay test plates were installed to test a multiple injection point system of grout placement under varying bulkheading and concrete preparation conditions. The South simulation bay test plates were installed to test the single grout injection point system with various concrete surface preparations. One plate was formed on three sides and drypacked with Masterflow #713 as a comparison to the pressure grouting techniques. (See Exhibit #A for Grouting Plan Arrangement).

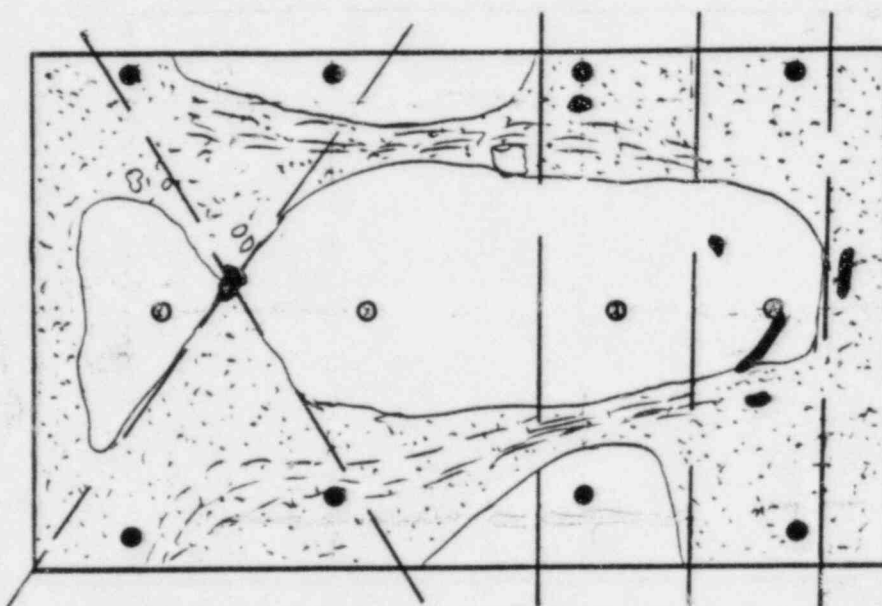
1. Peripheral bubbles about nipples?  
 #1 (South) No (Peripheral bubbles from #2 over hole) #3 No  
 #2 Yes - Towards #1 #4 (North) No
2. Air noted in underslab notch grout projections? Yes
3. Grout leakdown at air vent holes? No, but lead wool hole plugs extending into grout slab 3/4" past plate edge.
4. Noticeable general air bubble pattern? Yes

- LEGEND
- Full contact surface areas (all plates)
  - Areas of less than full contact containing small air voids. The densities of the small air voids are not indicated. (Pressure grout plates only)
  - Porous and/or less than full contact areas.
  - Injection point nipples
  - Cut groove patterns
  - Anchor bolt holes (8 each per plate)
  - Noticeable air bubble chains
  - Void areas deeper than 1/8"
  - Void areas 1/8" or less deep

5. Calculated void area in excess of 1/4" Ø nominal sizing = 0.9% percent of surface area.
6. General quality evaluation of grout/concrete contact area.  
 North  $\frac{1}{2}$ : Poor, satisfactory, good, excellent  
 South  $\frac{1}{2}$ : Poor, satisfactory, good, excellent
7. General evaluation of test plate: For some reason, this plate has a lot of little air bubbles and they form chains of flow lines. This is by far the worst of the plates (#2, #3, & #4) placed on same day as far as general appearance and numbers of small bubbles are concerned. The cut grooves appear to have had little, if any effect on the pattern of these bubbles. This was the last plate done on this day.

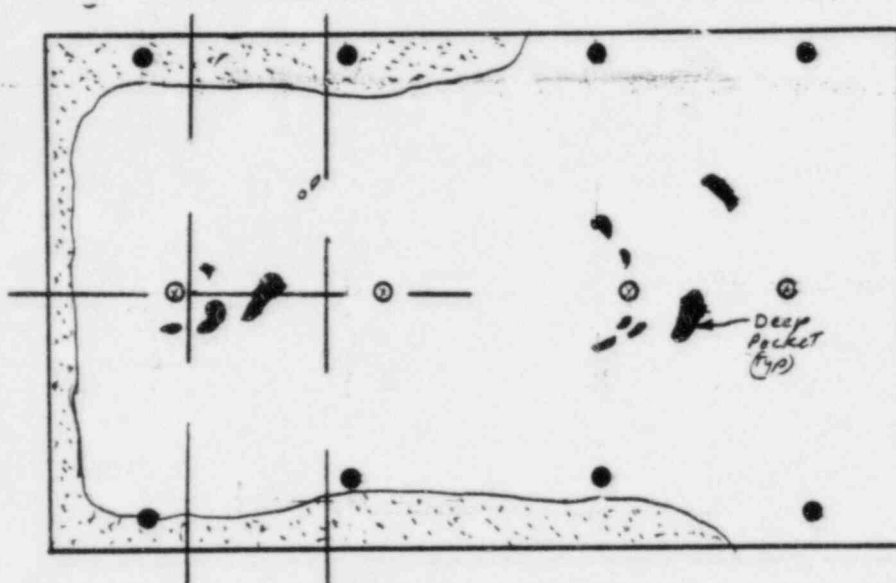
2. Air noted in underslab notch grout projections? Yes, Minor

3. Grout leakdown at air vent holes? n/a  
Leadwool/exp. metal bulkhead

4. Noticeable general air bubble pattern? Yes, minor

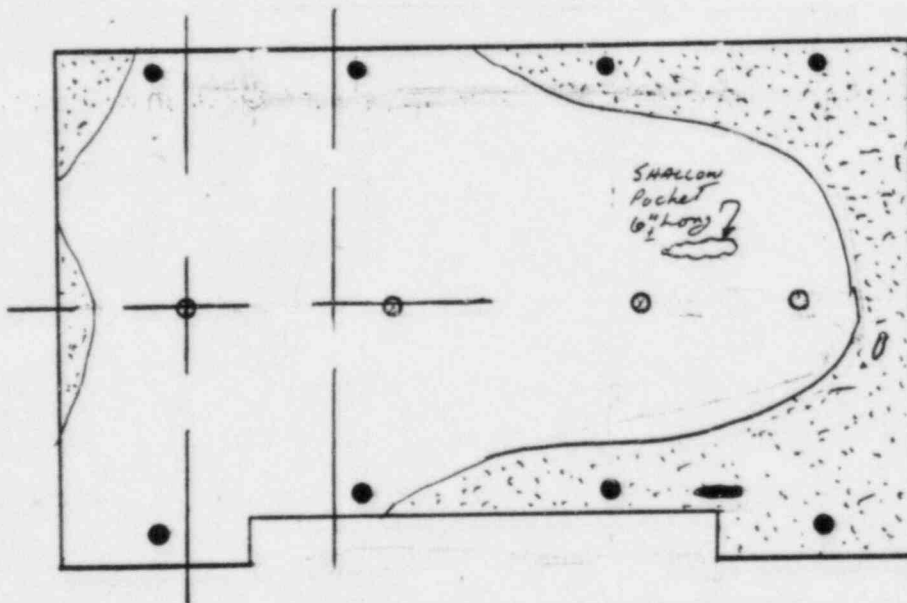
2. Air noted in underslab notch grout projections? Yes

3. Grout leakdown at air vent holes? No, one wood plug too deeply inserted, though.

4. Noticeable general air bubble pattern? Yes

7. General evaluation of test plate: The wooden bulkhead with wooden grout hole plugs seem to have worked quite well. No major advantages noted for grooved half.

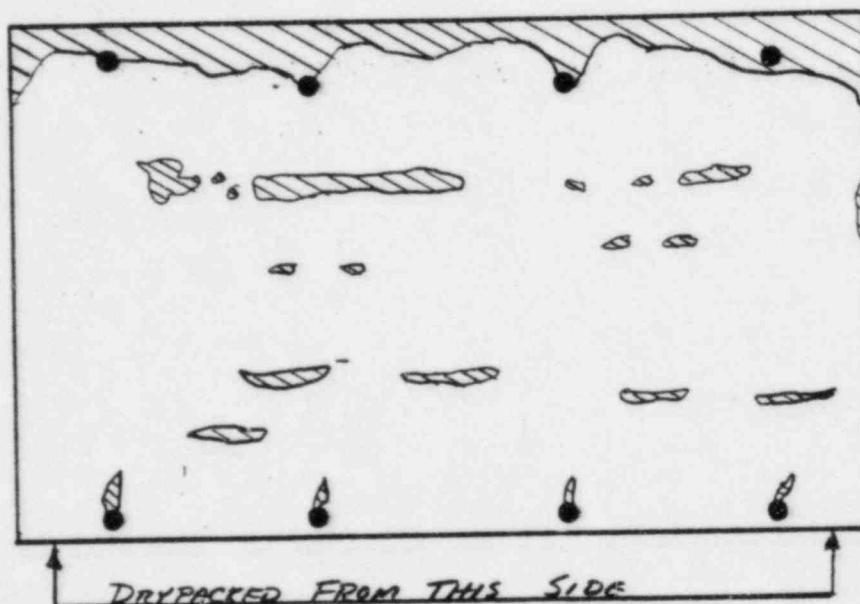
2. Air noted in underslab notch grout projections? n/a

3. Grout leakdown at air vent holes? n/a

4. Noticeable general void pattern? Yes

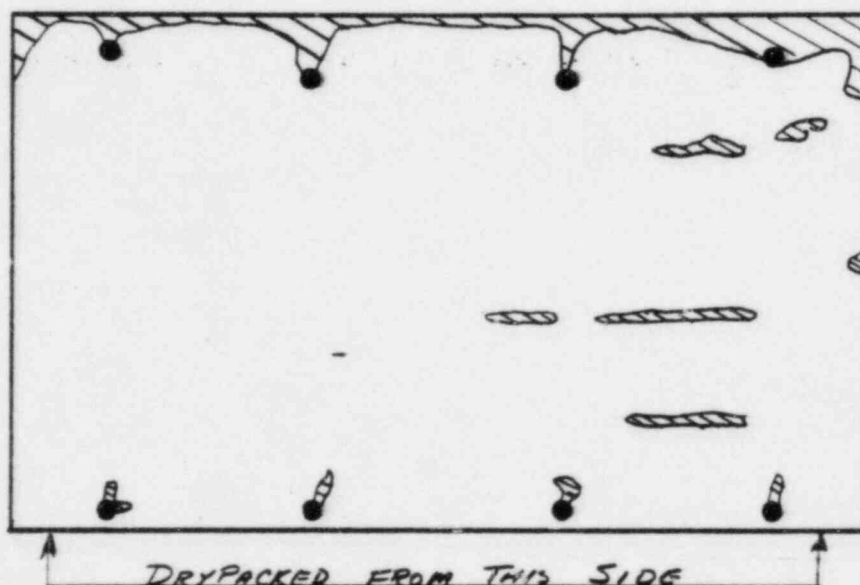
2. Air noted in underslab notch grout projections? n/a

3. Grout leakdown at air vent holes? n/a

4. Noticeable general void pattern? Yes

5. Calculated void area in excess of 1/4" Ø nominal sizing = 7.0% percent of surface area.

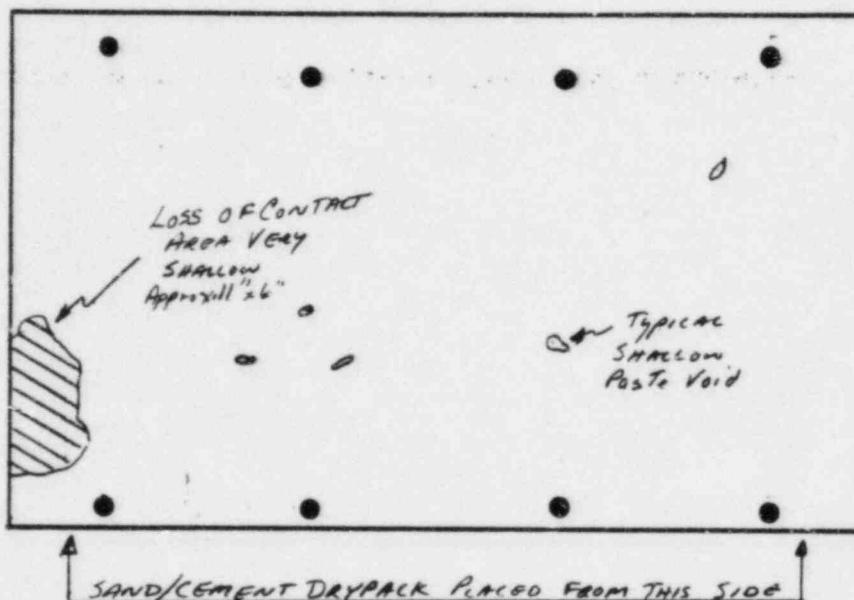
2. Air noted in underslab notch grout projections? n/a

3. Grout leakdown at air vent holes? n/a

4. Noticeable general void pattern? No

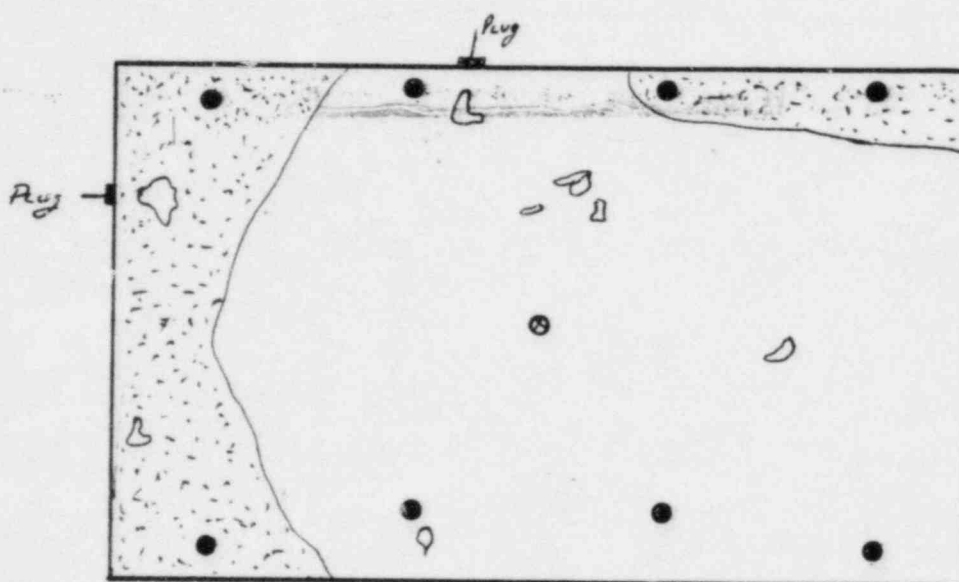
2. Air noted in underslab notch grout projections? n/a

3. Grout leakdown at air vent holes? Yes, at 2 locations, both are lead wool plugs (3" x 2") at North end east plug & 1 1/2" x 1/2" at East side north middle plug, both are shallow depressions.

4. Noticeable general air bubble pattern? Yes, minor

5. Calculated void area in excess of 1/4" Ø nominal sizing = 0.8% percent of surface area.

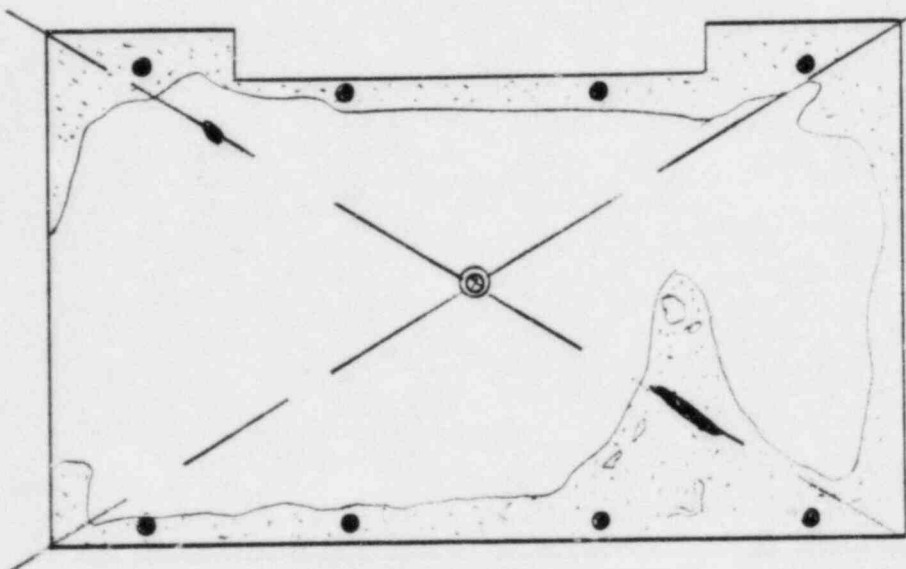
2. Air noted in underslab notch grout projections? Yes

3. Grout leakdown at air vent holes? No

4. Noticeable general air bubble pattern? Yes, minor

7. General evaluation of test plate: The expansion bolts on the East side appear to have pulled or never were snug at 1 1/2". Grout pad thickness increased up to 2 1/2" nominally. Overall evaluation is as good as plate #6. No advantage noted due to fountain or cut grooves.

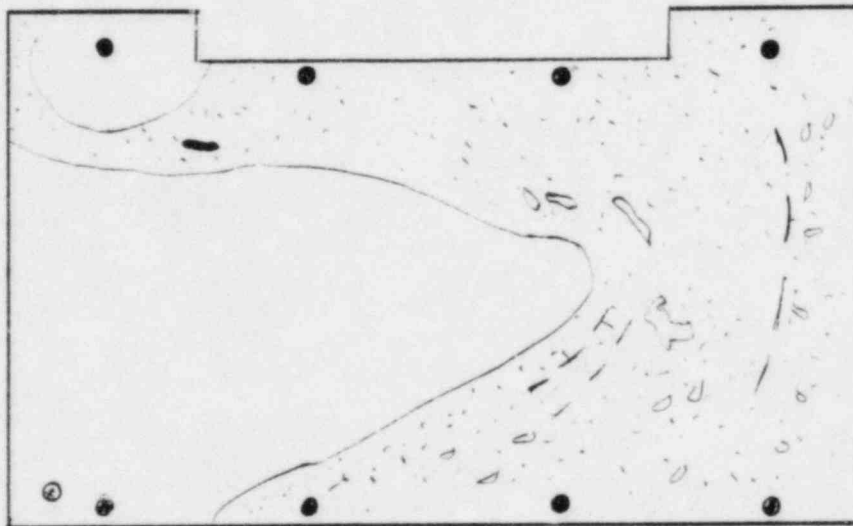
2. Air noted in underslab notch grout projections? n/a

3. Grout leakdown at air vent holes? No

4. Noticeable general air bubble pattern? Yes

7. General evaluation of test plate: General condition evaluation is that this plate is no worse than plate #1. One injection nipple in the corner gives a lesser quality product than one in the middle of the plate.

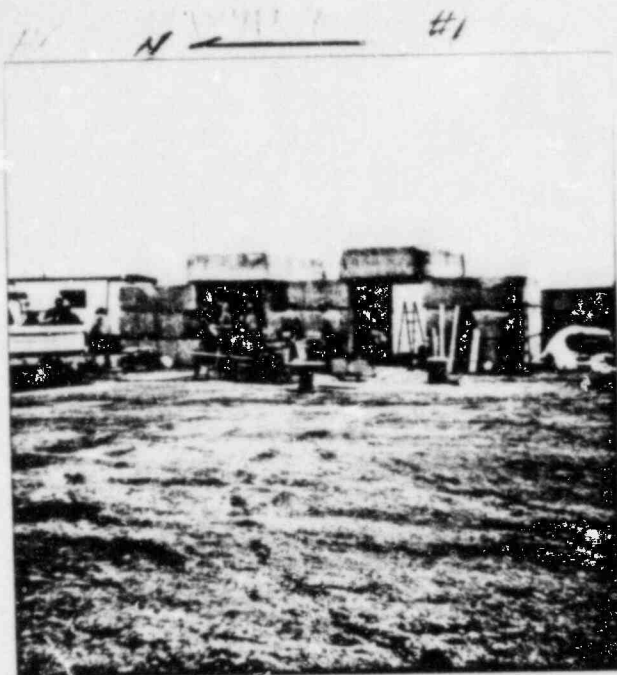
6/28/83 GROUTING TEST SITE  
@ POSEYVILLE YARD.

The simulation of actual conditions which exist under a structure being underpinned was accomplished by utilizing concrete blocks (crane counter weights) cribbed by other concrete blocks to create two test bays. (See Exhibit D - Photographs #1 and #5).

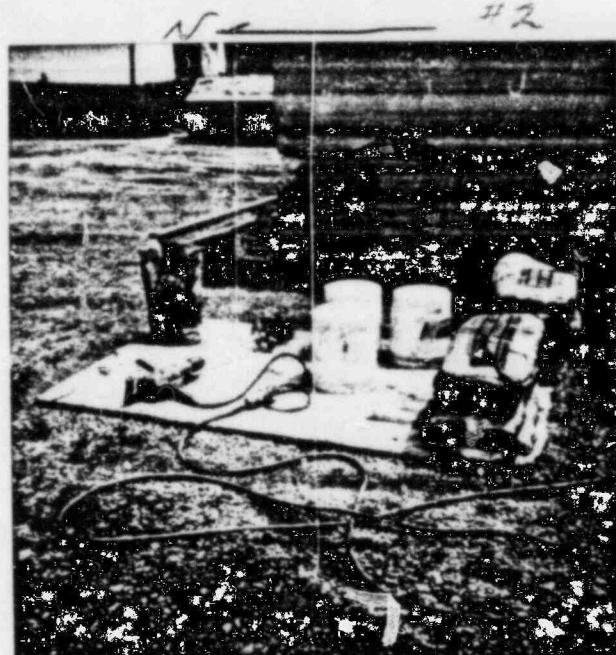
6/28/83 GROUT MIX STATION FOR  
TEST RATES #1 THRU #4 POSEYVILLE  
YARD

The flowable grout used was Masterflow #713 mixed in accordance with Mergentime Grouting Procedure MCP 15.000 (See Exhibit D - Photograph #2 and Exhibit E). Where multiple injection points were used, grouting progressed south to north.

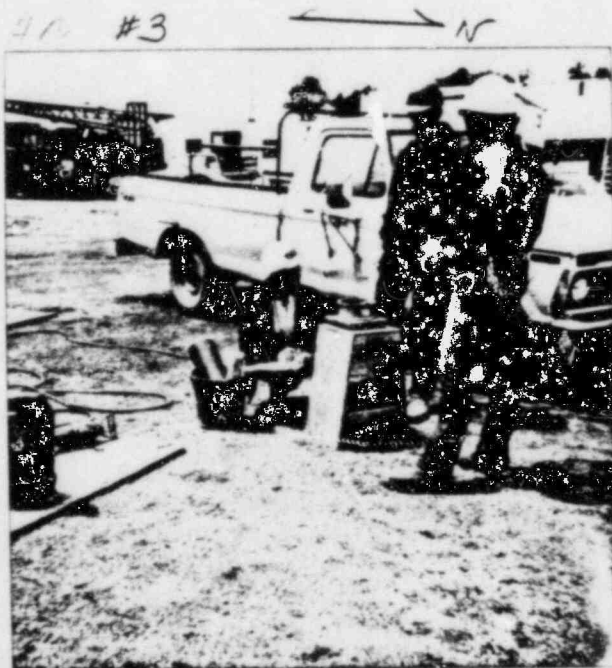
6/28/83 U.S. TESTING - FLOW CONE  
SETUP FOR TEST RATES #1 THRU #4  
ONE SUCCESSFUL TEST TAKEN FOR  
ALL RATES PER MCP 15.000 SECT. 11.2

U.S. Testing was present at the start of grouting and drypacking each day and to take flow cone tests and to make strength cubes (see Exhibit D - Photograph #3) for verification of material characteristics (see Exhibit C). It should be noted that no curing was performed on the grout test pads and that they were all stripped within approximately 20 hours of being placed.

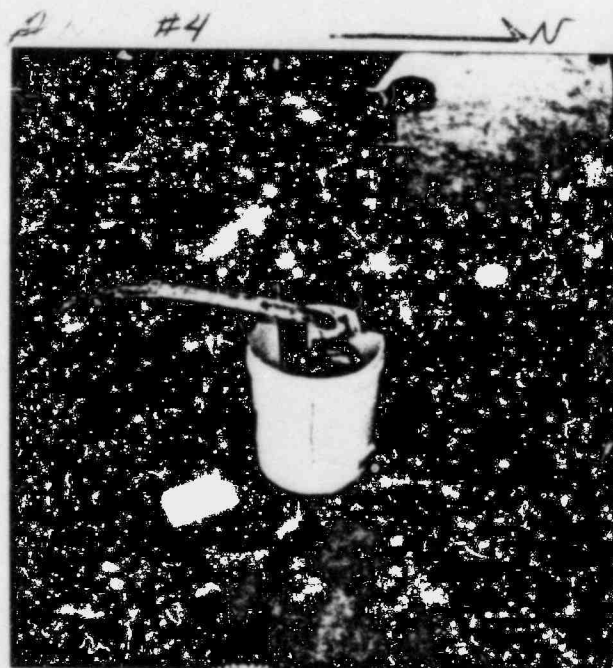
6/28/83 GROUT PUMP SET UP  
PUMP = AIRPLACO MODEL #HG-5,  
S.N. - 821121, Pressure Gauge 0-60 PSI  
2 1/2" DIAL  
ALL APPEAR TO BE IN GOOD CONDITION.

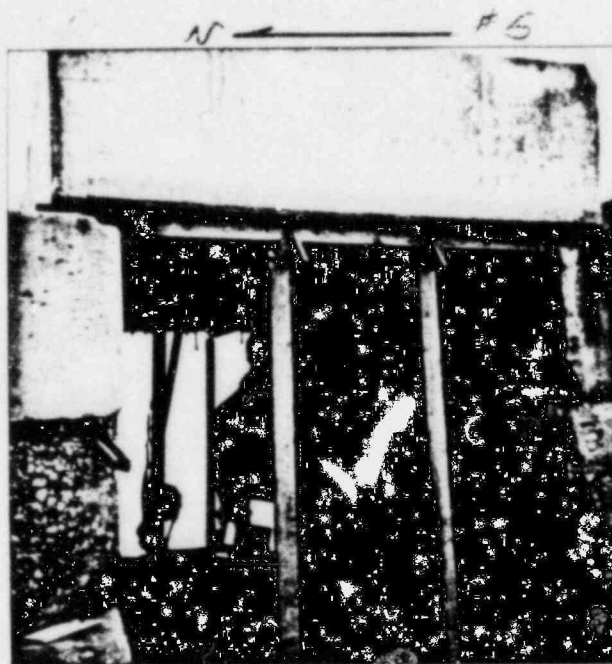
6/28/83 CIRCUITING TEST SITE  
NORTH BAY (RATES #1-#4)  
LOOKING EAST SHOWING WIND BREAK  
ON FAR END AND BULKHEAD WITH  
BRACING

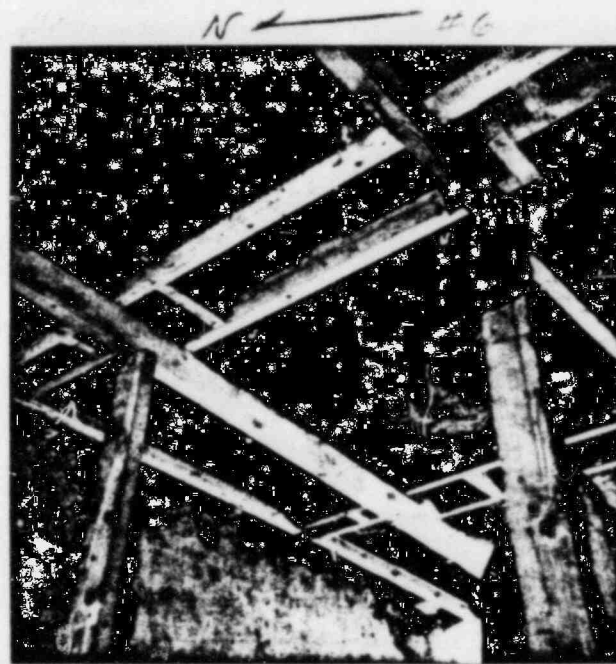
6/28/83 WOODEN BULKHEAD AT RATES  
#2 & #3. BOTH WITH LEAD WOOL/EXP.  
METAL BEHIND

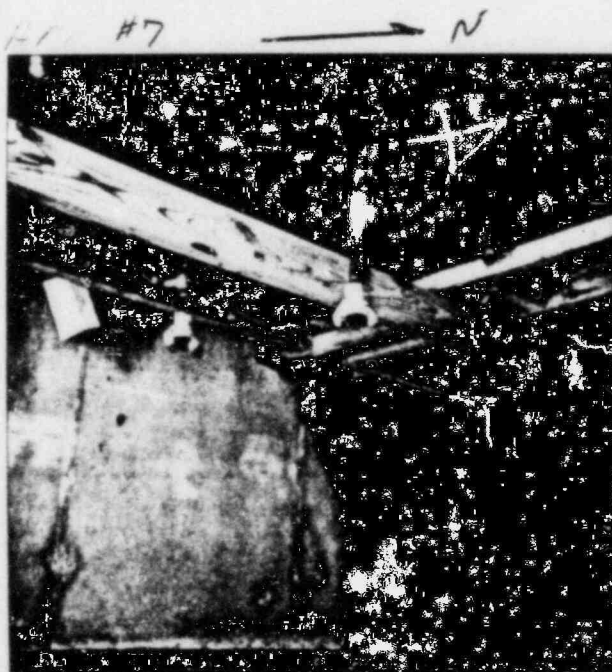
6/28/83 TYPICAL GROUT NIPPLE  
SET-UP WITH C.P. COUPLING, PIPE  
NIPPLE, VALVE and WELDED NIPPLE.  
(SHOWN @ RATE No. 4)

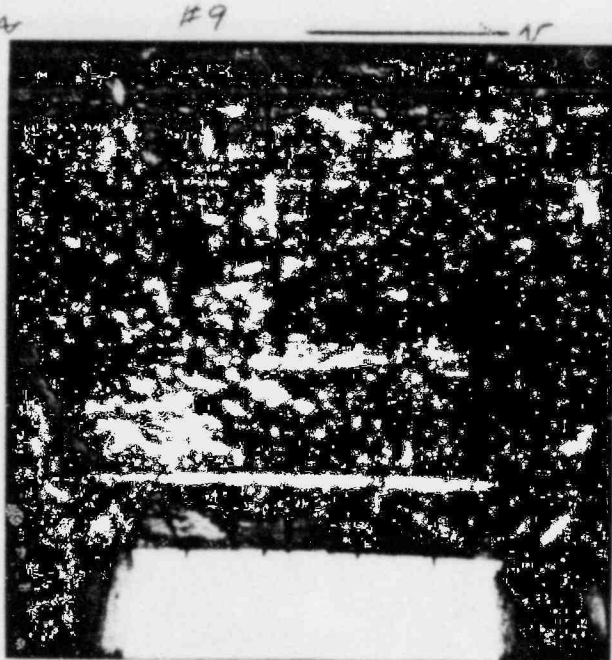
7/2/83 NORTH BAY UNDERSLAB LOOKING WEST. CUT GROVE PATTERNS VISIBLE.

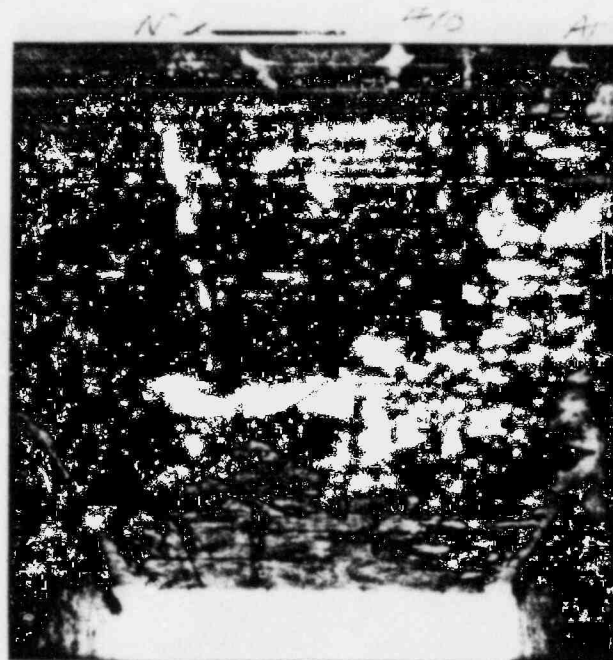
7/2/83 NORTH BAY UNDERSLAB LOOKING EAST. CUT GROVE PATTERNS VISIBLE

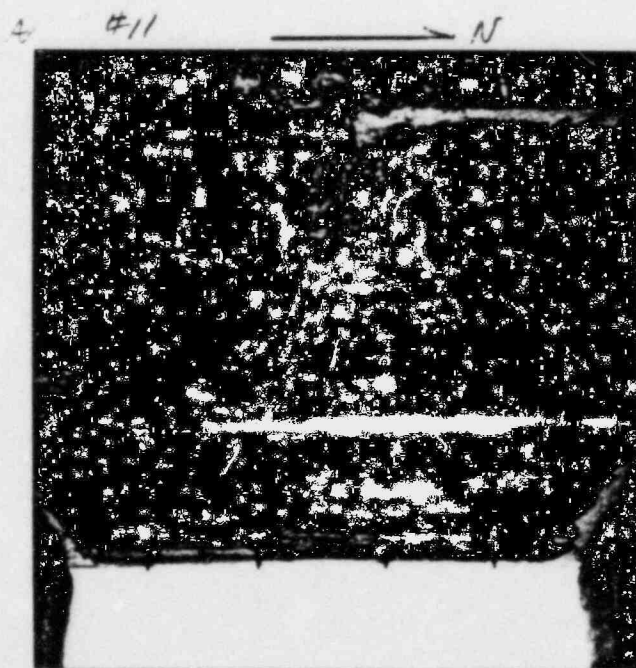
7/2/83 SOUTH BAY UNDERSLAB LOOKING WEST. SCARIFIED PAD #6 and DAYPACK PAD #5 (BSA) AT FAR END

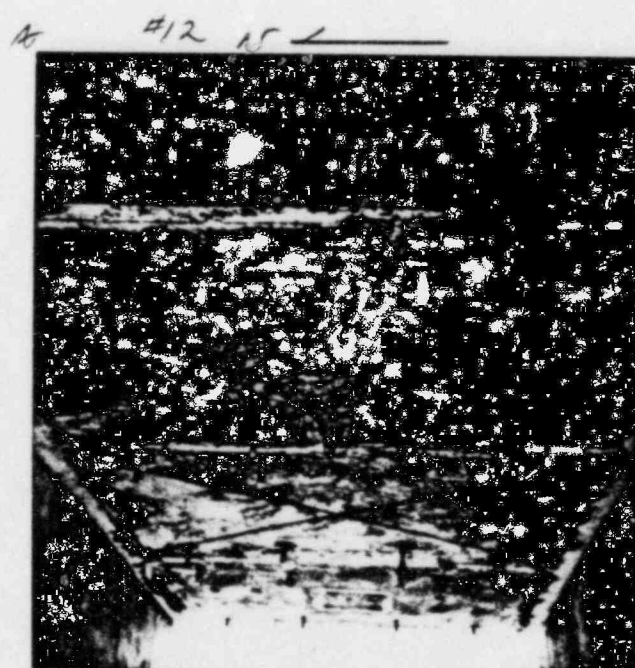
7/2/83 SOUTH BAY UNDERSLAB LOOKING EAST. SCARIFIED AND CUT GROVES VISIBLE.

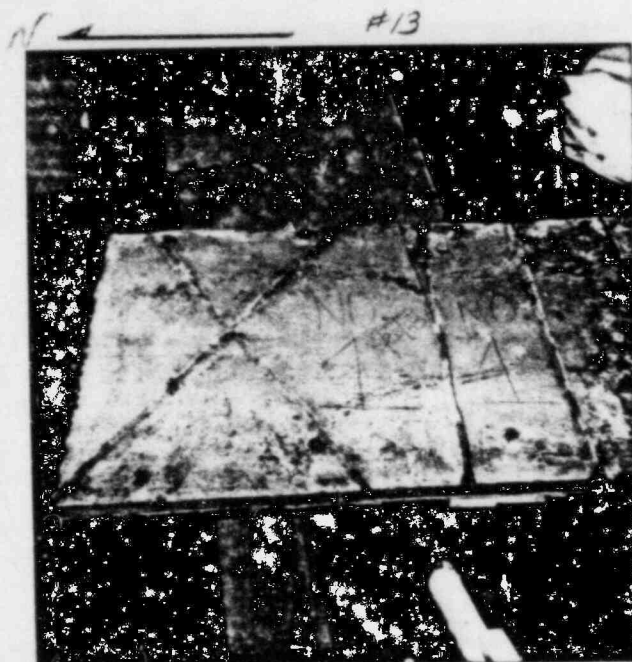
6/29/83 PLATE No. 1 (NORTH END)  
CONCRETE CUT "X" PATTERN, 4 NIPPLES  
FOR RATE, WOOD BULKHEAD

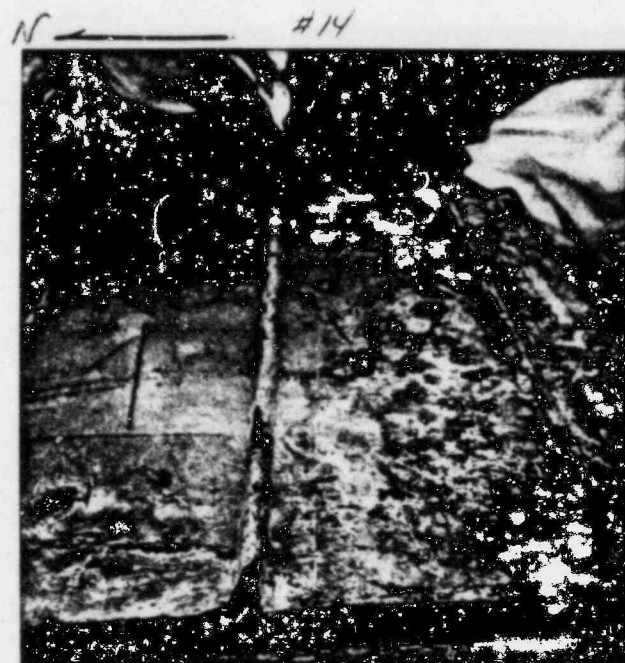
6/29/83 PLATE No. 1 (SOUTH END)  
CONCRETE CUT PARALLEL LINES,  
4 NIPPLES FOR RATE, WOOD BULKHEAD

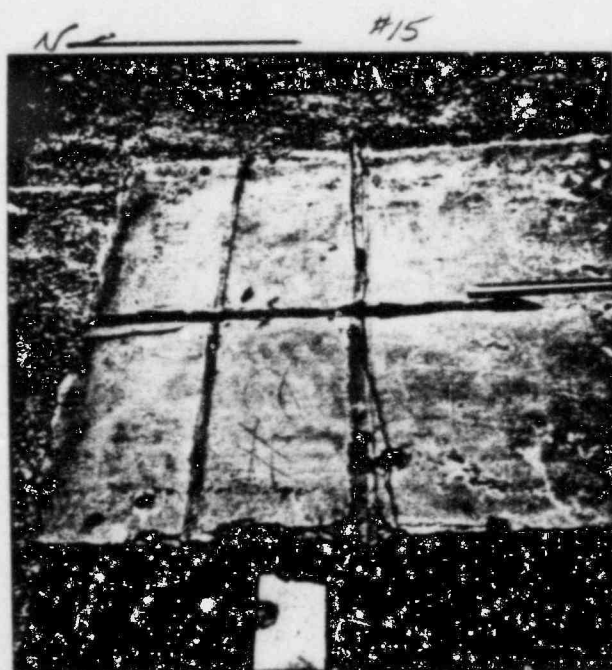
6/29/83 PLATE No. 2 (NORTH END)  
CONCRETE CUT "H" PATTERN  
LEAD WOOL/EXP. METAL BULKHEAD  
4 GROUT NIPPLES FOR WHOLE RATE

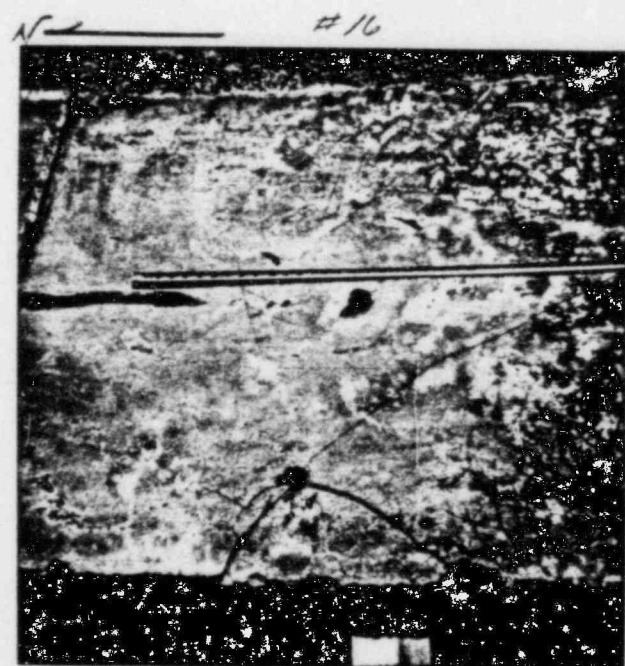
6/29/83 PLATE No. 2 (SOUTH END)  
NO CONCRETE CUT, 4 NIPPLES,  
LEAD WOOL/EXP. METAL BULKHEAD

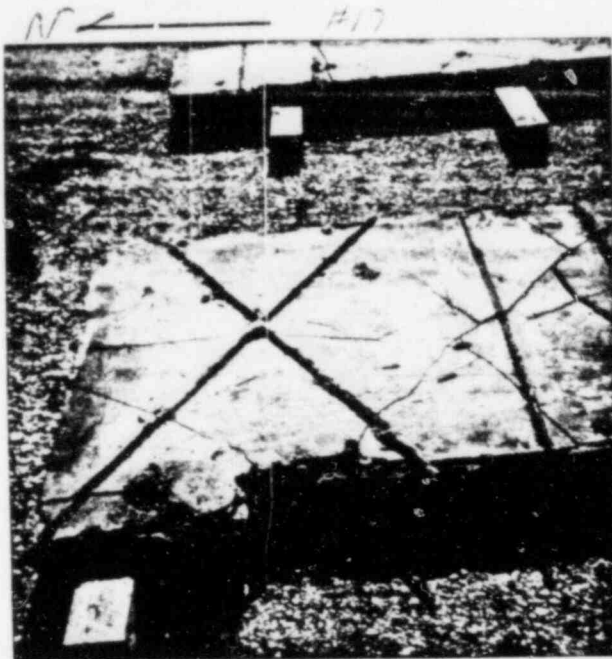
6/29/83 PLATE No. 3 (NORTH END)  
CONCRETE CUT "X" PATTERN, 4 NIPPLES  
FOR PLATE, LEAD WOOL/EXP. METAL

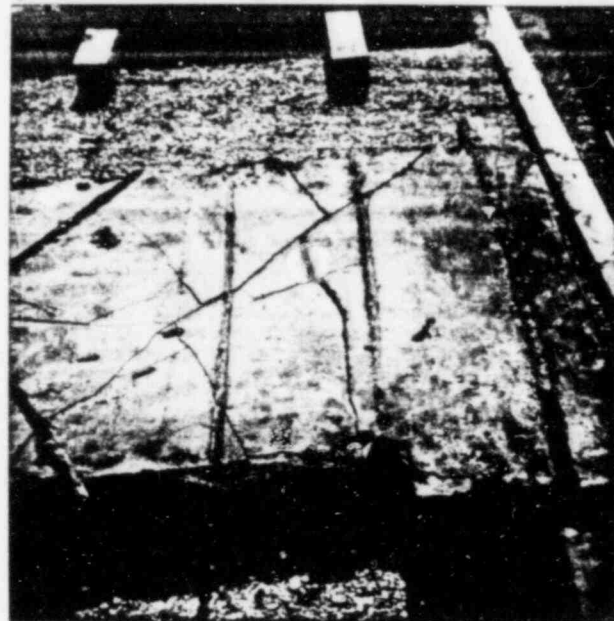
6/29/83 PLATE No. 3 (SOUTH END)  
CONCRETE PARALLEL LINES, 4 NIPPLES  
FOR PLATE, LEAD WOOL/EXP. METAL  
BULKHEAD

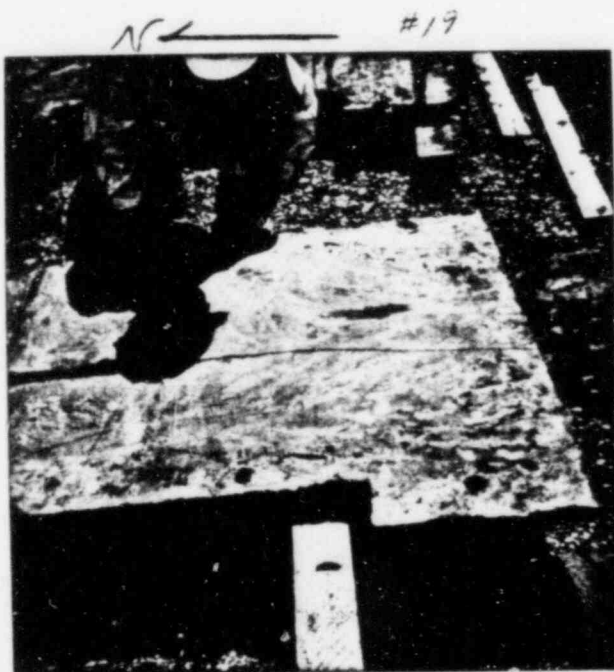
6/29/83 PLATE No. 4 (SOUTH END)  
NO CONCRETE CUT, 4 NIPPLES FOR PLATE,  
WOOD BULKHEAD

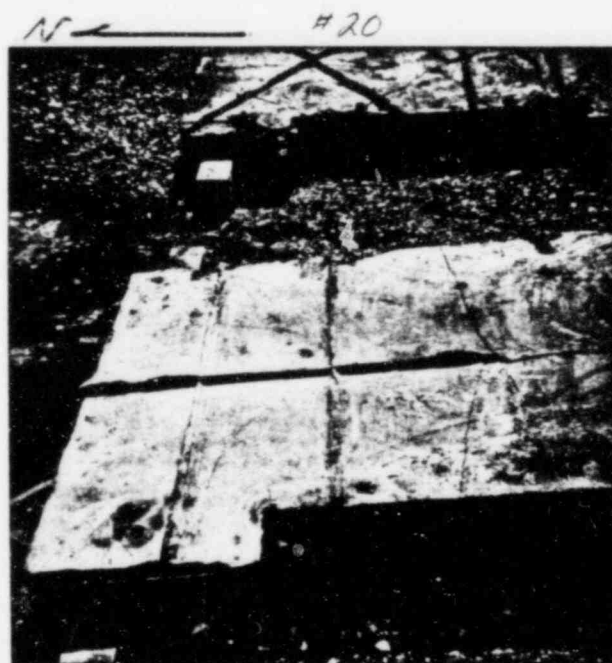
6/29/83 PLATE No. 4 (NORTH END)  
CONCRETE CUT "H" PATTERN, 4 NIPPLES FOR  
PLATE, WOOD BULKHEAD

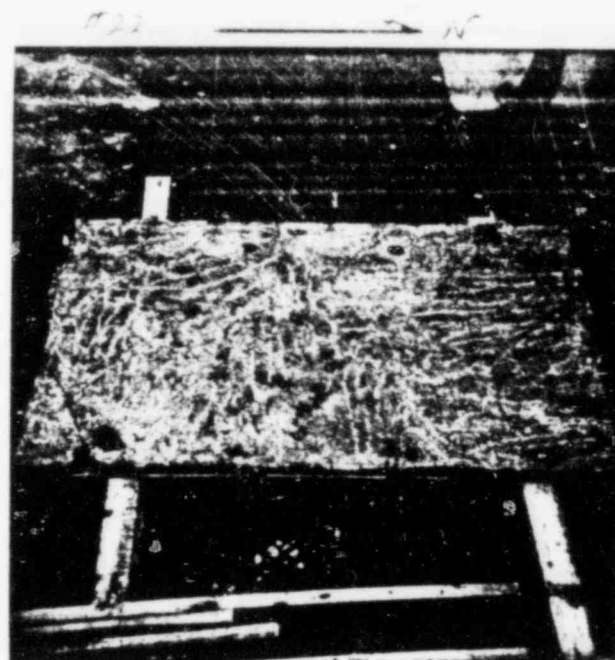
4/30/83 PLATE No. 6  
TEST PLATE WITH CHISEL PREP. ON  
CONCRETE SURFACE

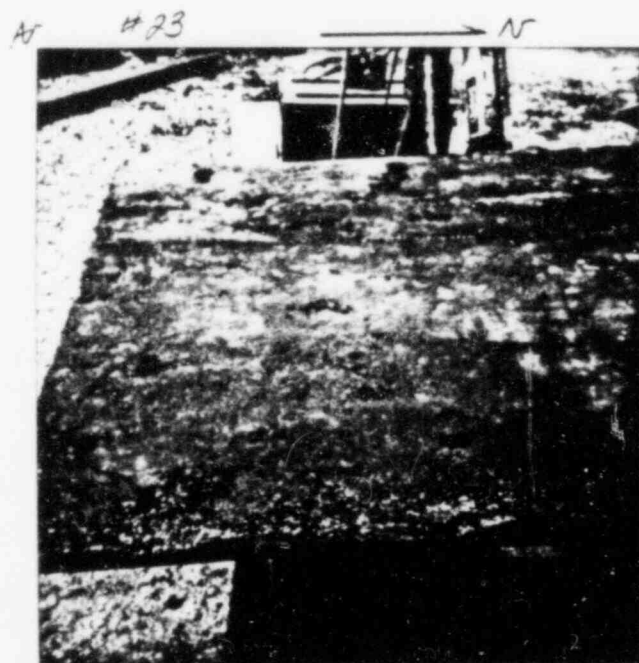
7/2/83 PLATE No. 5A (SOUTH END)  
SECOND DRYPACK TEST PLATE AT  
SAME LOCATION ALSO USING  
MASTERFLOW #713

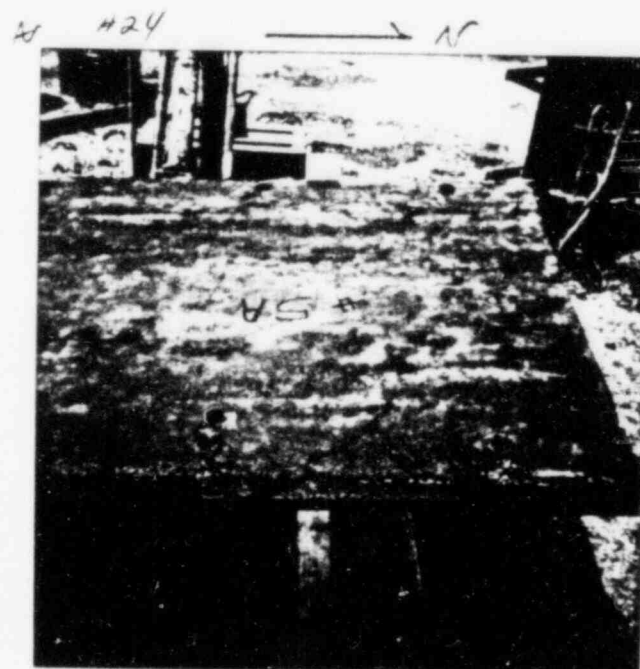
7/2/83 PLATE #5A (NORTH END)  
SECOND DRYPACK TEST PLATE AT  
SAME LOCATION AS PLATE #5

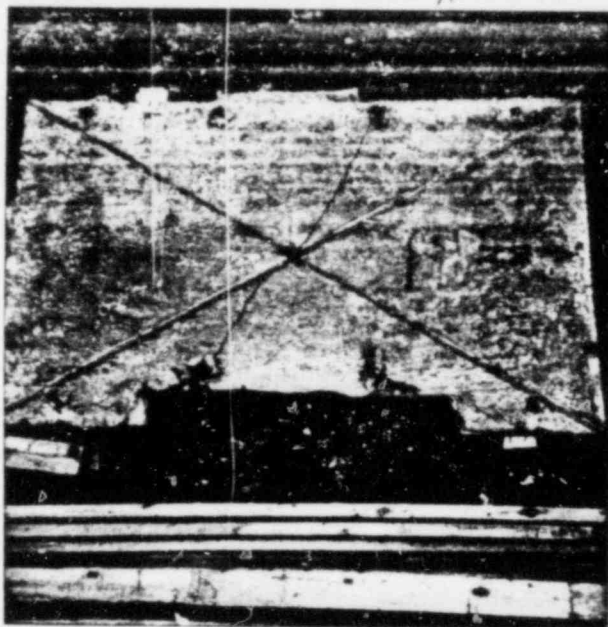
6/30/83 PLATE No. 7  
TEST PLATE WITH CORE HOLE IN  
SLAB @ CENTER.

Test plate #7 had a special condition of a pipe extension of the injection nipple up into a 1½" drilled hole in the underslab concrete. No advantages to this system were noted in the resultant underslab/grout contact surface to merit further consideration.

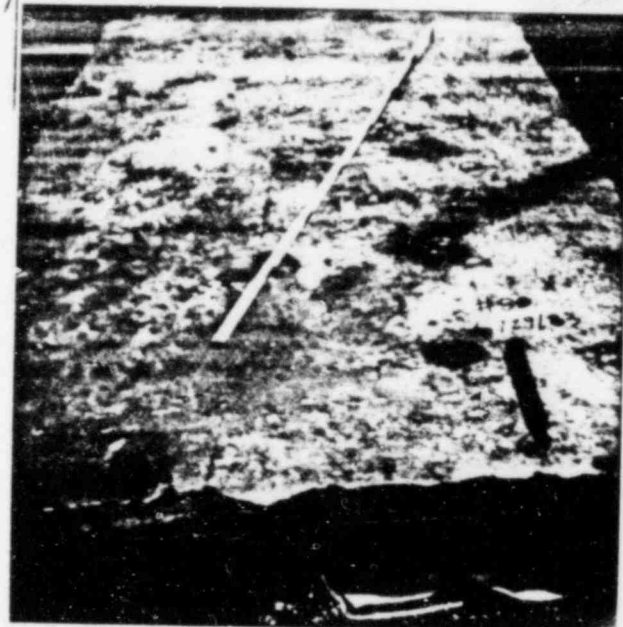
7/1/83 PLATE No. 8  
TEST PLATE WITH GROUTING NIPPLE  
IN NORTH WEST CORNER

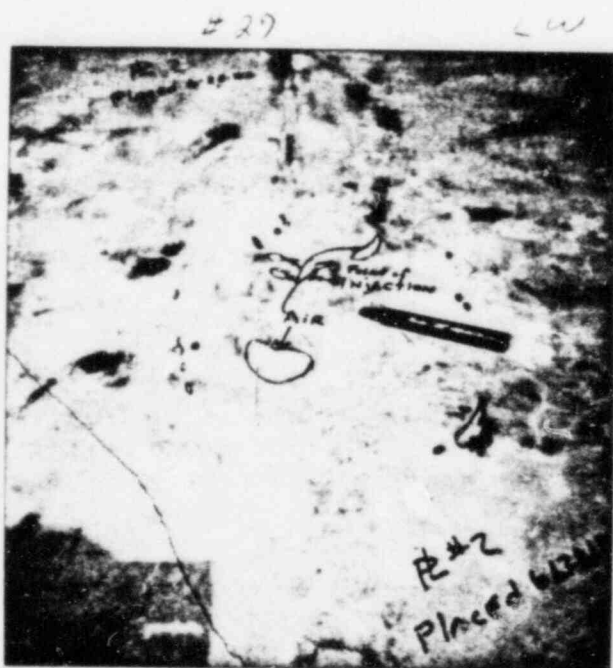
7/1/83 PLATE No. 2  
NOTING PERIPHERALLY ORIENTED  
AIR HOLES AROUND INJECTION HOLE  
#2 (from SOUTH END)

The results of all test plates grouted with Masterflow #713 were satisfactory. The utilization of various patterns of specially cut grooves in the underslab concrete appeared to have had no influence on relieving entrapped air. In certain instances air bubbles were entrapped continuously across a cut groove. The larger (over  $\frac{1}{2}$ " diameter and  $\frac{1}{8}$ ") air bubbles appeared almost exclusively on the plates with four (4) injection points. (See Exhibit D - Photograph #27). Since the first injection point generally filled the bulk of each test area it appears that these bubbles may be portions of a larger bubble that was formed when grout was placed from a previous injection point. There is no definite pattern on entrapped air bubbles other than they appear to be radially oriented about one or more of the three subsequent injection points.

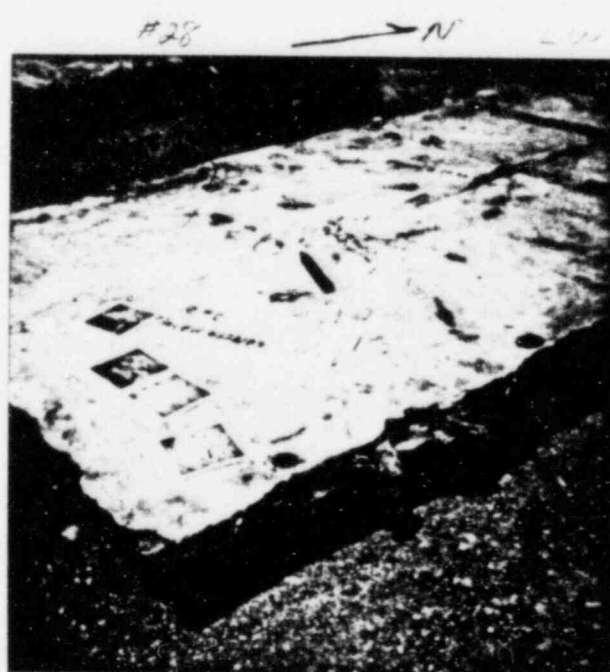
7/1/83 TEST PLATE No. 2  
SHOWING LOST GROUT PAD AREA  
DUE TO LEAD WOOL PACKING TYPE  
BULKHEAD

Both the wood form and expanded metal/leadwool bulkhead methods effectively contained the grout and provided adequate avenues for escaping air. The wood forms left a neat uniform grouted edge while the Expanded metal/leadwool created a void area approximately  $\frac{3}{4}$ " back from the test plate edge. (See Exhibit D - Photograph #28).

No advantages were noted by use of the expanded metal/leadwool system over the more conventional wooden bulkhead system. A major disadvantage was, however, noted in that there was a definite loss in available grout pad size in the leadwool system. Consequently production plates utilizing this bulkhead system would require larger sized plates to makeup for the lost grout pad area.

Utilization of leadwool as a form of bulkheading for pressure grouting should be kept as an option for areas where the more conventional wood bulkheading can not be utilized. There may be instances during grouting where the use of leadwool will provide the best and most reasonable means of stopping grout movement. Care will still have to be exercised to ensure that use of leadwool does not reduce the required effective bearing area of the grout pad.

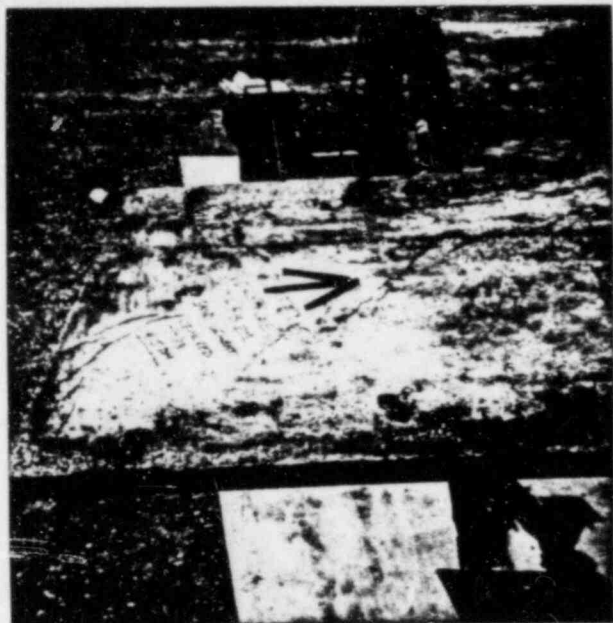
N #29

7/7/93 PLATE No. 5B (SOUTH END)  
3<sup>RD</sup> DRYPACK TEST PLATE BUT MADE  
WITH SAND/CEMENT MIX #713

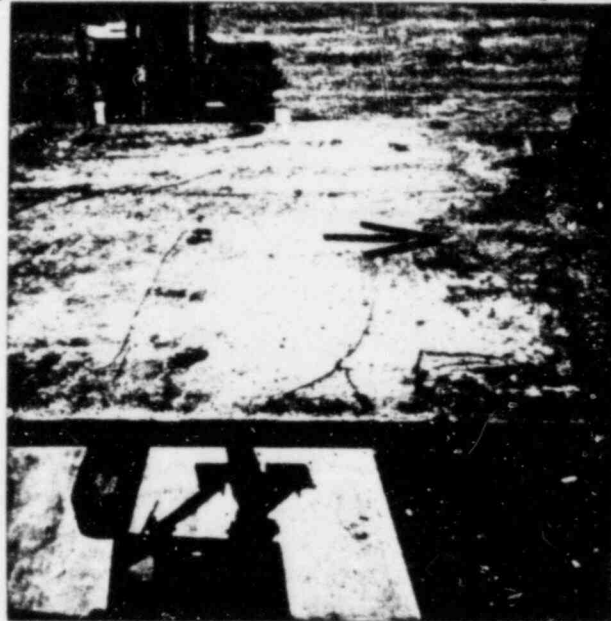
A #30

7/7/93 PLATE No. 5B (NORTH END)  
3<sup>RD</sup> DRYPACK TEST PLATE BUT MADE WITH  
SAND/CEMENT MIX #713

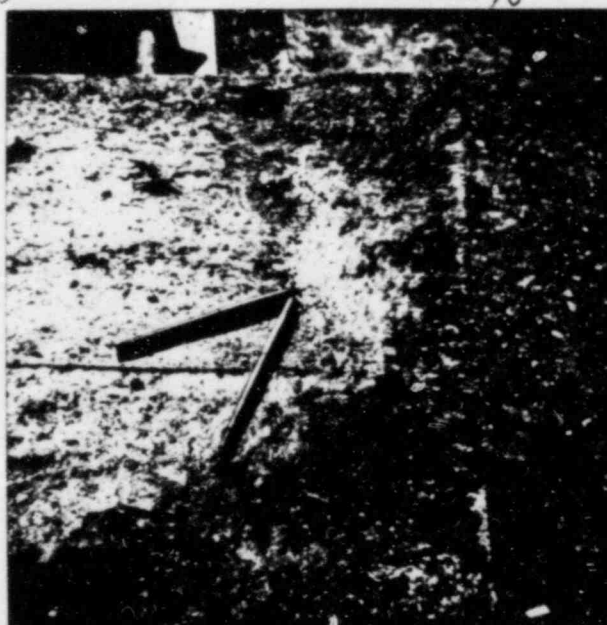
A #31

7/7/93 PLATE No. 5B (NORTH WEST CORNER)  
APPEARANT LOSS OF CONTACT AREA  
211"x6". THE H.B. APPEAR TO HAVE SLIPPED  
ON THE WEST SIDE. (1 1/2" TO 2" GROUT FILL)

Two drypack test plates were made using Masterflow #713 for comparison purposes. Neither of these two test plates proved to be better than the pressure grouted test plates. Proper consolidation of the drypack on the far side of the test plate and behind anchor bolts appears to be the weak areas for these plates. A third drypack test plate was made using a 1 to 1 sand/cement ratio which proved to be the best test plate except for a loss of contact area in the northwest corner, apparently a result of the plate moving during final stages of drypacking.
