GPC-07-102  
Revision 1  
September 1983  
GPC007.0102

DESIGN REPORT  
FOR  
WELD OVERLAY REPAIRS  
AND FLAW EVALUATIONS  
IN  
RECIRCULATION AND RHR SYSTEMS  
AT  
E. I. HATCH NUCLEAR POWER PLANT  
UNIT 2

Prepared for  
Georgia Power Company

Prepared by  
NUTECH Engineers, Inc.  
San Jose, California

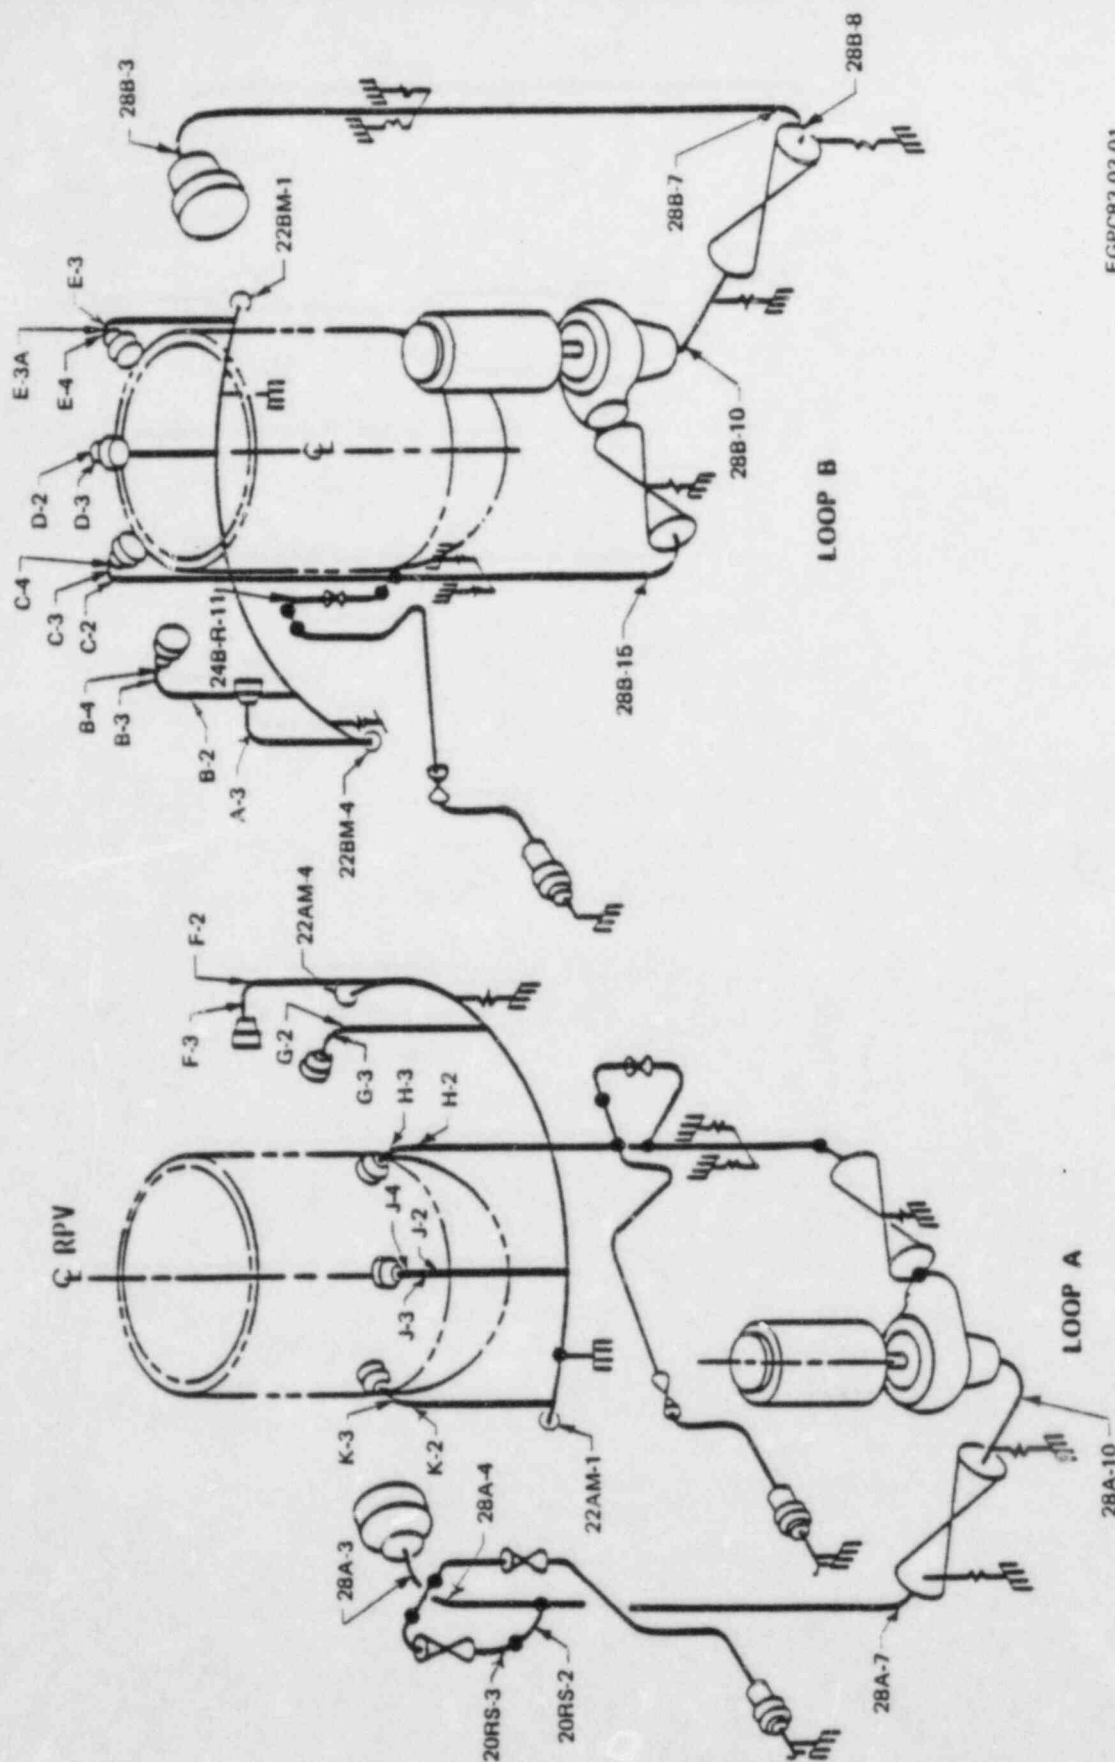
Figure 1.1  
CONCEPTUAL DRAWING OF RECIRCULATION SYSTEM

Figure 1.1 shows all the welds in relation to the Reactor Pressure Vessel and other portions of the Recirculation and RHR systems. Table 1.1 lists the welds evaluated in this report, describes the indications found at each location, and identifies the type of repair (as defined in Section 2) performed. All of the existing affected RHR and Recirculation system materials are Type 304 stainless steel.

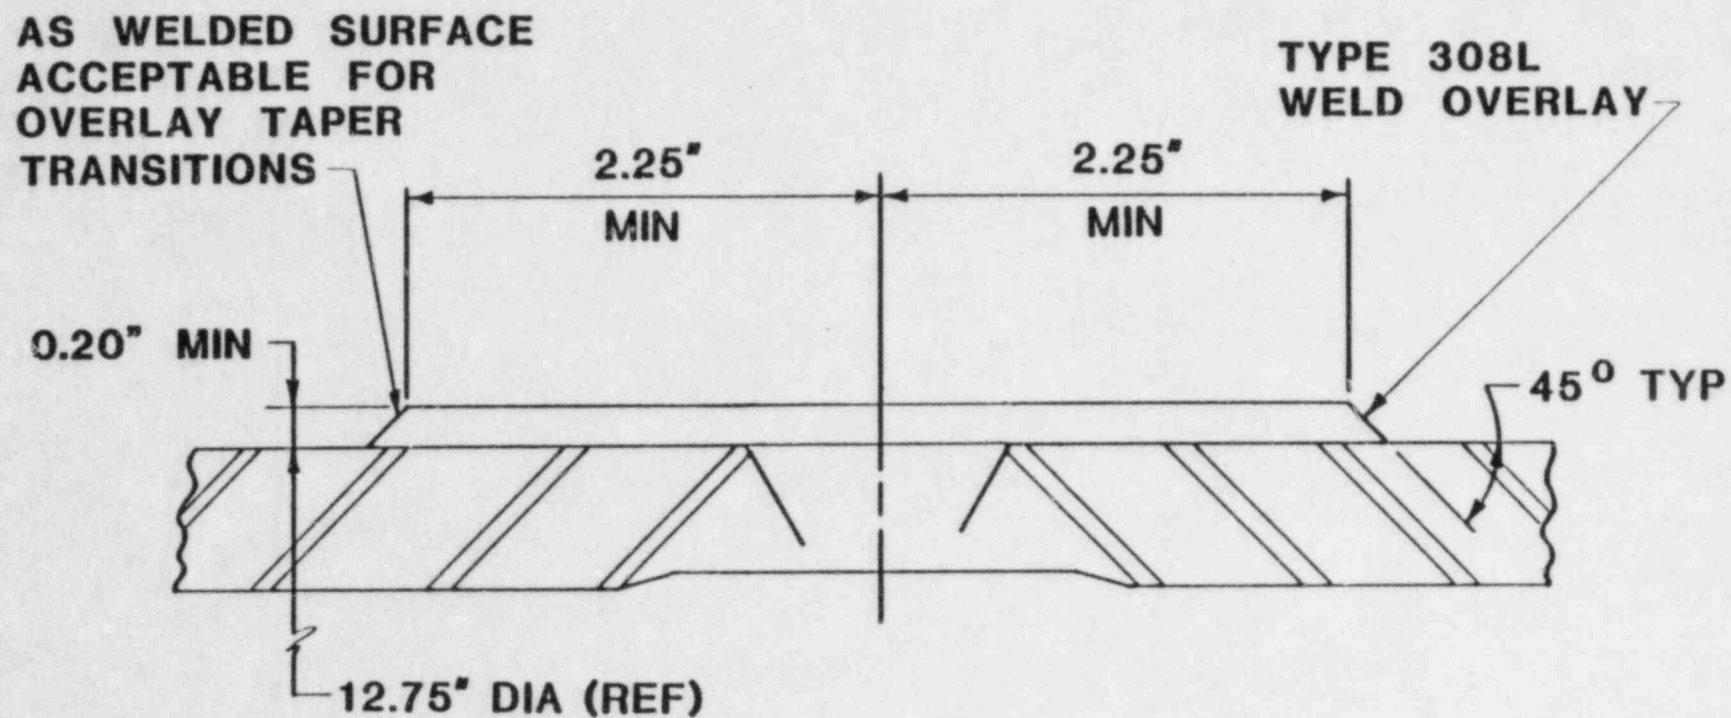
The indications in the pipe side of the safe ends, 12" elbows, 12" pipes, and three of the four end cap weld heat-affected zones have been repaired by establishing additional "cast-in-place" pipe wall thickness from weld metal deposited 360 degrees around and to either side of the existing weld, as shown in Figures 2.1 through 2.3. The fourth end cap was cut off and replaced with a new end cap. The weld-deposited band over the cracks provides wall thickness equal to that required to provide the original design safety margins. In addition, the weld metal deposition produces a favorable compressive residual stress pattern. The deposited weld metal is type 308L stainless steel, which is resistant to propagation of IGSCC cracks.

STANDARD OVERLAY DESIGN 12" RECIRCULATION PIPING

UT indications were detected in the heat-affected zones on the pipe side of the weld between four recirculation inlet safe ends and the recirculation piping. Three of the indications had maximum depths of less than 30% of the wall thickness. The mini overlay shown in Figure 2.2 was used to repair these locations. The 12BR-C-4 weld had an indication with a maximum depth of 32% of the wall thickness (see Table 1.1). The standard overlay shown in Figure 2.1 was used to repair this location.

with the mini-overlay design (Figure 2.2) and one elbow weld, 12BR-C-3, was repaired with the standard overlay design (Figure 2.1).

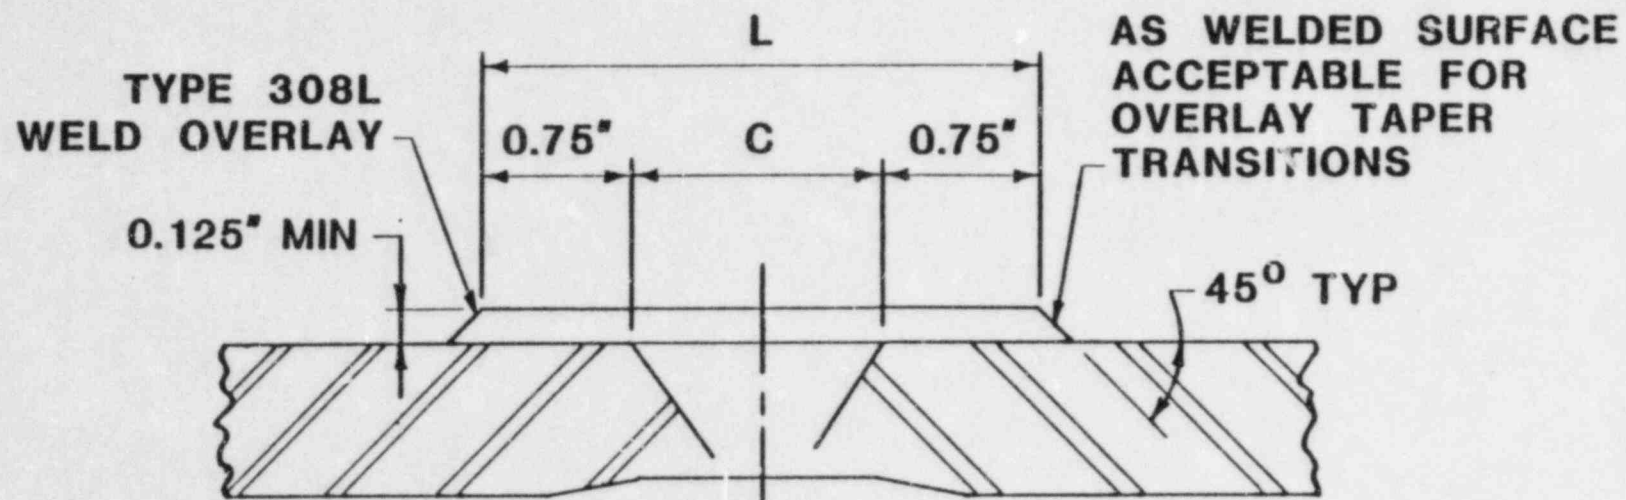
Figure 2.2

$$L_{\text{MINIMUM}} = 1.5" + C$$

C = WELD CROWN WIDTH

MINI - WELD OVERLAY 12" RECIRCULATION PIPING

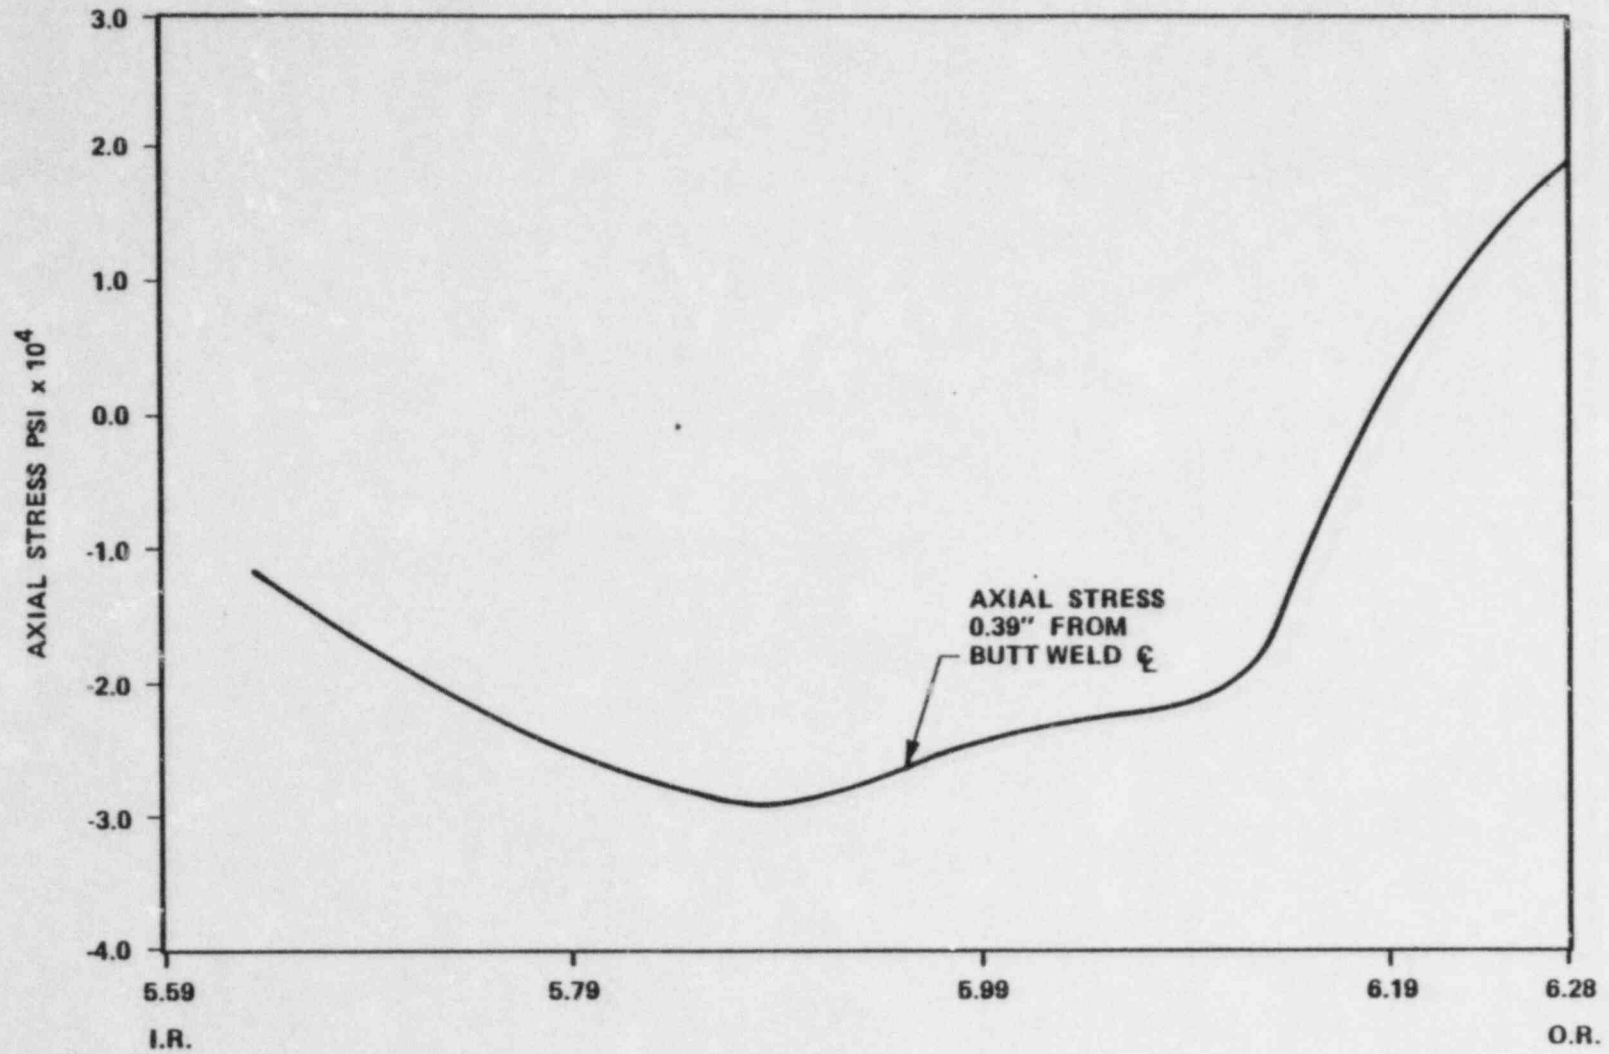
Figure 5.1  
WELDING RESIDUAL STRESS FOR SAFE END  
STANDARD WELD OVERLAY

that the weld overlay produces significant axial compressive stress in the original pipe cross section. These stress profiles will prevent or mitigate the growth of cracks, as shown in Section 5.2. Only axial residual stress profiles are presented, since all of the observed cracks are circumferentially oriented.

IGSCC crack growth was calculated using the overlay residual stress distributions shown in Figures 5.1 and 5.2 and the upper bound crack growth law for weld-

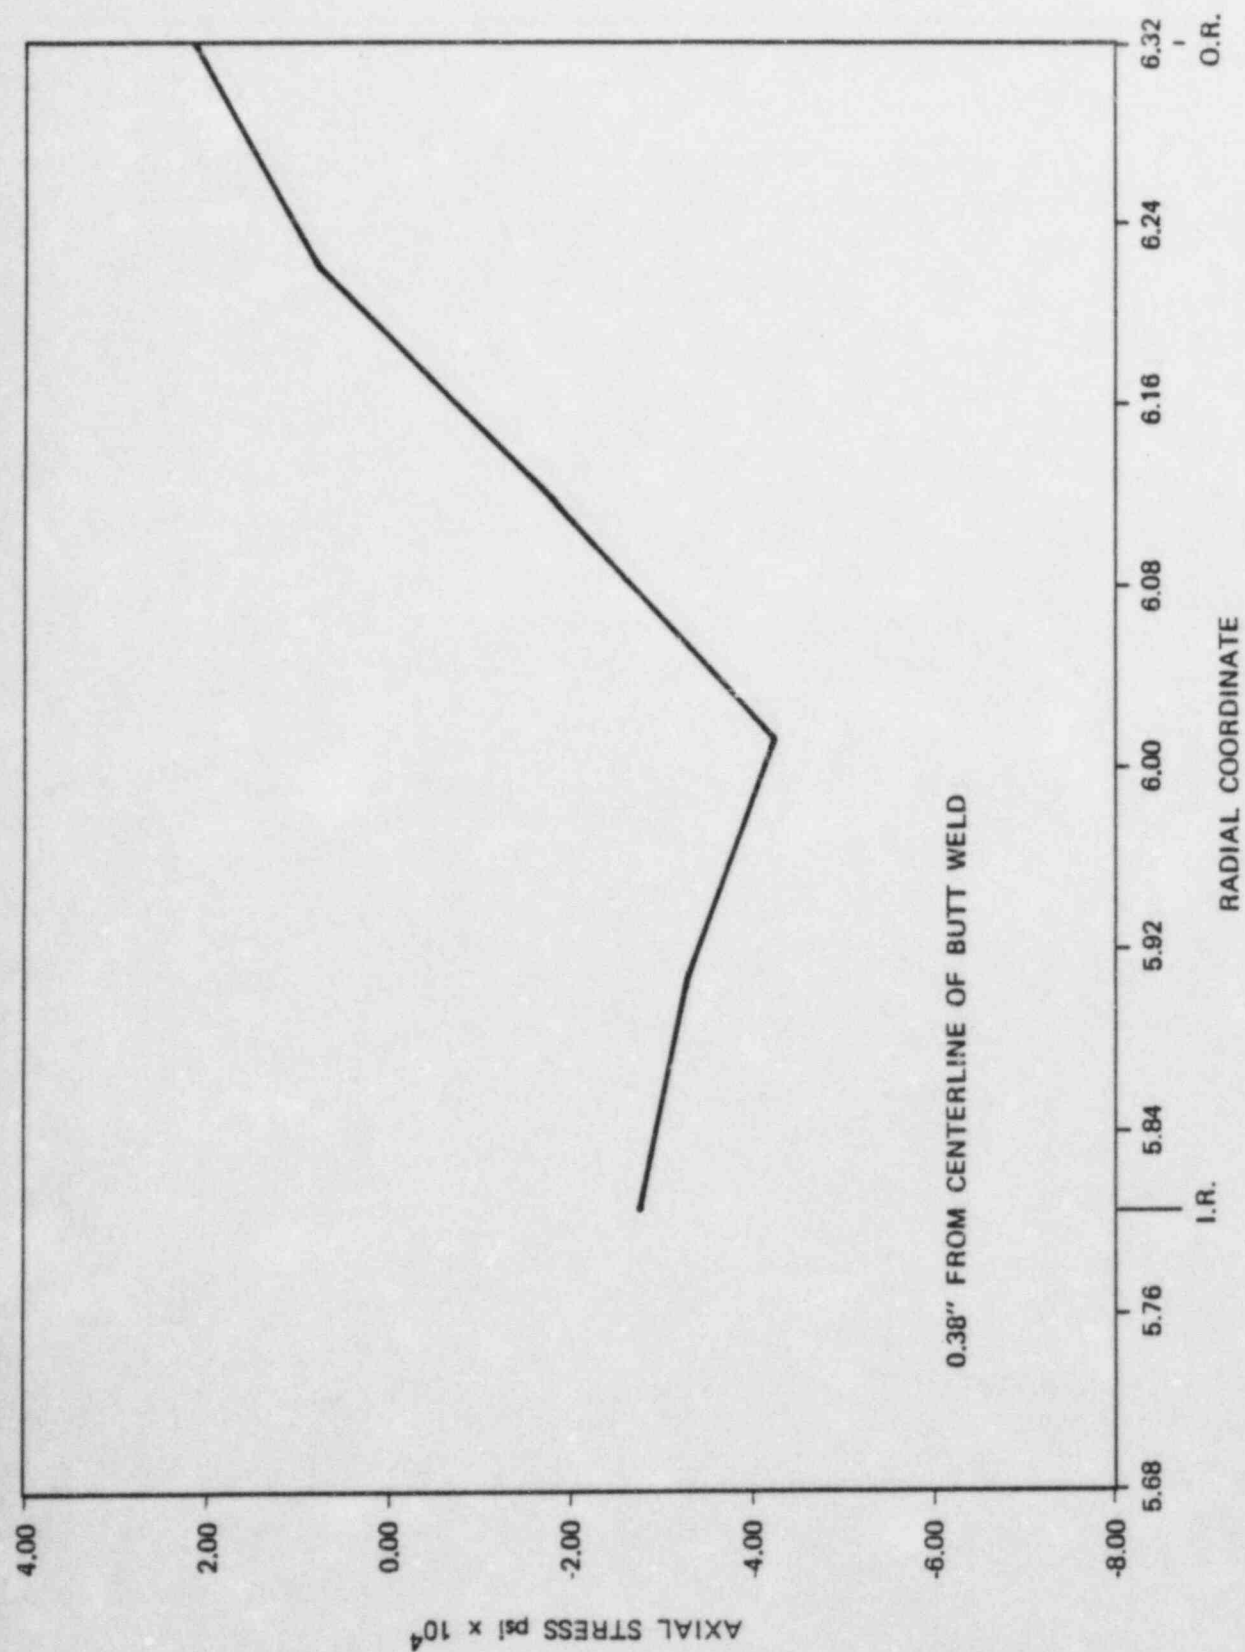
Figure 5.3

WELDING RESIDUAL STRESS FOR ELBOW STANDARD WELD OVERLAY

IGSCC crack growth was calculated using the overlay residual stress patterns shown in Figures 5.3 and 5.4. The steady state loads of pressure, dead weight, thermal expansion and axial weld shrinkage (Section 5.4) were also applied. The results are shown in Figure 5.16. The fatigue crack growth due to five years of the cycles shown in Figure 5.10 is less than 0.01 inch. Inspection of Figure 5.16 will show that maximum crack depth after five years is predicted to be 0.22 which is less than the allowable crack depth. The weld overlay repairs are therefore acceptable for at least 5 years.

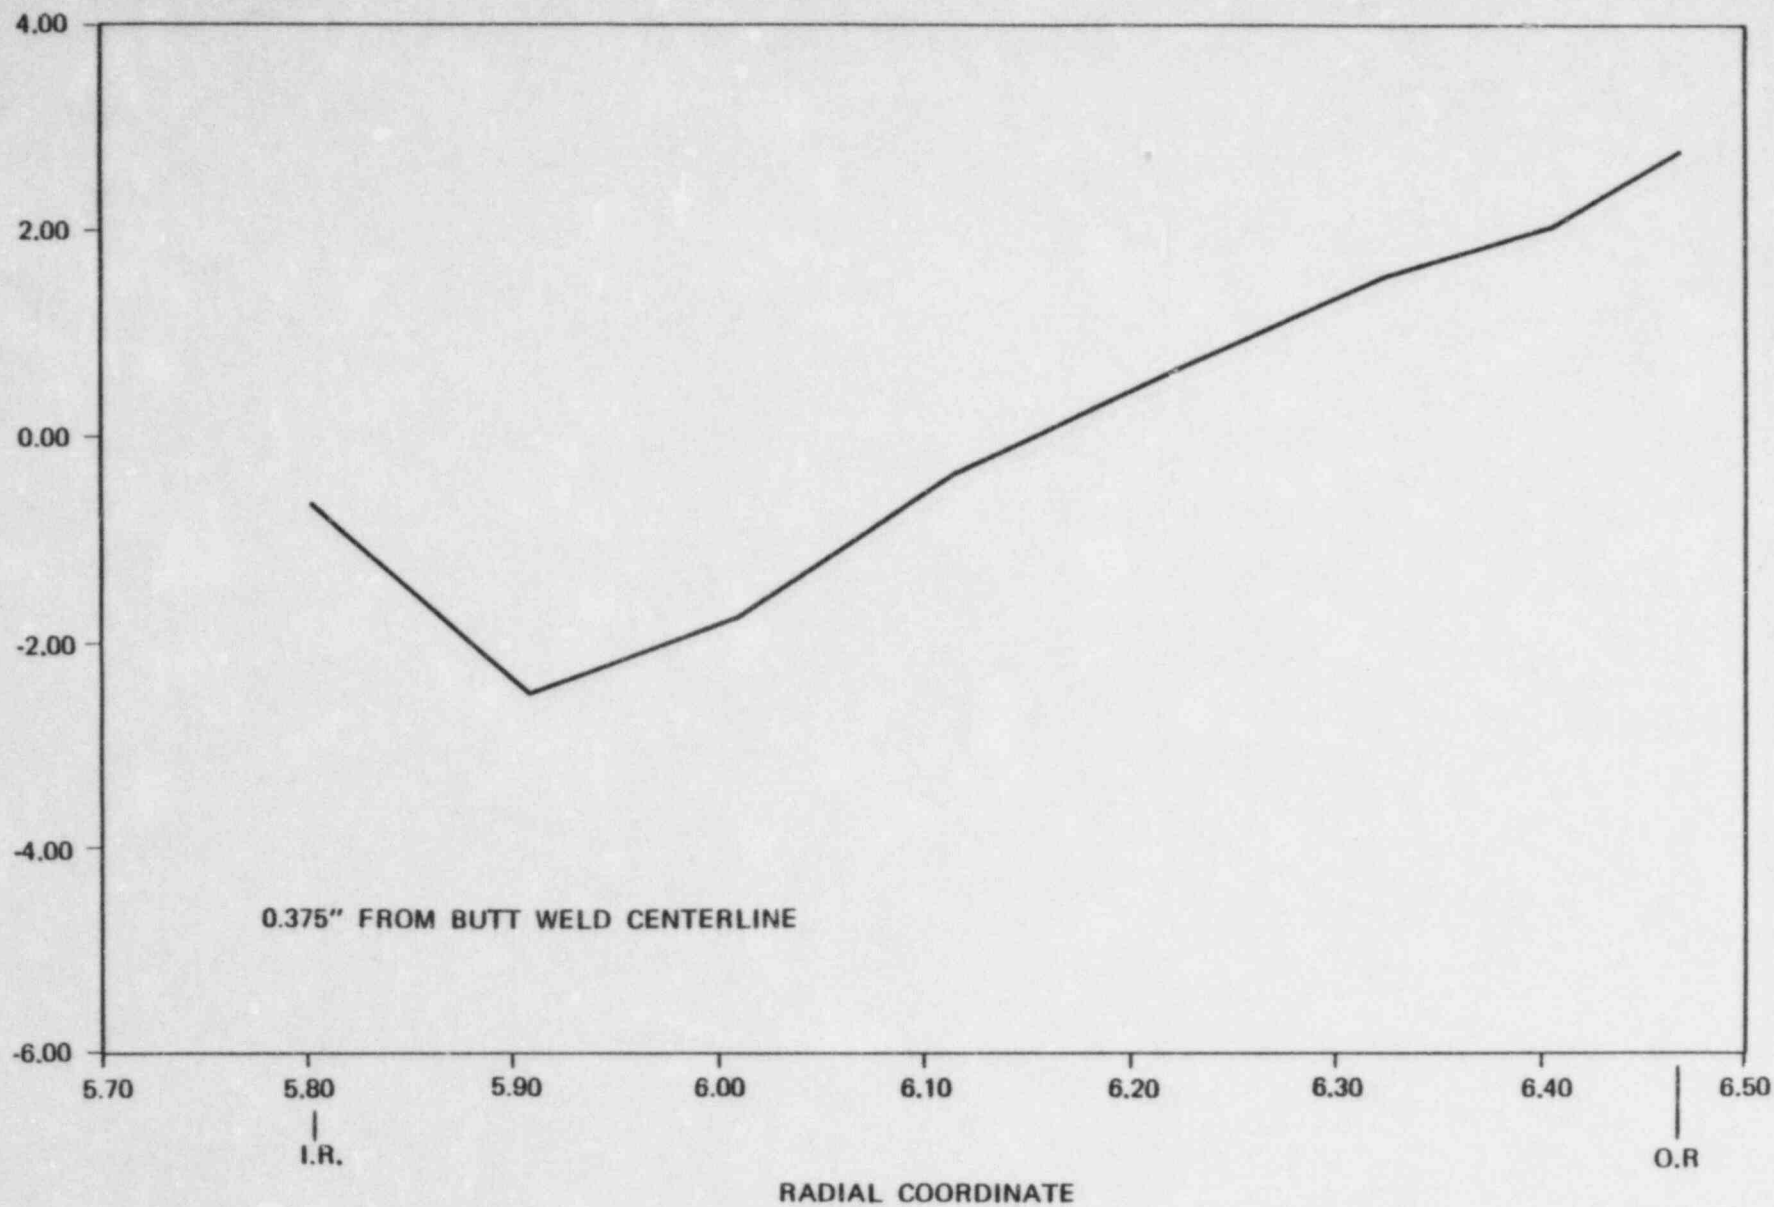
Figure 5.4

WELDING RESIDUAL STRESS FOR ELBOW MINI-WELD OVERLAY

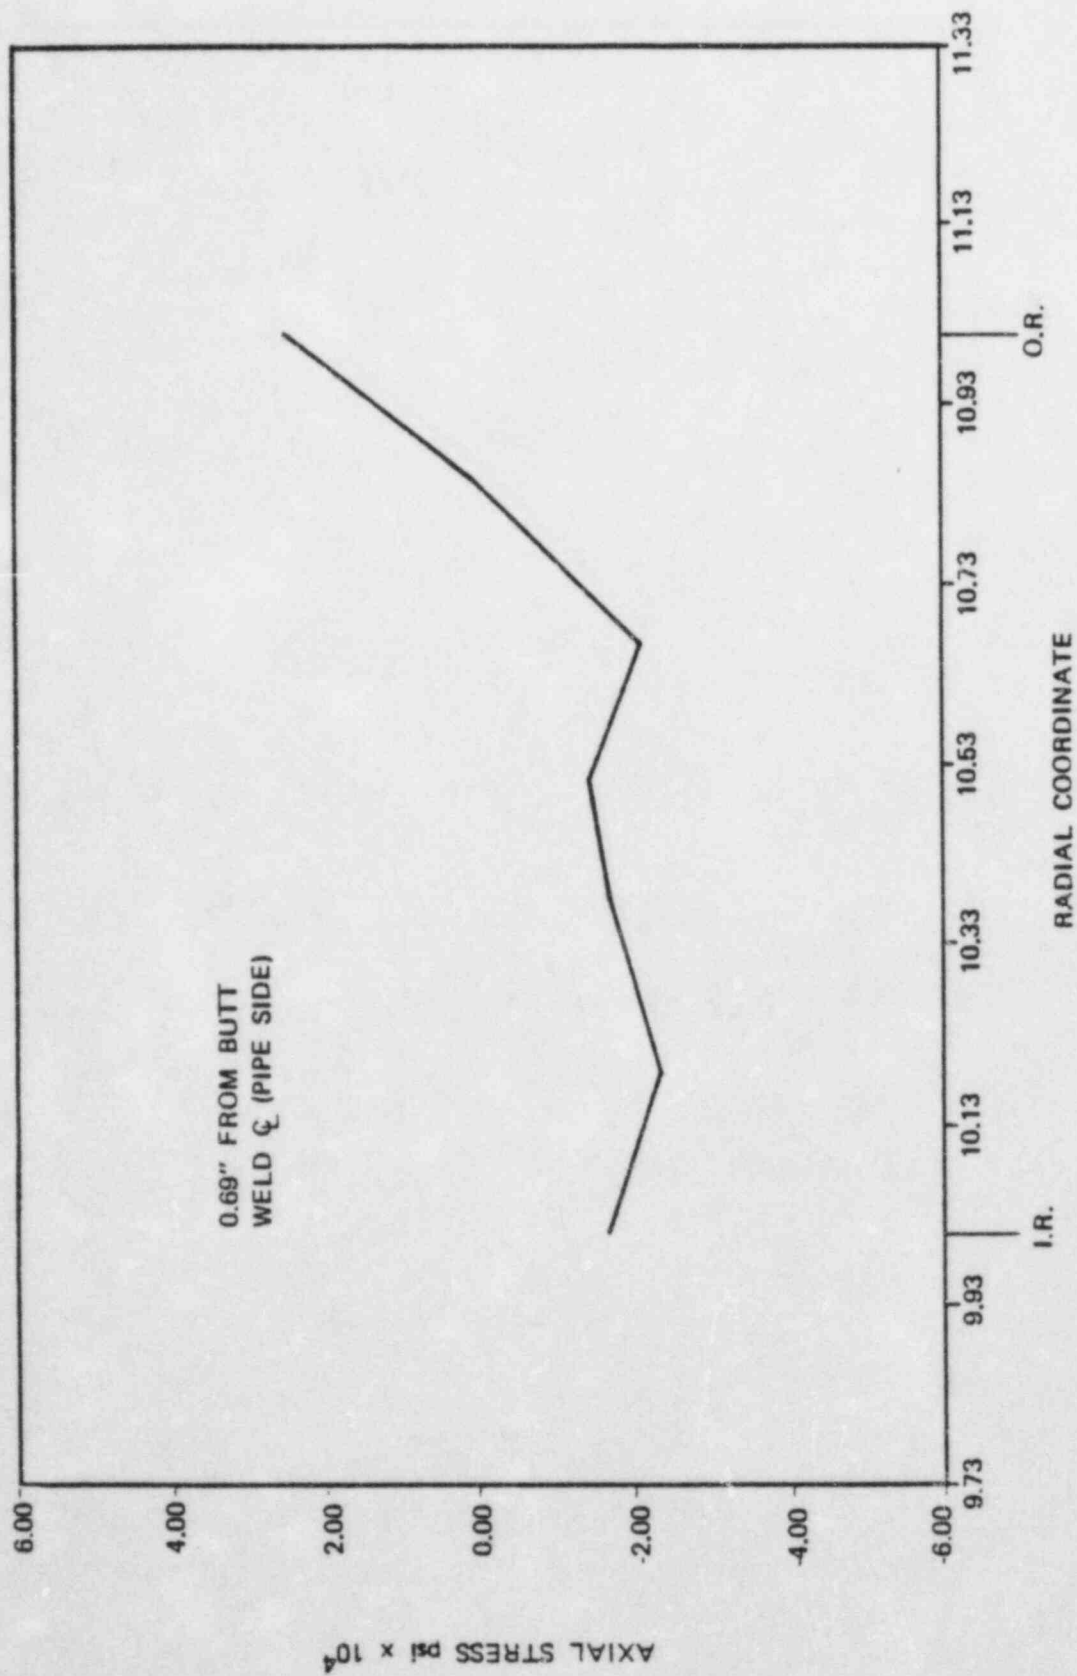
Figure 5.5  
WELDING RESIDUAL STRESS FOR END  
CAP WELD OVERLAY

IGSCC crack growth was calculated using the upper bound crack growth law shown in Figure 5.5. The residual stress was based on both the original butt weld residual stress and that due to the overlay as shown in Figure 5.5. The crack growth analysis was performed with the NUTECH computer program NUTCRAK (Reference 13). Crack growth as a function of time is

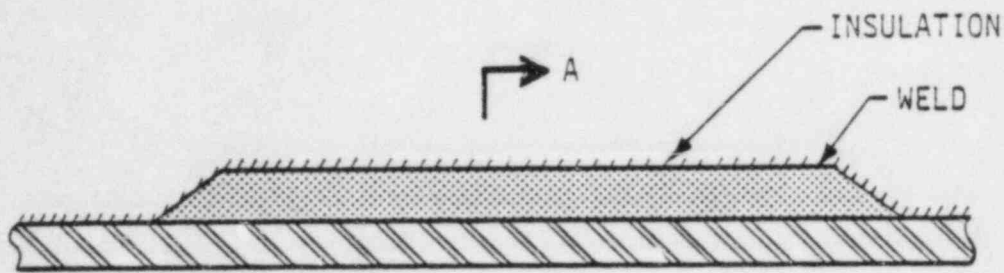
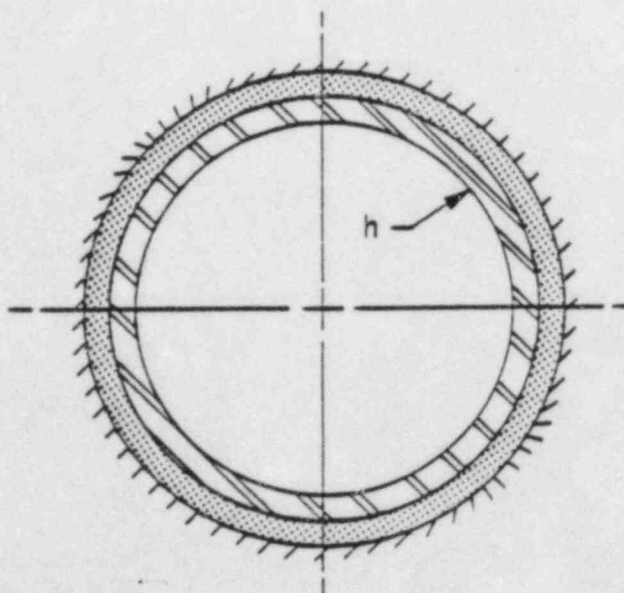
WELD OVERLAY THERMAL MODEL

SECTION A-A

$$h = 738 \text{ BTU/hr-ft}^2\text{-}^\circ\text{F}$$

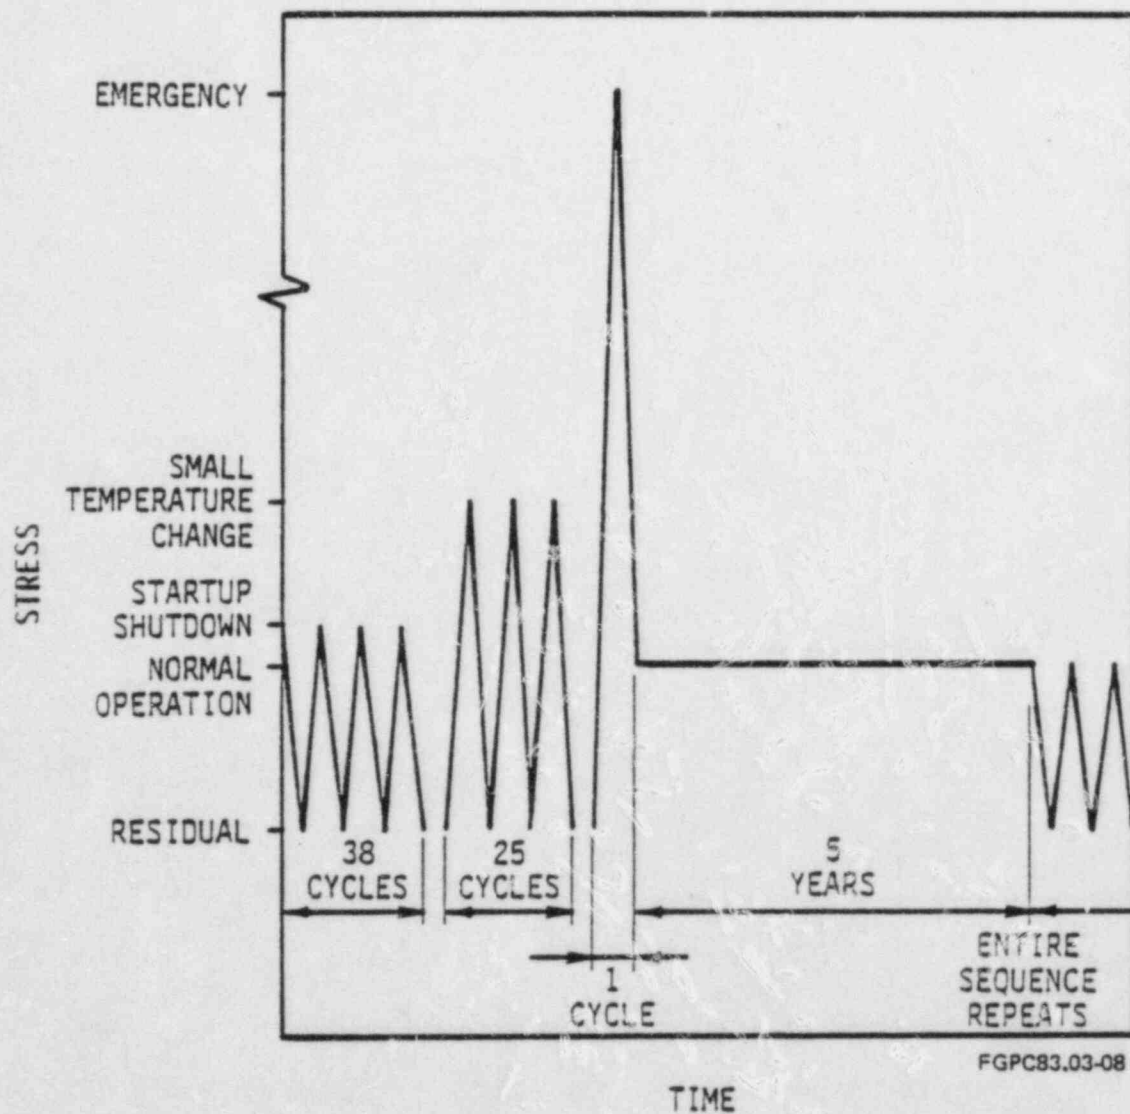
Figure 5.10  
THERMAL TRANSIENTS

The existing cracks could grow due to both fatigue and stress corrosion. Fatigue growth due to the three types of thermal transients defined in Section 4.2 was calculated using the material properties from Reference 14. The fatigue crack growth for five years of the cycles shown in Figure 5.10 was calculated to be less than 0.01 inch.

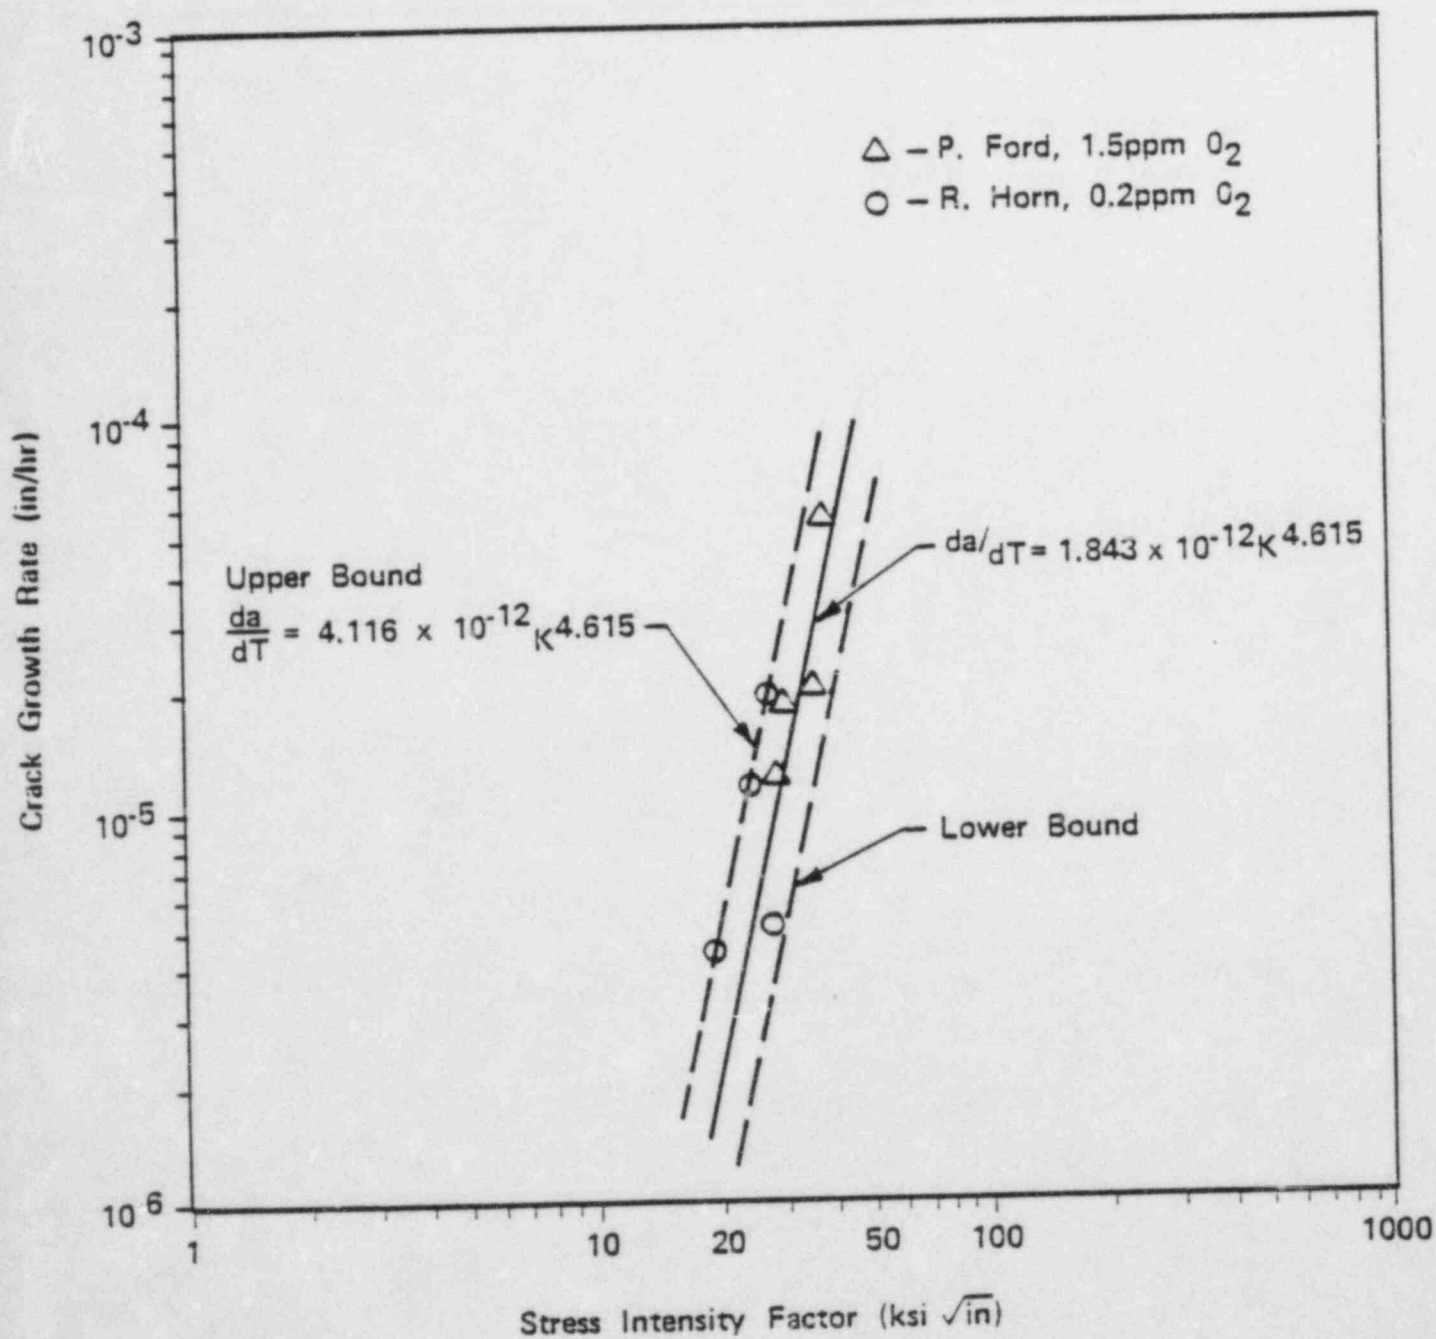
Figure 5.11  
 TYPICAL IGSCC CRACK GROWTH DATA  
 (WELD SENSITIZED 304SS IN BWR ENVIRONMENT)

sensitized stainless steel (Figure 5.11). The steady state loads of pressure, dead weight, thermal expansion and axial weld shrinkage (Section 5.4) were also applied. The results are shown in Figure 5.12.

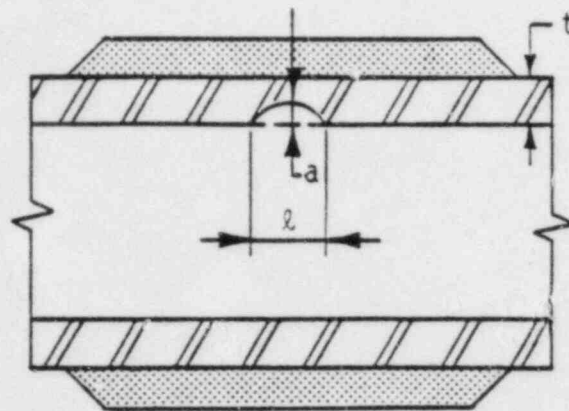
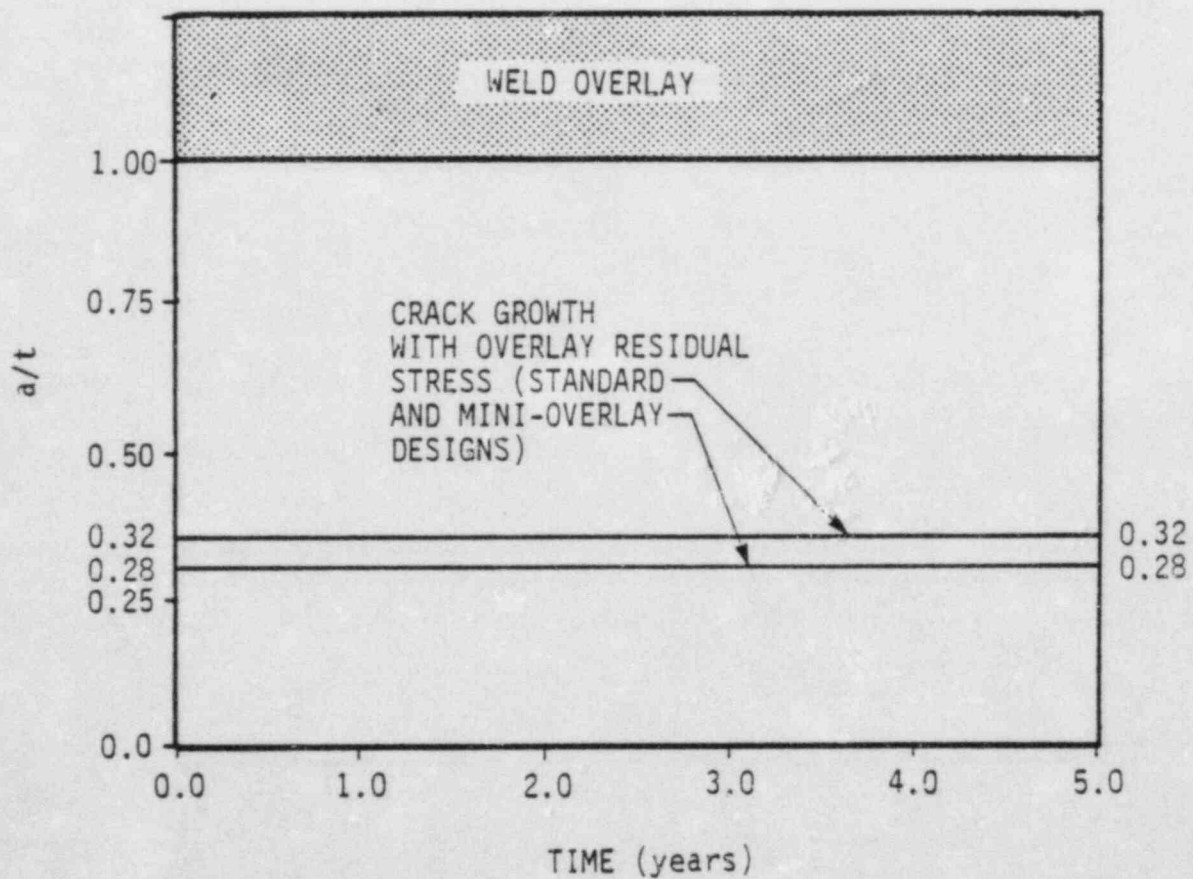
Inspection of Figure 5.12 will show that the maximum depth achieved after five years by a 360° circumferential crack is approximately 0.23 inch, which is well below the allowable size.

SAFE END CRACK GROWTH

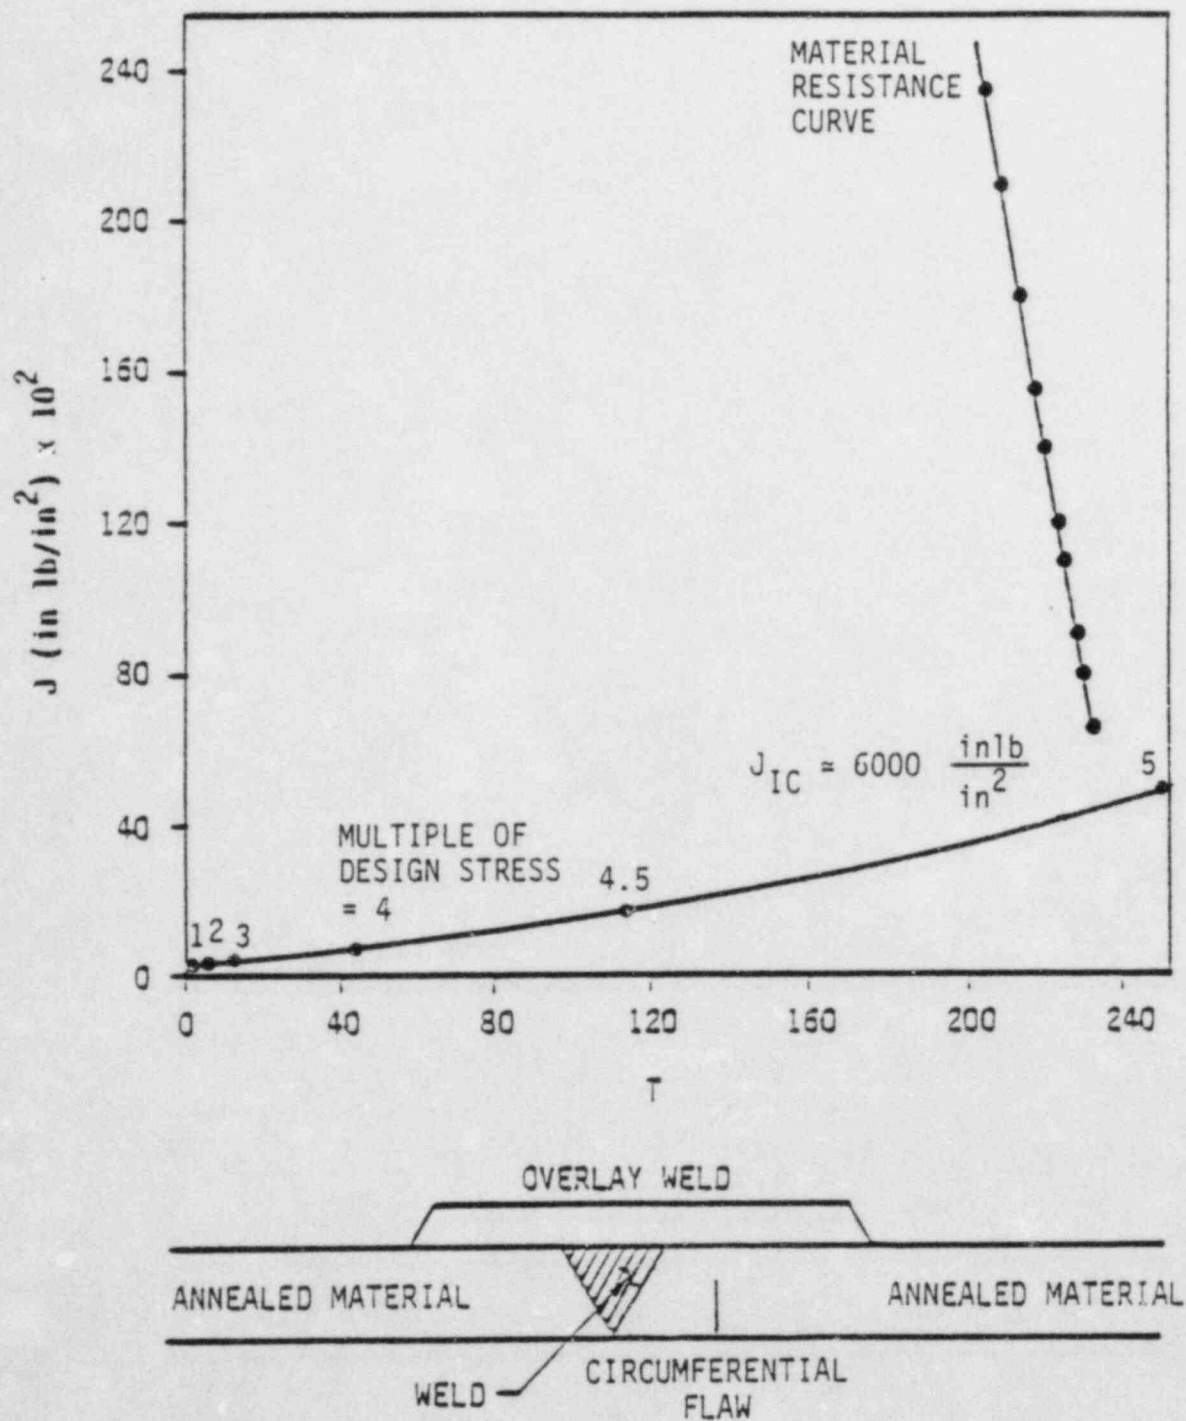
The postulated flaw and the results are shown in Figure 5.13. The upper dotted line represents the inherent material resistance to unstable fracture in terms of J-integral and Tearing Modulus,  $T$ . The line originating at the origin represents the applied loading. Increasing load results in applied J-T combinations moving up this line, and unstable fracture is predicted at the intersection of this applied loading line with the material resistance line.

Figure 5.13 shows that the predicted failure load is in excess of 4 times the normal applied loads. Thus, there is a safety factor on normal loads (including OBE seismic) of at least 4, which is well in excess of the safety factor inherent in the ASME Code, even in the presence of this worst case assumed crack.

# SAFE END TEARING MODULUS

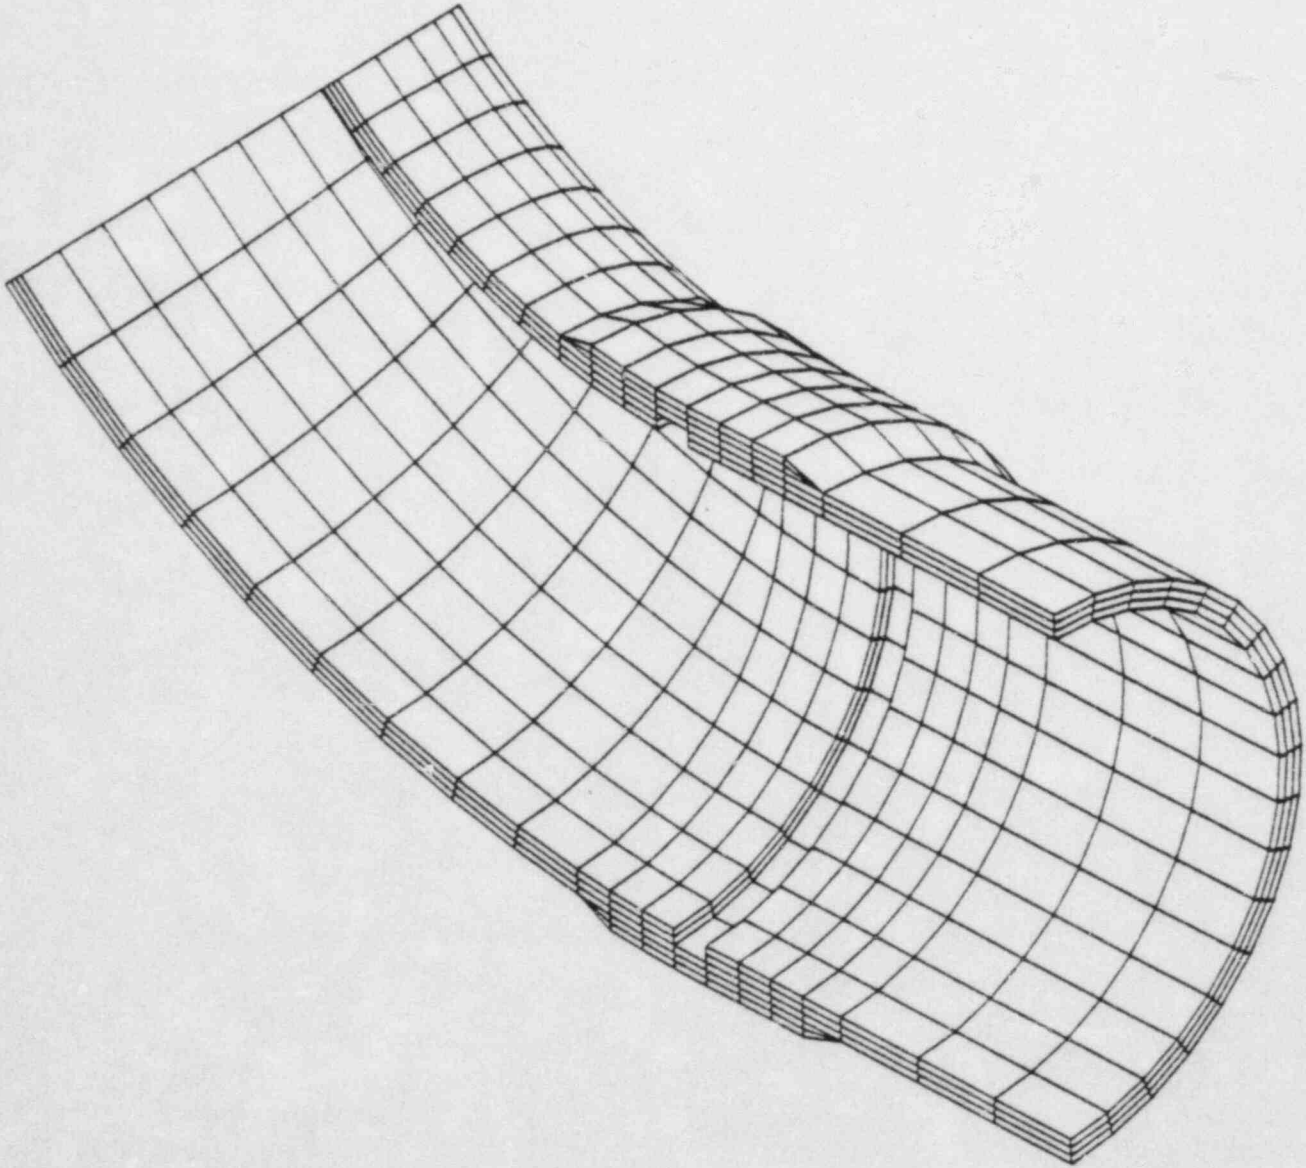
Figure 5.14  
THREE DIMENSIONAL 12"  
ELBOW FINITE ELEMENT MODEL

$a = \text{FLAW DEPTH} = 0.32t$   
 $a = 0.220''$   
 $\text{FLAW LENGTH} = 2a$   
 $2a = 0.440''$

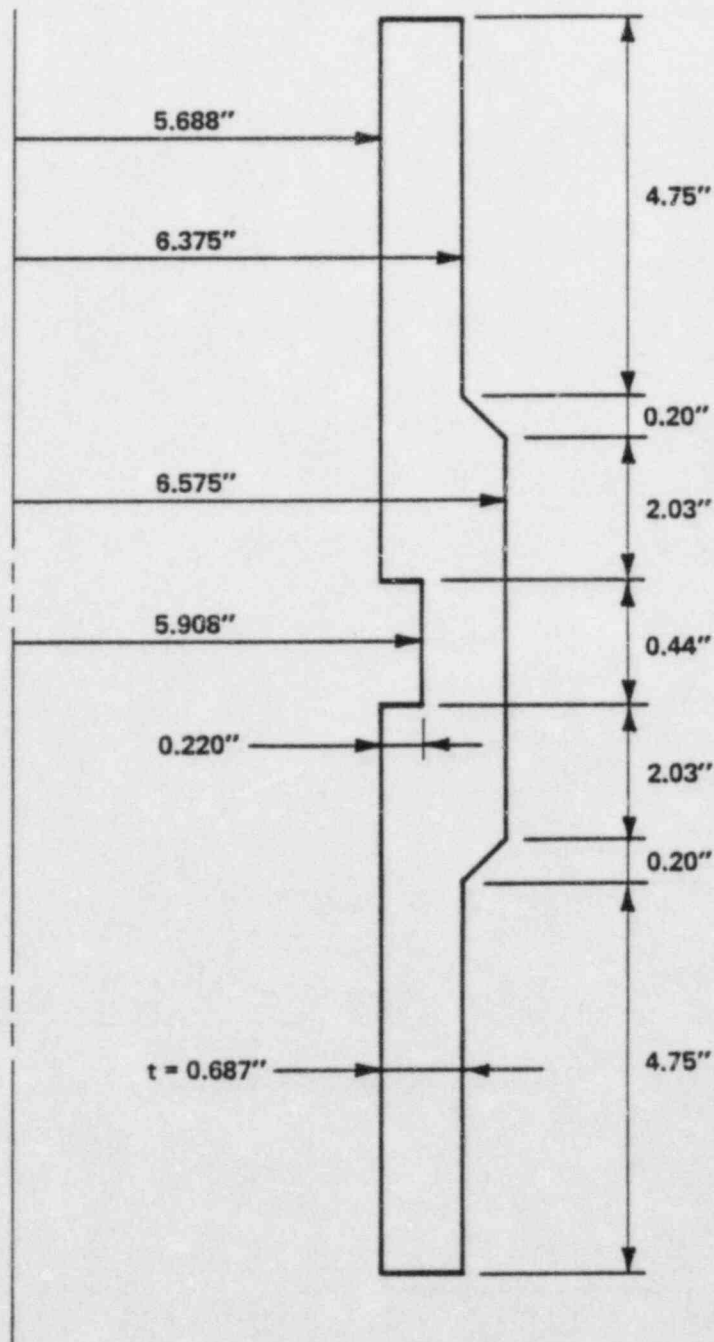
Figure 5.15

BOSOR 4 MODEL FOR 12" ELBOW  
 STANDARD WELD OVERLAY DESIGN
