GPC-07-102  
Revision 1  
September 1983  
GPC007.0102

DESIGN REPORT  
FOR  
WELD OVERLAY REPAIRS  
AND FLAW EVALUATIONS  
IN  
RECIRCULATION AND RHR SYSTEMS  
AT  
E. I. HATCH NUCLEAR POWER PLANT  
UNIT 2

Prepared for  
Georgia Power Company

Prepared by  
NUTECH Engineers, Inc.  
San Jose, California

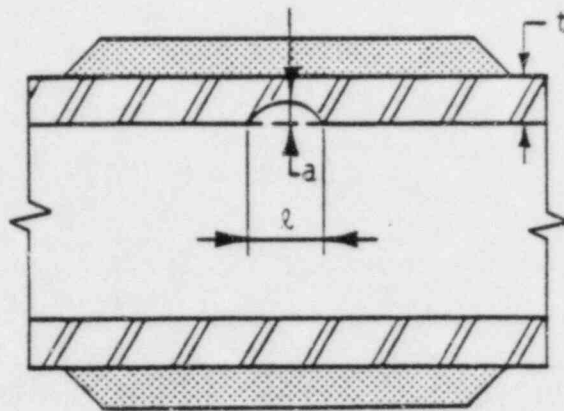
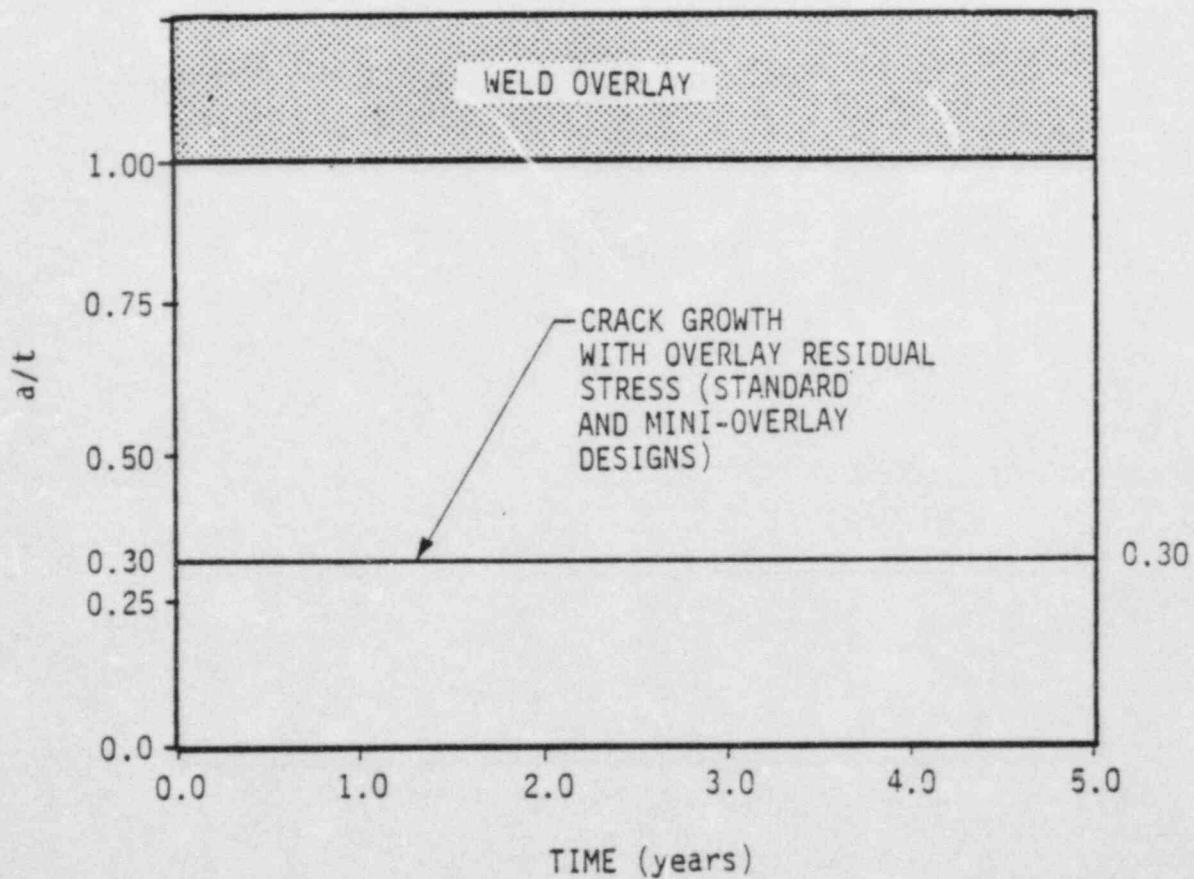
IGSCC crack growth was calculated using the overlay residual stress patterns shown in Figures 5.3 and 5.4. The steady state loads of pressure, dead weight, thermal expansion and axial weld shrinkage (Section 5.4) were also applied. The results are shown in Figure 5.16. The fatigue crack growth due to five years of the cycles shown in Figure 5.10 is less than 0.01 inch. Inspection of Figure 5.16 will show that maximum crack depth after five years is predicted to be 0.22 which is less than the allowable crack depth. The weld overlay repairs are therefore acceptable for at least 5 years.

12" ELBOW CRACK GROWTH

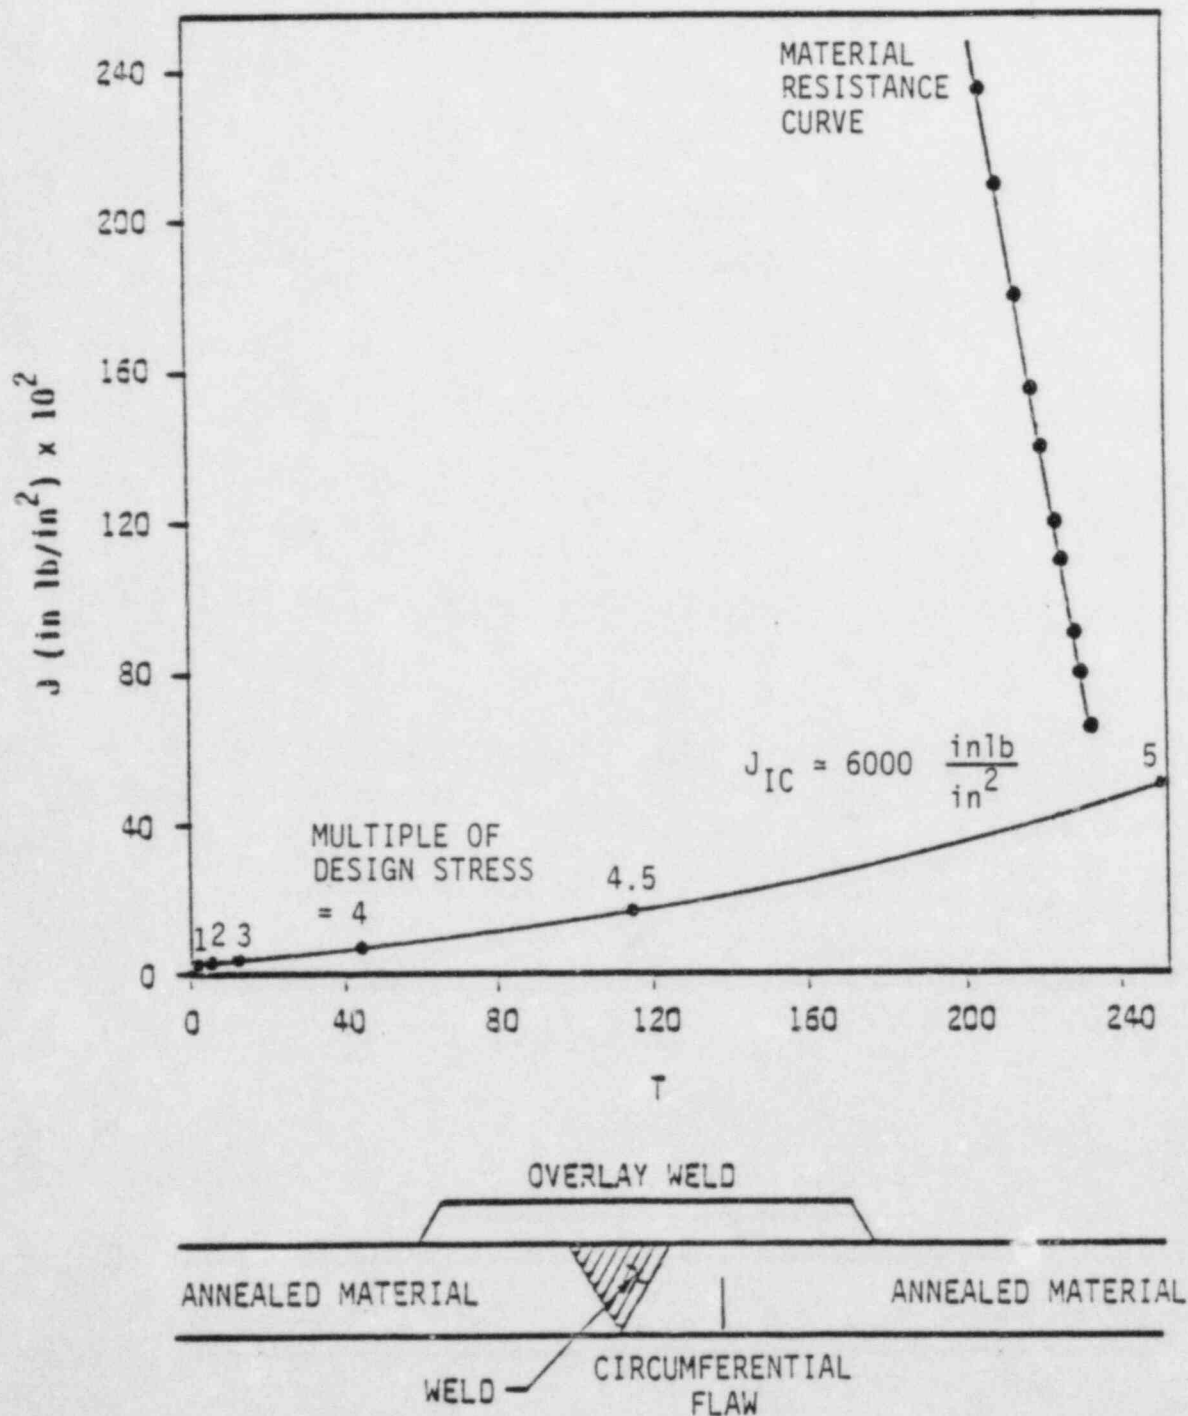
shown in Figure 5.17. The upper dotted line represents the inherent material resistance to unstable fracture in terms of J-integral and Tearing Modulus, T. The line originating at the origin represents the applied loading. Increasing load results in applied J-T combinations moving up this line, and unstable fracture is predicted at the intersection of this applied loading line with the material resistance line.

Figure 5.17 shows that the predicted failure load is in excess of 4 times the normal operating loads. Thus, there is a safety factor on normal operating loads, including OBE seismic, of at least 4, which is in excess of the safety factor inherent in the ASME Code, even in the presence of this worst case assumed crack.

12" ELBOW TEARING MODULUS

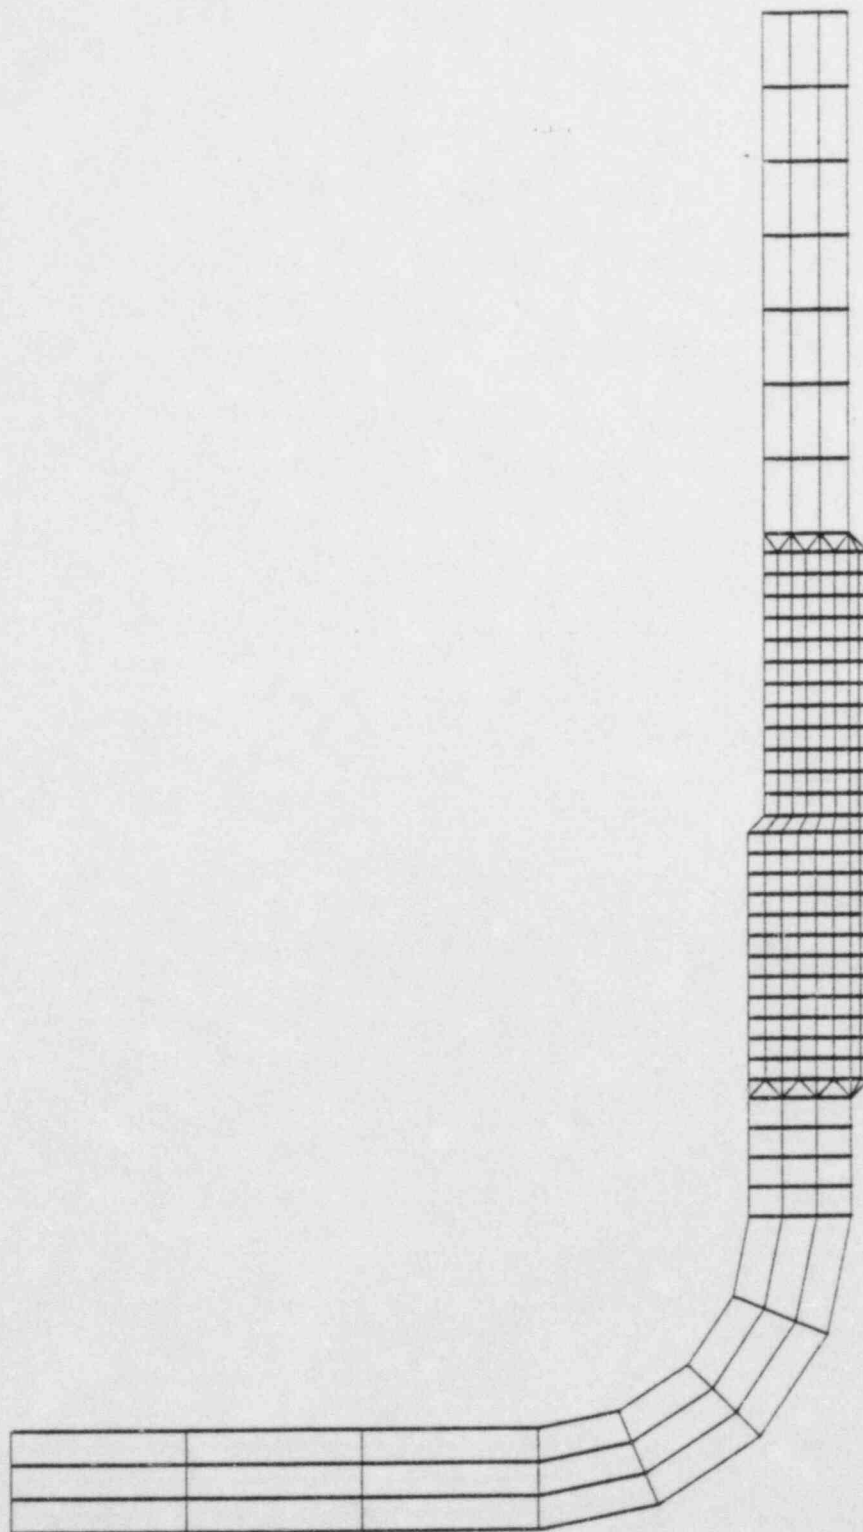
Figure 5.18

A finite element model of the repaired end caps was prepared using ANSYS as above. This model is shown in Figure 5.18. The stress in the end cap due to design pressure as described in Section 4.1 was calculated with the finite element model. The thermal analysis was performed in the same manner as for the safe end (Section 5.2.1), with appropriate dimensional changes.

END CAP FINITE ELEMENT MODEL

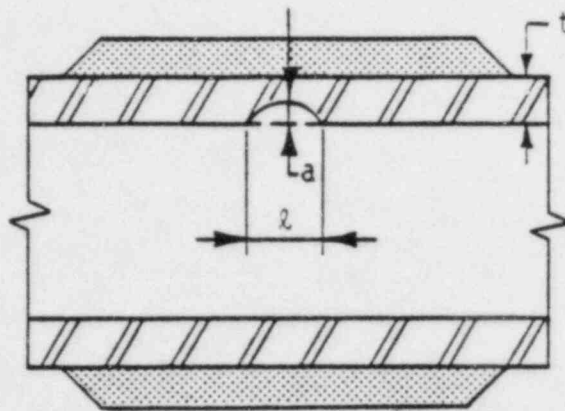
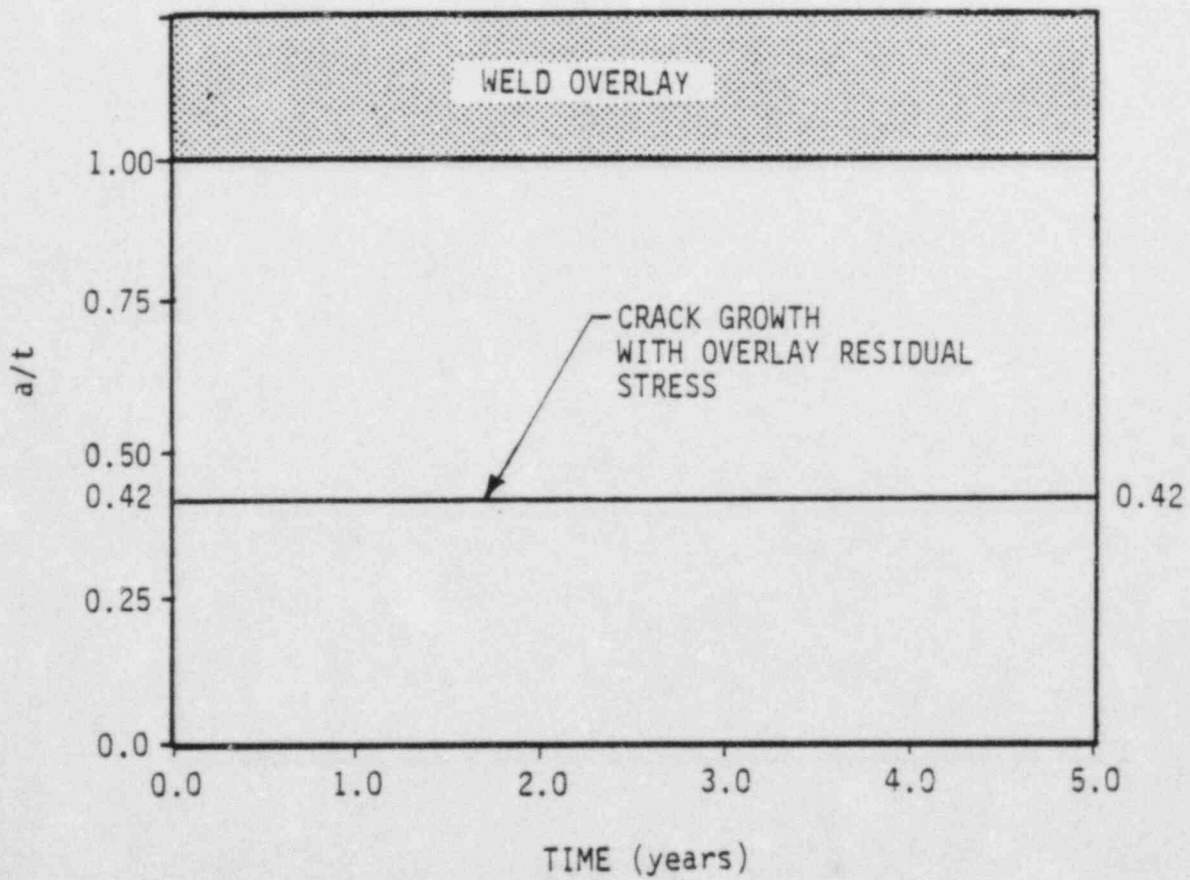
shown in Figure 5.19. Inspection of Figure 5.19 will show that maximum crack depth after five years is predicted to be 0.48 inch which is well below the allowable of 0.89 inches.

### END CAP CRACK GROWTH

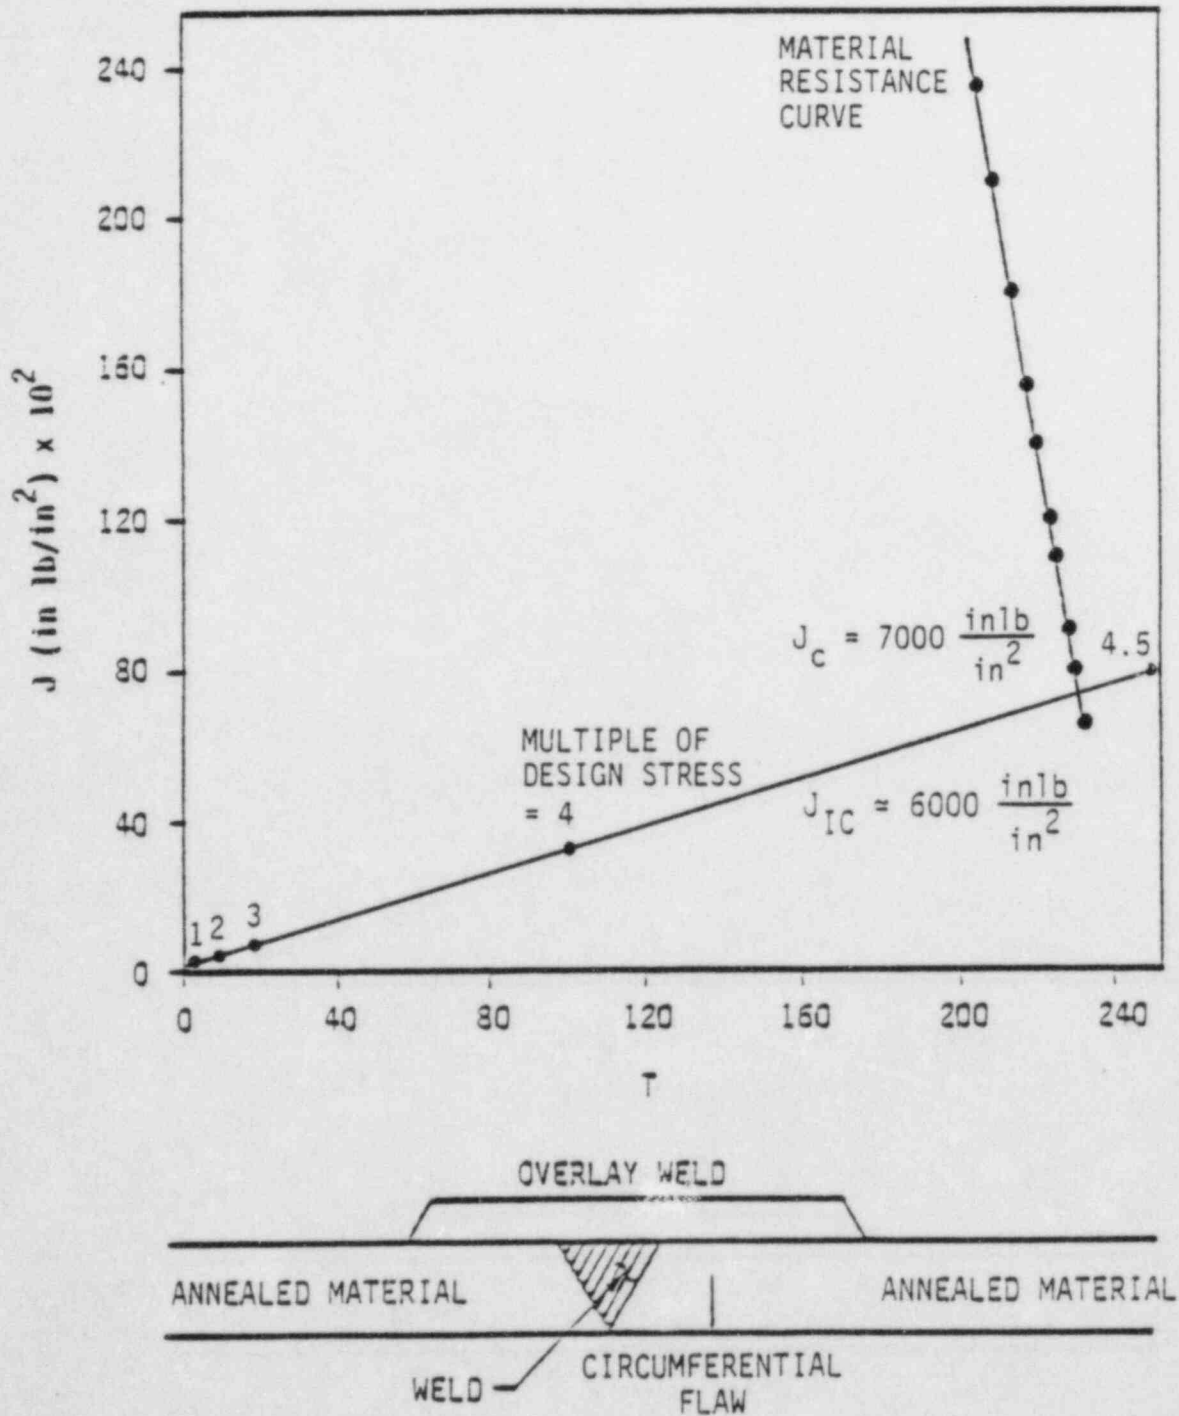
Figure 5.20

# END CAP TEARING MODULUS

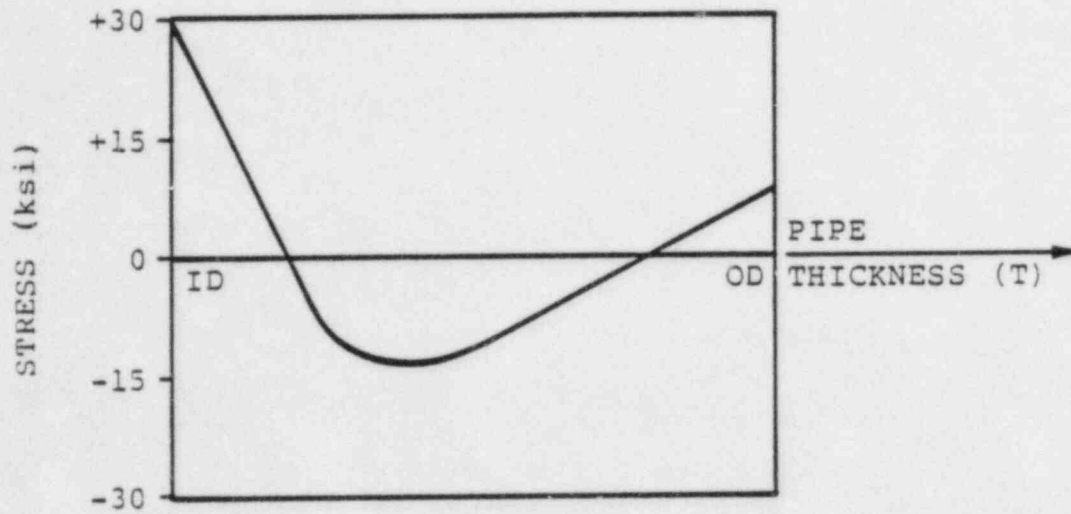
Figure 5.21  
AXIAL RESIDUAL STRESS  
PIPE DIAMETER OF 20" TO 28"

T%	STRESS (ksi)
0	+30.0
19	0.0
25	- 9.9
59	-14.2
50	-12.0
81	0.0
100	+ 8.1

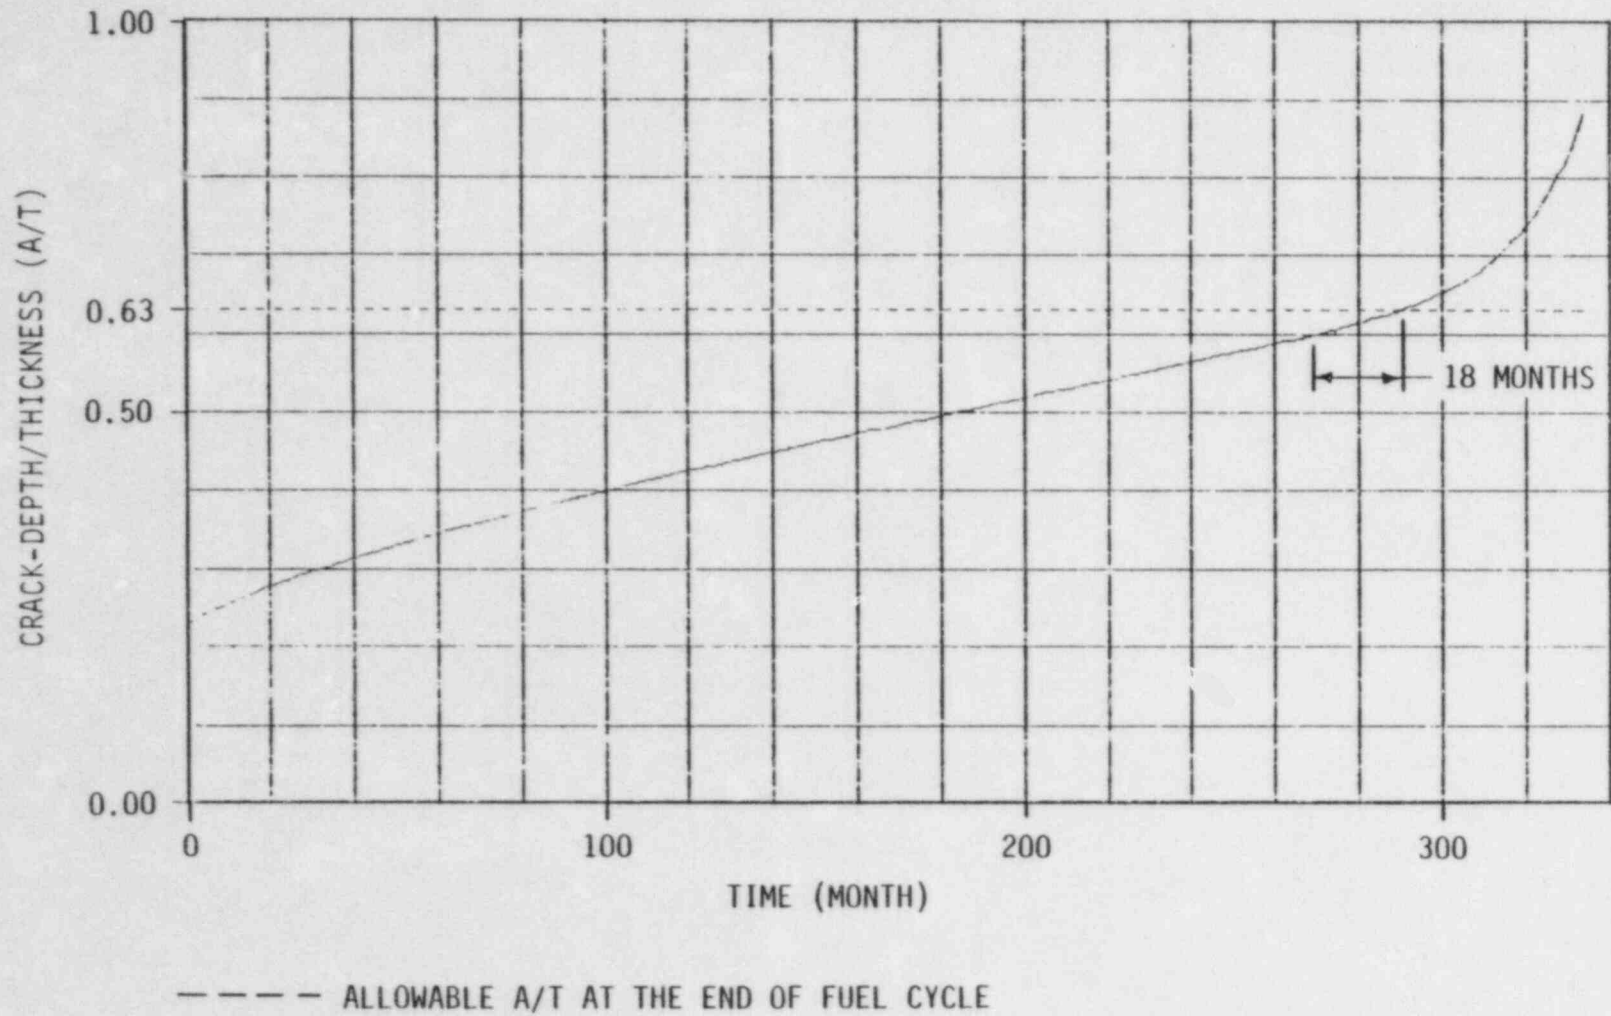
Figure 5.23

CRACK GROWTH FOR RECIRCULATION SYSTEM WELD 28B-15

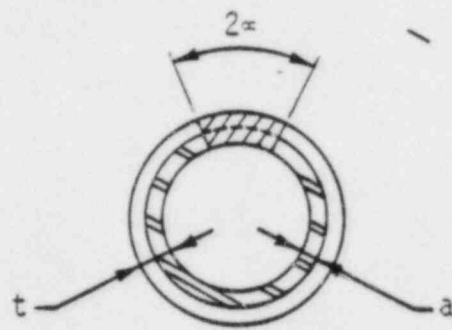
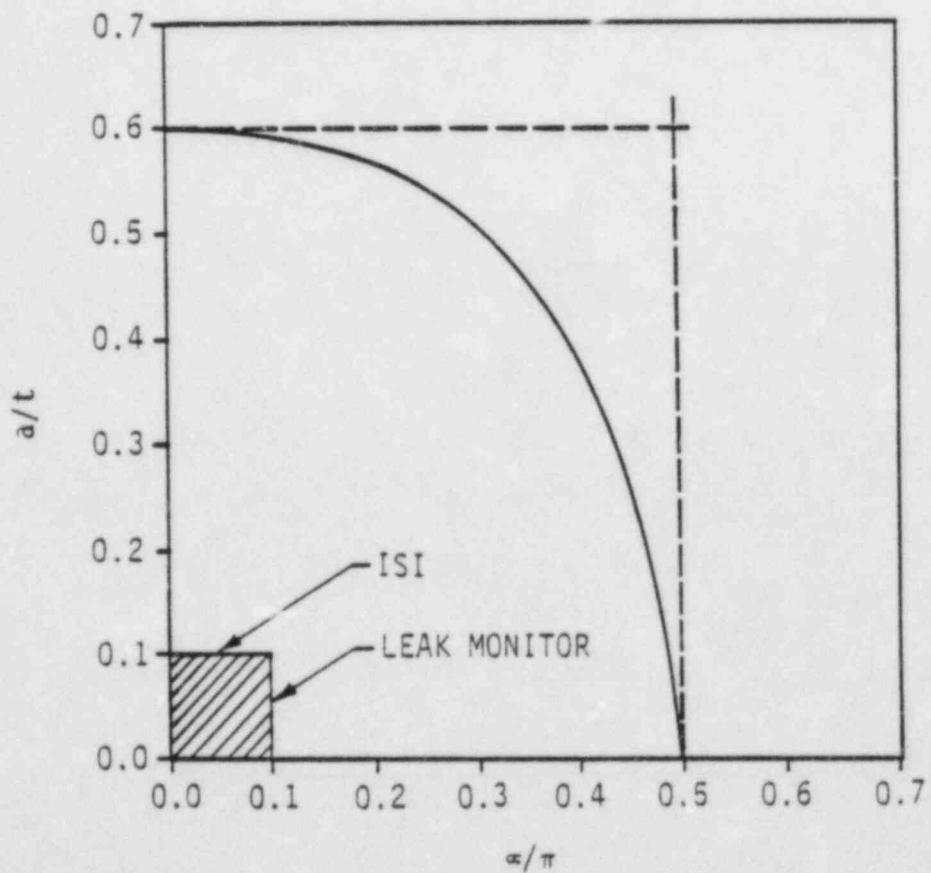
Figure 6.4  
TYPICAL PIPE CRACK FAILURE LOCUS FOR COMBINED  
THROUGH - WALL PLUS 360° PART - THROUGH CRACK

PIPE CROSS SECTION
