Commonwealth Edison Company

Dresden Nuclear Power Station
 R. R. #1
 Morris, Illinois 60450
 September 8, 1971

SUBJECT: LICENSE DPK-19, DRESDEN NUCLEAR POWER STATION UNIT 2: REPORT
 OF PARTIAL CONTROL ROD INSERTION FOLLOWING SPURIOUS REACTOR
 SCRAM SIGNAL.

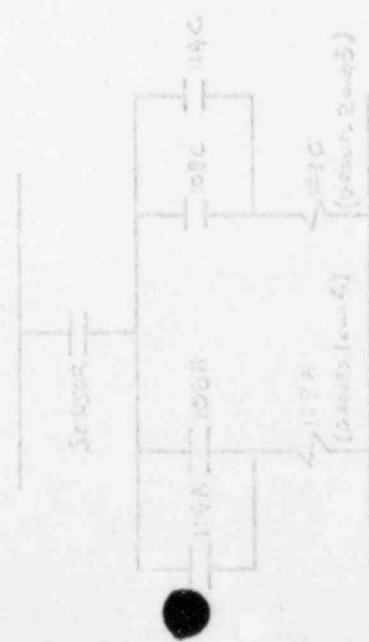
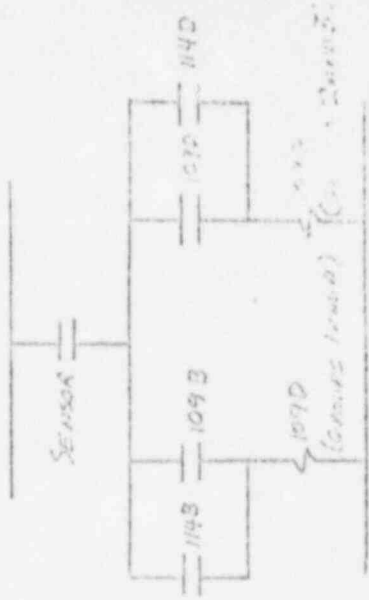
FIGURE 2

Resetting the scram relays is accomplished through the reset relay circuit shown in Figure 2. The operator uses a single reset switch as shown in Figure 3 for the reset circuit. When the reset switch is in the center position, all switch contacts are open. When the switch is operated to the right, scram relays for control rod Groups 2 and 3 in Channels "A" and "B" are reset (re-energized.) When the switch is operated to the left, scram relays for control rod groups 1 and 4 in Channel A and B are reset.

SIMPLIFIED CIRCUIT DIAGRAM DEFCON PROTECTION SYSTEM START AND RESET RELAYS

Relays 114A, B, C and D are the reset relays. The 114 relays are energized through the reset switch following a scram. When the 114 relays are energized their contacts close and energize the scram relay thereby returning the scram relays to their normal energized position. When the reset switch is released, the 114 relays de-energize (see figure 3) but the scram relays remain energized through their own seal-in contacts (see figure 2).

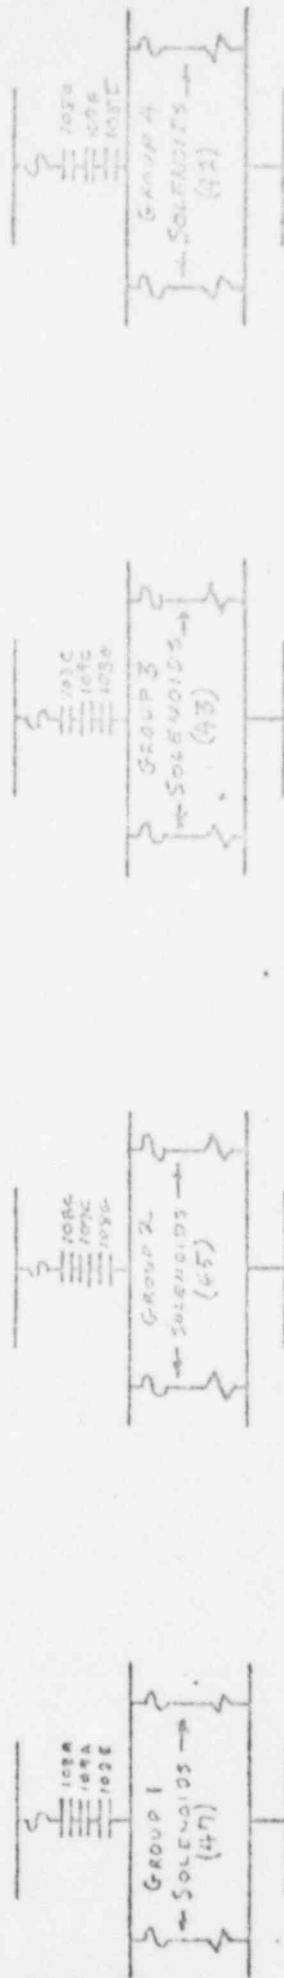
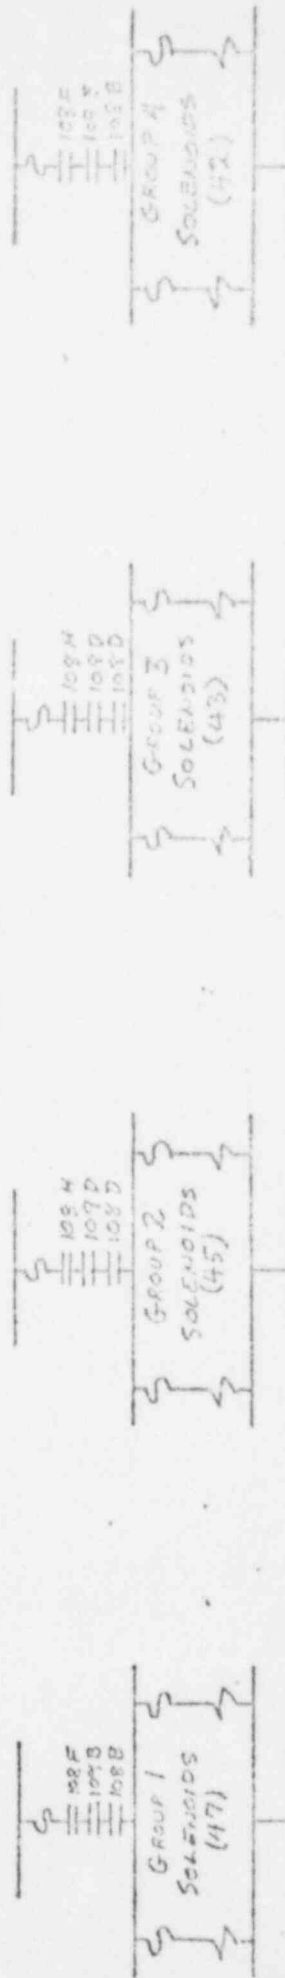
FIGURE 5

SUPPLIED SCHEMATIC DIAGRAM

REACTOR PROTECTION SYSTEM PILOT SEVEN VALVE SOLENOIDS

The control rods are divided into four nearly equal groups, identified as Groups 1, 2, 3 and 4. Group 1 and 4 control rods are scrambled by Channel "A" relays 108A, 108E and 109A and Channel "B" relays 108B, 108F and 109B. Group 2 and 3 control rods are scrambled by Channel "A" relays 108C, 108G and 109C and Channel "B" relays 108D, 108H and 109D. (See Figure 1 & 5).

The operator then completed his reset action by turning the switch to the group 1 & 4 position. This successfully energized reset relay 11A, and re-energized scram relay 10SE in Channel "A" and the pilot scram valve solenoids in Channel "A" groups 1 & 4. This left the solenoids of Channel "A" groups 2 & 3 and Channel "B" groups 1 & 4 de-energized; no rod group had both Channel "A" and "B" solenoids de-energized. (See figure 5).
