FIRE ENDURANCE AND HOSE STREAM TESTS

WALL PENETRATION FIRE STOPS

DESIGN WP694

PHILADELPHIA ELECTRIC COMPANY

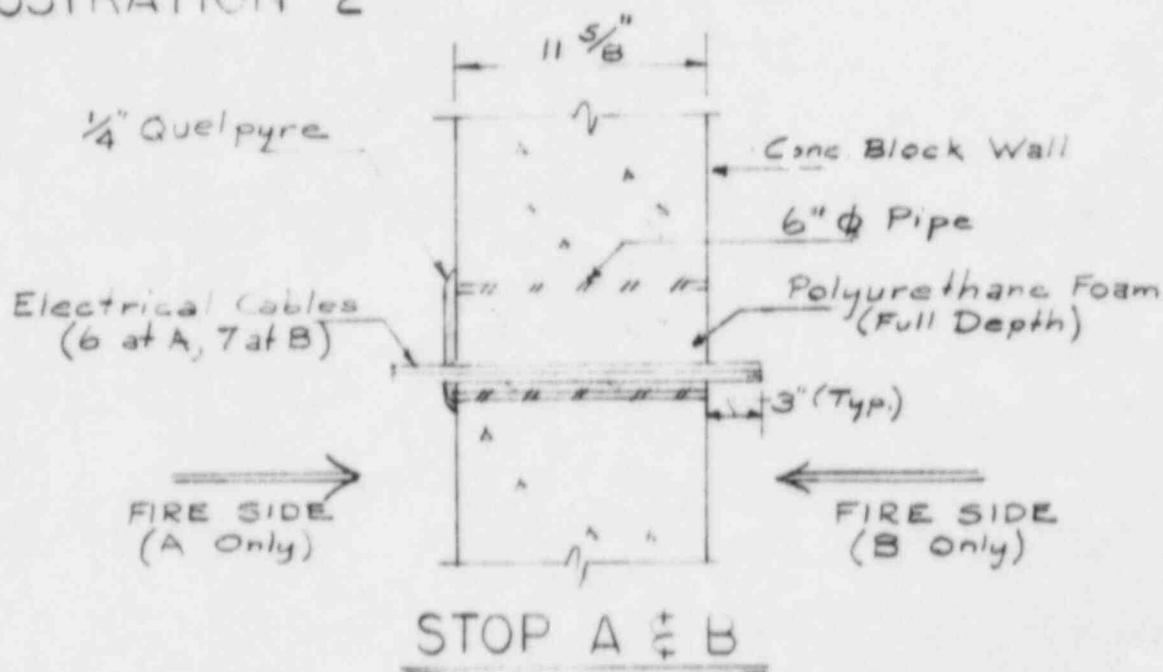
ILLUSTRATION 2

The construction of each fire stop penetration is shown on Illustrations 2 through 8. A description of each fire stop follows:

Fire Stop A - Nominal 6 in. (152.4 mm) diameter steel pipe with six cables, three of each type. The cables were placed at random within the sleeve. These cables were positioned near the bottom of the sleeve, but held away from the sleeve and separated from other cables by approximately 1/2 in. (12.7 mm) using pieces of Kaowool each measuring 1/2 in. (12.7 mm) thick by 1 in. (25.4 mm) long. These separators were placed approximately 1 in. (25.4 mm) in from the end of the sleeve. The cables extended 3 in. (76.2 mm) beyond each end of the sleeve.

This sleeve was then filled with polyurethane foam applied from the unexposed side with care to assure that the urethane is received below and between the cables using the kit dispenser -- see Illustration 2. The temporary dam which had been previously placed on the exposed side to hold the material in the sleeve, was removed. The excess urethane was cut off flush with the end of the sleeve at the unexposed side.

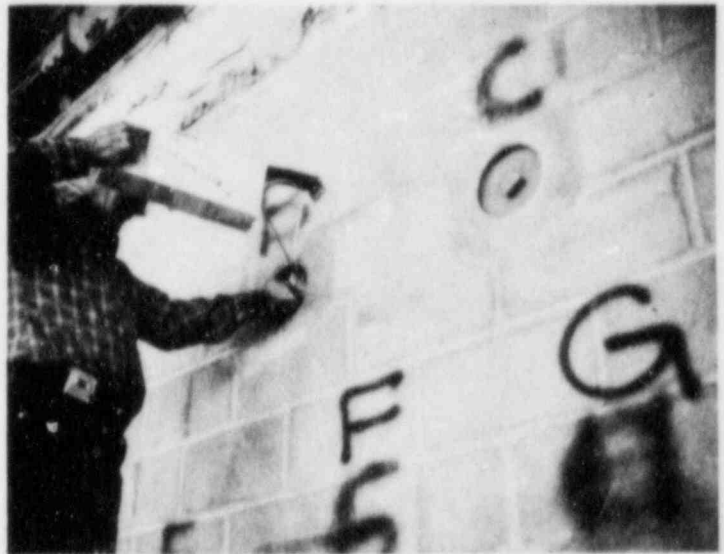
ILLUSTRATION 11

Installation of
Polyurethane Foam

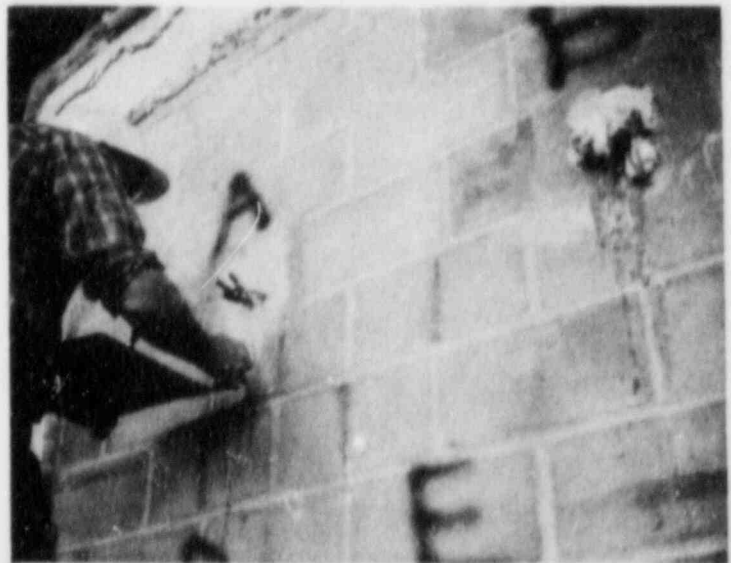
ILLUSTRATION 12

Installation of
Quelpyre Mastic

A 1/4 in. (6.35 mm) thick coating of Quelpyre Mastic 703-B was trowel applied to the fire exposed side in two 1/8 in. (3.18 mm) coats with approximately 5 hours allotted between applications.

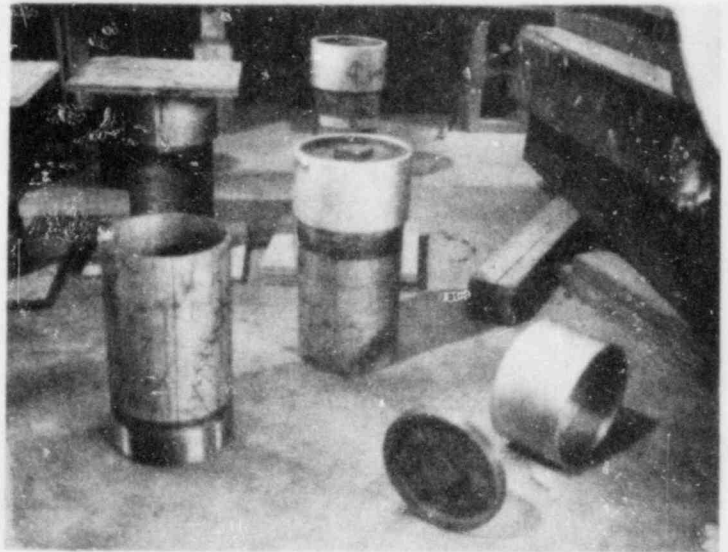
ILLUSTRATION 9

Nominal 6 in.
dia. pipe sleeves, pipe
couplings and pipe plugs

Pipe Sleeves - Six and ten inch (152.4 and 254 mm) diameter standard weight steel pipes were used. The 6 in. (152.4 mm) pipe was furnished in two types - one type having 1/4 in. (6.35 mm) wall thickness with threads on the outside circumference at one end and another type with 5/16 in. (7.94 mm) wall thickness with no threads at either end. The 10 in. (254 mm) steel pipe had 3/8 in. (9.52 mm) wall thickness and was not threaded. All the pipes were 12 in. (304.8 mm) long.

Pipe Couplings - Standard weight steel couplings, 7-1/4 in. (184.2 mm) O.D., 4-1/4 in. (108.0 mm) long with approximately 5/16 in. (7.94 mm) wall thickness. The inside circumference was threaded along the entire length.

Pipe Plug - 6-1/2 in. (165.1 mm) O.D. and measured 3/4 in. (19.0 mm) thick at the outer edge having a 1-3/4 in. (44.5 mm) square nut shape top. The plugs appeared to be made of brass or bronze and were marked '106-1/2'. The wall thickness was approximately 1/8 in. (3.18 mm).

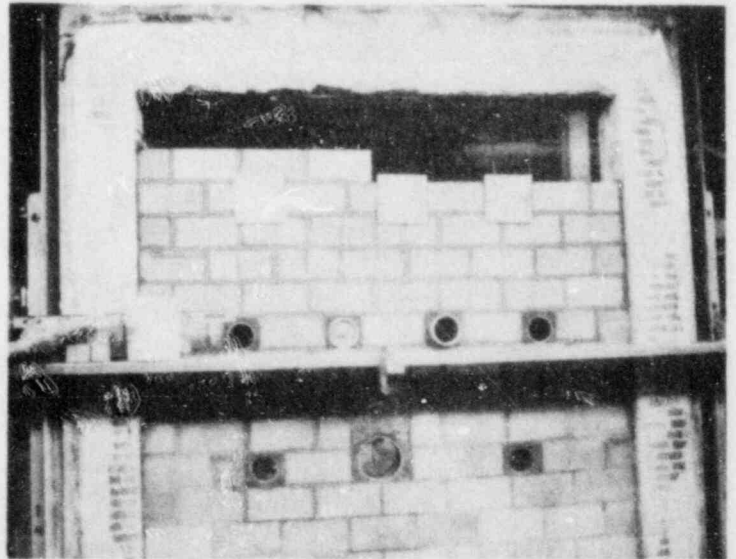
ILLUSTRATION 10

Exposed Surface During
Installation of
Penetration Seals

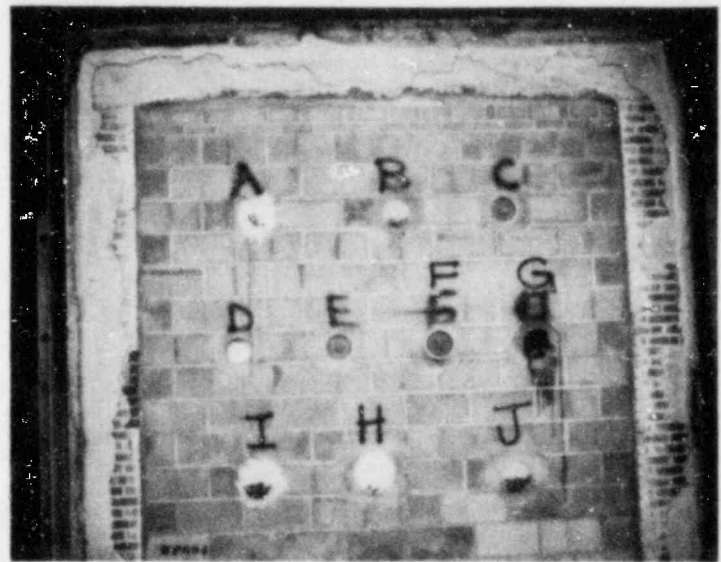
ILLUSTRATION 13

Exposed Surface Before
Fire Endurance Test

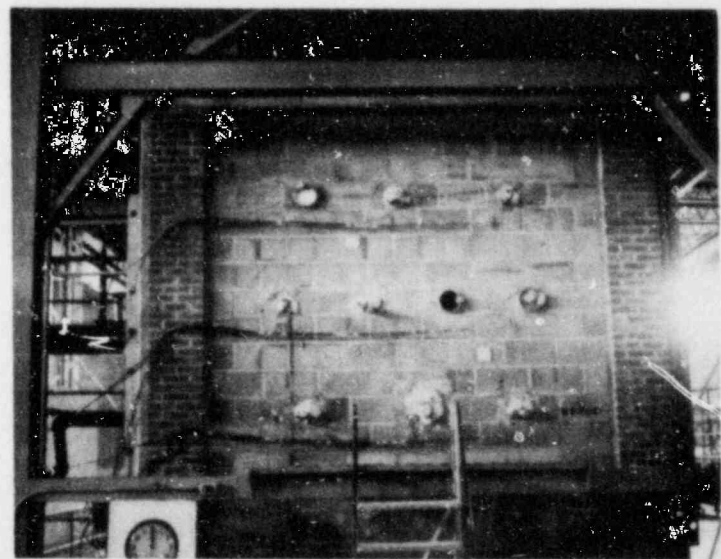
ILLUSTRATION 14

Unexposed Surface Before
Fire Endurance Test

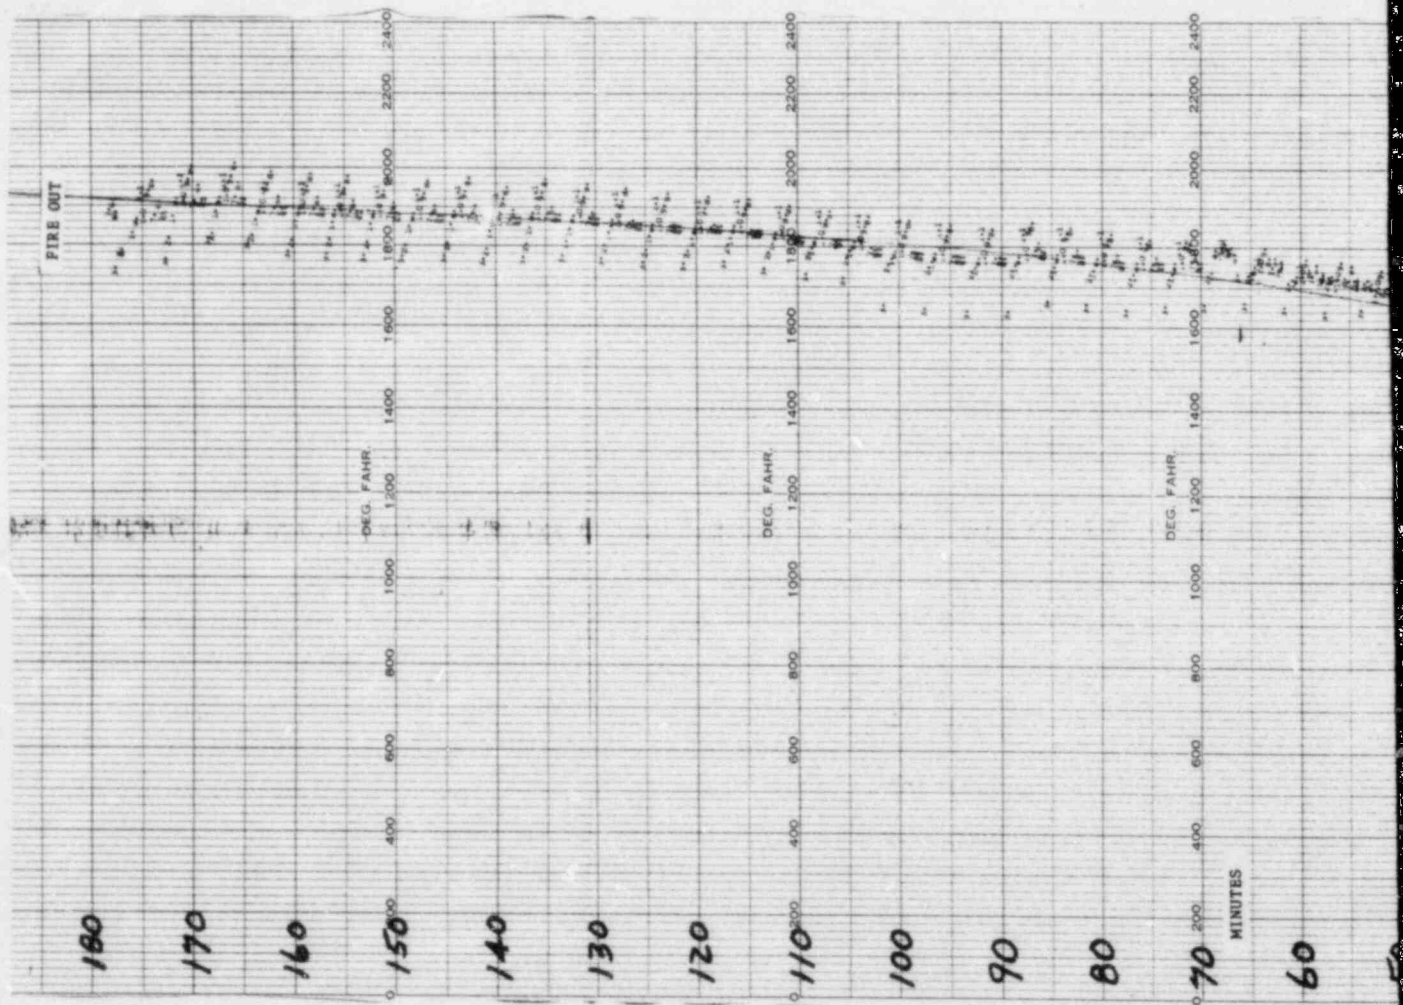
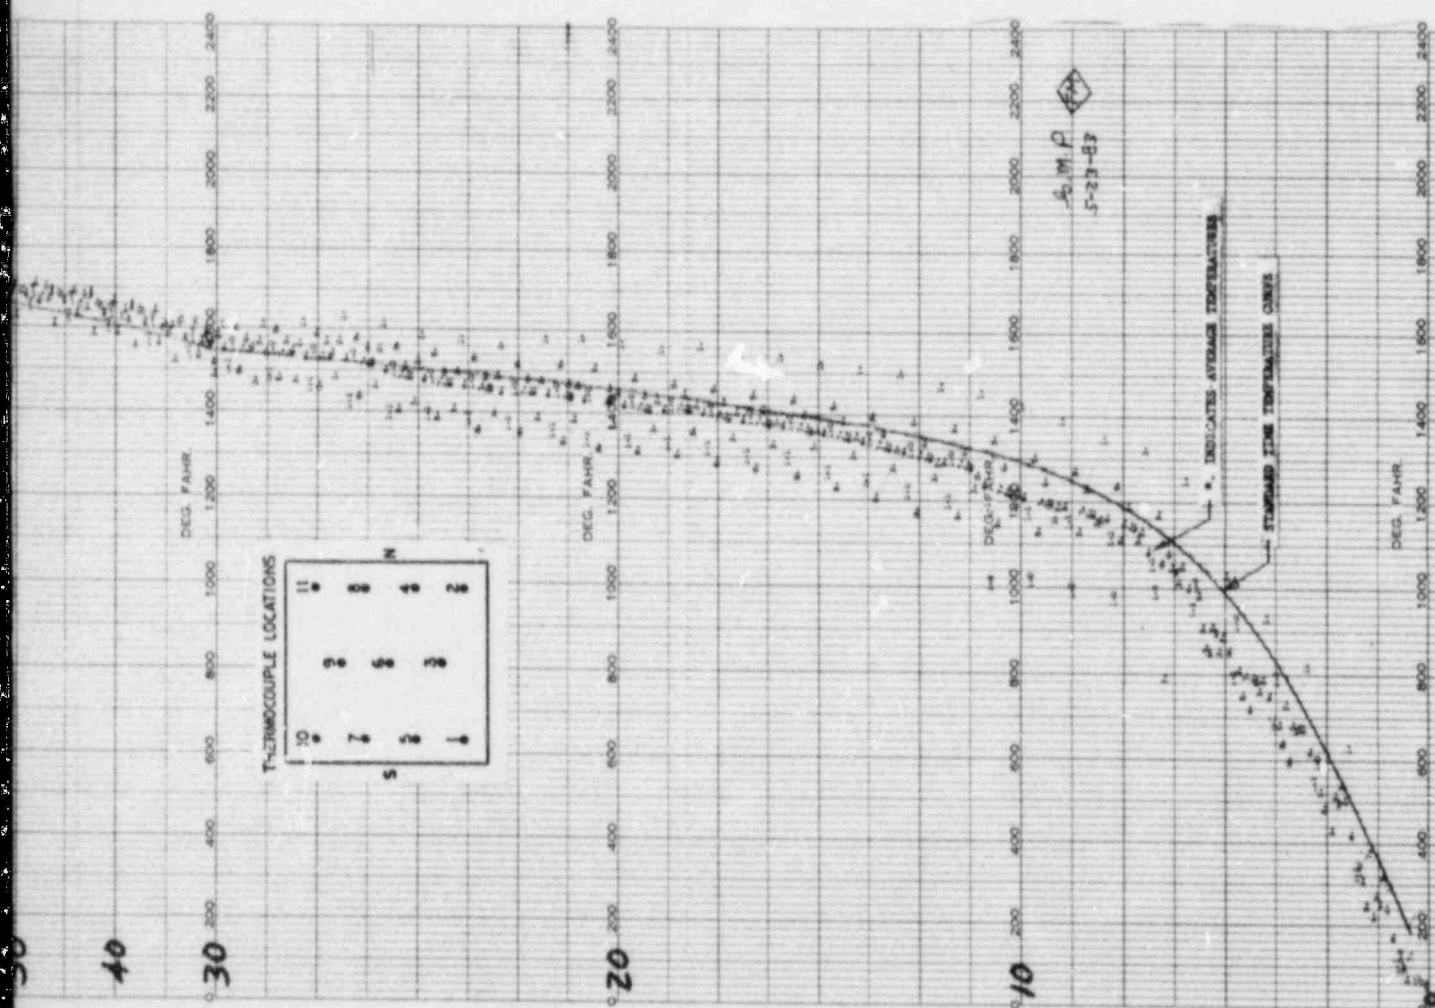
Illustration 15

FURNACE
FIRE EN
MAY
PHILADELPHIA

TEMPERATURES

DURANCE TEST

The furnace temperatures were measured by eleven thermocouples symmetrically located in the furnace chamber as shown on Illustration 15. The unexposed surface temperatures of the wall, penetration seals and cables were measured with thermocouples as shown on Illustrations 16 through 19. Each thermocouple was covered with a dry asbestos pad, 2 x 2 in. (50.8 x 50.8 mm) to provide thermal insulation.

Character and Distribution of the Fire - The fire was luminous and well distributed throughout the furnace during the test. The furnace temperatures were controlled in accordance with the Standard Time-Temperature Curve as shown on Illustration 15.

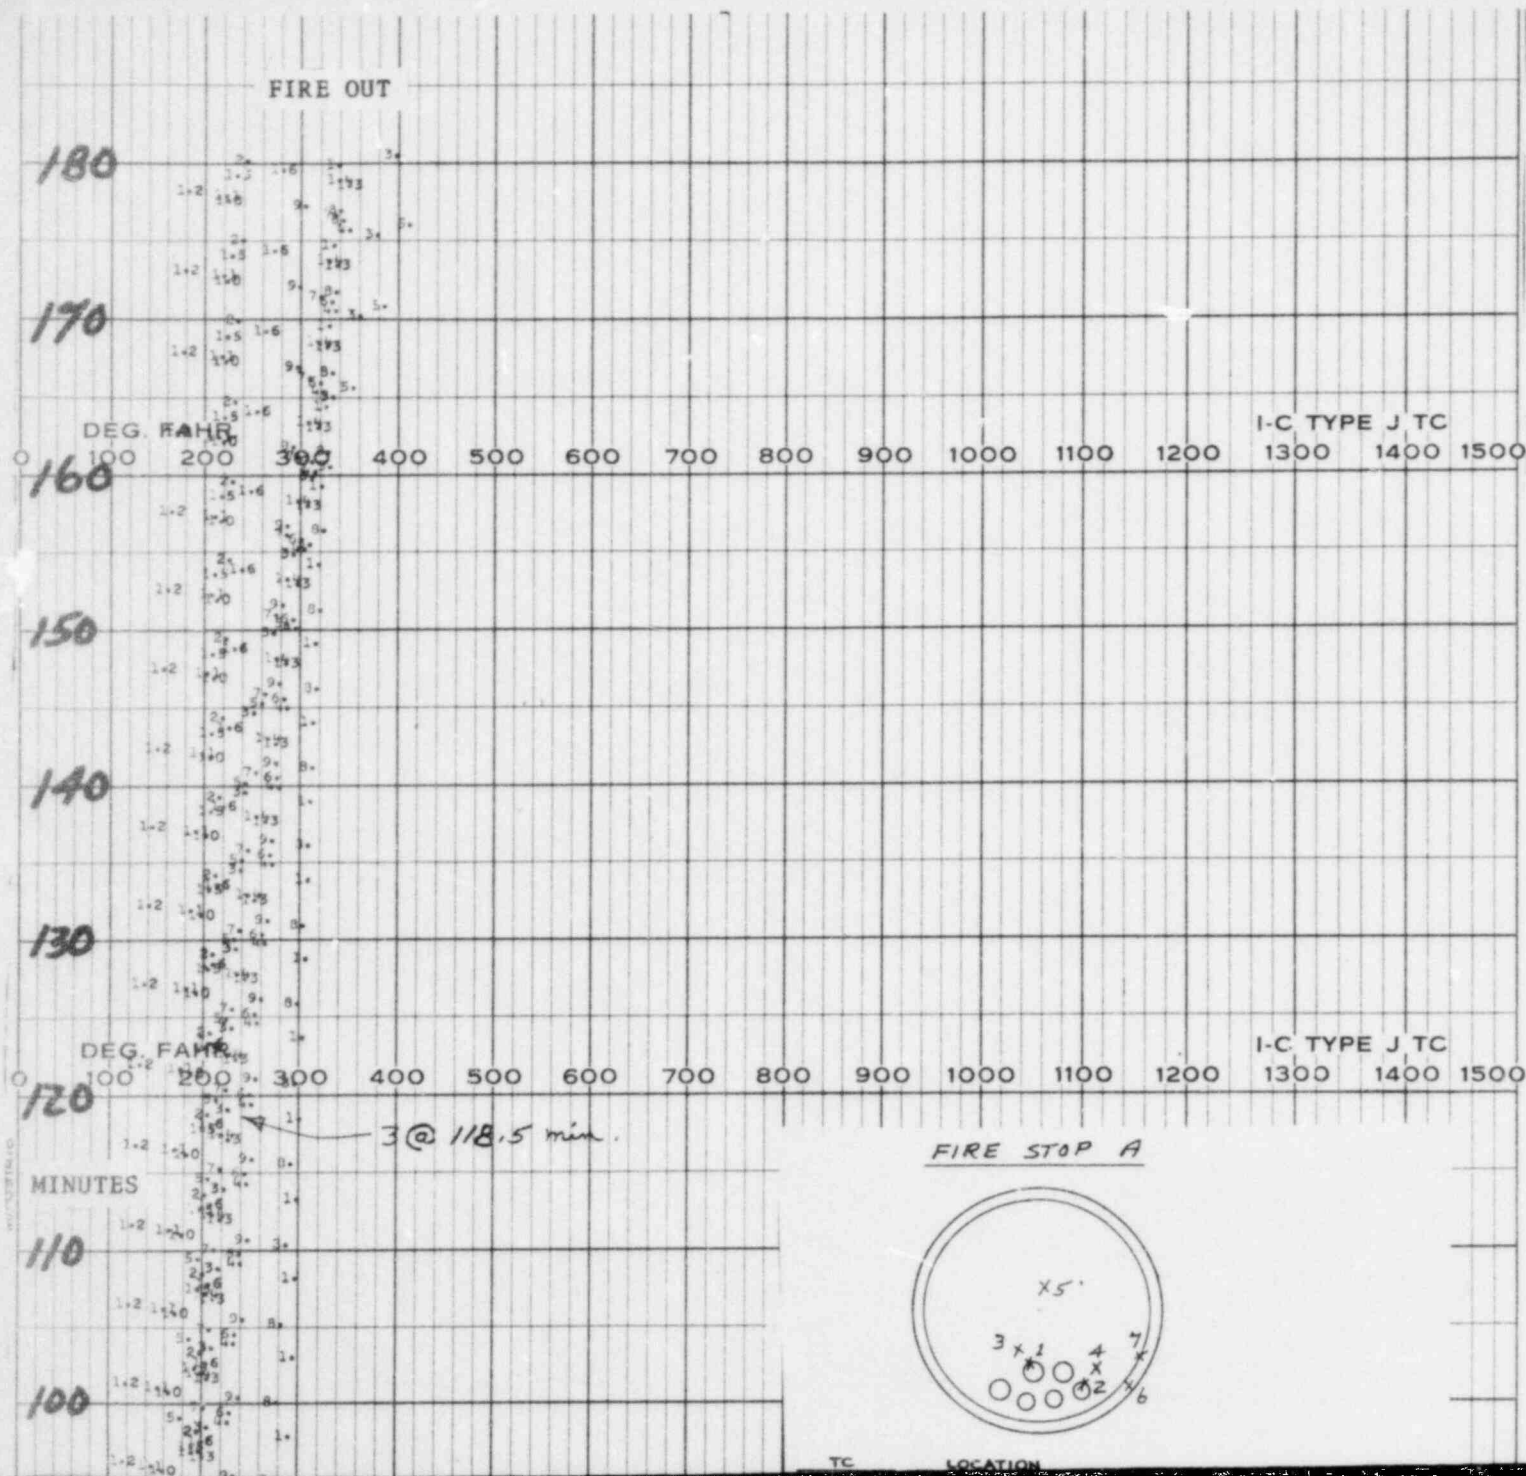
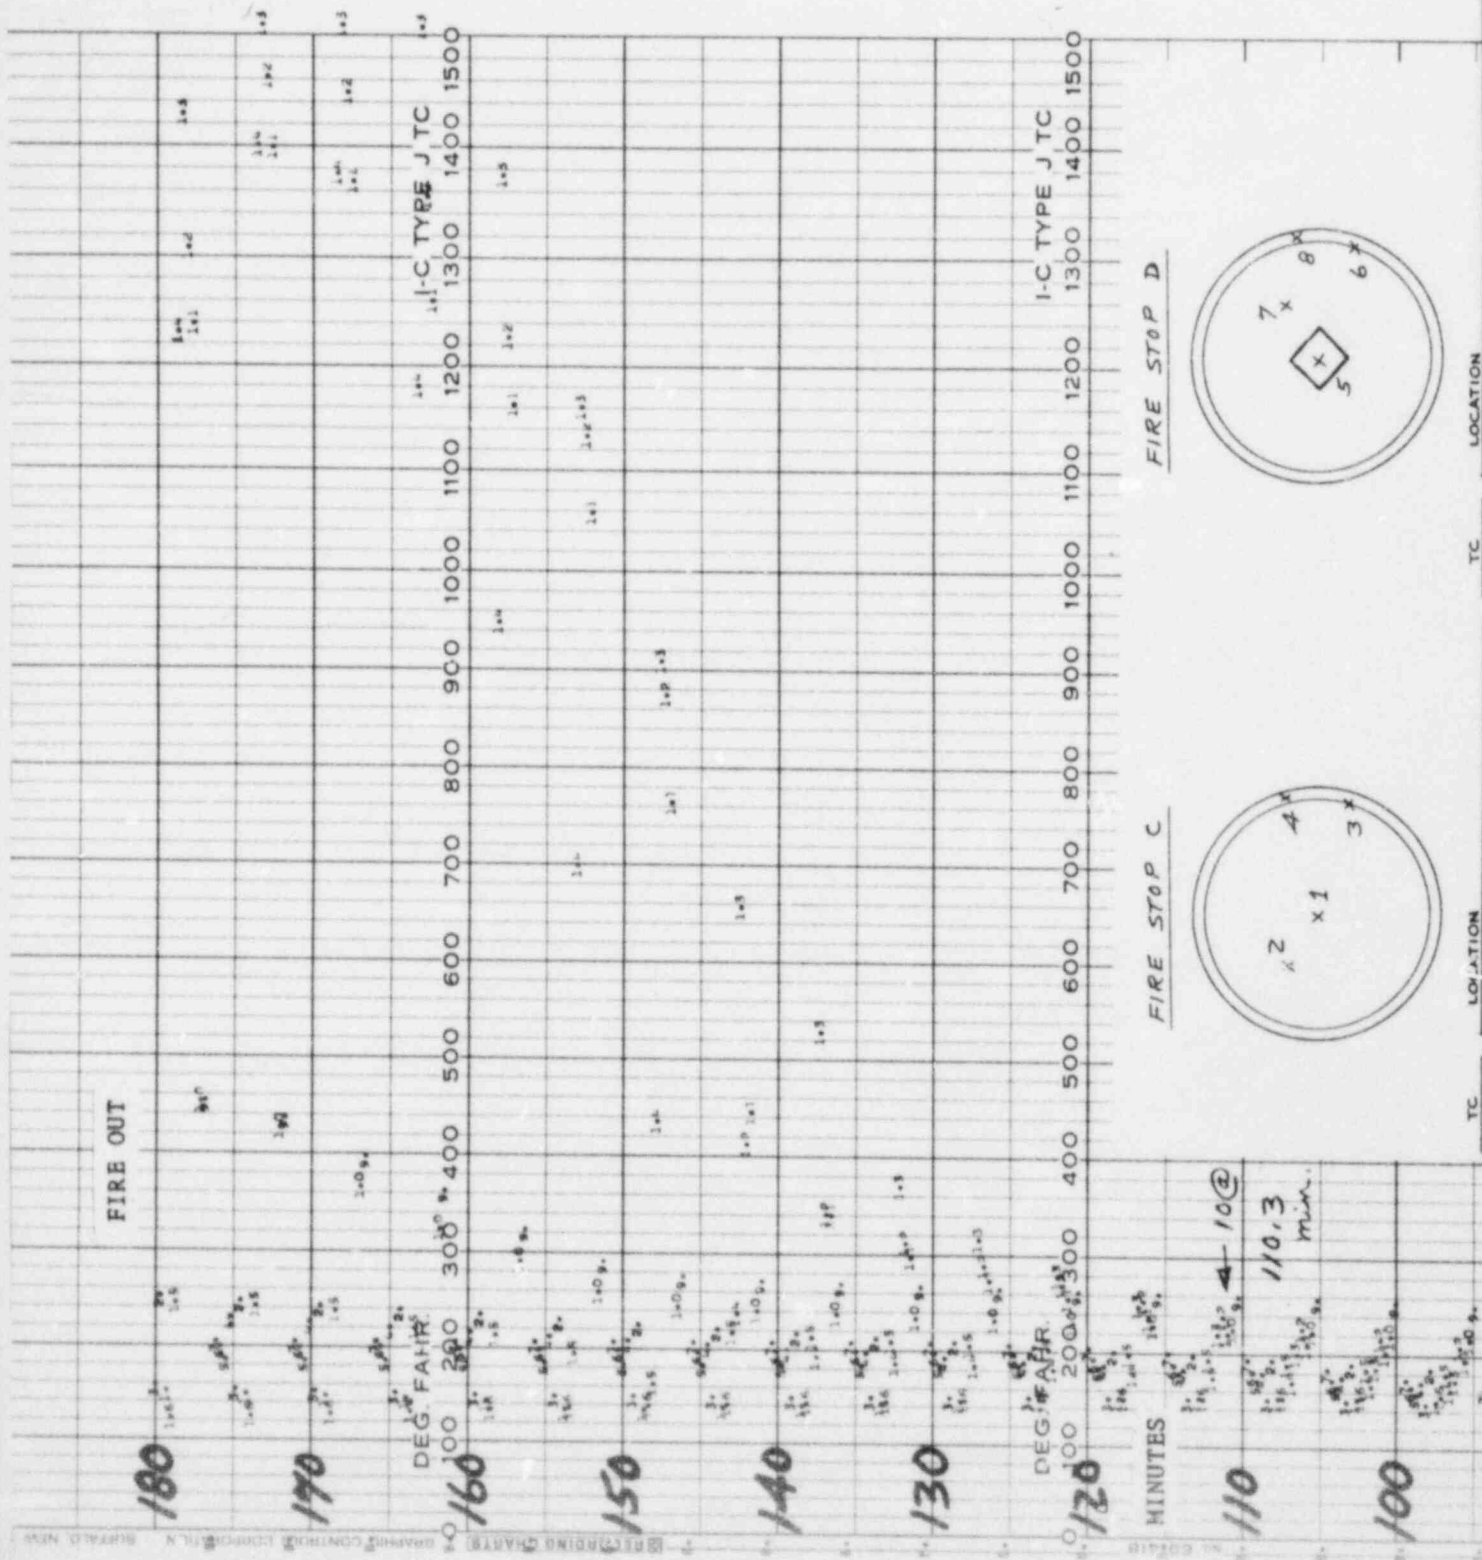
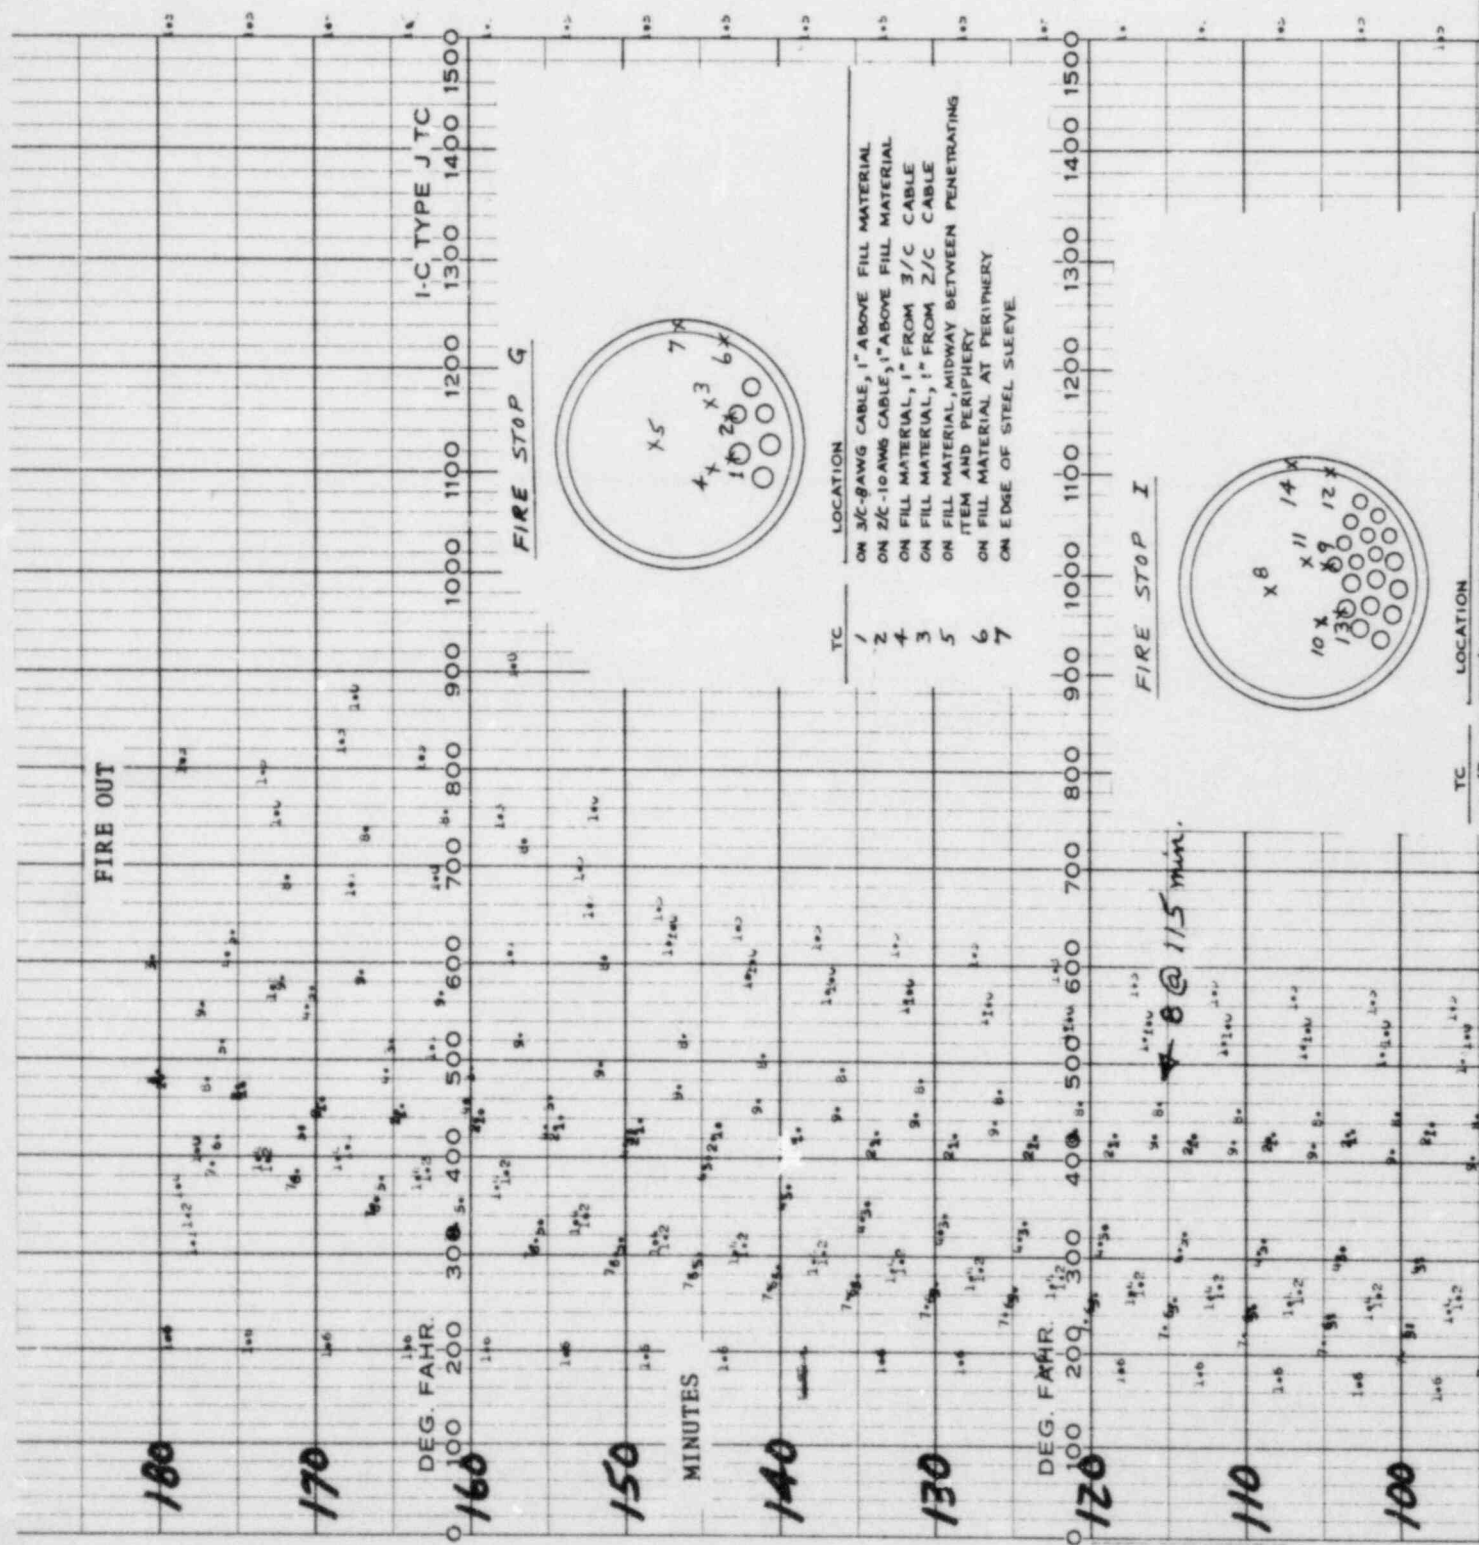
FACTORY MUTUAL RES
UNEXPOSED SURFACE
FIRE ENDURA
MAY 23,
PHILADELPHIA ELE

UNEXPOSED SURFACE
FIRE ENDURAN
MAY 23,
PHILADELPHIA ELEC

Temperatures at Unexposed Side of Stops - The temperatures that developed during the test and the thermocouple locations are shown on Illustrations 16 through 19.

A T rating may be assigned each fire stop that satisfies the fire endurance and the hose stream requirements of the ASTM E814-81 Standard. The T rating is based on the transmission of heat through the fire stops during the rating period. The T rating is determined by the rise in temperature on the unexposed surface of the fire stop or on any penetrating item. The temperature rise cannot be more than 325°F (163°C) above the initial temperature. The initial temperature was established to be 75°F (24°C) due to recalibration of the equipment.

Fire Stops C, D, G, H and J achieved T ratings based on the transmission of heat through the fire stops during the rating period. The T rating is determined by the rise in temperature on the unexposed surface of the fire stop or on any penetrating item. The temperature rise cannot be more than 325°F (163°C) above the initial temperature which was established at 75°F (24°C). Stops C and D achieved 3 hour T ratings; G and J achieved 1 hour T ratings and H achieved a 2 hour T rating.

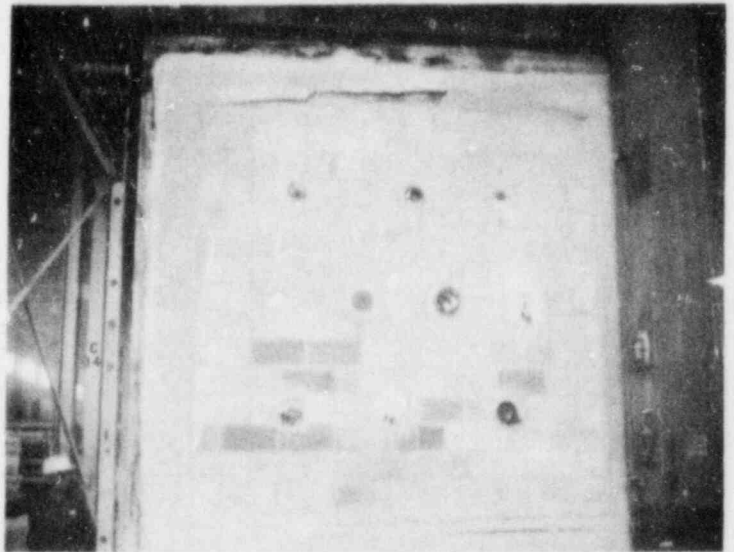
ILLUSTRATION 20

Exposed Surface After
Fire Endurance and
Before Hose Stream Test

See Illustration 20 for a view of the exposed surface after the fire endurance test.

The exposed and unexposed surfaces before the hose stream test are shown on Illustrations 20 and 21.

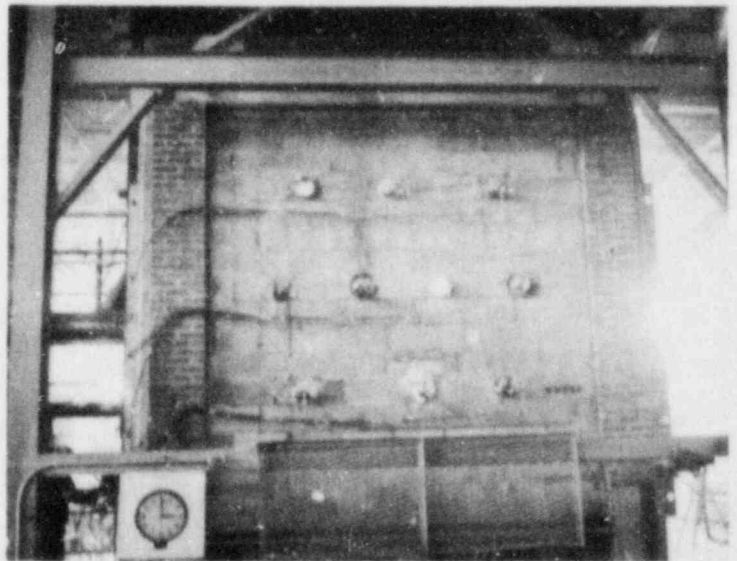
ILLUSTRATION 21

Unexposed Surface at
Three Hours of
Fire Exposure

See Illustration 21 for a view of the unexposed surface at 3 hours of exposure.

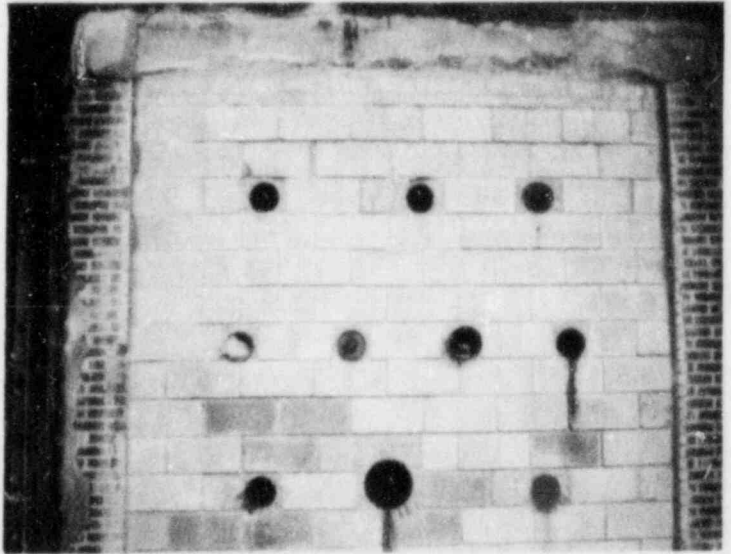
ILLUSTRATION 22

Exposed Surface After
Fire Exposure and
Hose Stream Test

Observations After the Hose Stream Test - The appearance of the exposed and unexposed surfaces of the assembly after the application of the hose stream and subsequent cooling are shown on Illustrations 22 and 23.

Fire Stop B - At the fire exposed side most of the seal material had been eroded. At the unexposed side the stop was intact except the water stream had caused the mastic material to pull away from the steel sleeve at the top creating an opening for water to project through the stop.

Fire Stop C - There was no noticeable change at the unexposed side of the stop. On the exposed side some of the pipe plug had deteriorated and the Kaowool was visible behind the plug.

Fire Stop D - There was no noticeable change on the unexposed side of the stop. On the exposed side some of the Kaowool was either dislodged or pushed back within the sleeve.

Fire Stop F - The pipe plug had disintegrated and there was no polyurethane present, however, the cables remained in the opening.

Fire Stop G - There was no through-opening in the seal. At the unexposed side the polyurethane was discolored. On the exposed side a majority of the silicone material had been removed.

Fire Stop H - There was no through-opening in the seal and no noticeable change at the unexposed side except a small area of discoloration of the seal near the cables. On the exposed side a large amount of seal material had been removed.

Fire Stop I - There was a through-opening of the seal; however, most of the material had been removed from the stop. The cables remained in the sleeve.

Fire Stop J - There are no through openings in the seal and no noticeable changes of the stop at the unexposed side. At the exposed side a large cavity existed where the seal material had eroded.

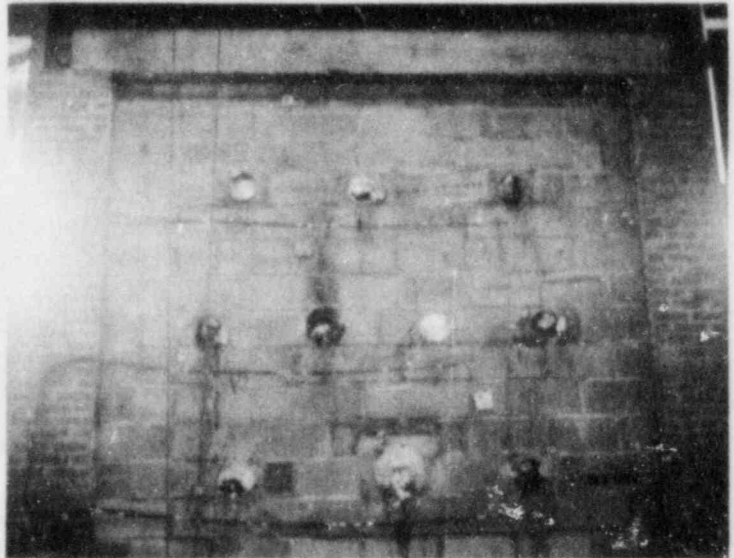
ILLUSTRATION 23

Unexposed Surface After
Fire Exposure and
Hose Stream Test
