NUCLEAR REACTOR PRESSURE VESSEL TRANSPORTATION INCIDENT

POINT BEACH UNIT 1

VOLUME I

PREPARED FOR
WISCONSIN MICHIGAN POWER COMPANY
231 WEST MICHIGAN STREET
MILWAUKEE, WISCONSIN 53201

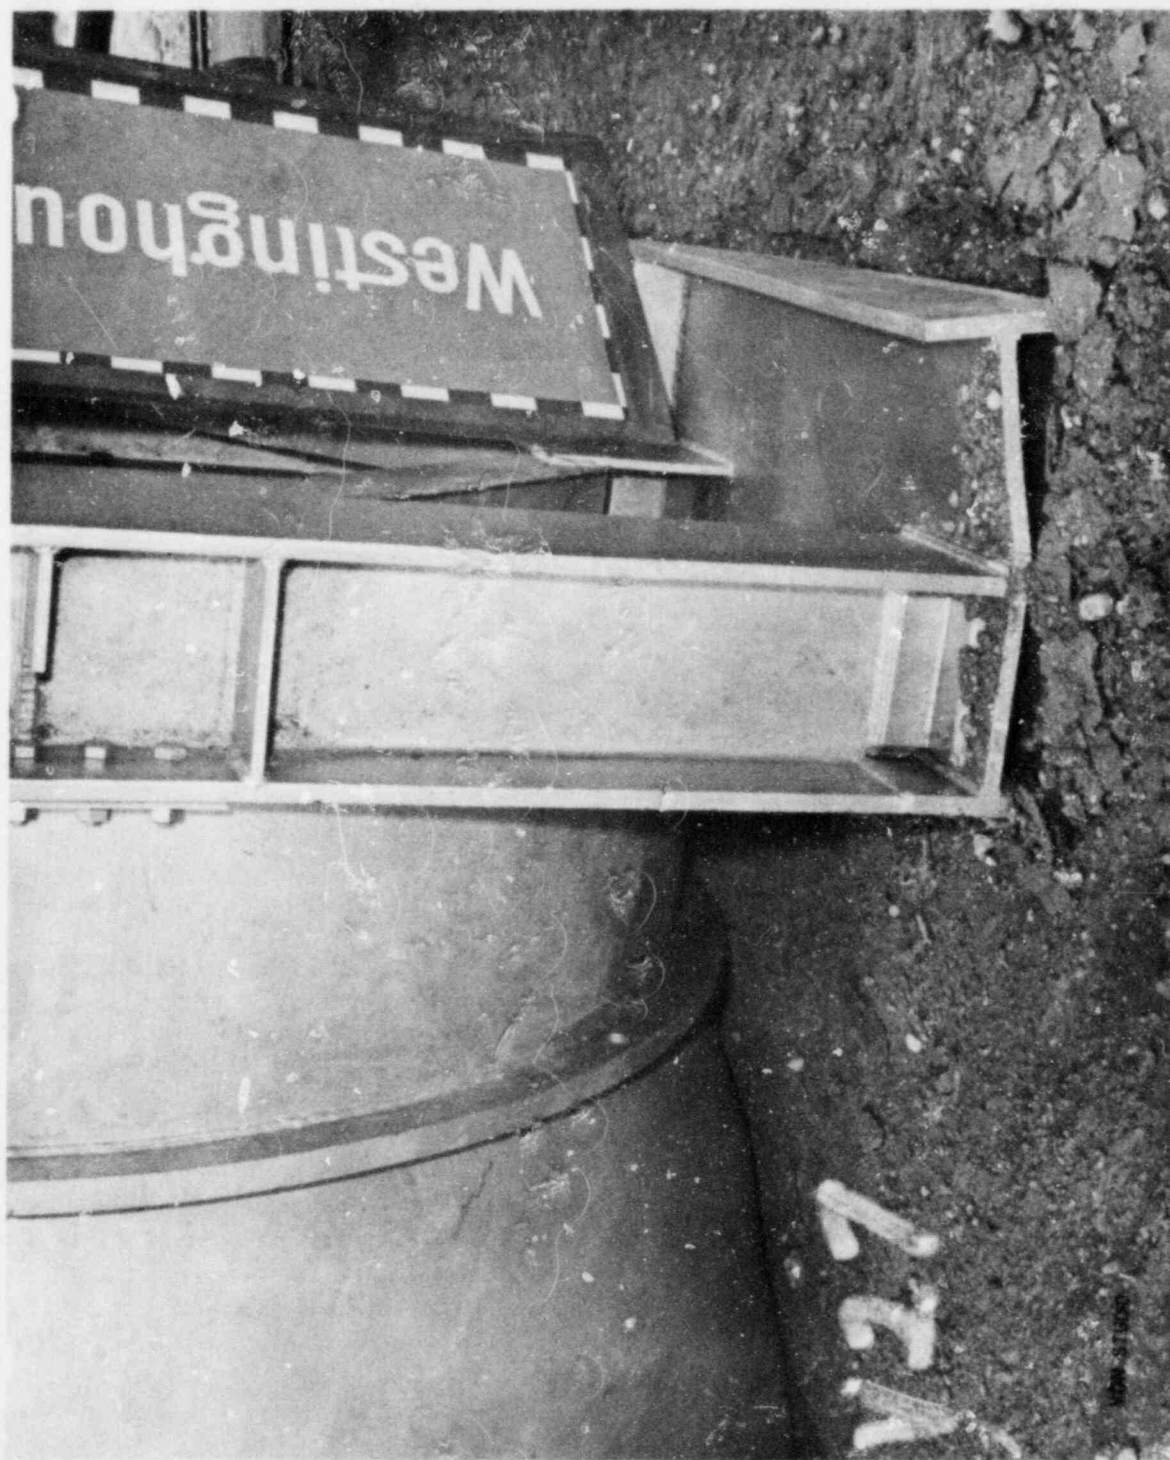
Figures 12 and 13 show the visible physical damage to the weld preparation of the inlet nozzle that penetrated the ground away from the dolly wheels. Figures 14 and 15 illustrate the visible physical damage to the outlet nozzle weld preparation caused by the rim of the dolly wheel. The internal bore of the outlet nozzle suffered some damage from the dolly axle. This damage is not visible in any of the photographs. The scar was initially judged to be about 0.045 inch deep; but after preliminary grinding that removed the upset area, it was re-evaluated and judged to be only about 0.095 inch deep. The only other visible damage to the object was some distortion of the vessel shipping skid; this can be seen in Figures 3, 4, 5, and 16.

FIGURE 16. PORTION OF VESSEL SHIPPING SKID SHOWING DISTORTION.

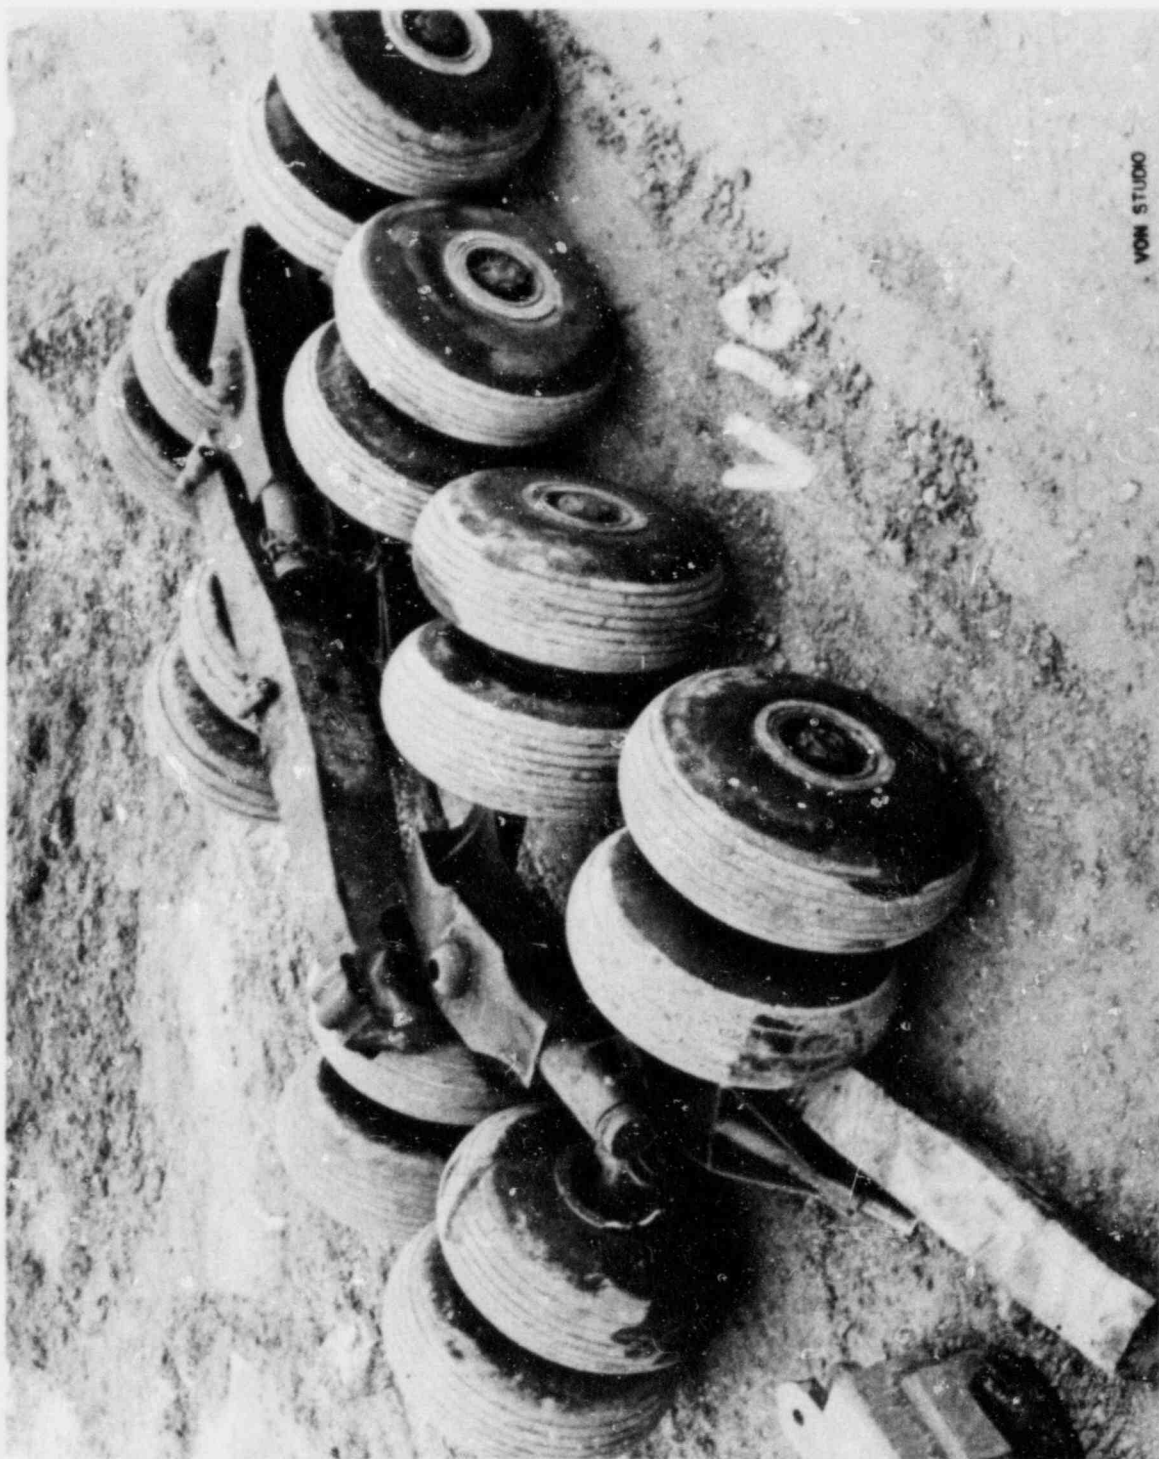
The cause of the occurrence is attributed to the failure to remove the wheel blocking and the lack of proper supervision by Mr. Holmes, Superintendent for Belding Engineering Corporation, in operating the lead tractor instead of directing the activity and personally giving the "all clear" signal to move after being satisfied that all blocking had been removed from the dolly wheels. Figure 19 illustrates the wooden block used to block the rear tandem of the right tandem dolly.

FIGURE 19. VIEW SHOWING THE WOODEN BLOCK USED TO BLOCK THE REAR TANDEM OF THE RIGHT TANDEM DOLLY.
