Report No.: SIR-91-077
Revision No.: 2
Project No.: GPCO-20Q-2
January 1992

IGSCC Flaw Evaluations and Weld Overlay
Activities During the E. I. Hatch Unit 1
Fall 1991 Outage

Prepared for:
Georgia Power Company

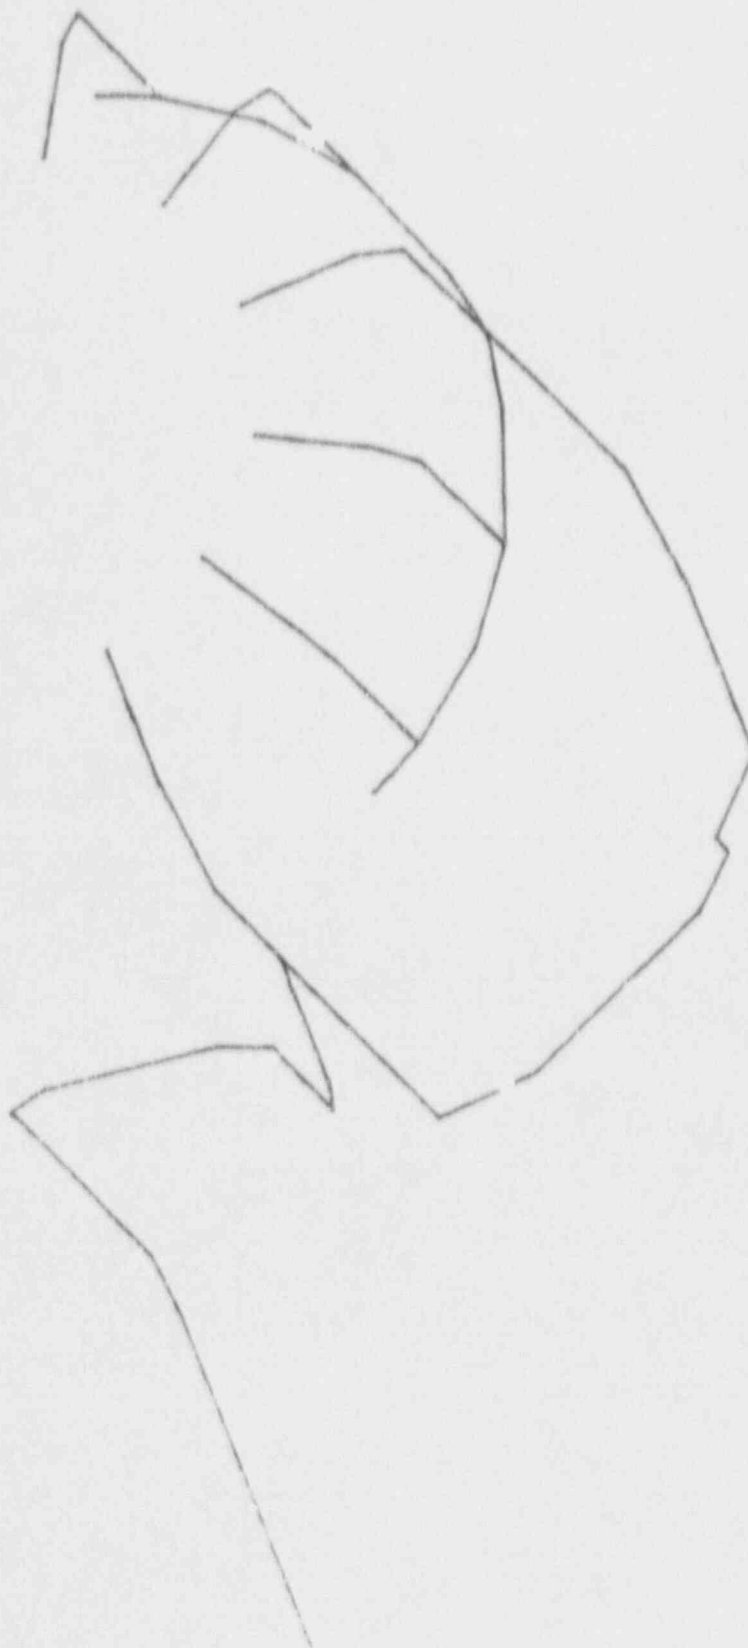
Figure 4-1. Finite Element Models: Loops A and B

Table 4-4 presents the modal response analysis results. The first mode was found to be about 5.52 hz. for the recirculation system without any overlays. With the overlays, the first mode frequency decreases to about 5.49 hz. for a difference of 0.68%. The biggest difference is about 2.1% for mode 20.

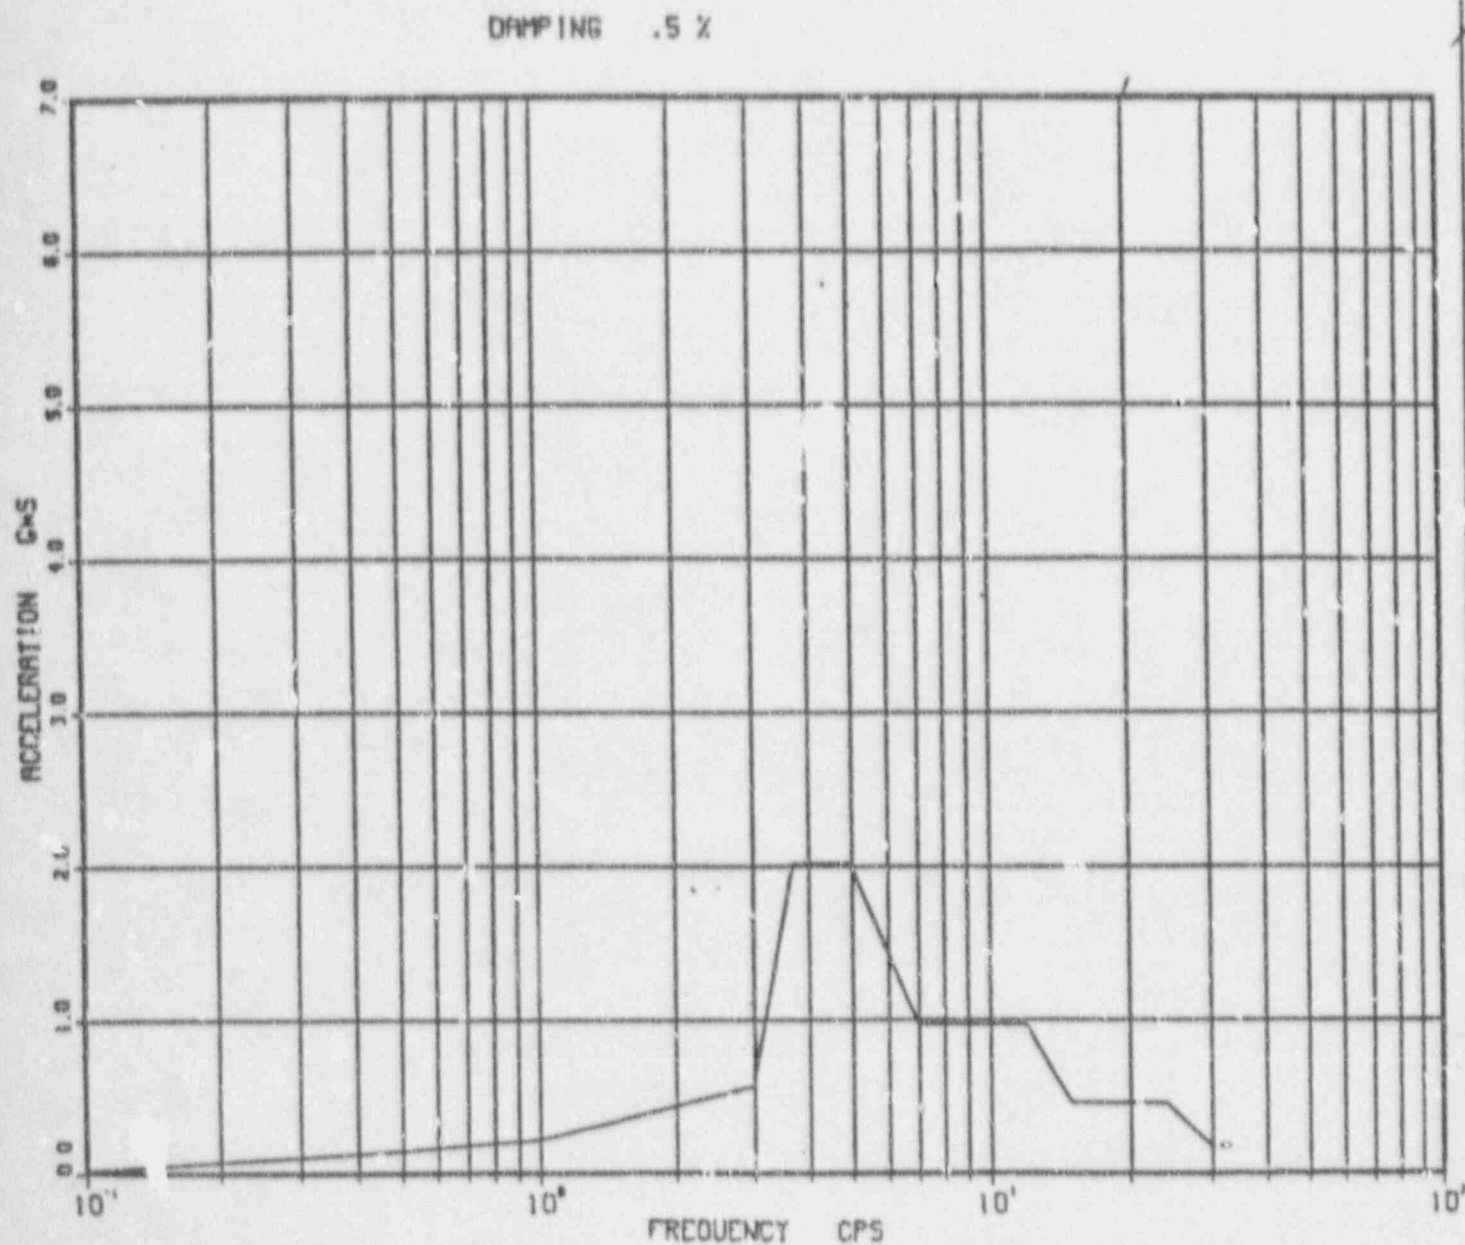
HNP UNIT 1 RPV HORIZONTAL OBC MASS PT 19 CL. 146'-0"

Figure 4-2. Hatch Seismic Response Spectra: Elev. 146 ft.

Figures 4-2 and 4-3 present the Hatch Unit 1 response spectra at reactor vessel elevations 146 ft. and 172 ft. They both show a peak response at a frequency range of about 3.5 hz. to 5 hz. With the first mode of 5.52 hz. when there are no overlays, the response is very close to the peak of the spectrum. Even though a decrease in the mode frequency would correspond to an increased response for the given spectrum, the magnitude of the decrease in the first mode frequency is so small that it would not cause a significant change in the response. With only about 50% of the welds overlaid, the change in the first mode frequency would be even smaller. Therefore, it is concluded that the overlays, either in the current or any imagined future configuration, would have a negligible effect on the dynamic analysis of the system.

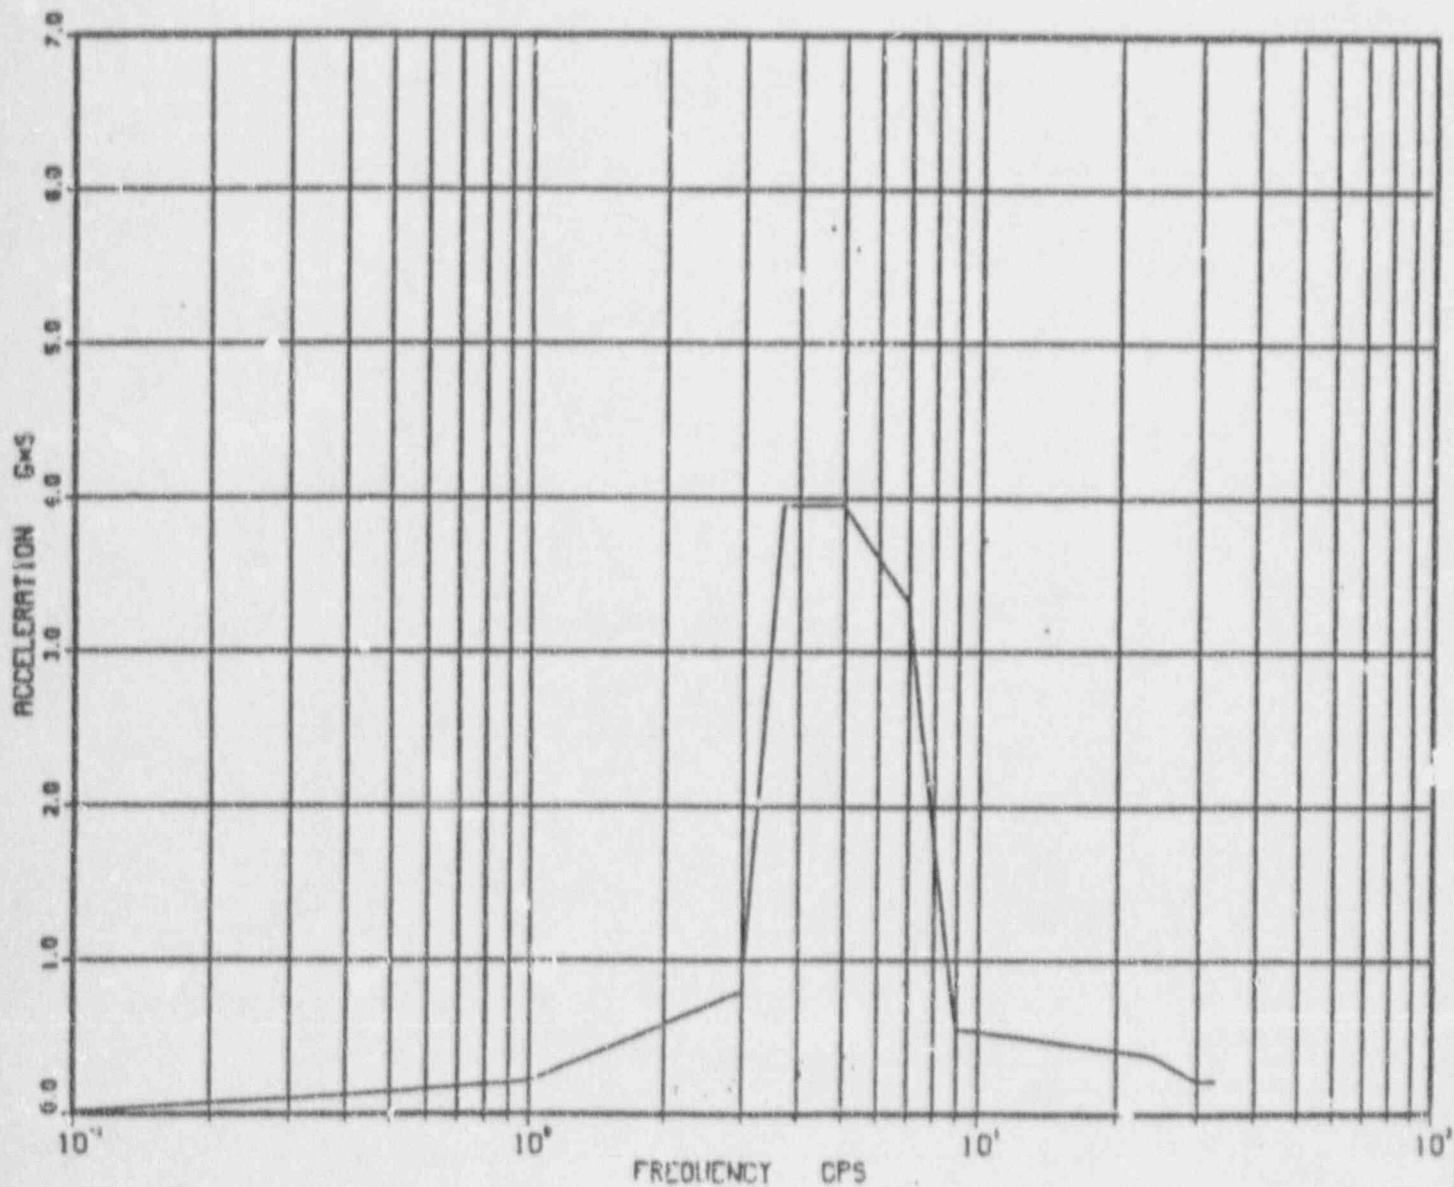
HNP UNIT 1 RPV HORIZONTAL DBC MASS PT 20 EL. 172'-0"

Figure 4-3. Hatch Seismic Response Spectra: Elev. 172 ft.

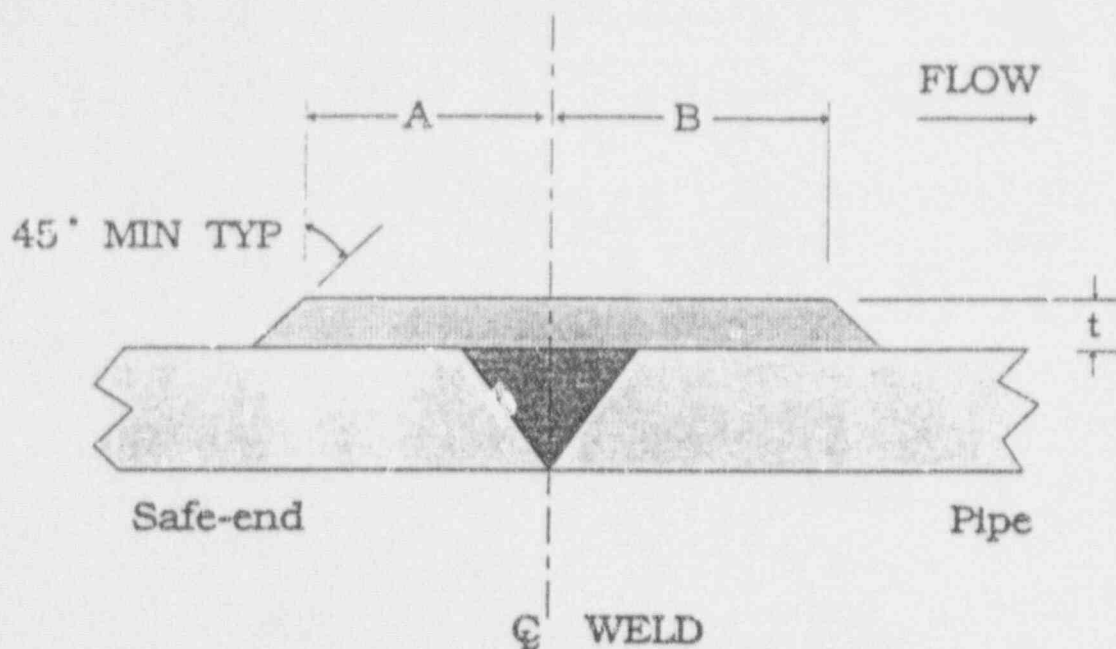
Job No: GPCO-20Q	Plant/Unit Georgia Power Company Plant Hatch Unit 1	 	STRUCTURAL INTEGRITY ASSOCIATES, INC.
File No: GPCO-20Q-401			
Drawing No: GPCO-20Q-07	Title: Standard Weld Overlay Design		Sheet <u>2</u> of <u>2</u>

WELD NUMBER	FLAW CHARACTERIZATION	DESIGN DIMENSIONS			COMMENTS
		t	A	B	
1B31-1RC-28B-2	Assumed 360° Circ. 100% throughwall flaw	0.52"	4.0"	4.0"	Overlay Thickness revised.
1	GAM 10/22/91	NGC 10/22/91	NRD 10/22/91		Overlay dimensions based on as-built thickness.
0	NRD 6/18/91	HT 6/18/91	REC 6/18/91		
Revision	Prepared by/ Date	Checked by/ Date	Approved by/ Date	COMMENTS	
Job No:	GPCO-20Q		Plant/Unit

4. First weld layer is to have a measured delta ferrite content greater than 7.5 FN. This requirement does not apply to the final weld layer.
5. Design thickness includes no allowance for surface conditioning operations to facilitate UT inspections.

6. Design length is that required for structural reinforcement; greater length may be required for effective UT inspection. This is to be determined in the field.

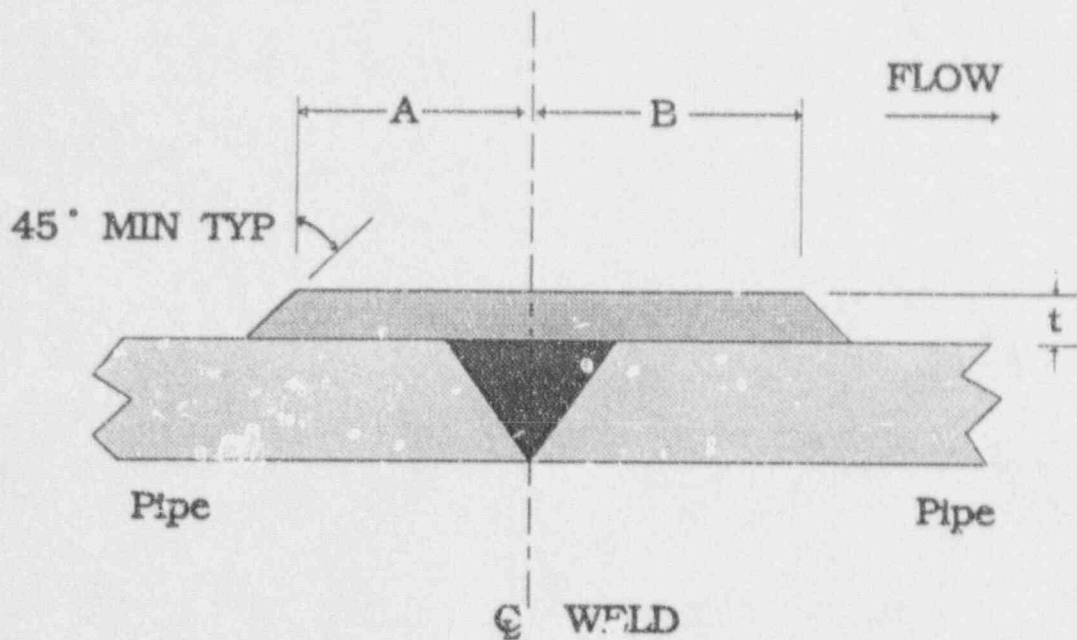
STRUCTURAL INTEGRITY ASSOCIATES, INC.
File No: GPCO-20Q-401		
Drawing No: GPCO-20Q-13	Title: Standard Weld Overlay Design	Sheet <u>2</u> of <u>2</u>

WELD NUMBER	FLAW CHARACTERIZATION	DESIGN DIMENSIONS			COMMENTS
		t	A	B	
1E11-1RHR-20B-D-4	Assumed 360° Circ. 100% throughwall flaw	0.36"	3.0"	3.0"	
0	11/18/91	6/18/91	6/18/91	6/18/91	
Revision	Prepared by/ Date	Checked by/ Date	Approved by/ Date	COMMENTS	
Job No: GPCO-20Q		Plant/Unit Georgia Power Company Plant Hatch Unit 1

4. First weld layer is to have a measured delta ferrite content greater than 7.5 FN. This requirement does not apply to the final weld layer.
5. Design thickness includes no allowance for surface conditioning operations to facilitate UT inspections.

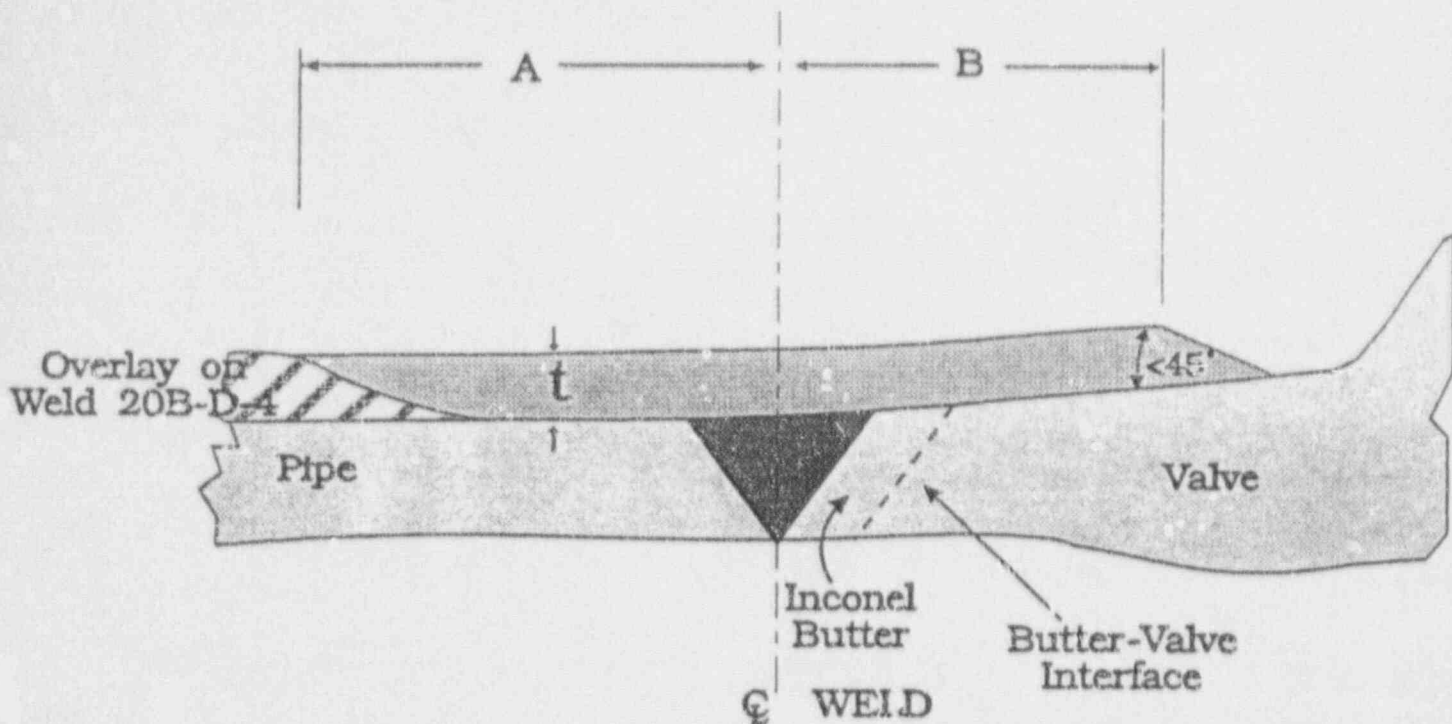
STRUCTURAL INTEGRITY ASSOCIATES, INC.
File No: GPCO-20Q-401			
Drawing No: GPCO-20Q-14	Title: Standard Weld Overlay Design	Sheet <u>2</u> of <u>2</u>

WELD NUMBER	FLAW CHARACTERIZATION	DESIGN DIMENSIONS			COMMENTS
		t	A	B	
WE11-1RHR-20B-D-5	Assumed 360° Circ. 100% throughwall flaw	0.33"	Note 1	3"

1. Blend repair into adjacent repair on weld 20B-D-4. Follow contour of transition with all weld layers. Repair should blend into valve body transition at an angle of 45 degrees or less with the component surface.

5. Design thickness includes no allowance for surface conditioning operations to facilitate UT inspections.
6. Design length is that required for structural reinforcement; greater length may be required for effective UT inspection. This is to be determined in the field.

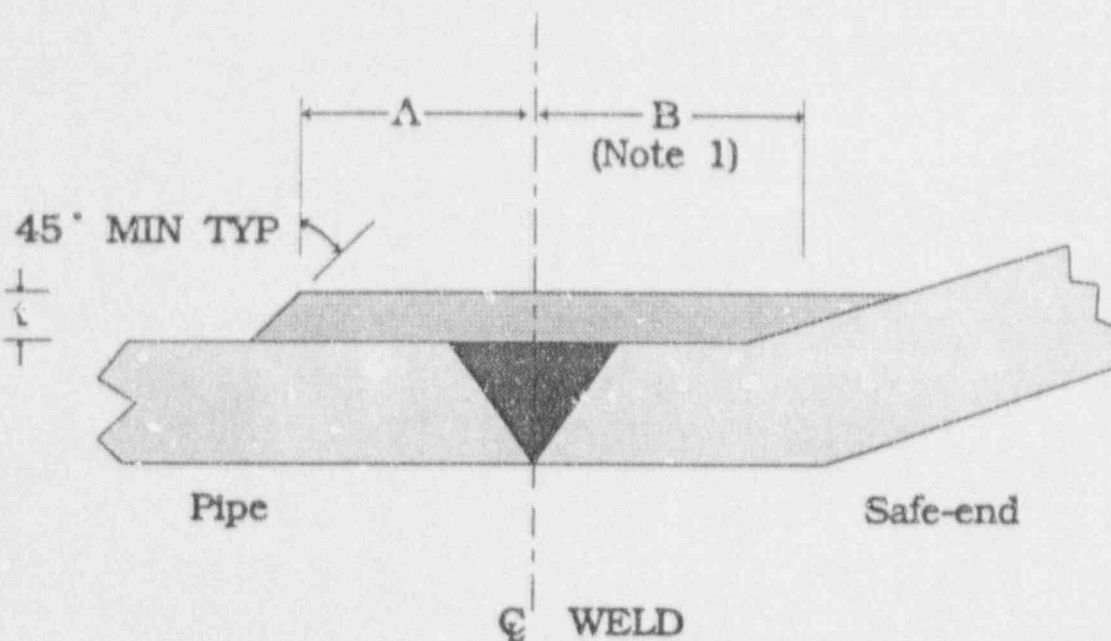
STRUCTURAL INTEGRITY ASSOCIATES, INC.
File No: GPCO-20Q-401		
Drawing No: GPCO-20Q-28	Title: Standard Weld Overlay Design	Sheet <u>2</u> of <u>2</u>

WELD NUMBER	FLAW CHARACTERIZATION	DESIGN DIMENSIONS			COMMENTS
		t	A	B	
1B31-1RC-12AR-G4	Assumed 360° Circ. 100% throughwall flaw	0.26"	2.0"	NA	
1	HLD 10/23/91	QJZ 10/23/91	QJZ 10/23/91		Revised to show safe-end transition
0	HLD 6/18/91	QJZ 6/18/91	QJZ 6/18/91		
Revision	Prepared by/ Date	Checked by/ Date	Approved by/ Date	COMMENTS	
Job No: GPCO-20Q		Plant/Unit Georgia Power Company Plant Hatch Unit 1

1. Blend repair into transition.
2. Weld overlay wire is to be type ER308L, with as-deposited delta ferrite content greater than 7.5 FN.
3. Component surface is to be examined by dye penetrant method and accepted as clean prior to overlay application in order to include the entire deposited overlay thickness in meeting the design thickness requirement, per NUREG-0313, Revision 2.

5. First weld layer is to have a measured delta ferrite content greater than 7.5 FN. This requirement does not apply to the final layer.
6. Design thickness includes no allowance for surface conditioning operations to facilitate UT inspections.

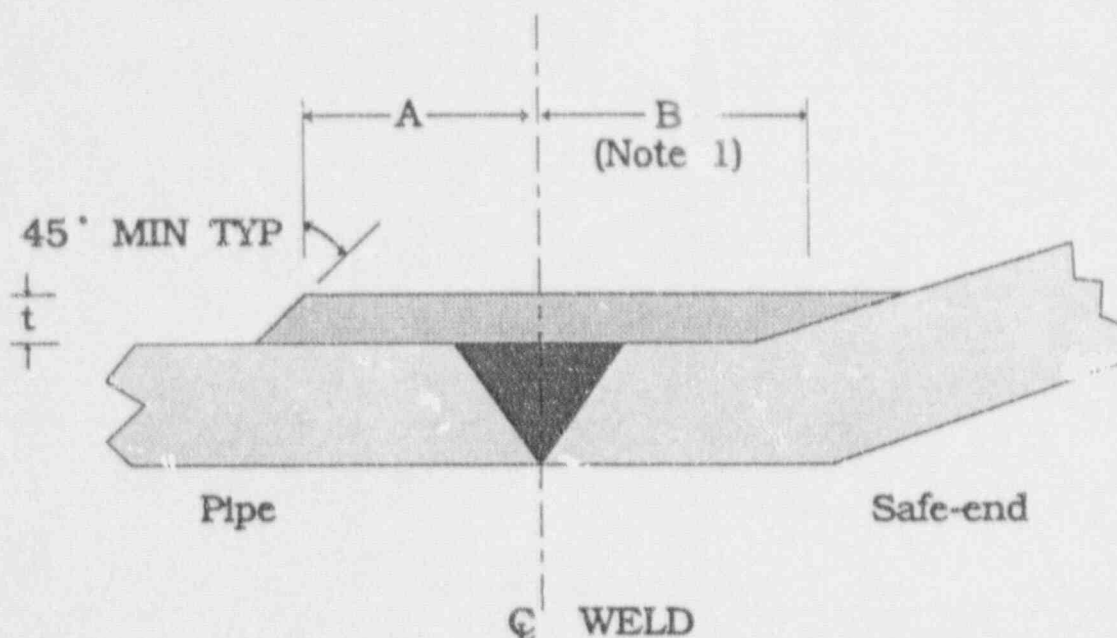
STRUCTURAL INTEGRITY ASSOCIATES, INC.
File No: GPCO-20Q-401			
Drawing No: GPCO-20Q-33	Title: Standard Weld Overlay Design		Sheet <u>2</u> of <u>2</u>

WELD NUMBER	FLAW CHARACTERIZATION	DESIGN DIMENSIONS			COMMENTS
		t	A	B	
RC-12BR-E4	Assumed 360° Circ. 100% throughwall flaw	0.27"	2.0"	NA	
1	Hand 10/23/91	Hand 10/25/91	Hand 10/25/91		Revised to show safe-end transition
0	Hand 6/18/91	Hand 6/18/91	Hand 6/18/91		
Revision	Prepared by/ Date	Checked by/ Date	Approved by/ Date	COMMENTS	
Job No: GPCO-20Q		Plant/Unit

1. Blend repair into transition.
2. Weld overlay wire is to be type ER308L, with as-deposited delta ferrite content greater than 7.5 FN.
3. Component surface is to be examined by dye penetrant method and accepted as clean prior to overlay application in order to include the entire deposited overlay thickness in meeting the design thickness requirement, per NUREG-0313, Revision 2.

5. First weld layer is to have a measured delta ferrite content greater than 7.5 FN. This requirement does not apply to the final layer.
6. Design thickness includes no allowance for surface conditioning operations to facilitate UT inspections.

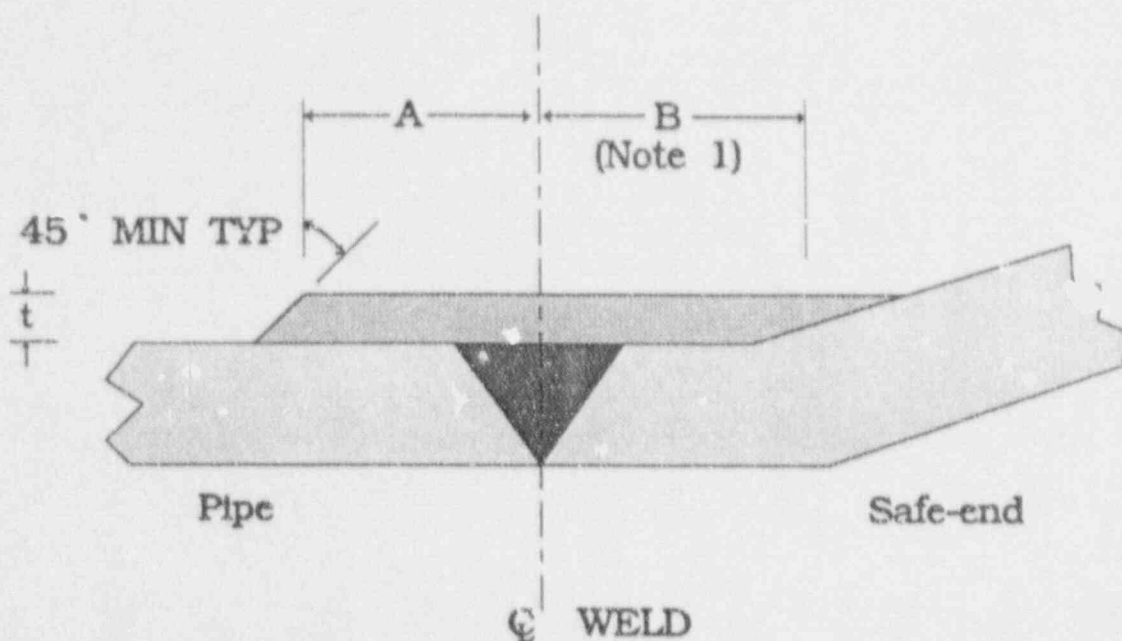
WELD NUMBER	FLAW CHARACTERIZATION	DESIGN DIMENSIONS			COMMENTS
		t	A	B	
1B31-1RC-12BR-A4	Assumed 360° Circ. 100% through-wall flaw	0.27"	2.0"	NA	
1	NLD 10/23/91	QJZ 10/23/91	QJZ 10/23/91		Revised to show safe-end transition
0	NLD 6/18/91	QJZ 6/18/91	QJZ 6/18/91		
Revision	Prepared by/ Date	Checked by/ Date	Approved by/ Date	COMMENTS	
Job No: GPCO-20Q		Plant/Unit Georgia Power Company Plant Hatch Unit 1

1. Blend repair into transition.
2. Weld overlay wire is to be type ER308L, with as-deposited delta ferrite content greater than 7.5 FN.
3. Component surface is to be examined by dye penetrant method and accepted as clean prior to overlay application in order to include the entire deposited overlay thickness in meeting the design thickness requirement, per NUREG-0313, Revision 2.

5. First weld layer is to have a measured delta ferrite content greater than 7.5 FN. This requirement does not apply to the final layer.
6. Design thickness includes no allowance for surface conditioning operations to facilitate UT inspections.

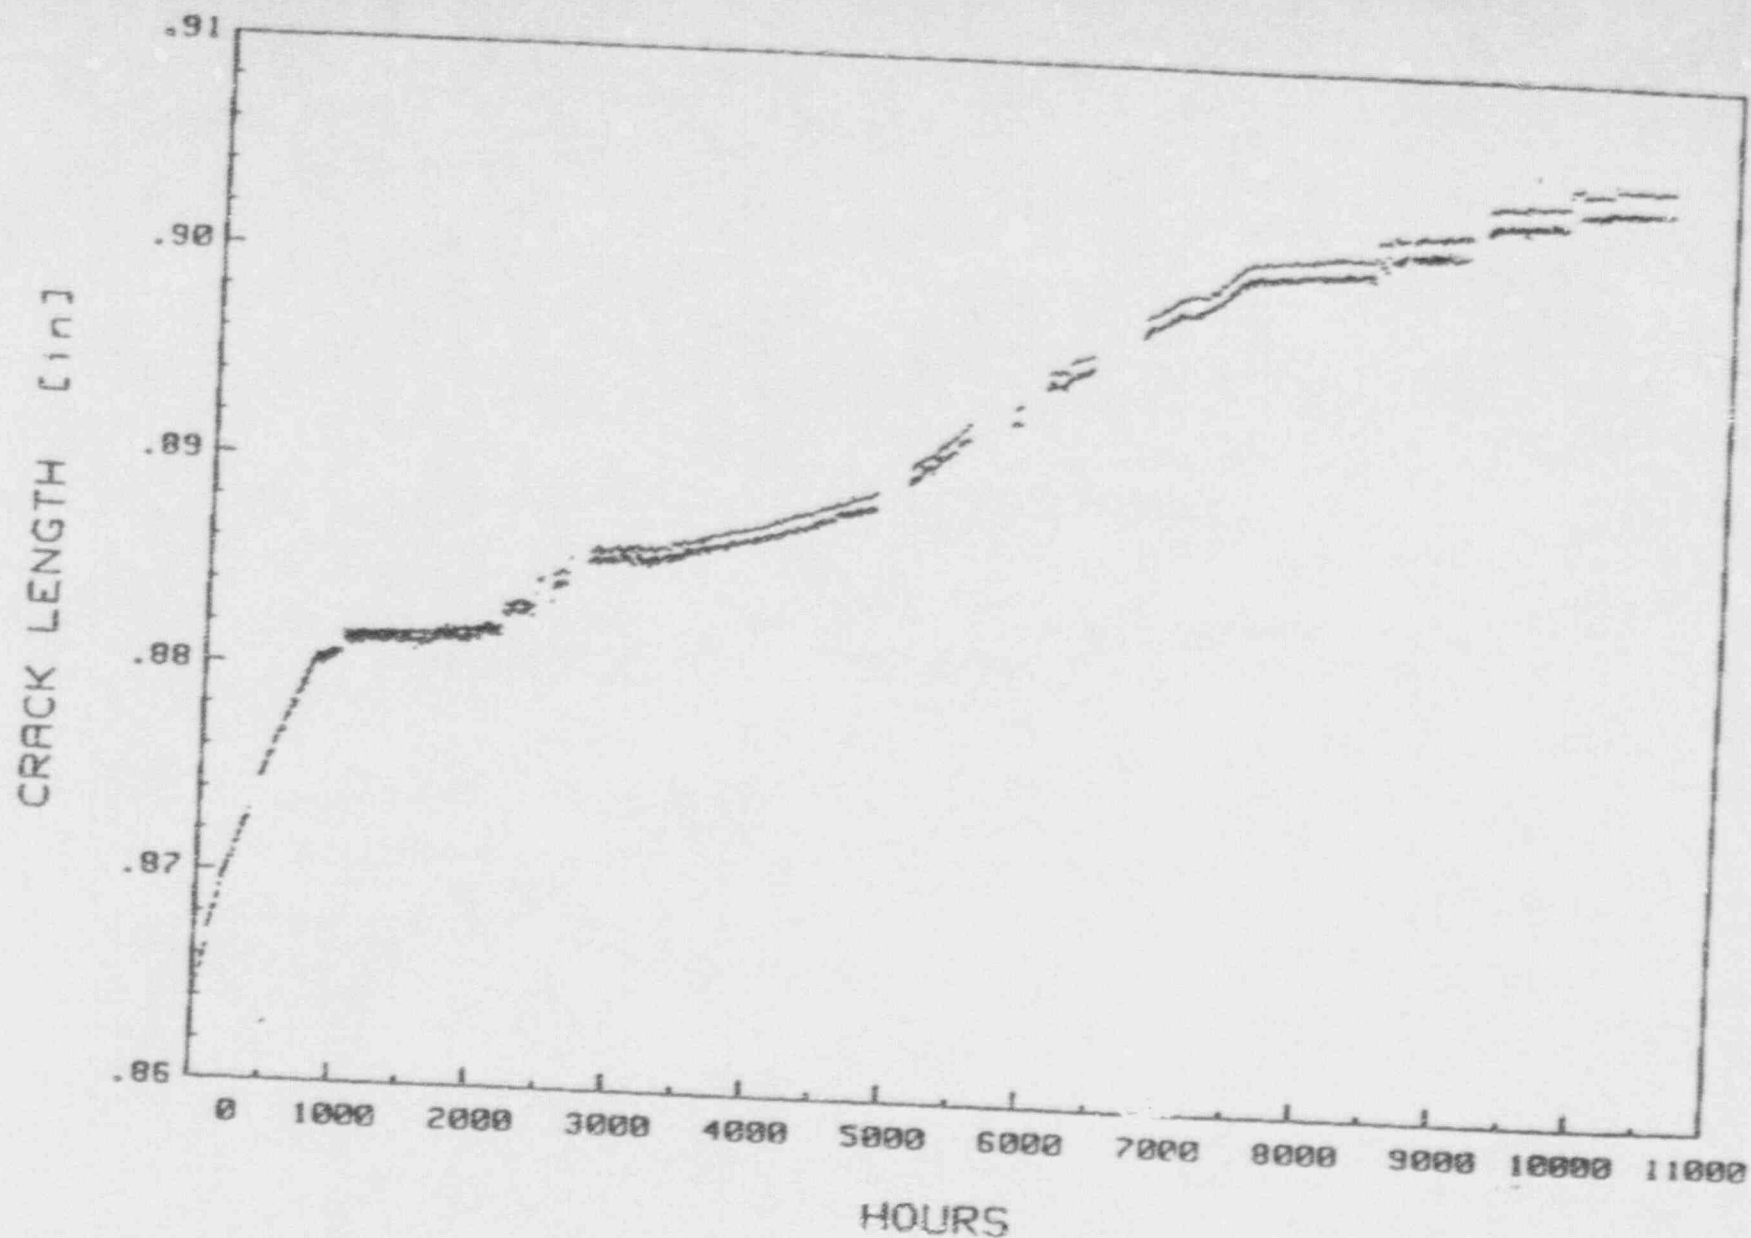
Figure 1. Plant Hatch Unit 1 CAV, Crack Length Versus Time Data, Fuel Cycle 13, Alloy 182, Specimen IMC-76, Stress Intensity 25 ksi/in.

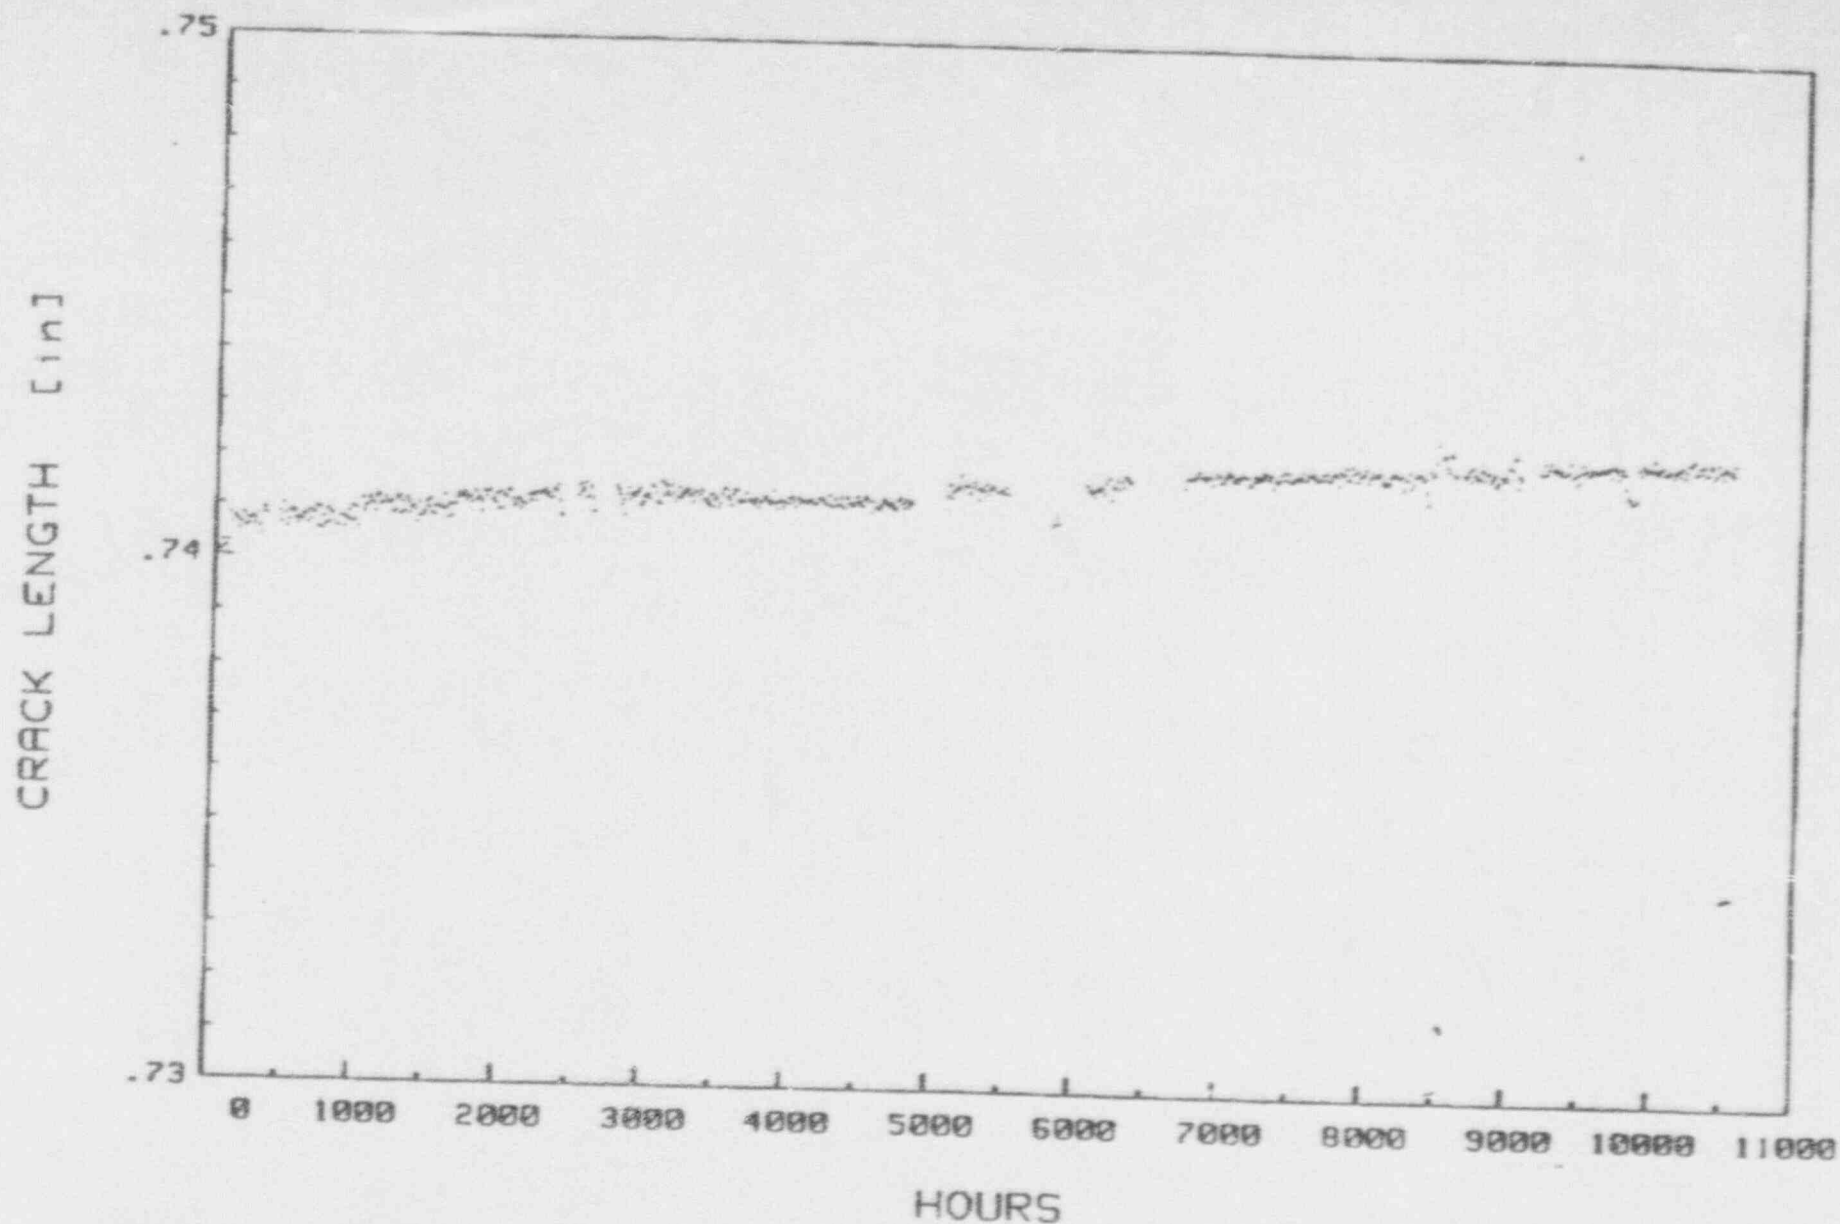
Figure 2. Plant Hatch Unit 1 CAV, Crack Length Versus Time Data, Fuel Cycle 13, Type 304 Stainless Steel (sensitized), Specimen SS-144, Stress Intensity 20 ksi/in.

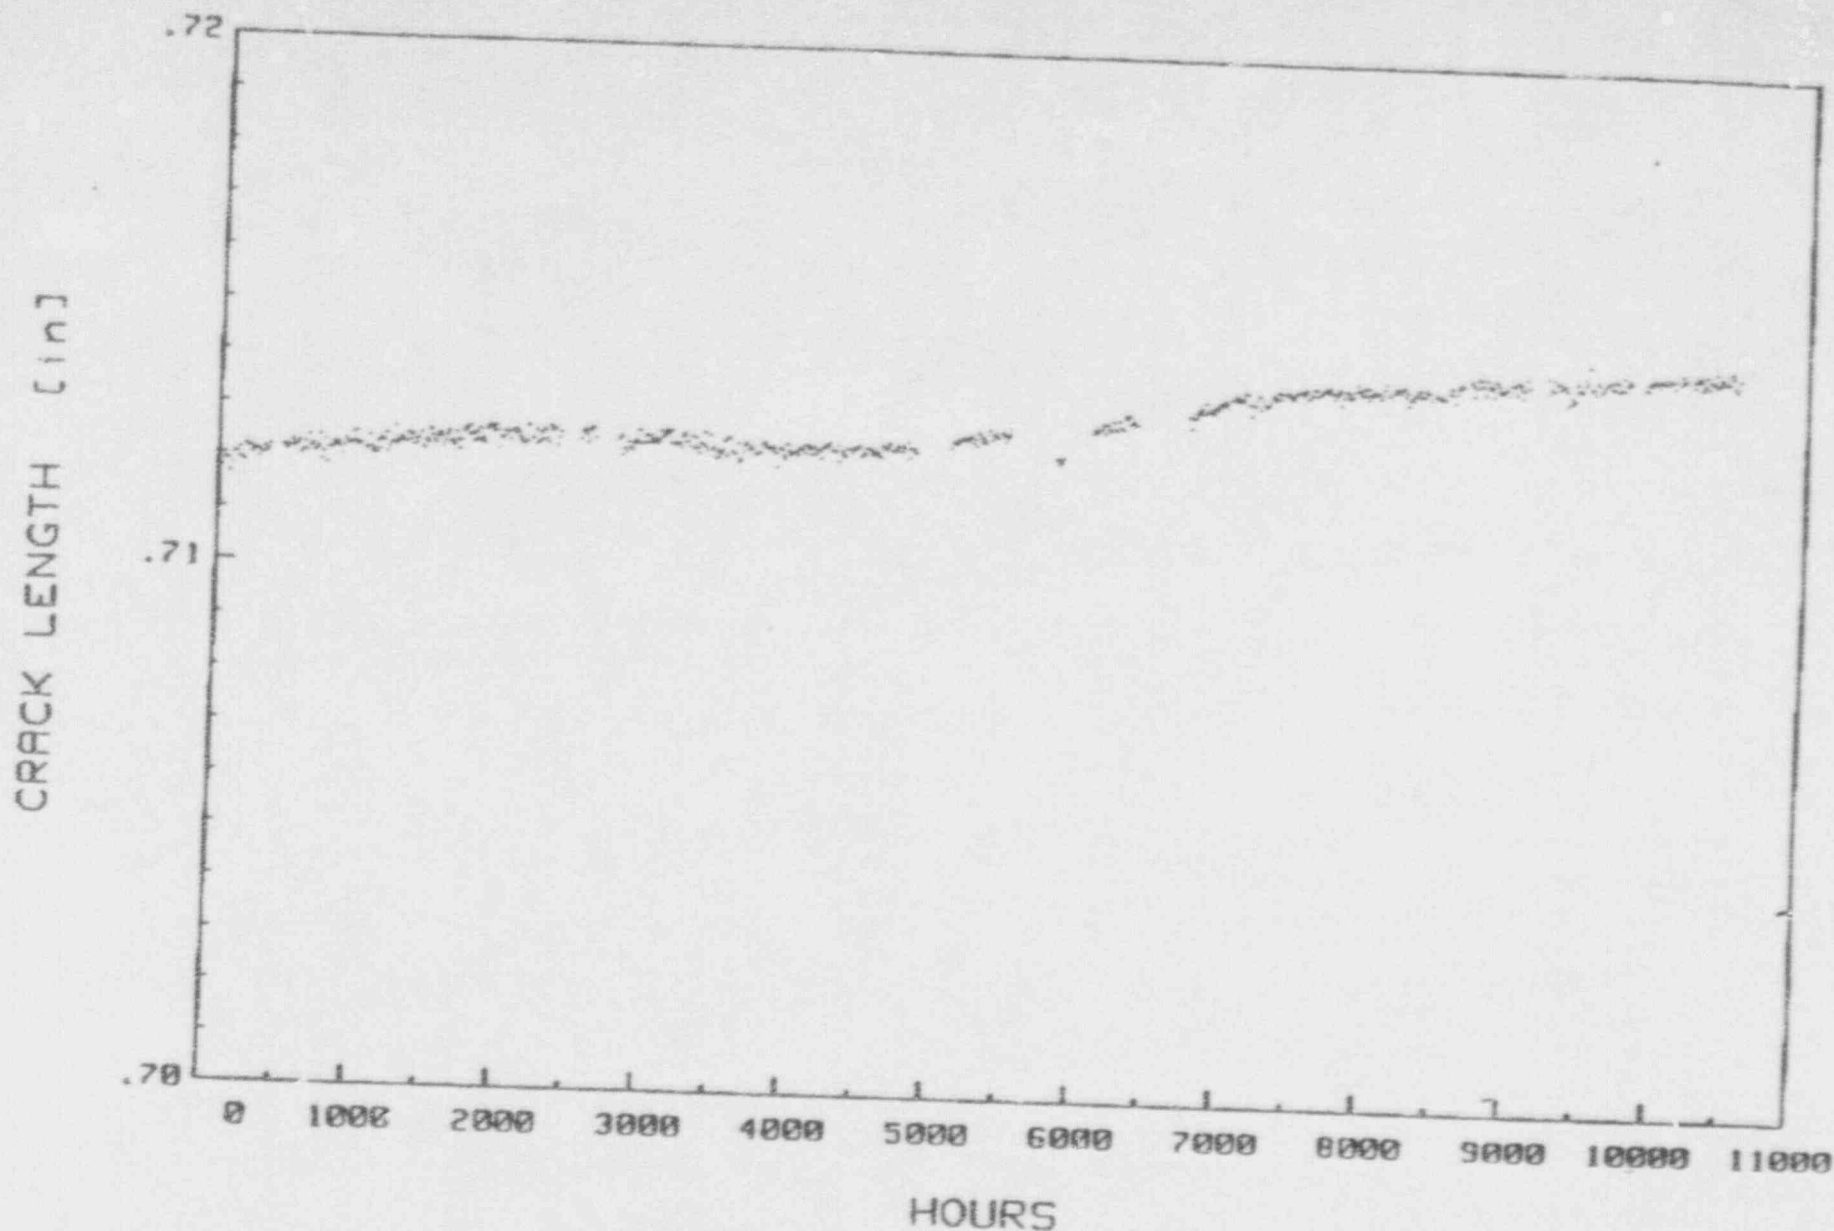
Figure 3. Plant Hatch Unit 1 CAV, Crack Length Versus Time Data, Fuel Cycle 13, Type 316NG Stainless Steel, Specimen SS-126, Stress Intensity 20 ksi/in.

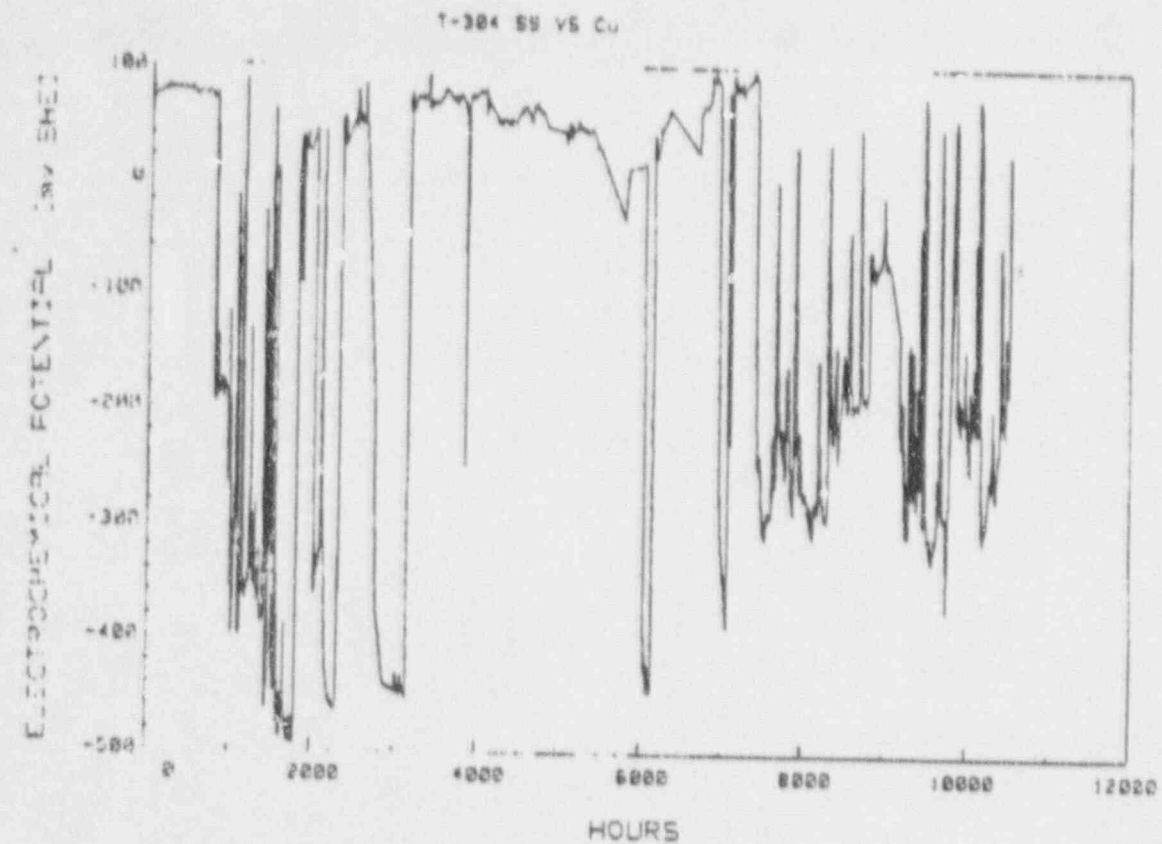
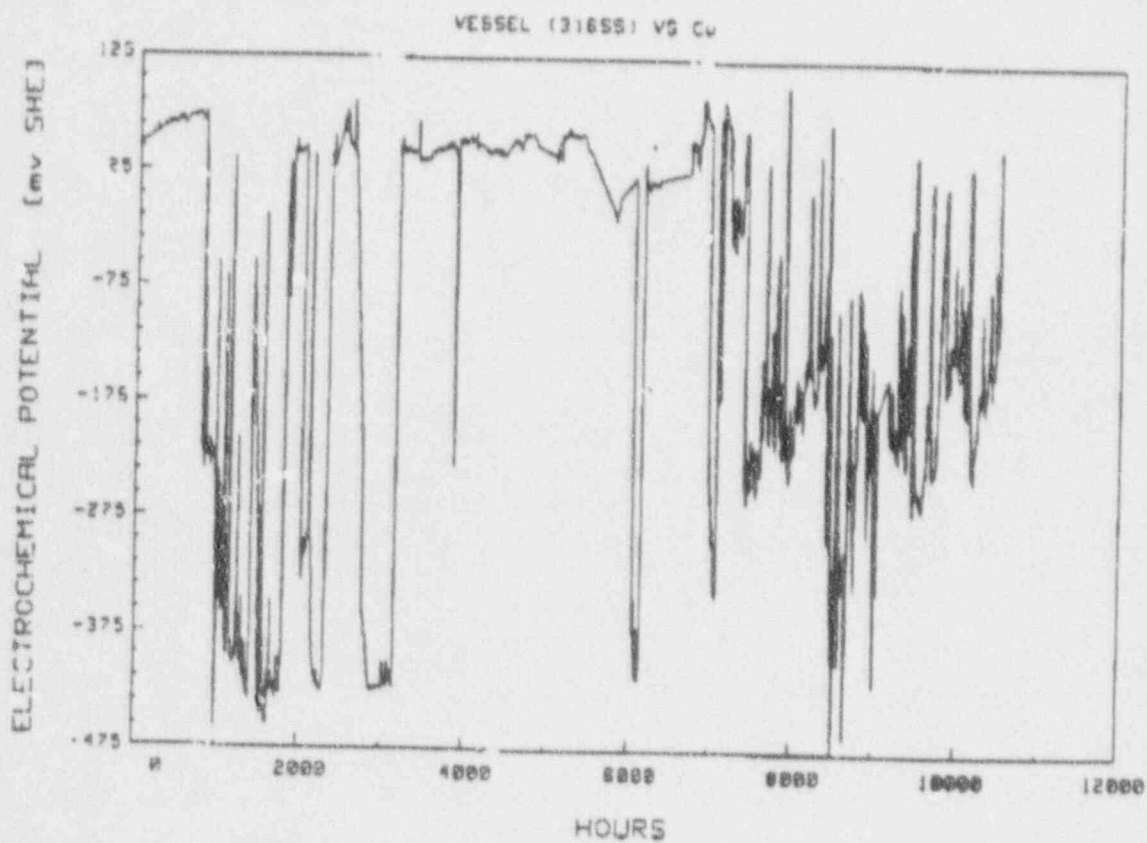
Figure 4. Plant Hatch Unit 1 CAV, Electrochemical Potential (ECP) Data, Fuel Cycle 13.

The water chemistry records at Hatch Unit 1 were reviewed to determine the water quality during operating cycle 13 as well as the effectiveness of the hydrogen injection system. The ECP was obtained in the crack arrest verification system (CAVS) autoclave. The CAVS results revealed that the HWC system was on and produced full protection for approximately 41% of the time at power. During the remaining 59% of the time the system was either partially protective or not protective. The total time in which no protection was observed was approximately 47% of the time at temperature and pressure. No investigation was performed to ascertain why the system was providing no protection during this period of time during the cycle. However, it is noteworthy that for approximately 4500 hours during

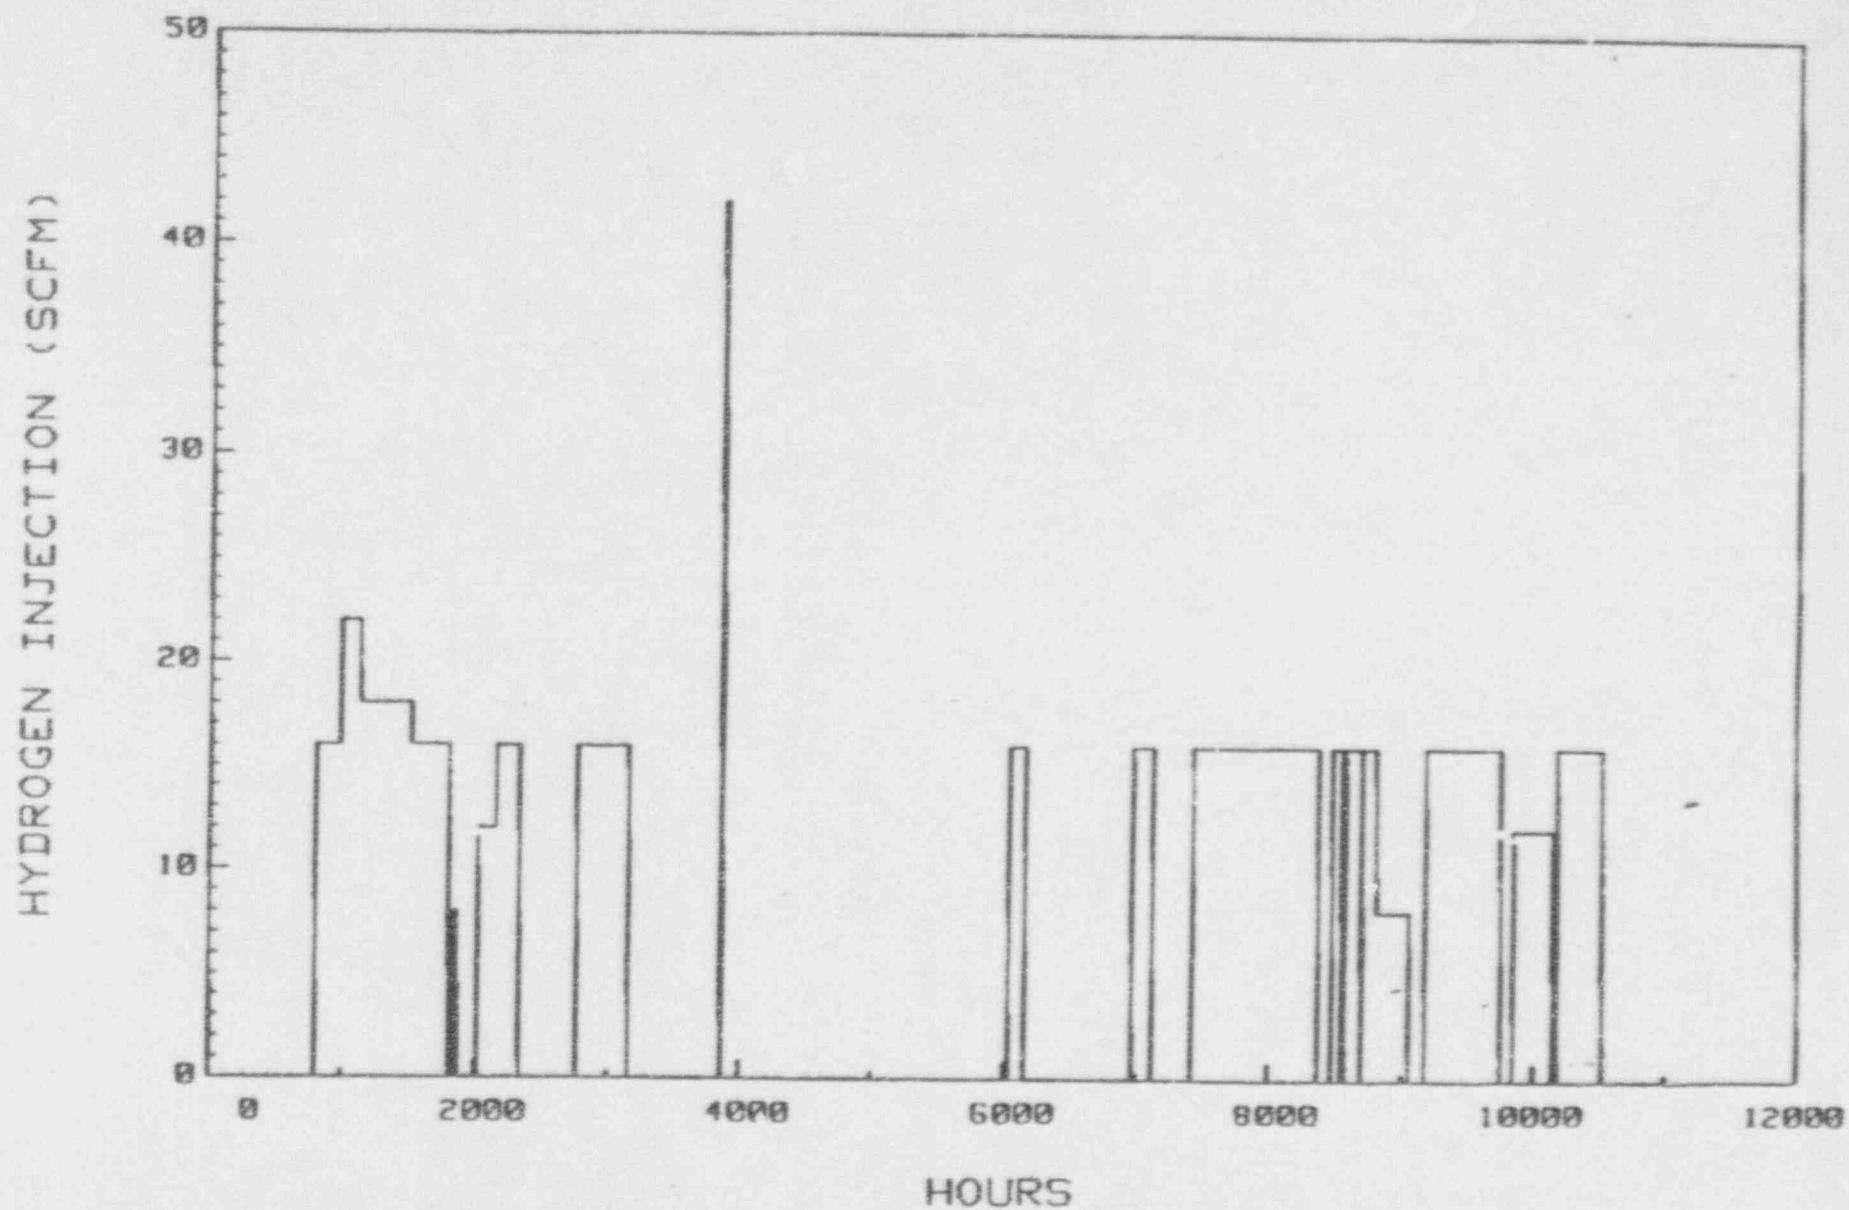
Figure 5. Plant Hatch Unit 1, Hydrogen Addition Rates, Fuel Cycle 13.
