Report No.: SIR-91-077
Revision No.: 2
Project No.: GPCO-20Q-2
January 1992

IGSCC Flaw Evaluations and Weld Overlay
Activities During the E. I. Hatch Unit 1
Fall 1991 Outage

Prepared for:
Georgia Power Company

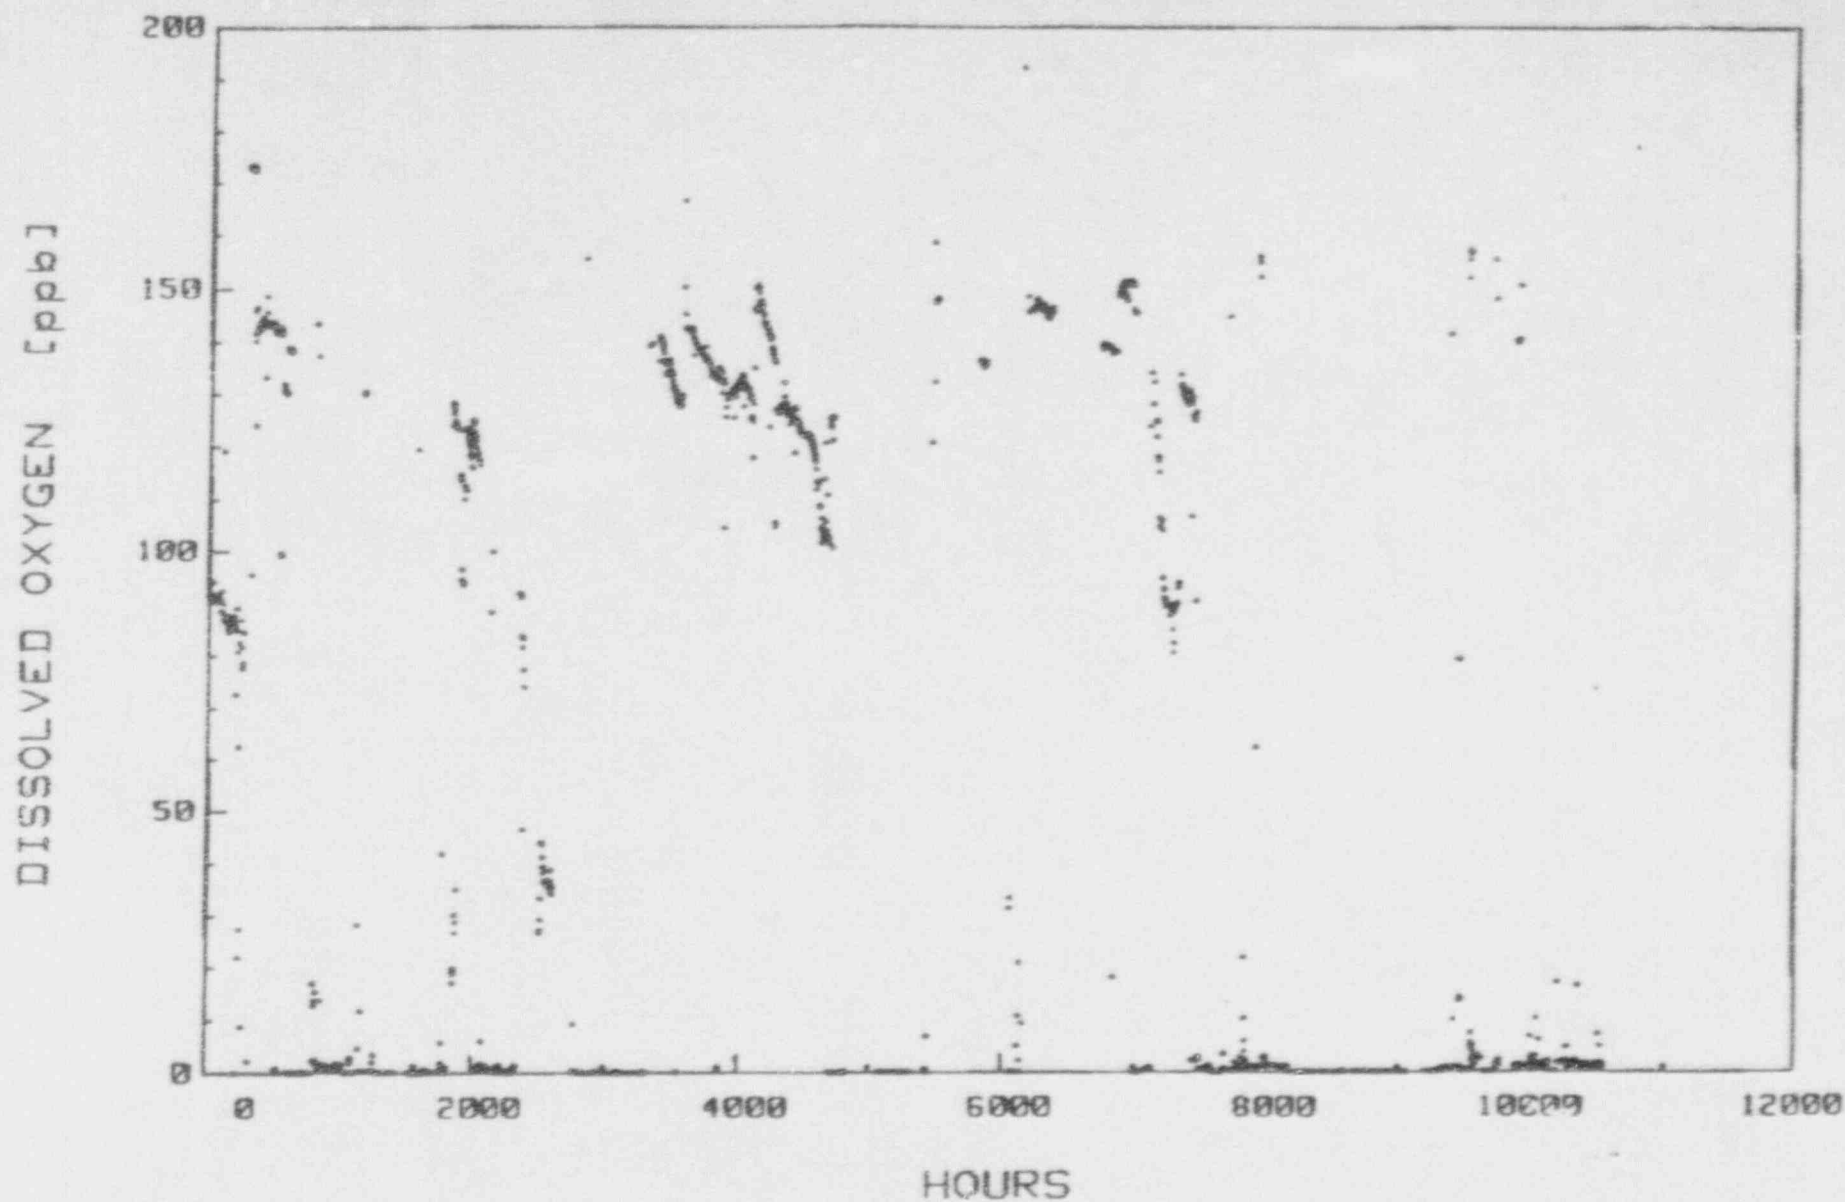
Figure 6. Plant Hatch Unit 1 CAV, Dissolved Oxygen Data, Fuel Cycle 13

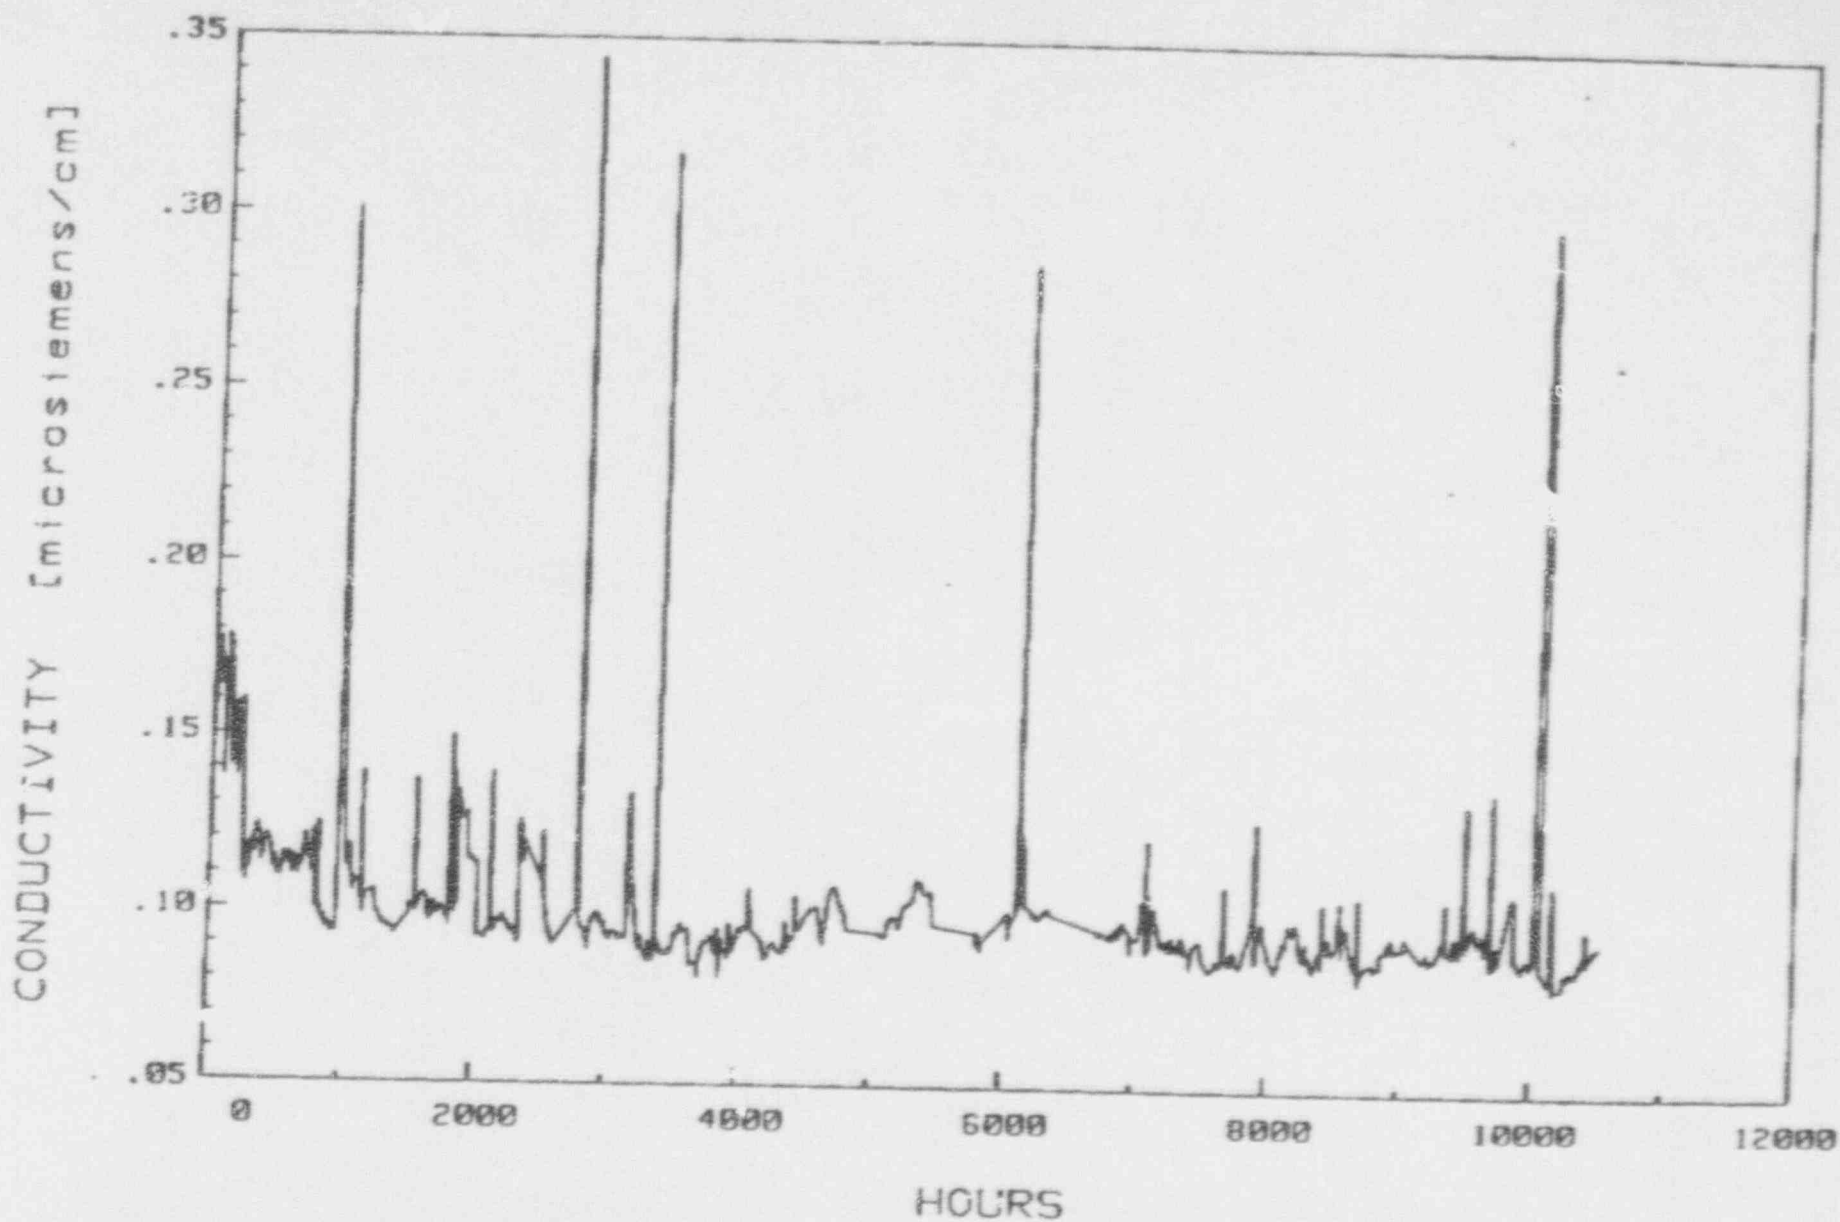
Figure 7. Plant Hatch Unit 1 CAV, Conductivity Data, Fuel Cycle 13.

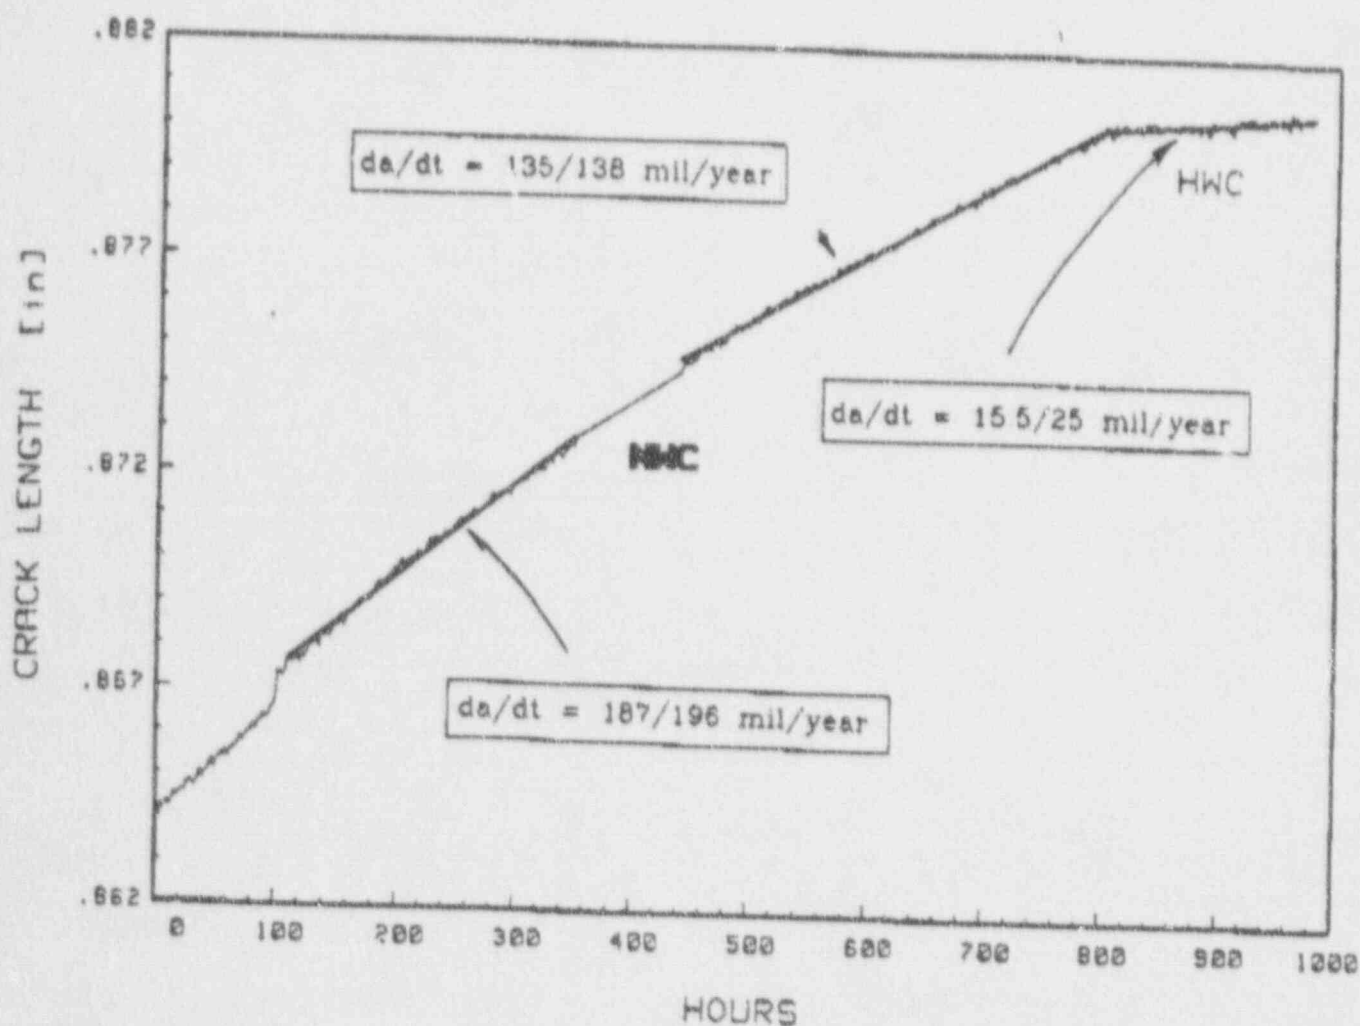
Figure 8. Plant Hatch Unit 1 CAV, Expanded View of Alloy 182 Crack Length Versus Time Data For Initial Application of Hydrogen Water Chemistry.

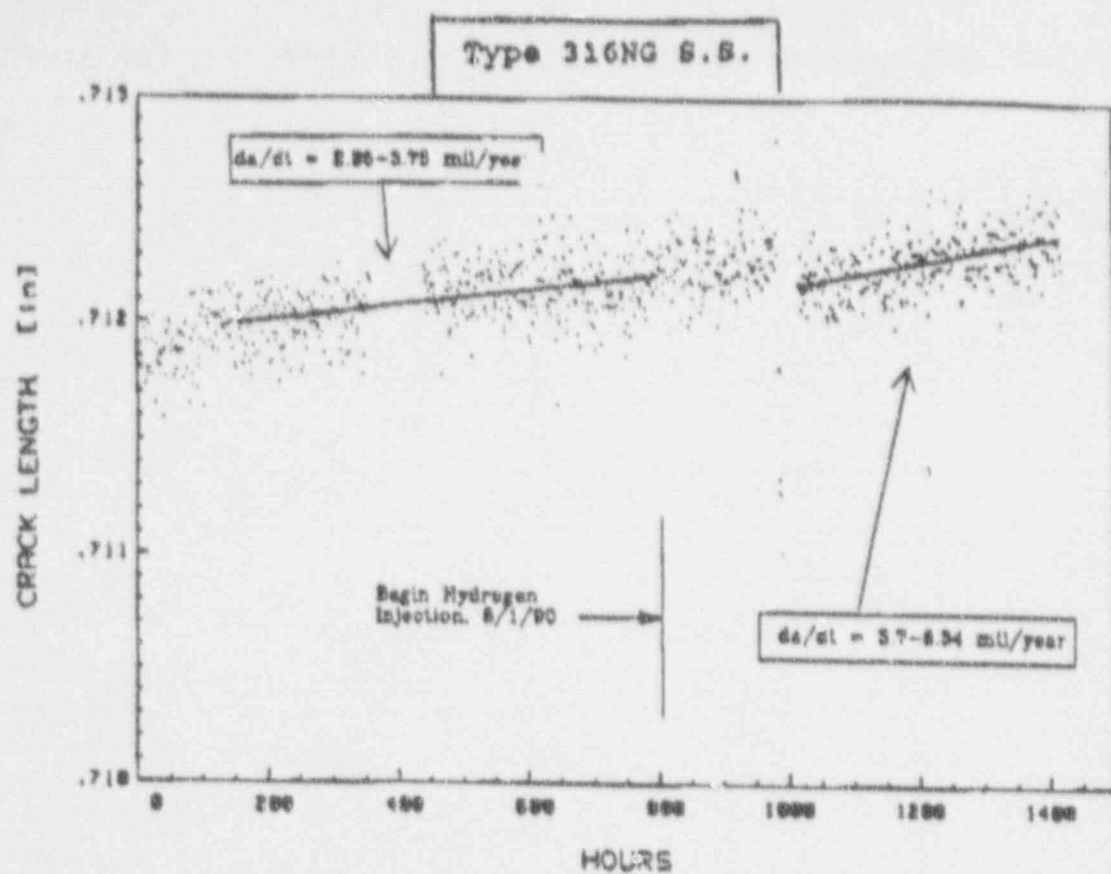
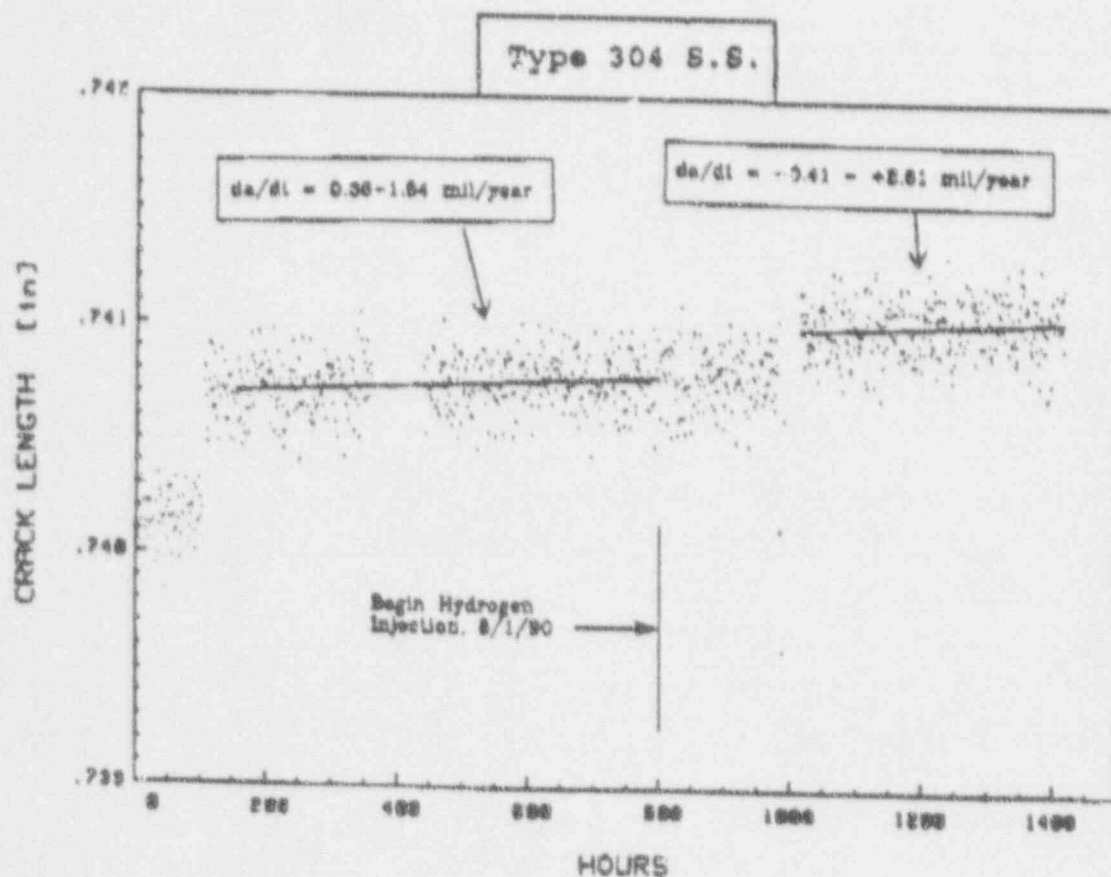
Figure 9. Plant Hatch Unit 1 CAV, Expanded View of Type 304 and 316NG Stainless Steel Crack Length Versus Time Data For Initial Application of Hydrogen Water Chemistry.

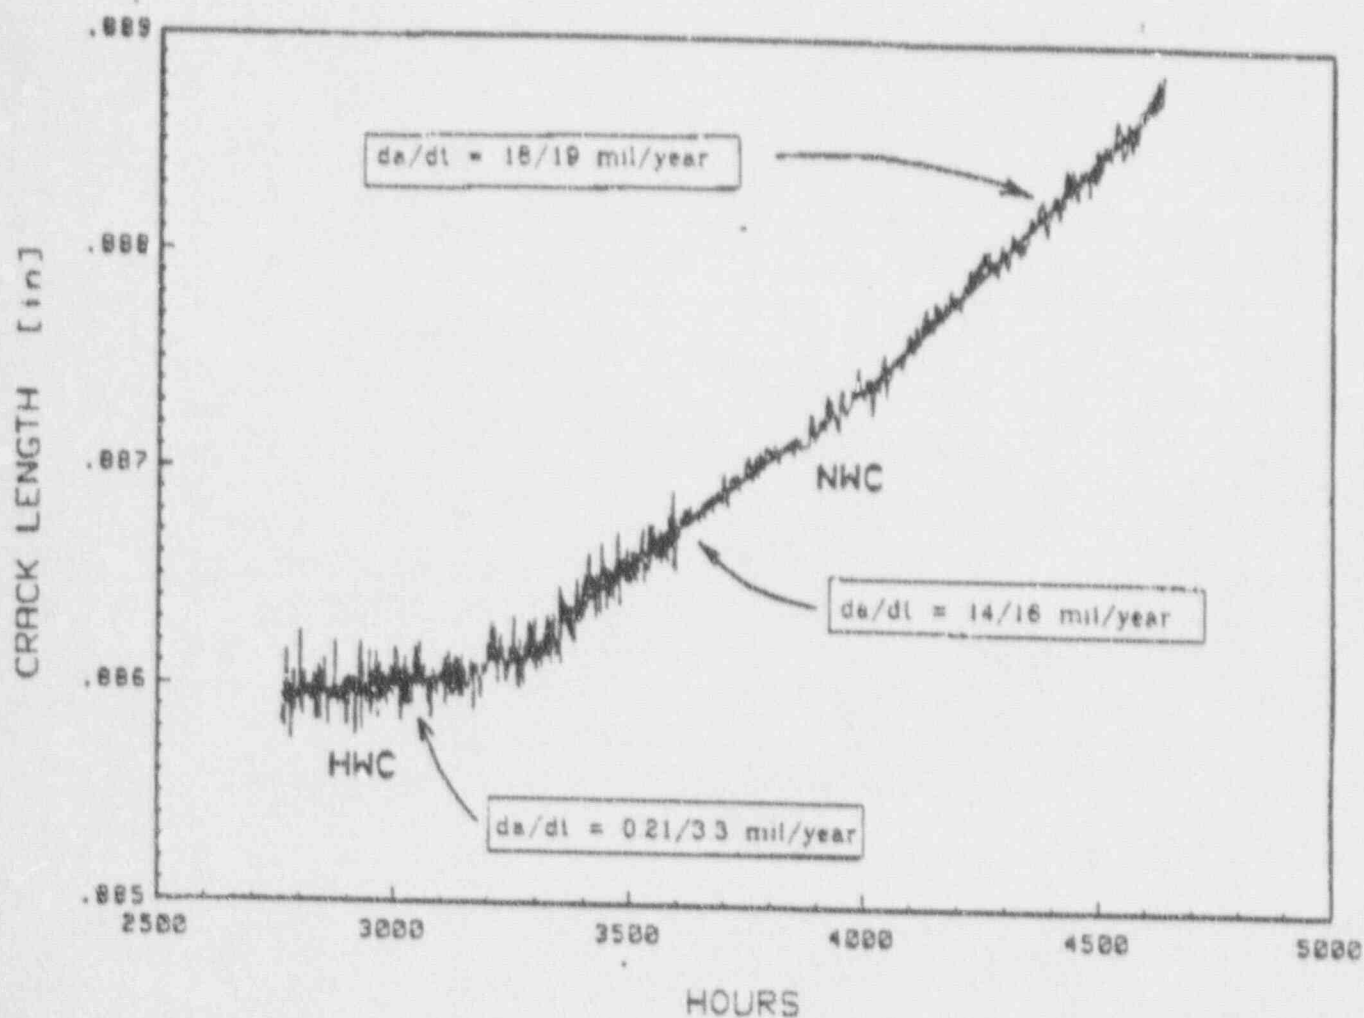
Figure 10. Plant Hatch Unit 1 CAV, Expanded View of Alloy 182 Crack Length Versus Time Data For Time Period After Resumption of Normal Water Chemistry, October/November 1990.

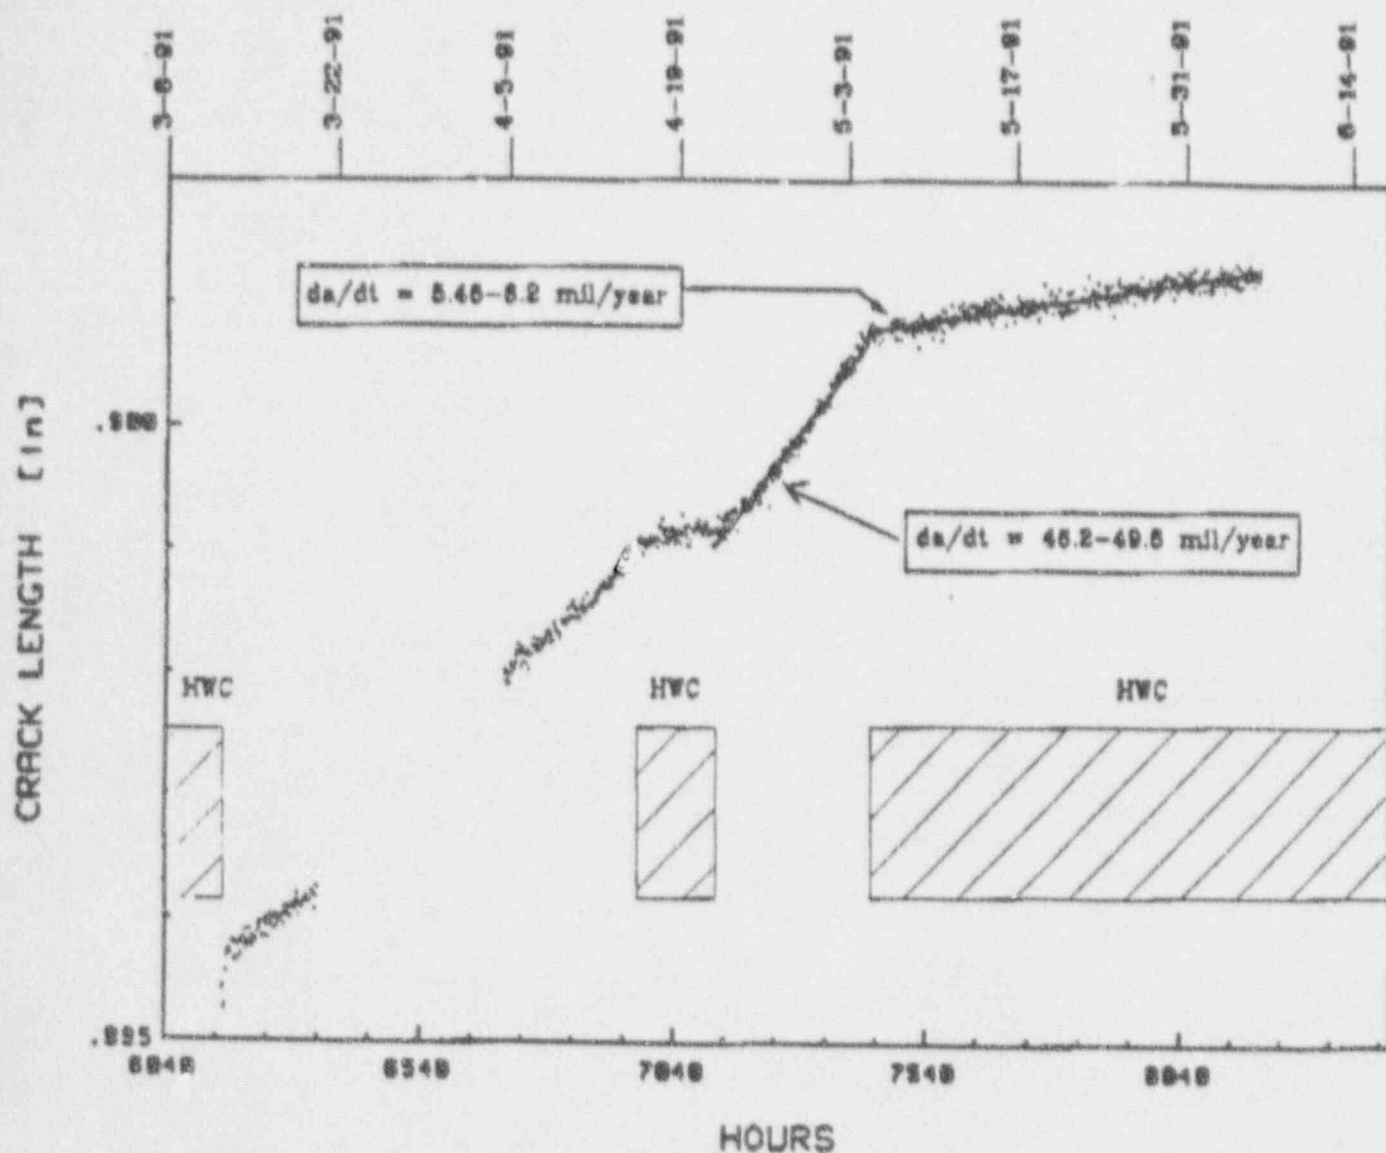
Figure 11. Plant Hatch Unit 1 CAV, Expanded View of Alloy 182 Crack Length Versus Time Data For Time Period After Resumption of Normal Water Chemistry, March/June 1991.

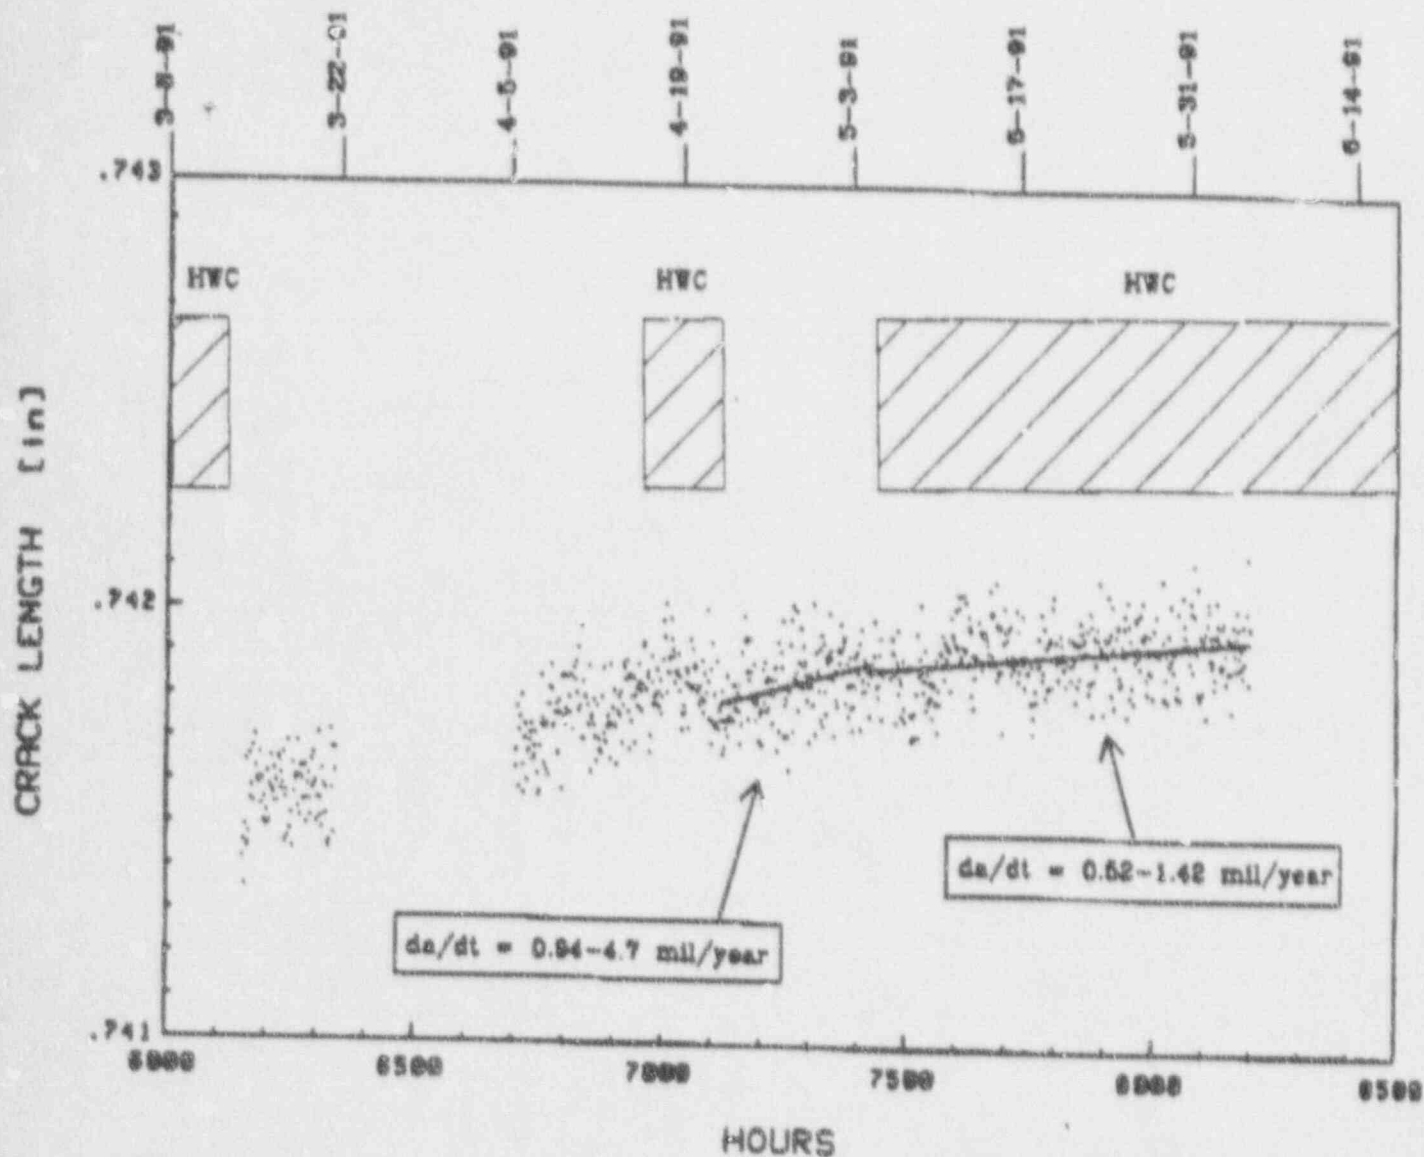
Figure 12. Plant Hatch Unit 1 CAV, Expanded View of Type 304 Stainless Steel Crack Length Versus Time Data For Time Period After Resumption of Normal Water Chemistry, March/June 1991.

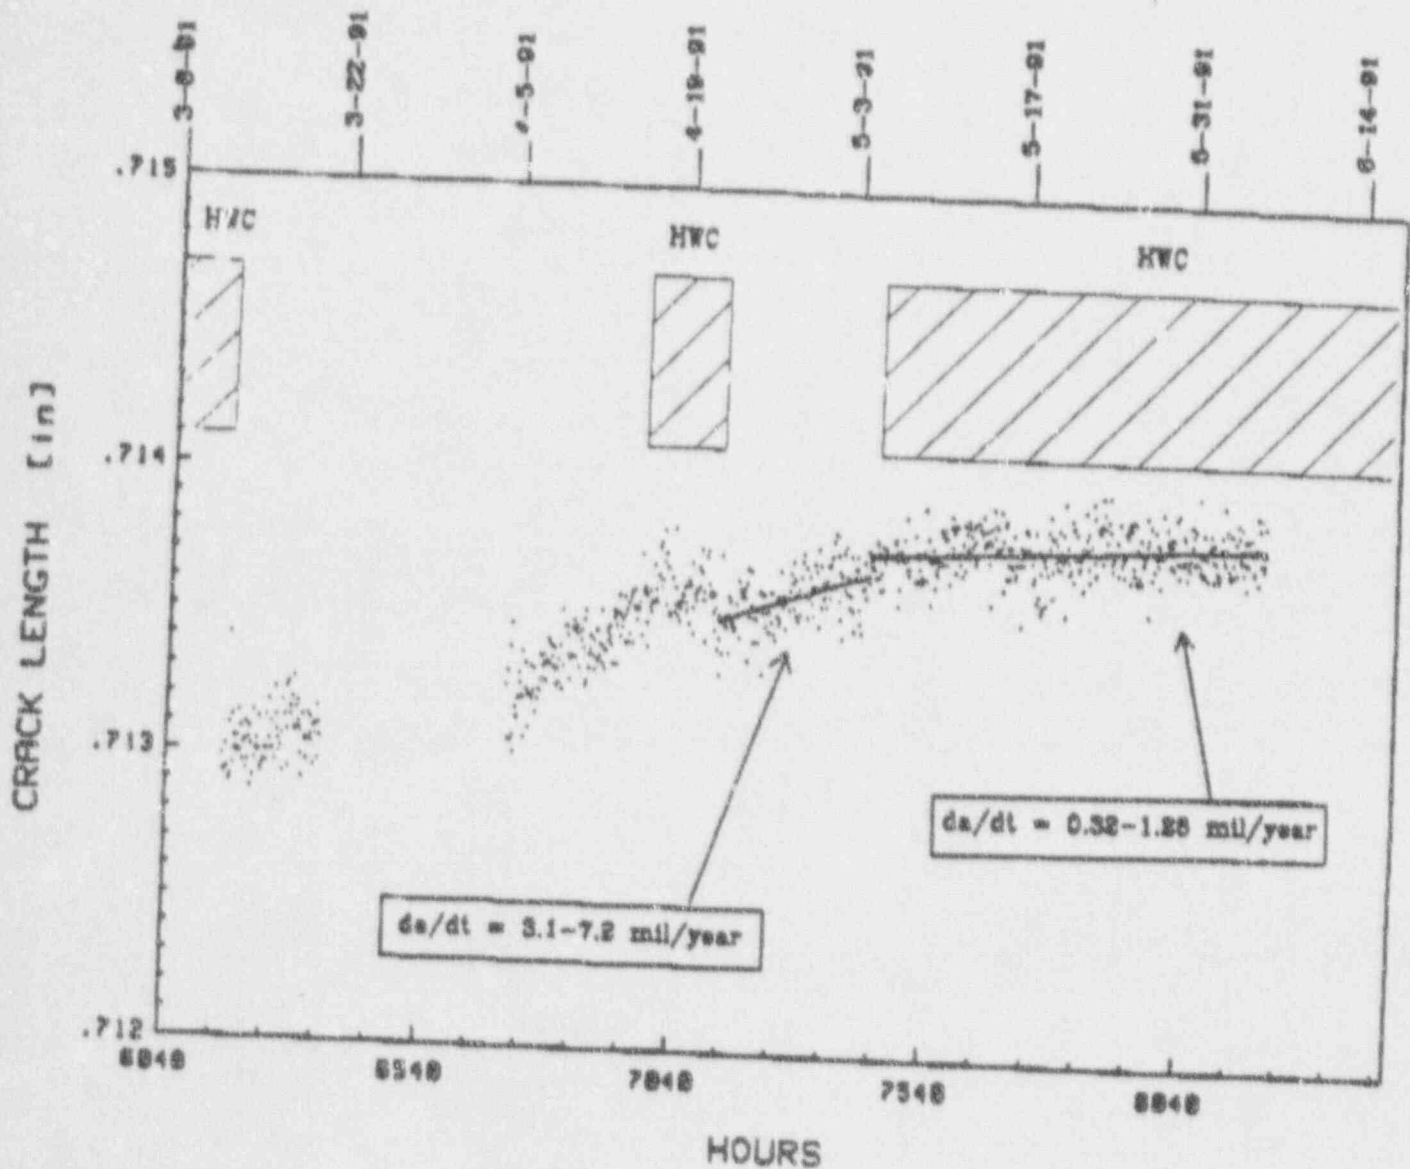
Figure 13. Plant Hatch Unit 1 CAV, Expanded View of Type 316NG Stainless Steel Crack Length Versus Time Data For Time Period After Resumption of Normal Water Chemistry, March/June 1991.
