INVESTIGATION OF TYPES AF AND AE PISTON SKIRTS

Prepared by
Failure Analysis Associates

Prepared for
TDI Diesel Generator Owners Group

May 23, 1984

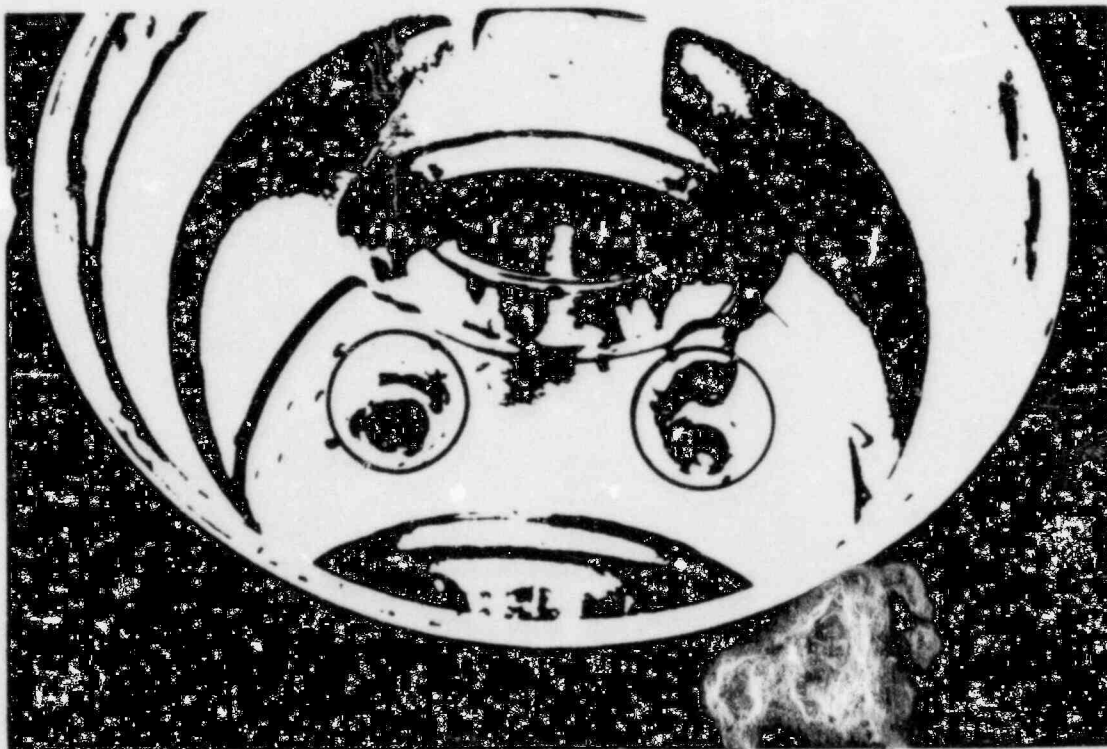
Figure 2-2. Interior of an AF-type piston skirt. The white coating and red dye are from the dye penetrant examination. Through holes for the crown studs and spot-faced boss are circled.

Figure 2-1 is a photograph of one of the modified AF-type piston skirts after disassembly from the crown. The interior of a piston skirt is shown in Figure 2-2. The white color is from the dye-penetrant test. The spot-faced bosses are shown in Figures 2-3 and 2-4. A linear indication of red dye from the dye penetrant test is seeping out of a suspected crack as shown in Figure

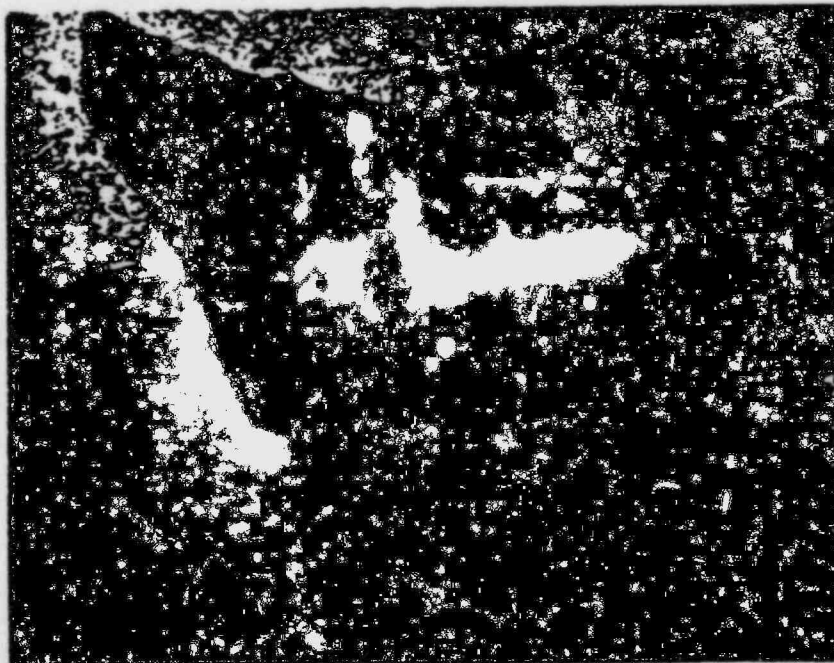
Figure 2-8. Macrophotograph of a pre-existing crack cut out of EDG #103, No. 7 cylinder piston skirt and fractured open. This low magnification photograph shows both of the mating fracture surfaces after the ridge segment was opened.

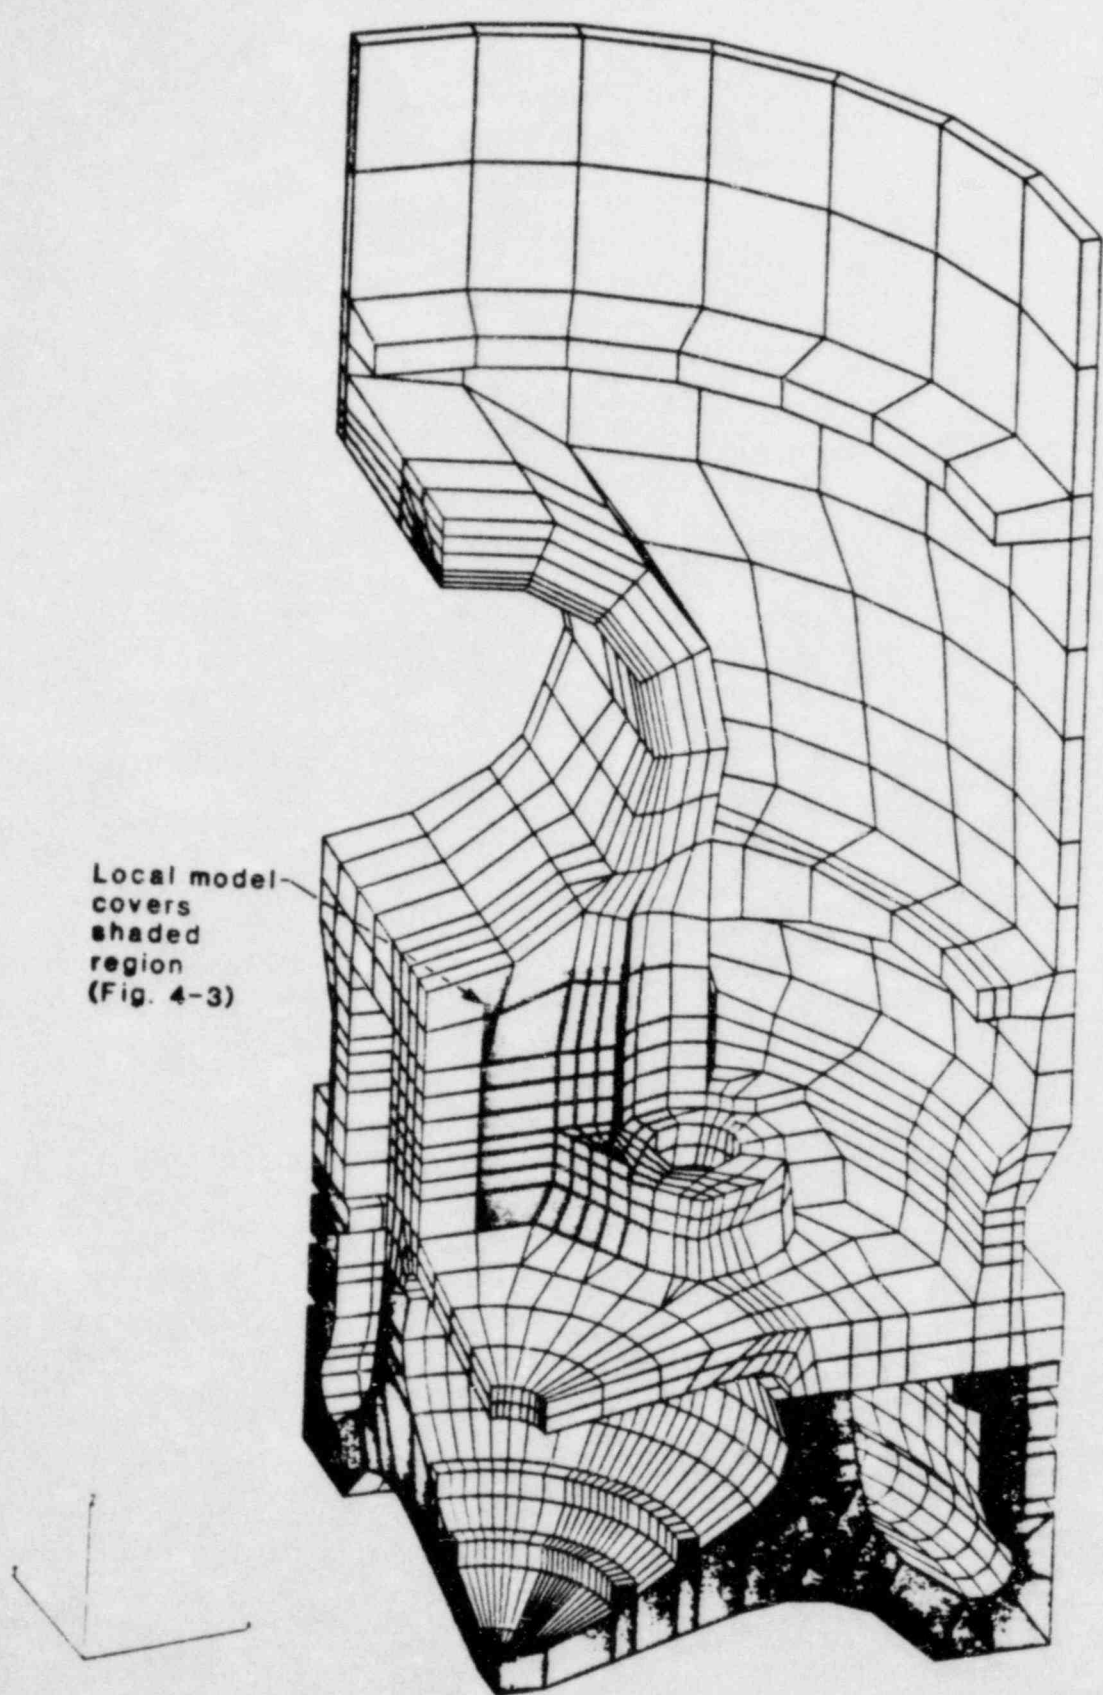
Local model
covers
shaded
region
(Fig. 4-3)

Figure 4-2. AE piston skirt global model with crown.

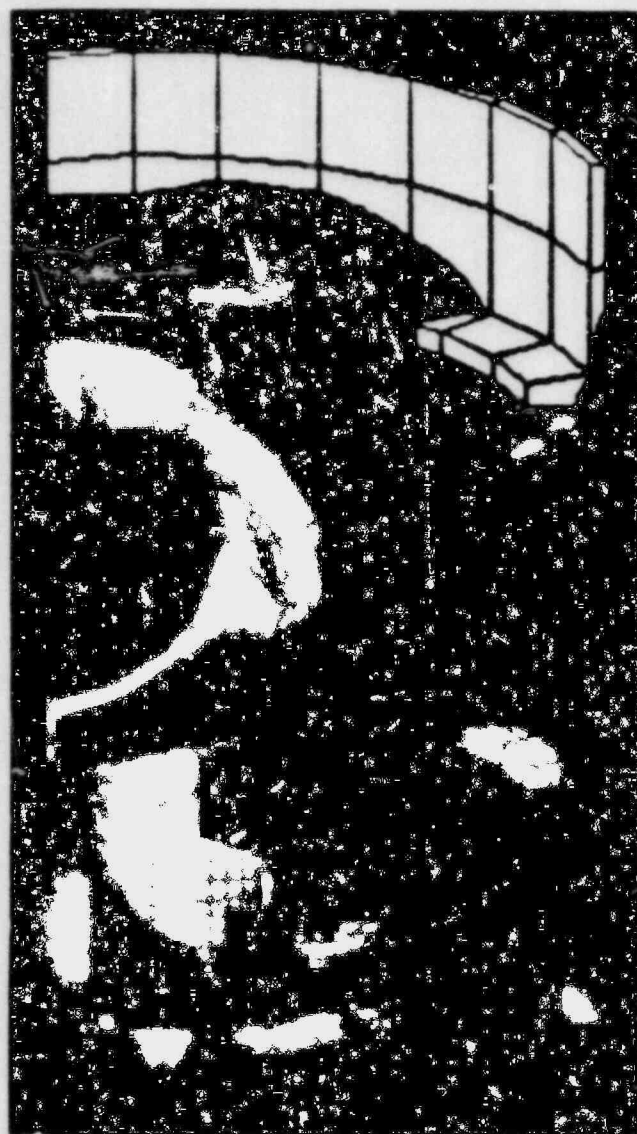
Figure 4-4. Al piston skirt global model with stress contour of average element (σ_{III}) stresses for a skirt with a pressurized crown and no loading on the outer ring.

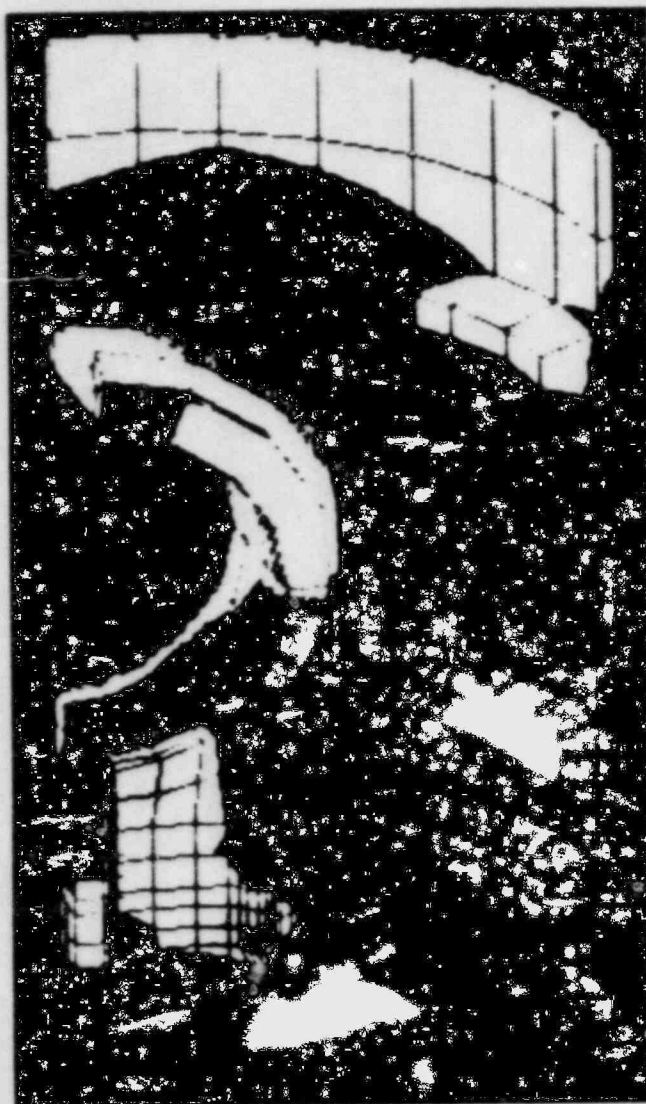
Figure 4-8. Al piston skirt global model with stress contour of average element (σ_{III}) stresses for a skirt with a pressurized crown and no loading on the outer ring.
