Subj: Additional Information regarding Commonwealth Edison Company's
Response to Questions Regarding the Increase in the
Interim Plugging Criteria for
Byron Unit 1 and Braidwood Unit 1
NRC Docket Numbers: 50-454 and 50-456

REQUEST FOR ADDITIONAL INFORMATION
REGARDING THE PROPOSED REVISIONS TO THE TECHNICAL SPECIFICATIONS
RELATED TO THE STEAM GENERATOR TUBE VOLTAGE-BASED REPAIR CRITERIA
BYRON, UNIT 1, AND BRAIDWOOD, UNIT 1
DOCKET NOS. STN 50-454 AND STN 40-456

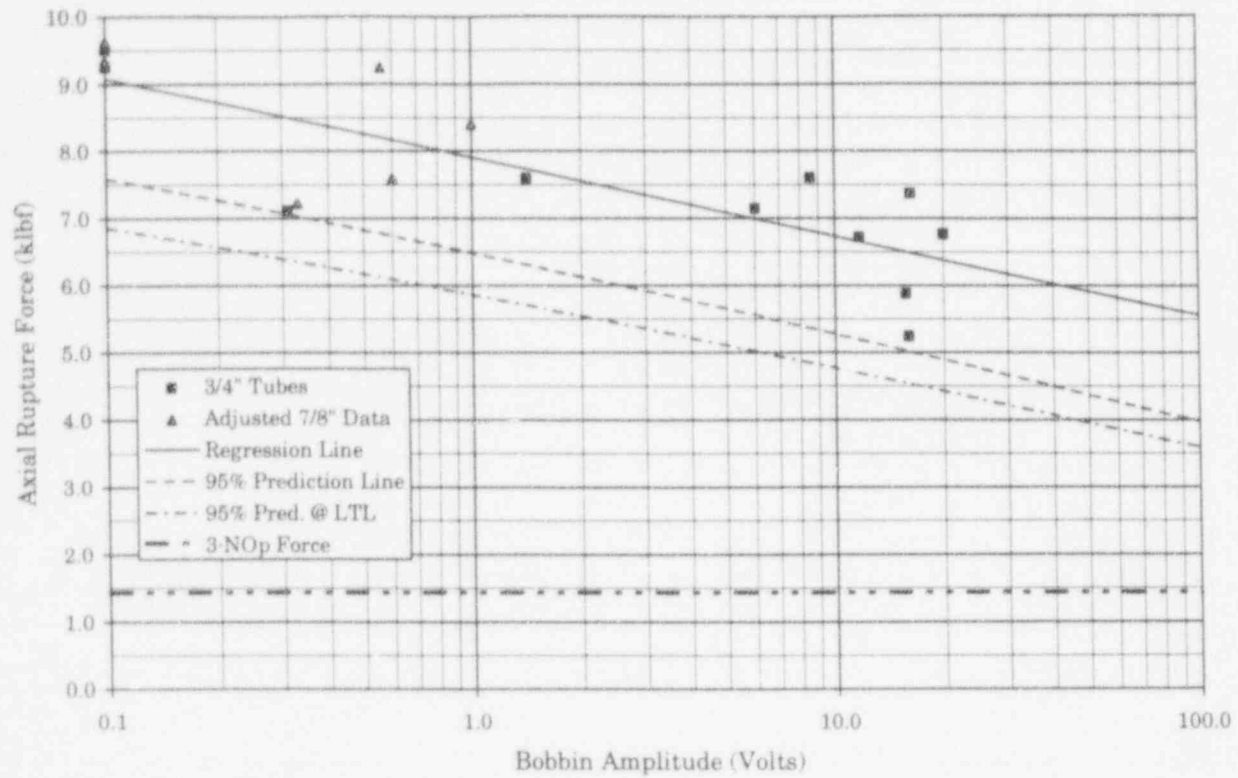
Figure 54-1: Axial Rupture Force vs. Bobbin Amplitude
 Data Adjusted to 3/4" x 0.043" SG Alloy 600 MA Tubes, $S_r = 75$ ksi

As noted previously, the correlation of the remaining CSA *fraction* to the bobbin amplitude was found to be approximately independent of tube size. Hence, a correlation of the remaining CSA (i.e., area rather than fraction of undegraded area) to the bobbin amplitude would be dependent on tube size. This is also expected to be the case for a correlation of the axial rupture force to the bobbin amplitude. Thus, in order to consider a merged database, an adjustment of the data based on the tube CSA is needed. Intuitively, one would expect that a simple adjustment based on the non-degraded CSA could be valid since this is the type of adjustment to be made to correlate results for non-degraded tubes. Thus, the correlation of the axial rupture force divided by the undegraded area to the bobbin amplitude was investigated. This was done for this analysis by simply reducing the axial force data for 7/8" tubes by the ratio of the non-degraded area of a 3/4" tube to that of a 7/8" tube, i.e., the force results for 7/8" tubes were reduced by a factor of 0.737 to be representative of 3/4" tubes, and then correlating the axial rupture force to the bobbin amplitude for 3/4" diameter tubes. The basic assumption being made here is that the slope of the correlation of the rupture force to the bobbin amplitude is independent of volts. A visual examination of the resulting database, see Figure 54-1, confirmed the assumption as being reasonable.

The results of the regression analysis are provided in Table 54-3 and illustrated on Figure 54-1. In summary, the axial rupture force in thousands of pounds, klbs, can be reliably predicted from the bobbin amplitude as,

Using the above equation, a 95% one-sided prediction bound for the rupture force as a function of bobbin amplitude was calculated. The resulting curve was also adjusted to represent 95/95 lower tolerance limit (LTL) material properties. Both of these curves are also depicted on Figure 54-1. It is apparent that the structural limit obtained from this analysis approach is in excess of 100 volts.

Separate regression analyses were performed for the 3/4" and 7/8" databases (See Figures 54-4 and 54-5). The intercepts from these regression analyses were 7.824 and 10.776, respectively. Adjusting the 7/8" result by a factor of 0.737 results in an intercept of 7.942; which is very close to the result obtained for the 3/4" data. The slope for the 3/4" data was found to be -1.102; while that for the 7/8" data was -1.726. Since the database for the 7/8" tubes is rather small, four degraded tube results, the value of the slope obtained relative to that from the 3/4" data is not judged to be unreasonable. To verify this judgement, the pooled estimate of the variance of the residuals from the two regressions and the t statistic for the difference in the slopes were calculated. These were found to be 0.936 and 0.578, respectively. The probability of obtaining an absolute value of t greater than or equal to 0.578 for 13 DoFs is about 57%. Thus, the data do not contradict the assumption that the slope of the correlation could be considered to be independent of the tube size, i.e., there is no indication that merging the data based only on an adjustment of the rupture force, which is independent of voltage, is not justified. Although the upper prediction bound is not shown on Figure 54-1, all of the data fall within the a two-sided 90% prediction band.

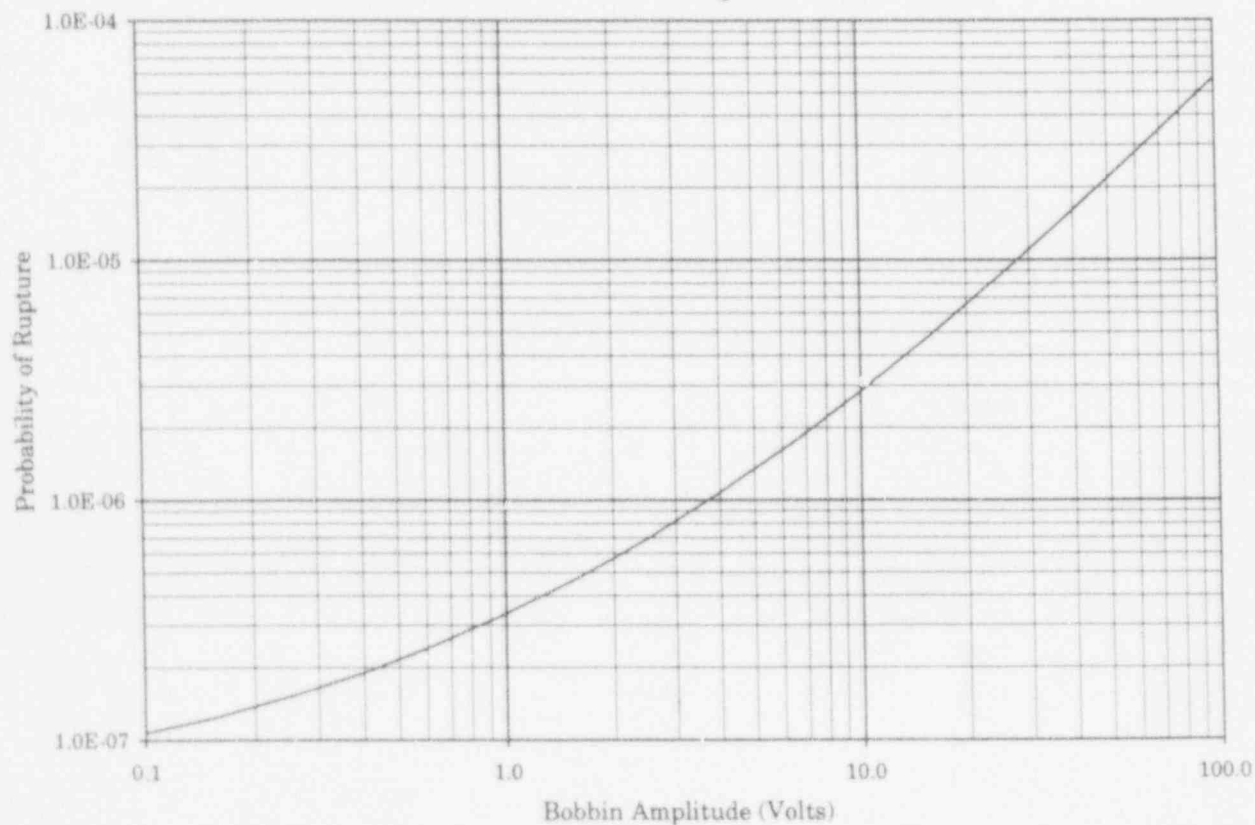
Figure 54-6: Probability of Rupture vs. Bobbin Amplitude
TSP ODSCC for 3/4" x 0.043" Alloy 600 MA SG Tubes

Using the results of the regression analyses, the probability of rupture (PoR) of an individual indication was estimated using the methodology described in Section 5 of Reference 2, which includes the effect of the uncertainties in determining the regression coefficients. The results are illustrated on Figure 54-6. For a single 10 volt indication, the PoR is on the order of $3 \cdot 10^{-6}$. The rupture force is taken as the product of two normal distributions, i.e., the regression prediction times a factor accounting for the distribution of material properties, so the distribution of the rupture force is skewed right. Therefore, estimating the PoR based on inference statistics for a symmetric distribution yields conservative results.
