ENGINEERING REPORT NO. HE-05-1991

STARTING AIR VALVE INVESTIGATION

NOVEMBER 25, 1991

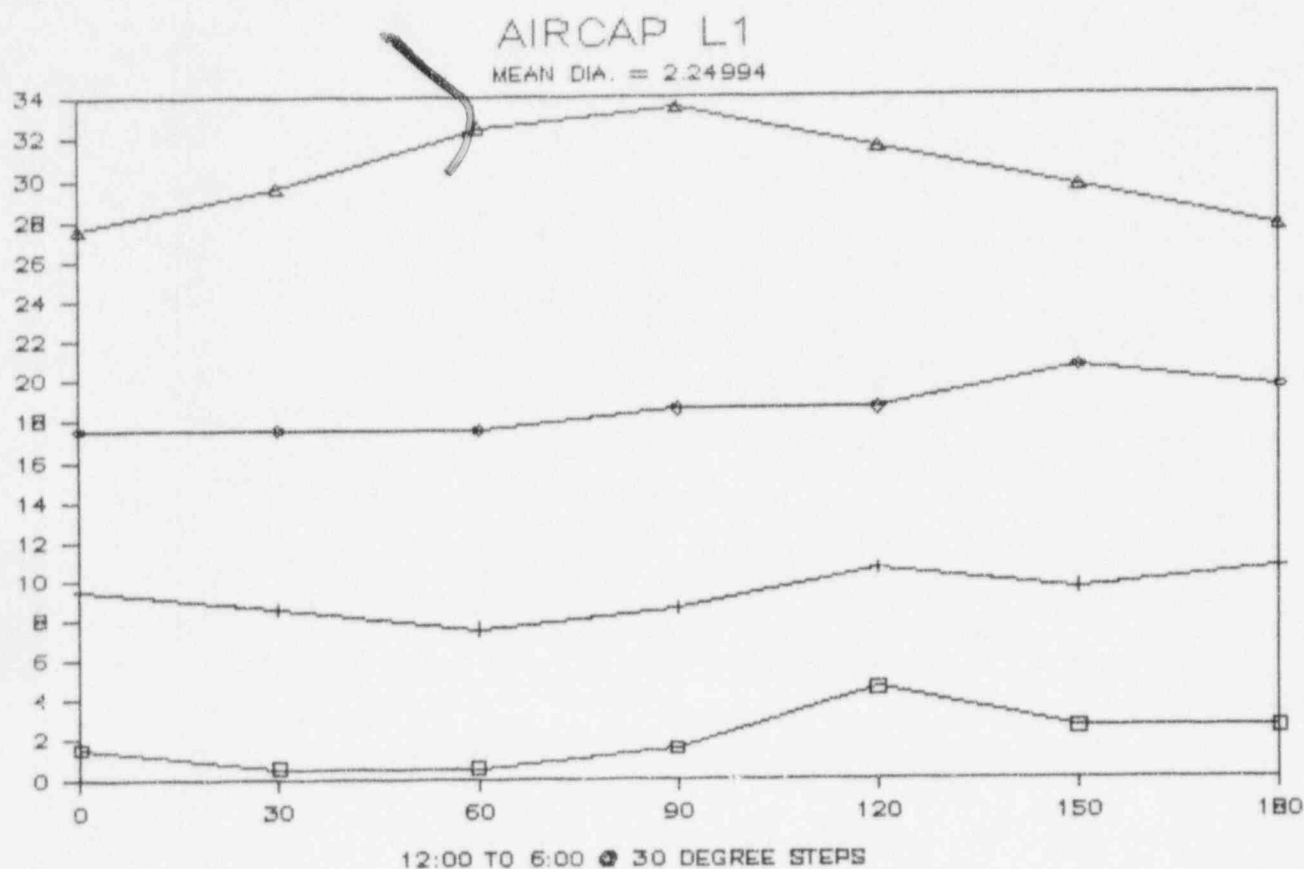
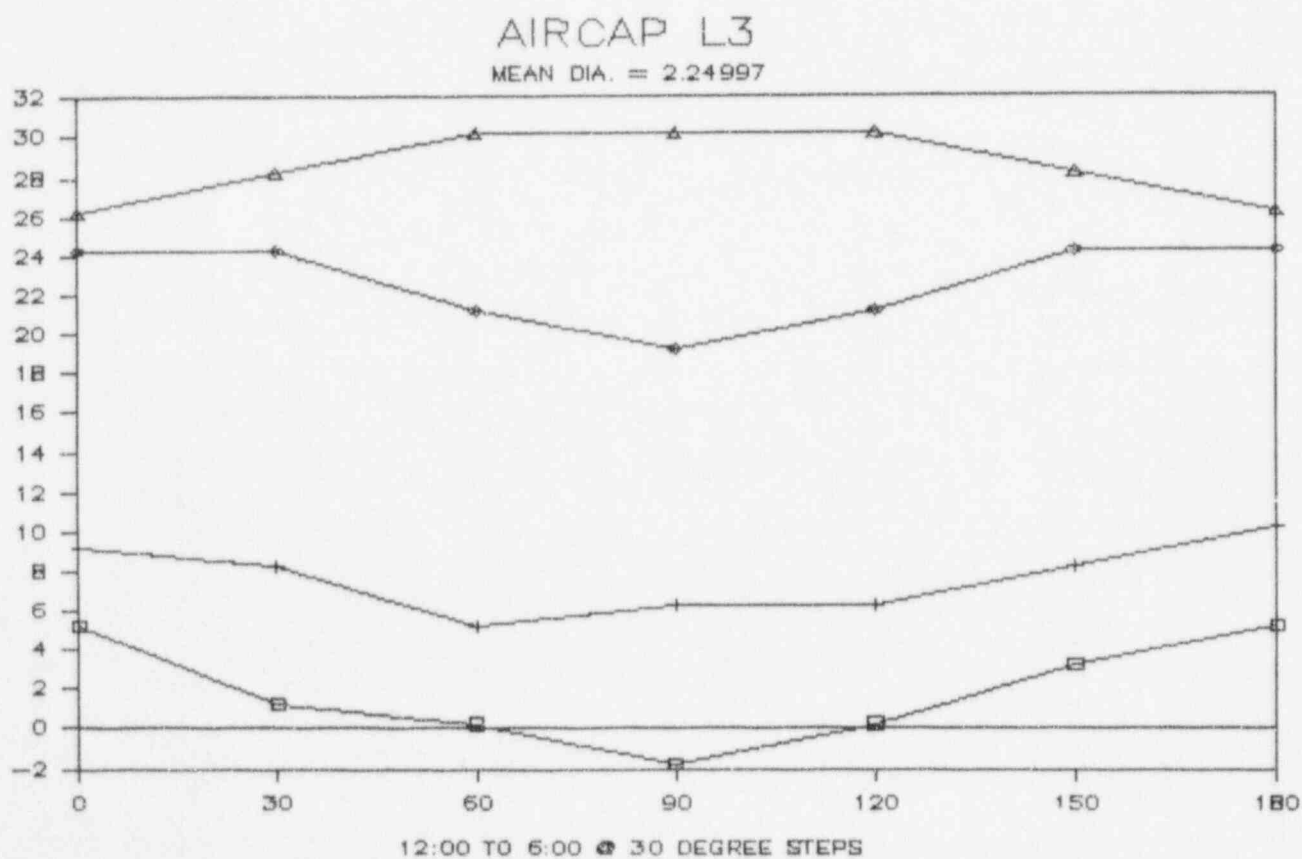
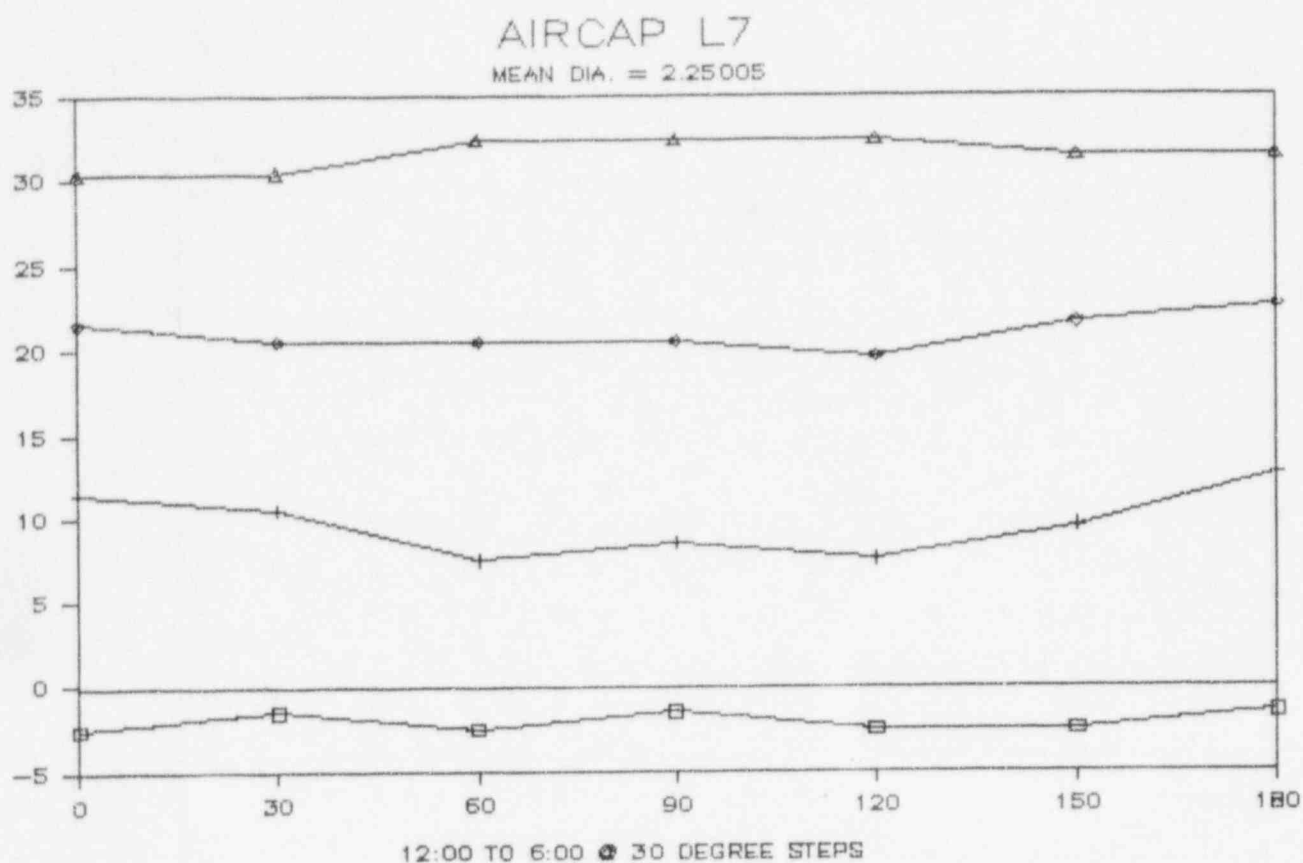
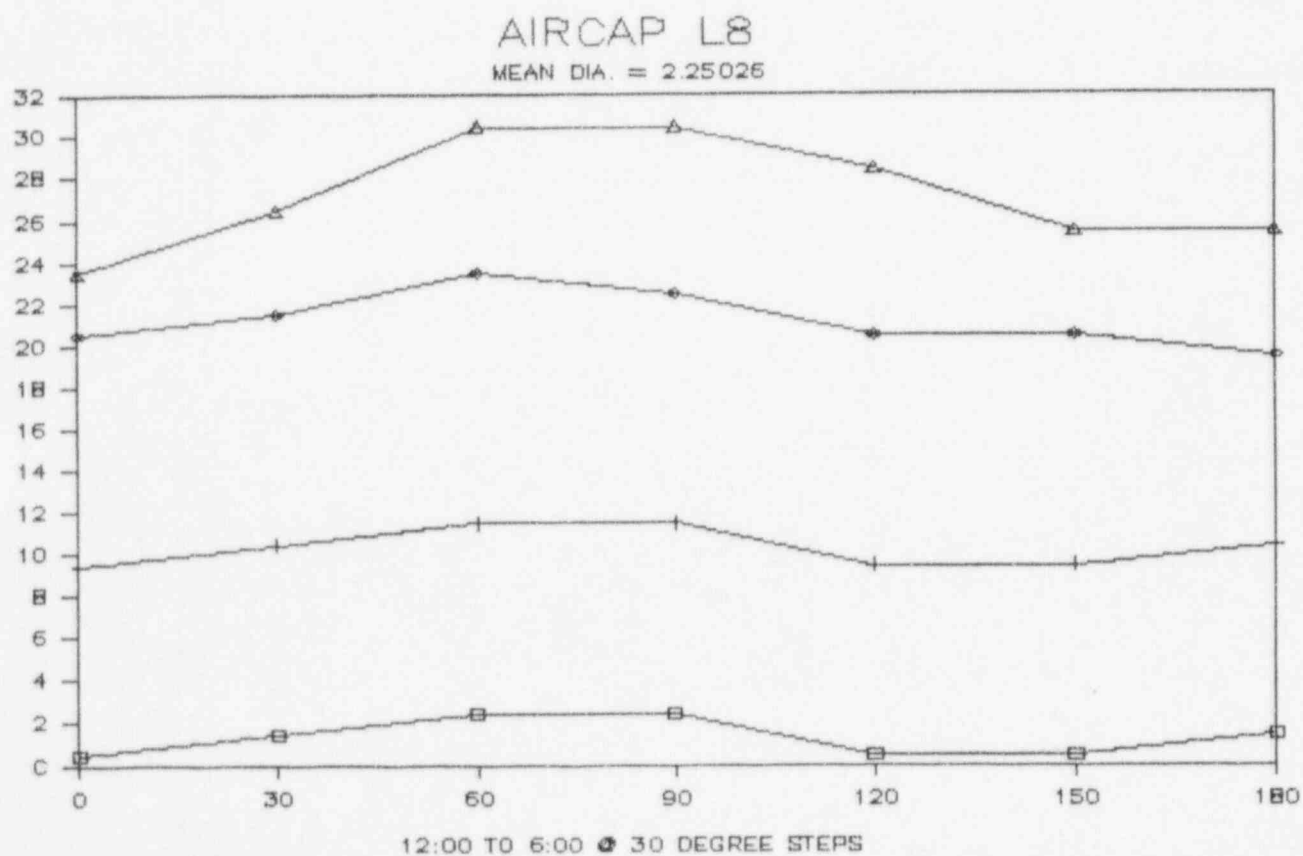
ATTACHMENT II

FOUR EQUALLY SPACED DEPTHS

Graphical representation of the bore measurements is shown in *Attachment II*. The linear graphs trace the deviation from the mean diameter at each 30° interval from bolt hole flange to bolt hole flange. The four measurement depths are shown equally spaced from the bottom of the bore to the bore lip. Measurements are in 1/10 mils. In general the bores appear to be slightly elongated along the axis coincident to the bolt hole flanges. Some exceptions to that are the measurements taken at the lip of cap bores L1, L3 and L8. Those measurements show the bores at that location to be slightly longer in the direction perpendicular to the bolt hole flanges.

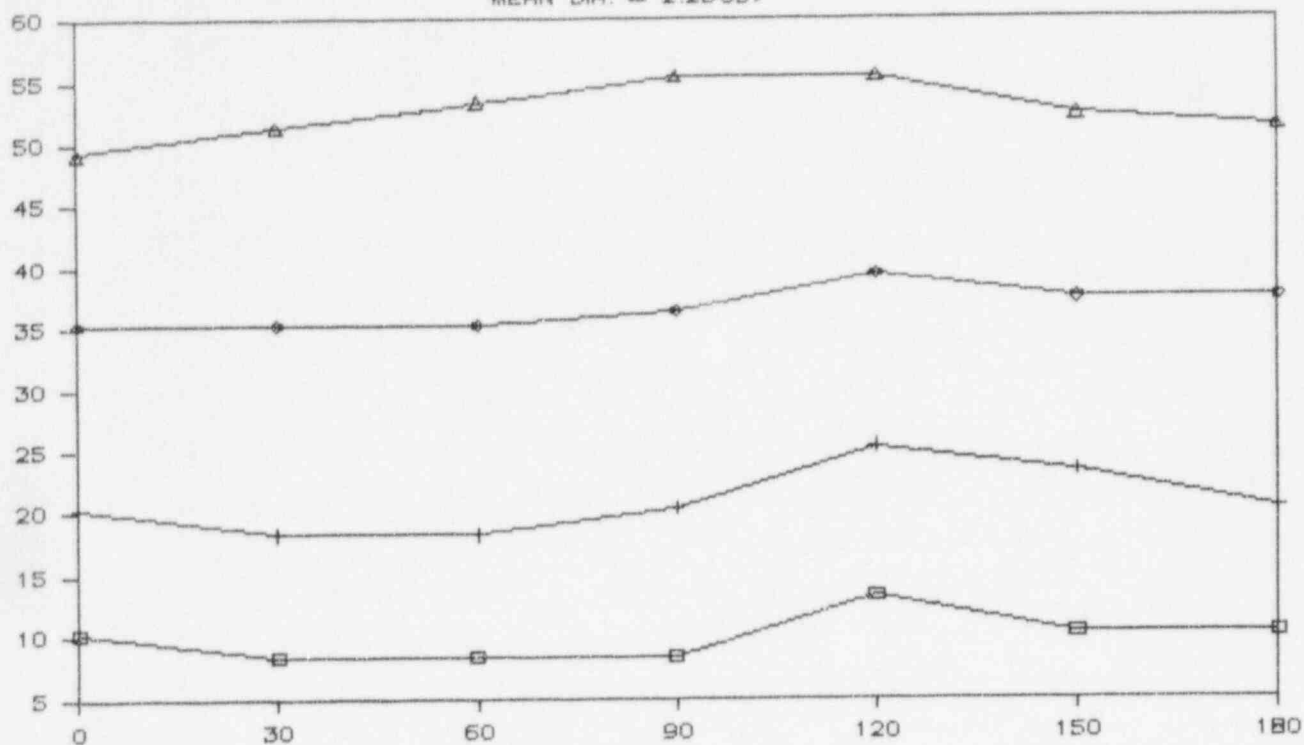
AIRCAP L5

MEAN DIA. = 2.25057

12:00 TO 6:00 @ 30 DEGREE STEPS

FOUR EQUALLY SPACED DEPTHS

Several comments can be made regarding the results. Firstly, all of the cap bores conformed to the design specification of 2.2495"/2.2505" with the exception of cap L5. Measurements of that bore were found to be as much as 1.9 mils over nominal diameter along the bottom depth. Diametral deviation was no greater than the other caps at that location and the remaining depths were measured within specification. No reasons for that nonconformance were visibly apparent but it should be noted that those measurements were taken as close as possible to the 3/32" re-entrant fillet at the bottom of the bore. A slightly oversized fillet, chamfer, or taper could have attributed to the unexpected bore measurements. Additionally, the oversized bore at that location would not induce piston seizure.

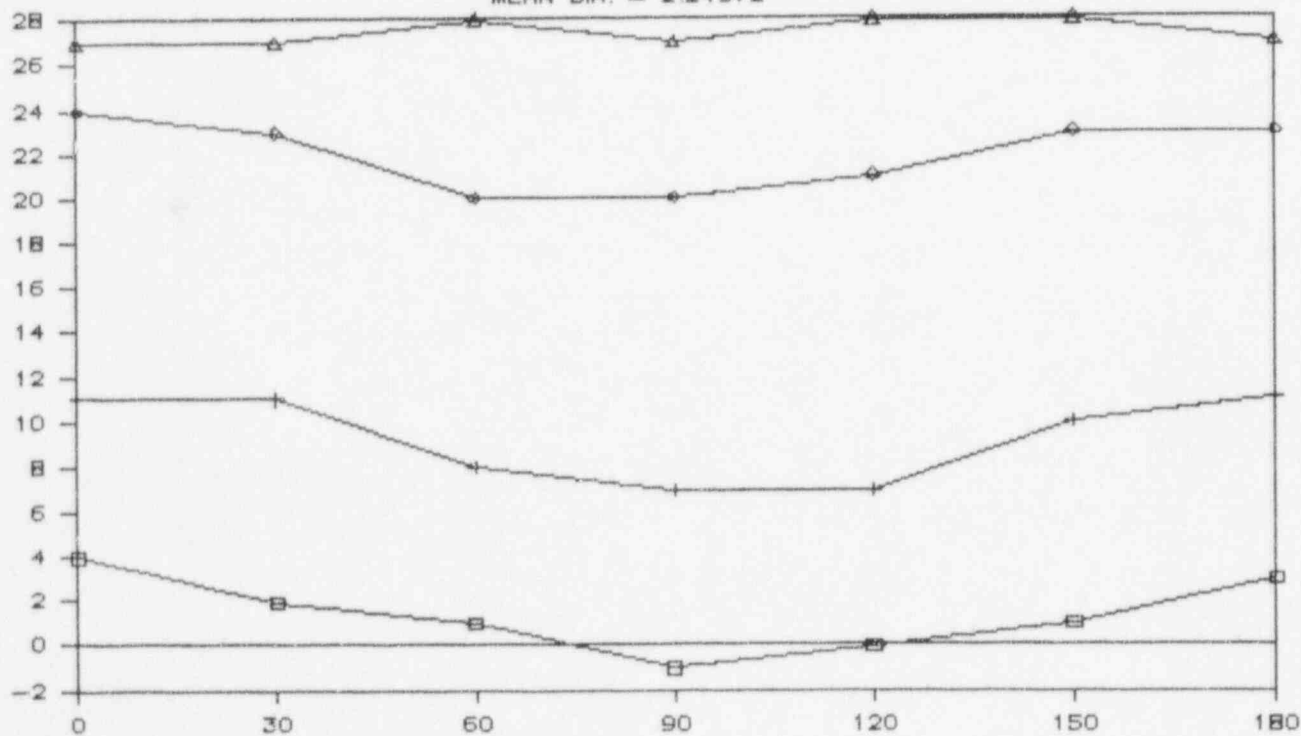
AIRCAP L6

MEAN DIA. = 2.24972

12:00 TO 6:00 @ 30 DEGREE STEPS

FOUR EQUALLY SPACED DEPTHS

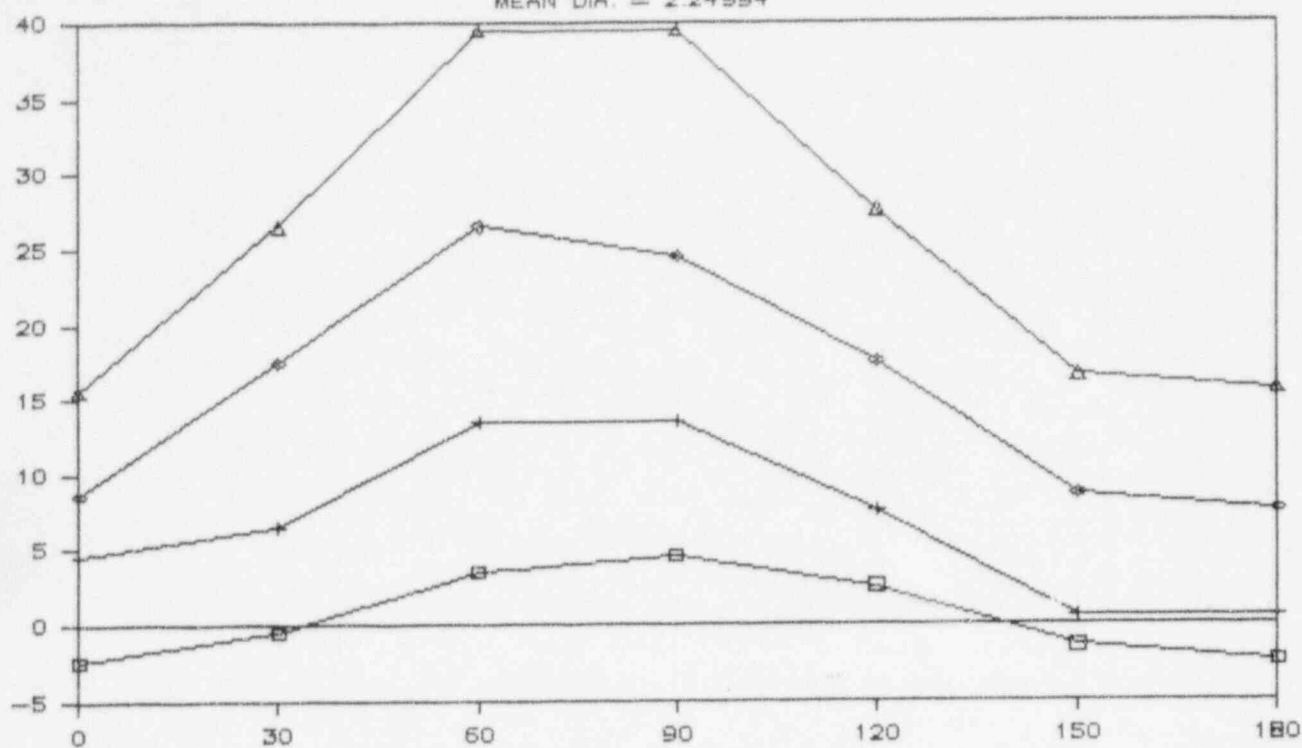
AIRCAP L1

MEAN DIA. = 2.24994

FOUR EQUALLY SPACED DEPTHS

12:00 TO 6:00 @ 30 DEGREE STEPS

The cap bores were remeasured while chucked in a lathe at the bolt hole flanges to simulate the forces imparted by the hydraulically operated v-chucks that were at one time used during cap manufacturing. These measurements and the corresponding graphs are shown in *Attachments III* and *IV*. Although I was not able to chuck the caps to produce round bores, the plots show that material did deform and cause the bores to elongate in the direction perpendicular to the bolt hole flanges. A comparison of the chucked and unchucked measurements shows the Georgia Power caps to be out of round in the direction one would expect if excessive clamping force was applied to the bolt hole flanges during machining.

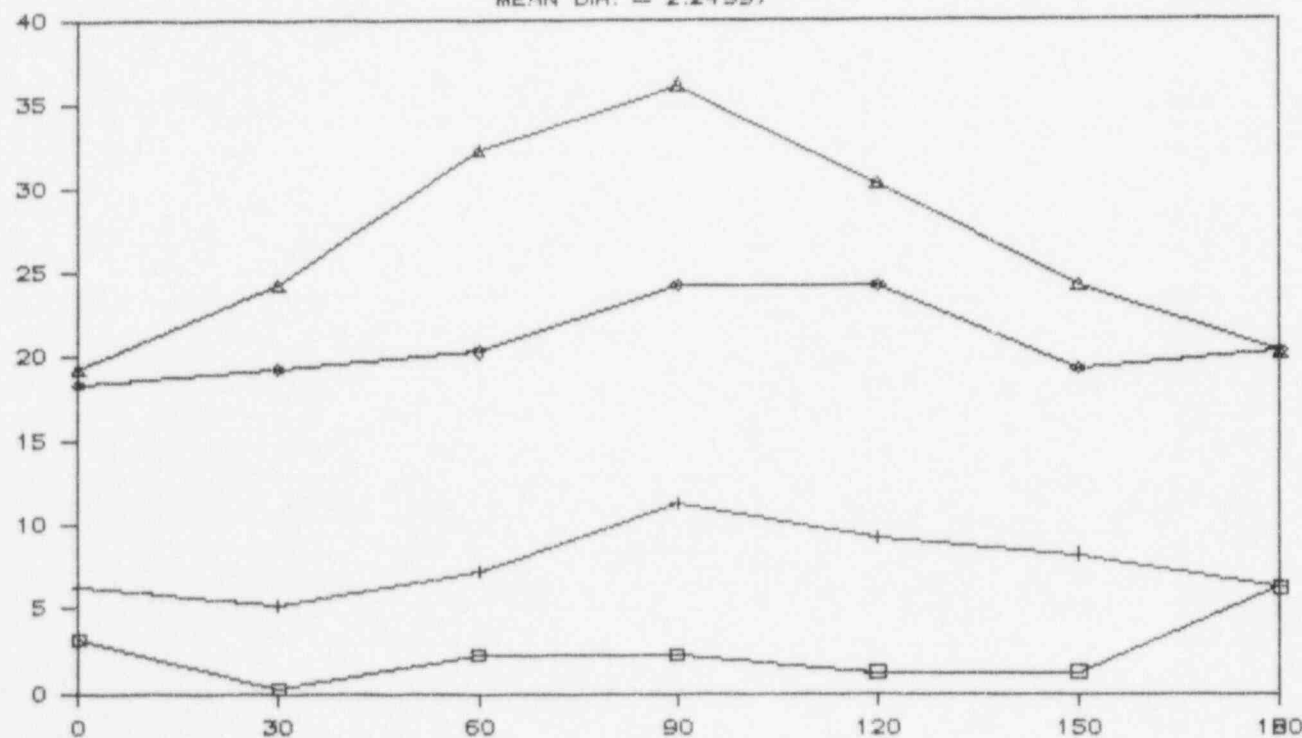
AIRCAP L3

MEAN DIA. = 2.24997

FOUR EQUALLY SPACED DEPTHS

12:00 TO 6:00 @ 30 DEGREE STEPS

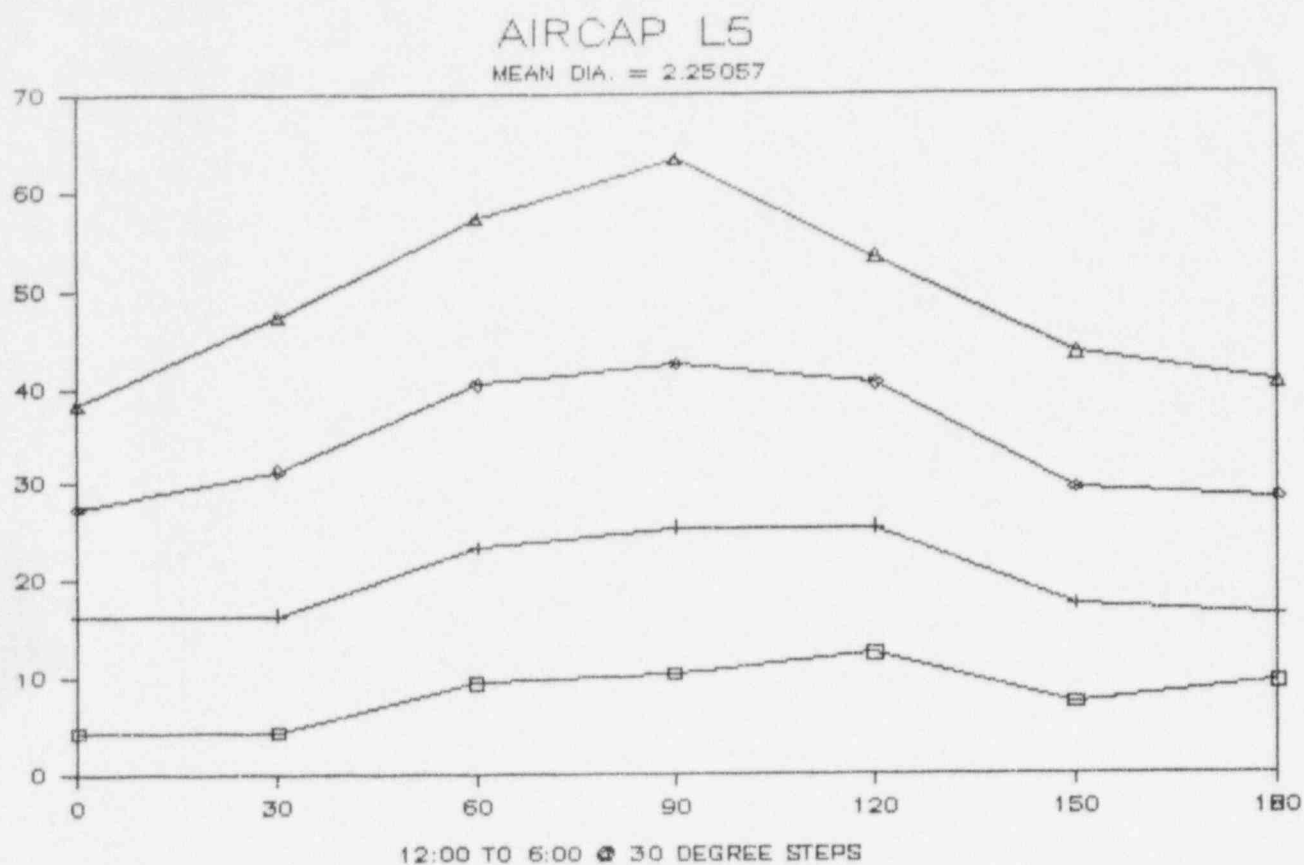
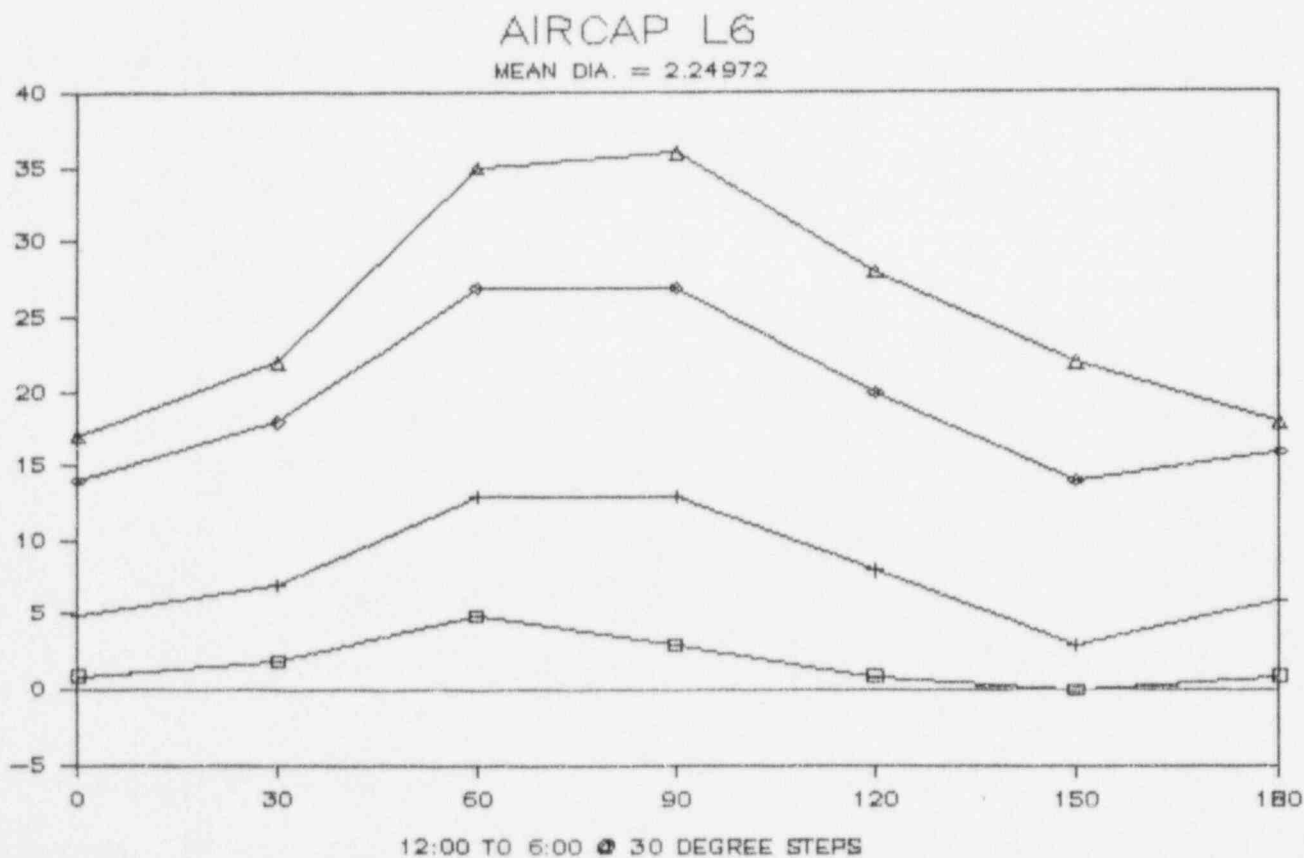
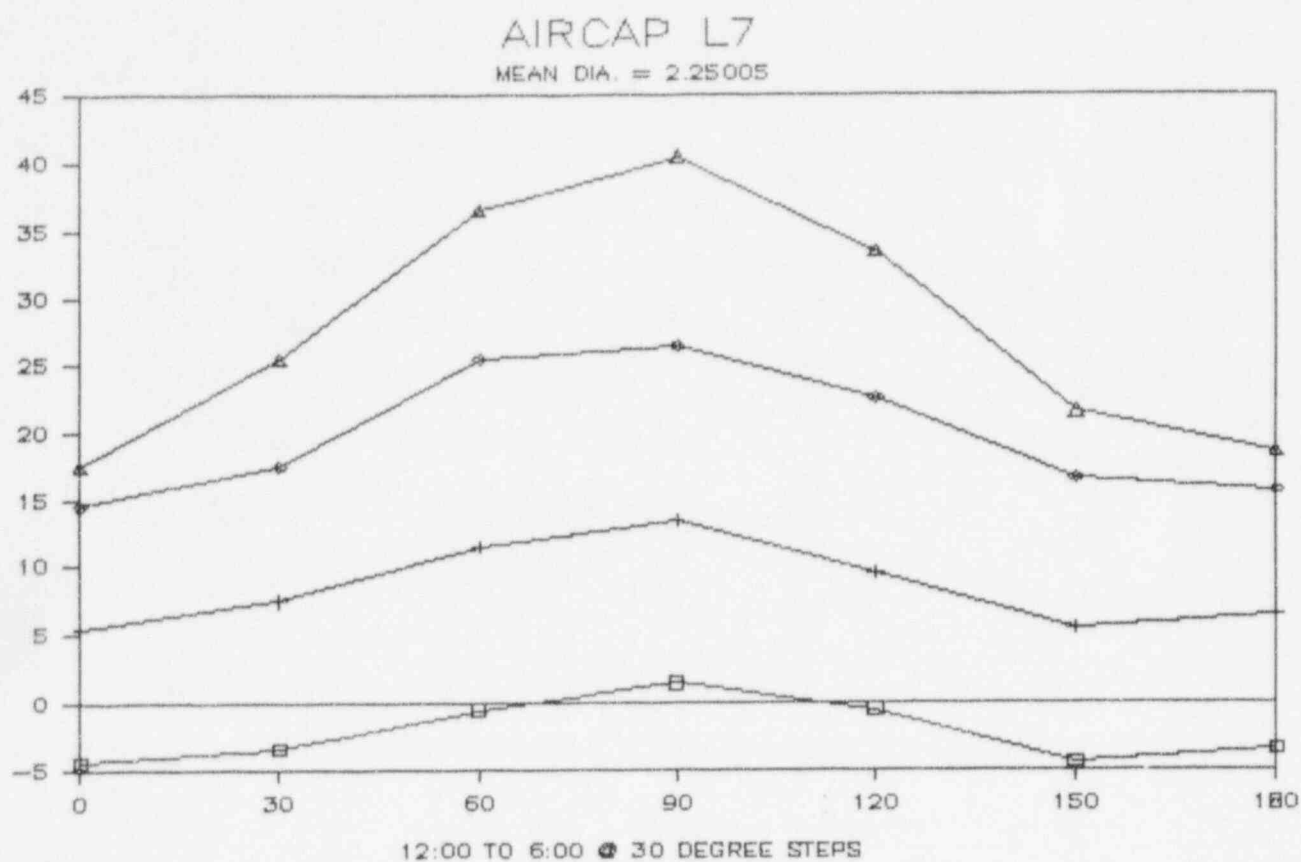
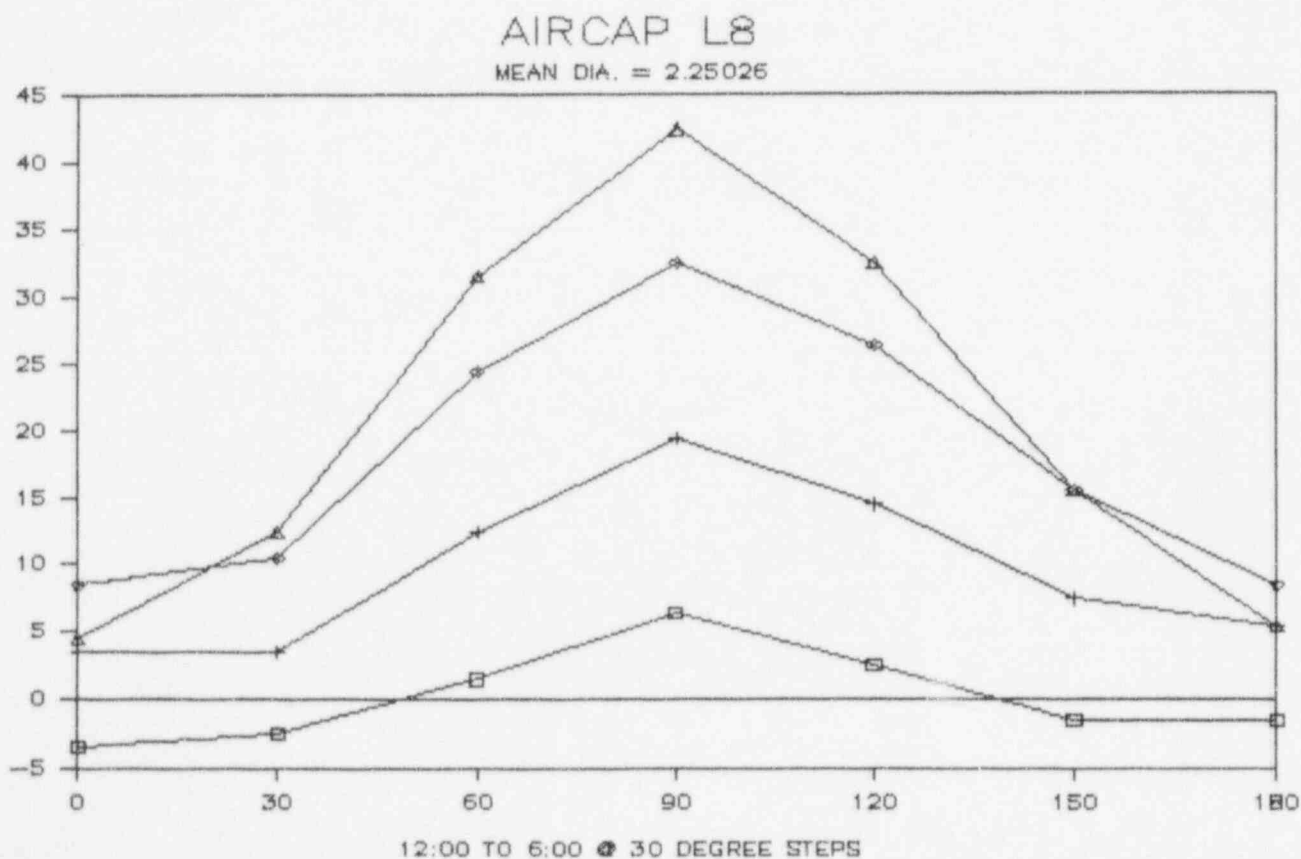
FOUR EQUALLY SPACED DEPTHS
