# Condition of 44-Year Naturally Aged Cable

**Pyrotrol III,  
Raychem  
Flamtrol,  
and RSCC  
Firewall III  
Cable (15 years)**

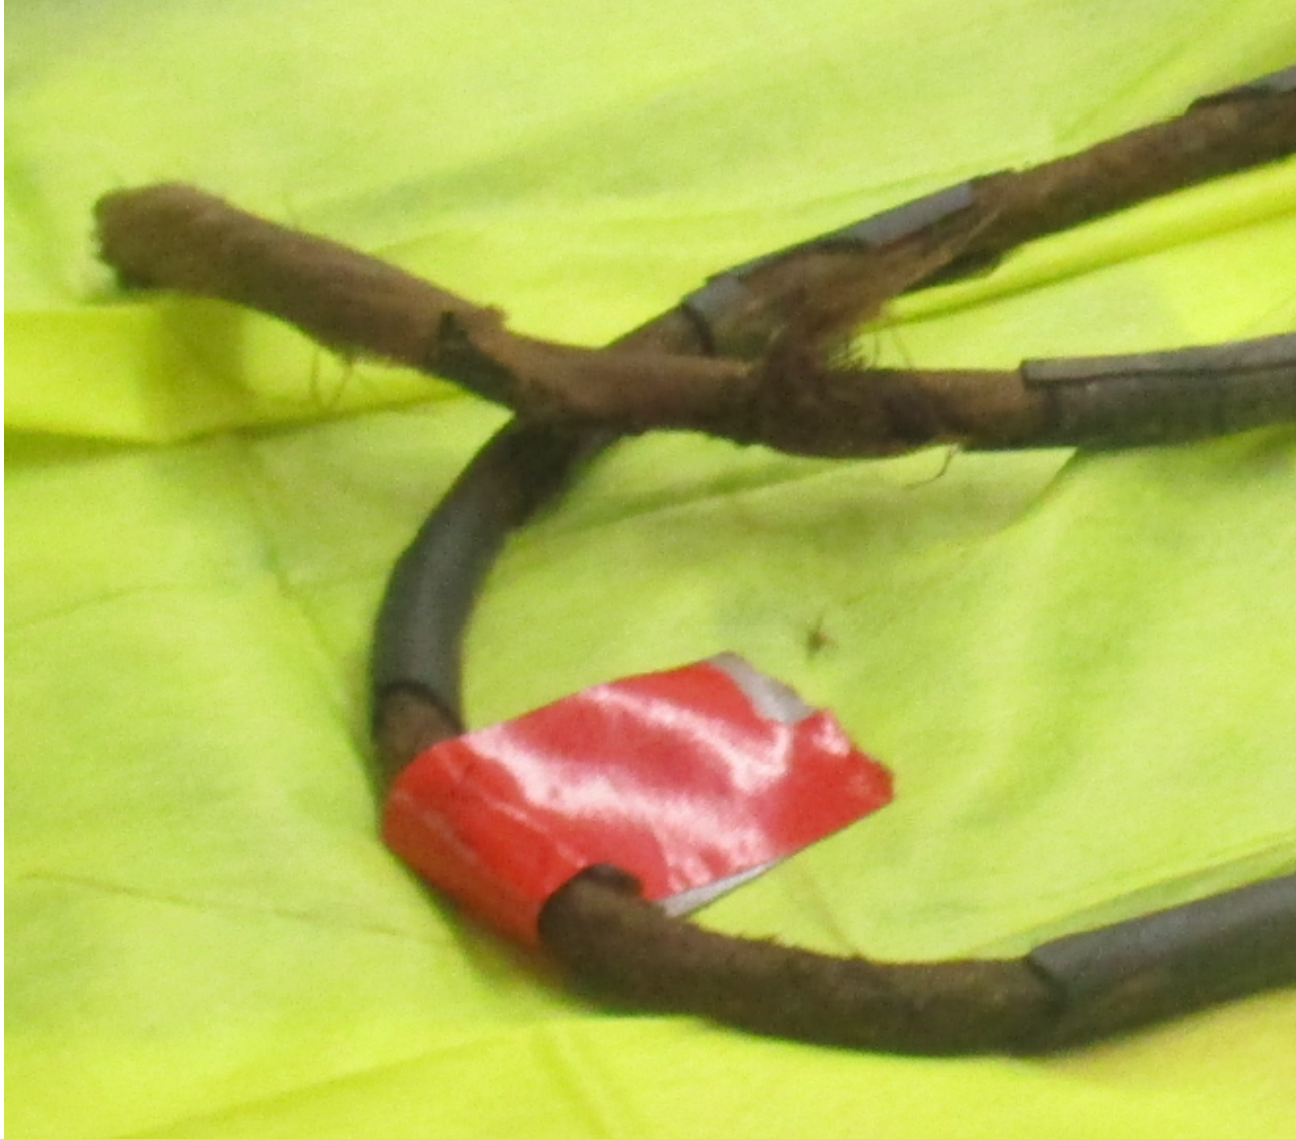
**Condition of  
Rockbestos  
(Cerro)  
Pyrotrol III  
Outer Jacket.**

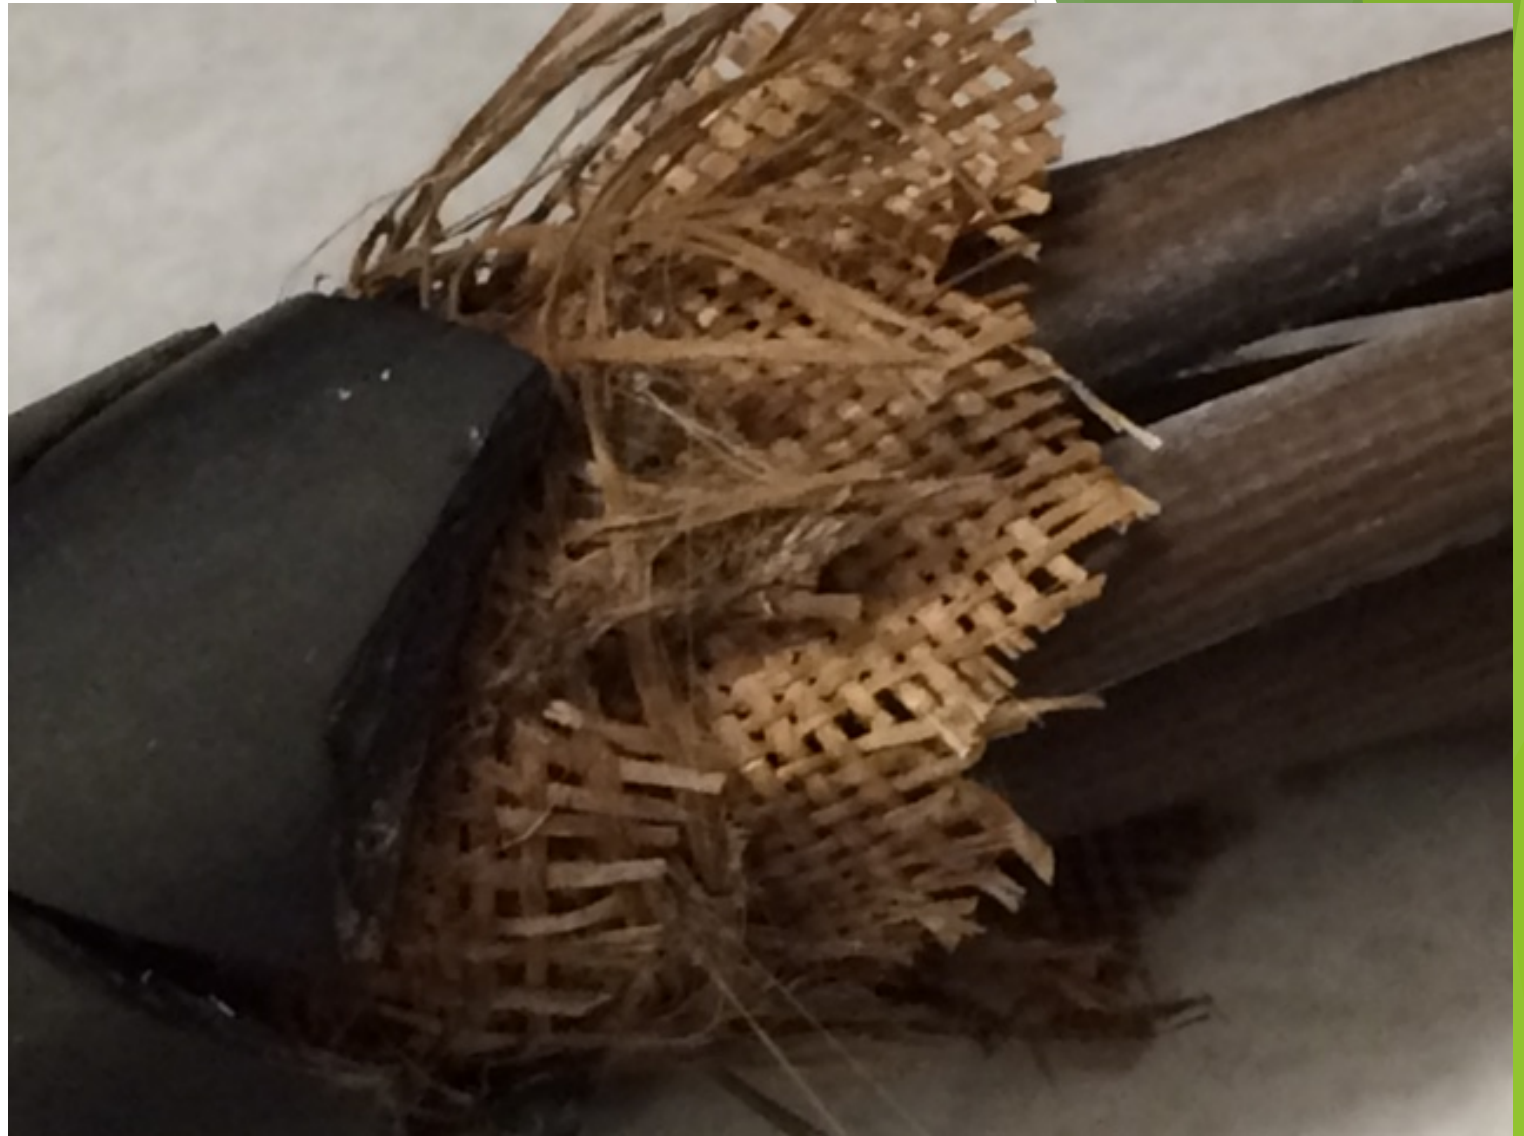
Once the braid and jacket were removed, the underlying conductor insulation was generally in good shape, intact, and moderately flexible

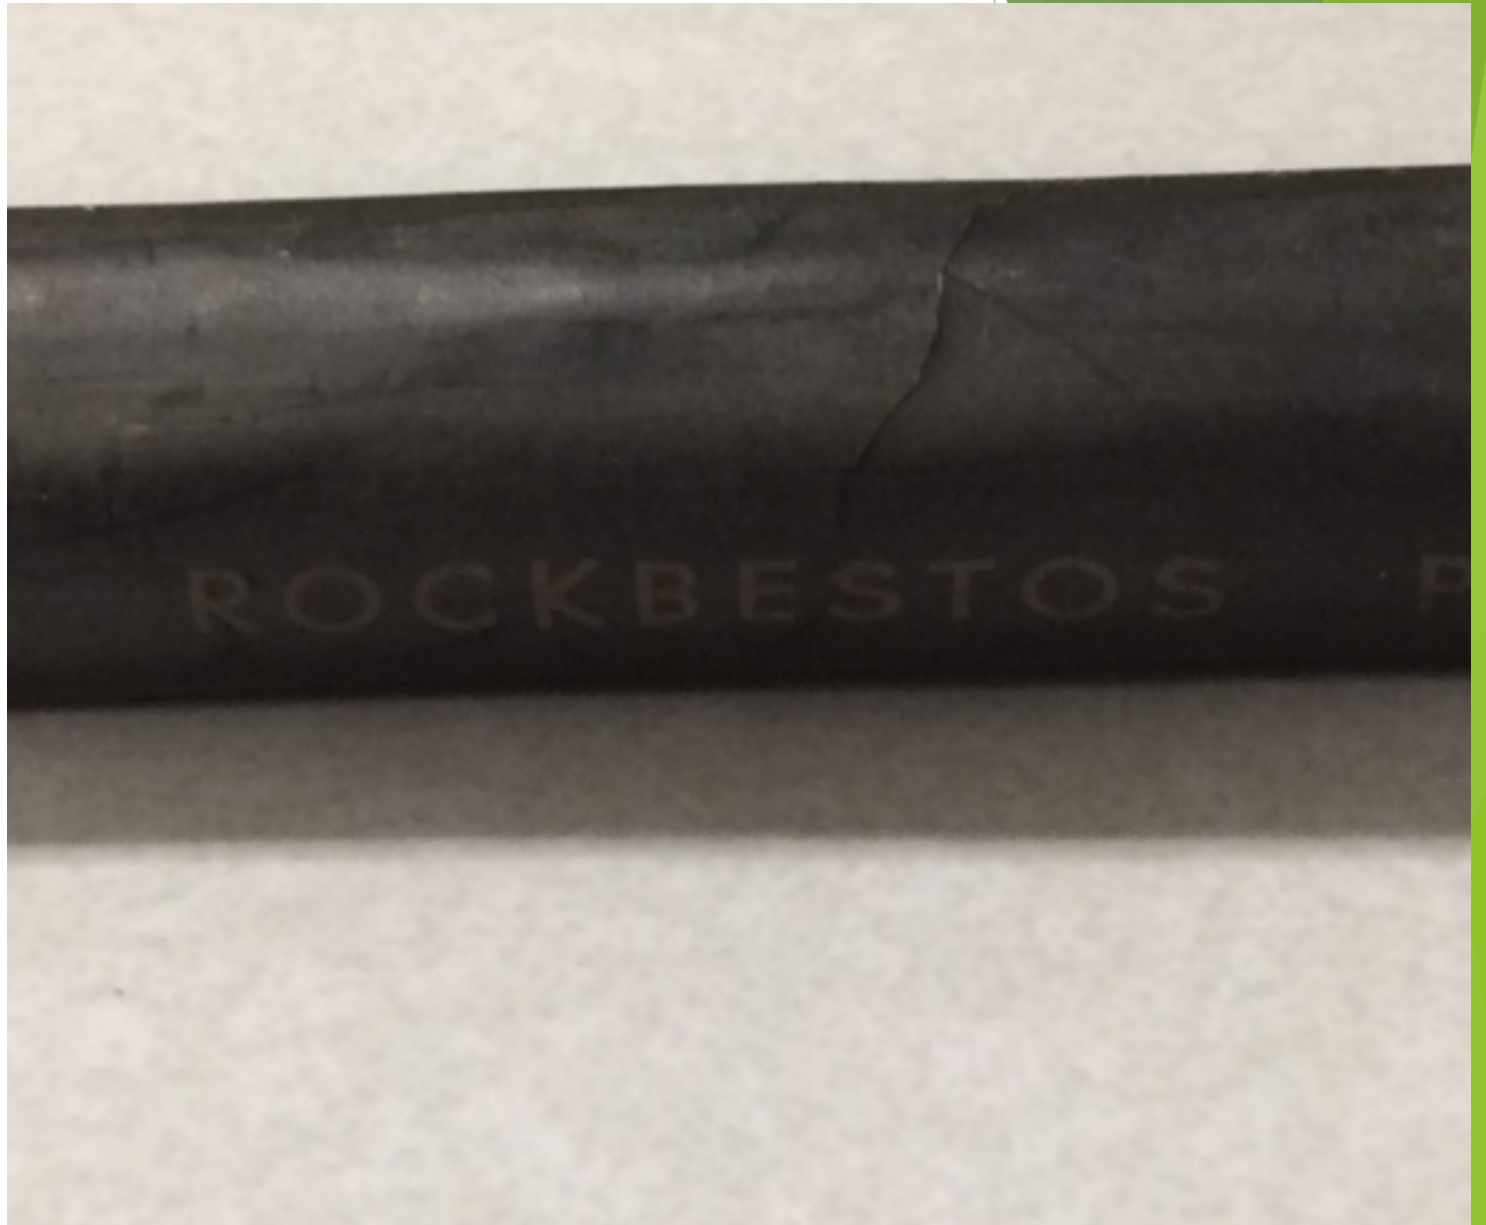
**The Surprise:**  
Once we recovered the Cerro Pyrotrol III cable, we discovered that instead of the name “Cerro” they were “Rockbestos” Pyrotrol III cable.

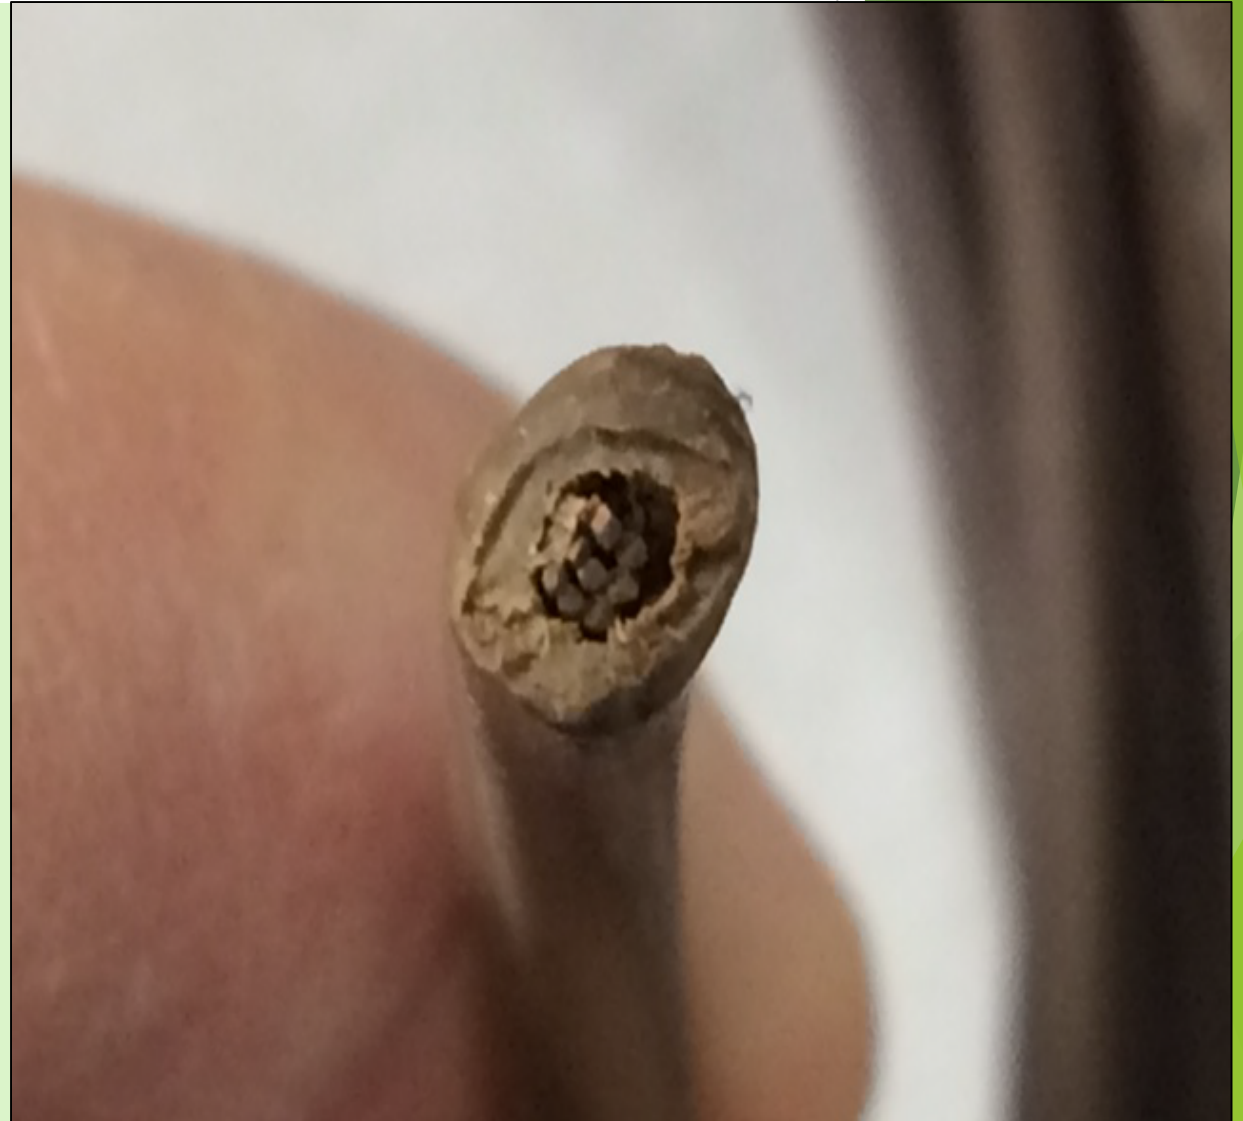
## INDIVIDUAL PYROTROL III CONDUCTOR WITH OUTER JACKET REMOVED.

The Chemically Cross-linked polyethylene conductor insulation was in reasonably good condition after 44 years of installation in an average of 150°F (65.5°C) ambient environment. There were ambient excursions up to about 180°F (82.2°C). These were control conductors with little or no heat rise.

The stranded copper conductors did not exhibit any corrosion or rust.

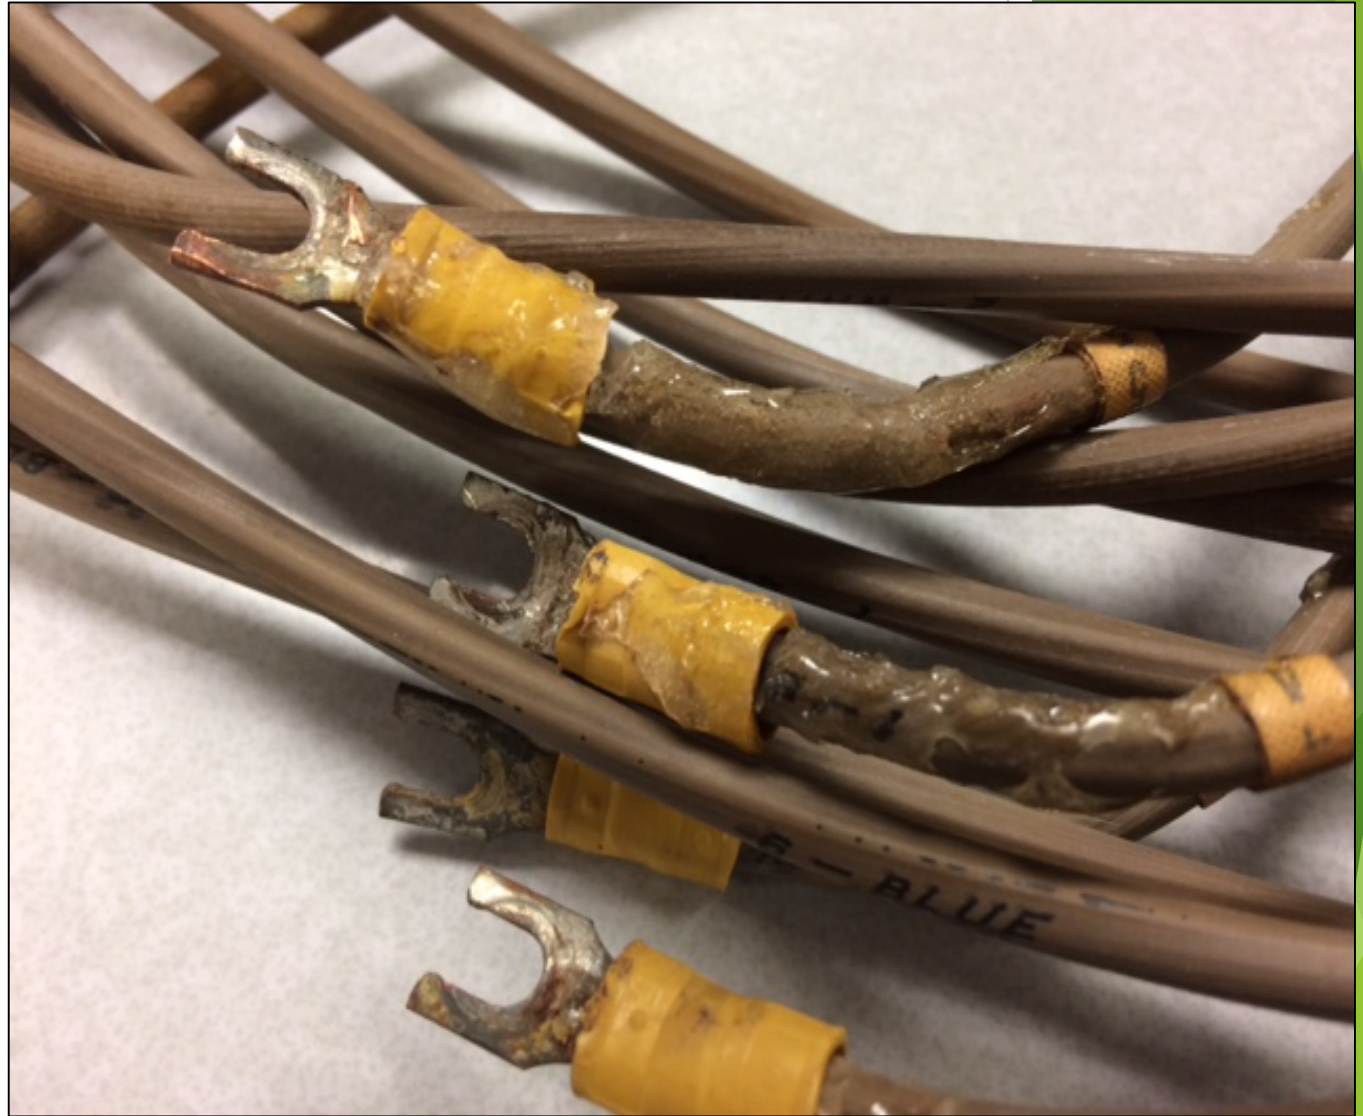
# CONDITION OF PYROTROL III AT THEIR TERMINATION

**LUGS.** The shiny clear substance on and behind the terminal lug is Patel Engineers Conformal Coating (PECC).

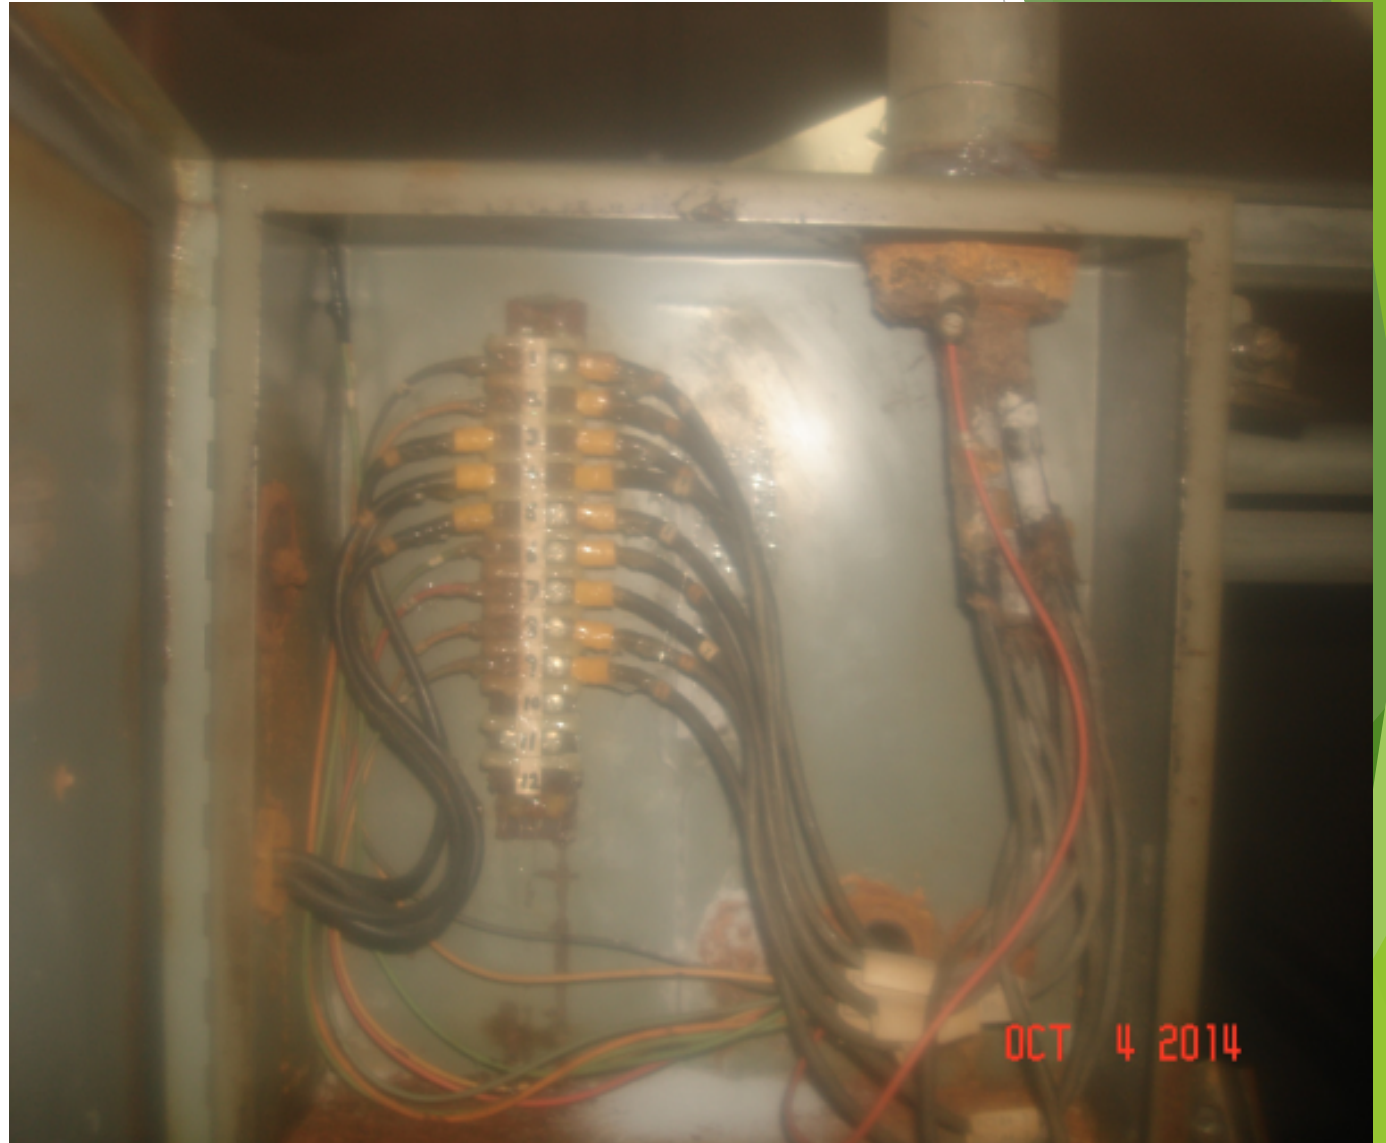
**Terminal Box Rust and Corrosion:** The photo to the right shows a typical CNS terminal box inside the Steam Tunnel. While not all terminal boxes were rusted and corroded, several were. The pictured terminal box is among the worst case examples (2014).

- ▶ Know various heat loads affecting cables
- ▶ Get Temp Element data to track ambient
- ▶ Apply as many TEs or Monitors as possible
- ▶ Inspect condition of cable ends periodically
- ▶ Inspect terminal boxes & conduit entry for rust and corrosion
- ▶ Make sure cable qualified life is solidly based (DOR)
- ▶ Have cables replaced in a conservative time frame

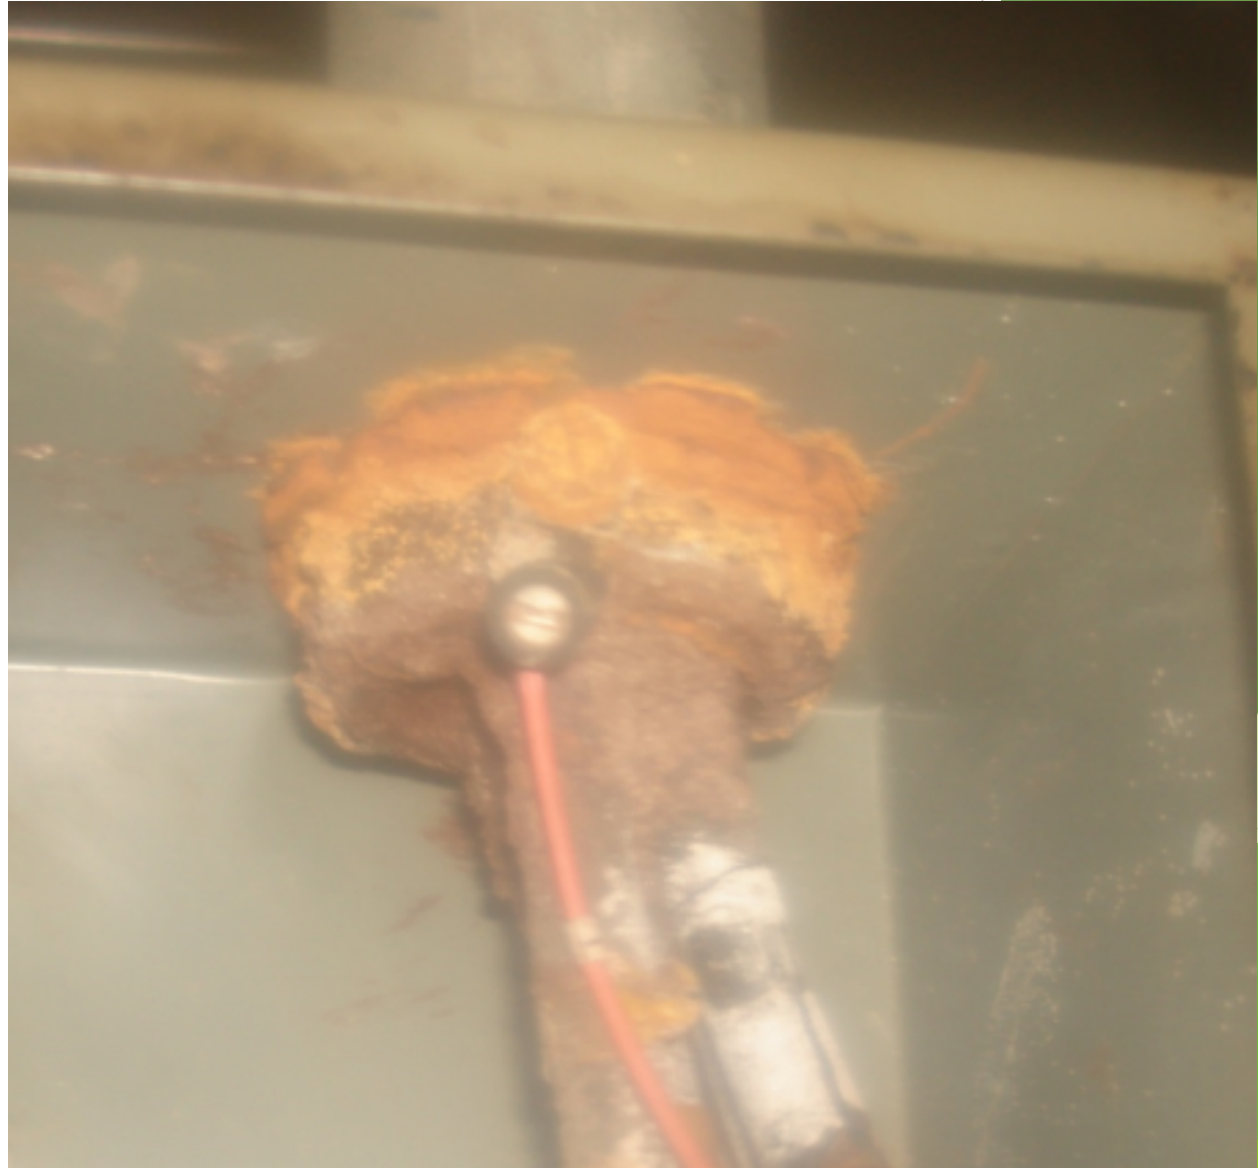
Rust formation in terminal boxes is not necessarily a failure mechanism. In a *static* state, the outer jacket will prevent rust from reaching the conductor insulation. The evidence for this is shown that after 42 years in the hot and humid Steam Tunnel, the rust had not reached a point where it would cause any damage to the cables.

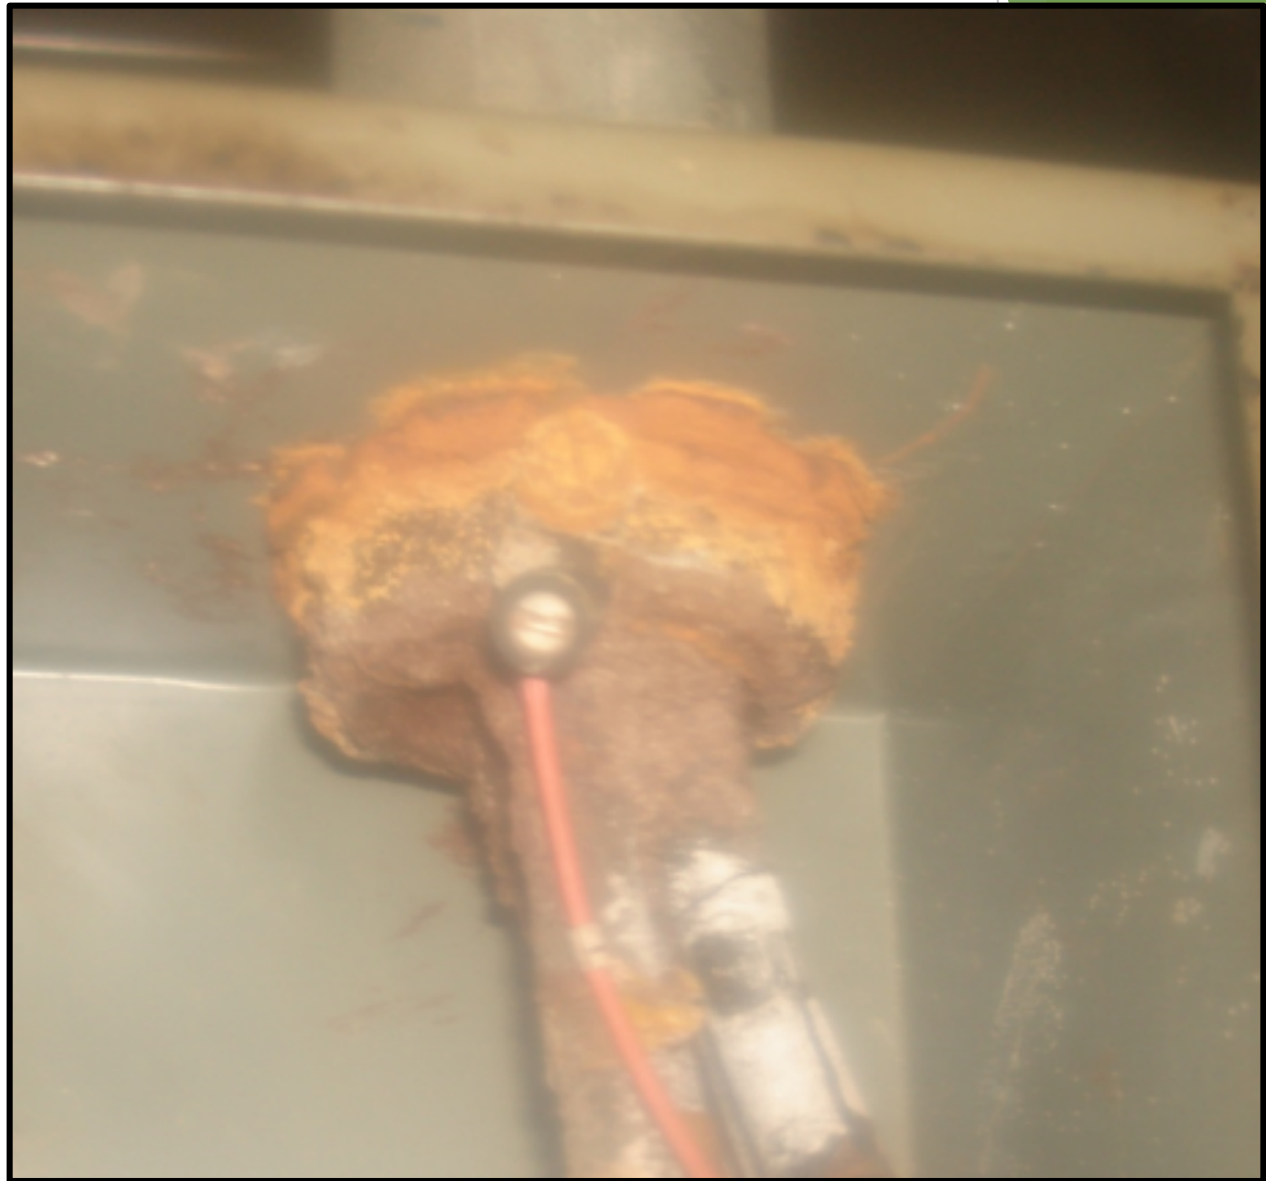
## THE PROBLEM WITH EXCESSIVE RUST IS IT MAY AFFECT CABLE RATING

When cables were being removed, the electrical team used brushes as they pulled the old cable out and the new cable in through the conduit.

They reported that there were significant quantities of rust and corrosion from the conduit walls - along with moisture.

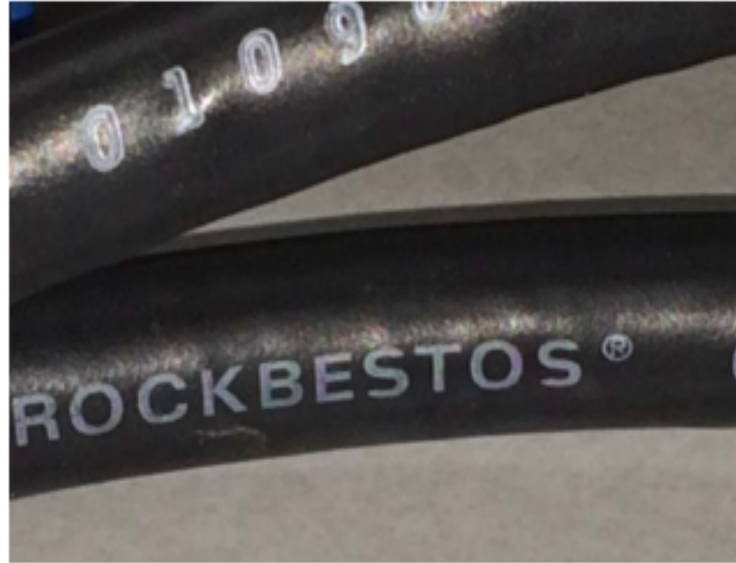
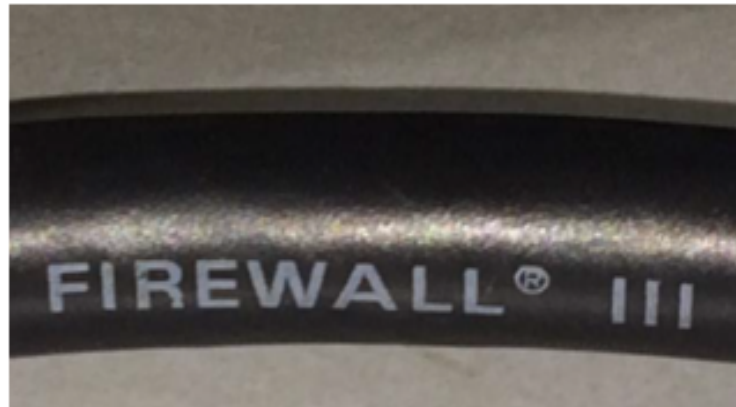
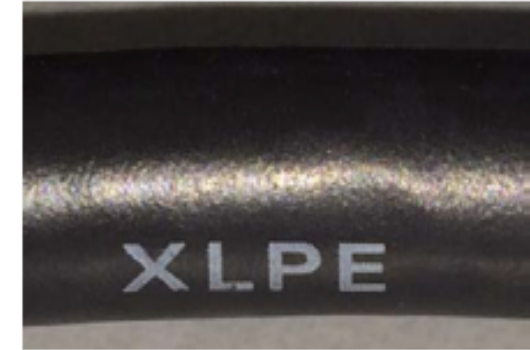
**RSCC (Rockbestos)  
Firewall III cable** was  
also inadvertently  
removed during the  
2016 outage. It was a  
small length between  
two terminal boxes in  
close proximity to one  
another in the Steam  
Tunnel.

**Rockbestos  
Firewall III** after  
15 years in the  
Steam Tunnel ...  
in pristine  
condition

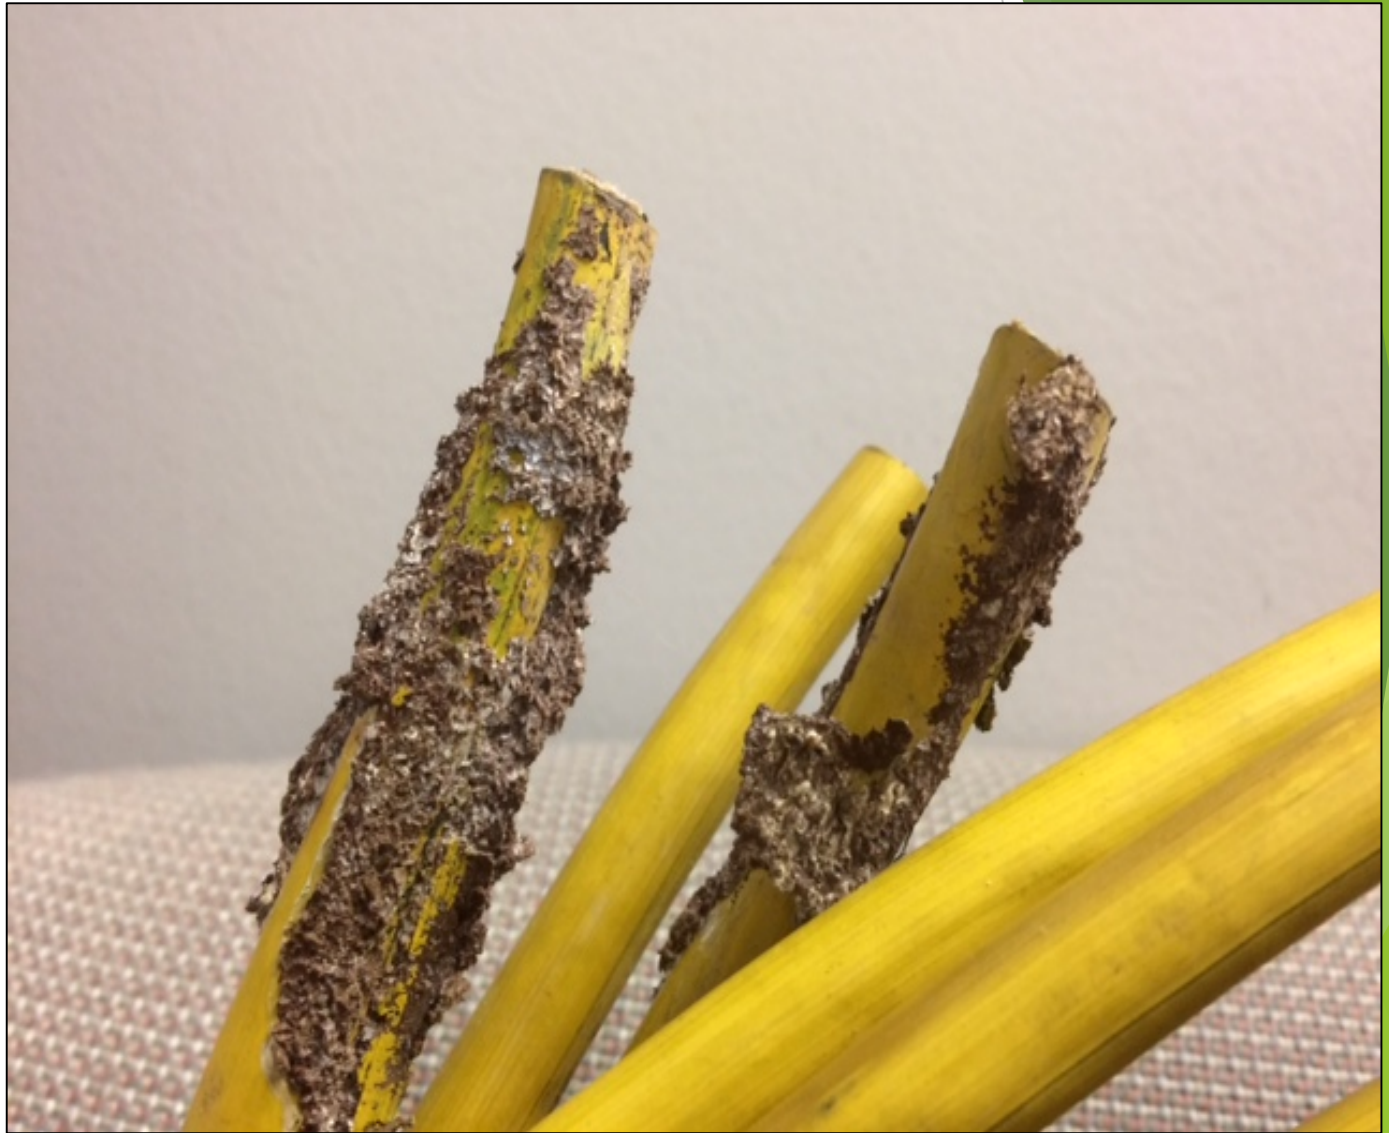
## BALANCE OF CABLES PULLED IN 2018.

More precisely,  
their Elongation-At-  
Break and  
Insulation  
Resistance would  
likewise have been  
about the same as  
the 2016 cables.

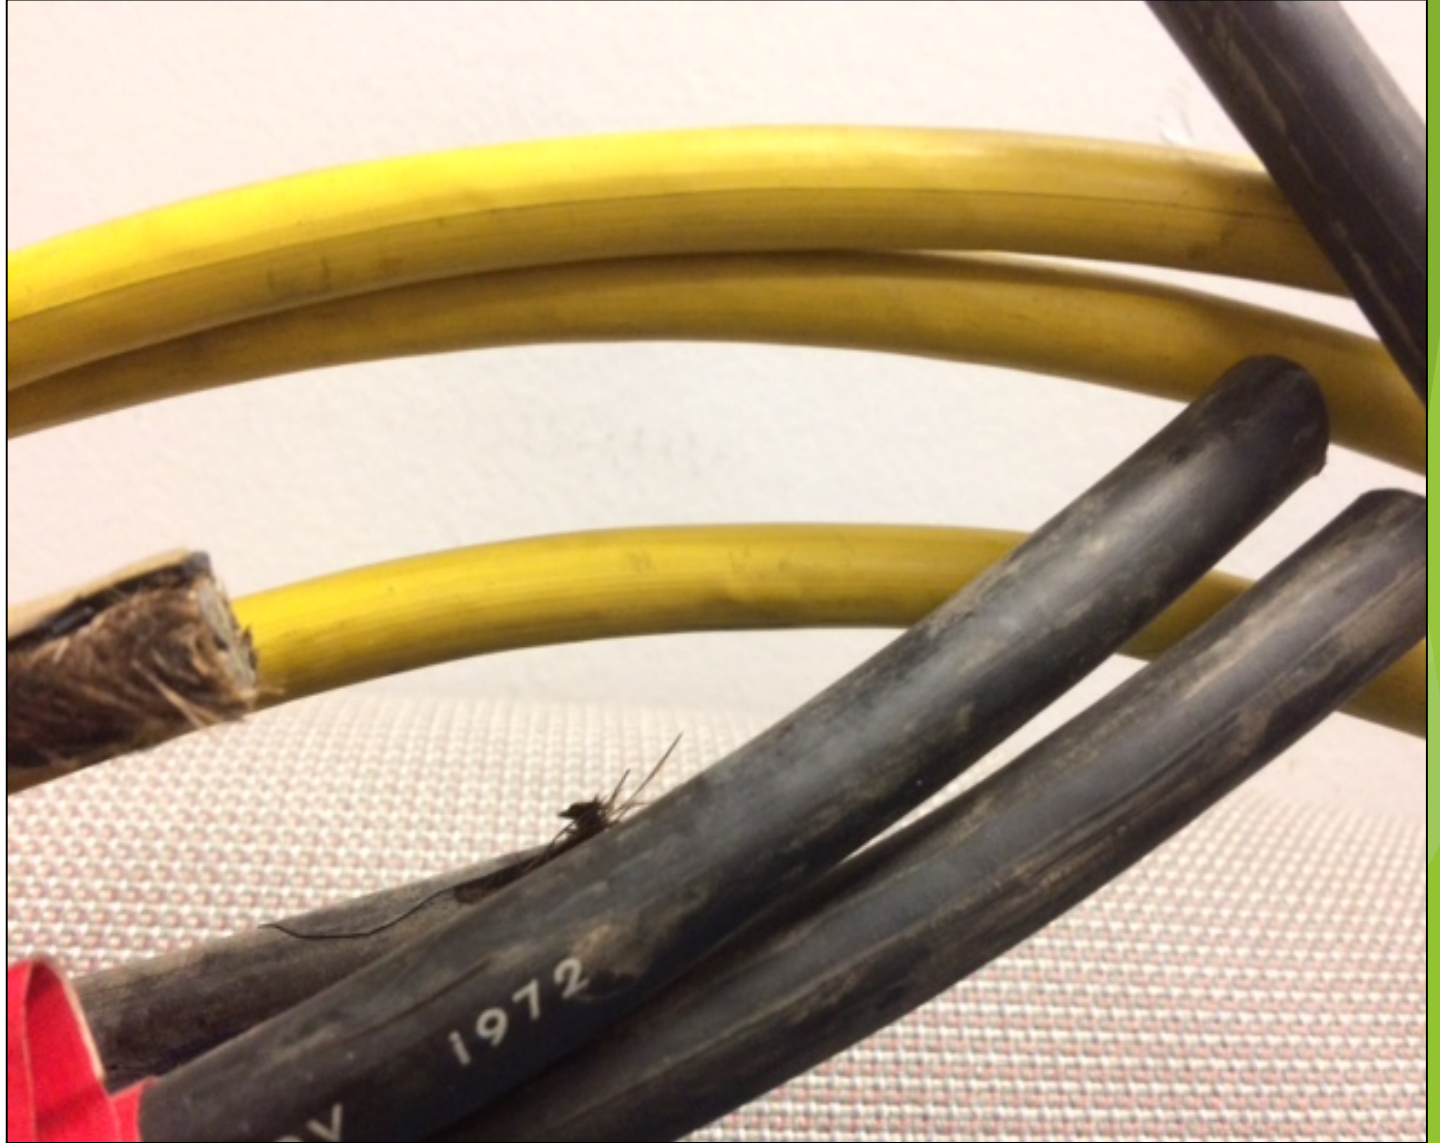
... because the  
remaining life also  
has to account for  
any HELB  
accident.

**CNS  
conservatively  
chose to replace  
the Pyrotrol III  
Cables**

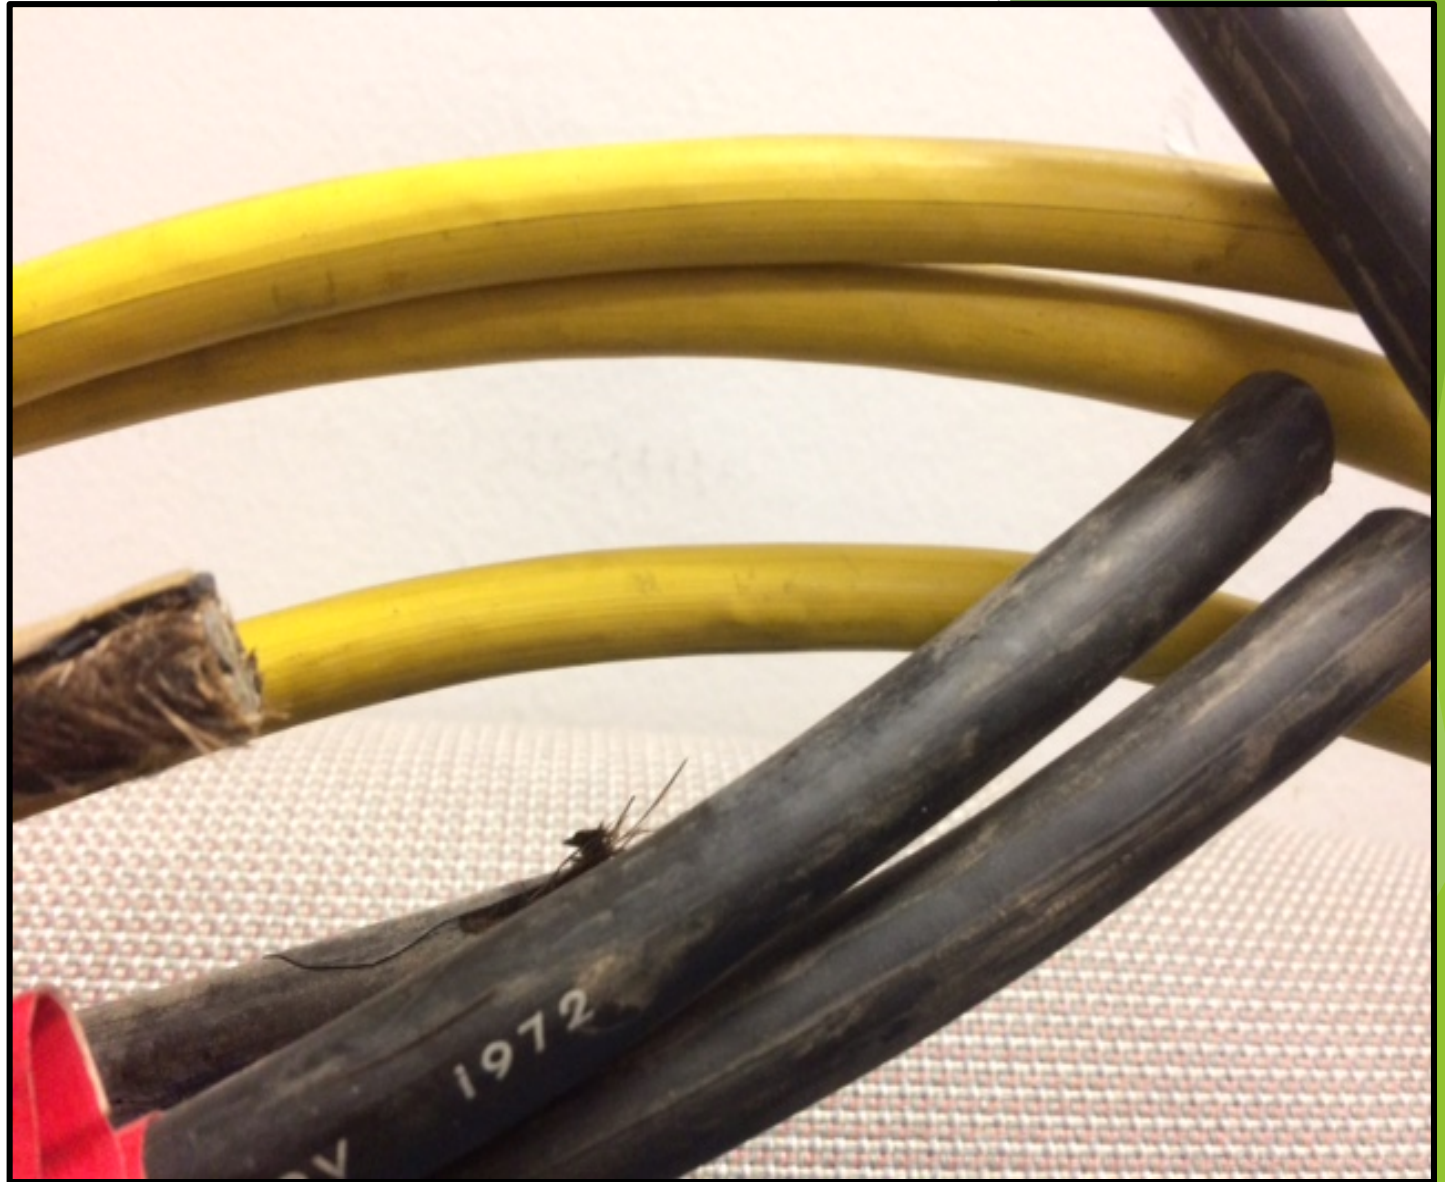
The four packages are from the 2018 cable pull. They represent the vintage, manufacturer, and condition.

One yellow cable shows a transition from being in very good condition to being severely degraded within about a foot. This suggests that the load or nearby equipment was extremely hot at one end.

The conductors, however, are still in good condition and flexible.
