Report No.: SIR-91-077
Revision No.: 3
Project No.: GPCO-20Q-2
February 1992

IGSCC Flaw Evaluations
and Weld Overlay Activities
During the E. I. Hatch Unit 1
Fall 1991 Outage

Prepared for:
Georgia Power Company

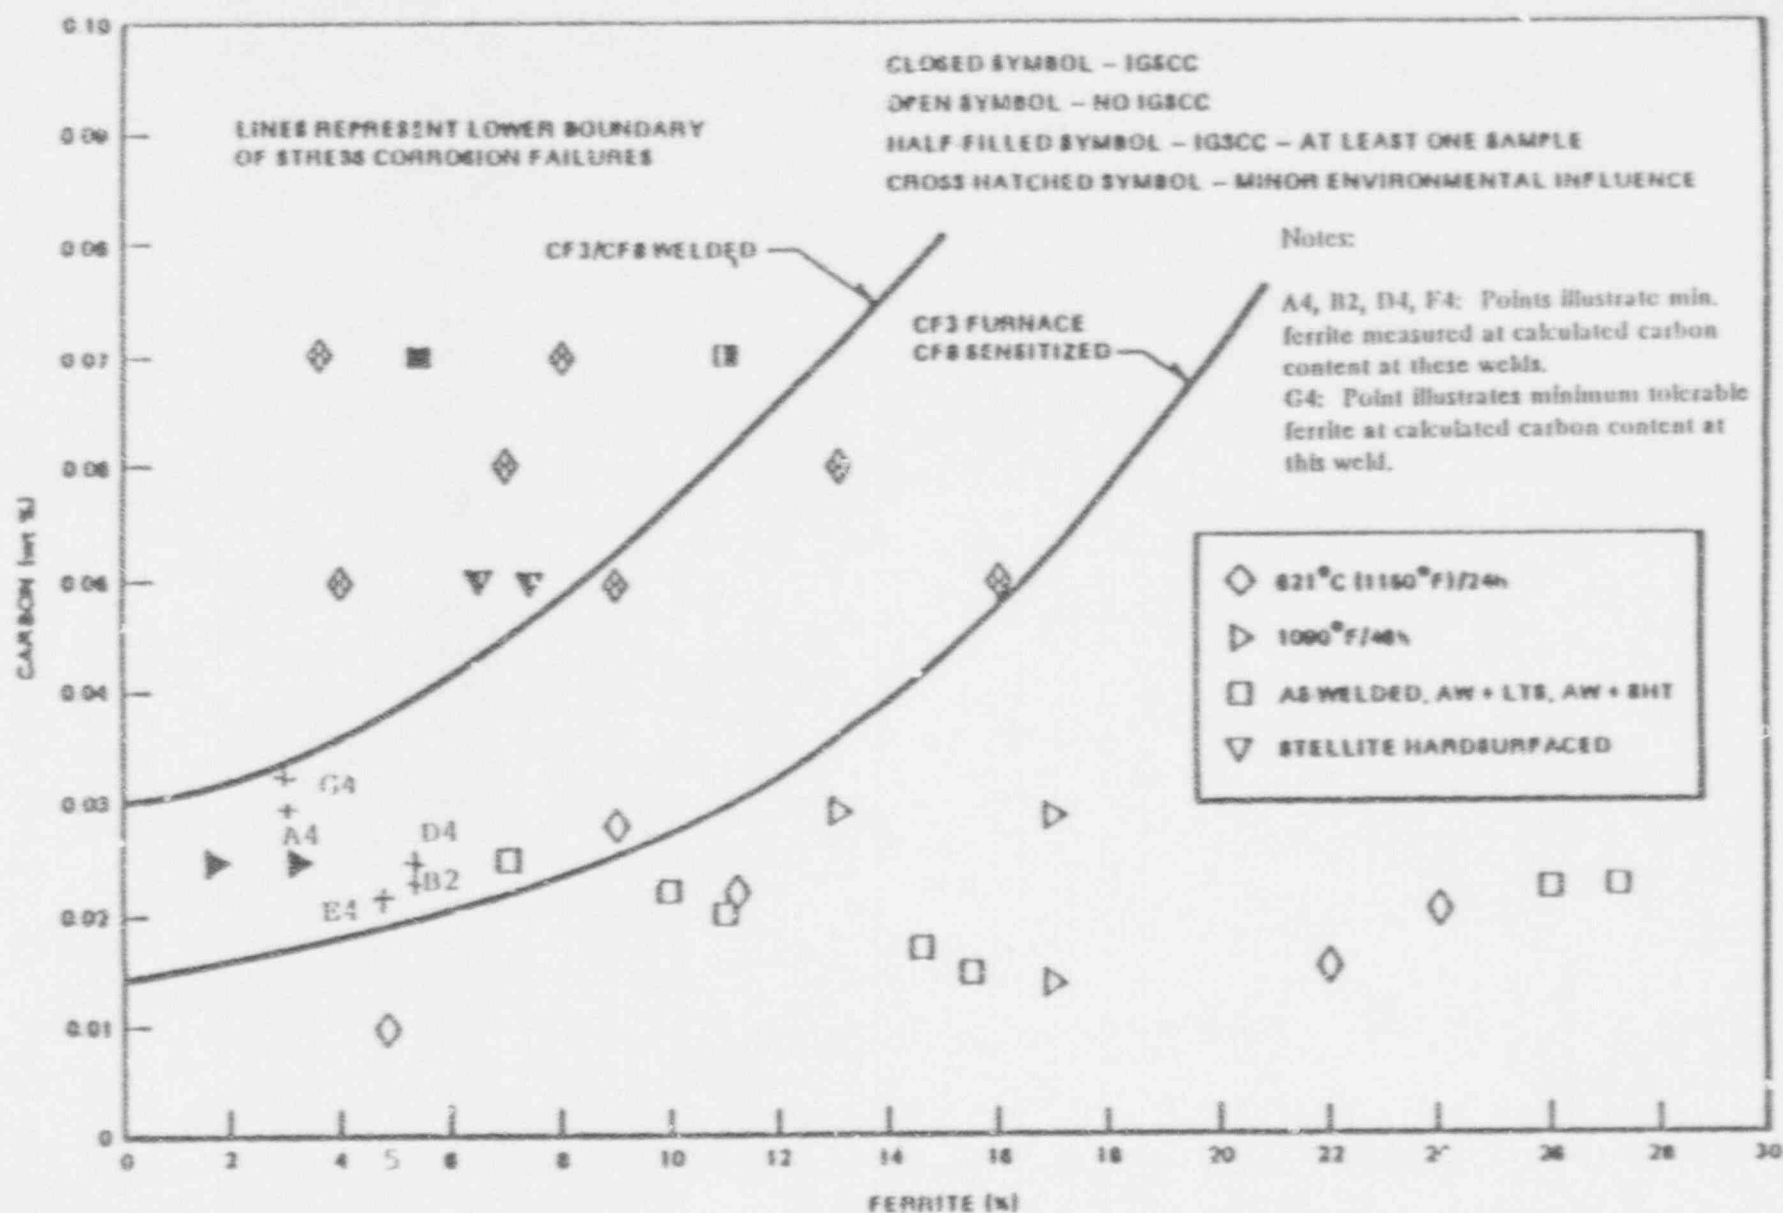
Figure 3-1. IGSCC Resistance Figure from Reference 6, with Worst Case 1991 Hatch Data Points Added

Figure 3-1 includes data points representative of each of the five stainless steel weld overlay locations. These data have been superimposed on the Reference 6 curve and data. These weld overlay data points reflect the as-diluted first layer carbon content, and the lowest

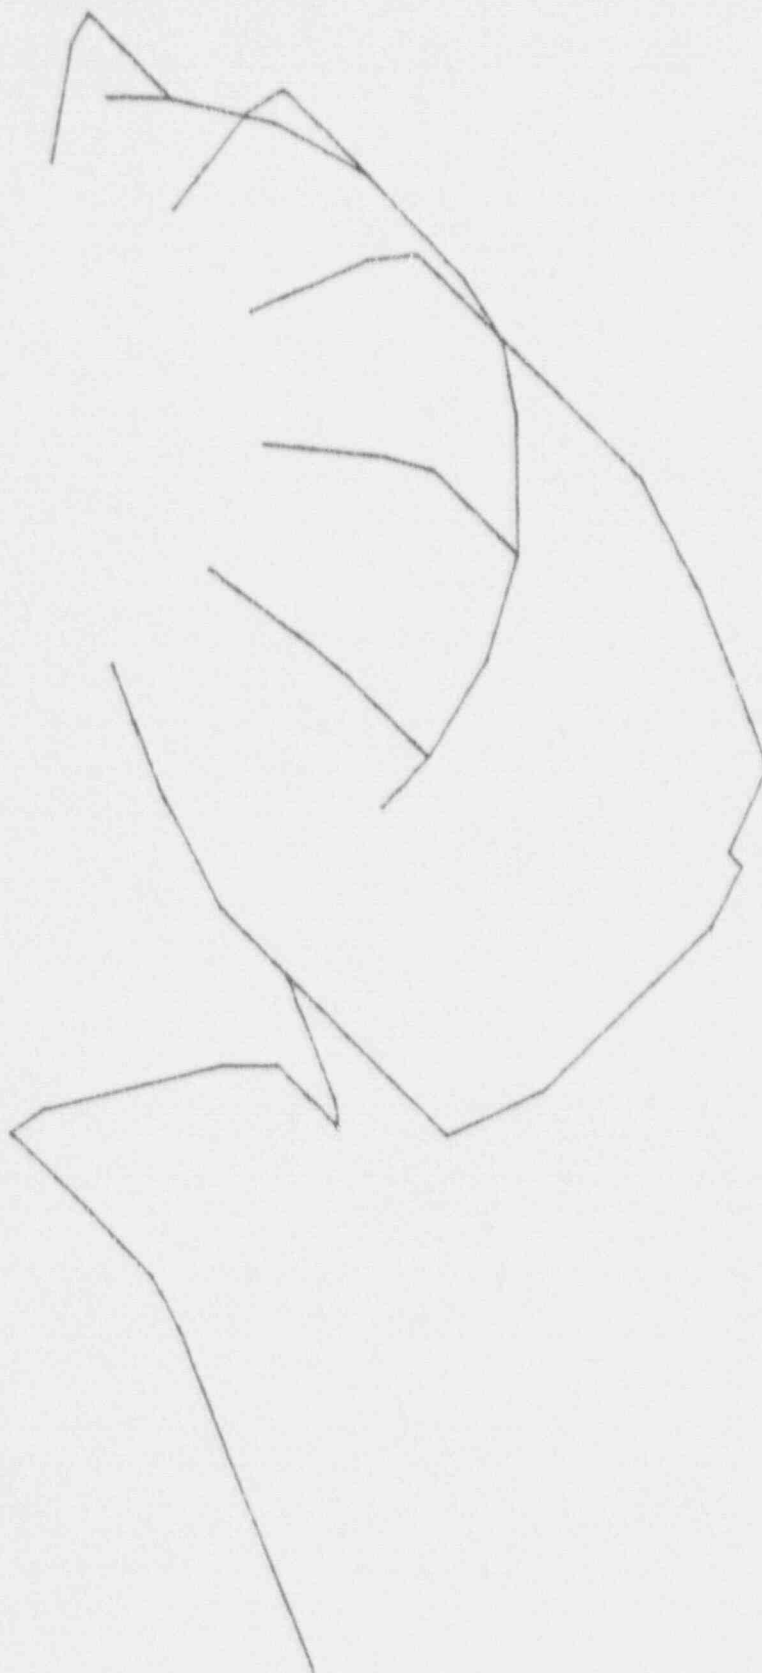
Figure 4-1. Finite Element Models: Loops A and B

Table 4-4 presents the modal response analysis results. The first mode was found to be about 5.52 hz. for the recirculation system without any overlays. With the overlays, the first mode frequency decreases to about 5.49 hz. for a difference of 0.68%. The biggest difference is about 2.1% for mode 20.

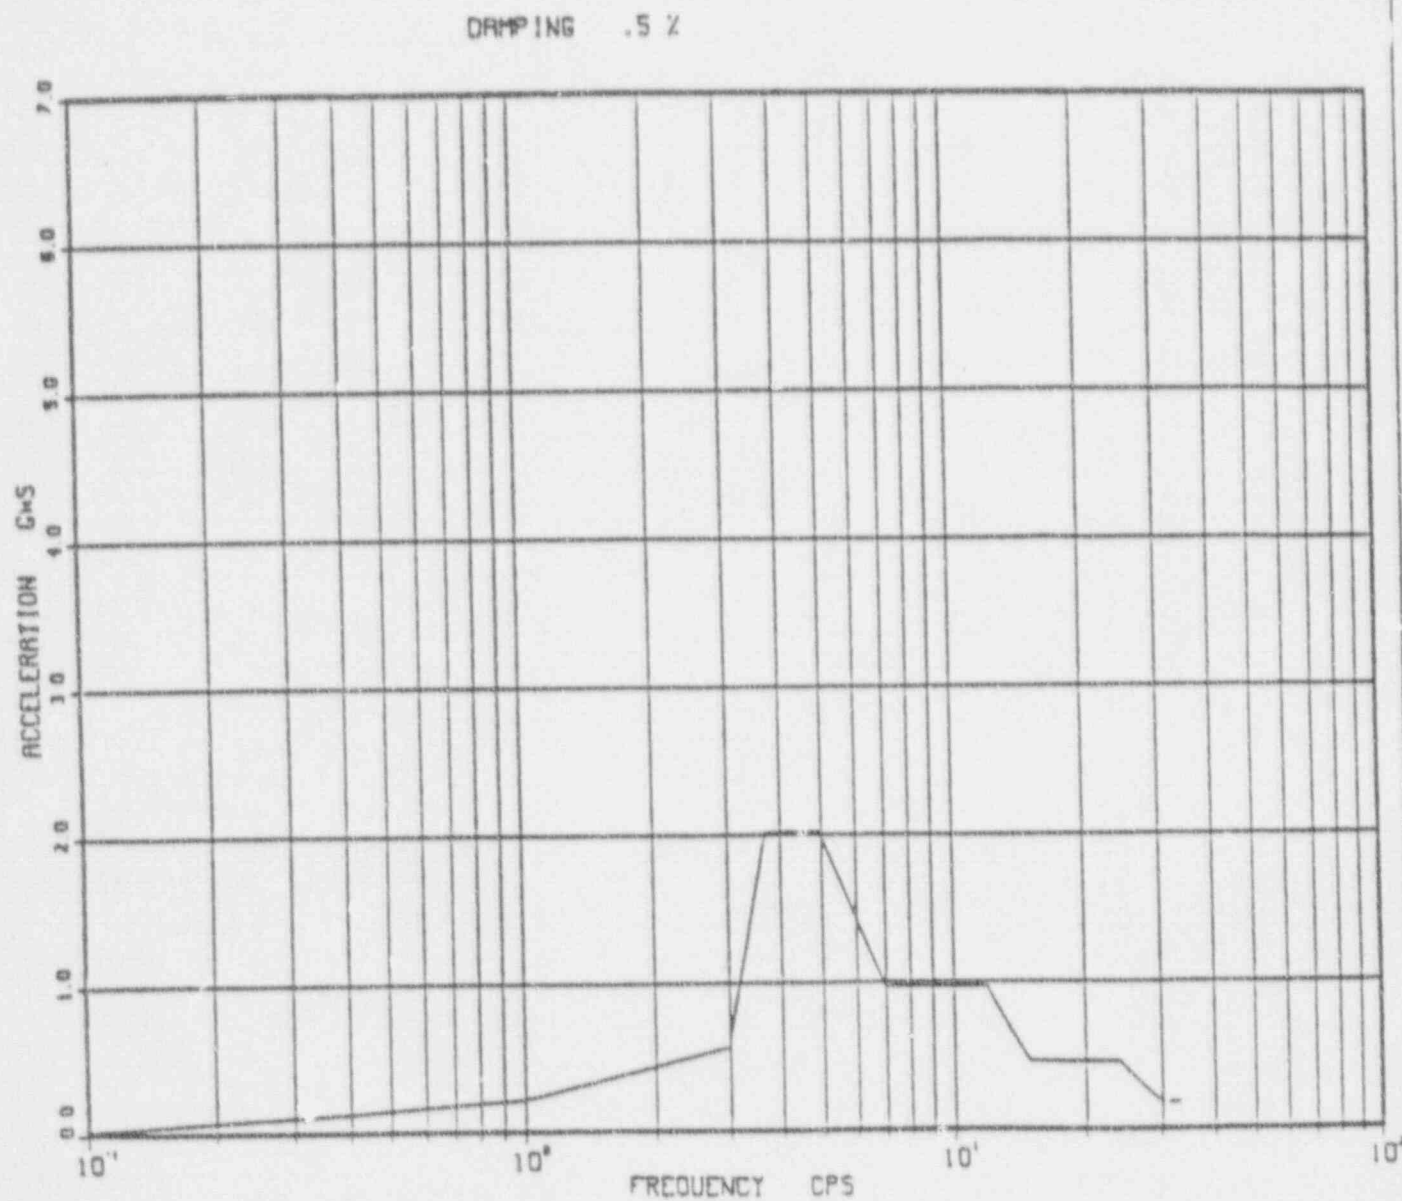
HNP UNIT 1 RPV HORIZONTAL OBC MASS PT 19 CL. 146'-0"

Figure 4-2. Hatch Seismic Response Spectra: Elev. 146 ft.

Figures 4-2 and 4-3 present the Hatch Unit 1 response spectra at reactor vessel elevations 146 ft. and 172 ft. They both show a peak response at a frequency range of about 3.5 hz. to 5 hz. With the first mode of 5.52 hz. when there are no overlays, the response is very close to the peak of the spectrum. Even though a decrease in the mode frequency would correspond to an increased response for the given spectrum, the magnitude of the decrease in the first mode frequency is so small that it would not cause a significant change in the response. With only about 50% of the welds overlaid, the change in the first mode frequency would be even smaller. Therefore, it is concluded that the overlays, either in the current or any imagined future configuration, would have a negligible effect on the dynamic analysis of the system.

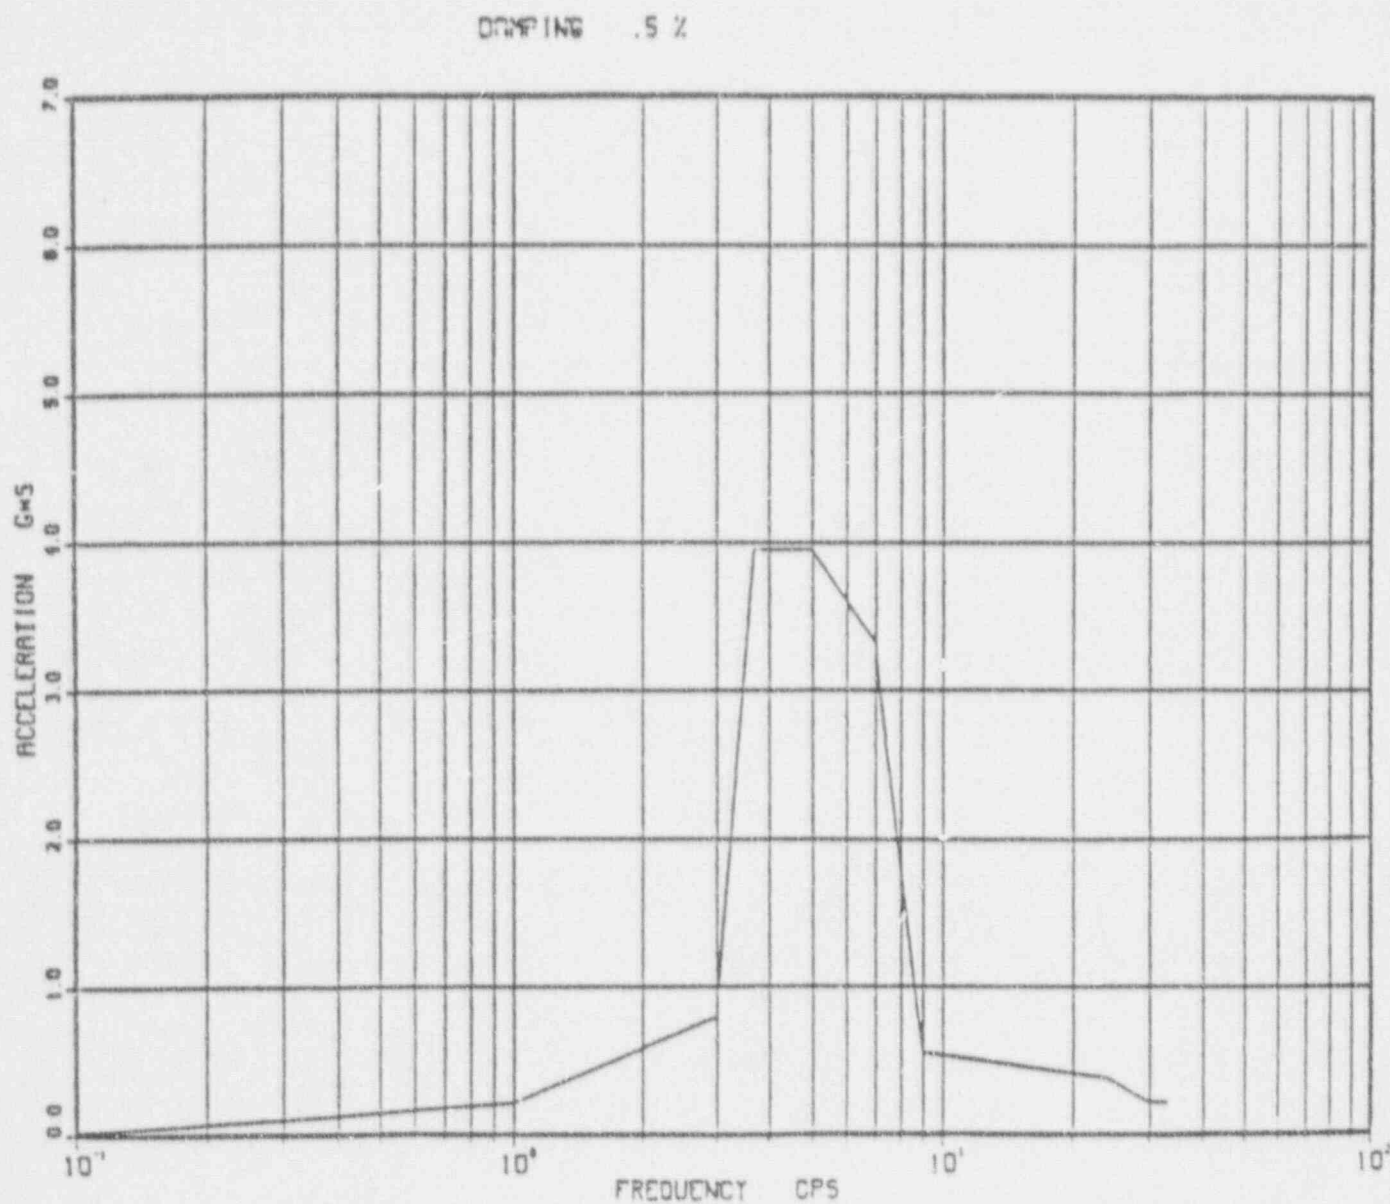
HNP UNIT 1 RPV HORIZONTAL OBC MASS PT 20 CL. 172 -0

Figure 4-3. Hatch Seismic Response Spectra: Elev. 172 ft.

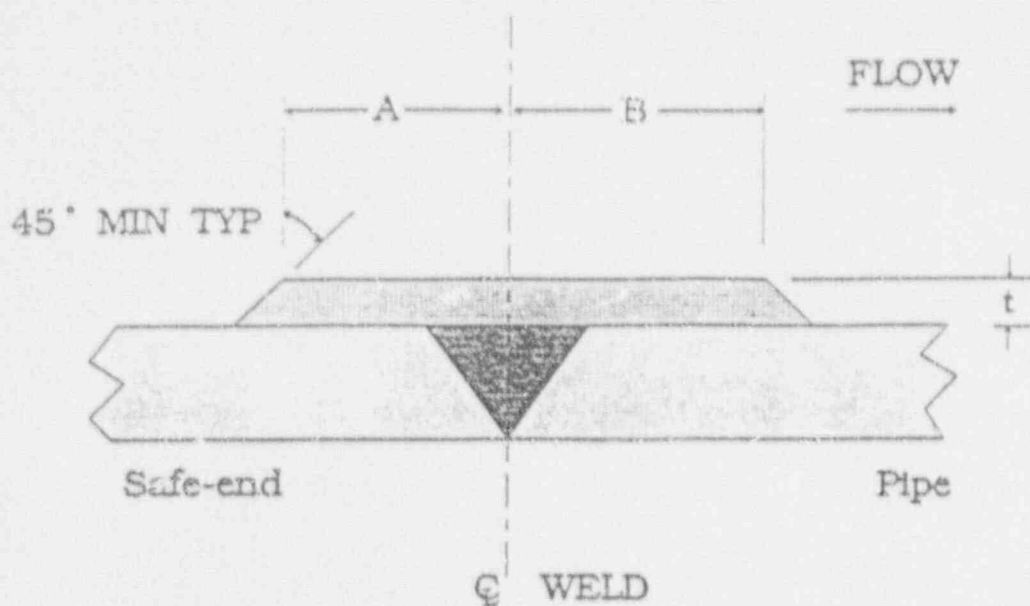
STRUCTURAL INTEGRITY ASSOCIATES, INC.
File No: GPCO-20Q-401		
Drawing No: GPCO-20Q-07	Title: Standard Weld Overlay Design	Sheet <u>2</u> of <u>2</u>

WELD NUMBER	FLAW CHARACTERIZATION	DESIGN DIMENSIONS			COMMENTS
		t	A	B	
1B31-1RC-28B-2	Assumed 360° Circ. 100% throughwall flaw	0.52"	4.0"	4.0"	Overlay Thickness revised.
1	GAM 10/22/91	NGC 10/22/91	NTD 10/22/91		Overlay dimensions based on as-built thickness.
0	HL 6/18/91	HT 6/18/91	REC 6/18/91		
Revision	Prepared by/ Date	Checked by/ Date	Approved by/ Date	COMMENTS	
Job No: GPCO-20Q		Plant/Unit

4. First weld layer is to have a measured delta ferrite content greater than 7.5 FN. This requirement does not apply to the final weld layer.
5. Design thickness includes no allowance for surface conditioning operations to facilitate UT inspections.

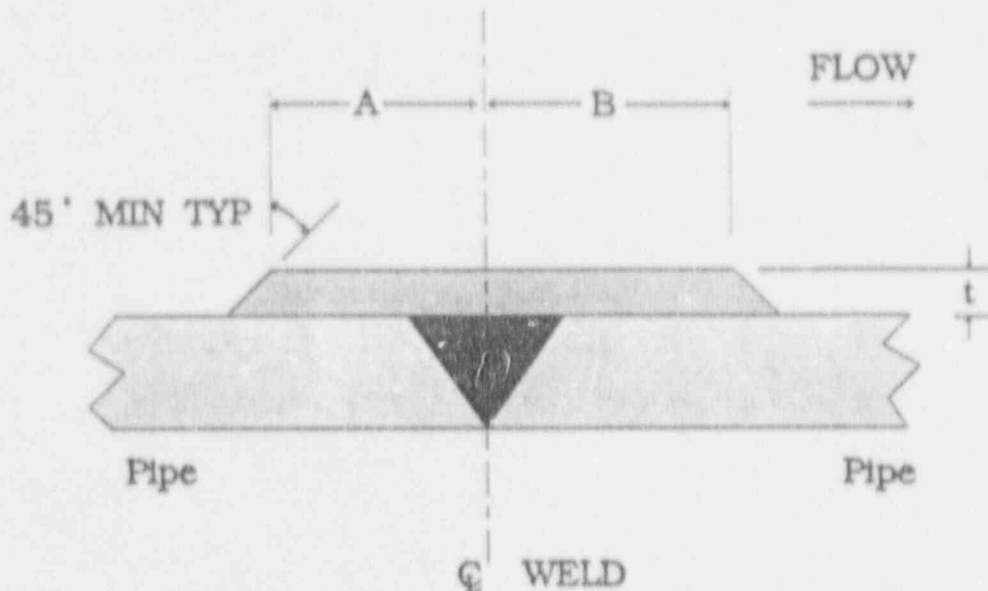
STRUCTURAL INTEGRITY ASSOCIATES, INC.
File No: GPCO-20Q-401		
Drawing No: GPCO-20Q-13	Title: Standard Weld Overlay Design	Sheet <u>2</u> of <u>2</u>

WELD NUMBER	FLAW CHARACTERIZATION	DESIGN DIMENSIONS			COMMENTS
		t	A	B	
1E11-1RHR-20B-D-4	Ass. ned 360° Circ. 100% throughwall flaw	0.36"	3.0"	3.0"	
0	11/18/91	6/18/91	6/18/91	6/18/91	
Revision	Prepared by/ Date	Checked by/ Date	Approved by/ Date	COMMENTS	
Job No: GPCO-20Q		Plant/Unit

4. First weld layer is to have a measured delta ferrite content greater than 7.5 FN. This requirement does not apply to the final weld layer.
5. Design thickness includes no allowance for surface conditioning operations to facilitate UT inspections.

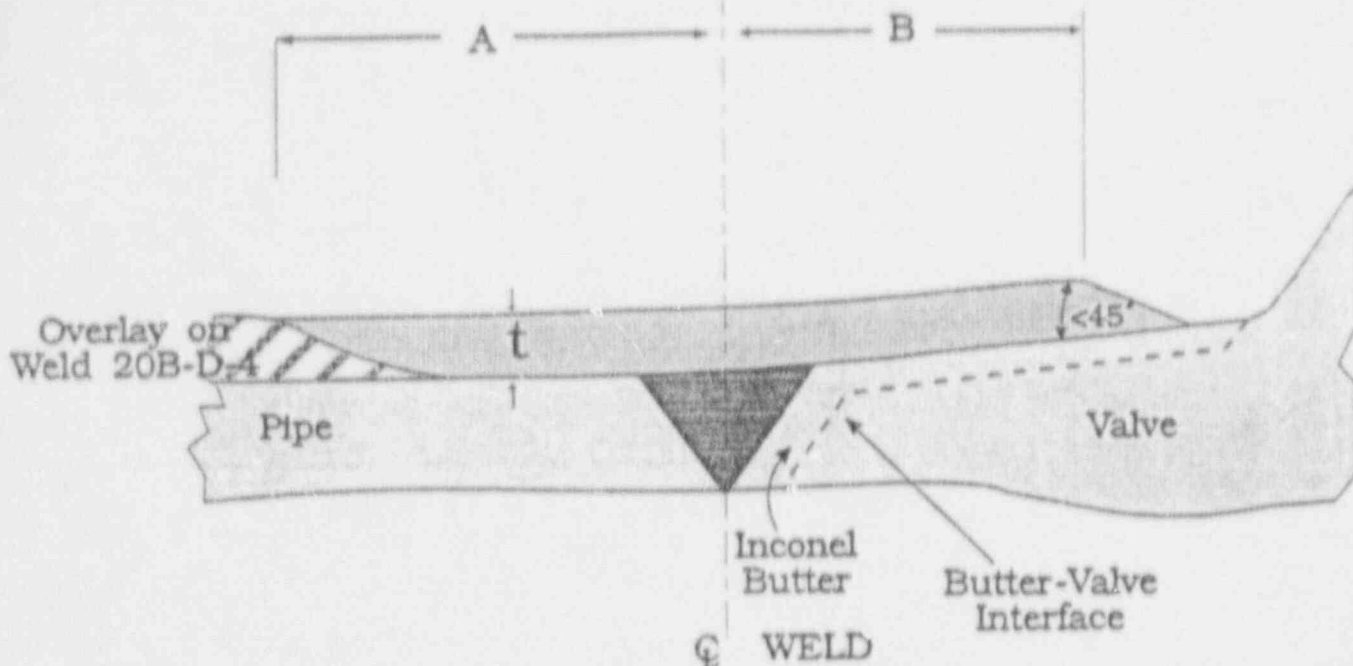
STRUCTURAL INTEGRITY ASSOCIATES, INC.
File No: GPCO-20Q-401		
Drawing No: GPCO-20Q-14	Title: Standard Weld Overlay Design	Sheet <u>2</u> of <u>2</u>

WELD NUMBER	FLAW CHARACTERIZATION	DESIGN DIMENSIONS			COMMENTS
		t	A	B	
1E11-1RHR-20B-D-5	Assumed 360° Circ. 100% throughwall flaw	0.33"	Note 1	3"	
3	HLD 2/17/92	GH/B 2/17/92	GH/B 2/17/92	GH/B 2/17/92	Revised to show Inconel butter on valve body transition
2	HLD 11/4/91	GH/B 11/4/91	GH/B 11/4/91	GH/B 11/4/91	Revised to show inspection requirements
1	HLD 11/1/91	GH/B 11/1/91	GH/B 11/1/91	GH/B 11/1/91	Revised to show weld transition detail
0	HLD 6/18/91	GH/B 6/18/91	GH/B 6/18/91	GH/B 6/18/91	
Revision	Prepared by/ Date	Checked by/ Date	Approved by/ Date	COMMENTS	
Job No: GPCO-20Q		Plant/Unit Georgia Power Company Plant Hatch Unit 1

1. Blend repair into adjacent repair on weld 20B-D-4. Follow contour of transition with all weld layers. Repair should blend into valve body transition at an angle of 45 degrees or less with the component surface.

5. Design thickness includes no allowance for surface conditioning operations to facilitate UT inspections.
6. Design length is that required for structural reinforcement; greater length may be required for effective UT inspection. This is to be determined in the field.

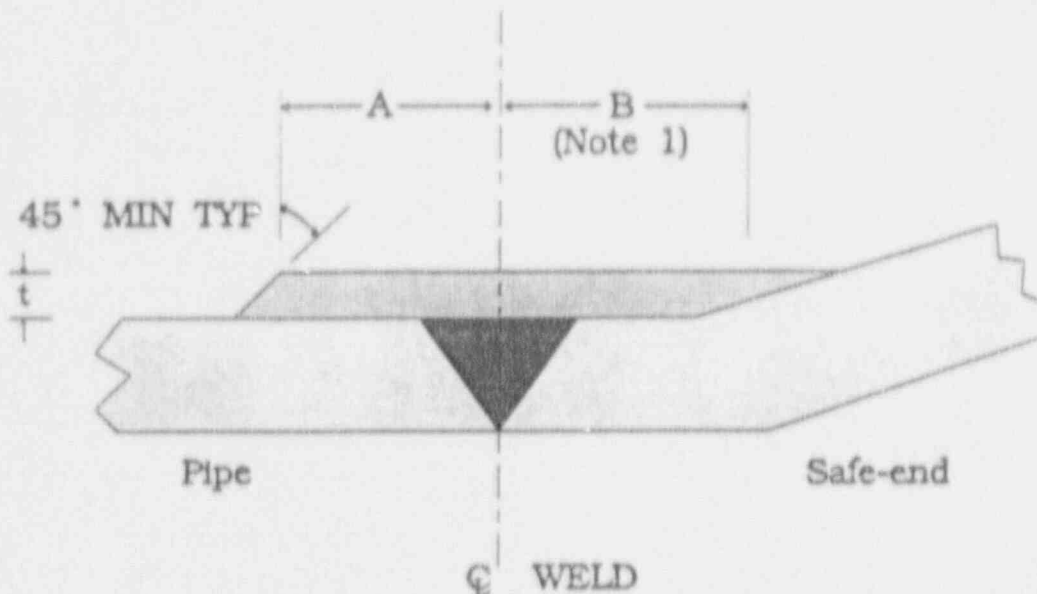
STRUCTURAL INTEGRITY ASSOCIATES, INC.
File No: GPCO-20Q-401			
Drawing No: GPCO-20Q-28	Title: Standard Weld Overlay Design		Sheet <u>2</u> of <u>2</u>

WELD NUMBER	FLAW CHARACTERIZATION	DESIGN DIMENSIONS			COMMENTS
		t	A	B	
1B31-1RC-12AR-G4	Assumed 360° Circ. 100% throughwall flaw	0.26"	2.0"	NA	
1	NLD 10/23/91	QJB 10/23/91	QJB 10/23/91		Revised to show safe-end transition
0	NLD 6/18/91	QJB 6/18/91	QJB 6/18/91		
Revision	Prepared by/ Date	Checked by/ Date	Approved by/ Date	COMMENTS	
Job No: GPCO-20Q		Plant/Unit Georgia Power Company Plant Hatch Unit 1

1. Blend repair into transition.
2. Weld overlay wire is to be type ER308L, with as-deposited delta ferrite content greater than 7.5 FN.
3. Component surface is to be examined by dye penetrant method and accepted as clean prior to overlay application in order to include the entire deposited overlay thickness in meeting the design thickness requirement, per NUREG-0313, Revision 2.

5. First weld layer is to have a measured delta ferrite content greater than 7.5 FN. This requirement does not apply to the final layer.
6. Design thickness includes no allowance for surface conditioning operations to facilitate UT inspections.

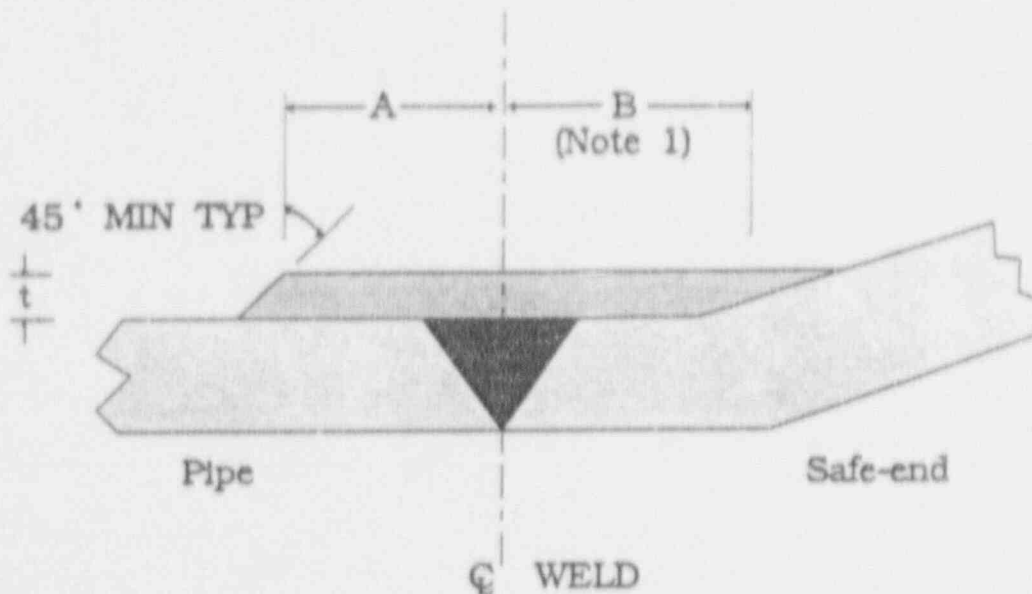
STRUCTURAL INTEGRITY ASSOCIATES, INC.
File No: GPCO-20Q-401		
Drawing No: GPCO-20Q-33	Title: Standard Weld Overlay Design	Sheet <u>2</u> of <u>2</u>

WELD NUMBER	FLAW CHARACTERIZATION	DESIGN DIMENSIONS			COMMENTS
		t	A	B	
1B31-1RC-12BR-E4	Assumed 360° Circ. 100% throughwall flaw	0.27"	2.0"	NA	
1	HLD 10/23/91	CLS 10/25/91	CLS 10/25/91		Revised to show safe-end transition
0	HLD 6/18/91	CLS 6/18/91	CLS 6/18/91		
Revision	Prepared by/ Date	Checked by/ Date	Approved by/ Date	COMMENTS	
Job No: GPCO-20Q		Plant/Unit

1. Blend repair into transition.
2. Weld overlay wire is to be type ER308L, with as-deposited delta ferrite content greater than 7.5 FN.
3. Component surface is to be examined by dye penetrant method and accepted as clean prior to overlay application in order to include the entire deposited overlay thickness in meeting the design thickness requirement, per NUREG-0313, Revision 2.

5. First weld layer is to have a measured delta ferrite content greater than 7.5 FN. This requirement does not apply to the final layer.
6. Design thickness includes no allowance for surface conditioning operations to facilitate UT inspections.

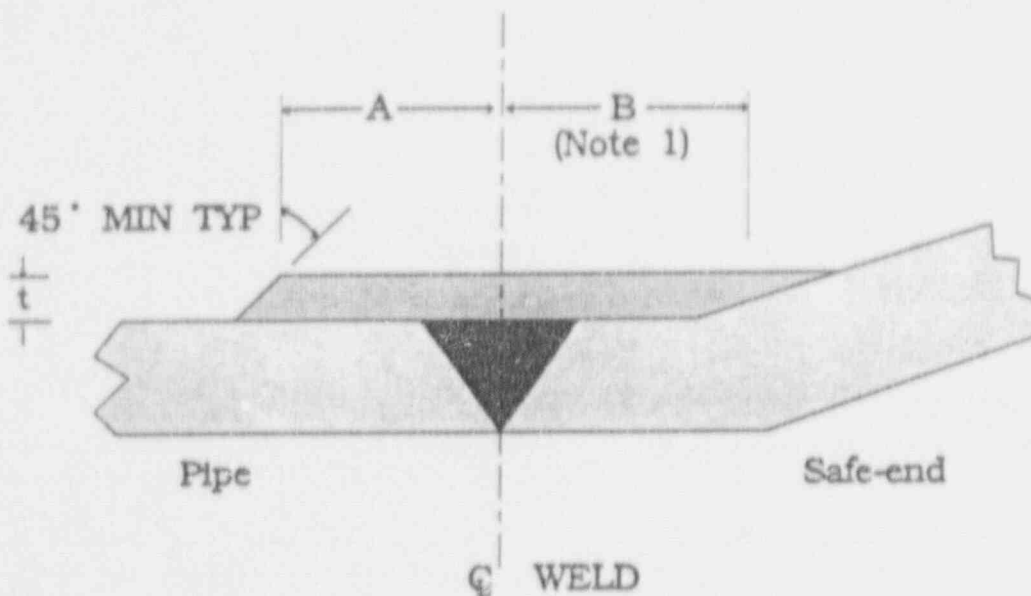
WELD NUMBER	FLAW CHARACTERIZATION	DESIGN DIMENSIONS			COMMENTS
		t	A	B	
1B31-1RC-12BR-A4	Assumed 360° Circ. 100% throughwall flaw	0.27"	2.0"	NA	
1	HLD 10/23/91	GJS 10/23/91	GJS 10/23/91		Revised to show safe-end transition
0	HLD 6/18/91	GJS 6/18/91	GJS 6/18/91		
Revision	Prepared by/ Date	Checked by/ Date	Approved by/ Date	COMMENTS	
Job No:	GPCO-20Q		Plant/Unit

1. Blend repair into transition.
2. Weld overlay wire is to be type ER308L, with as-deposited delta ferrite content greater than 7.5 FN.
3. Component surface is to be examined by dye penetrant method and accepted as clean prior to overlay application in order to include the entire deposited overlay thickness in meeting the design thickness requirement, per NUREG-0313, Revision 2.

5. First weld layer is to have a measured delta ferrite content greater than 7.5 FN. This requirement does not apply to the final layer.
6. Design thickness includes no allowance for surface conditioning operations to facilitate UT inspections.

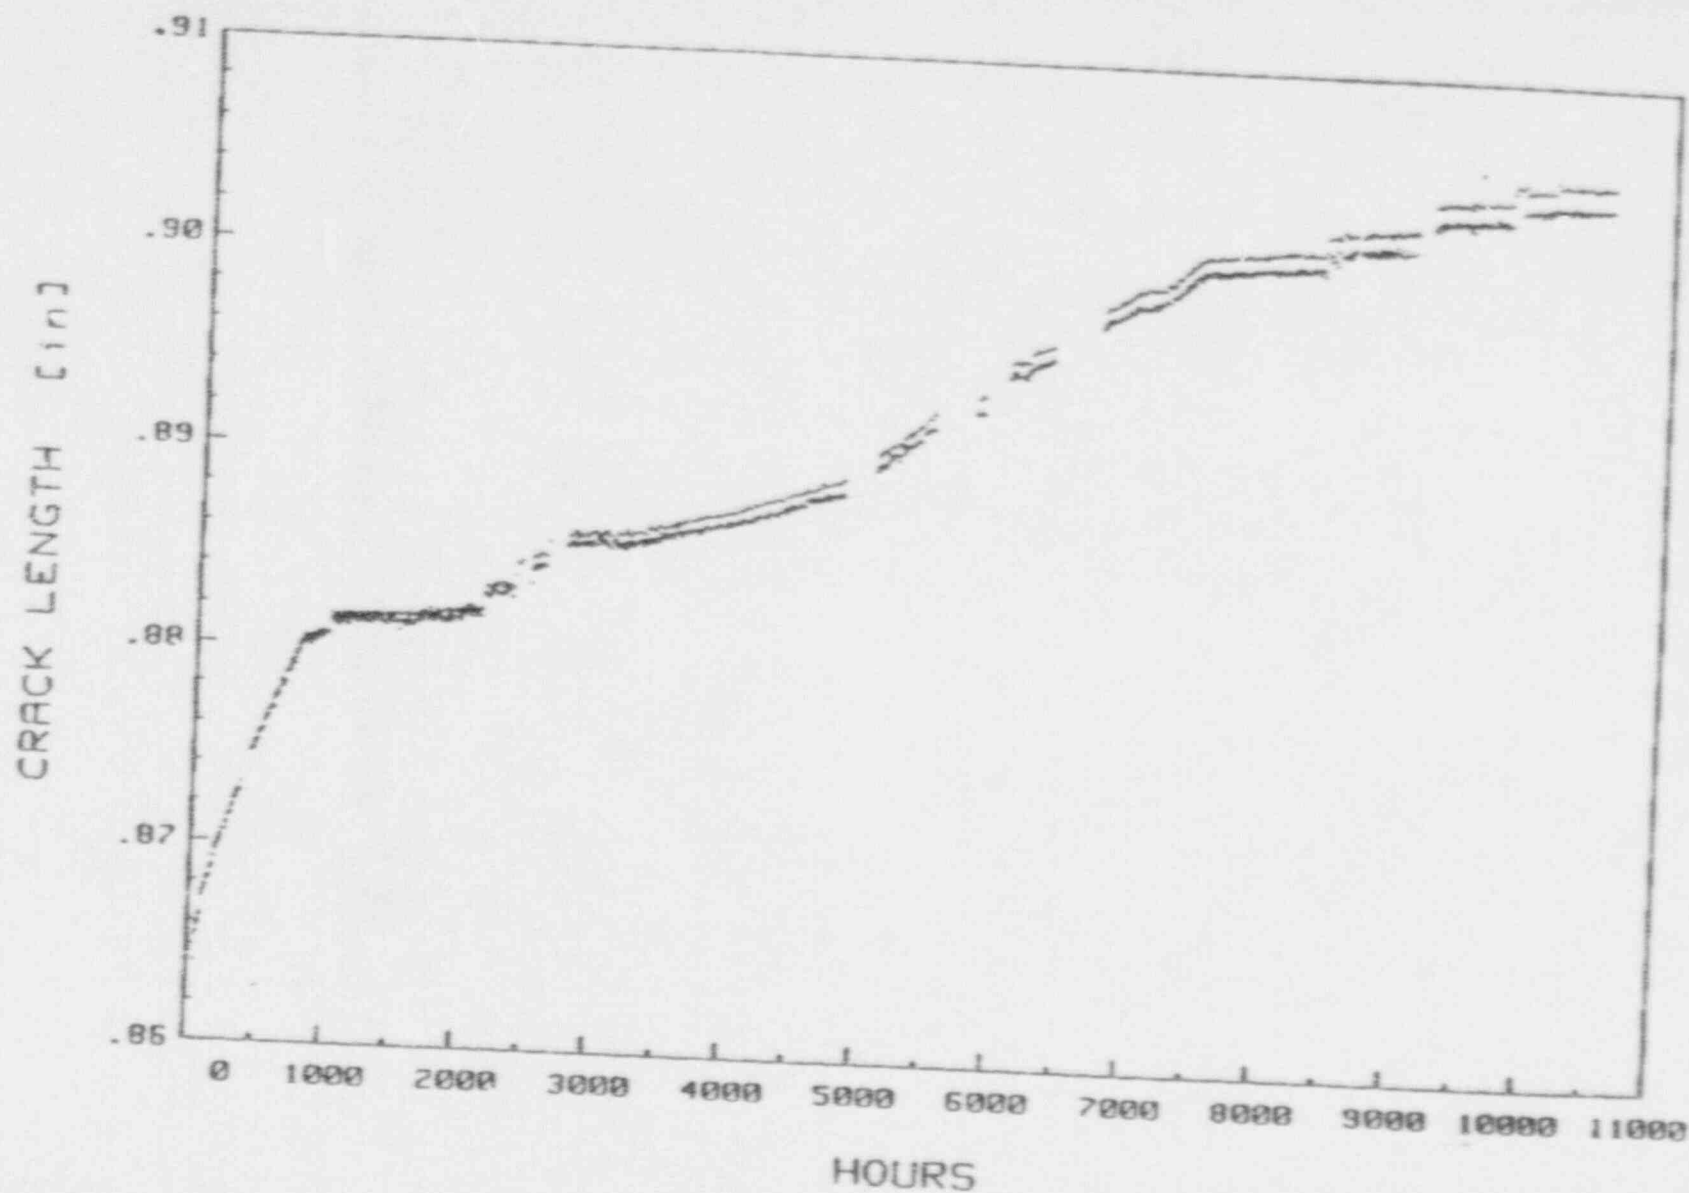
Figure 1. Plant Hatch Unit 1 CAV, Crack Length Versus Time Data, Fuel Cycle 13, Alloy 182, Specimen IMC-76, Stress Intensity 25 ksi/in.

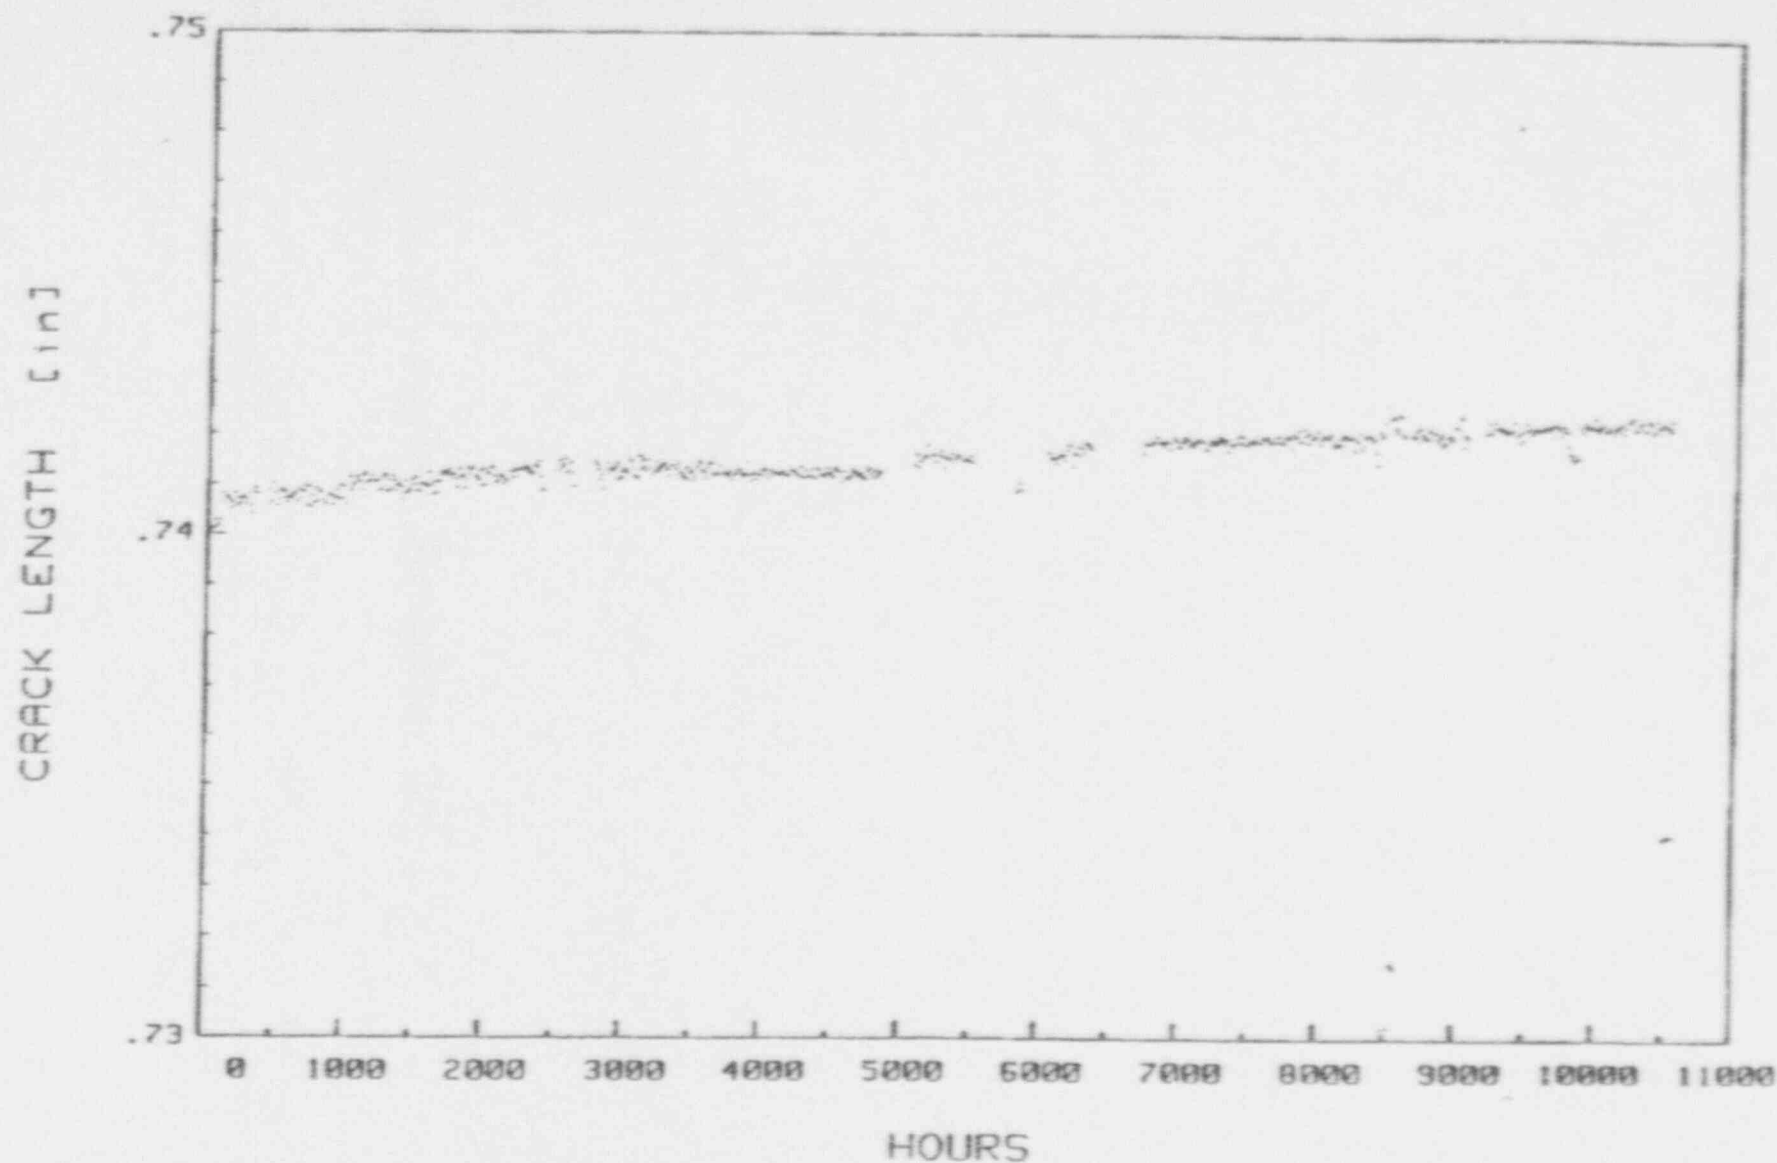
Figure 2. Plant Hatch Unit 1 CAV, Crack Length Versus Time Data, Fuel Cycle 13, Type 304 Stainless Steel (sensitized), Specimen SS-144, Stress Intensity 20 ksi/in.

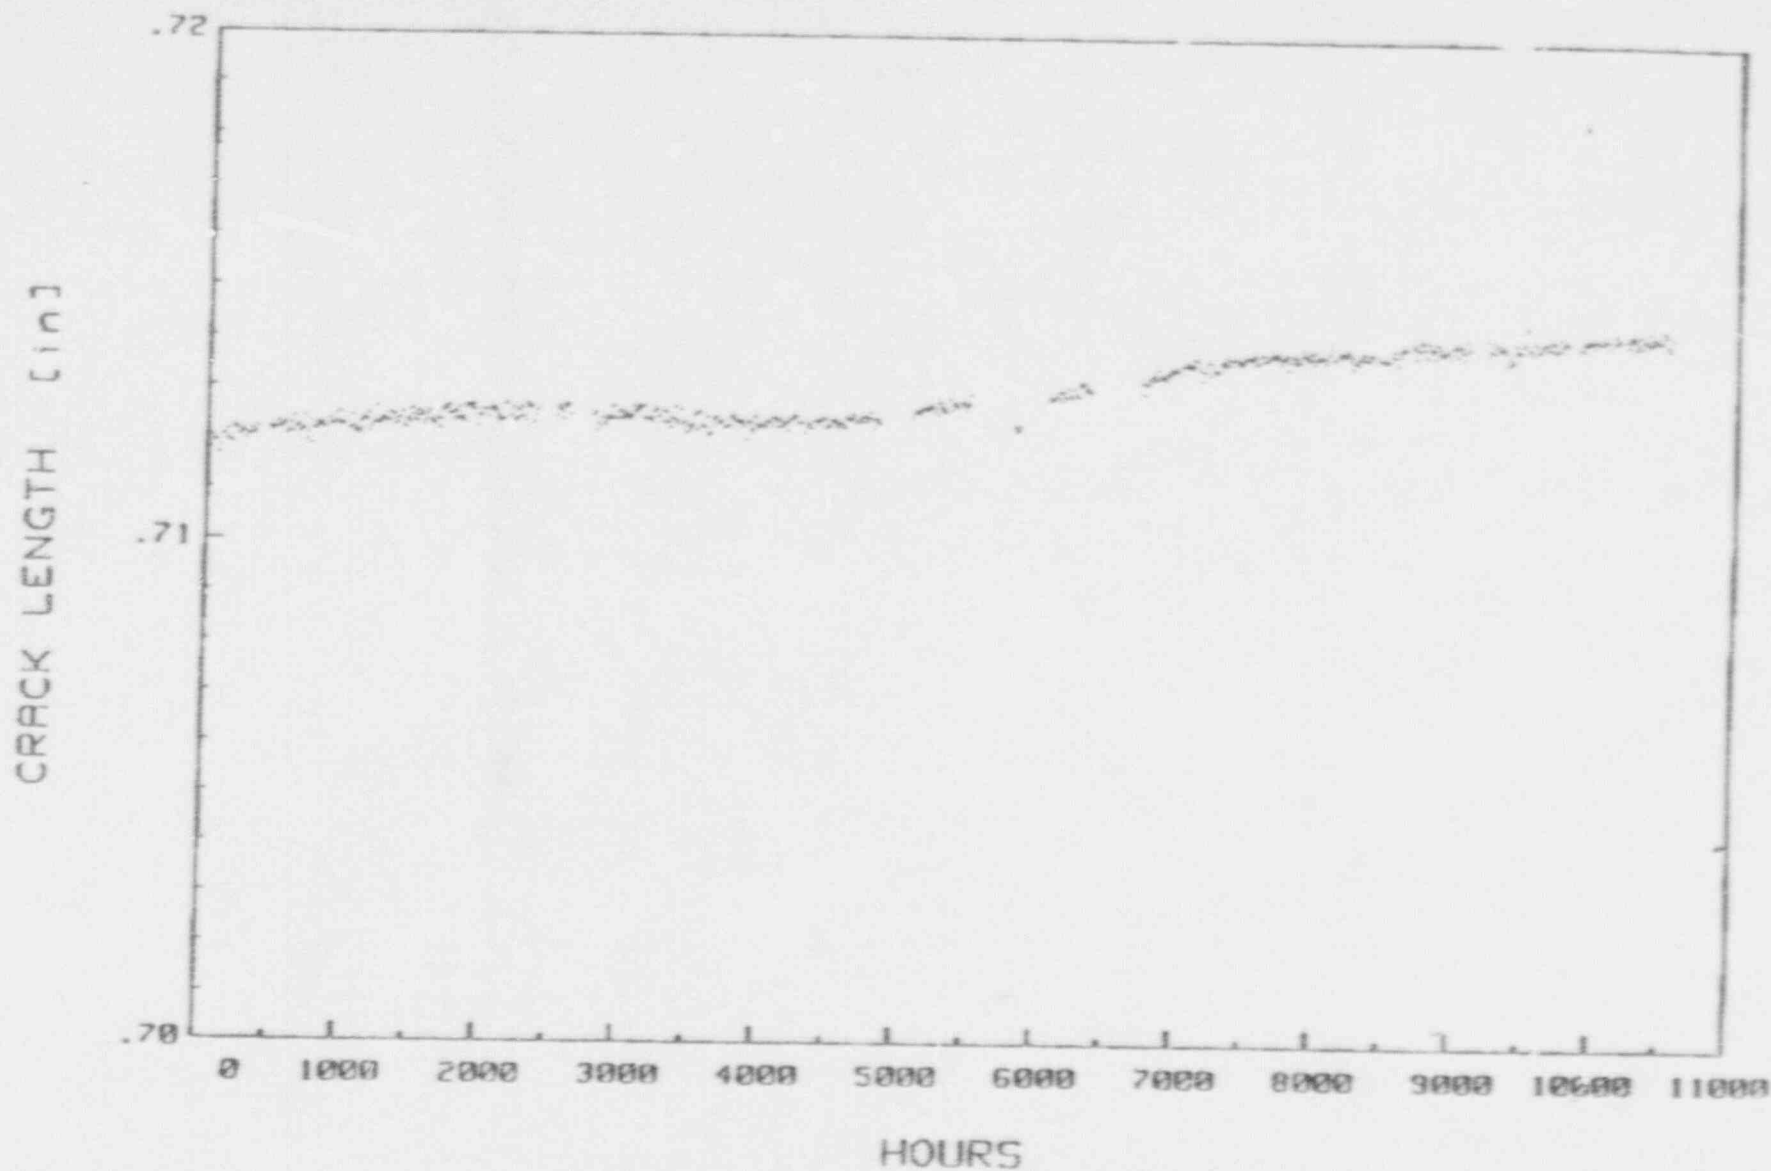
Figure 3. Plant Hatch Unit 1 CAV, Crack Length Versus Time Data, Fuel Cycle 13, Type 316NG Stainless Steel, Specimen SS-126, Stress Intensity 20 ksi/in.

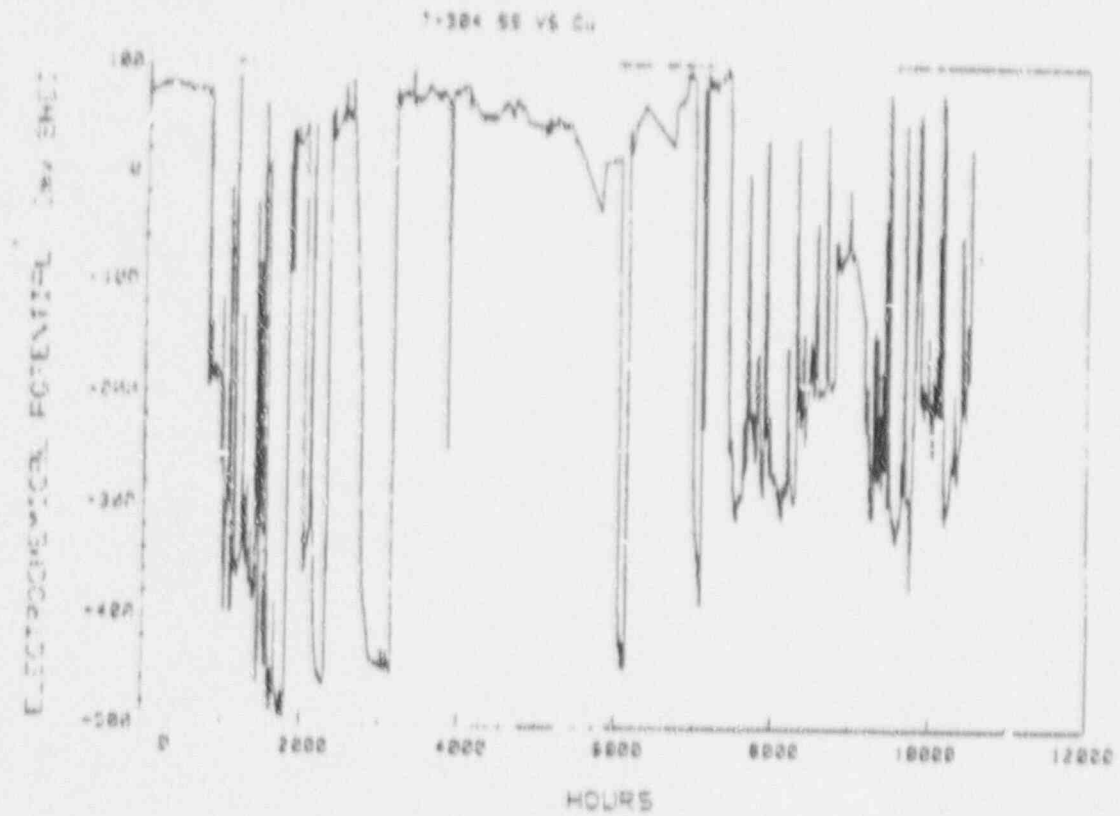
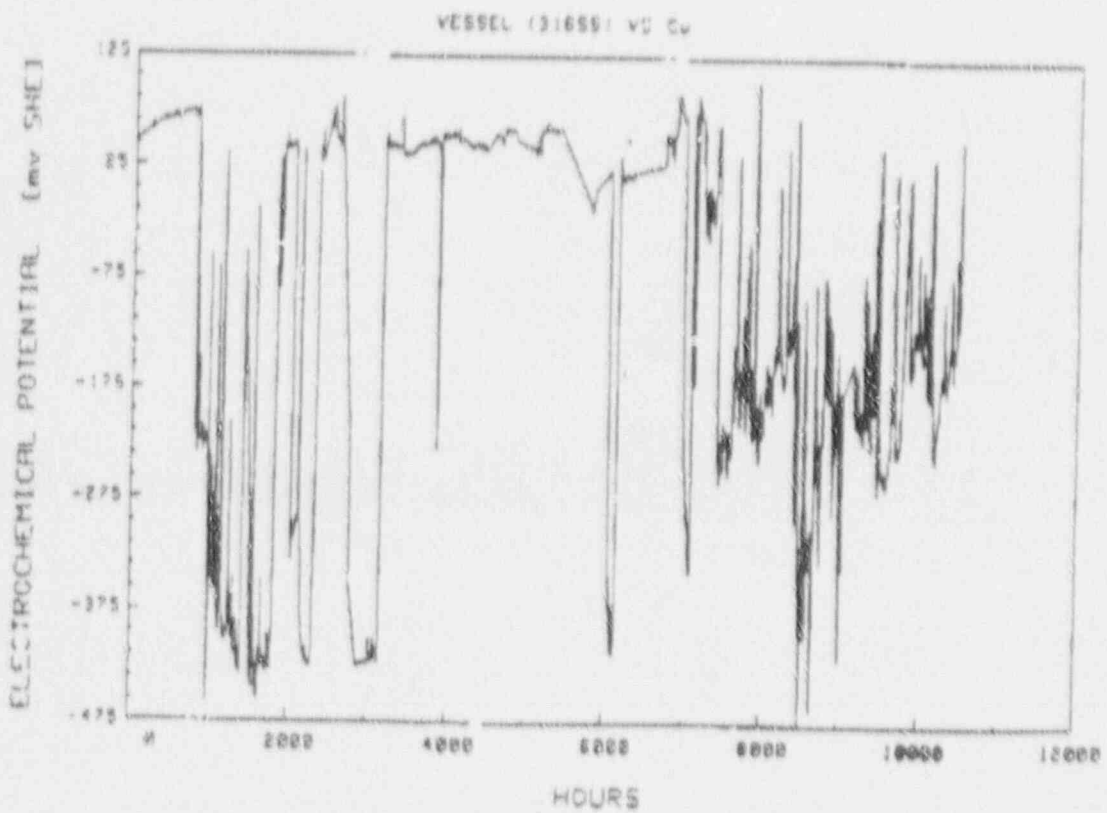
Figure 4. Plant Hatch Unit 1 CAV, Electrochemical Potential (ECP) Data, Fuel Cycle 13.

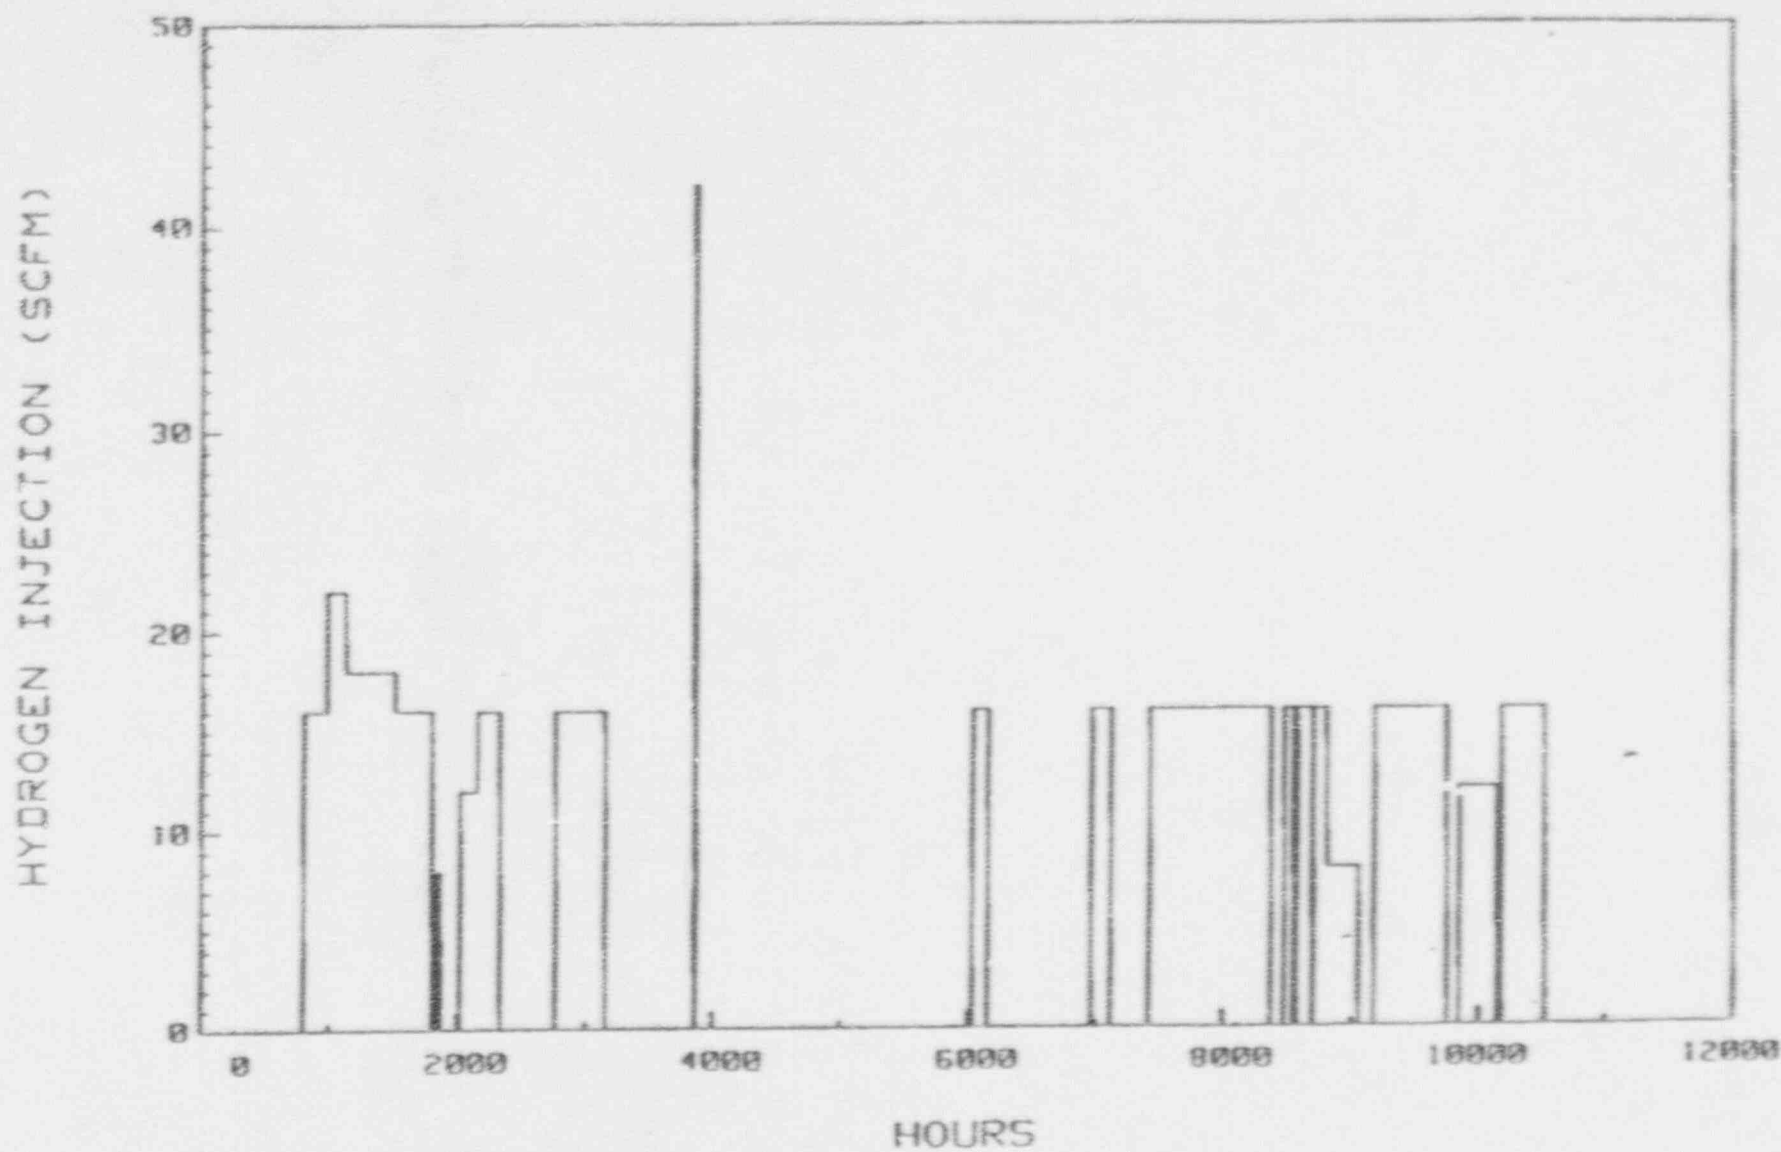
Figure 5. Plant Hatch Unit 1, Hydrogen Addition Rates, Fuel Cycle 13.
