Report No.: SIR-91-077
Revision No.: 3
Project No.: GPCO-20Q-2
February 1992

IGSCC Flaw Evaluations
and Weld Overlay Activities
During the E. I. Hatch Unit 1
Fall 1991 Outage

Prepared for:
Georgia Power Company

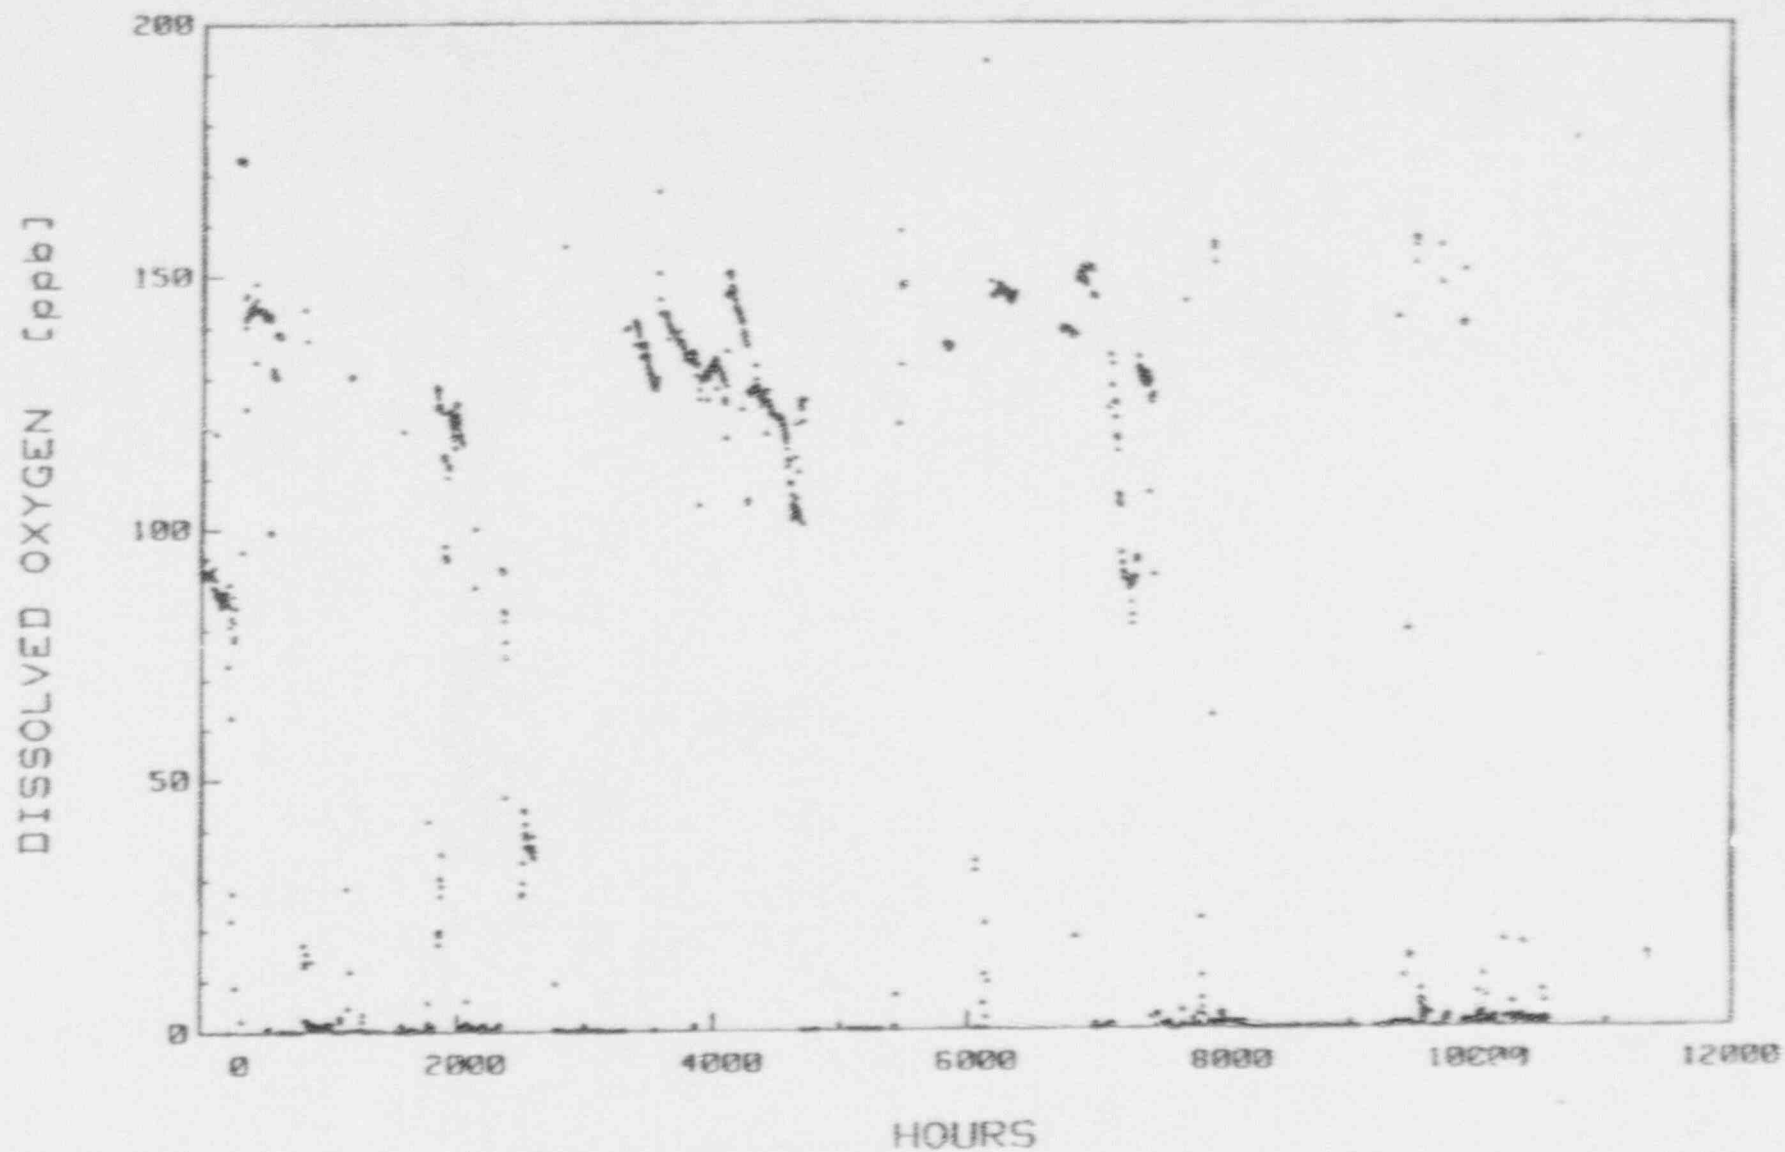
Figure 6. Plant Hatch Unit 1 CAV, Dissolved Oxygen Data, Fuel Cycle 13

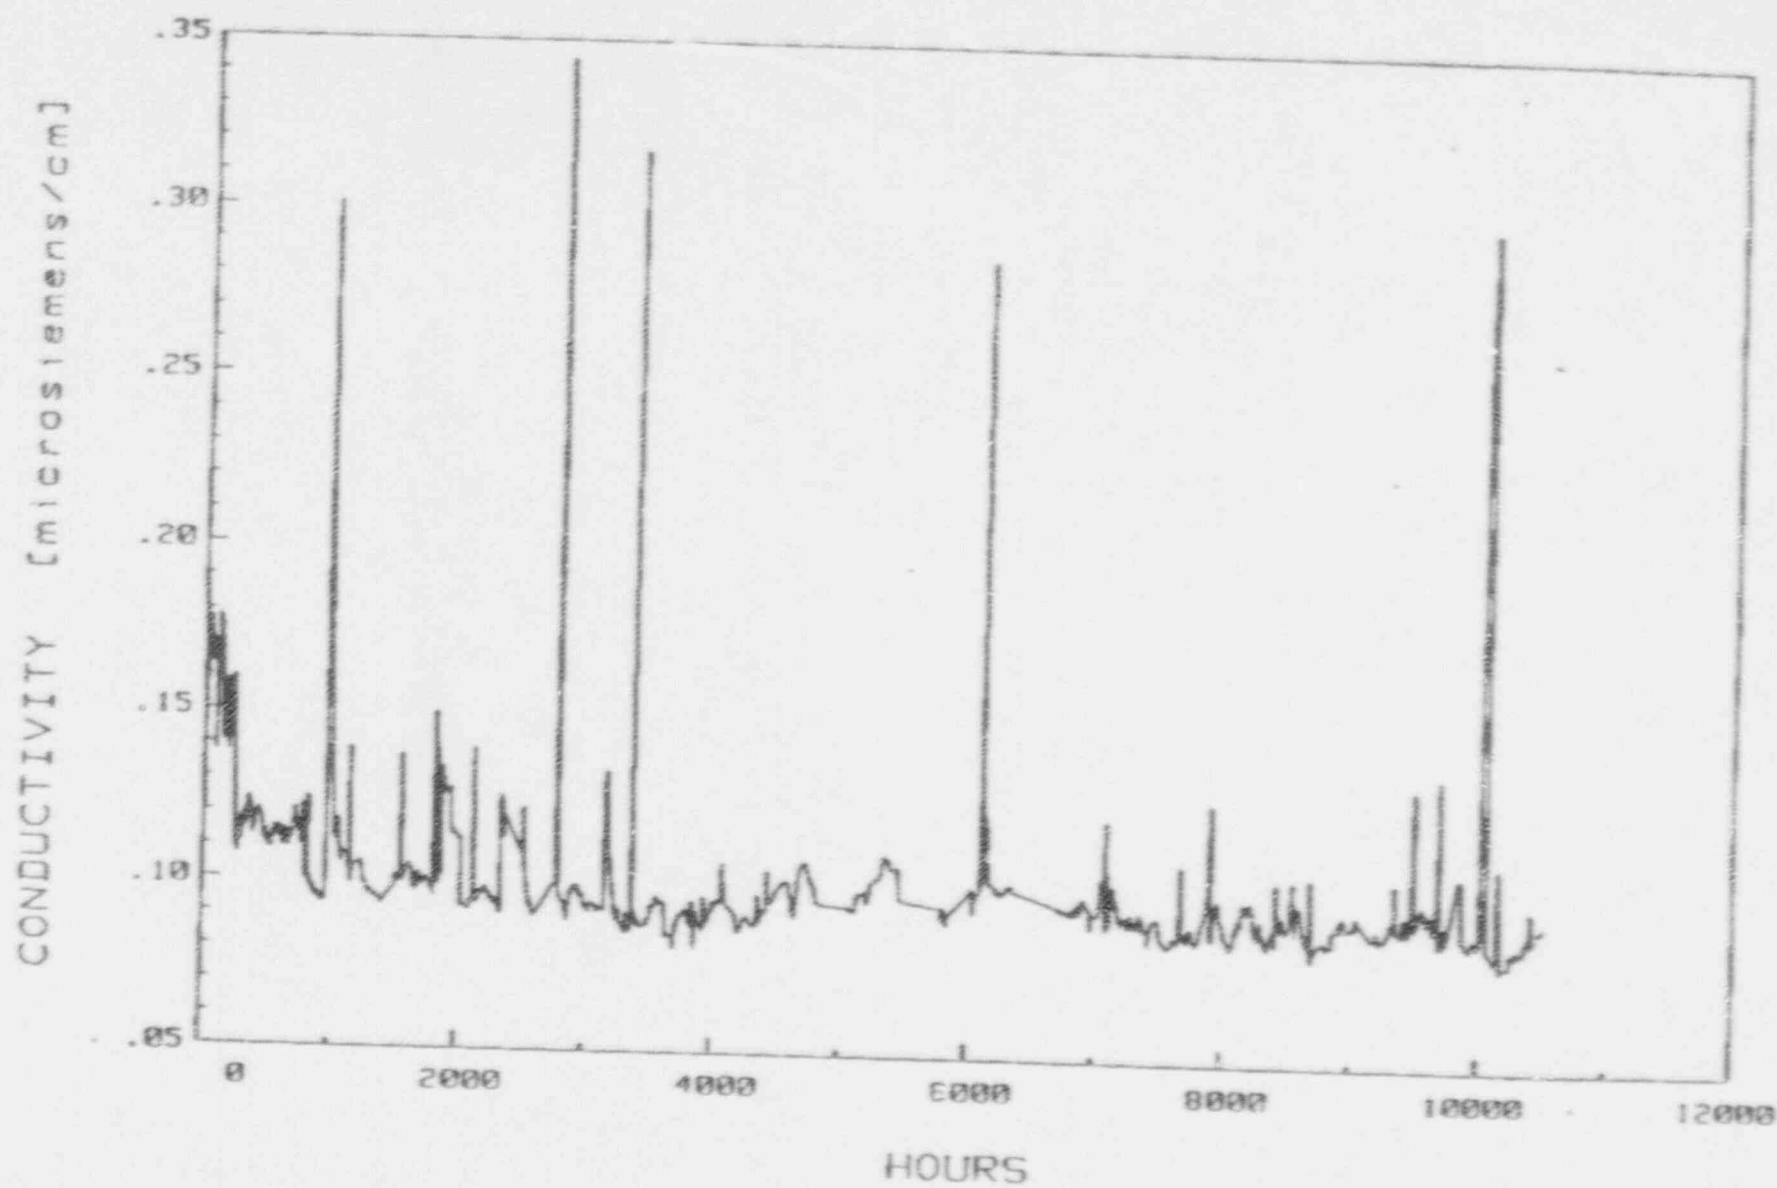
Figure 7. Plant Hatch Unit 1 CAV, Conductivity Data, Fuel Cycle 13.

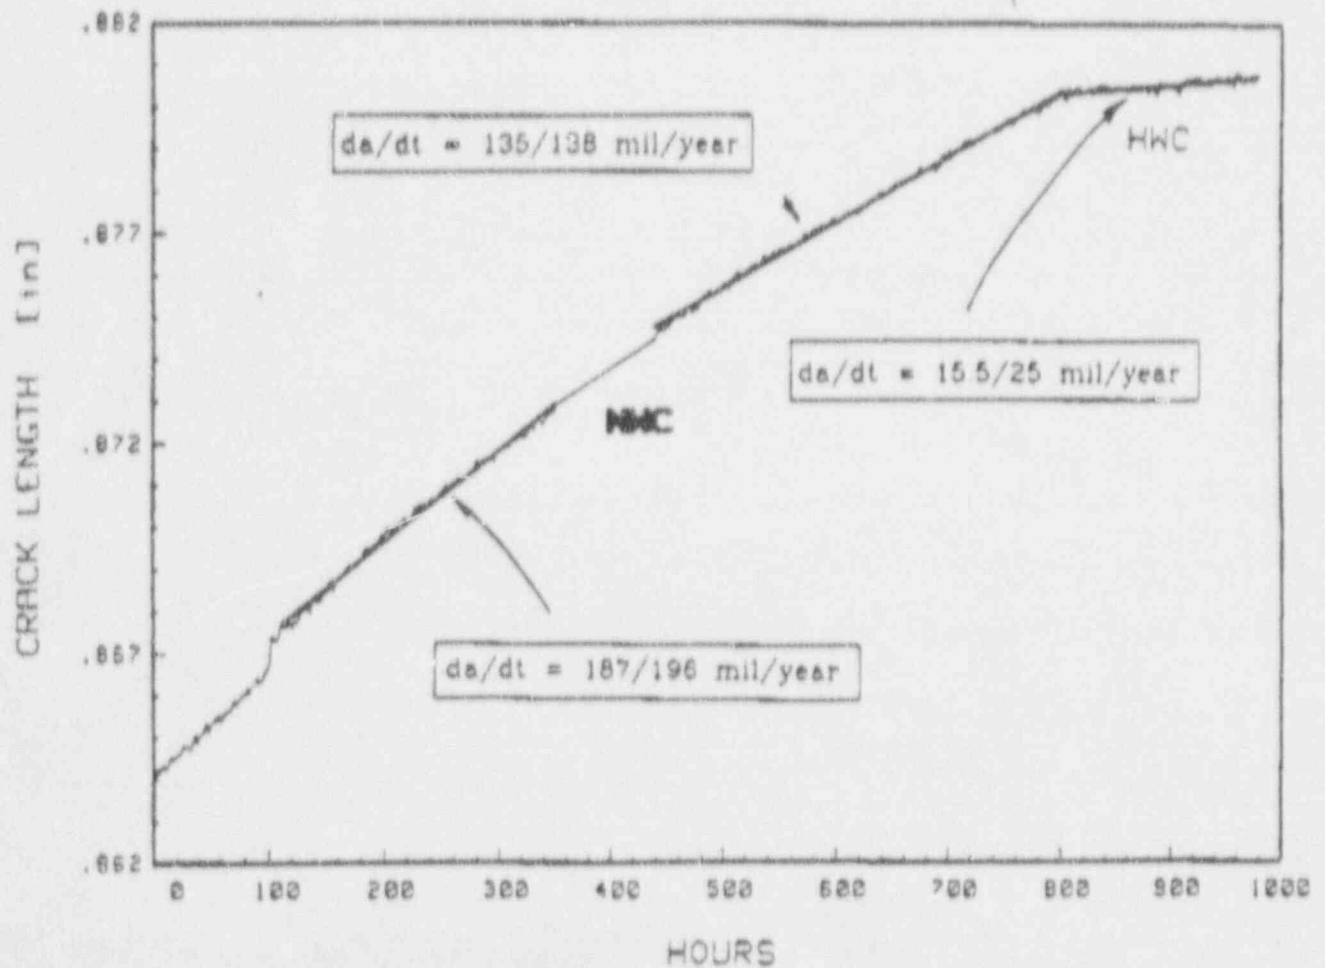
Figure 8. Plant Hatch Unit 1 CAV, Expanded View of Alloy 182 Crack Length Versus Time Data For Initial Application of Hydrogen Water Chemistry.

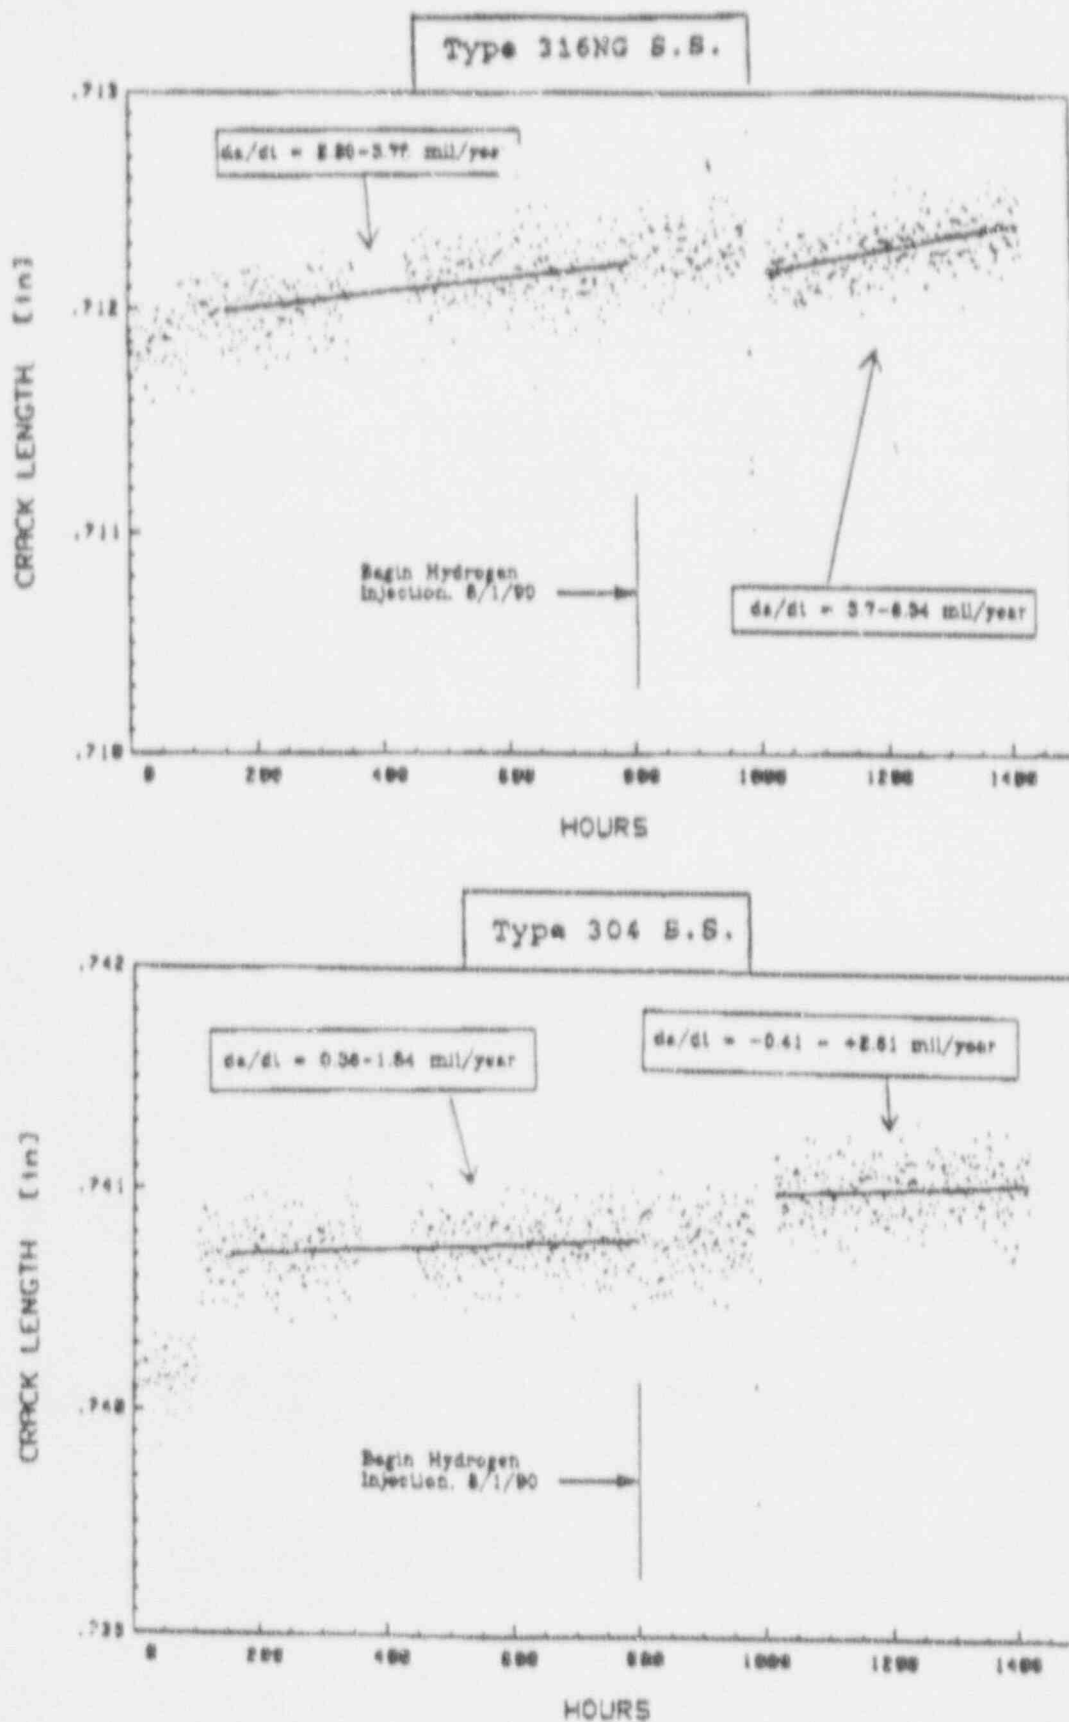
Figure 9. Plant Hatch Unit 1 CAV, Expanded View of Type 304 and 316NG Stainless Steel Crack Length Versus Time Data For Initial Application of Hydrogen Water Chemistry.

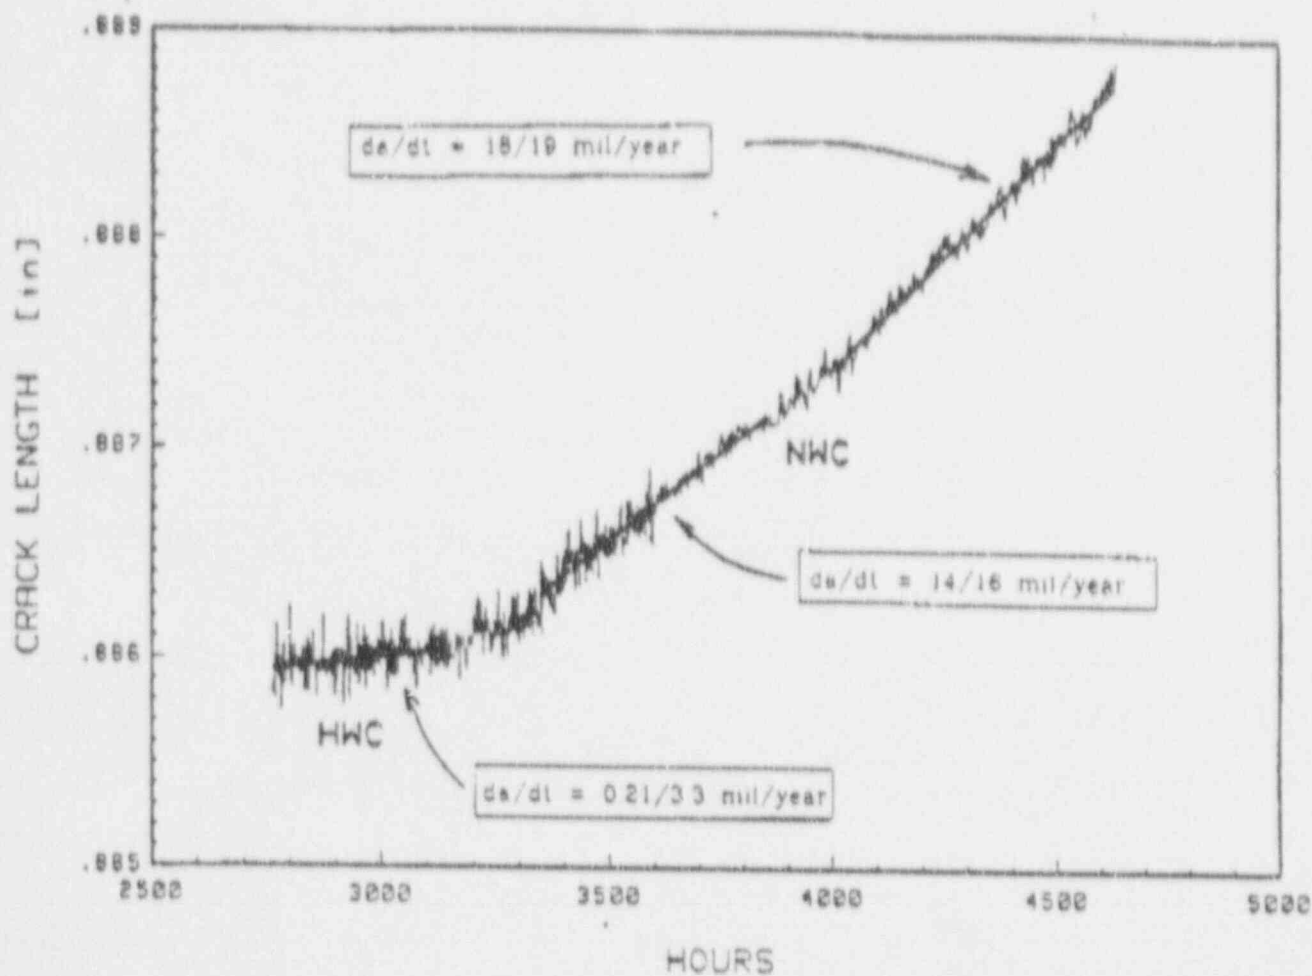
Figure 10. Plant Hatch Unit 1 CAV, Expanded View of Alloy 182 Crack Length Versus Time Data For Time Period After Resumption of Normal Water Chemistry, October/November 1990.

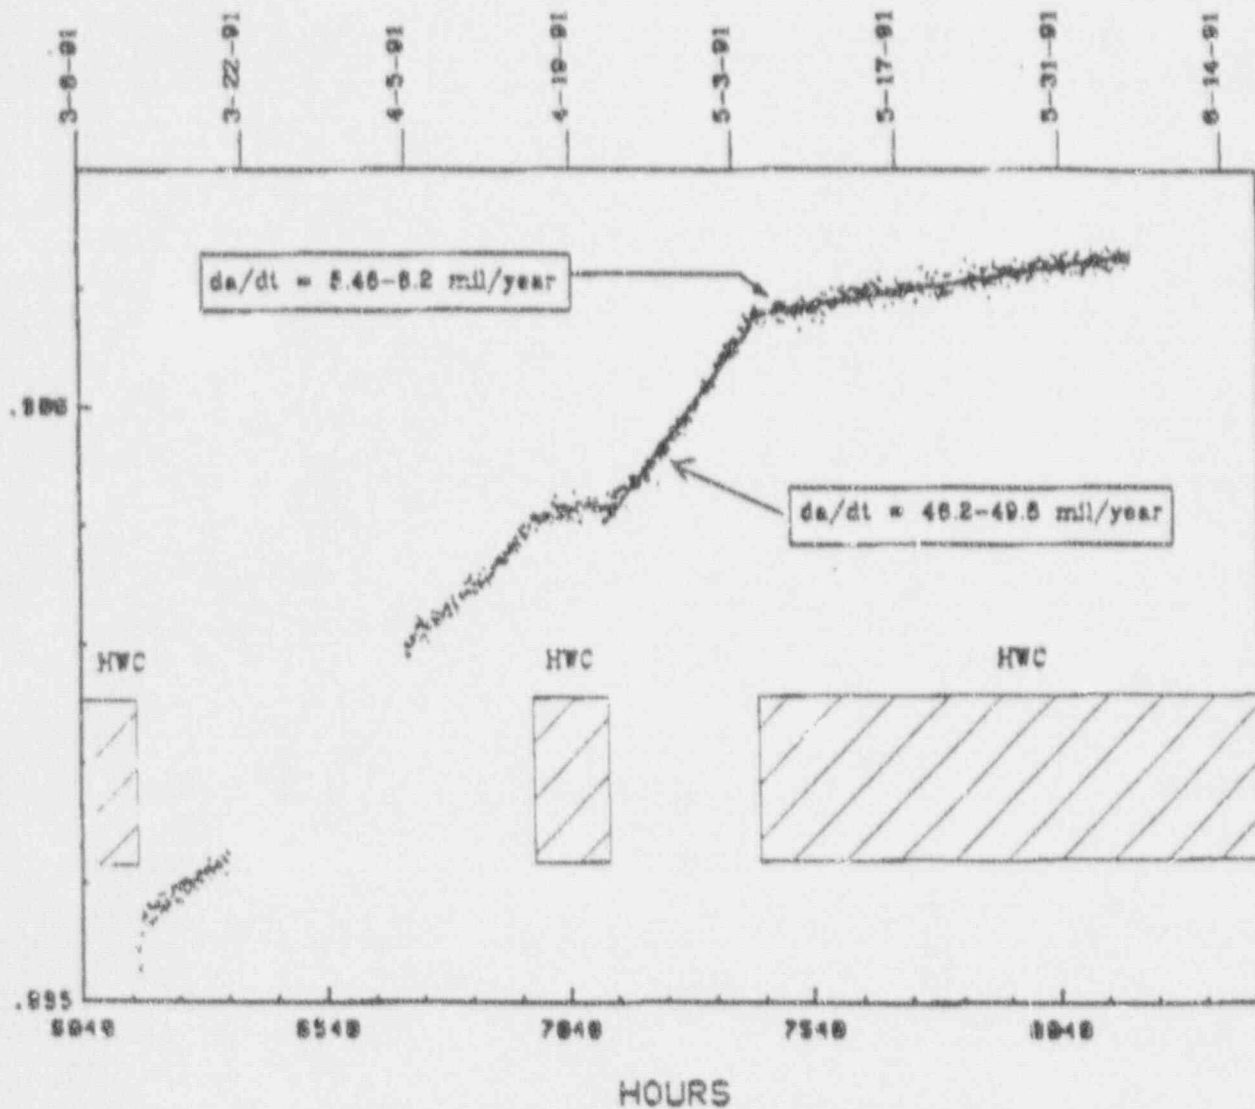
Figure 11. Plant Hatch Unit 1 CAV, Expanded View of Alloy 182 Crack Length Versus Time Data For Time Period After Resumption of Normal Water Chemistry, March/June 1991.

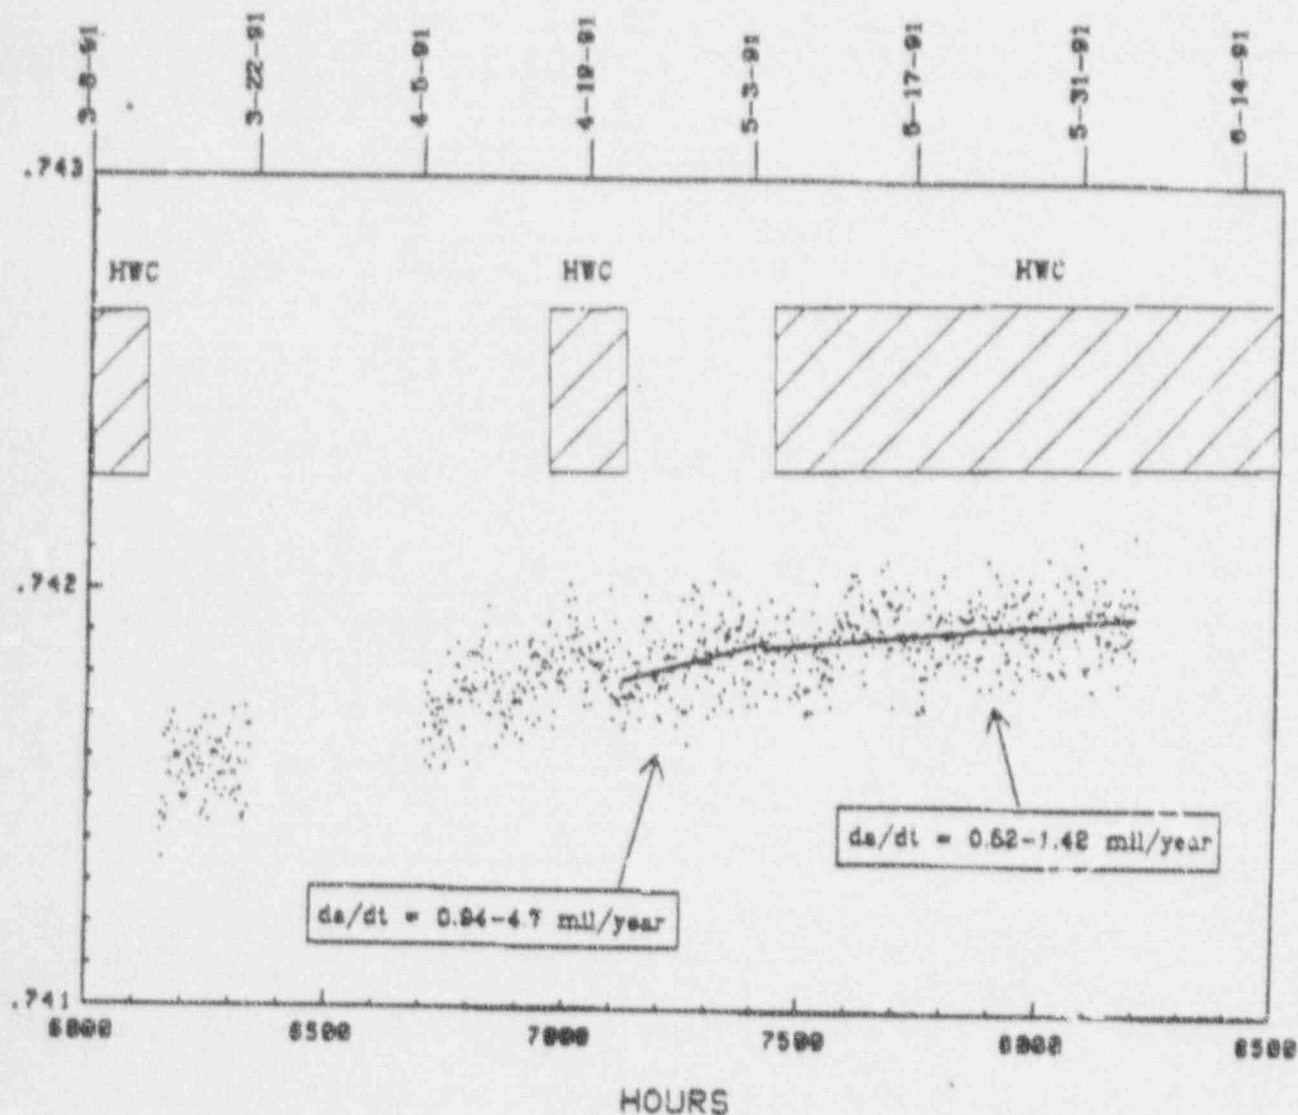
Figure 12. Plant Hatch Unit 1 CAV, Expanded View of Type 304 Stainless Steel Crack Length Versus Time Data For Time Period After Resumption of Normal Water Chemistry, March/June 1991.

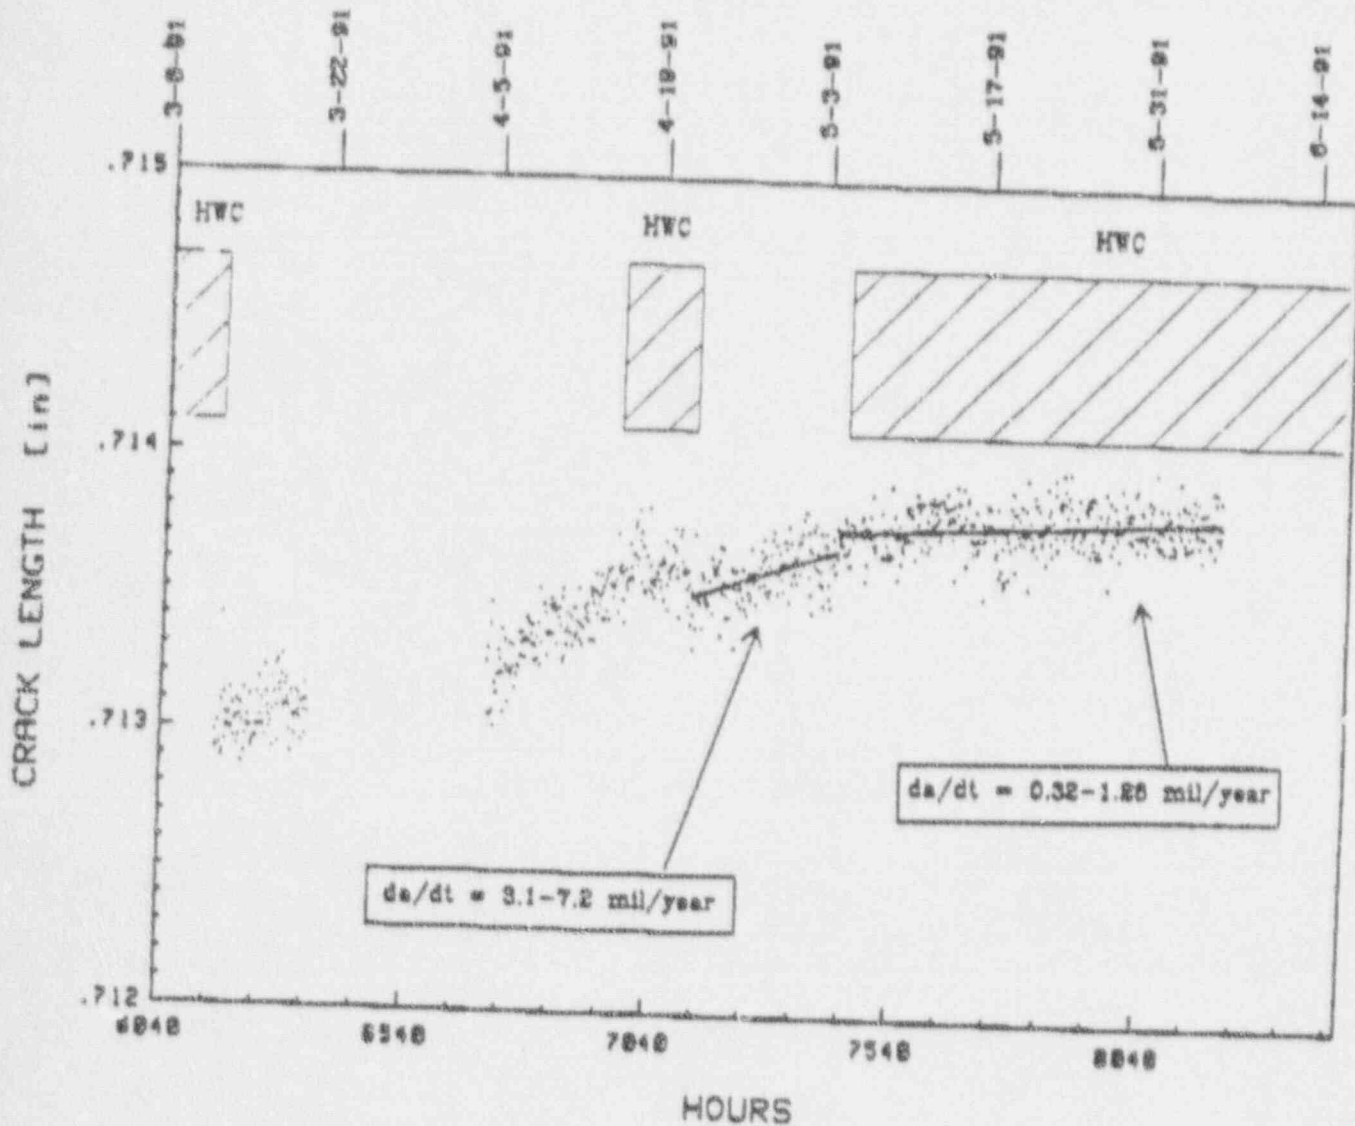
Figure 13. Plant Hatch Unit 1 CAV, Expanded View of Type 316NG Stainless Steel Crack Length Versus Time Data For Time Period After Resumption of Normal Water Chemistry, March/June 1991.
