BASIS FOR  
CABLE SYSTEM DESIGN  
POWER GENERATING STATIONS

Public Service Electric and Gas Company  
Newark, New Jersey  
July 16, 1971

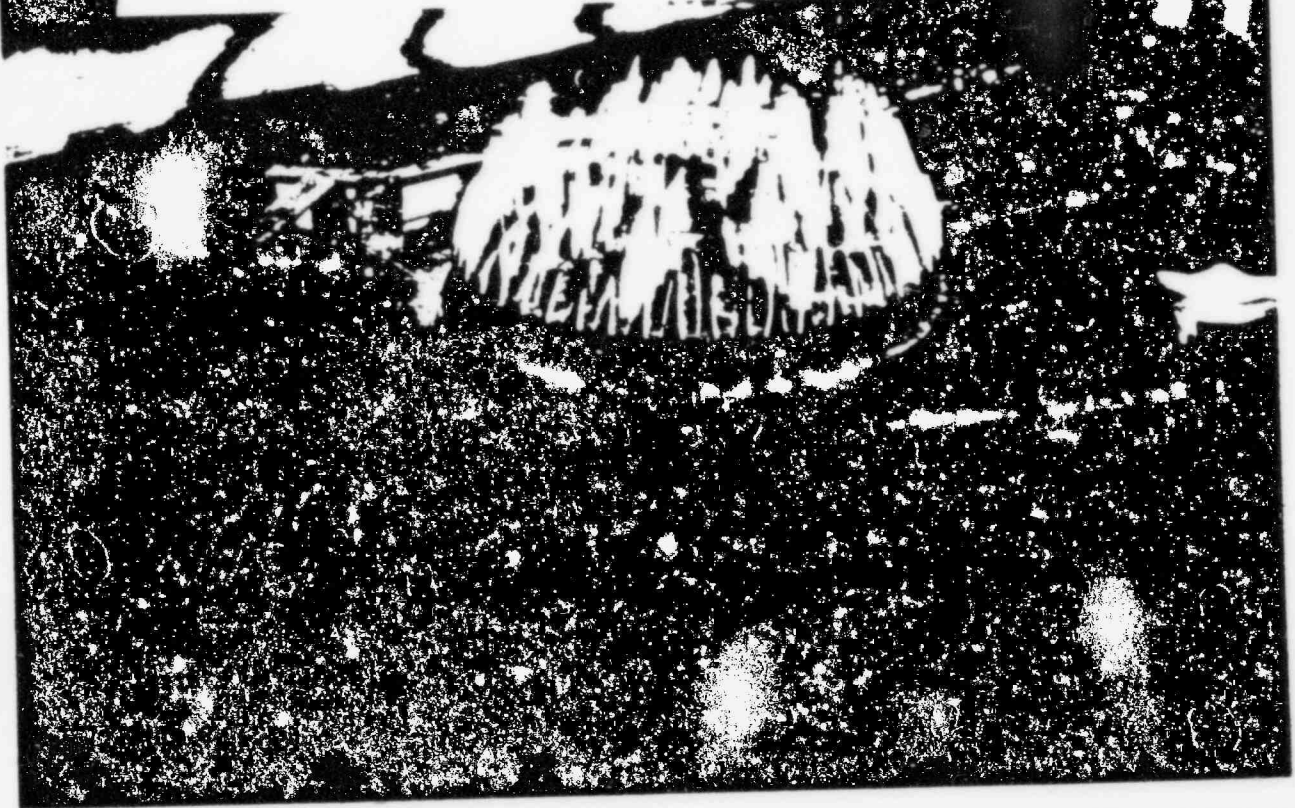
6. Burner Calibrations Prior to Flame Testing

5. An Ellipse wheel gas burner with a 14" outer diameter shall be used as the source of fire. The burner shall be located below the center point lower tray and shall be adjusted to produce a temperature of 1500°F at the point of impingement with the cables. (See Fig. 6)

The complete test data for all the tests is given in tables attached to this section. The gas burner was adjusted prior to the tests to 1500°F at the hottest part of the flame. It was noted that when the thermocouple was moved away from the hottest part of the flame, the temperature dropped off rapidly. During the tests the thermocouple directly above the burner never read above 1060°F because it was not possible to position the thermocouple in the hottest spot. During the test the temperature decreased because of movement of the cables and tray caused by the extreme heat.

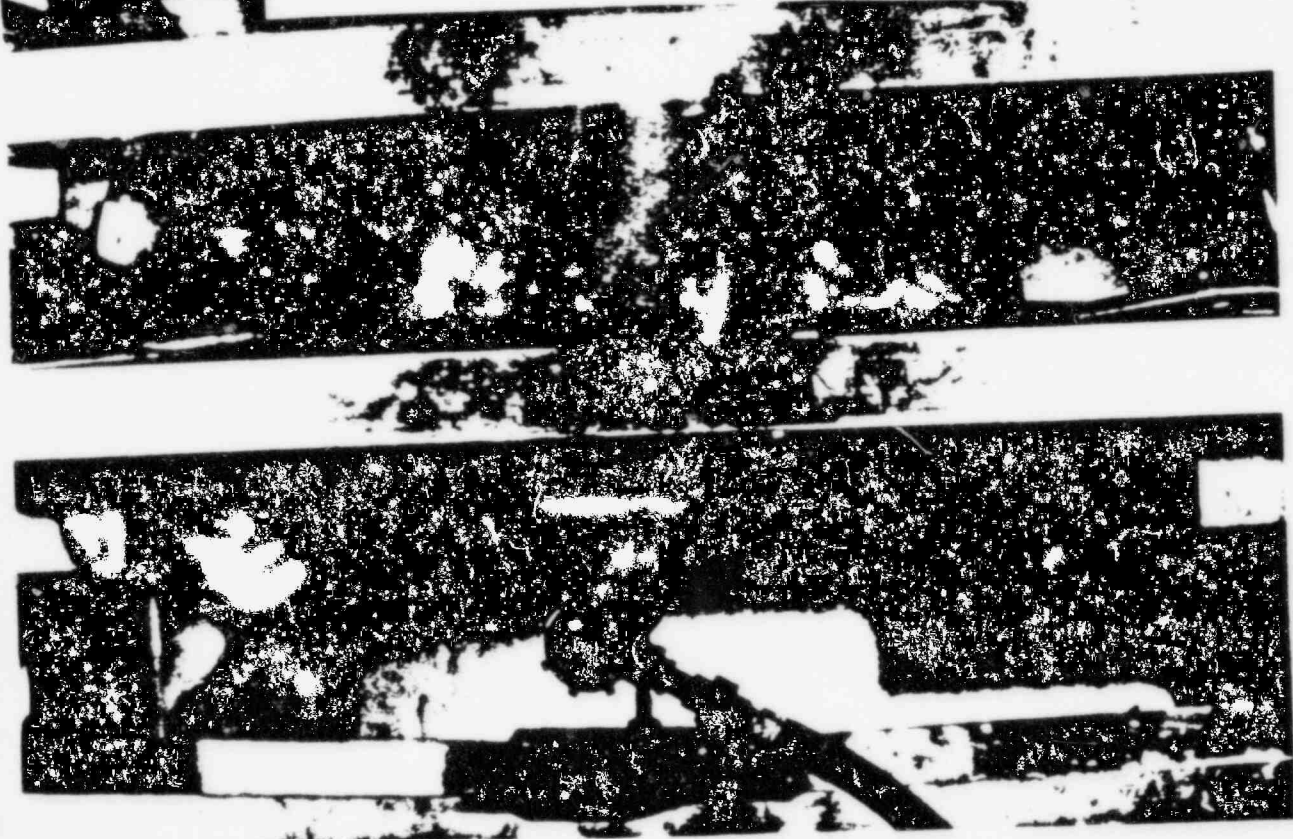
7. Cable Set-Up for Test 12-inch Tray Spacing

Prior to the start of the test the set-up was checked and even though the tray was filled with cables, there were spacings between the cables (See Fig. 8-12). At 11.5 minutes conductors in a T-201 cable shorted. Two minutes later it was observed that the flame had surrounded the bottom tray along the lateral edges. At 15 minutes conductors in a T-214 cable shorted (See Fig. 13-15). At this time the burner was turned off. Most of the flame extinguished immediately, but a small flame continued to burn until 7.5 minutes after the burner was turned off (See Fig. 16-18). The cables in the upper tray with stood the entire test without a failure. The burned area in the cables in the lower tray was no greater than the area that the

burner flame contacted. There was no horizontal or vertical propagation of the fire.

1. There was no propagation of the fire from the lower to the upper tray with either 12" or 18" spacing with no barriers used in either tray. At the start of each test there were spacings between the randomly laid cables, but after the fire started the cables expanded and closed the openings, thereby restricting the fire from breaking through the cables. In the first test the fire broke through in 7 minutes and in the second test there was no breakthrough after 20 minutes of burning. The cable damage was primarily limited to the lower cables in the bottom tray.
2. There was no propagation of the fire horizontally outside the immediate area of the gas burner in any of the tests. The main part of the fire extinguished immediately when the gas burner was shut off. In several tests a small flame continued to burn after the burner was shut off. The maximum after burn time was 7 minutes.

3. The 18 inch separation provided greater protection than the 12 inch separation for the cables in the upper tray, although the cables in the upper tray were not damaged in either case. The maximum temperature at the bottom of the upper tray was 190°F for 18 inch separation and 520°F for 12 inch separation.
