Failure Analysis Associates

RE: Shoreham Nuclear Power Station
FaAA Job # PA07396

SUBJECT: Report on trip to Kodiak Electric Association, Inc. on January 22 to 27, 1984.

SUBJECT: Report of Trips on 1/10/84 to Transamerica Delaval,
Oakland, California

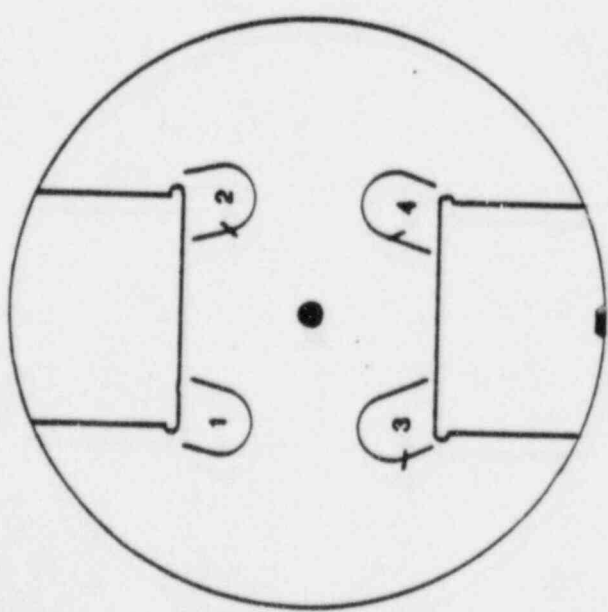
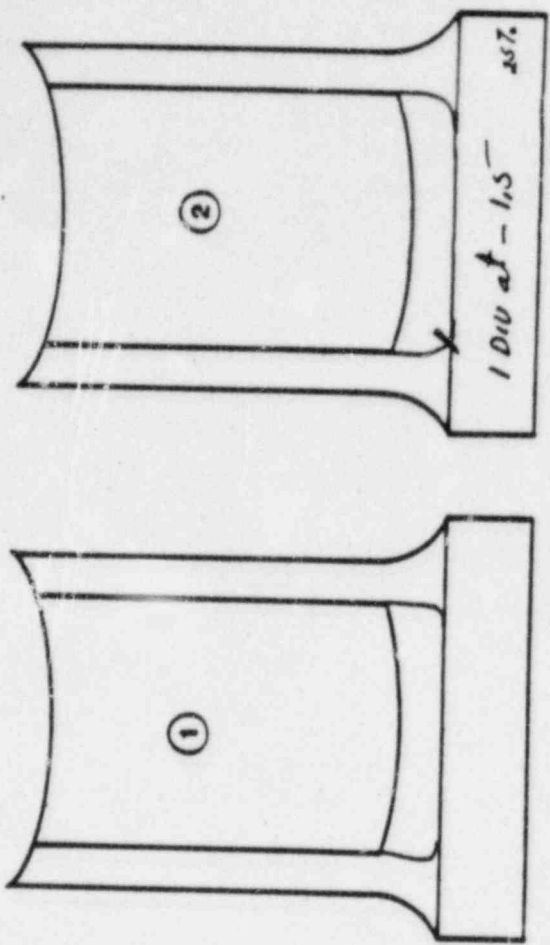
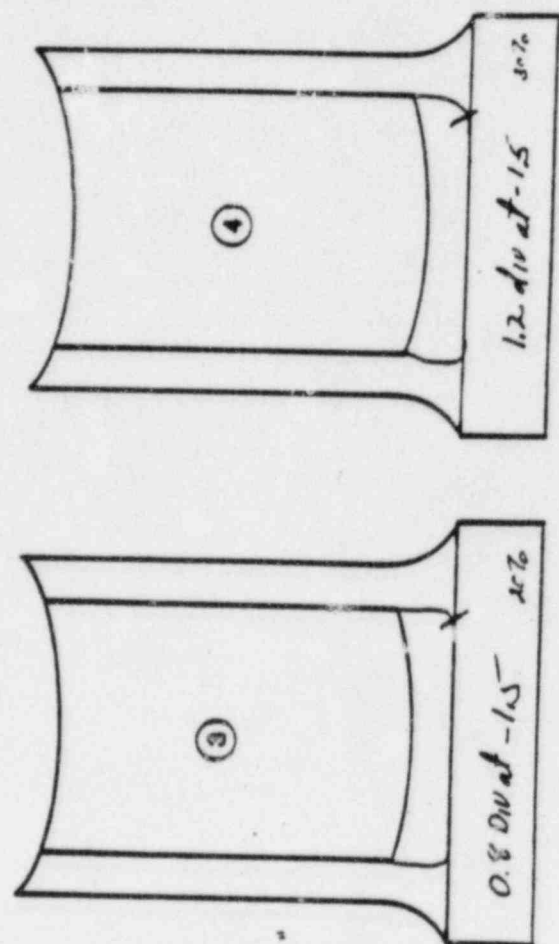
11.5.6.4

I found three indications with eddy-current on piston C-31 as shown on drawing 11.5.8.4. The attached reports and a photo pack will document the report.

Diesel engine ϕ 1 1/4
Piston ϕ C-31

Notch side

Overhead view

Side views, looking out from inside
