WCAP-13495

Catawba Unit-1  
Technical Support for Steam Generator  
Interim Tube Plugging Criteria for  
Indications at Tube Support Plates

September 1992

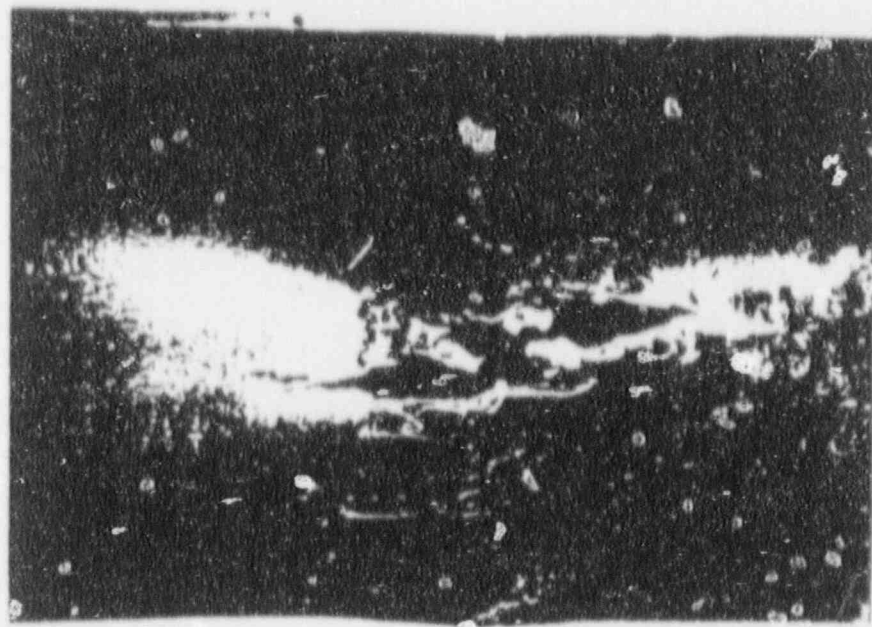
Figure 4-5. Photographs of the burst opening in tube 590-2 showing axial and circumferential cracking.

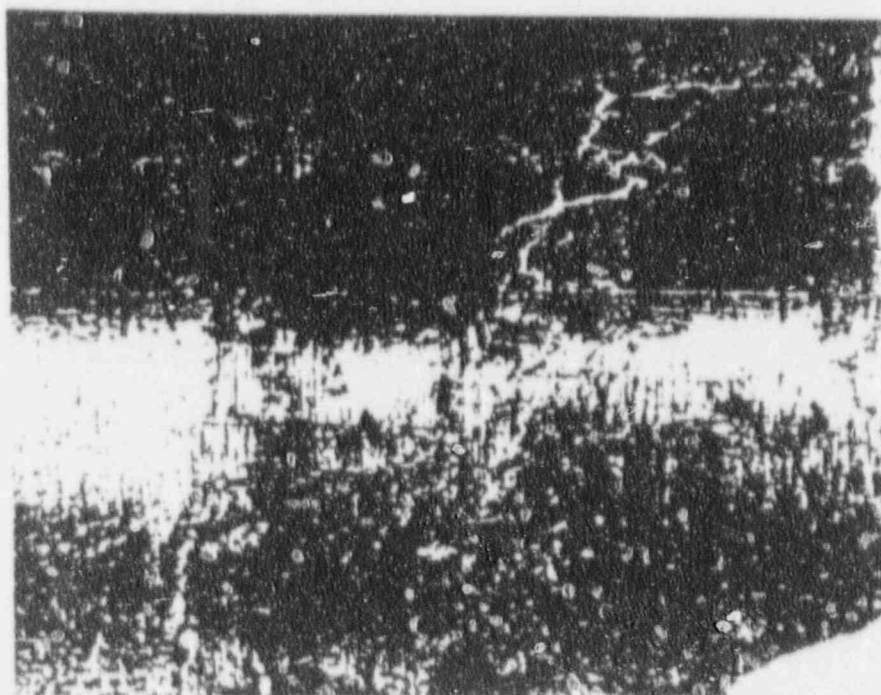
Figure 4-6. Photographs away from the burst opening in tube 590-2 showing axial and circumferential cracking.
