Braidwood Station, Units 1 and 2
Renewed Facility Operating License No. NPF-77
NRC Docket No. STN 50-457

Subject: Supplement to License Amendment Request for a One-Time Extension of the Steam Generator Tube Inspections

Exelon Generation Company has submitted a one-time Technical Specification change to defer the Braidwood Unit 2 A2R21, April 2020 steam generator (SG) tube eddy current inspection to the A2R22 outage, October 2021. The objective of this Operational Assessment (OA) is to provide the technical justification for deferring the A2R21 SG tube examination by one operating cycle. The evaluation is performed in accordance with EPRI Steam Generator Integrity Assessment Guidelines. This OA evaluates the predicted condition of the SGs after three cycles of operation (Cycles 20, 21, and 22).

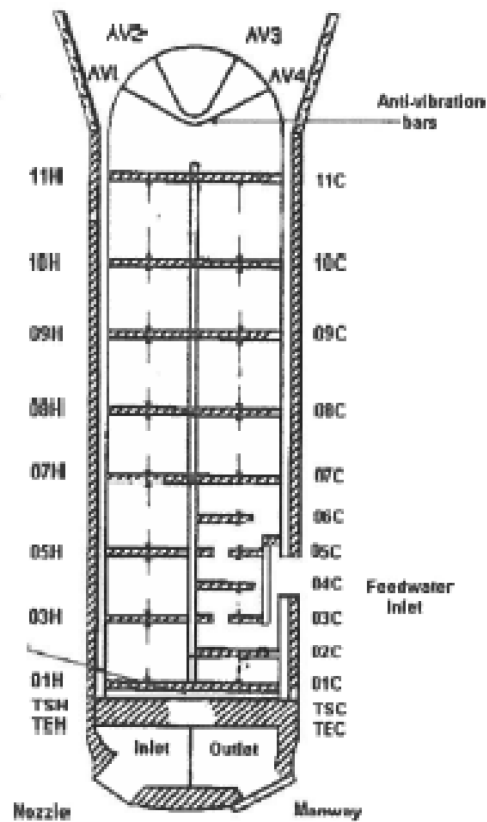
Figure 2-1 — Schematic Illustration of Braidwood Unit 2 SG Tube Bundle [4].

Westinghouse Model D-5 TSP and AVB Configuration

Note: AVB bars are denoted as AV in the figure.

The Braidwood Unit 2 SGs are Westinghouse Model D5 type, utilizing Alloy 600 thermally treated (A600TT) tube material, full depth hydraulic expansion in the tubesheet region, and stainless steel tube support structures. A schematic illustration of the Braidwood Unit 2 SGs is shown in Figure 2-1. The tube hole style at TSPs is a quatrefoil broached lobe design. These SGs utilize a preheater design which introduces the majority of the feedwater to the lower region of the cold leg side of the tube bundle. Within the preheater region, the tube hole style is a simple drilled hole.

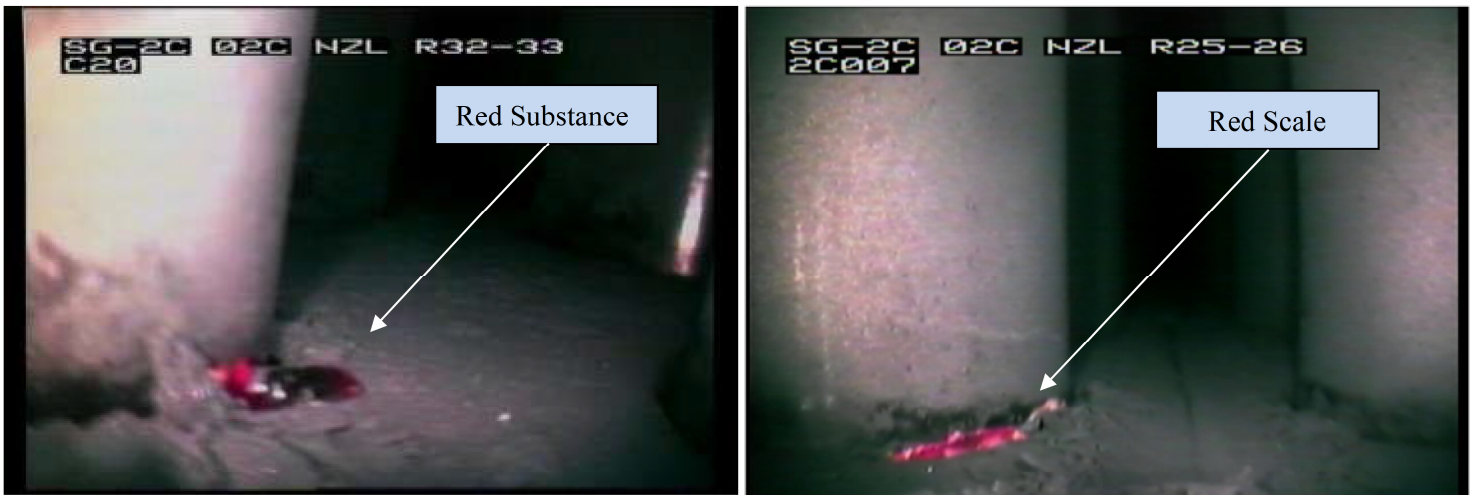
Figure D-2. A2R16 Examples of Red Substance and Red Scale in SG 2C TSP02C

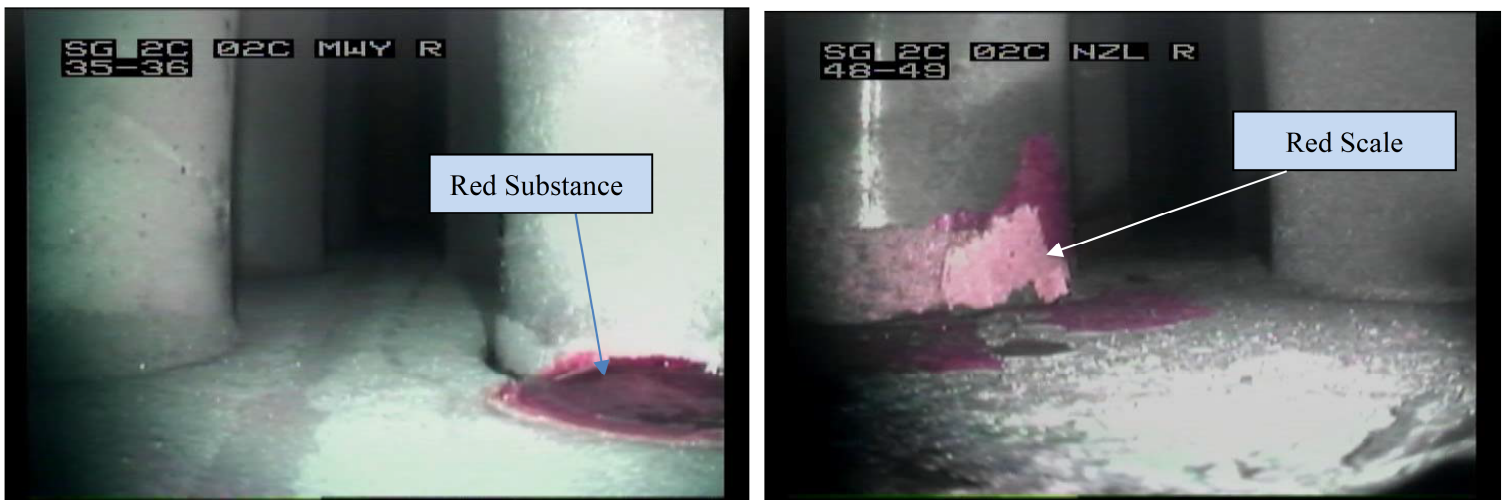
Figure D-3. A2R19 Examples of Red Substance and Red Scale in SG 2C TSP02C
