Report No.: CEN-42(P)

December 10, 1976

Palisades Steam Generator
Tube Repair Sleeving

A technique is presented for repairing degraded steam generator tubes in pressurized water reactor Nuclear Steam Supply Systems (NSSS). The technique described alleviates the need for removing steam generator tubes from service due to loss of structural capabilities. In this manner, the design generating capacity of the original NSSS need not be reduced. This work was performed under contract with Consumers Power Company for use in the Palisades Plant steam generators.

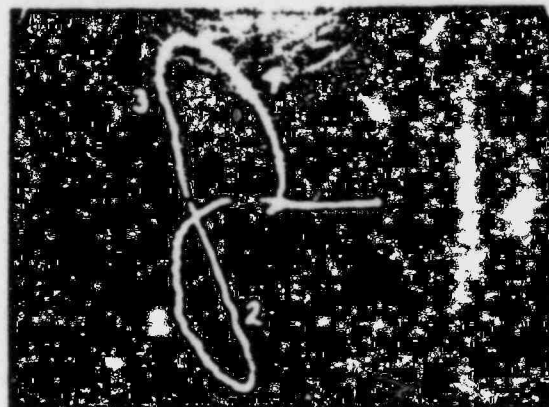
SIGNALS FROM SLEEVE OUTER SURFACE DEFECTS, TUBE CLEAN

100% Tube Wall
100% Sleeve Wall
100% Combined Wall

100% Tube Wall
55% Sleeve Wall
81% Combined Wall

Tube Through Wall Plus Sleeve Defect Signals

0% Tube Wall
100% Sleeve Wall
40% Total Wall
2 volts/div, horizontal & vertical

0% Tube Wall
34% Sleeve Wall
15% Total Wall

Sleeve Only Defect Signals

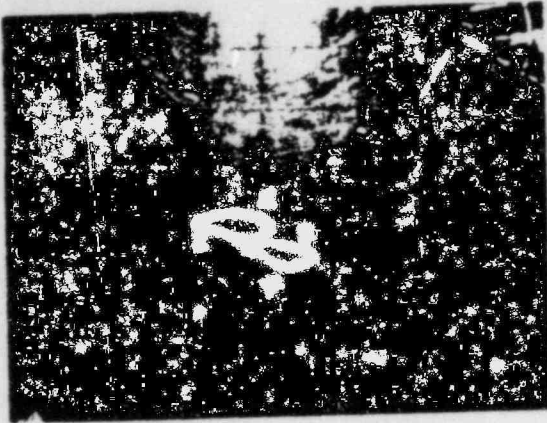
SIGNALS FROM TUBE OUTER SURFACE DEFECTS - NO SLEEVE DEGRADATION

100% Tube Wall
0% Sleeve Wall
60% Combined Wall

81% Tube Wall
0% Sleeve Wall
49% Combined Wall

61% Tube Wall
0% Sleeve Wall
37% Combined Wall

48% Tube Wall
0% Sleeve Wall
29% Combined Wall

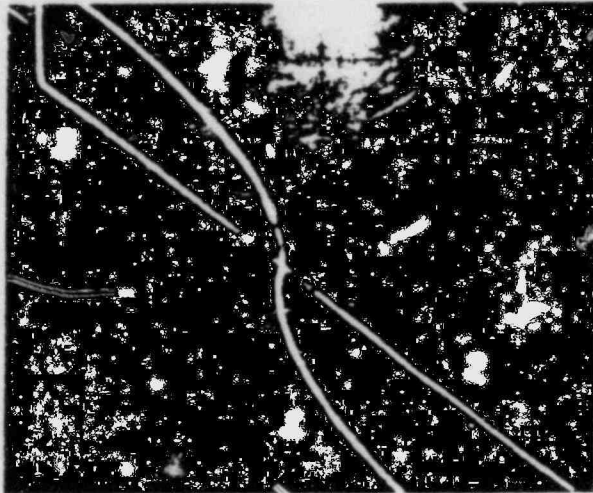
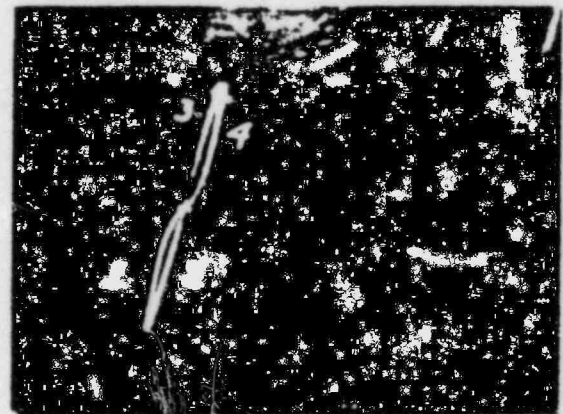
SIGNALS FROM SLEEVE OUTER SURFACE DEFECTS, TUBE CLEAN

100% Tube Wall
100% Sleeve Wall
100% Combined Wall

100% Tube Wall
32% Sleeve Wall
73% Combined Wall

Tube Through Wall Hole Plus Sleeve Defects

0% Tube Wall
100% Sleeve Wall
40% Combined Wall

0% Tube Wall
32% Sleeve Wall
15% Combined Wall
