EVALUATION OF NEAR-TERM BWR PIPING REMEDIES

(Research Project 701-1)

Final Report

Nuclear Energy Engineering Division
General Electric Company
175 Curtner Avenue
San Jose, California 95125

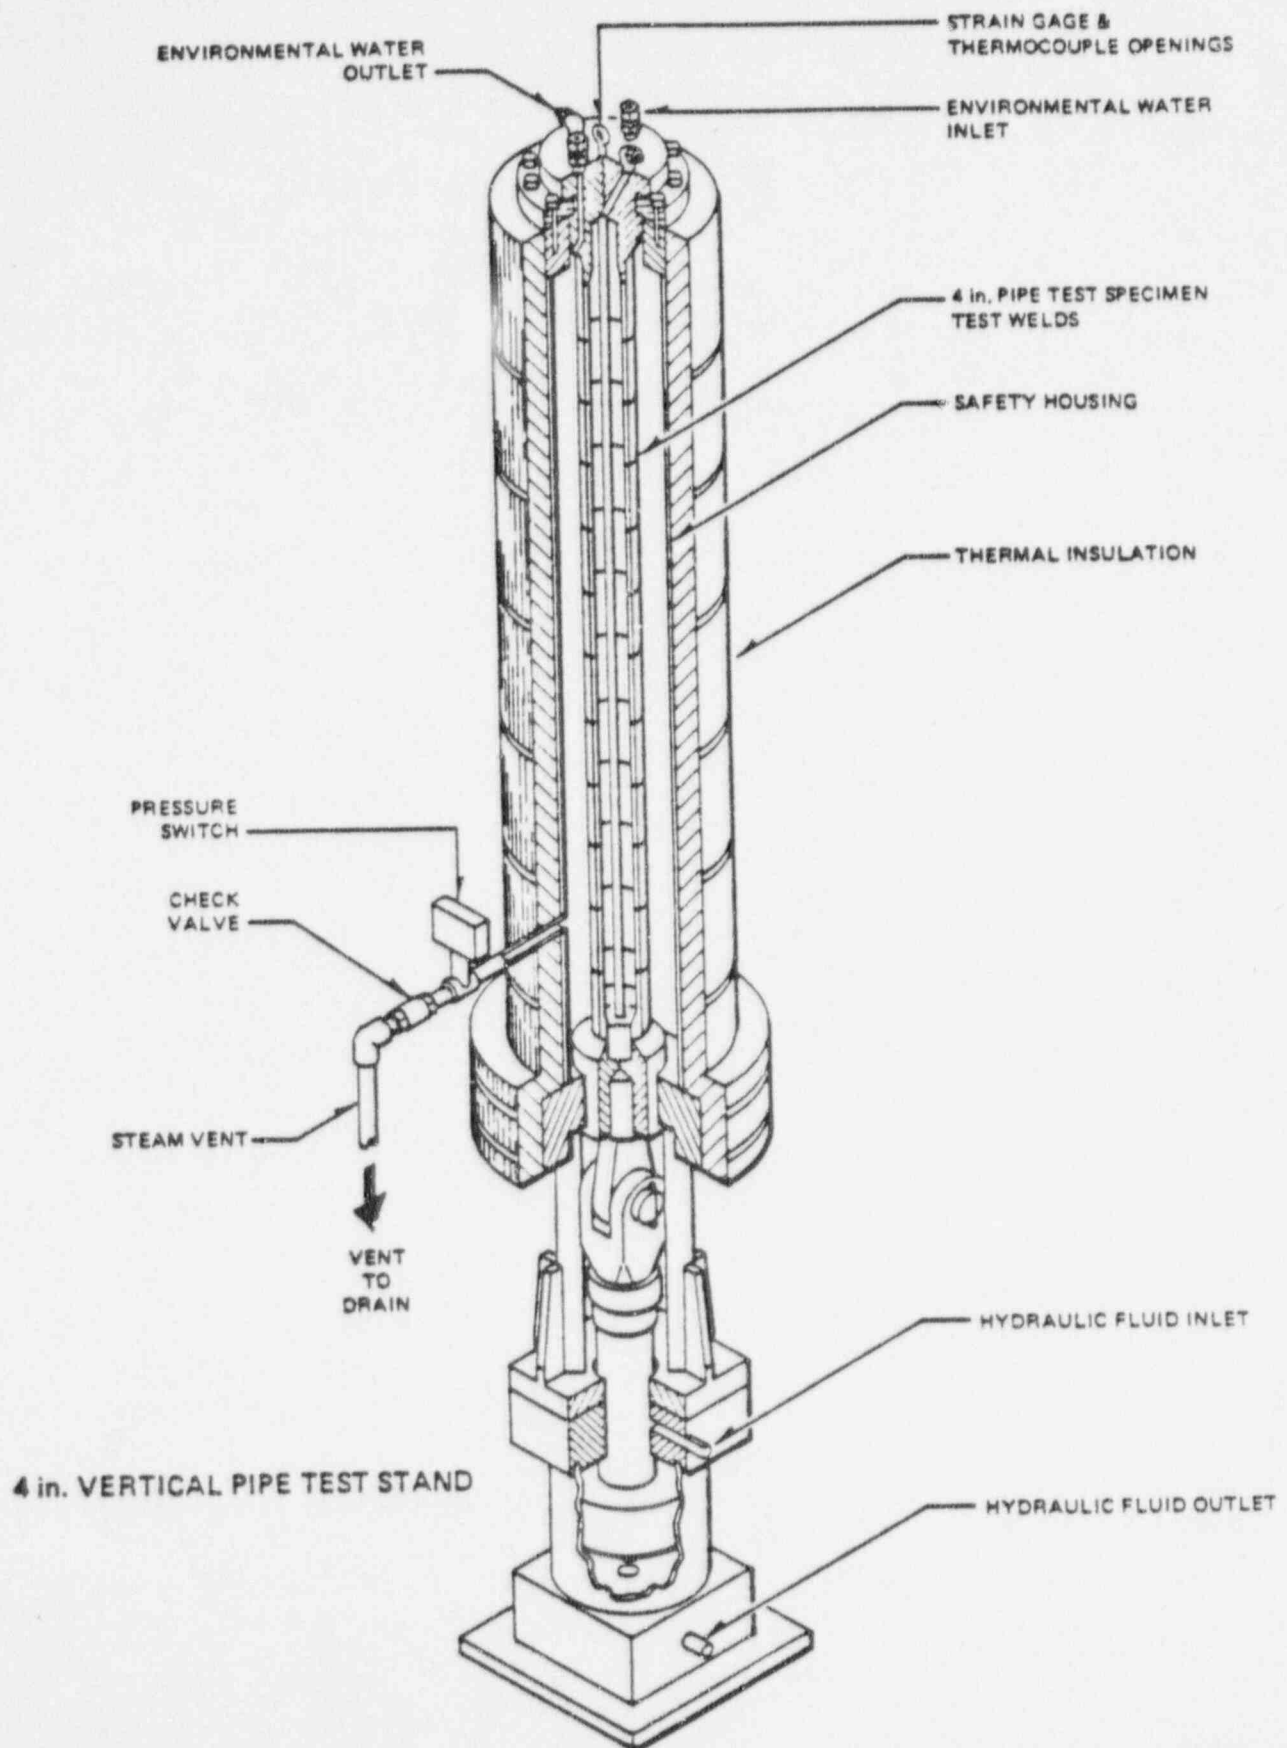
Figure 1-1. Four-inch Vertical Pipe Test Stand

A series of 11 full-size pipe tests have been performed to screen remedies. These tests have included four cyclic axial loaded pipe tests in the Large Environmental Fatigue Test Facility, two 4-point bending pipe tests in the CL-4 test facility, and six cyclic axial loaded pipe tests in the Pipe Test Laboratory. Figure 1-1 accelerated test conditions were used to reduce the required testing time to failure. These accelerants included high stress cyclic loading, high oxygen water environments, heavy grinding on the inner surface weld heat affected zones, and in some welds, high weld heat input.

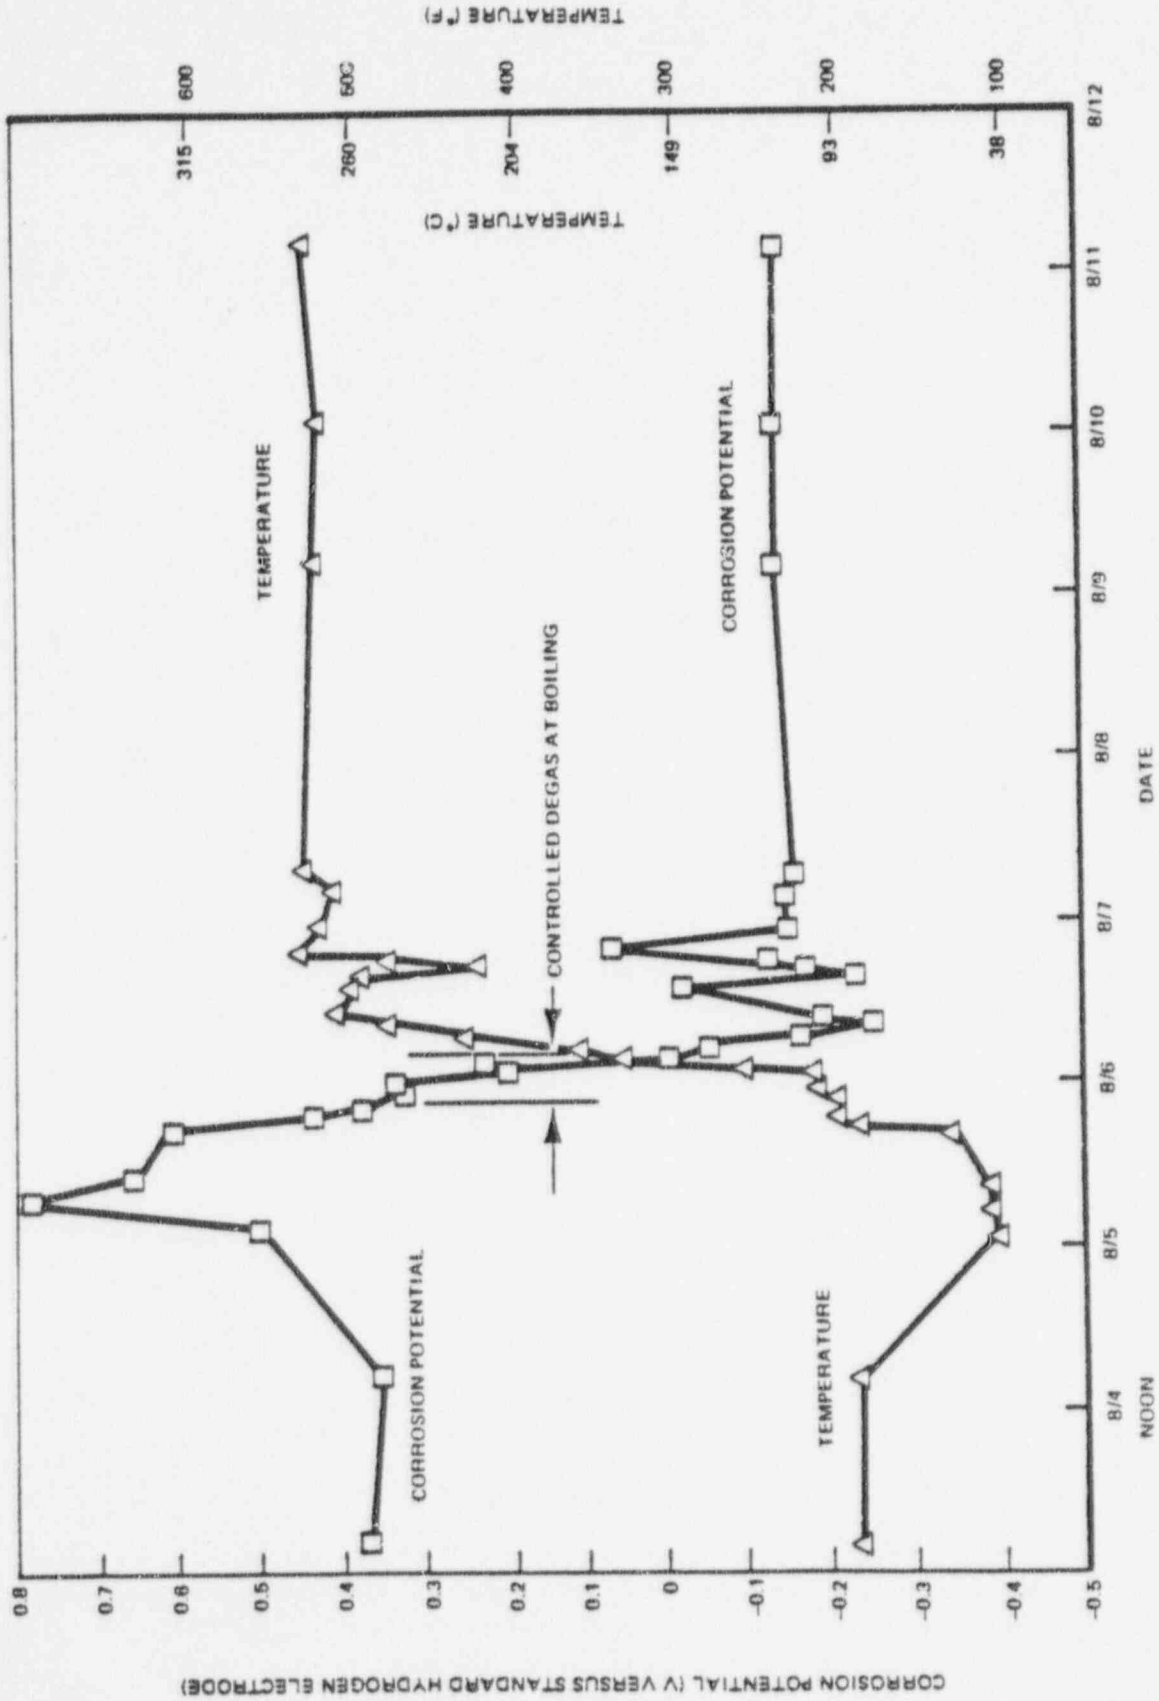
Figure 1-2. Corrosion Potential of Type-304 Stainless Steel During Reactor Startup

At the Vermont Yankee Boiling Water Reactor, corrosion potentials and supportive chemical analyses of the reactor water were determined during a reactor start-up. The corrosion potential of Type-304 stainless steel during reactor startup is shown in Figure 1-2. It was found that the potentials at low temperatures, less than about 125°C (257°F), were considerably higher than those which could be accounted for from just dissolved oxygen. A shift of potentials and water chemistry transient caused by the unexpected decomposition of ion exchange resins in the reactor during start-up were also measured.

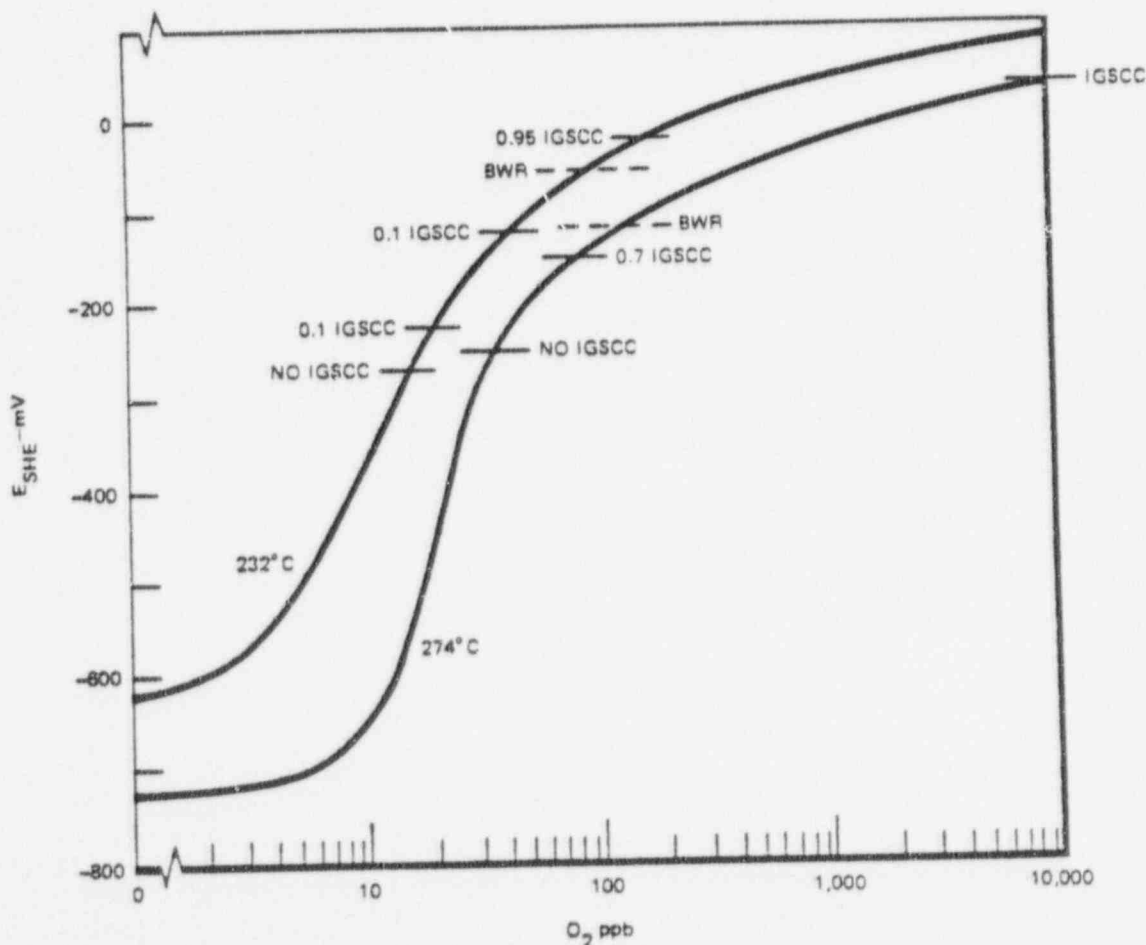
Figure 1-3. The Effect of Dissolved Oxygen on the Corrosion Potential and IGSCC of Type-304 Stainless Steel (Average Curves)

At any temperature, an increase in oxygen concentration caused an increase in potential. The effect was most dramatic for the potential/oxygen experiments conducted at $232^\circ C$ ($450^\circ F$) and $274^\circ C$ ($525^\circ F$) where, as shown in Figure 1-3, the potential increased about 0.75 V as the dissolved oxygen was increased from 10 ppb to 8 ppm. These large differences in potentials can be used to determine potential driving forces for IGSCC and calculating concentration factors in crevices.

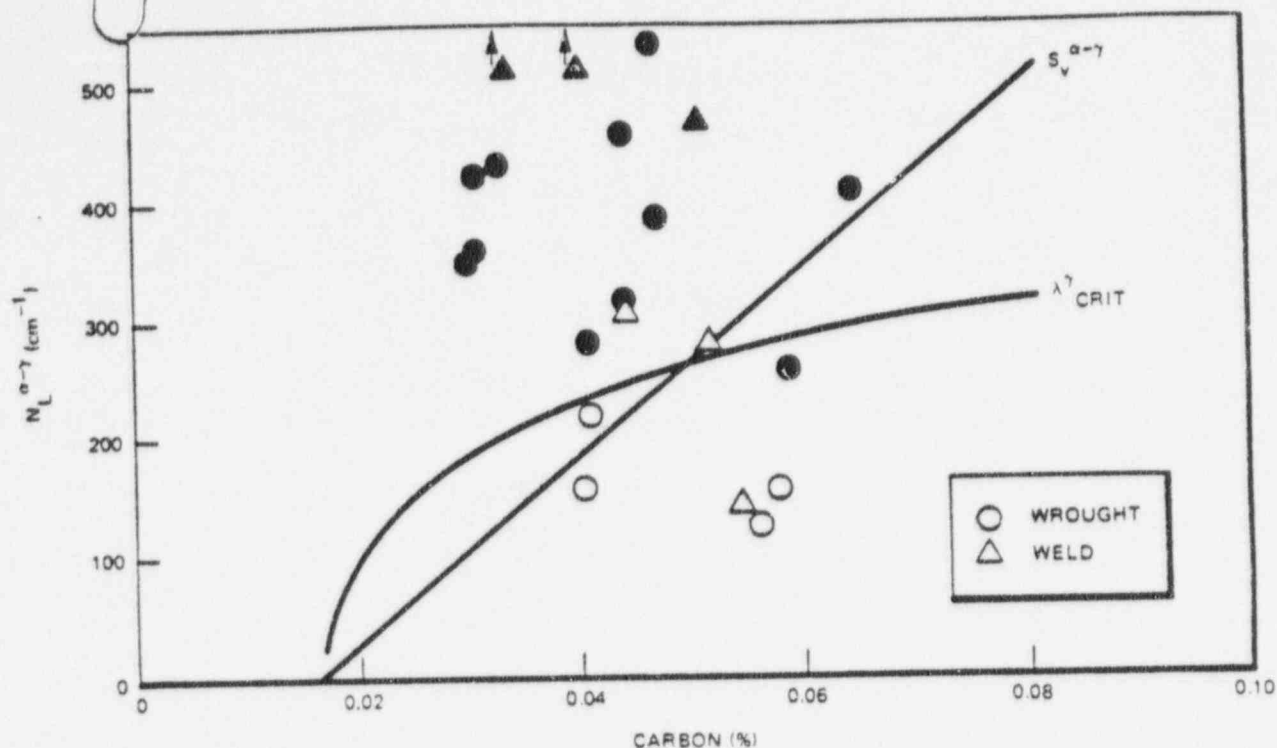
Figure 1-4. The Influence of $N_L^{\alpha-\gamma}$ on the Intergranular Corrosion Behavior of Aged Samples of Wrought and Weld-Deposited Type-308 Stainless Steel

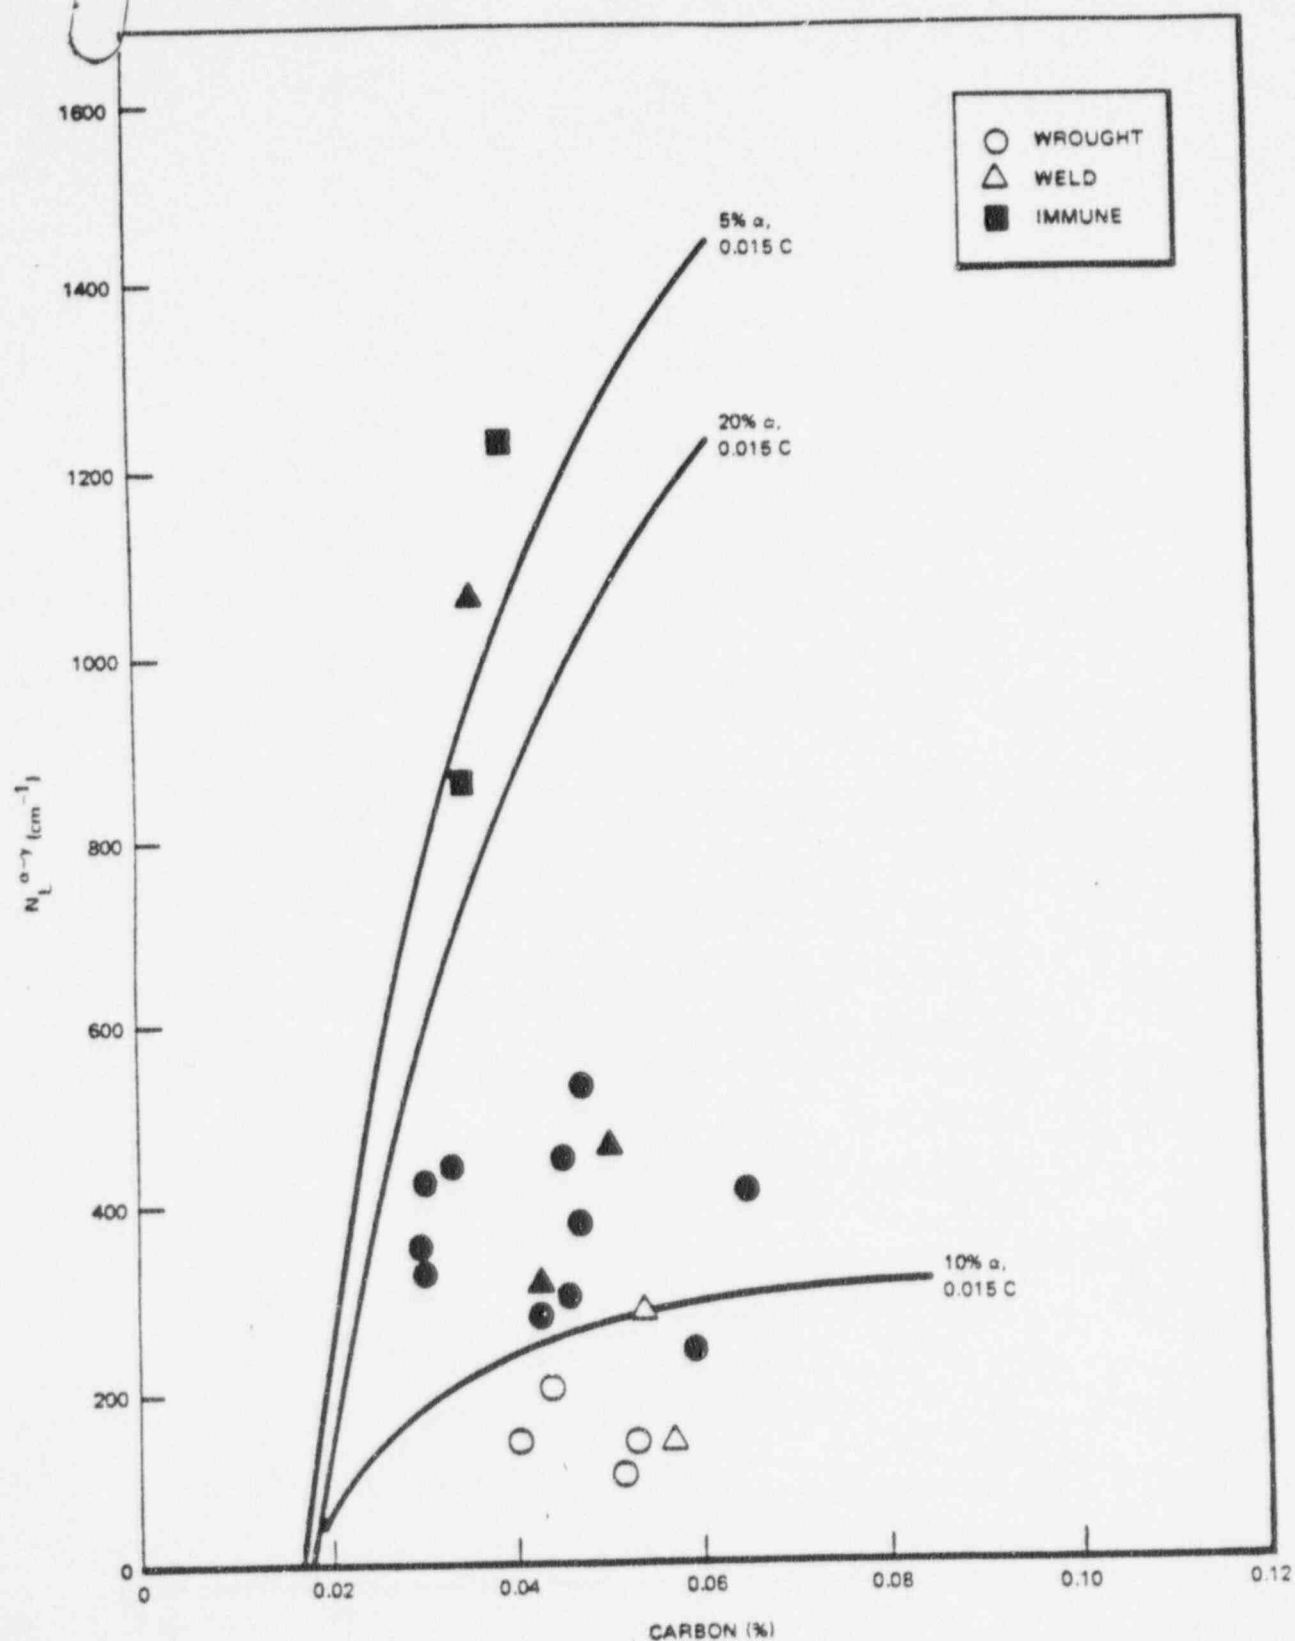
Figure 1-5. The Values of $N_L^{\alpha-\gamma}$ Required to Reduce the Austenite Mean-Free-Path to Levels Sufficient to (a) Restrict and (b) Prevent Sensitization of Type-308 Stainless Steel

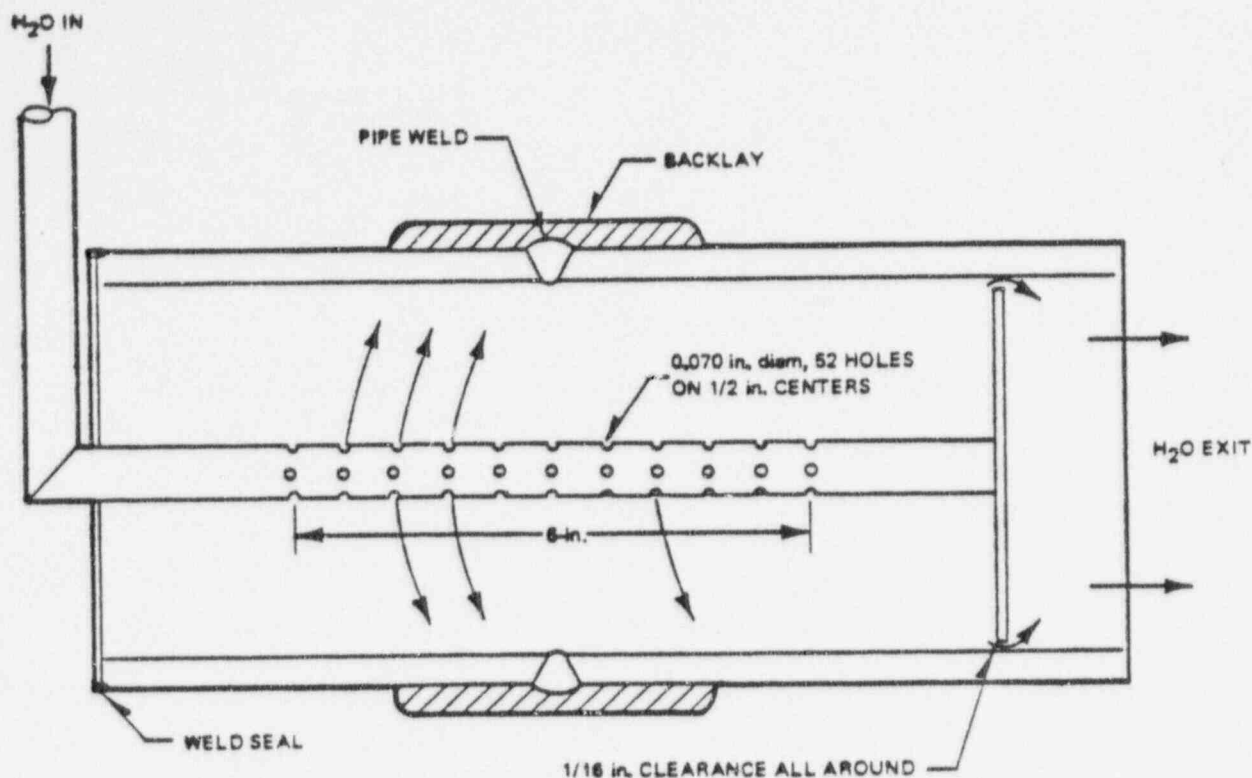
Figure 3-1. Backlay Applied with ID Water Spray Quench

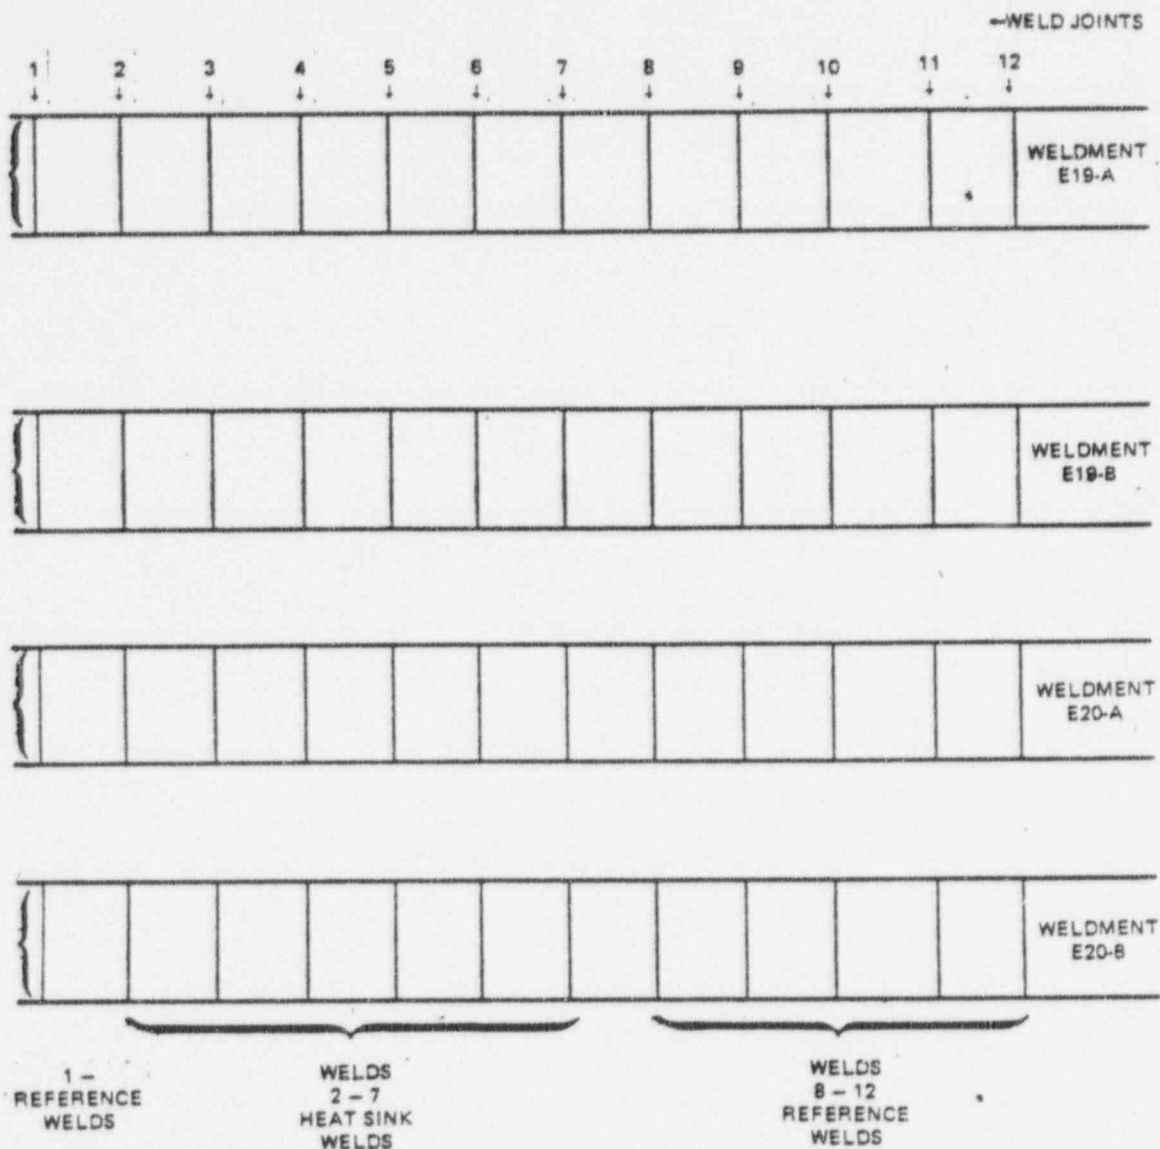
NOTES: WELDMENTS E19-A AND E20A WERE GROUND AND POLISHED ON THE INSIDE SURFACE AFTER ROOT PASS WELDING
 WELDMENTS E19-B AND E20B WERE NOT GROUND AND POLISHED AFTER ROOT PASS WELDING
 (SEE FIGURES 3-6, 3-6, 3-7)
 E19 WELDMENTS: MAXIMUM TEST LOAD STRESS - 1.36 X 288°C YIELD
 E20 WELDMENTS: MAXIMUM TEST LOAD STRESS - 1.10 X 288°C YIELD

A single heat sink screening weld in Weldment E21-B has 2013 test cycles (2869 test hours) in the PTL without failure which exceeds all other HSW joints on test. It has been on test at the high stress level (1.36) during this time. The improvement margin in this single test is high, but it is not statistically significant since it is a single weld. It does serve as a screening test to encourage continued evaluation of this pipe crack remedy.

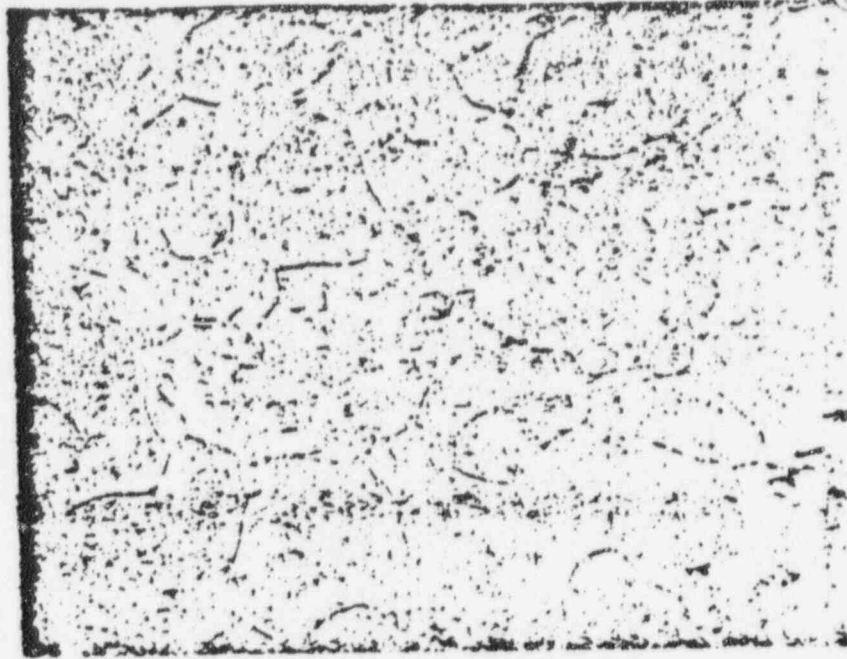
Figure 3-15. As-Welded Type-304 Stainless Steel (Heat No. A5351) After EPR Testing, Weld Joint TW-15, Manual Weld, Water Spray Inside Surface Cooled, High Heat Input (50X)

The TW-15 weldment after EPR testing is shown in Figure 3-15. The grain boundaries are decorated with carbides, but the extent is much less than that shown for TW-4 and 13, and this finding was substantiated by the values measured; i.e., Pa = 7.5 C/cm² for TW-15 compared to 26 and 34 C/cm² for TW-13 and TW-4, respectively. Regardless, the degree of sensitization was sufficient to render the TW-15 samples susceptible to intergranular stress corrosion cracking, as given by the data in Table 3-11.

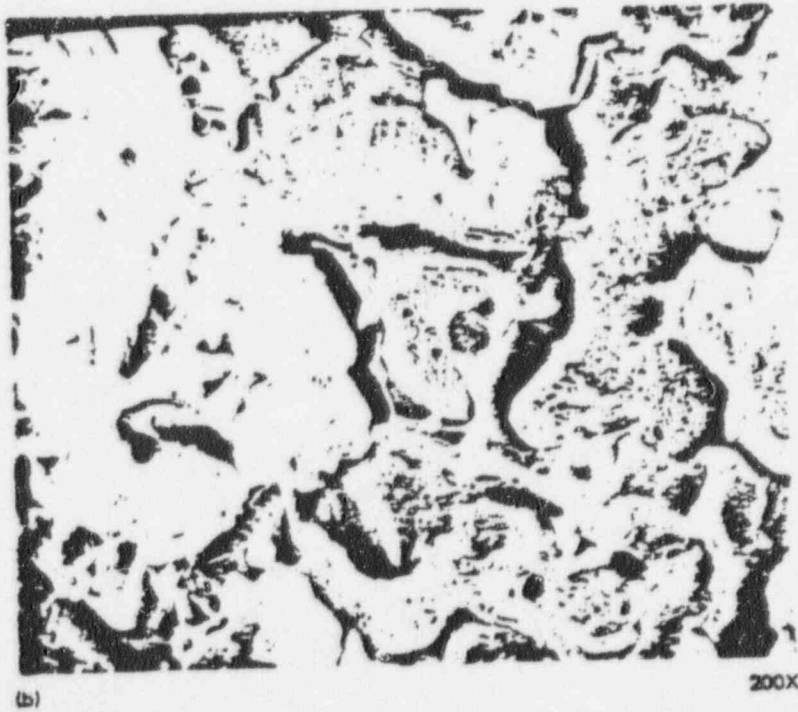
Figure 3-19. IGSCC in CF-8 (Heat 98695) Annealed and Welded Sample Tested by CERT in 550°F (288°C) Water With 8 ppm O_2 (SEM)

The casting from which this sample was machined was procured with a 20.16 cm (7.94 inch) outside diameter and a 6.2 cm (2.44 inch) inside diameter. This thickness, unusual for centrifugally cast pipe, resulted in uneven ferrite distribution and large grains. The fracture surface of the CF-8 sample is shown in Figure 3-19 where the intergranular (interdendritic) nature of the fracture is clearly evident. This fracture mode was unexpected, as welded cast CF-8 has never failed intergranularly in these types of corrosion tests in previous studies (especially since the sample contained 10–15% ferrite). Further investigation revealed an irregular morphology of the ferrite phase (Figure 3-20), and profuse precipitation (presumably carbides) of a relatively continuous phase at the grain boundaries (Figure 3-21). This grain boundary phase, which appears as interconnected particles, provided the path for propagation of the interdendritic stress corrosion cracks (Figure 3-22). The cracks propagated primarily along the elongated, "stringer-type" ferrite phase aligned parallel with the applied stress (refer to Figure 3-20). The reason for the unusual extent of precipitate formation is presently unknown. However, this precipitation was unique to the solution annealed and then welded condition. The sample which was welded and then solution annealed failed the stress corrosion test in a ductile manner (Figure 3-23), and the ferrite distribution appears somewhat more uniform (Figure 3-24) than the solution annealed and then welded condition. The welded and then solution annealed CF-8 microstructure did not reveal the profuse grain boundary precipitation characteristic of the solution annealed and welded condition.

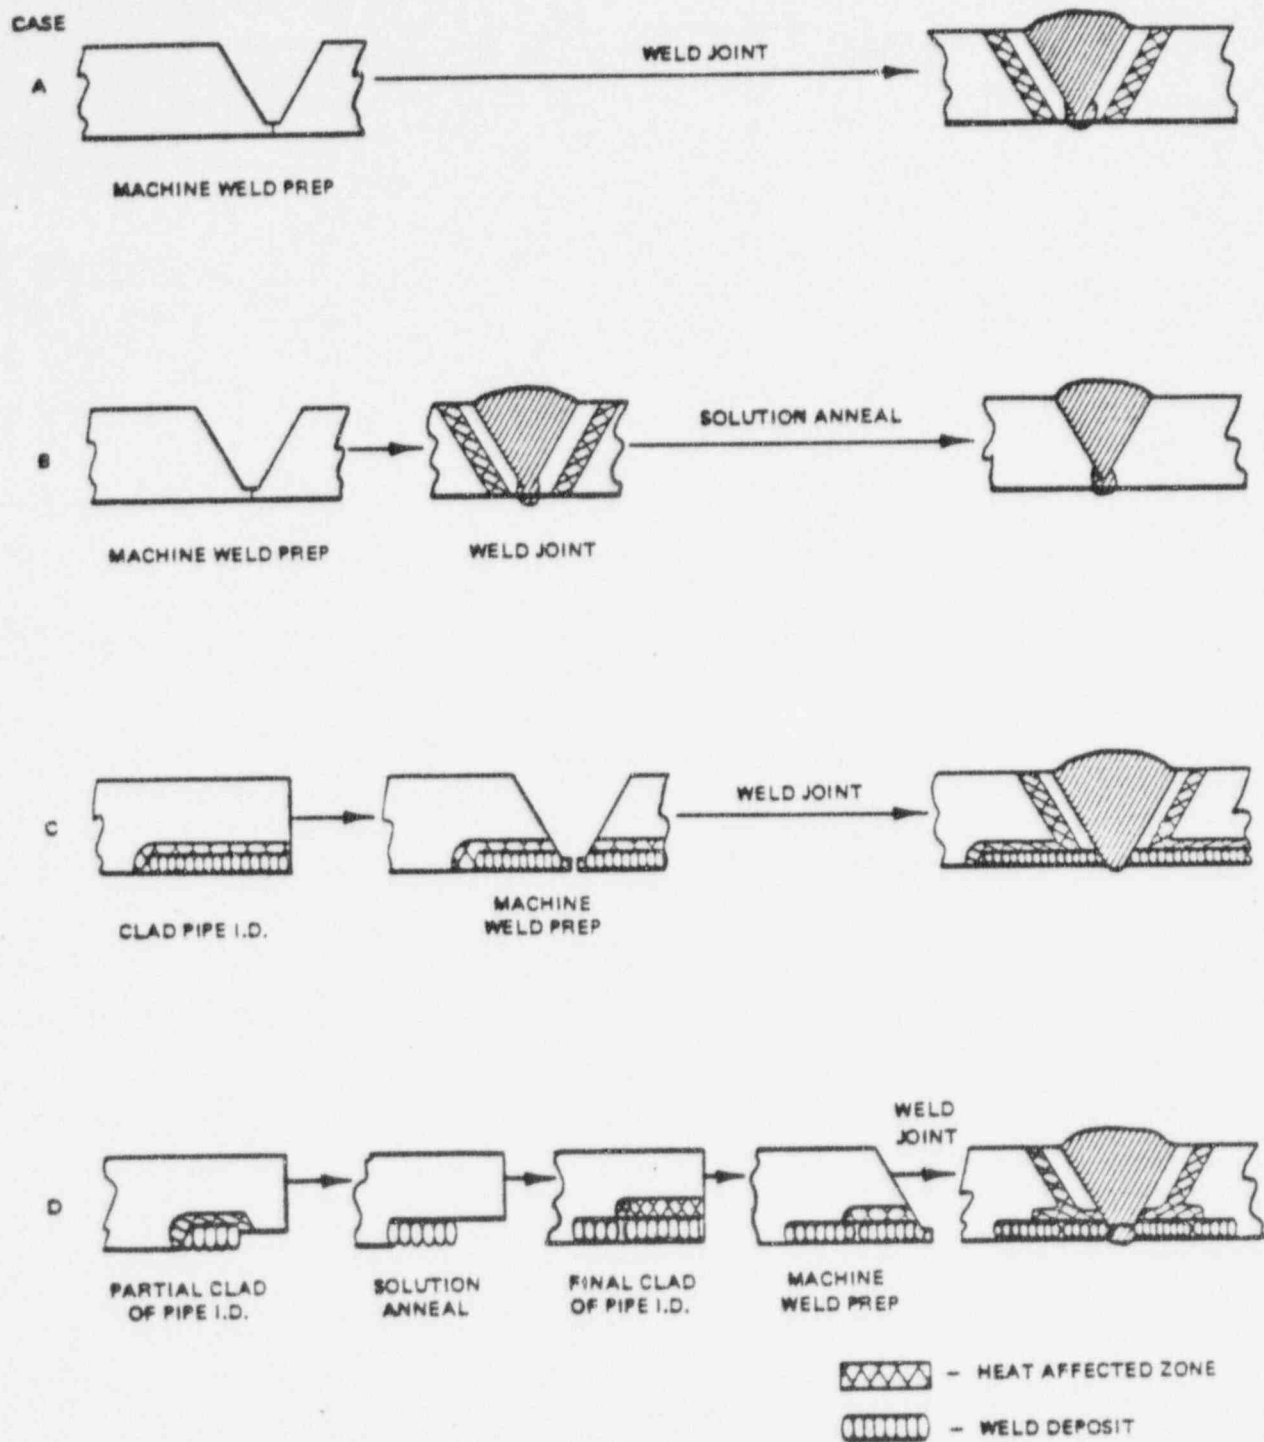
Figure 4-4. Schematic Showing Sequence of Fabrication Operations and Location of Heat-Affected Zones in Type-304 Stainless Steel Pipe Base Metal for Reference Welds (A), Solution Annealed Welds (B), Corrosion Resistant Clad Welds (C), and Annealed Corrosion Resistant Clad Welds (D)

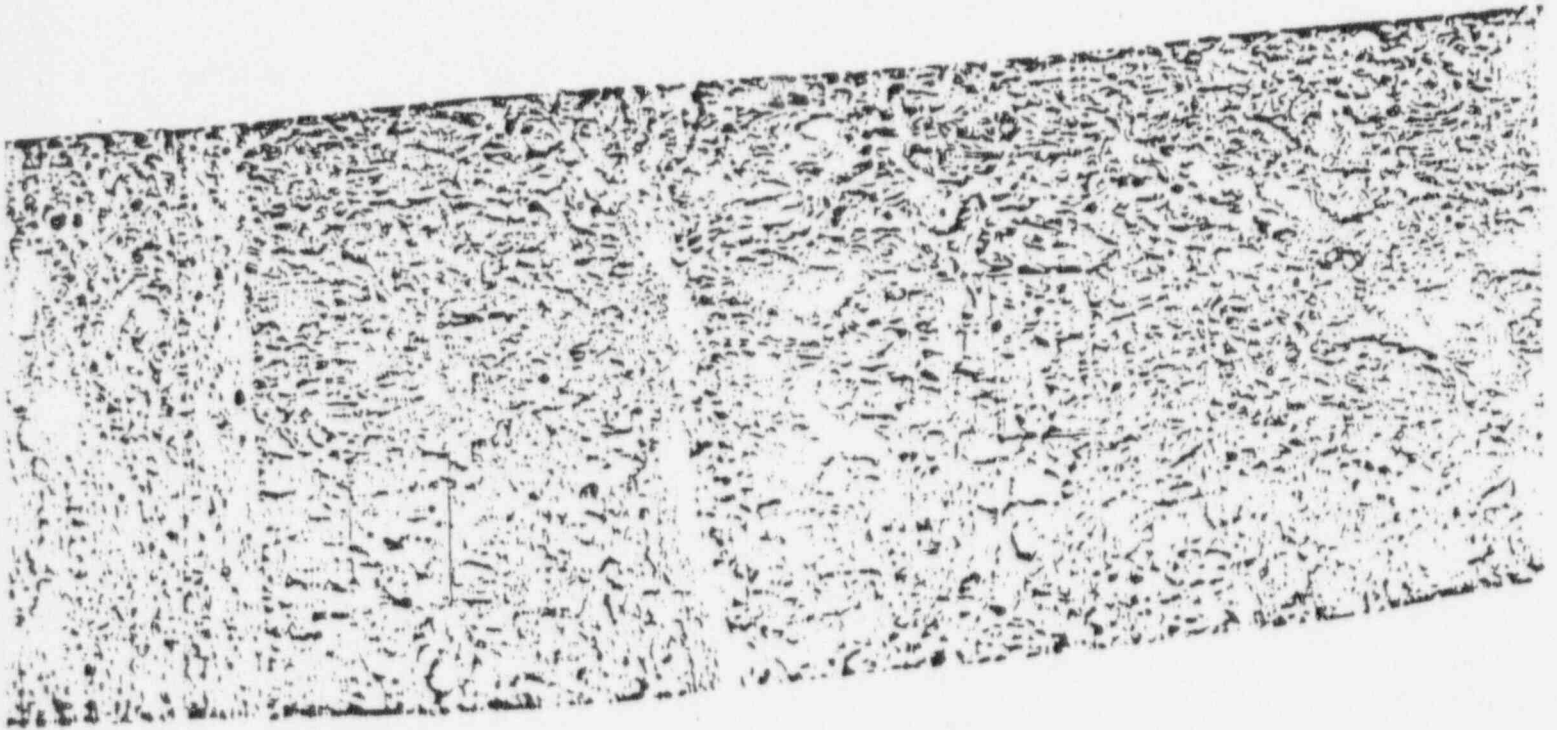
Figure 4-9. Pipe E12, Weld B Intergranular Corrosion of Ductile Overload Boxed Areas

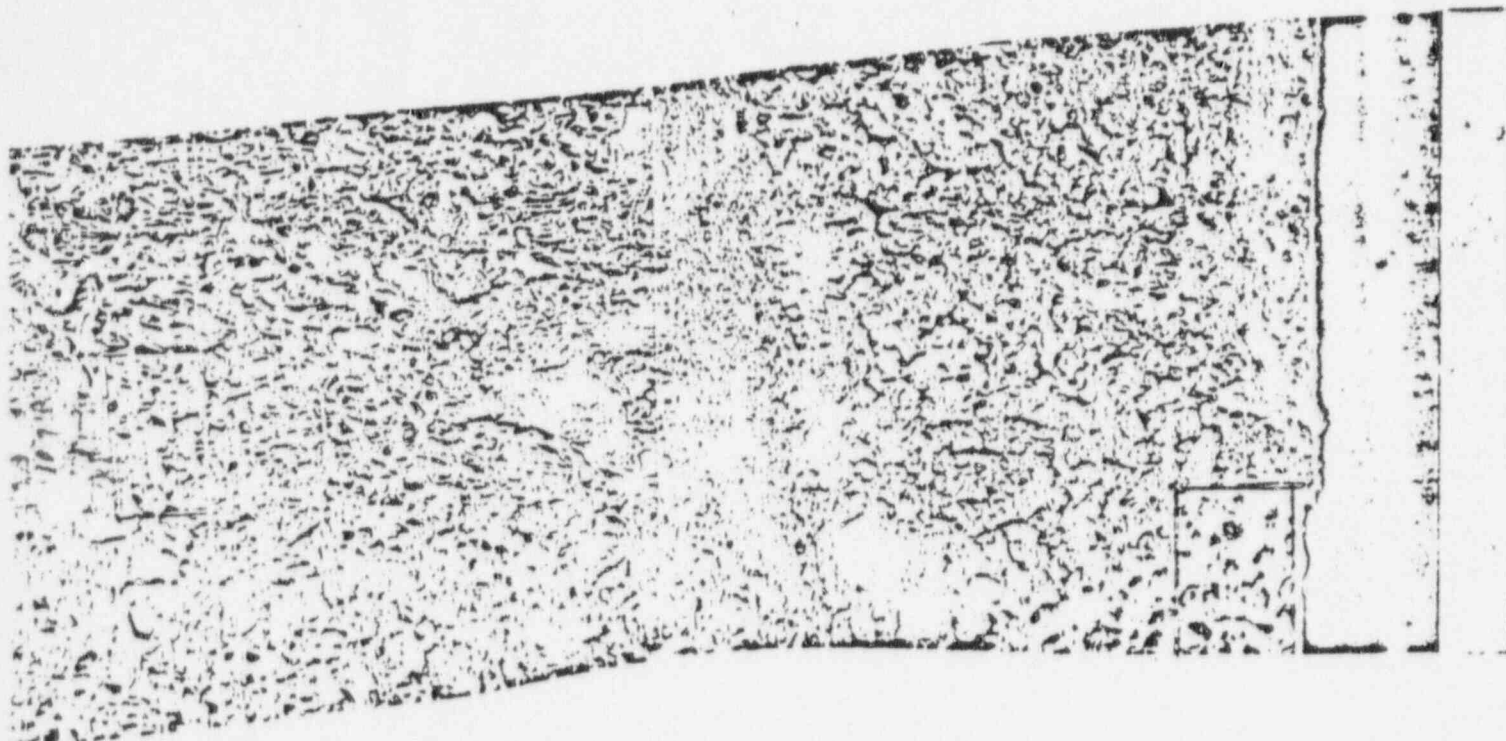
Figure 4-9. Pipe E12, Weld B Intergranular Crack Initiation and Propagation Followed by Cleavage Fracture to Point of Ductile Overload Boxed Areas are Enlarged in Figures 6-5, 6-7 and 6-8

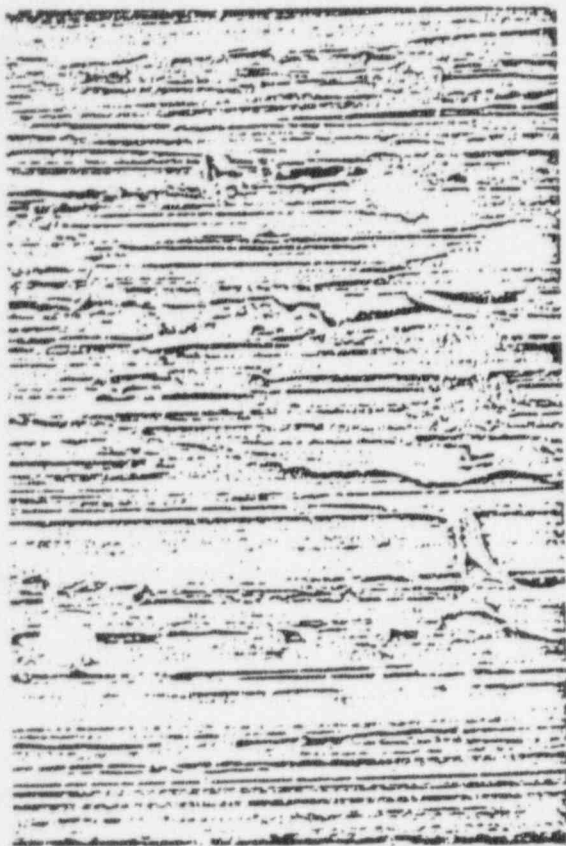
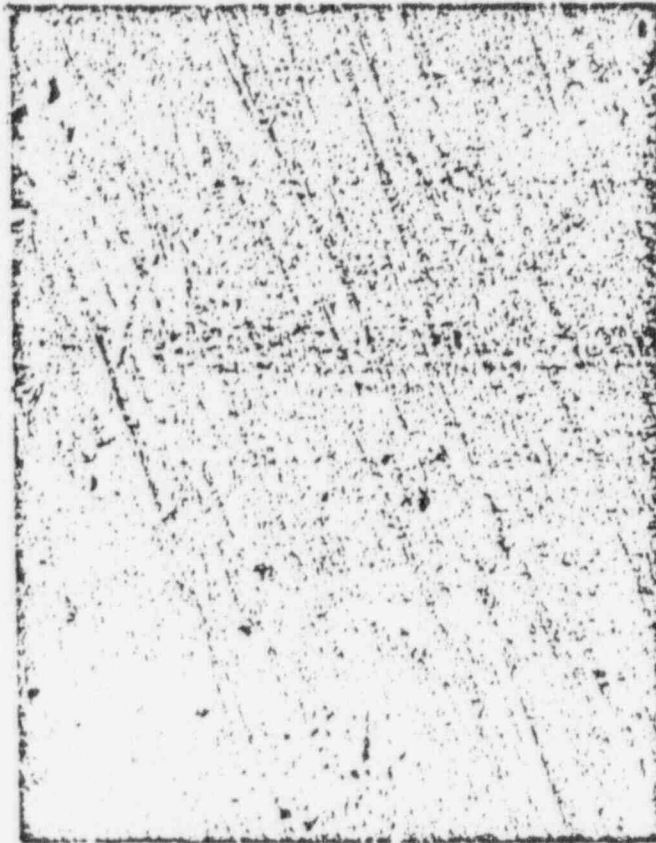
Figure 4-20. Typical Small Specimen Failure

SIDE OF SPECIMEN, GROUND AFTER
COMPLETION OF WELDING

(b) CROWN SIDE OF SPECIMEN, MACHINED AFTER
COMPLETION OF WELDING

(c) THROUGH-WALL SIDE OF SPECIMEN, MACHINED
AFTER COMPLETION OF WELDING

All failures were intergranular in nature and occurred in the weld heat affected zone, as shown in Figure 4-20. However, approximately half of the failures originated on the intact weld root-side surface and the other half originated on the crown-side surface which was machined after welding. No failures originated on either of the transverse (circumferentially oriented) sides of any specimen, although these surfaces were also machined after welding. Examination of the three different surfaces revealed that the surface finish on the transverse sides was much finer than that of either the root or crown sides of the specimens, as shown in Figure 4-24. These results would indicate a significant interaction between surface cold work and sensitization in the initiation of IGSCC. The results also indicated that the testing of specimens which had either not been ground, or had been ground prior to welding would not yield results which could be clearly interpreted because the probability of failure initiation on the crown-side surface was equal to that on the root-side surface of the reference condition. Investigation of grinding effects, utilizing small specimens, will require a different fabrication sequence than that used in the preparation of these specimens.

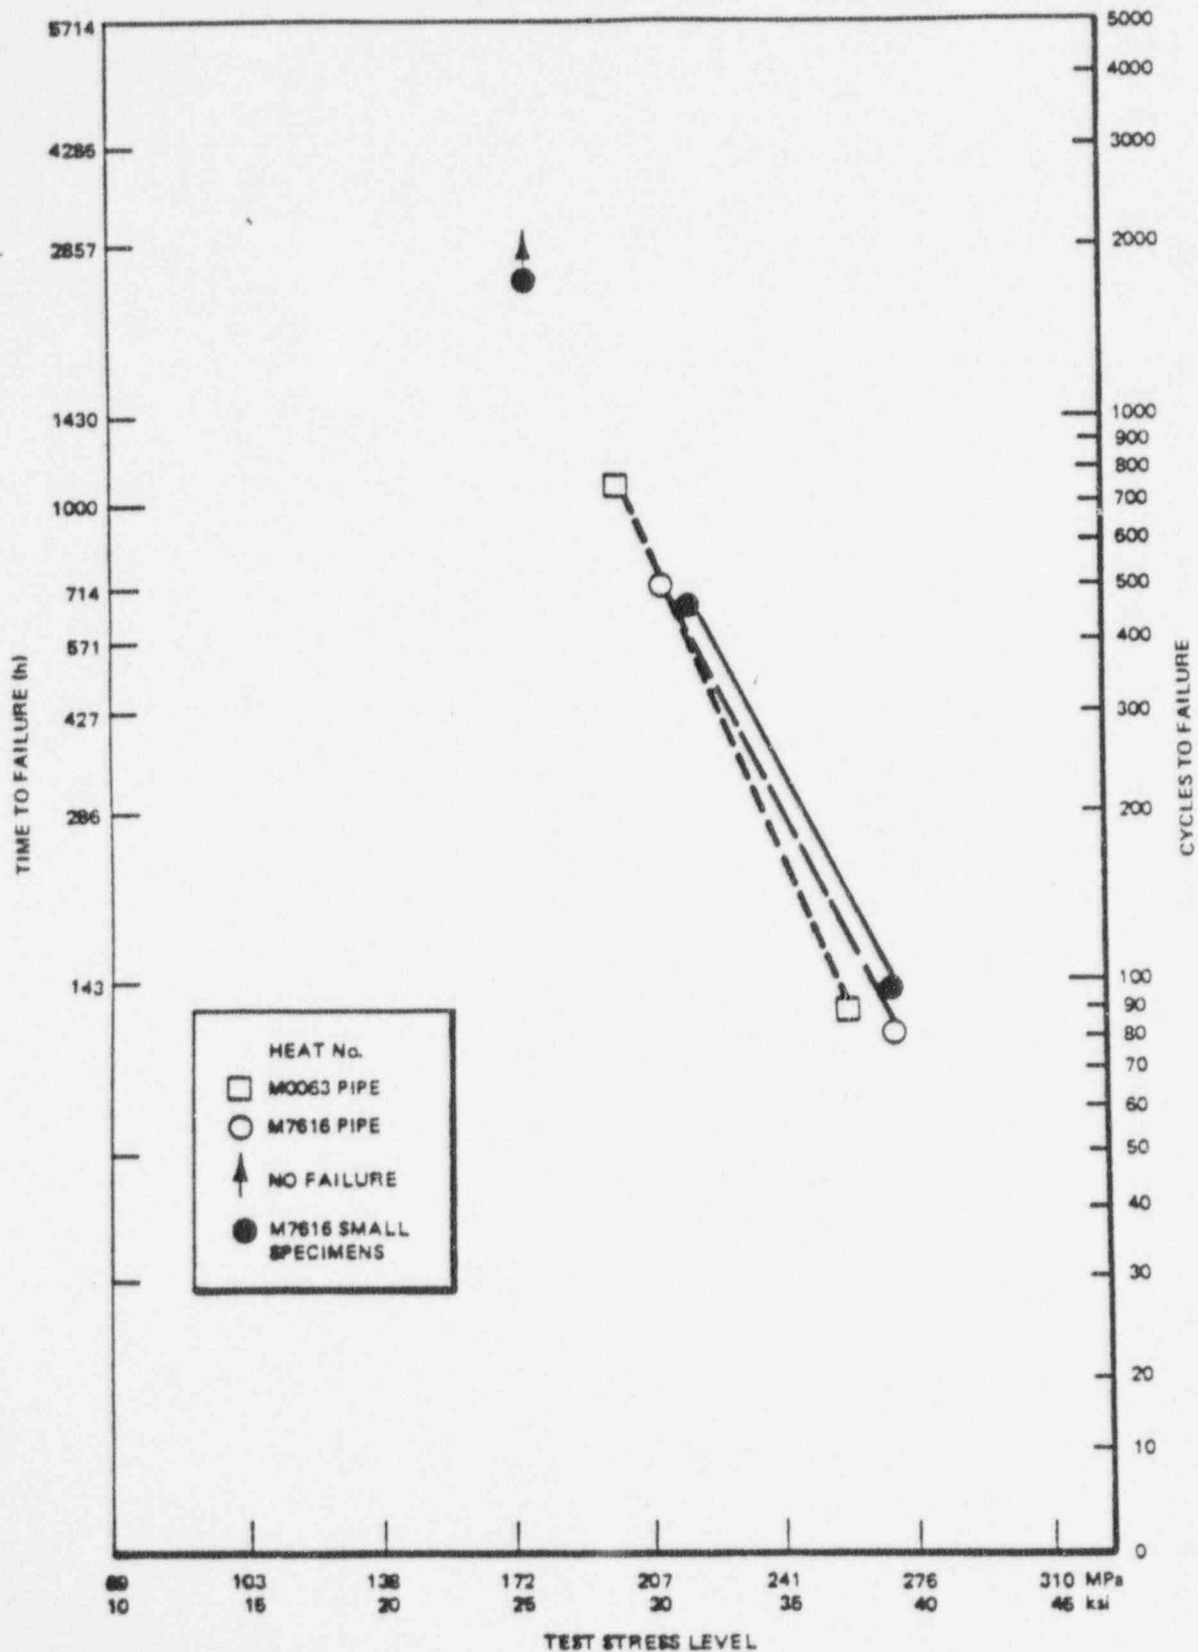
Figure 4-22. Effect of Stress on IGSCC of Welded Type-304 Stainless Steel Pipe and Small Specimens (0.67 cycle/h, air-saturated 288°C water)

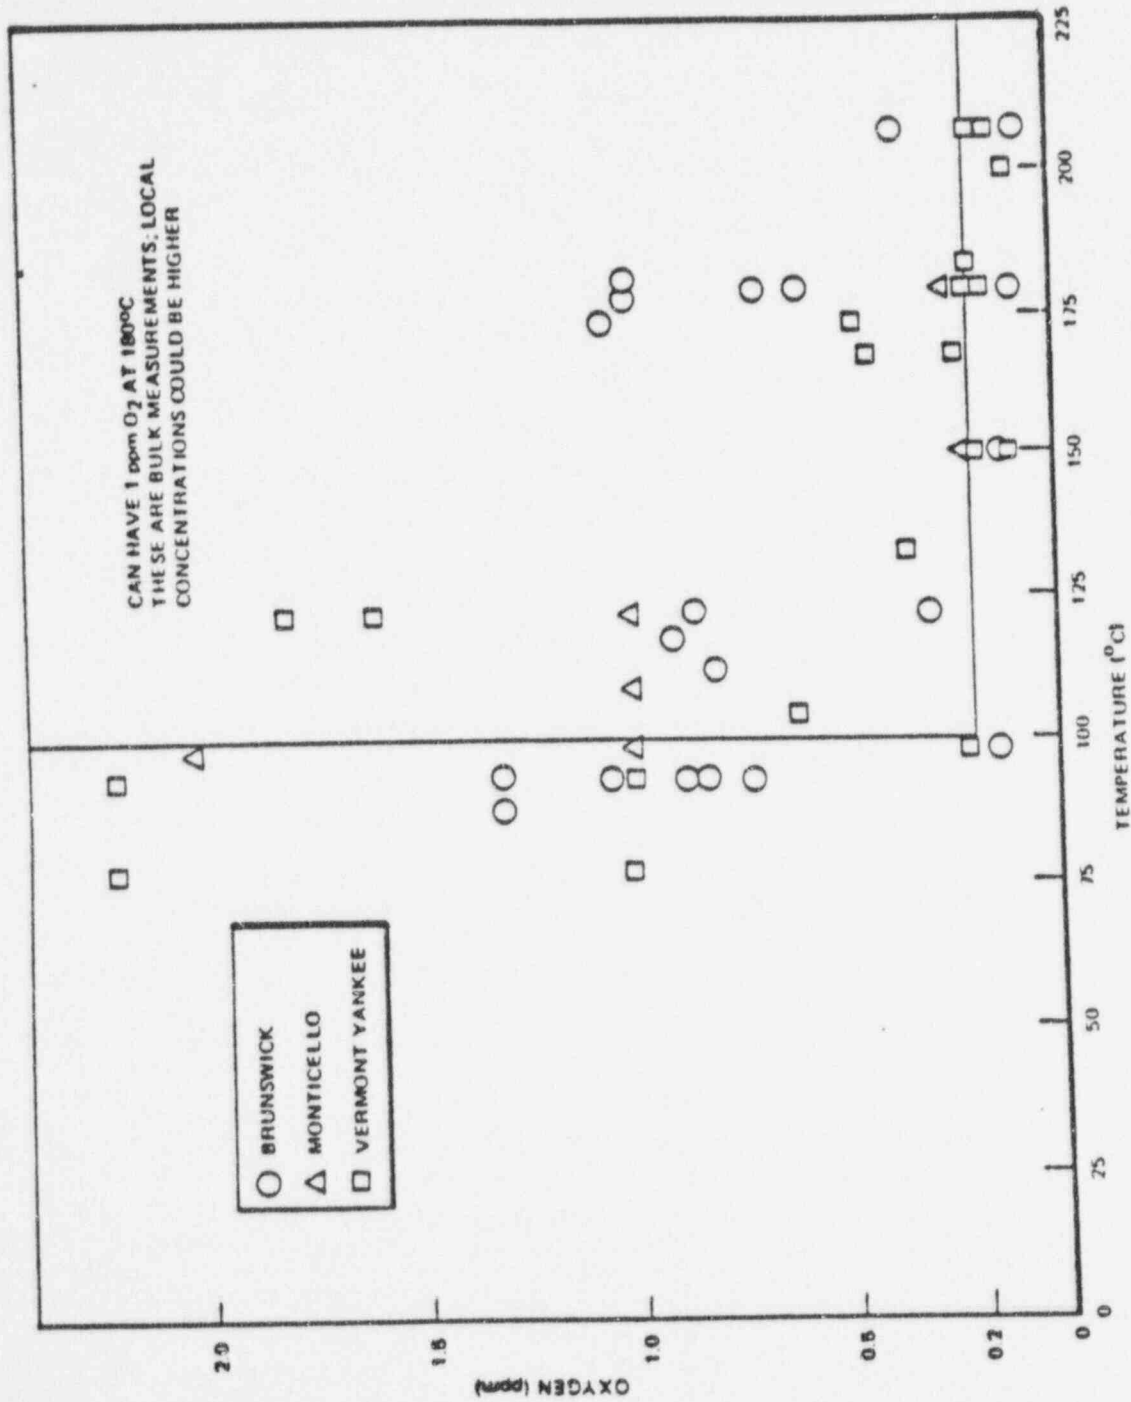
Figure 5.4 Variation of Oxygen with Temperature during Startups

The continuous decrease in potential with increasing temperature was observed until a temperature of about 256°C (493°F) was achieved. At this point an increase in potential was measured which persisted several hours (from about 2100 August 6 to 0200 August 7). This rise in potential was coincident with a decrease in the pH of the reactor water. The decrease in pH was caused by decomposition of ion exchange resins which had been dropped into the reactor vessel during shutdown. For this reason and because conductivity also rose, the reactor temperature was lowered to 215°C (420°F) and the reactor water cleanup system was run at maximum duty. During the cleanup period
