EVALUATION OF NEAR-TERM BWR PIPING REMEDIES

(Research Project 701-1)

Final Report

Nuclear Energy Engineering Division
General Electric Company
175 Curtner Avenue
San Jose, California 95125

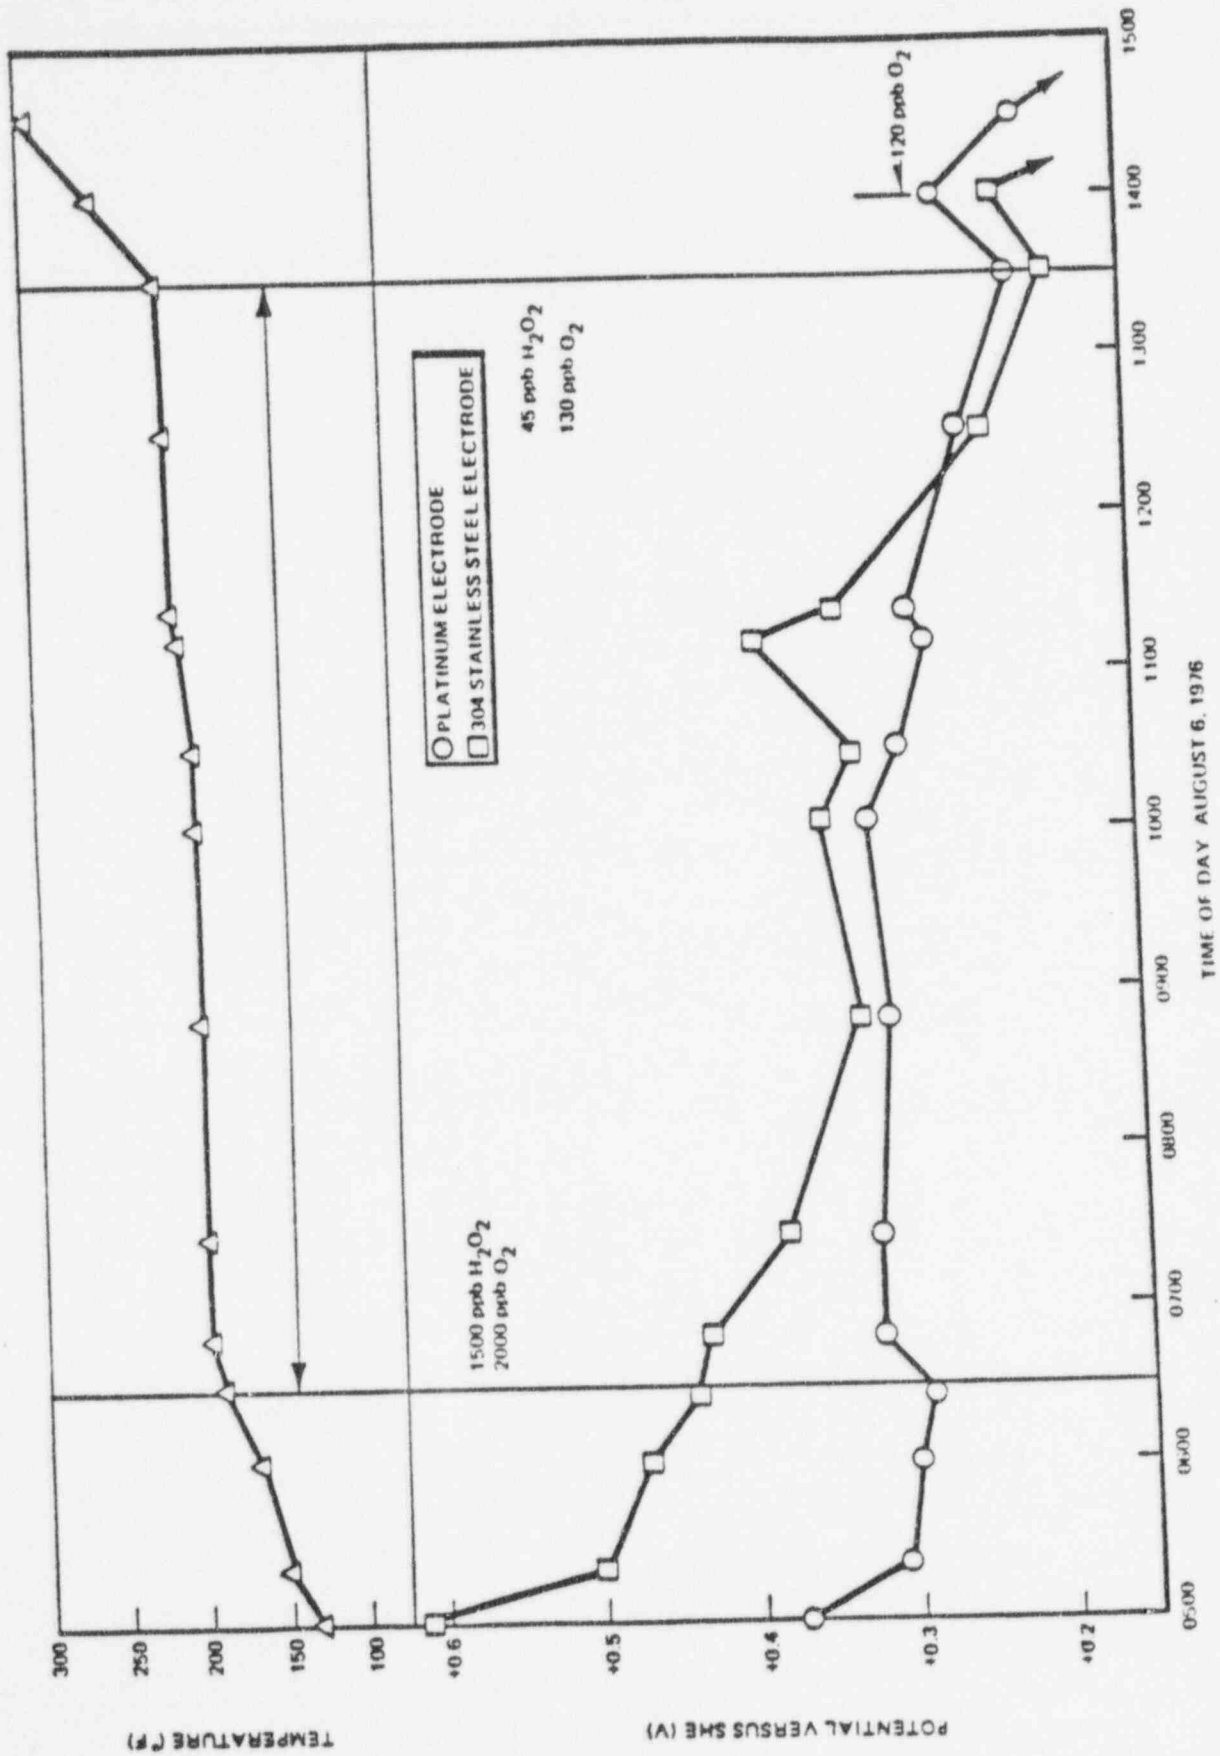
Figure 5-5 Corrosion and Oxidation Potential of Type-304 Stainless Steel and Platinum, Respectively, in Vermont Yankee during Controlled Degassing

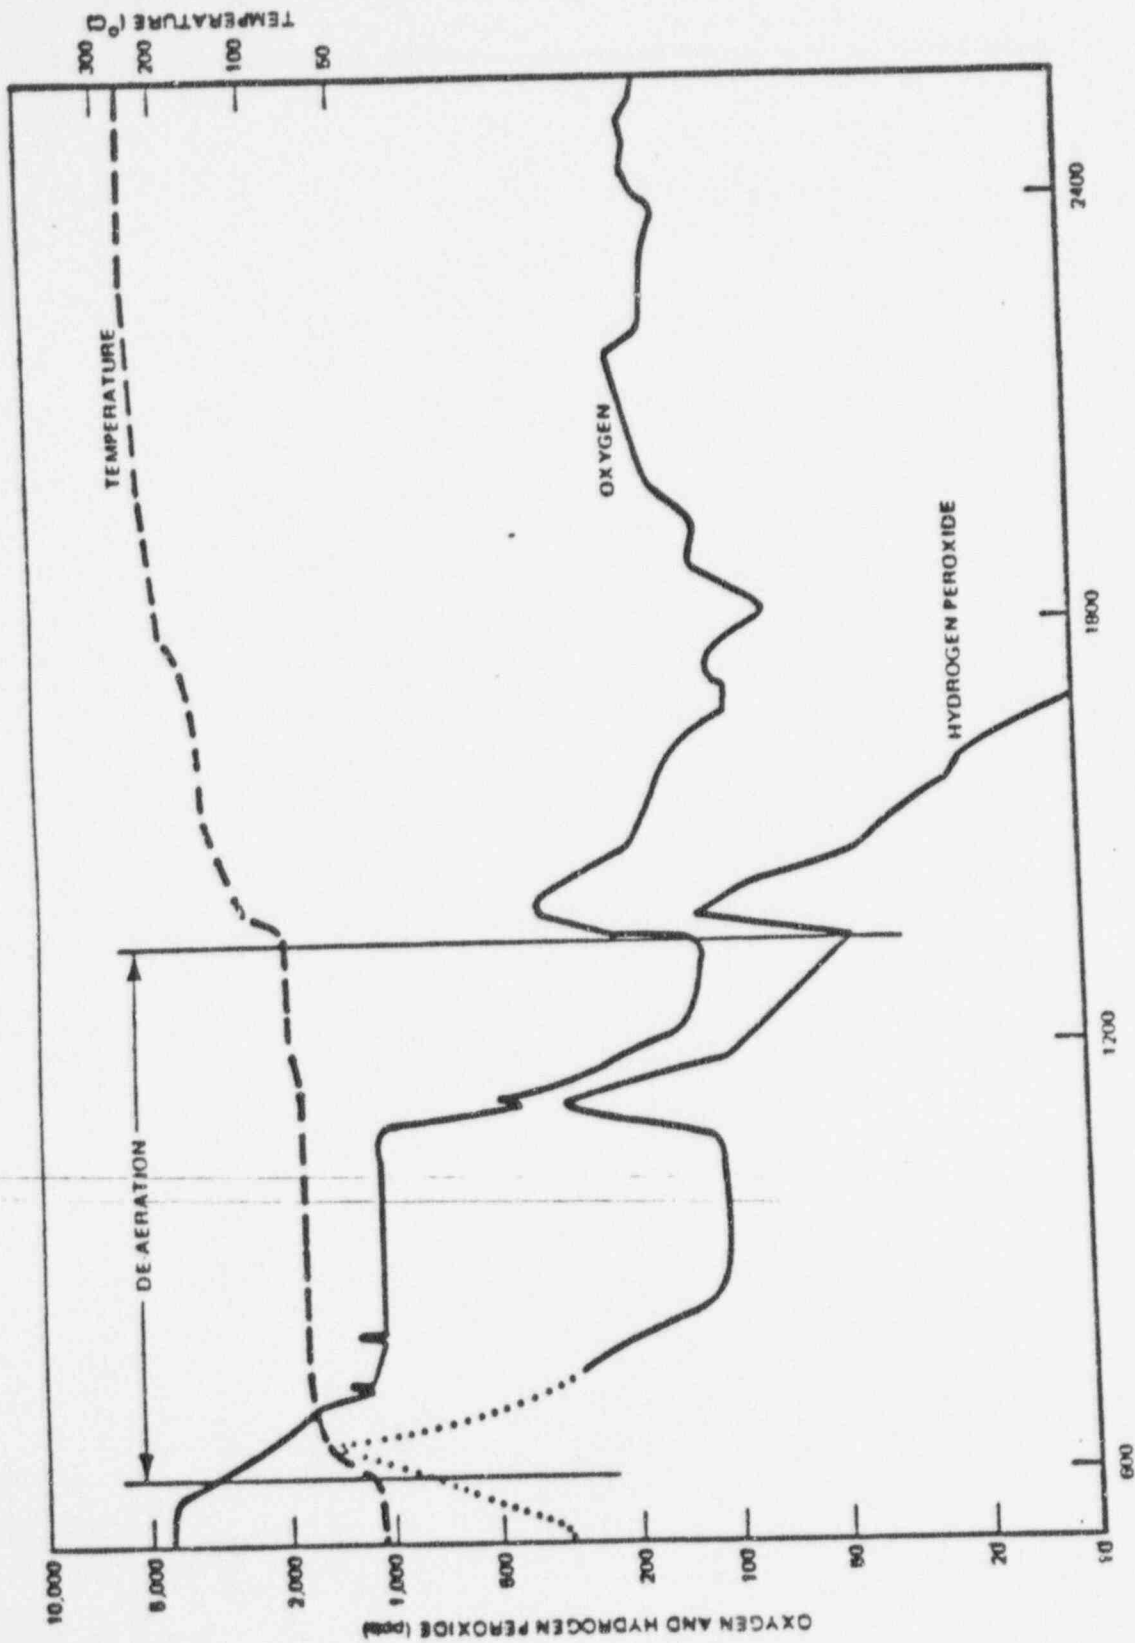
Figure 5-6 Oxygen and Hydrogen Peroxide During Vermont Yankee Startup, August 6, 1976

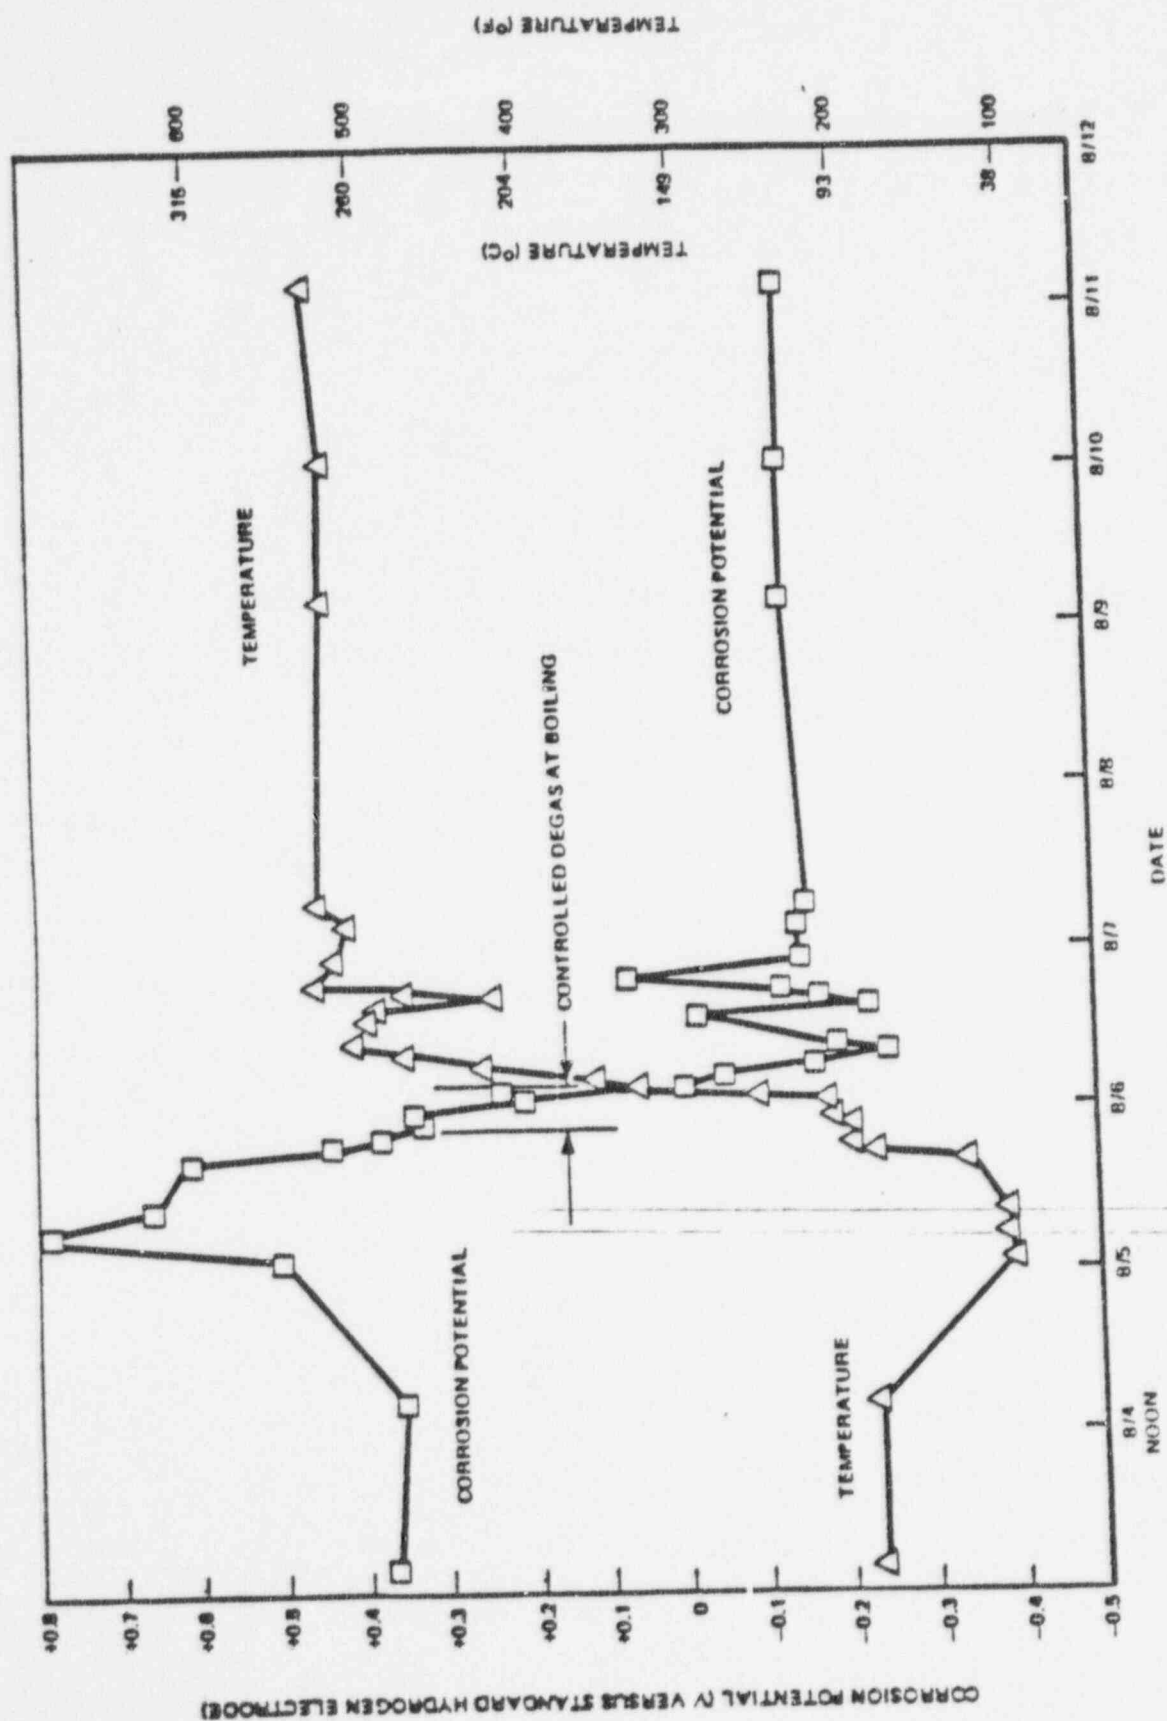
Figure 5-7. Corrosion Potential of Type 304 Stainless Steel During Reactor Startup

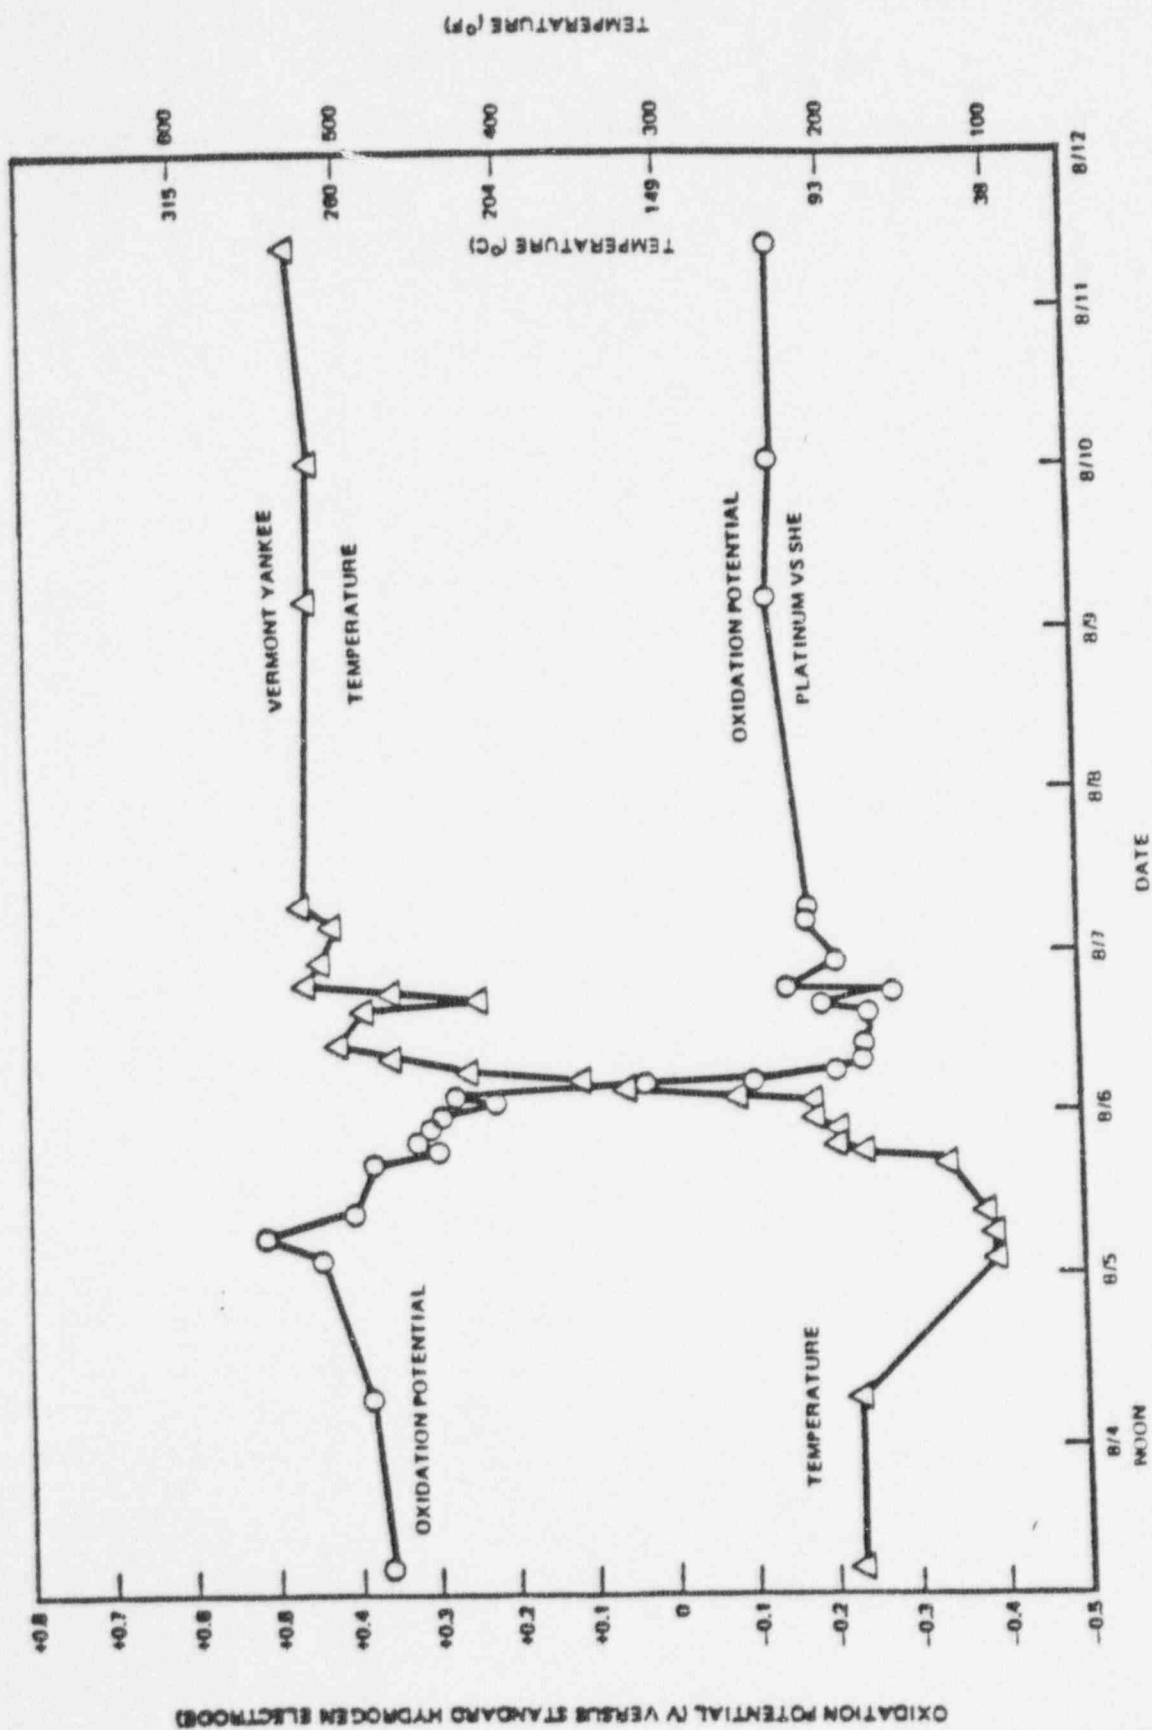
Figure 5-8. Oxidation Potential of Platinum During Reactor Startup

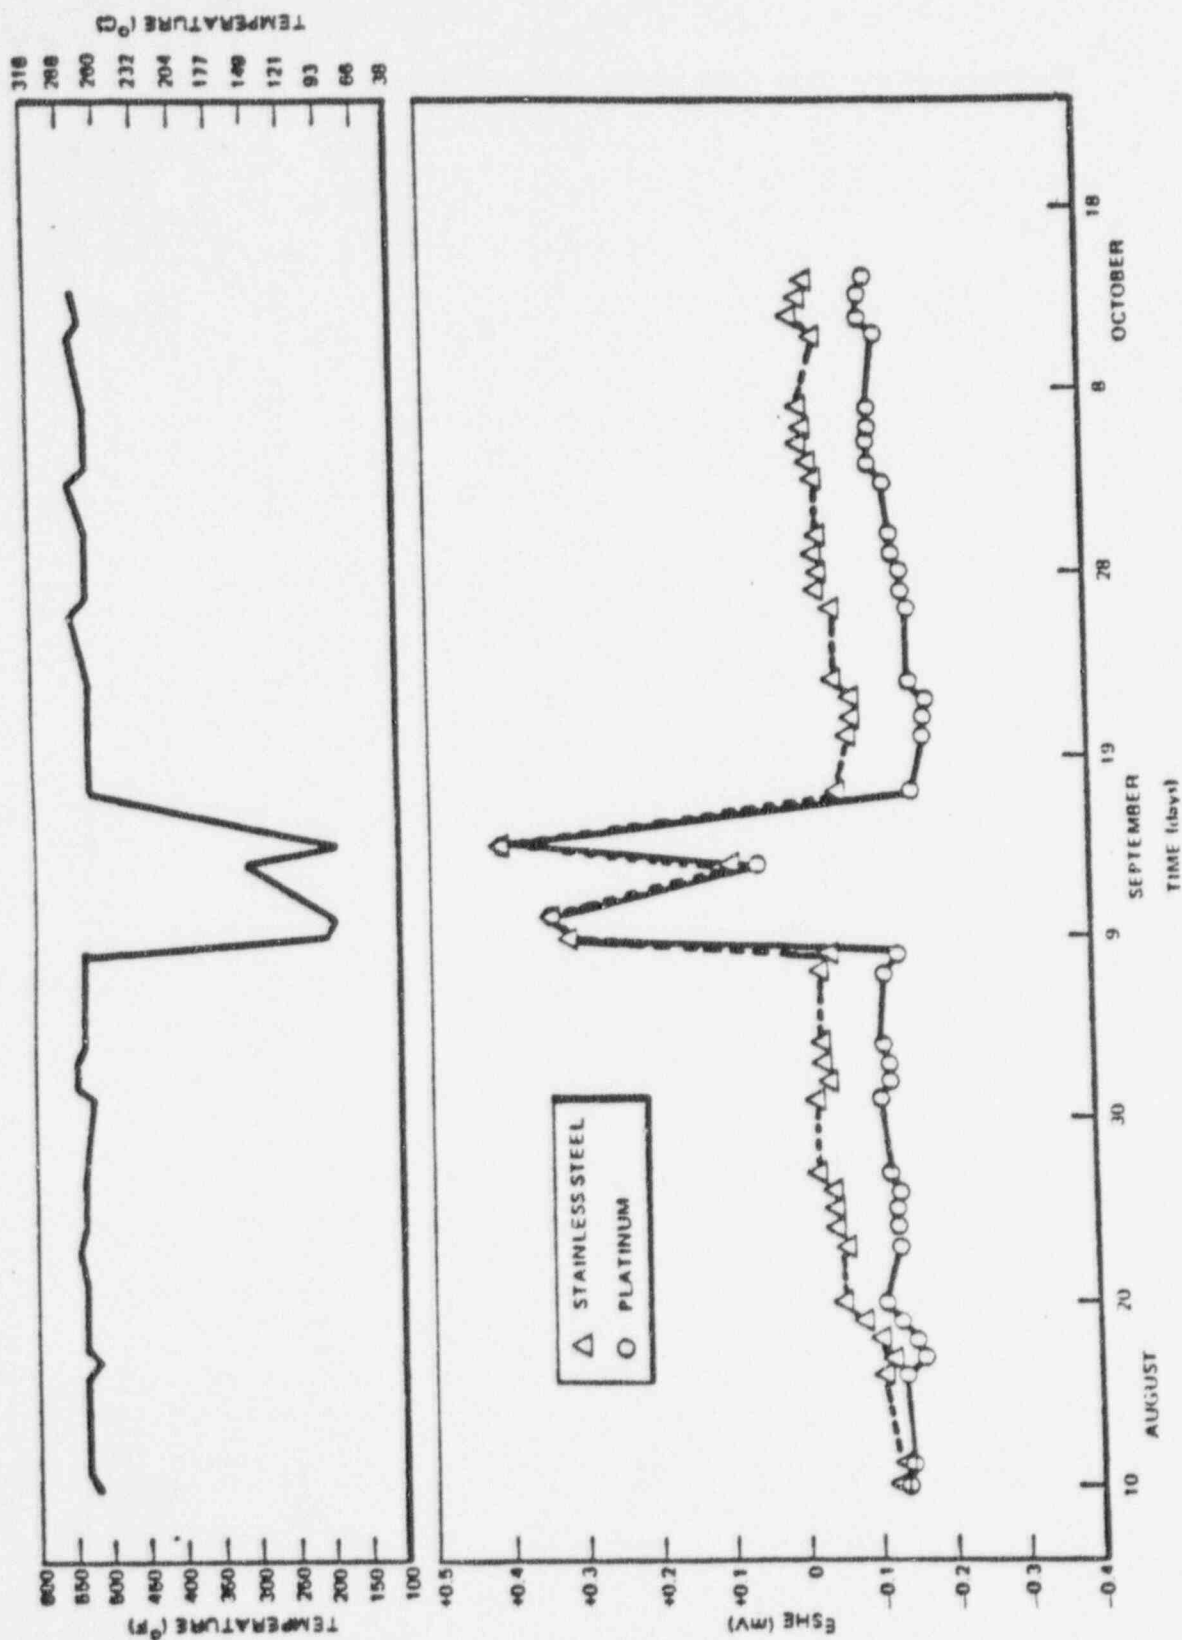
Figure 5-9 Potential versus Time Behavior at Vermont Yankee after Startup

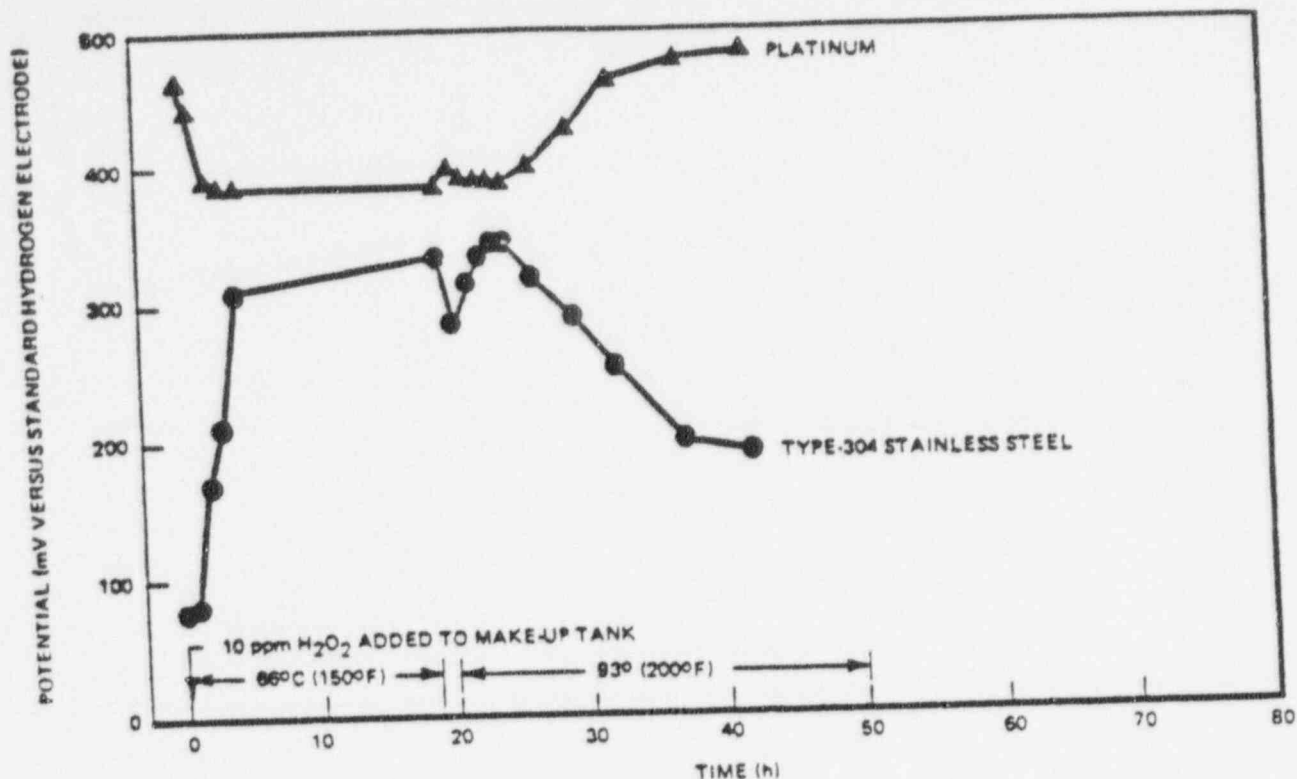
Figure 5-10 Effect of Hydrogen Peroxide on Oxidation and Corrosion Potential of Platinum and Type-304 Stainless Steel in Aerated Water

Hydrogen peroxide can effect the corrosion potential in a BWR significantly below 170°C. Thus, during reactor startups, combinations of H_2O_2 and O_2 can result in ranges of corrosion potentials that can either produce a propensity to IGSCC or mitigate IGSCC. At present, the envelope of these startup environments and oxidizing potentials which can result in IGSCC is not known and should be the subject of future studies.

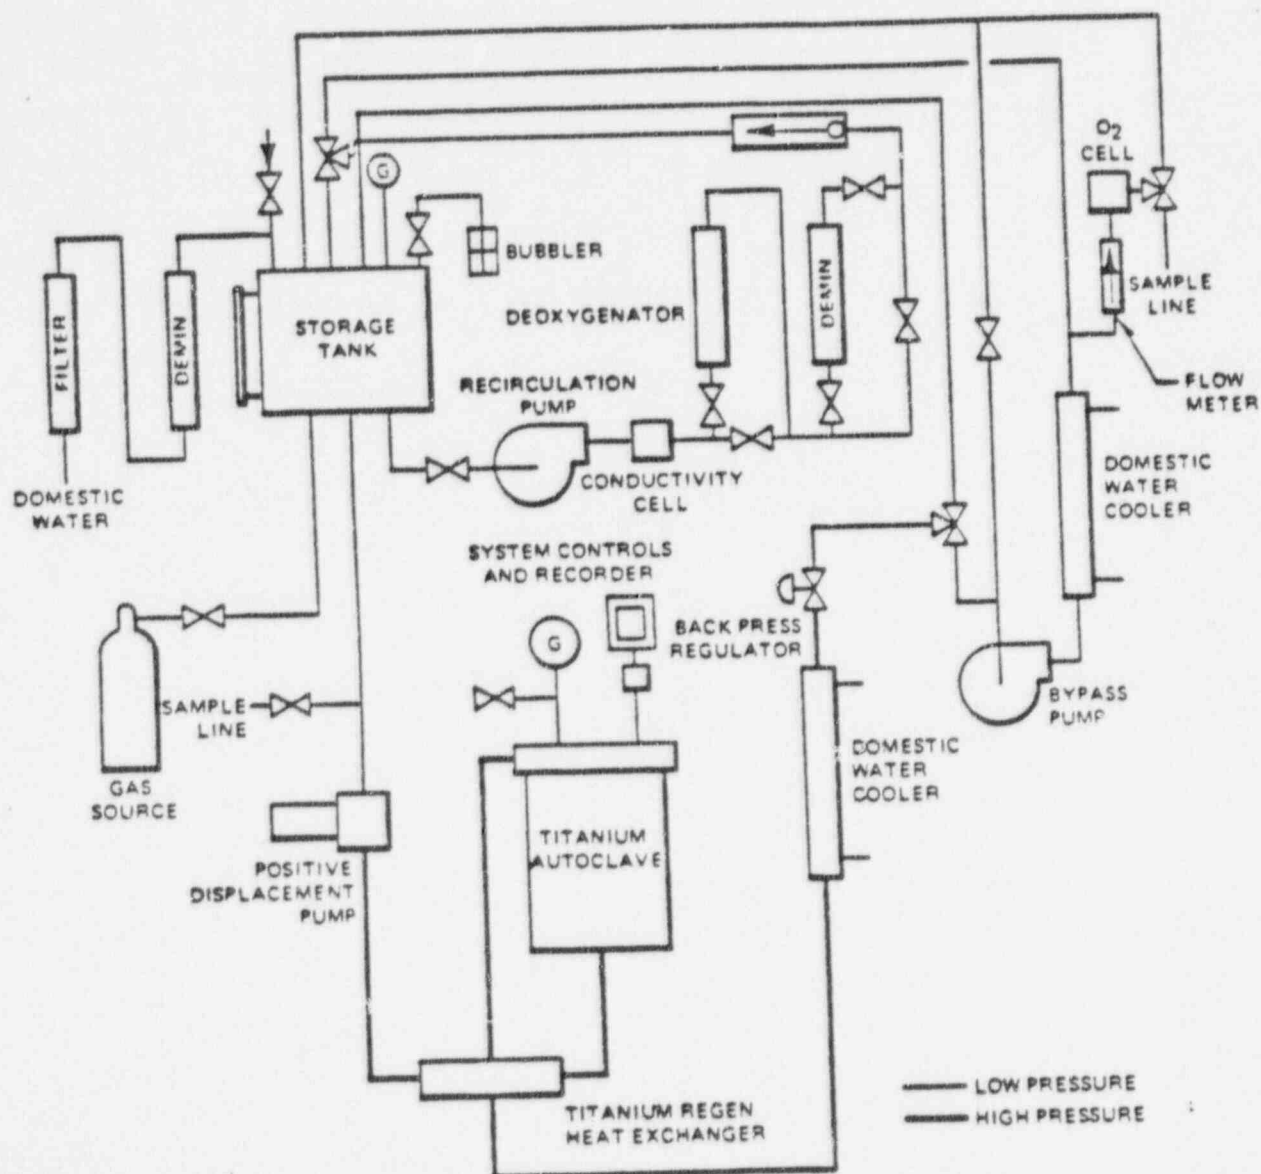
Figure 5-11. Refreshed Water Loop for Electrochemical Studies

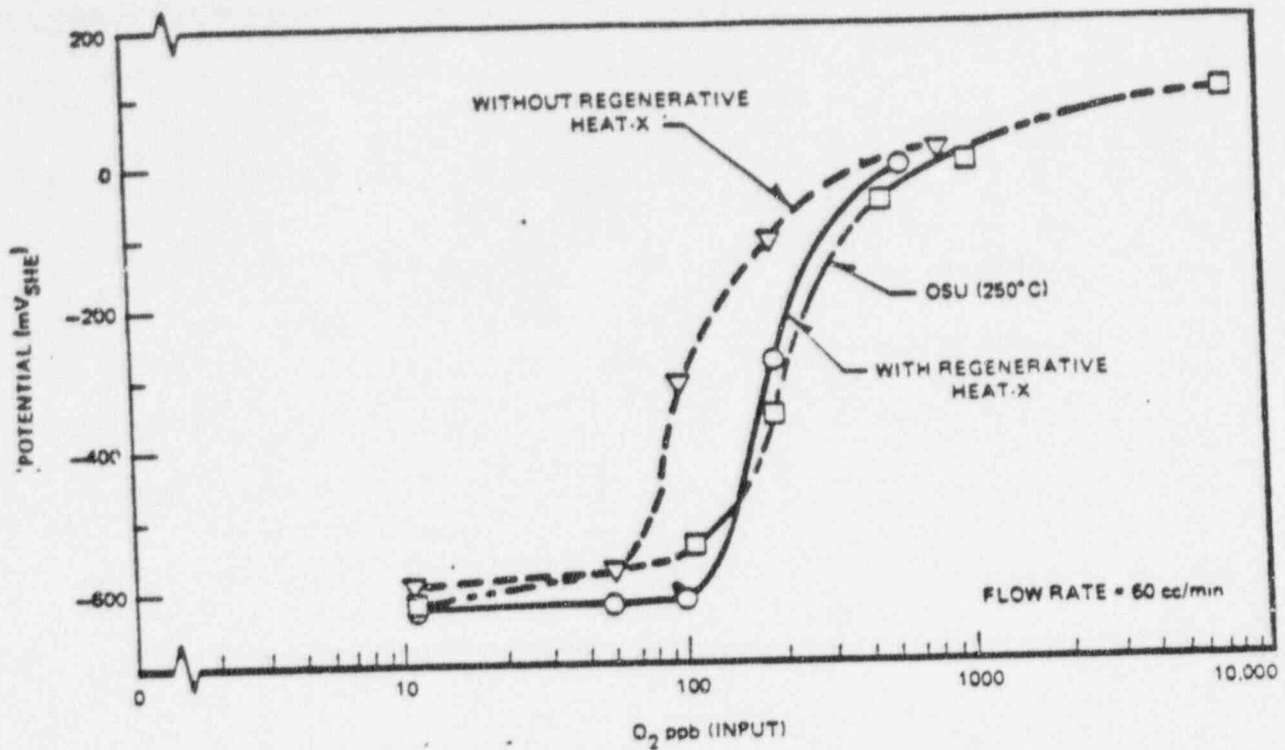
Figure 5-12. The Effect of Dissolved Oxygen on the Oxidation Potential of Platinum in High Purity Water at 274°C (525°F). With and Without Alloy 600 Regenerative Heat Exchanger. (Determined After 24 hours at Each Oxygen Level)

The result of the initial tests in the stainless steel autoclave and data obtained at Ohio State University (OSU) are shown in Figure 5-12. Oxygen concentrations were based solely on measurements from the storage tank. The initial data from the stainless steel system which contained an Inconel 600 heat exchanger were in excellent agreement with the OSU data. However, the laboratory potential measurements with 200 ppb dissolved oxygen were significantly lower than those obtained at Vermont Yankee (-0.350 versus -0.150 V_{SHE}). In addition, the data indicated that between 0 and 100 ppb dissolved O_2 the potential remained low, around -0.650 V_{SHE} . Above 100 ppb O_2 the potential increased dramatically. At low potentials, it is theorized that susceptibility to IGSCC is low. This large increase in potential could indicate the onset of IGSCC. Thus, from the initial GE and OSU data it might have been predicted that no IGSCC would occur below 100 ppb dissolved oxygen. System changes that decreased gettering such as removal of the heat exchanger, decreased gettering, moved the curve to left and improved the data. However, the major system improvement was the installation of a titanium autoclave (Ti-6Al-4V) and titanium heat exchanger. After an aging period in air saturated high temperature water for several weeks the oxygen gettering was reduced to a minimum (15 ± 10 ppb) and reliable data were obtained.

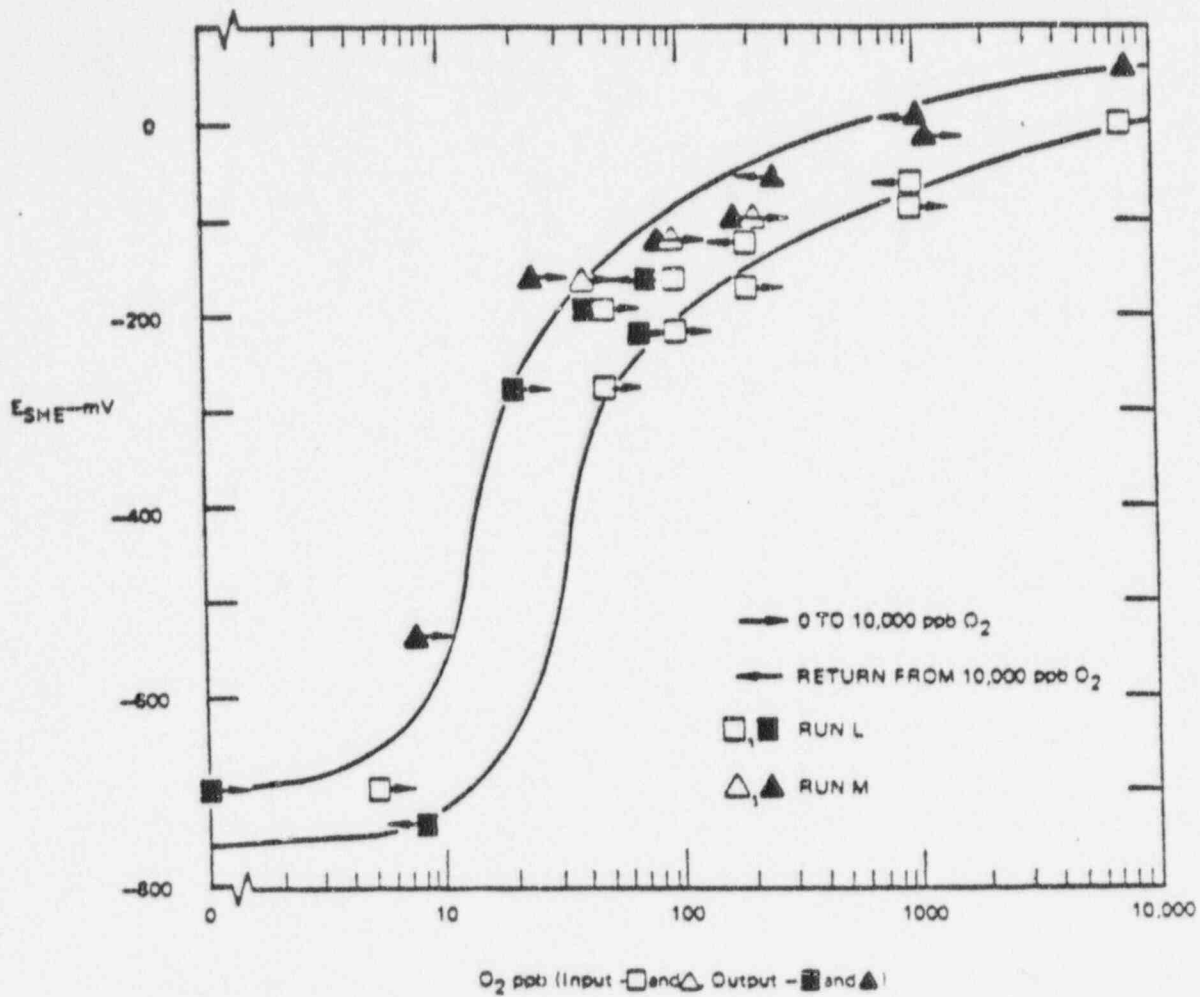
Figure 5-13. The Effect of Dissolved Oxygen on the Corrosion Potential of Type-304 Stainless Steel in High Purity Water at 274°C (525°F)

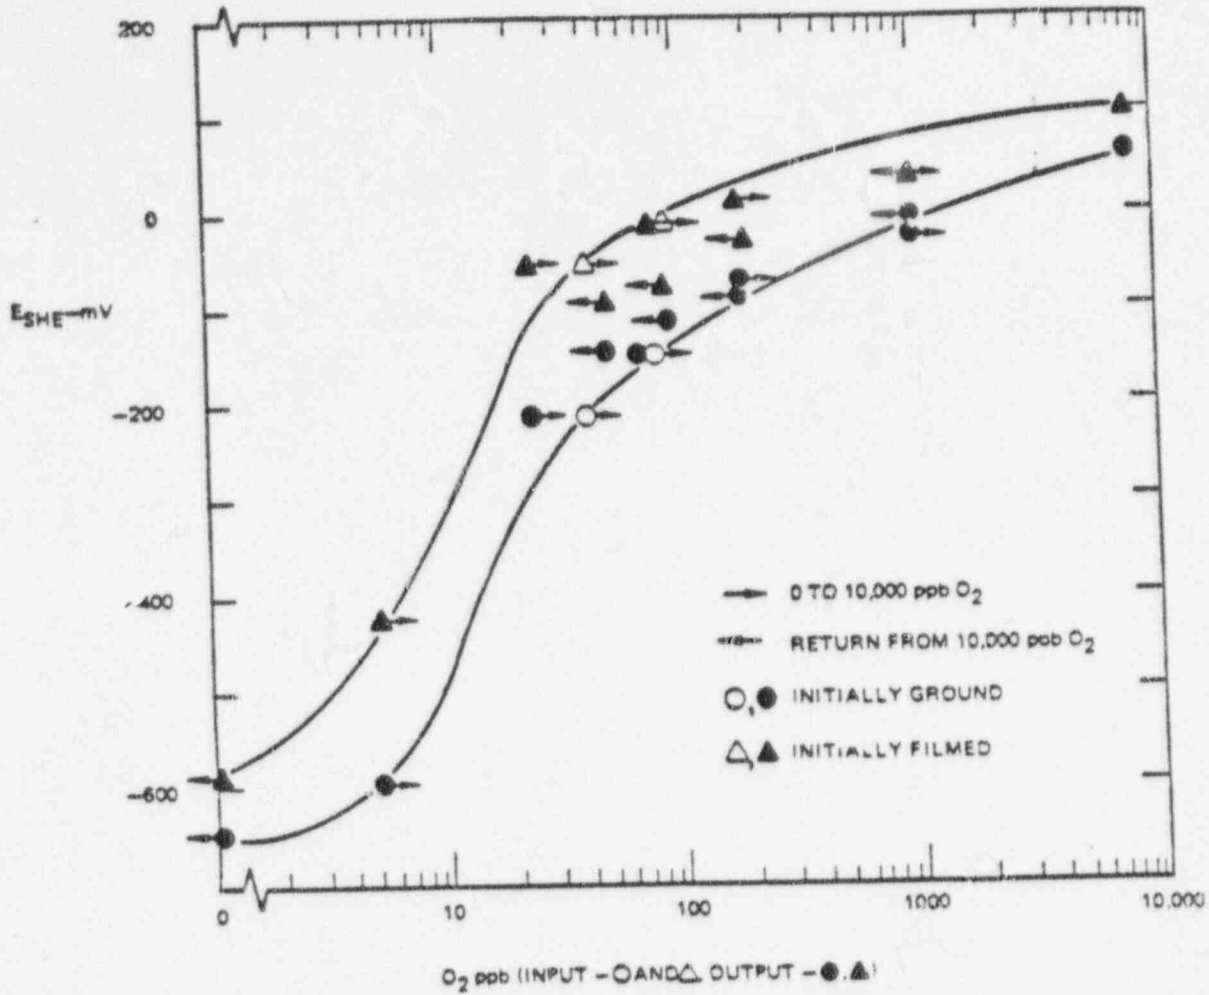
Figure 5-14. The Effect of Dissolved Oxygen on the Corrosion Potential of Type-304 Stainless Steel in High Purity Water at 232°C (450°F)

The effect of decreasing the temperature from 274°C (525°F) to 232°C (450°F) was to increase the potential approximately 80 mV at all oxygen concentrations (Figure 5-14). A comparison of the corrosion potentials between a prefilmed and an unfilmed stainless steel specimen is also given in Figure 5-14. The prefilmed specimen had been previously used in the experiments at 274°C (525°F), while the unfilmed specimen had been ground with 600 grit silicon carbide paper prior to use. In general, the filmed specimen exhibited higher corrosion potentials than the unfilmed sample. The potential differences were greatest during the time of the experiment when the oxygen concentration was increased from 0 to 10,000 ppb, and least when the oxygen was reduced from 10,000 to 0 ppb. The maximum potential difference between the stainless steel specimens was about a 0.150V and minimum potential difference was about 0.050V. The potential differences were probably caused by the higher metal oxidation rate of the

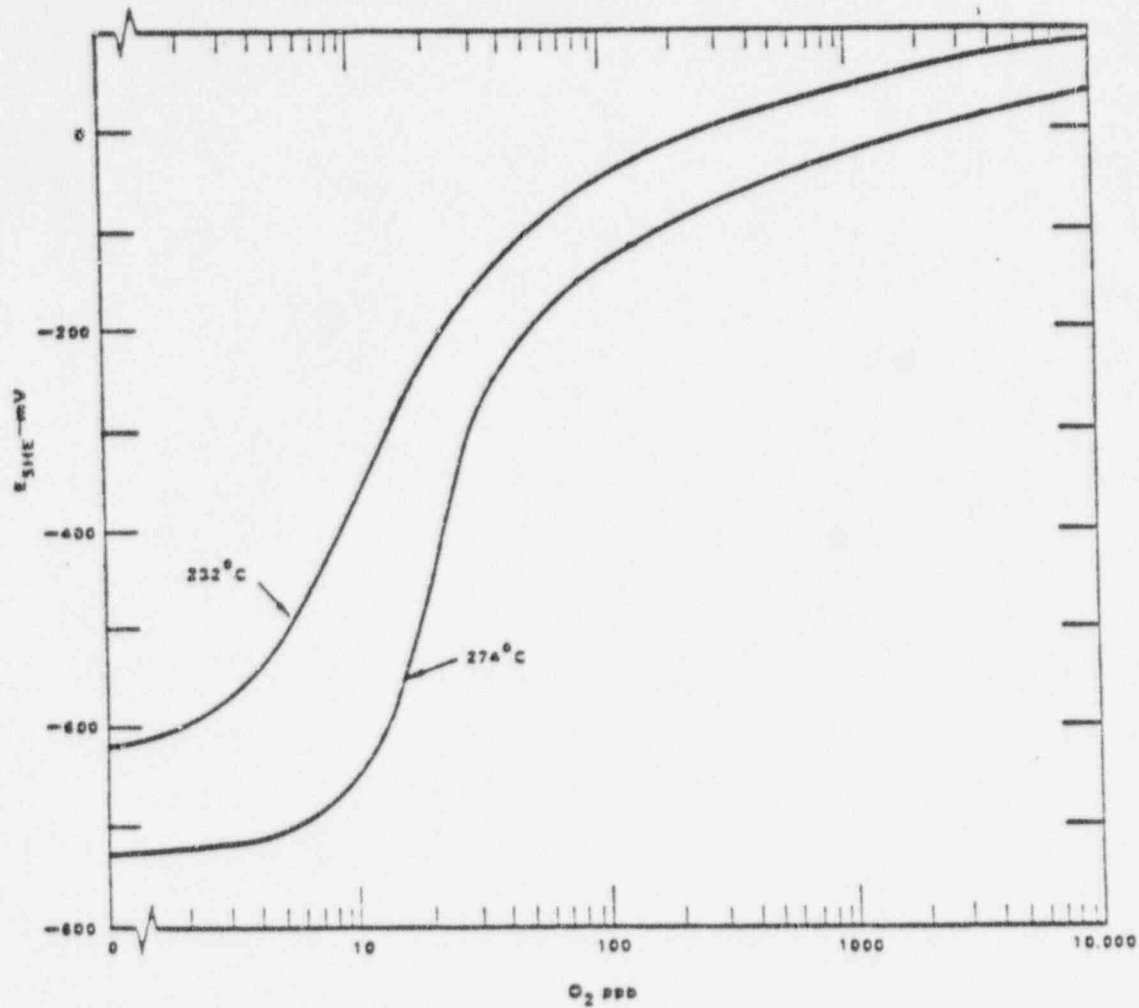
Figure 5-15. The Effect of Dissolved Oxygen on the Corrosion Potential and IGSCC of Type-304 Stainless Steel (Average Curves)

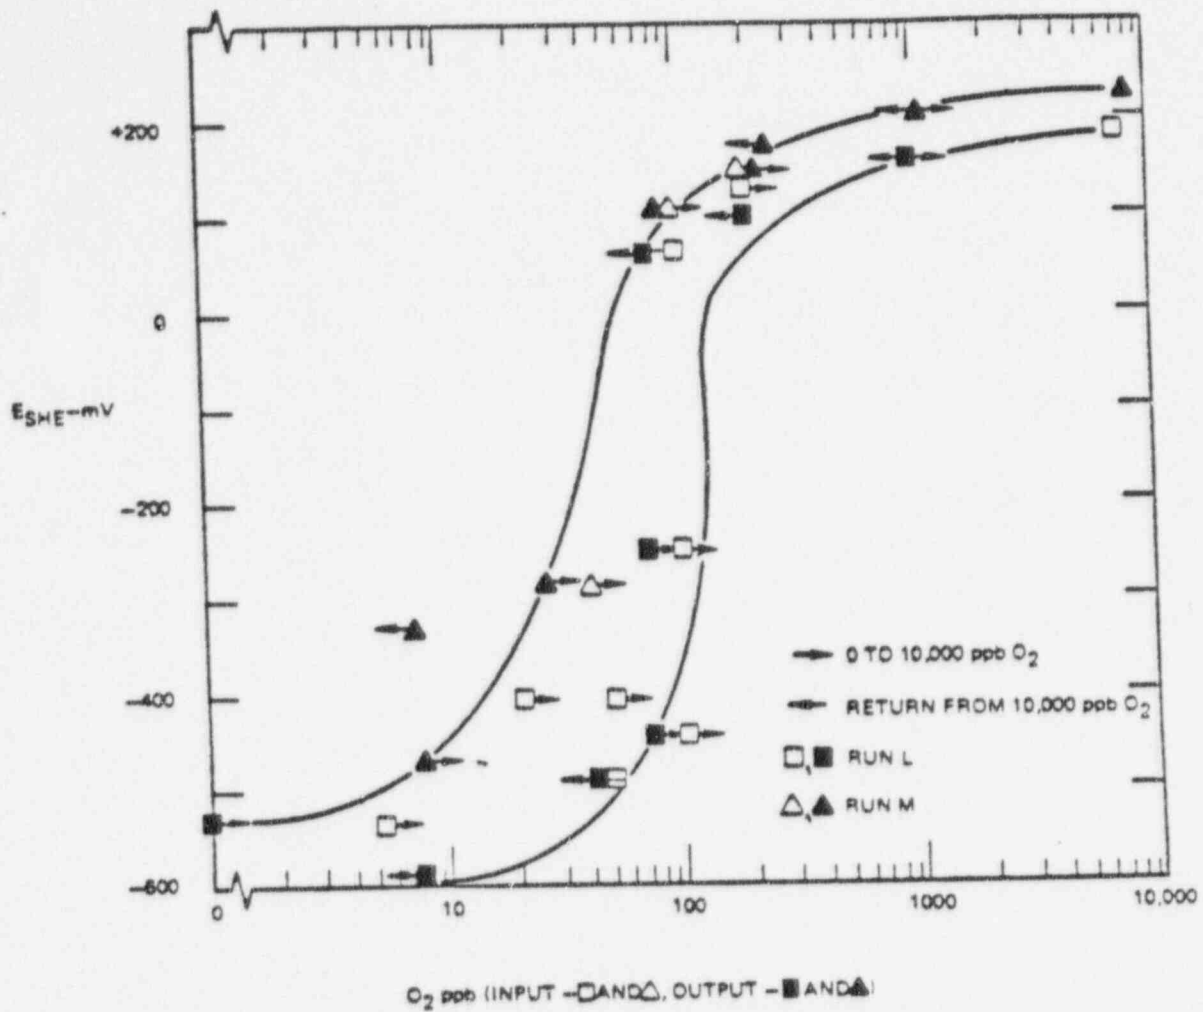
Figure 5-16. The Effect of Dissolved Oxygen on the Oxidation Potential of Platinum in High Purity Water at 274°C (525°F)

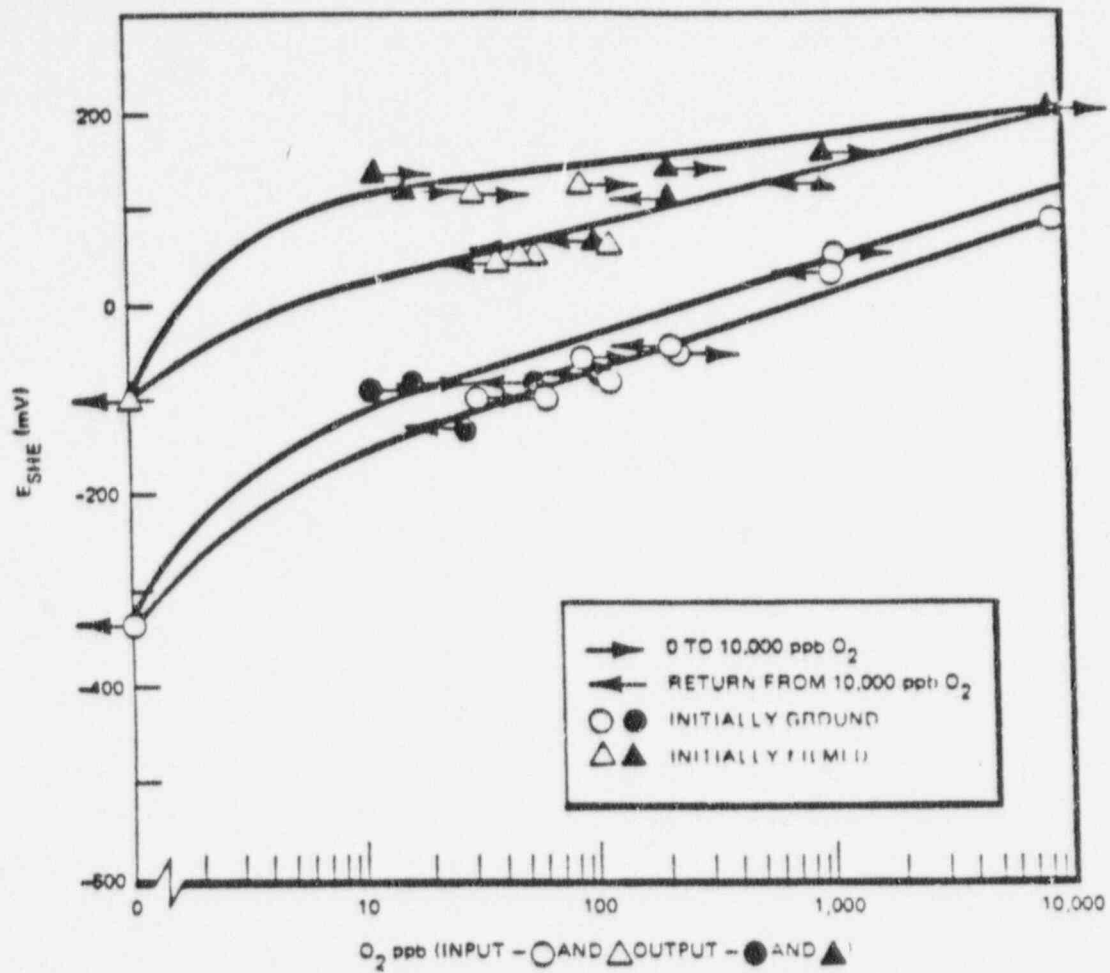
Figure 5-18. The Effect of Dissolved Oxygen on the Corrosion Potential of Type-304 Stainless Steel in High-Purity Water at 191°C (375°F)

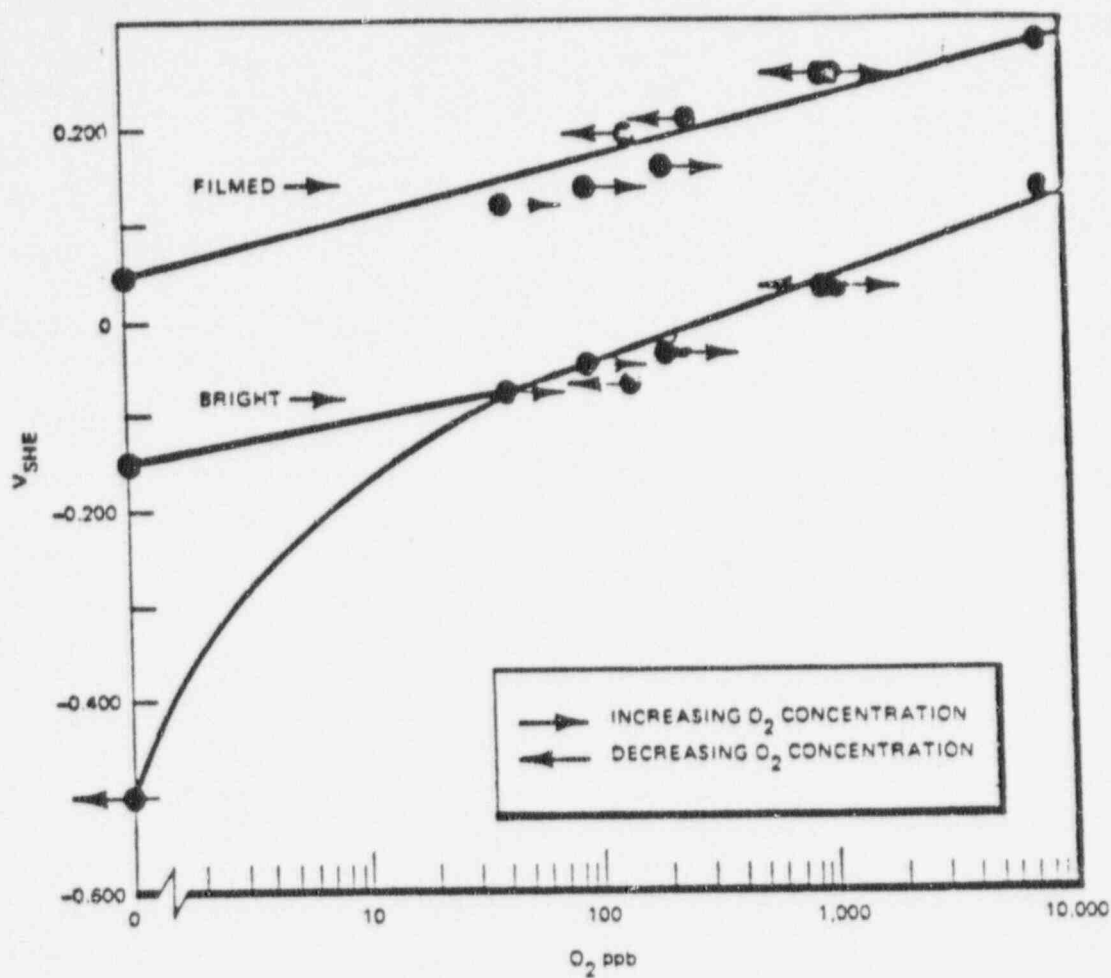
Figure 5-19. The Effect of Dissolved Oxygen on the Corrosion Potential of Bright and Filmed Type-304 Stainless Steel in Water at 149°C (300°F)

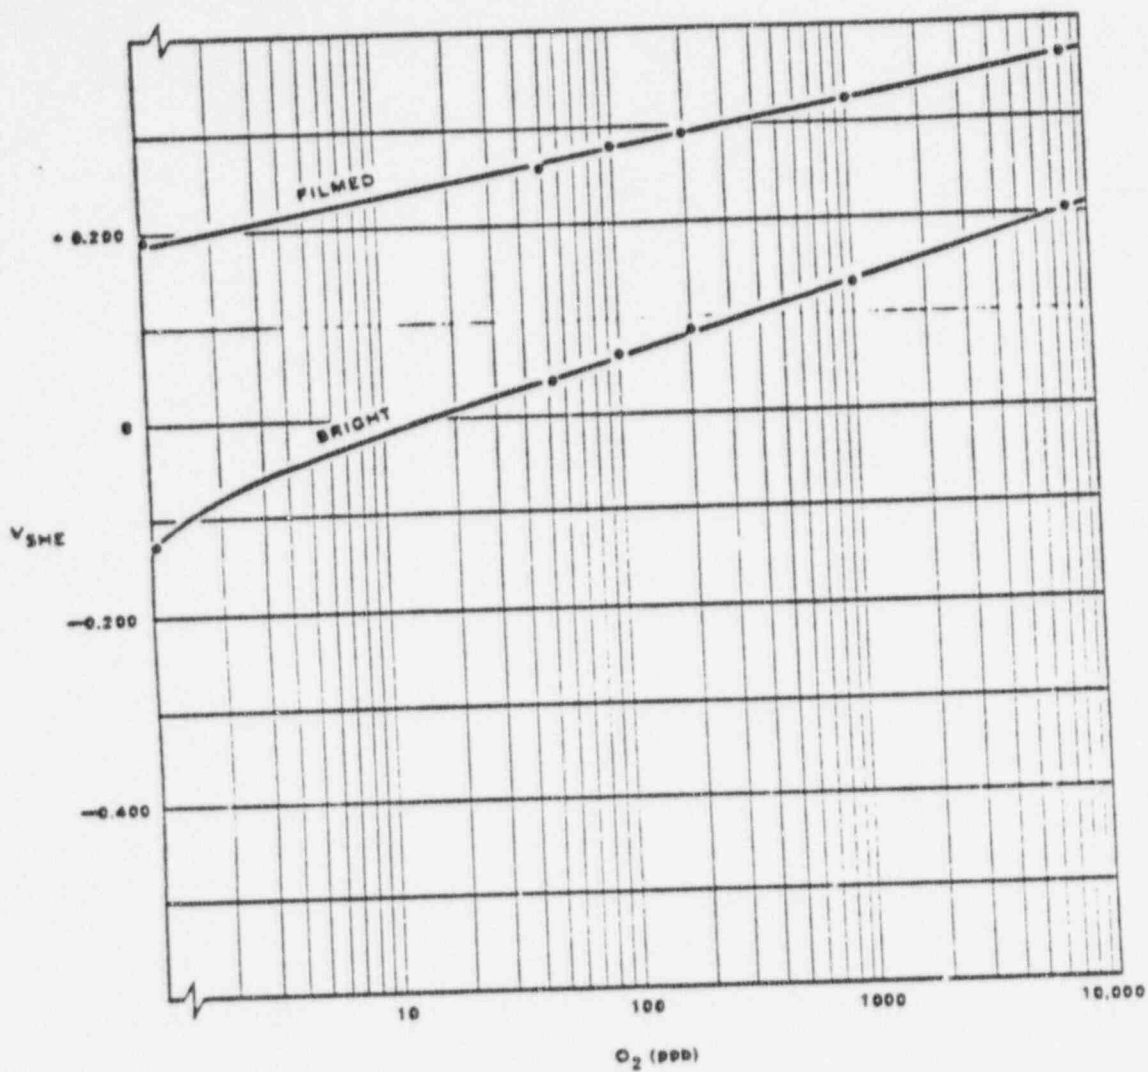
Figure 5-20. The Effect of Dissolved Oxygen on the Corrosion Potential of Bright and Filmed Type-304 Stainless Steel in Water at 107°C (225°F)
