EVALUATION OF NEAR-TERM BWR PIPING REMEDIES

(Research Project 701-1)

Final Report

Nuclear Energy Engineering Division
General Electric Company
175 Curtner Avenue
San Jose, California 95125

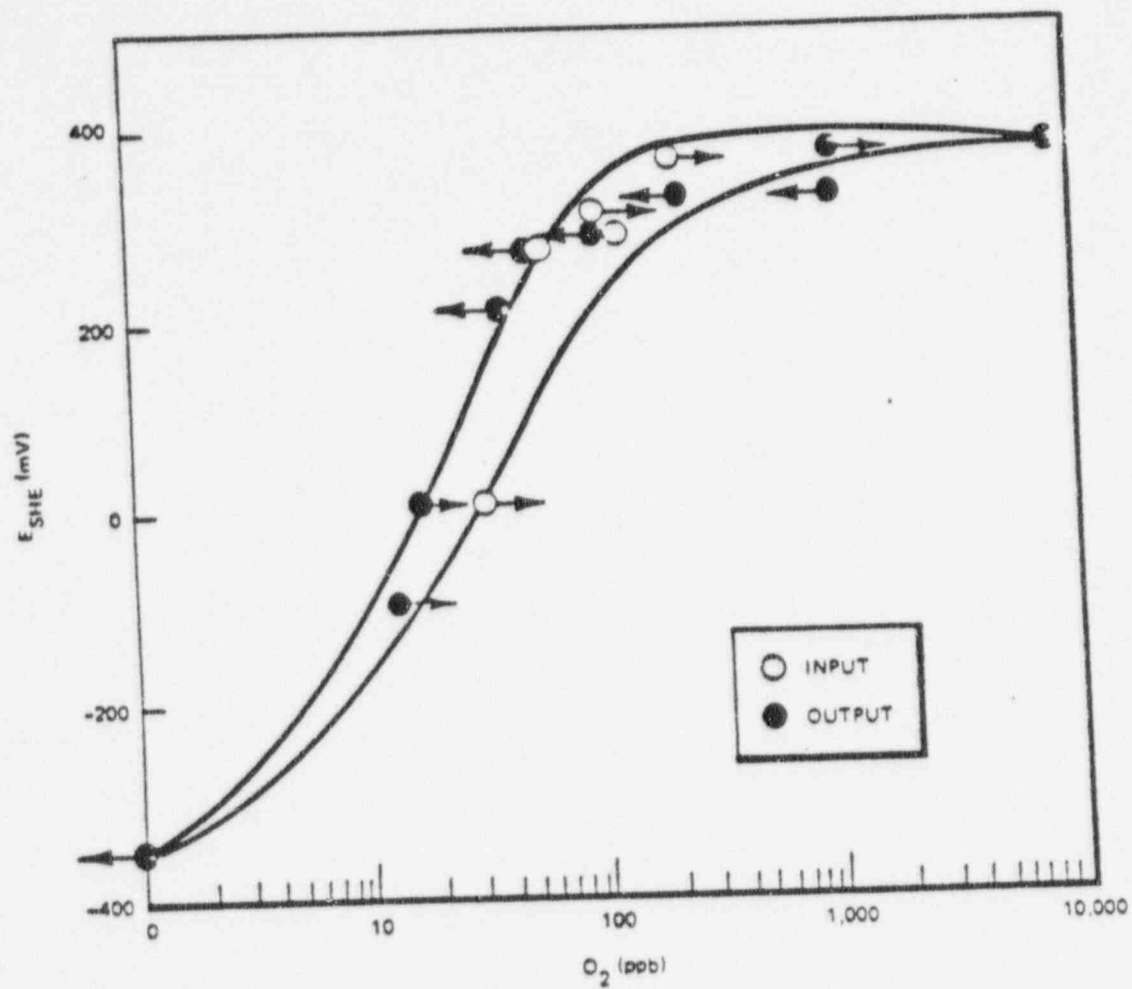
Figure 5-21. The Effect of Dissolved Oxygen on the Corrosion Potential of Platinum in High-Purity Water at 191°C (375°F)

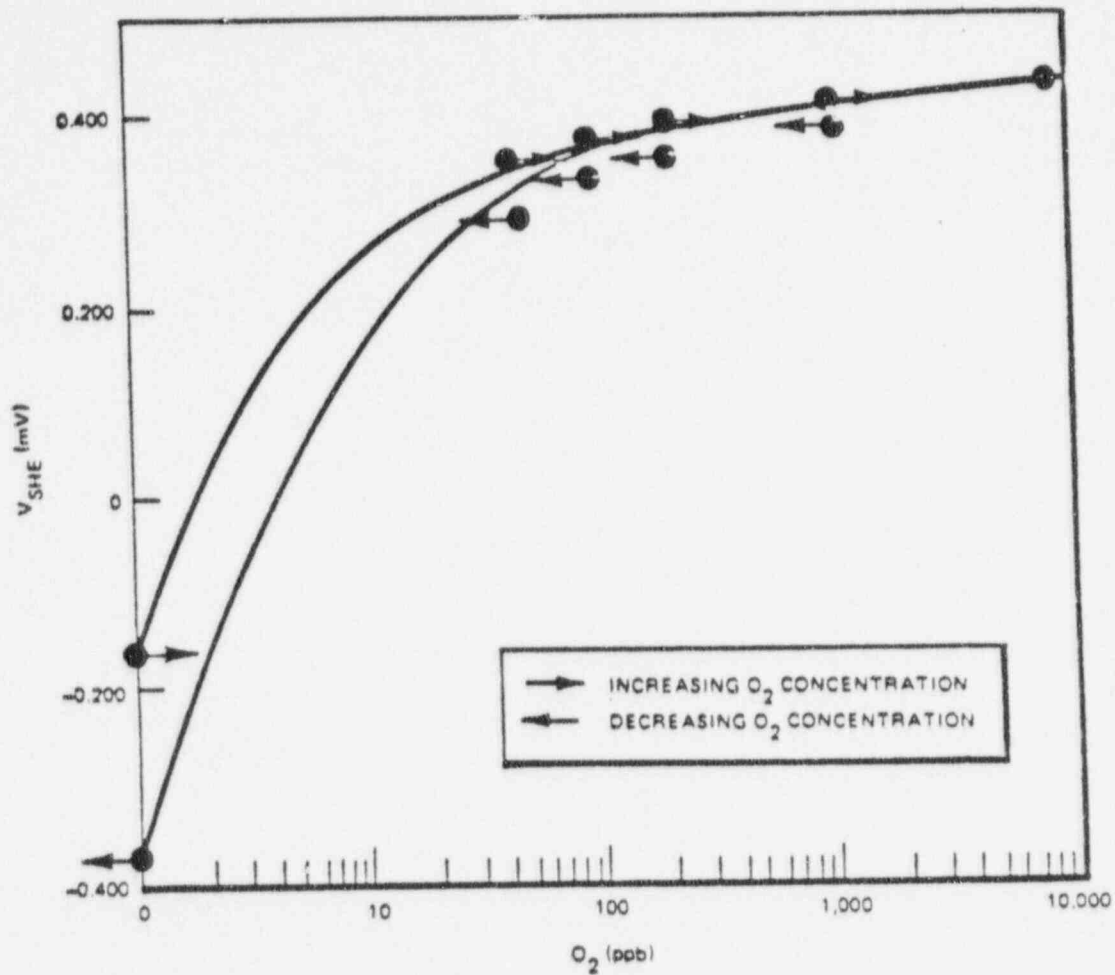
Figure 5-22. The Effect of Dissolved Oxygen on the Oxidation Potential of Platinum in Water at 149°C (300°F)

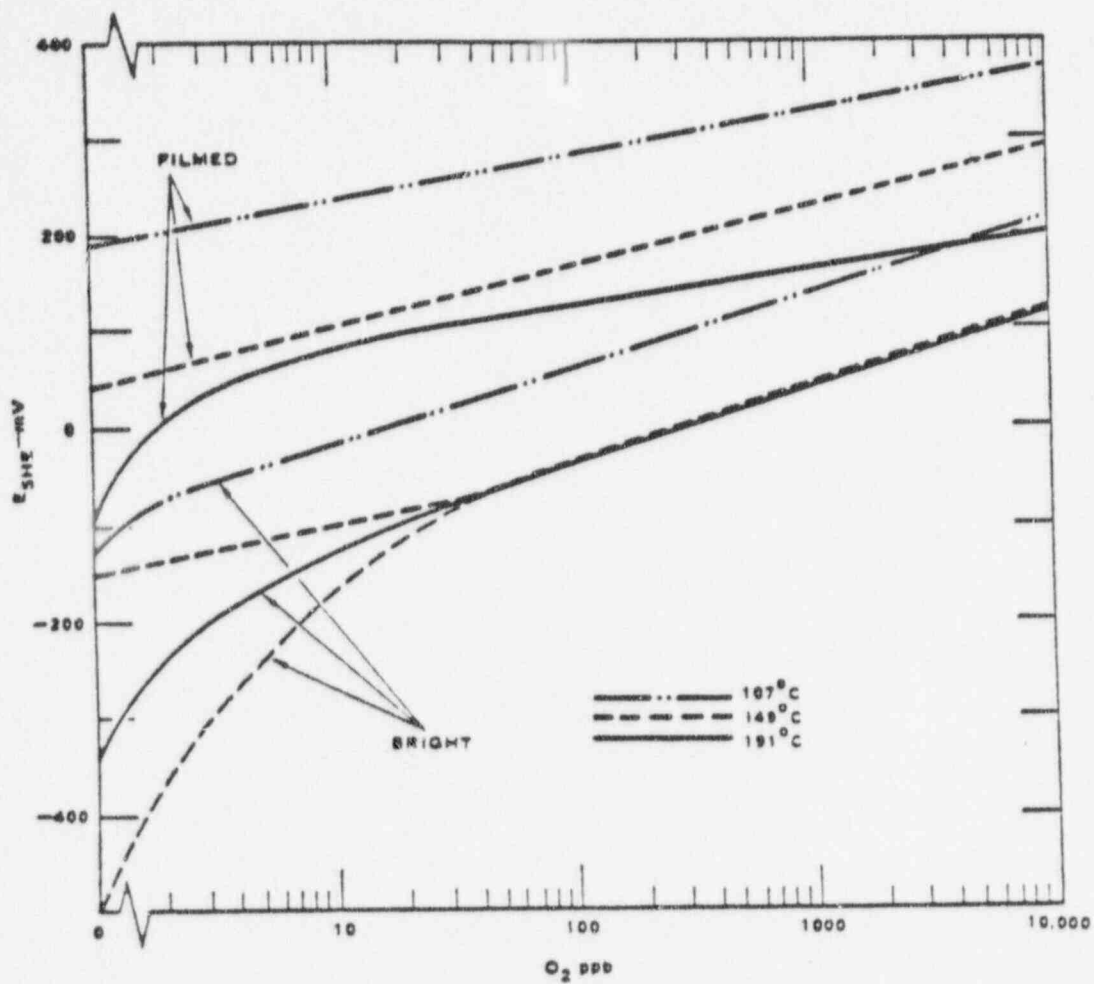
Figure 5-24. The Effect of Dissolved Oxygen on the Corrosion Potential of Bright and Filmed Type-304 Stainless Steel in Water (Average Curves)

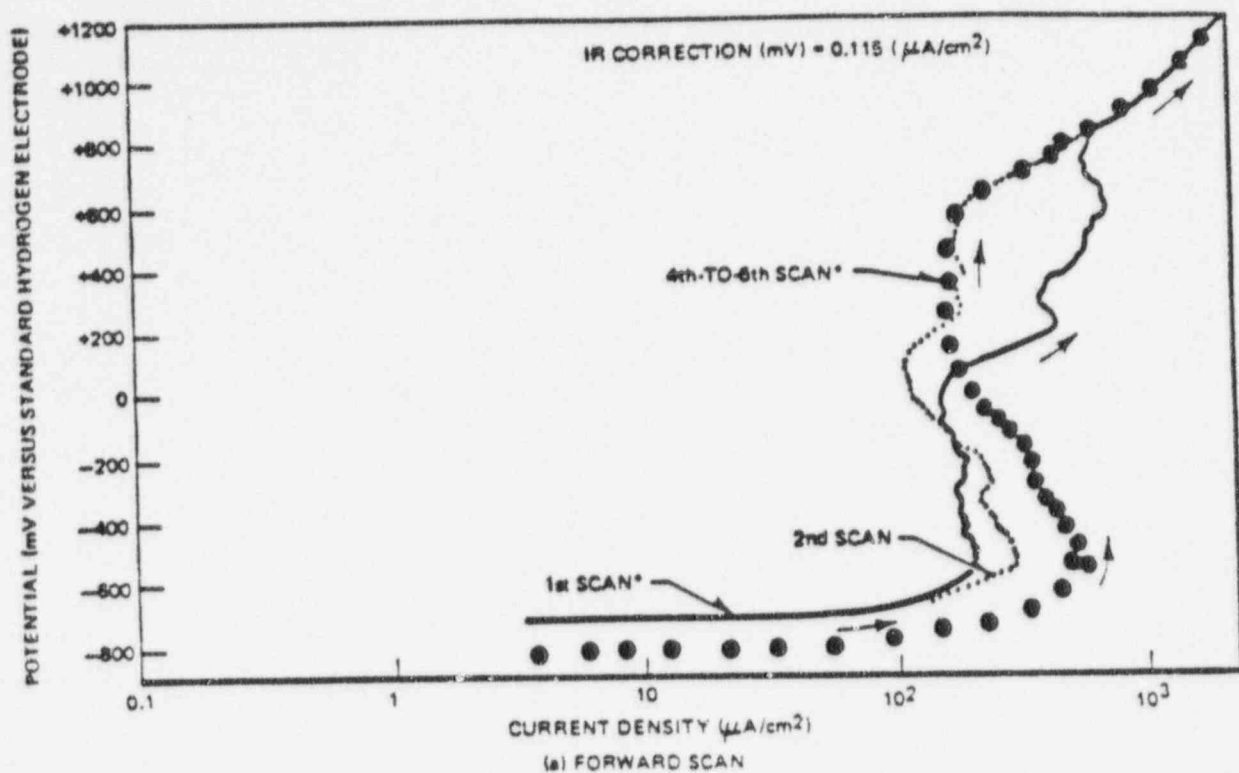
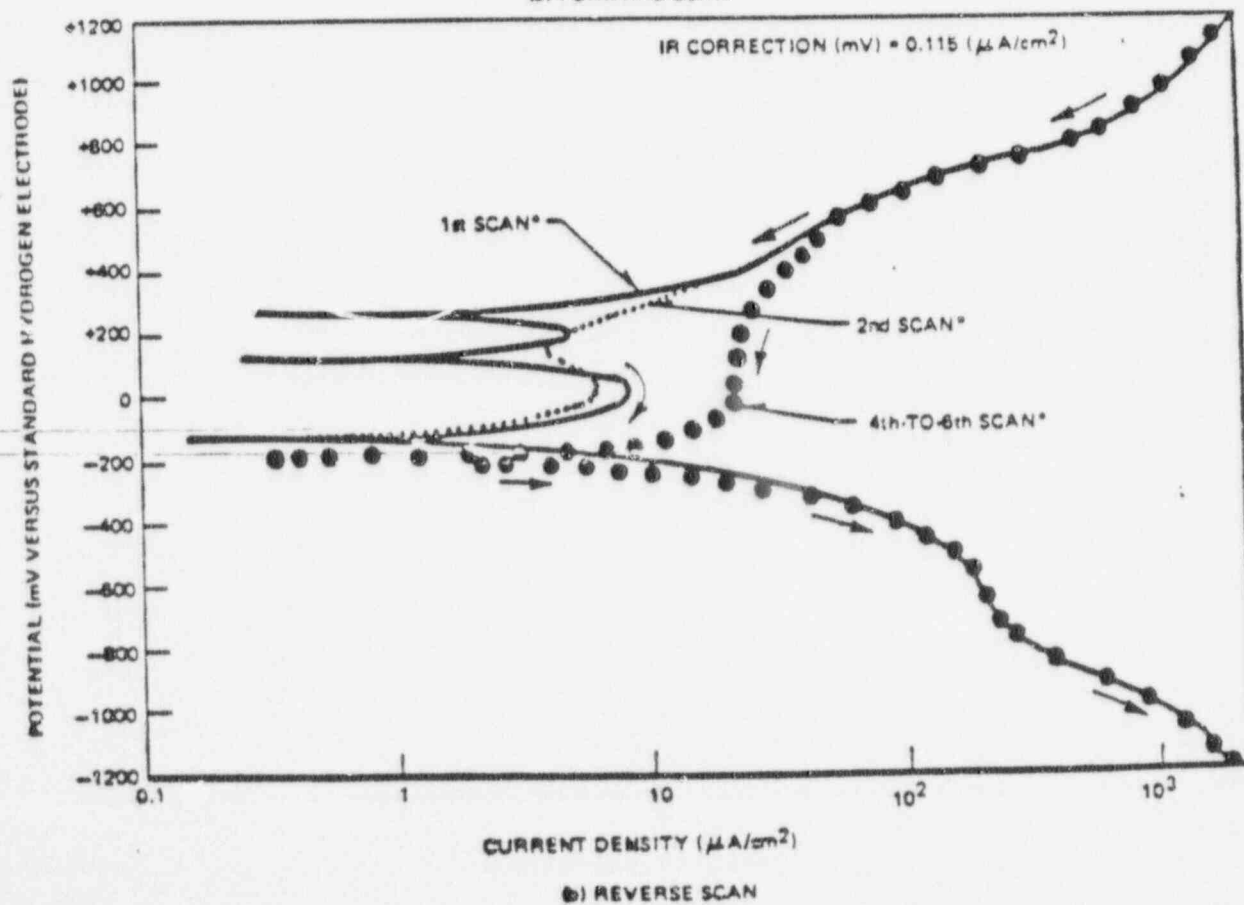
Figure 5-25. Forward (A) and Reverse (B) Scan Polarization Curves of Mill Annealed Type-304 Stainless Steel at 274°C (525°F) in Deaerated Water Containing 0.01 N Na_2SO_4 (Scan Rate 5 mV/sec)

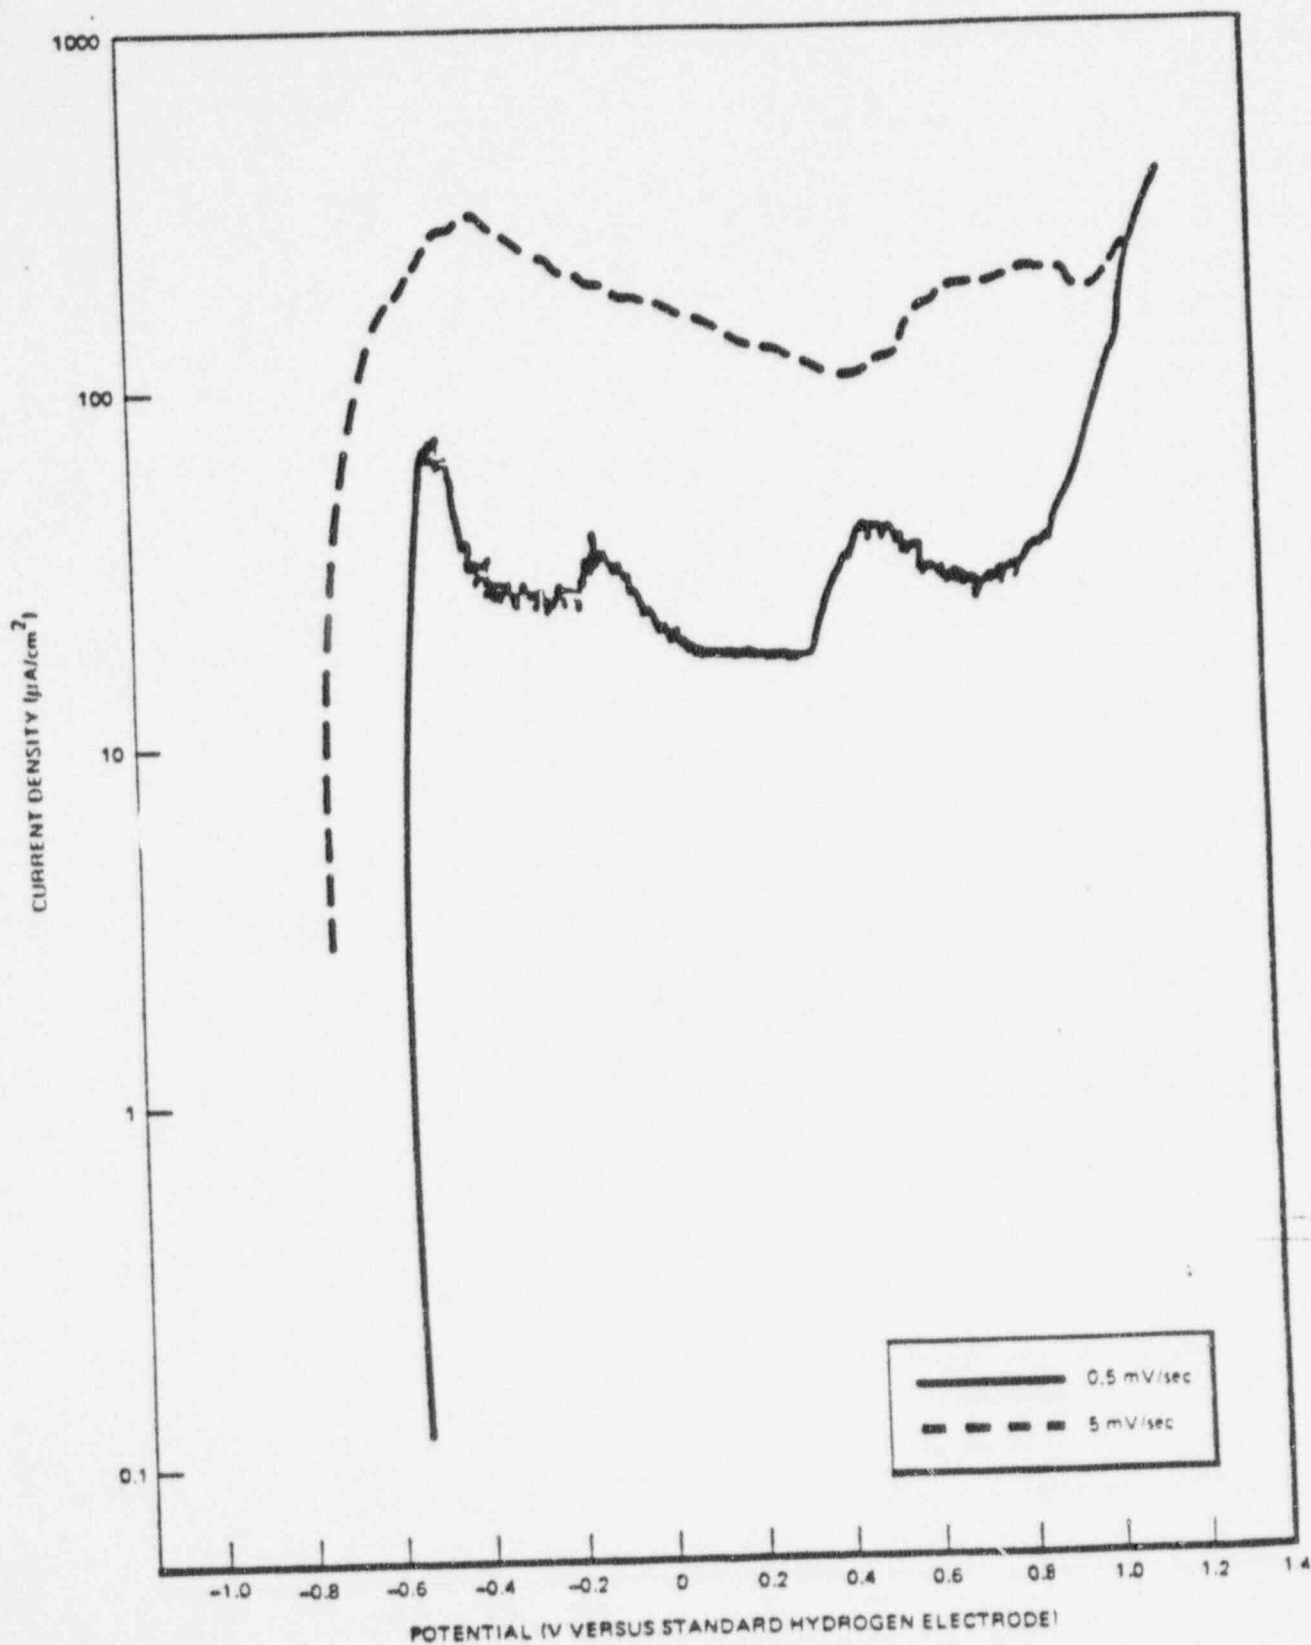
Figure 5-26. Effect of Scan Rate on Mill-Annealed Type-304 Stainless Steel at 177°C (350°F)

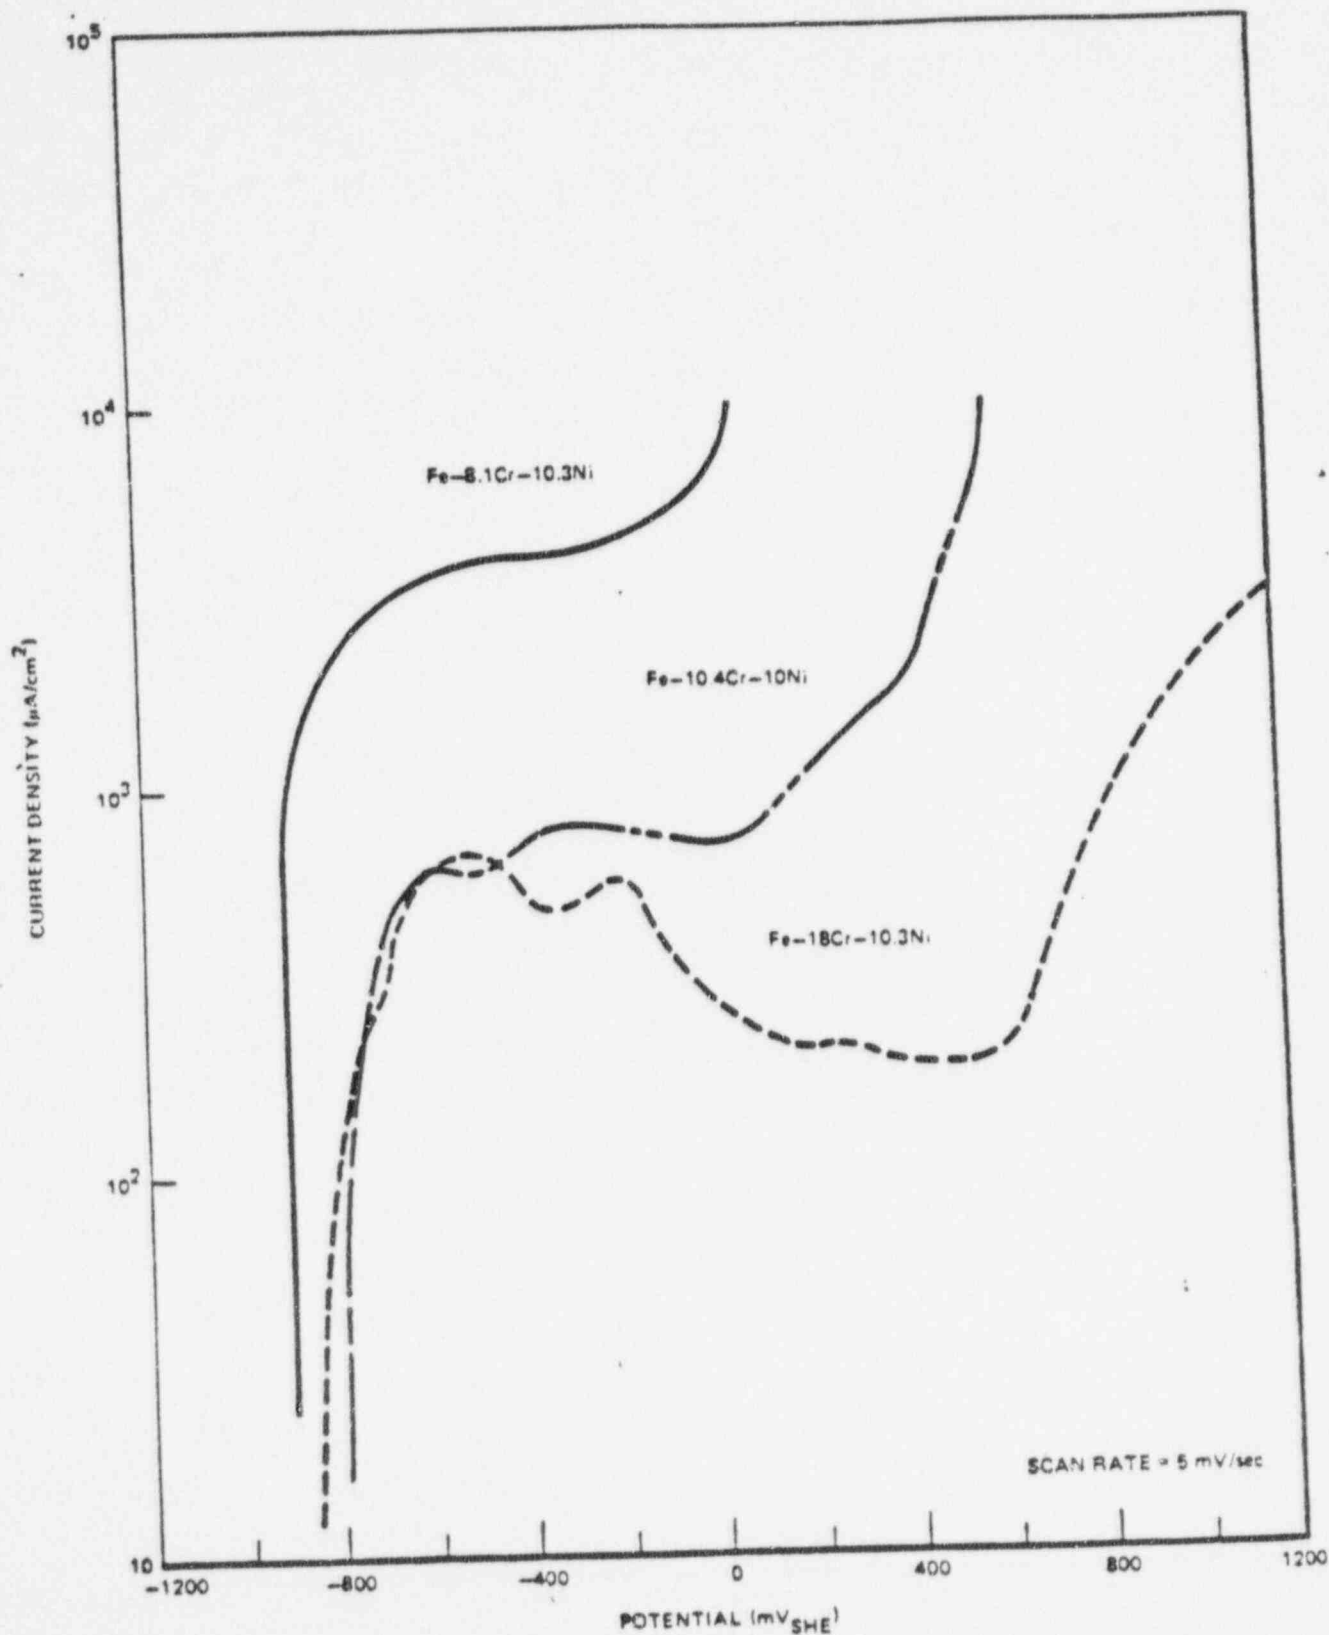
Figure 5-27. Effect of Chromium Content on the Anodic Polarization Behavior of Fe-Cr-Ni-Alloys in Deaerated Water Containing 0.01 N Na_2SO_4 at 288°C (550°F)

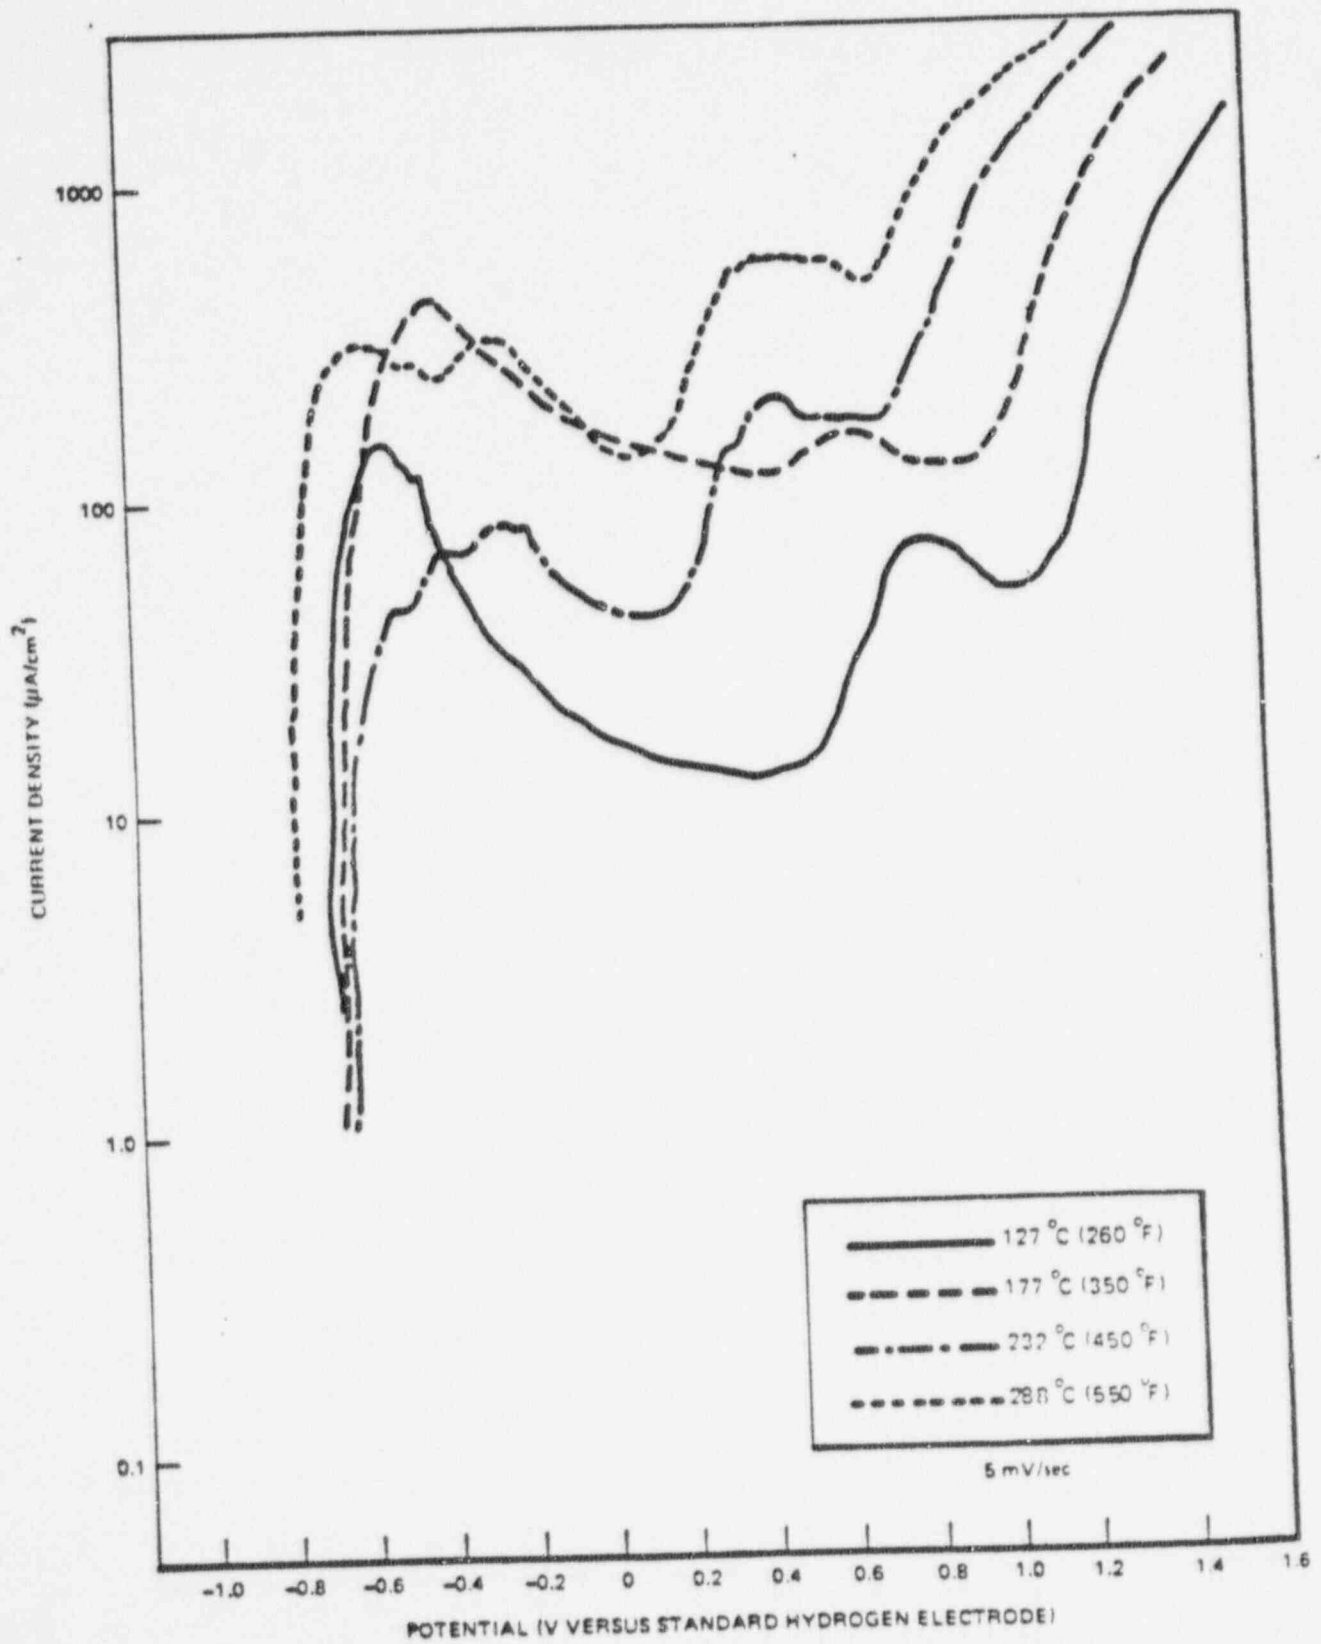
Figure 5-28. Effect of Temperature on Polarization Curves for Type-304 Stainless Steel

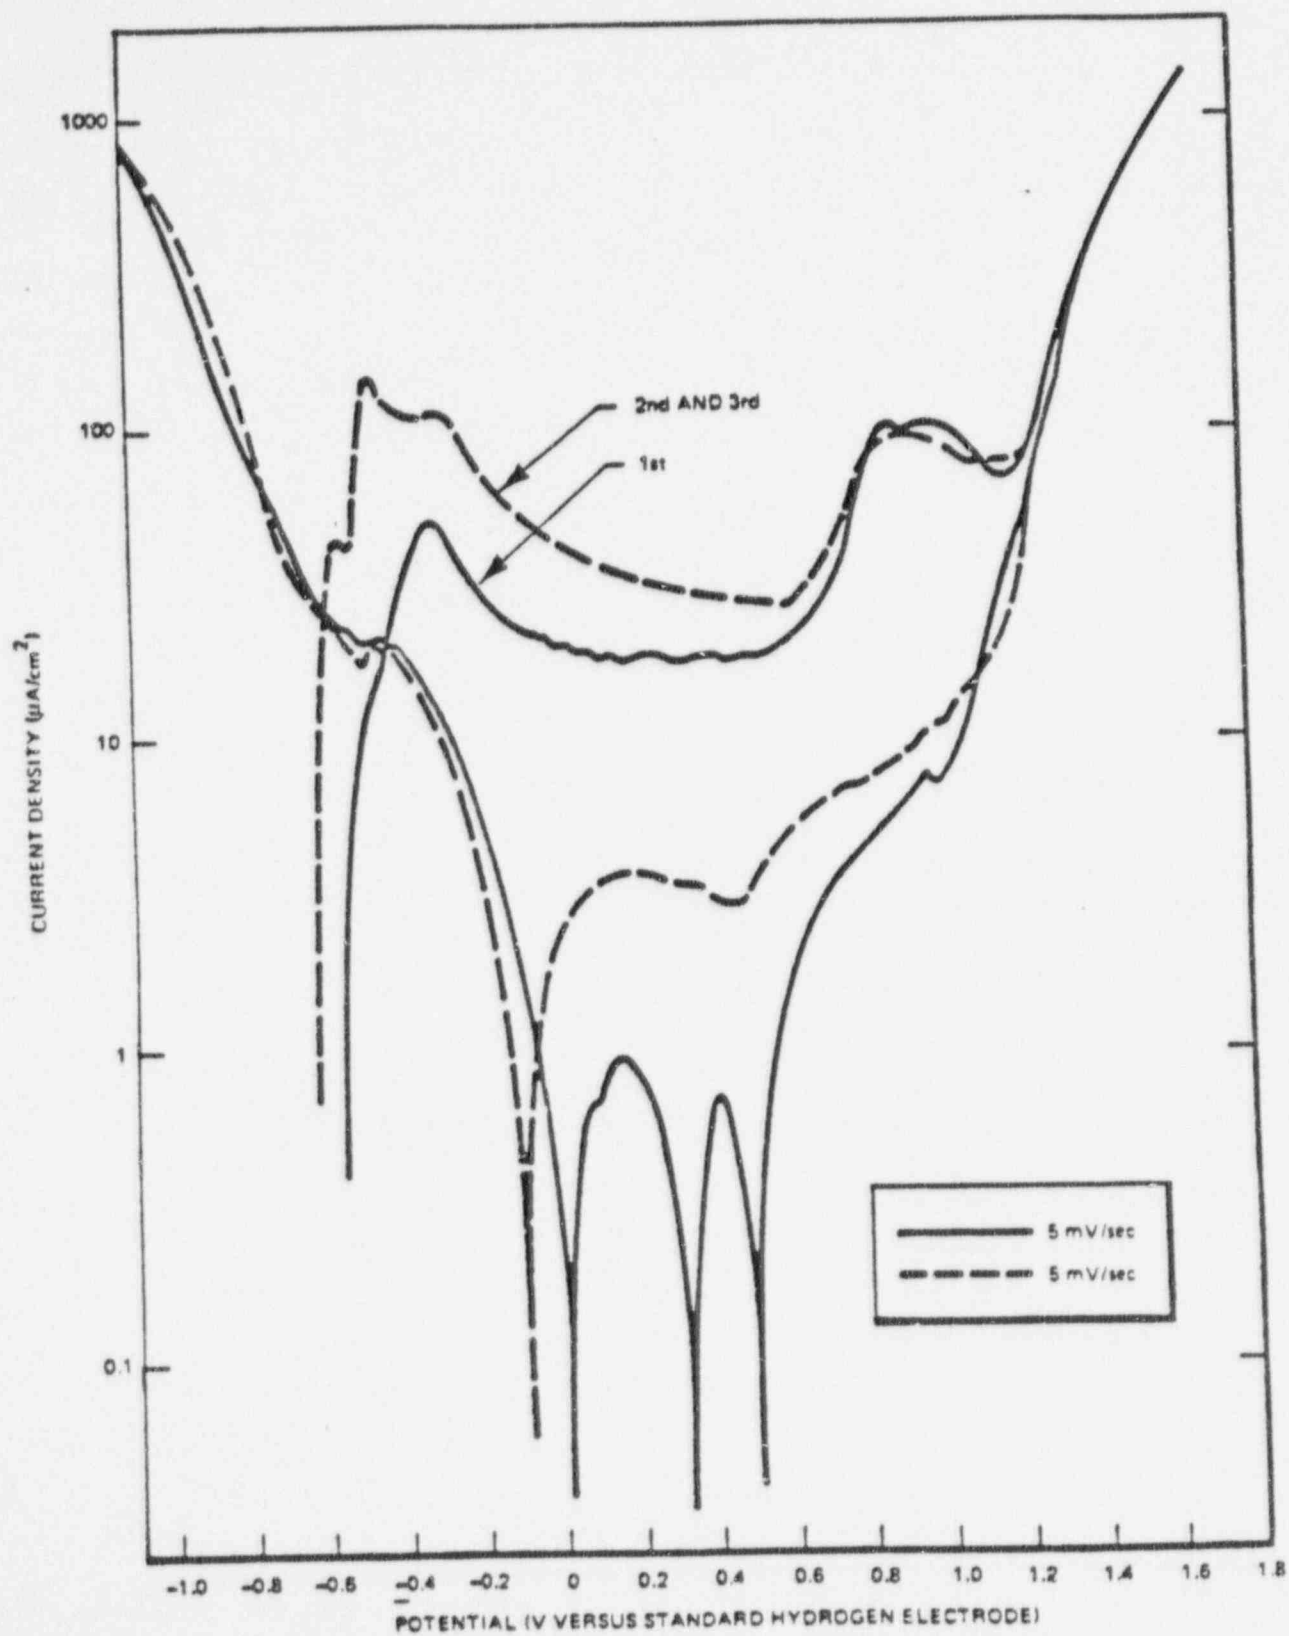
Figure 5-29. Forward and Reverse Polarization Scans of Type-304 Stainless Steel at 127°C (260°F)

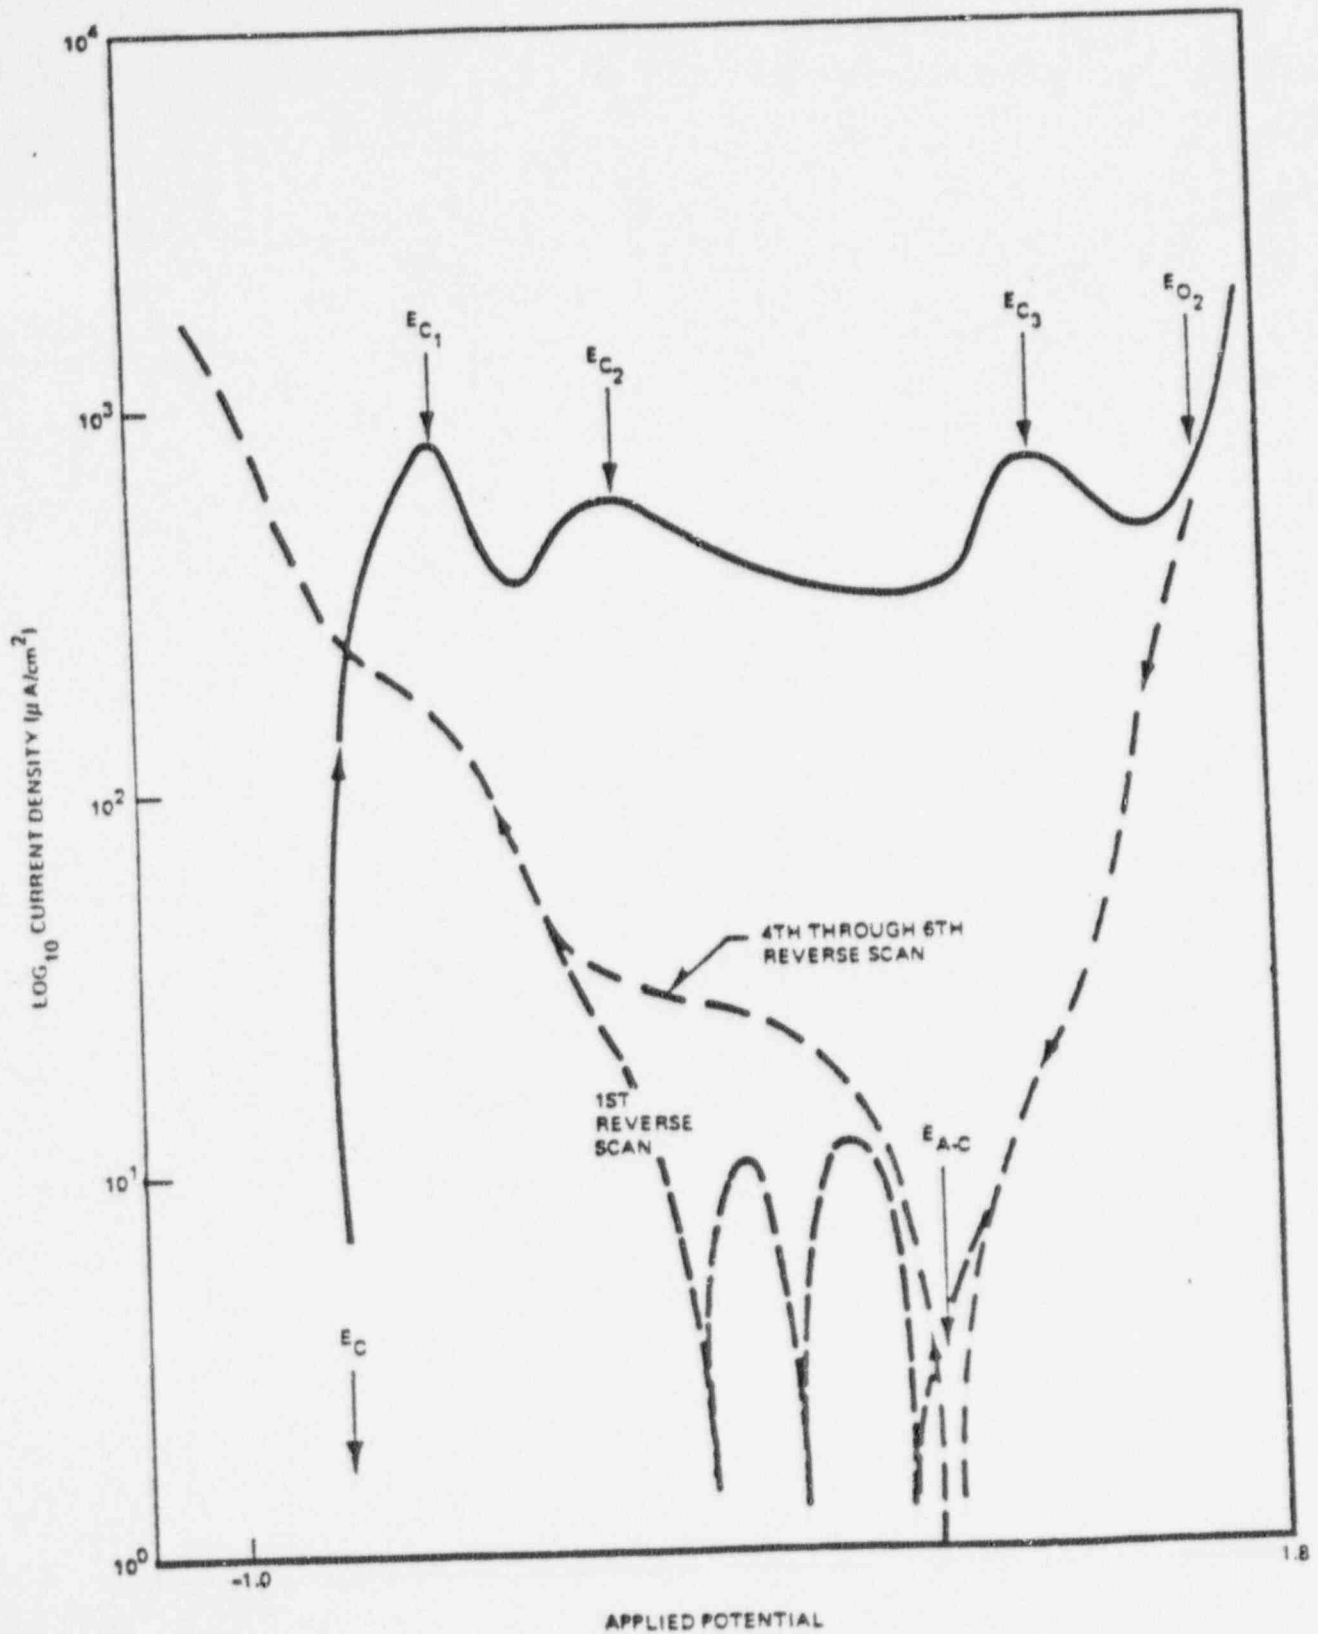
Figure 5-30. Schematic of the Shape of the Polarization Curve for Type-304 Stainless Steel in High Temperature With the Identification of Several Critical Potential Regions

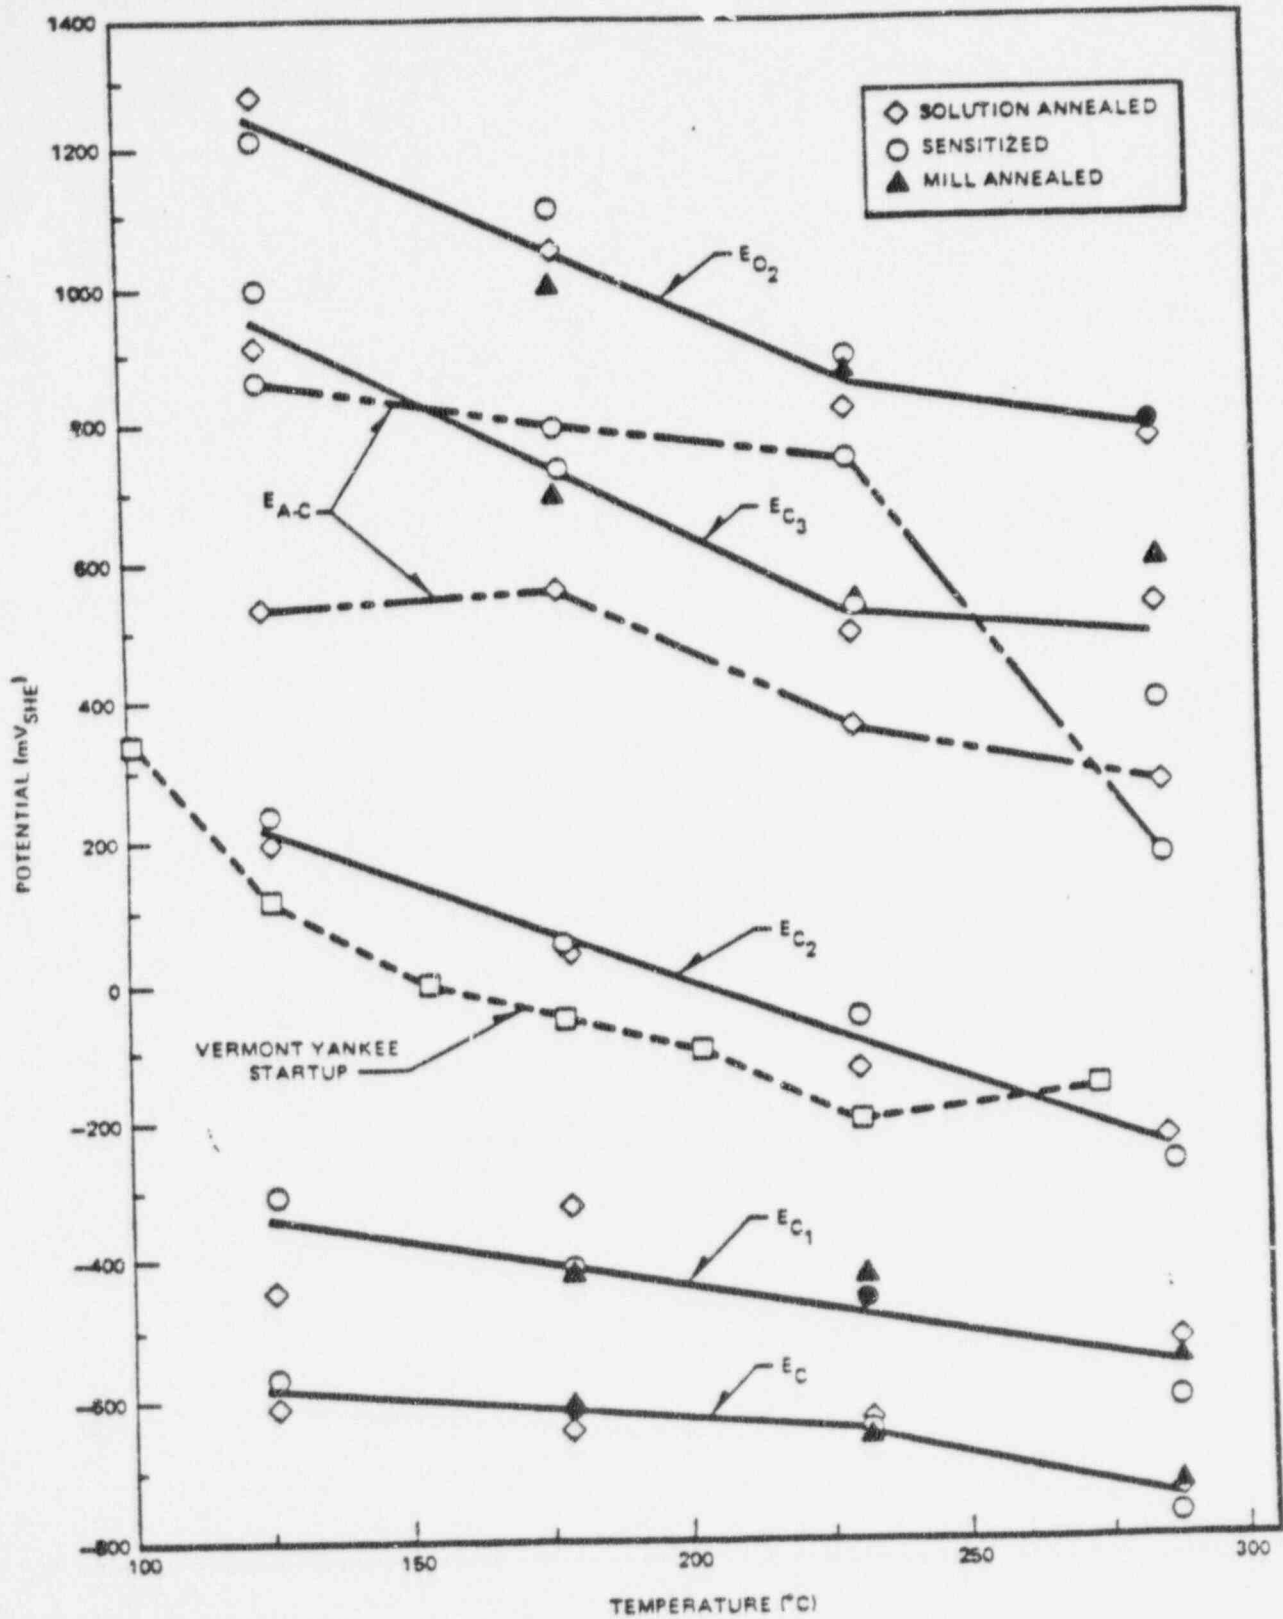
Figure 5-31. Effect of Temperature on Various Potentials of Type-304 Stainless Steel in Water With 0.01 N Na_2SO_4 .

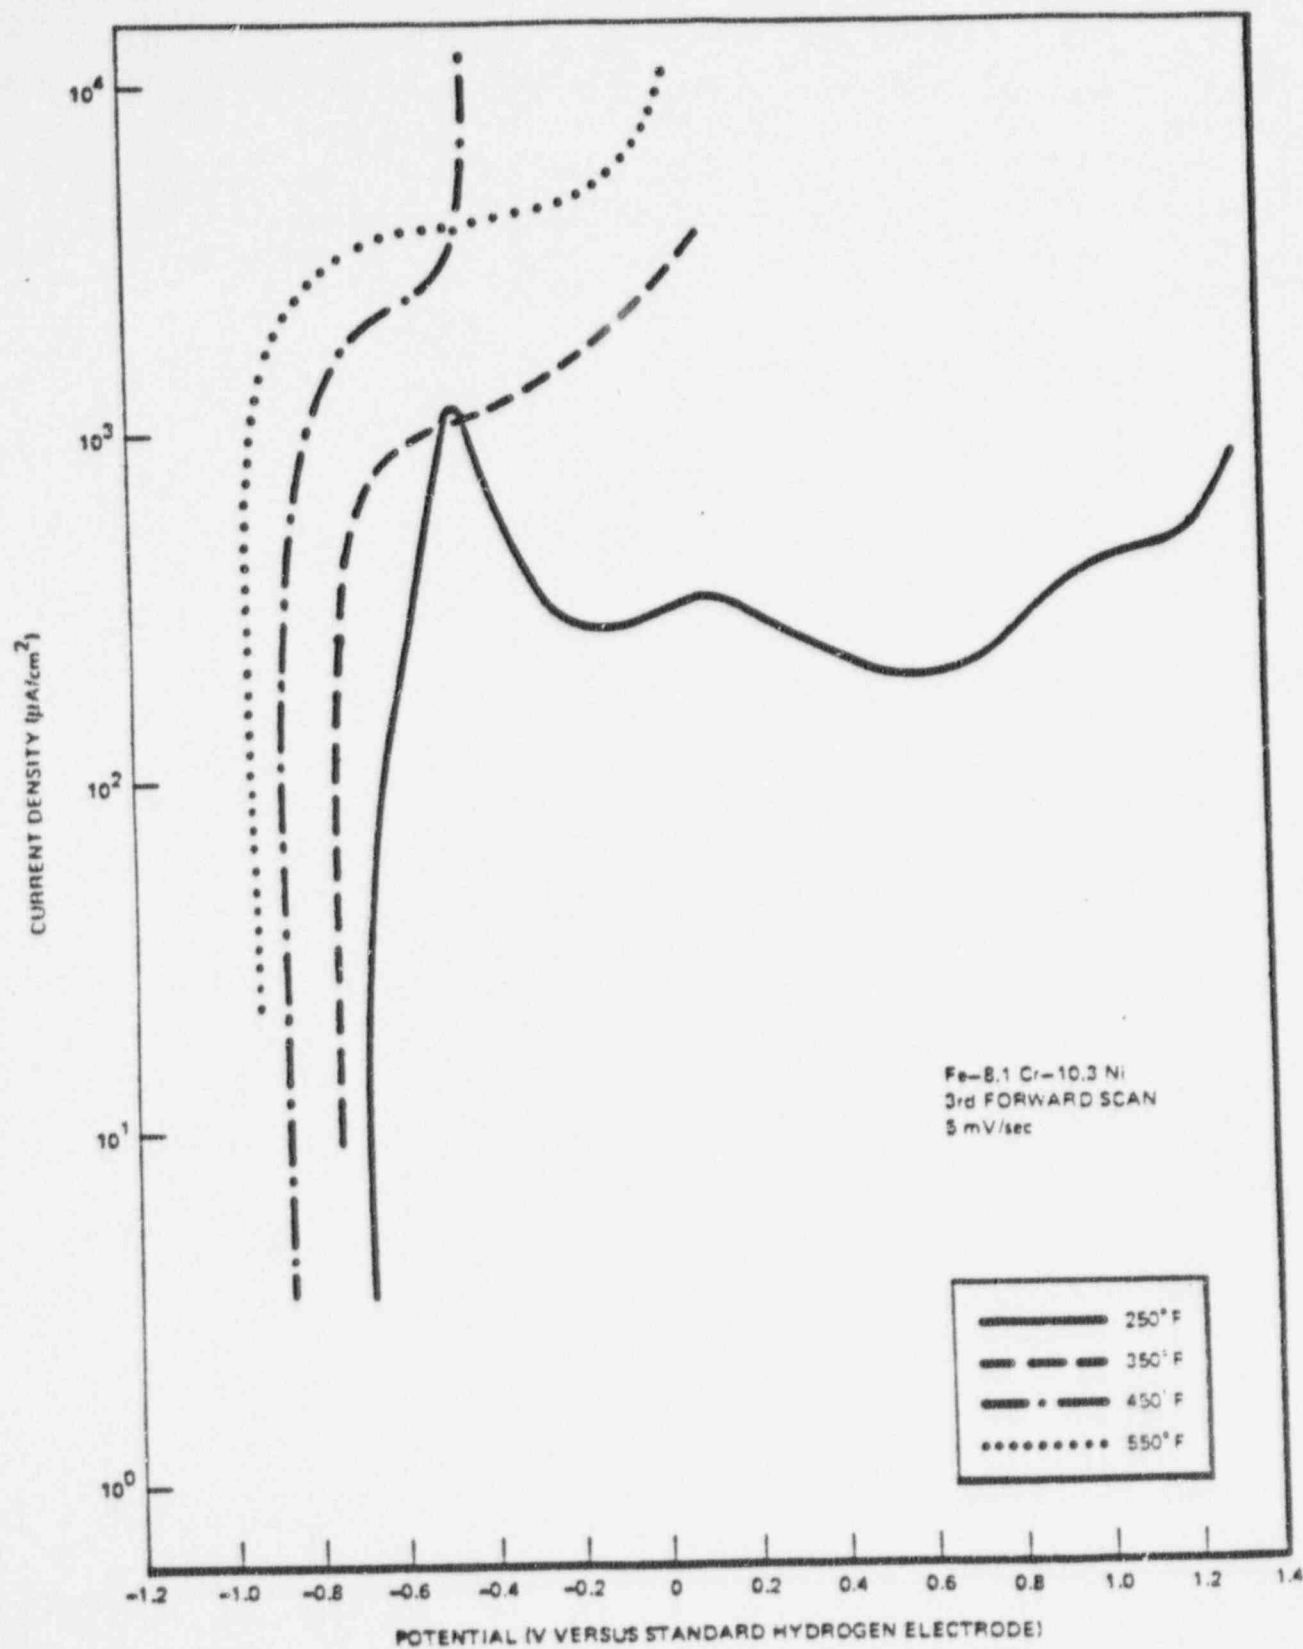
Figure 5-32. Polarization Behavior of 8% Chromium Alloy Versus Temperature

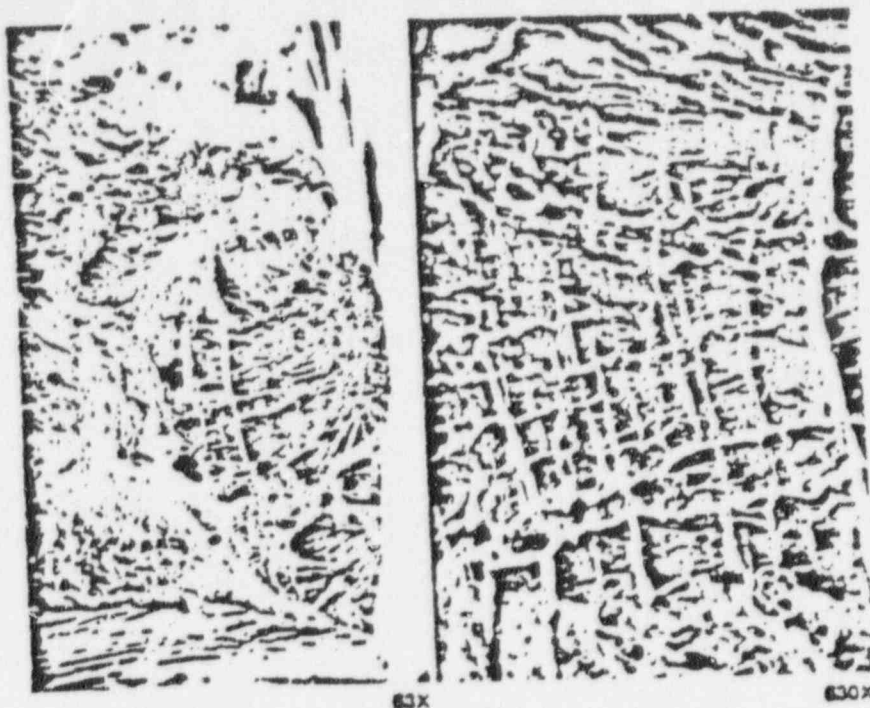
Figure 5-37. Cleaved Region of Transgranular Stress Corrosion Cracking Observed on the Fracture Surface of a Type-304 Stainless Steel Sample (Heat M7616) With Corrosion Resistant Clad Tested as a Straining Electrode at $-0.100V_{SHE}$ in $0.01N Na_2SO_4$ at $274^{\circ}C$. See Table 5-4

As indicated in Table 5-4 stress corrosion failures in the straining electrode tests at 274°C (525°F) were usually intergranular. However, samples having increased resistance to IGSCC failed in a predominantly ductile mode with a small amount of transgranular stress corrosion cracking. Increased resistance to IGSCC occurred when testing at a lower potential or on alloys that are not sensitized. Figure 5-36 shows some shallow transgranular cracks observed on all surfaces of an as-welded sample tested at $-0.400V_{SHE}$. At a potential of $-0.100V_{SHE}$, structures that are resistant to IGSCC (selected pipe remedies) show somewhat deeper transgranular stress corrosion cracks. Figure 5-37 shows a portion of the fracture surface on a specimen with corrosion-resistant cladding. The failure was predominantly ductile with a small cleaved region that contained fatigue-like striations. These fracture features are observed occasionally in both straining electrode tests and constant extension rate tests over a large range of potentials and are due to transgranular stress corrosion. Minor transgranular cracks, Figure 5-38, also appeared in wrought material outside of the corrosion-resistant cladding. It is postulated that, for the most part, the transgranular cracks occur at high strains and stresses that approach the ultimate tensile strength of the material. However, in some cases, a cold-worked surface caused by machining, grinding or other surface upsetting processes can produce short transgranular cracks upon small amounts of strain⁶.

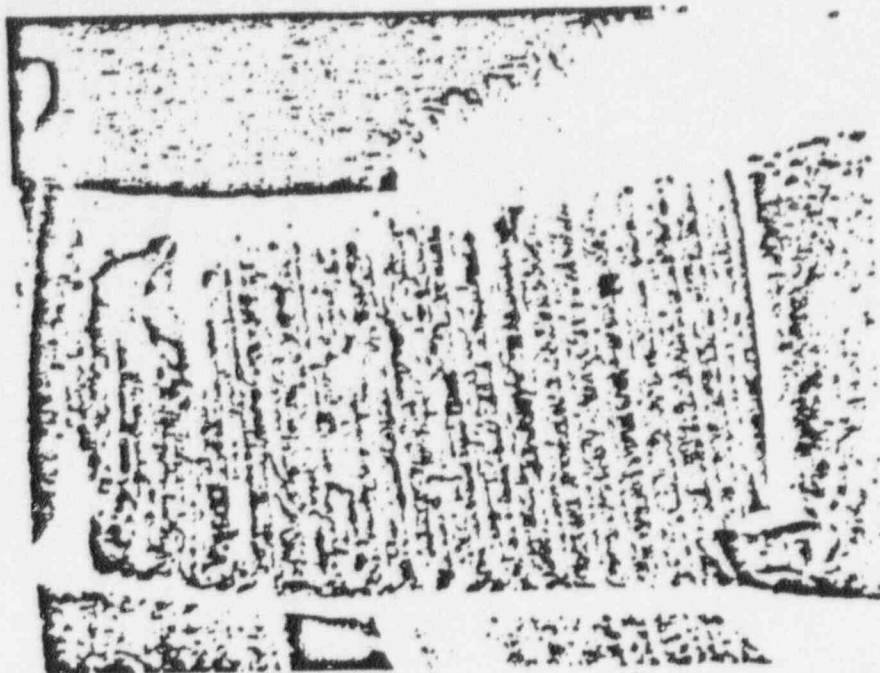
Figure 5-41. Scanning Electron Micrographs of the Fracture Surface of the Heat Affected Zone of a Welded (High Heat Input) Type-304 Stainless Steel (Heat No. M7616) Specimen (Mil-Annealed + Machined + Welded + 24 Hours at 500°C) Strained at $-0.450V_{\text{LWE}}$ in 0.01N Na_2SO_4 Water at 274°C. See Table 5-3
