EVALUATION OF NEAR-TERM BWR PIPING REMEDIES

(Research Project 701-1)

Final Report

Nuclear Energy Engineering Division
General Electric Company
175 Curtner Avenue
San Jose, California 95125

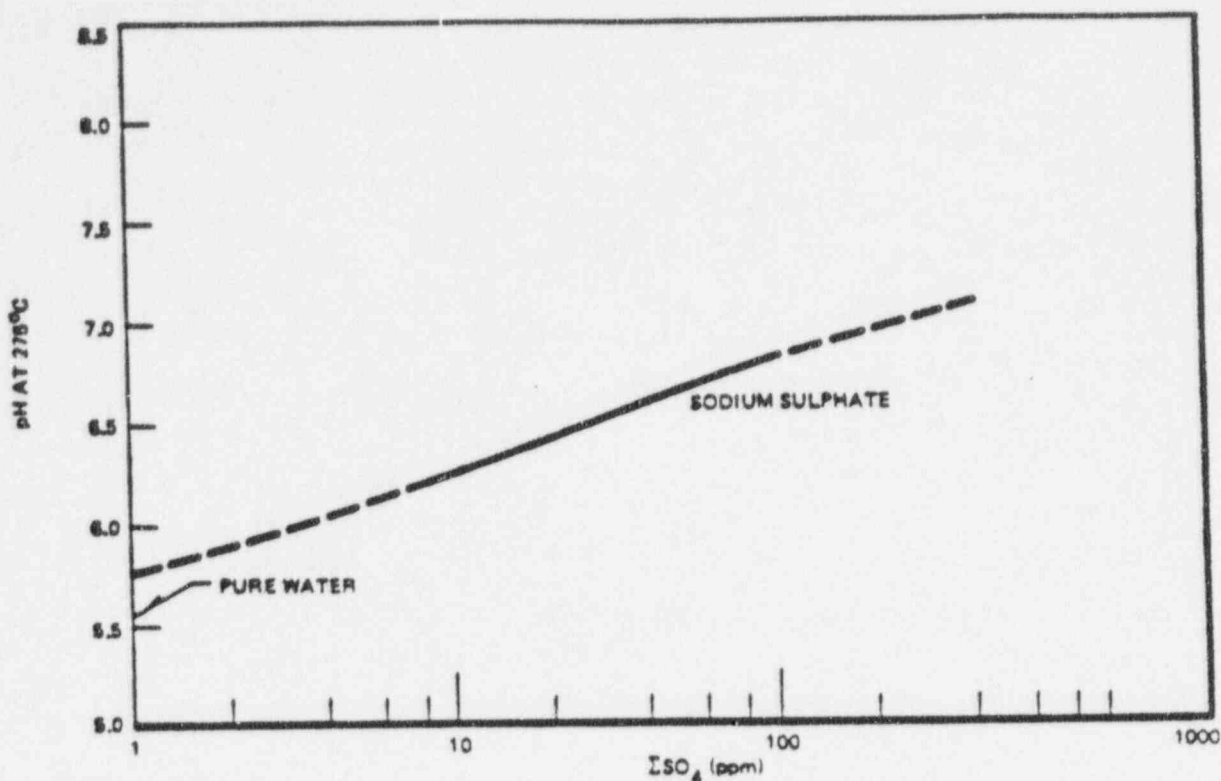
Figure 5-44. pH as a Function of Total PO₄ or SO₄ Concentration — Na₂PO₄, Na₂SO₄, 275°C

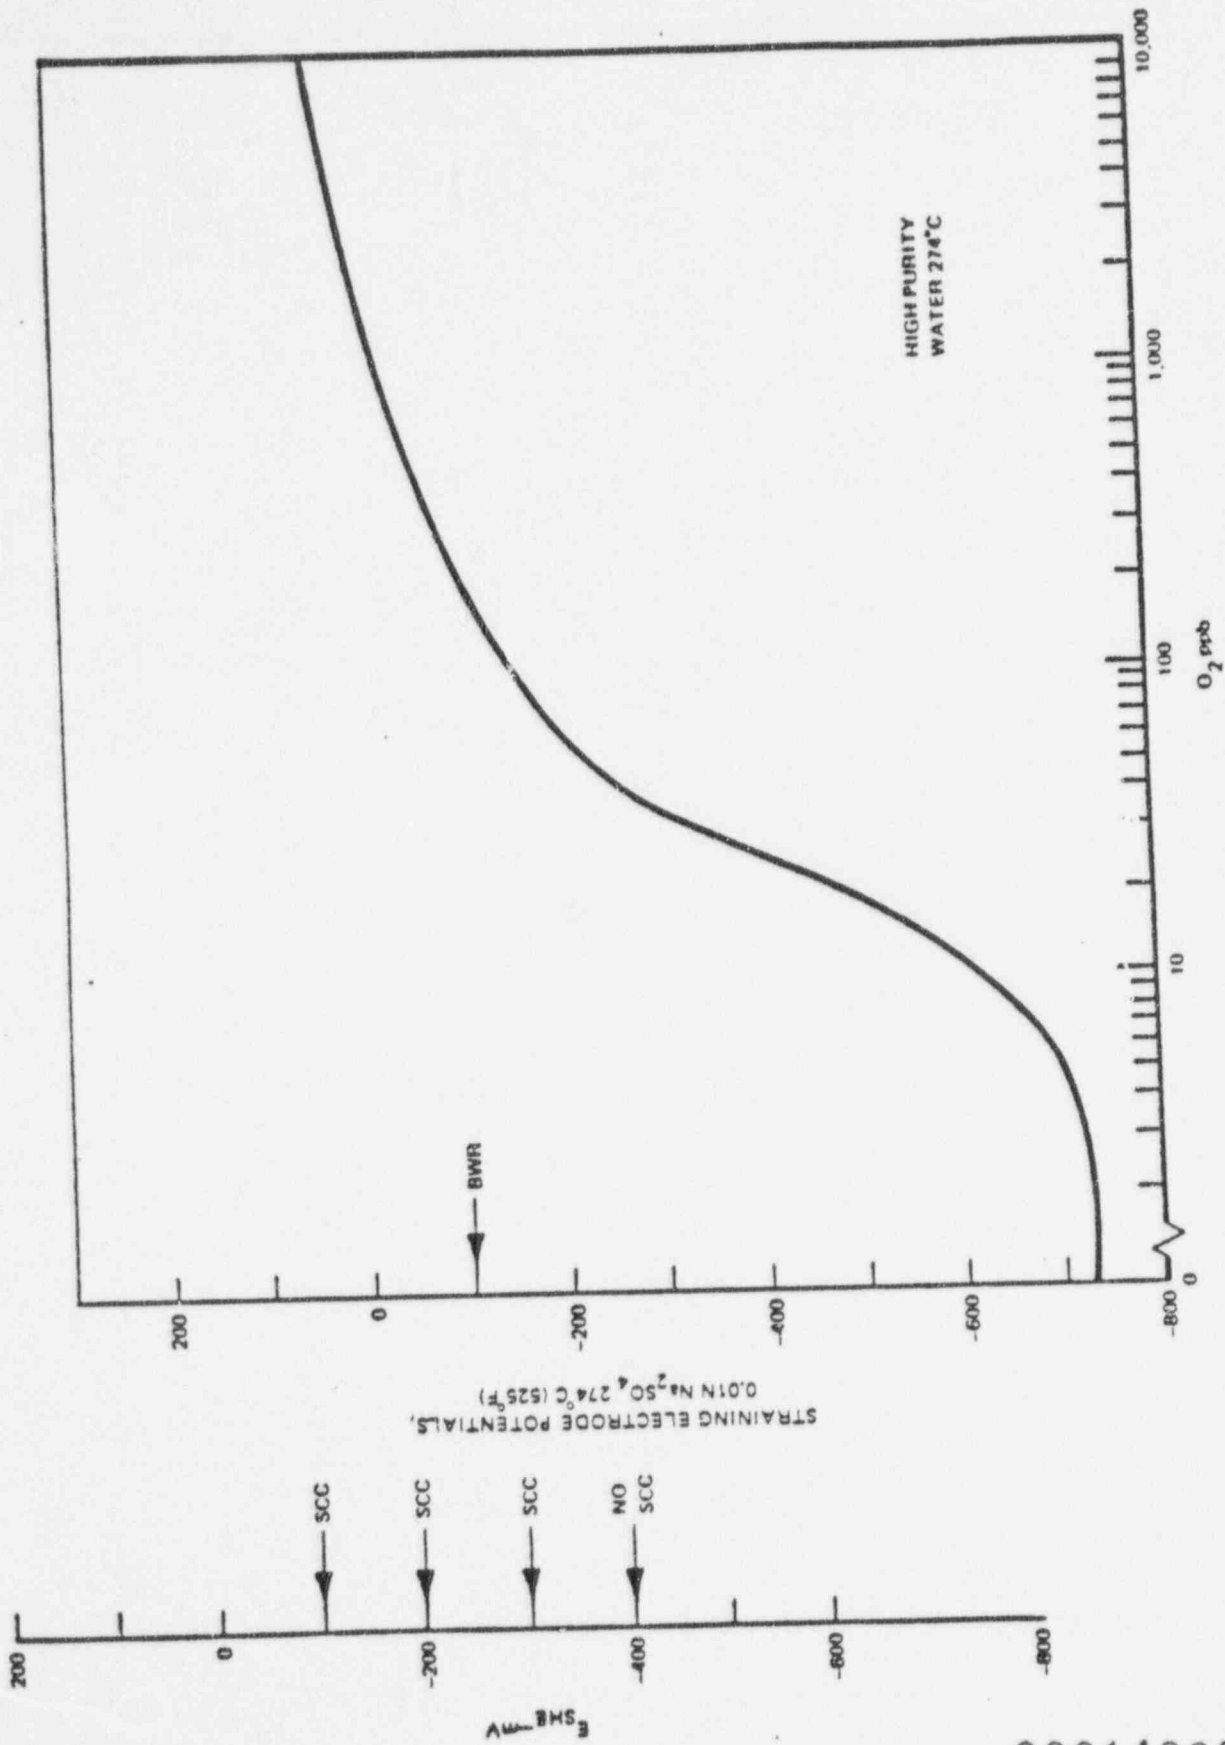
Figure 5-45 The Effect of Dissolved Oxygen on the Corrosion Potential of Type-304 Stainless Steel in High Purity Water at 274°C (525°F)

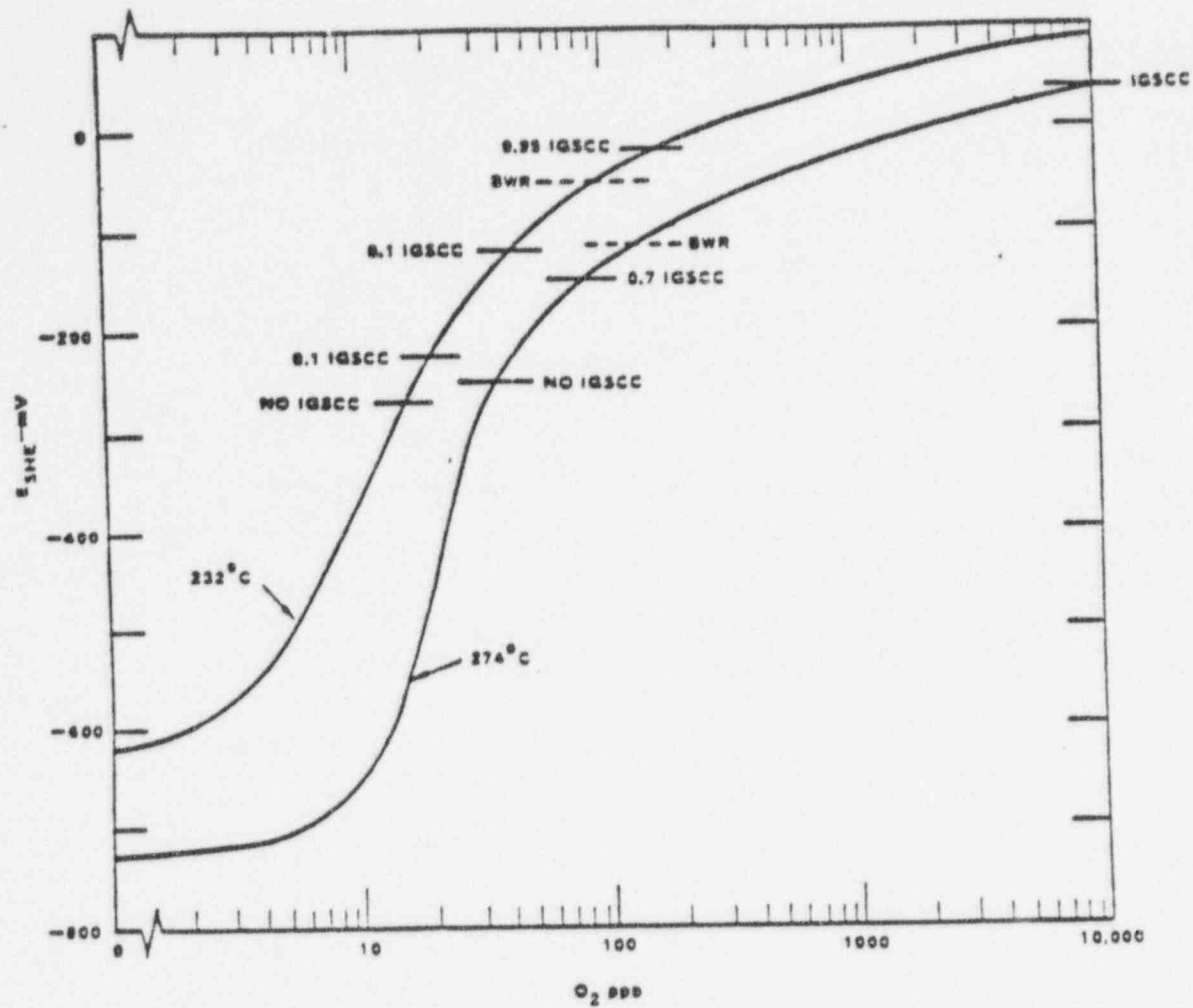
Figure 5-46. The Effect of Dissolved Oxygen on the Corrosion Potential and IGSCC of Type-304 Stainless Steel (Average Curves)

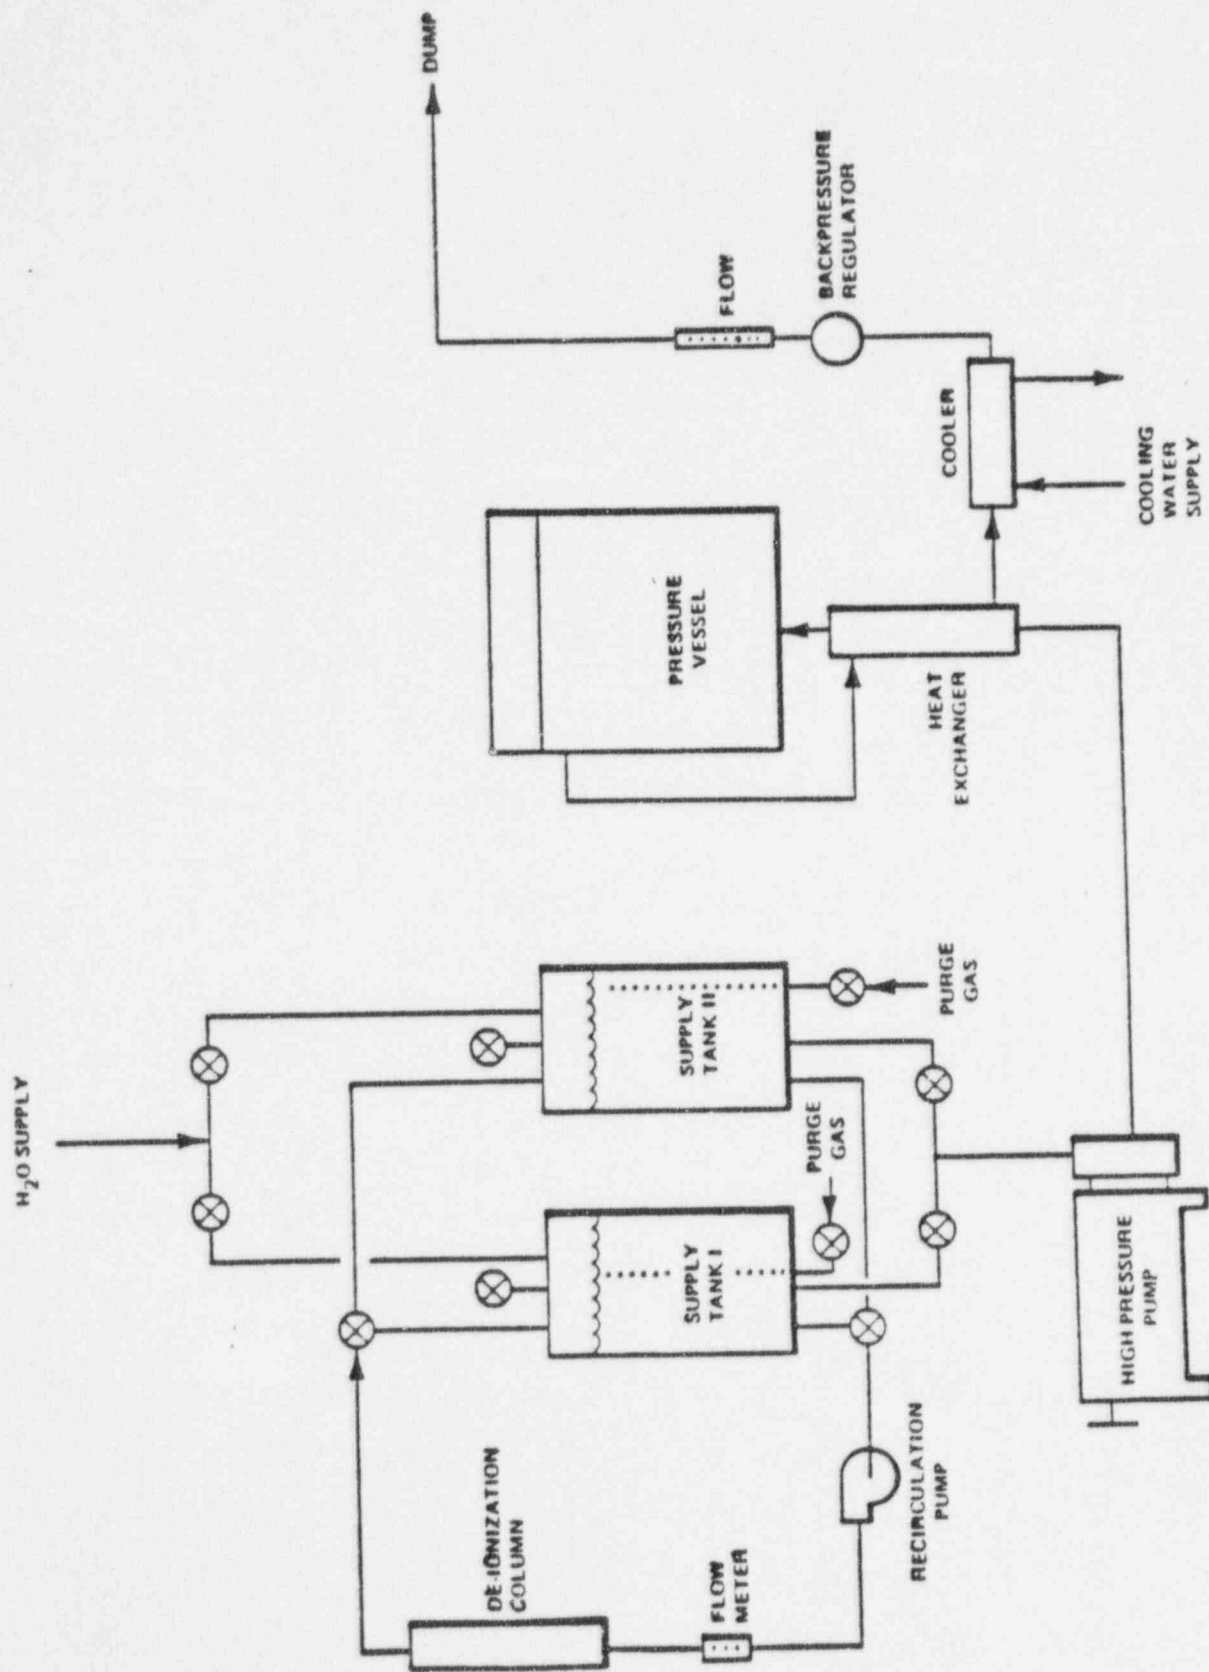
Figure 5-47 Reactor Temperature/Potential Simulator

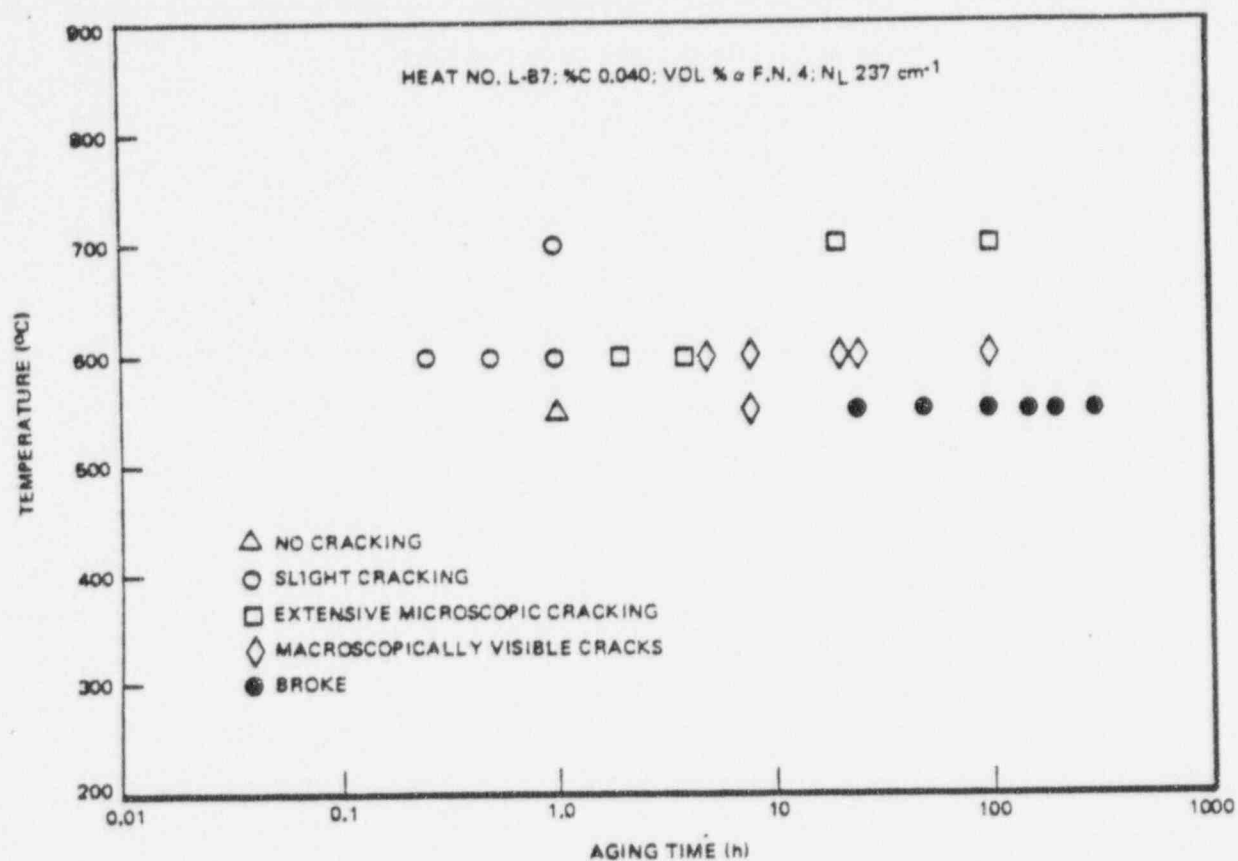
Figure 6-7. Effect of Aging Treatment on the Intergranular Corrosion Behavior of Type-308 Stainless Steel Annealed at 1250°C (2280°F)/1 h, Water Quenched

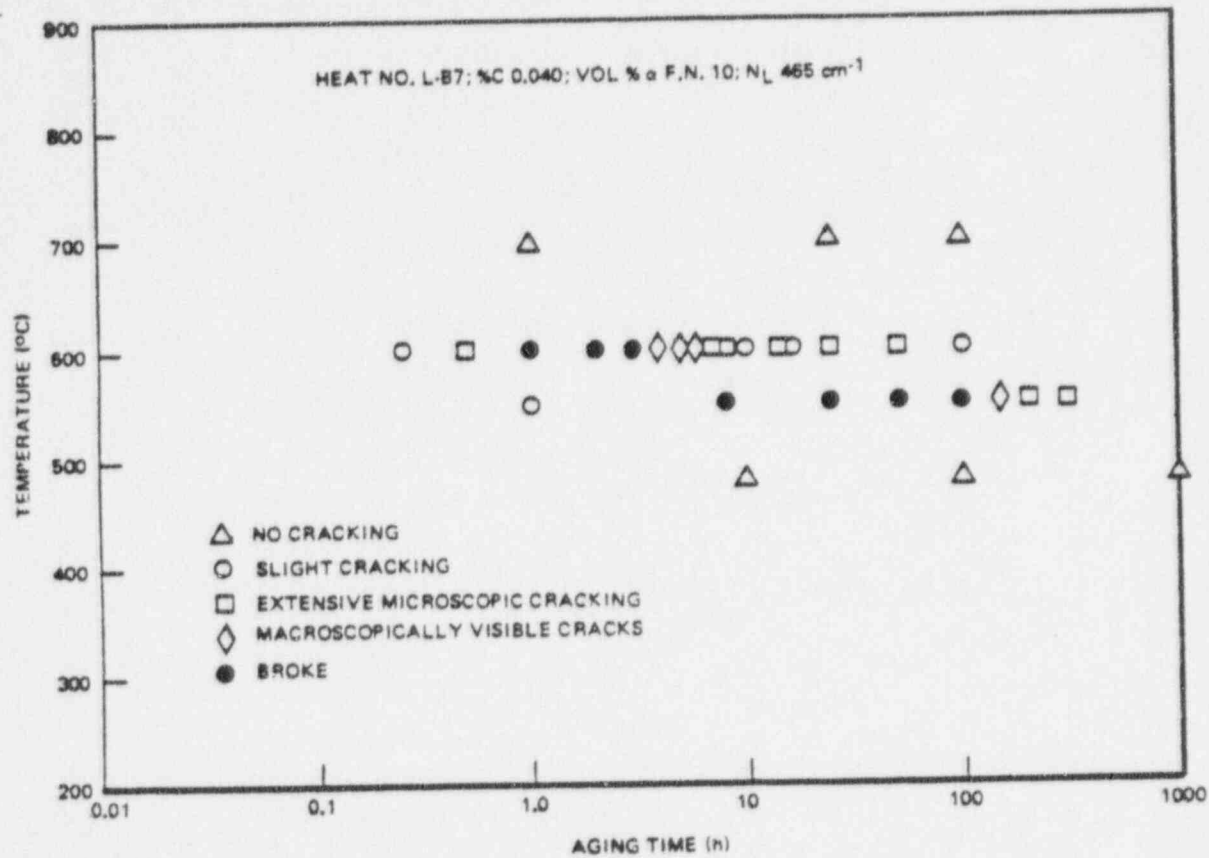
Figure 6-8. Effect of Aging Treatment on the Intergranular Corrosion Behavior of Type-308 Stainless Steel Annealed at 1300°C (2372°F)/1 h, Water Quenched

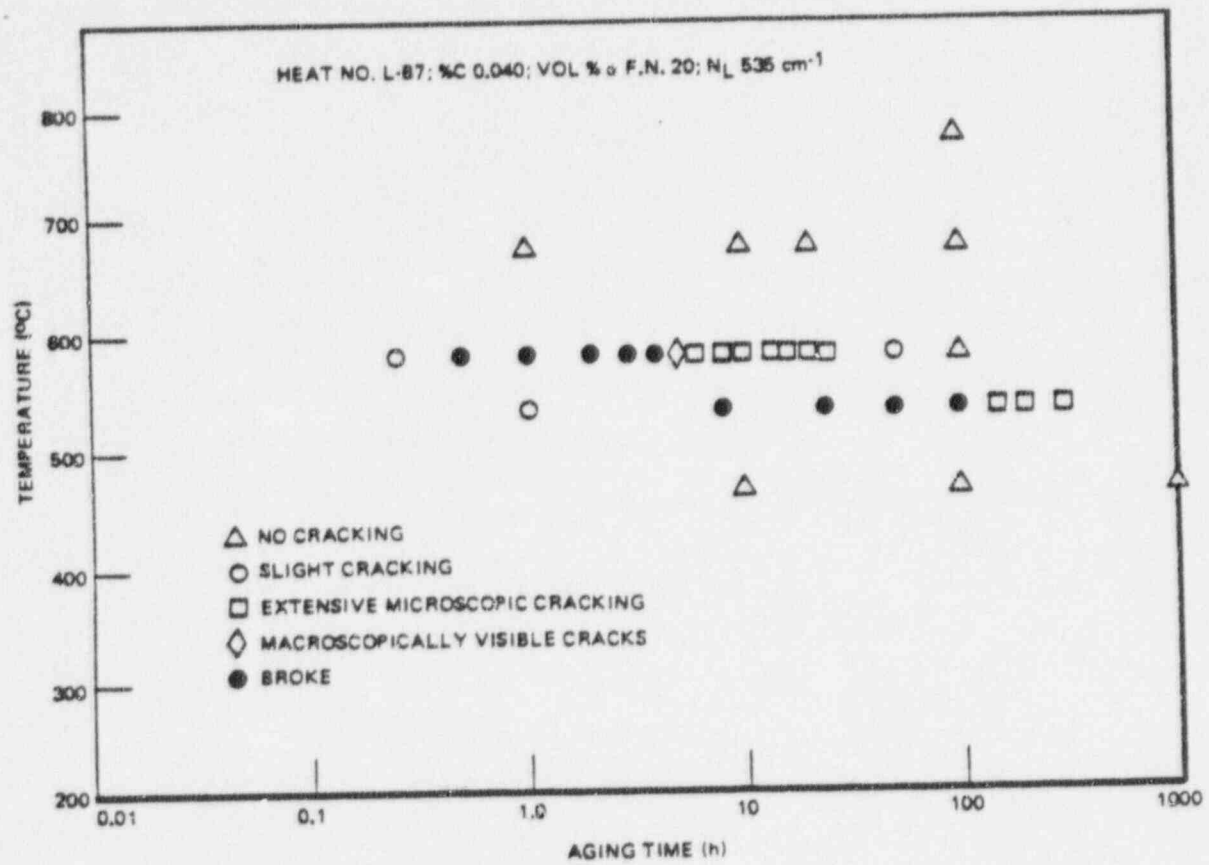
Figure 6-9. Effect of Aging Treatment on the Intergranular Corrosion Behavior on Type-308 Stainless Steel Annealed at 1350°C (2462°F)/1 h, Water Quenched

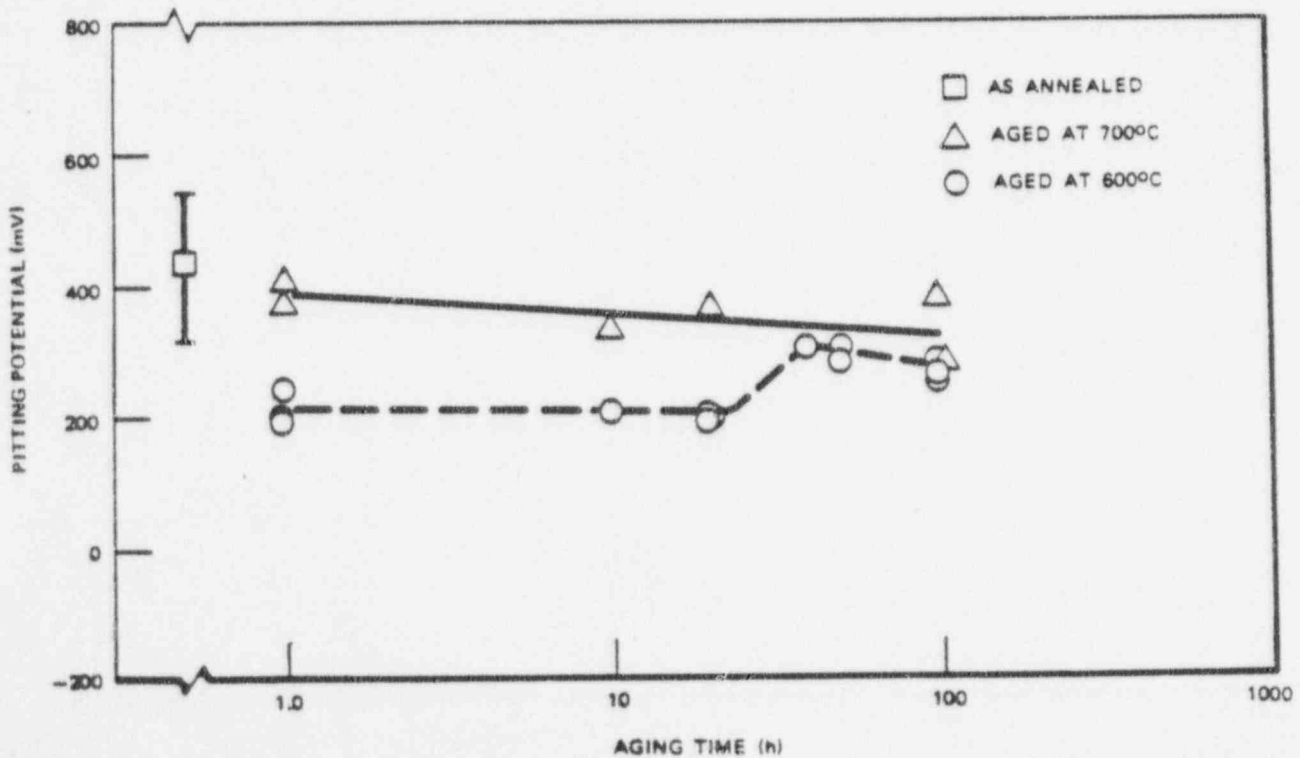
Figure 6-19. Influence of Aging Treatment on the Pitting Potential in 0.1 N HCl of Type-308 Stainless Steel Annealed at 1350°C (2462°F)/1 h, Water Quenched

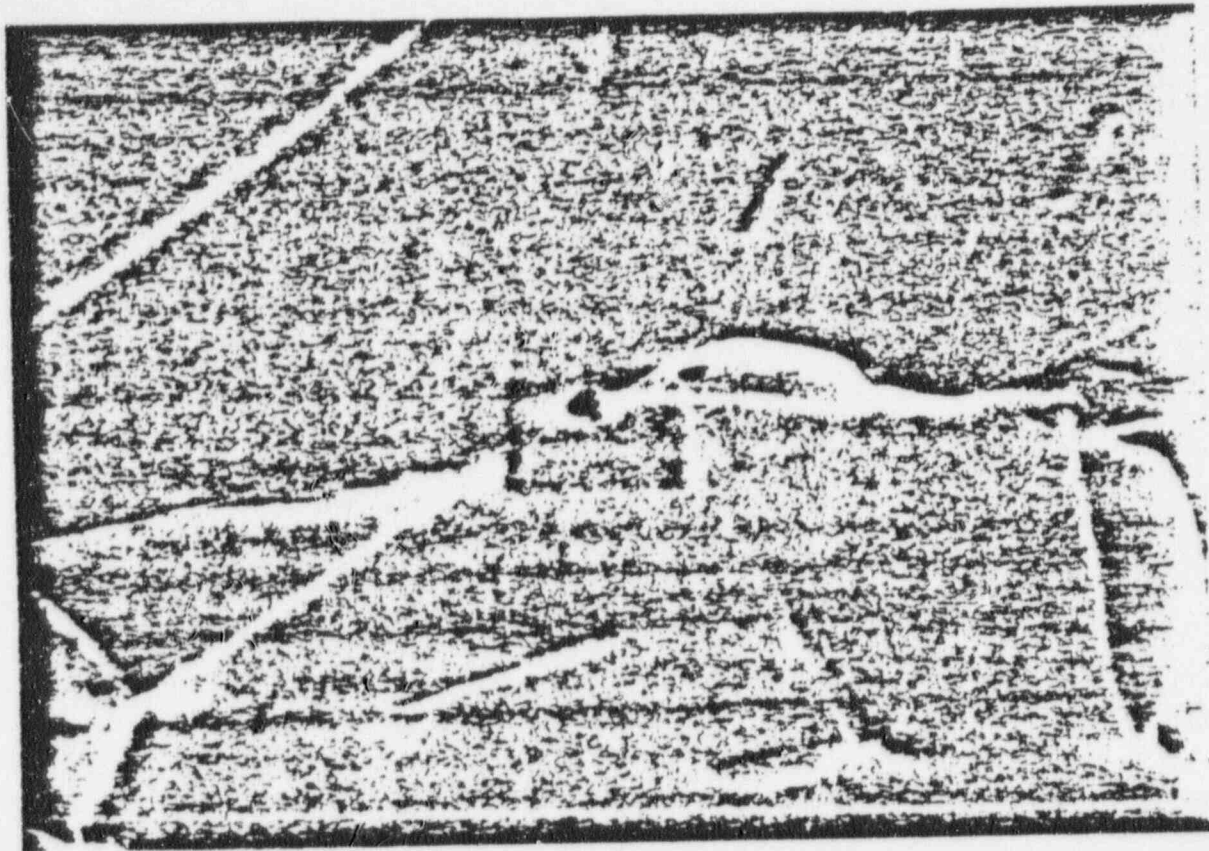
Figure 6-24. Pitting Initiation in Austenite at Austenite-Ferrite Boundaries in Sample of Type-308 Stainless Steel Heat Treated at 1350°C (2462°F)/1 h, Water Quenched + 500°C (1112°F)/1 h, 3860X

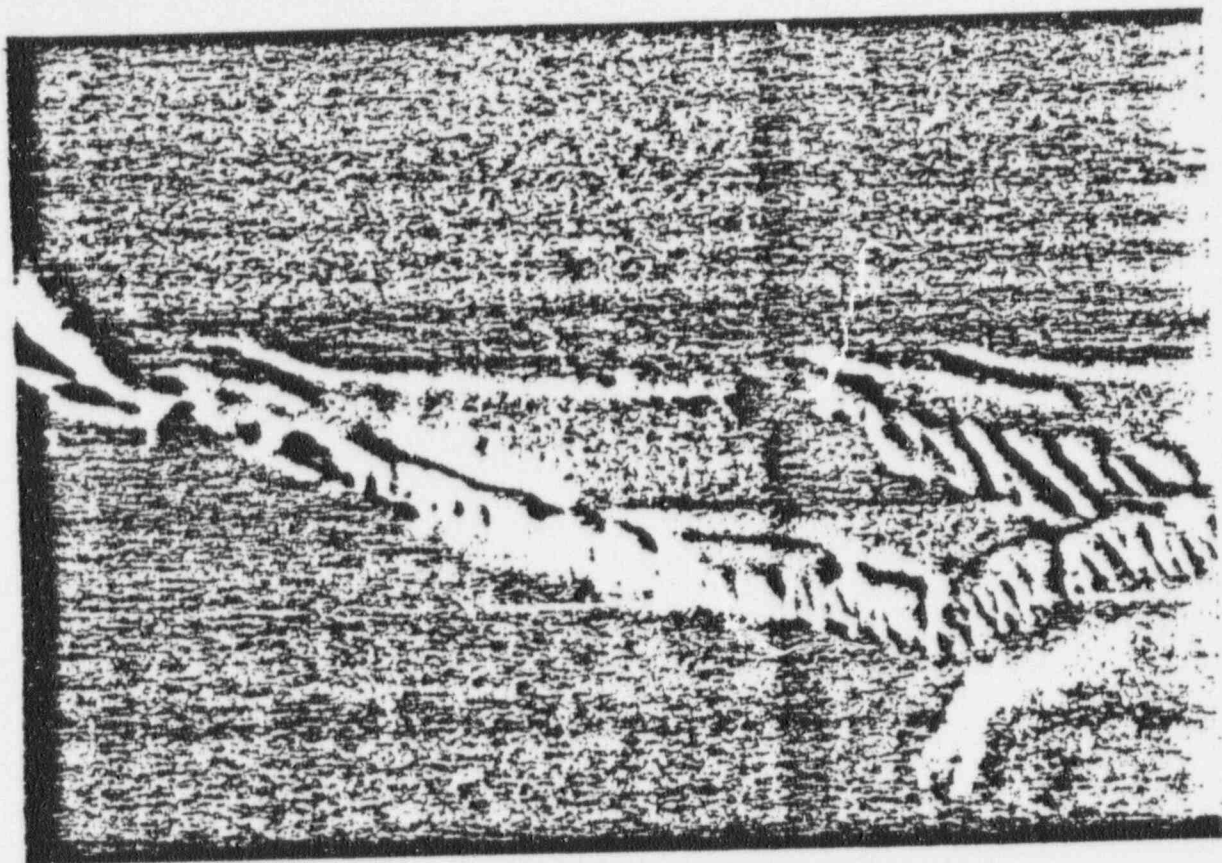
Figure 6-26. Pit Initiation at Austenite in Cellular $\gamma + M_{23}C_6$ Zone in Sample of Type-308 Stainless Steel Heat Treated at 1350°C (2462°F)/1 h, Water Quenched + 700°C (1292°F)/1 h, Water Quenched + 700°C (1292°F)/1 h, Water Quenched 6430X

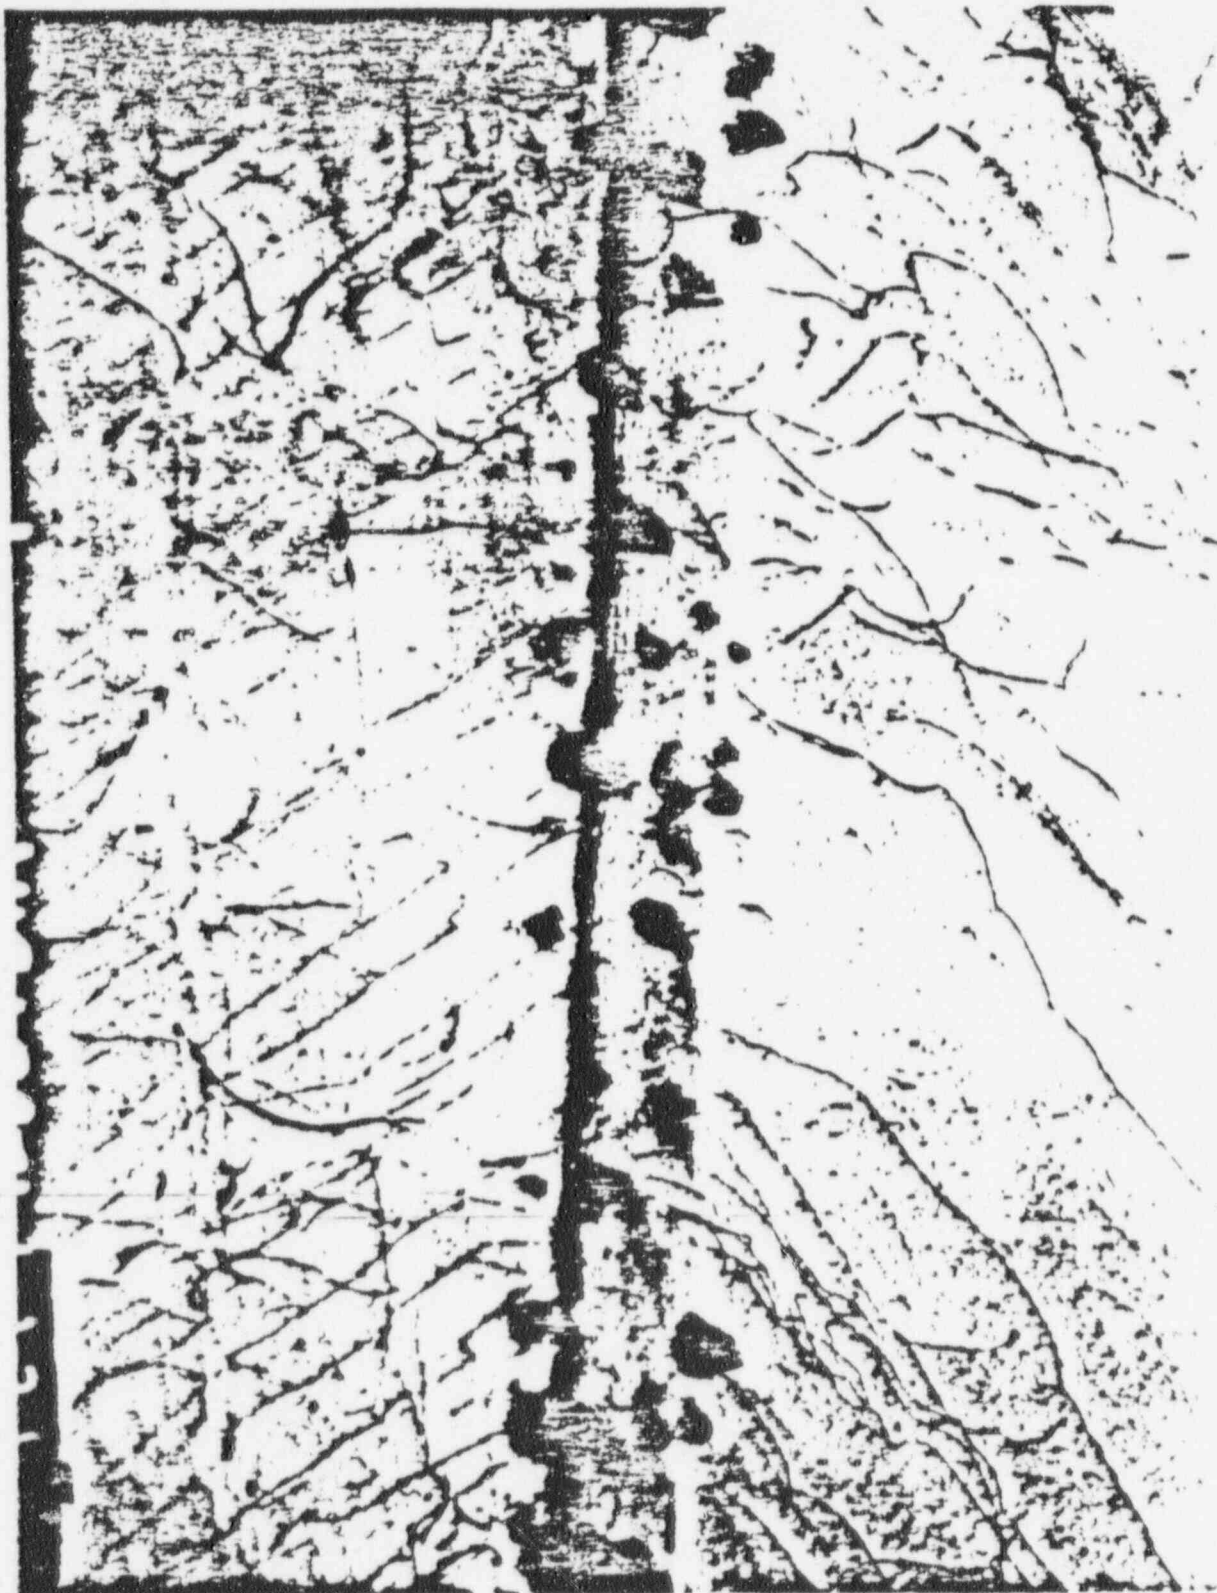
Figure 6-30. Transmission Electron Micrograph of Type-308 Stainless Steel Heat Treated at 1200°C (2192°F)/1 h, Water Quenched + 600°C (1112°F)/20 h, Water Quenched 75,000X

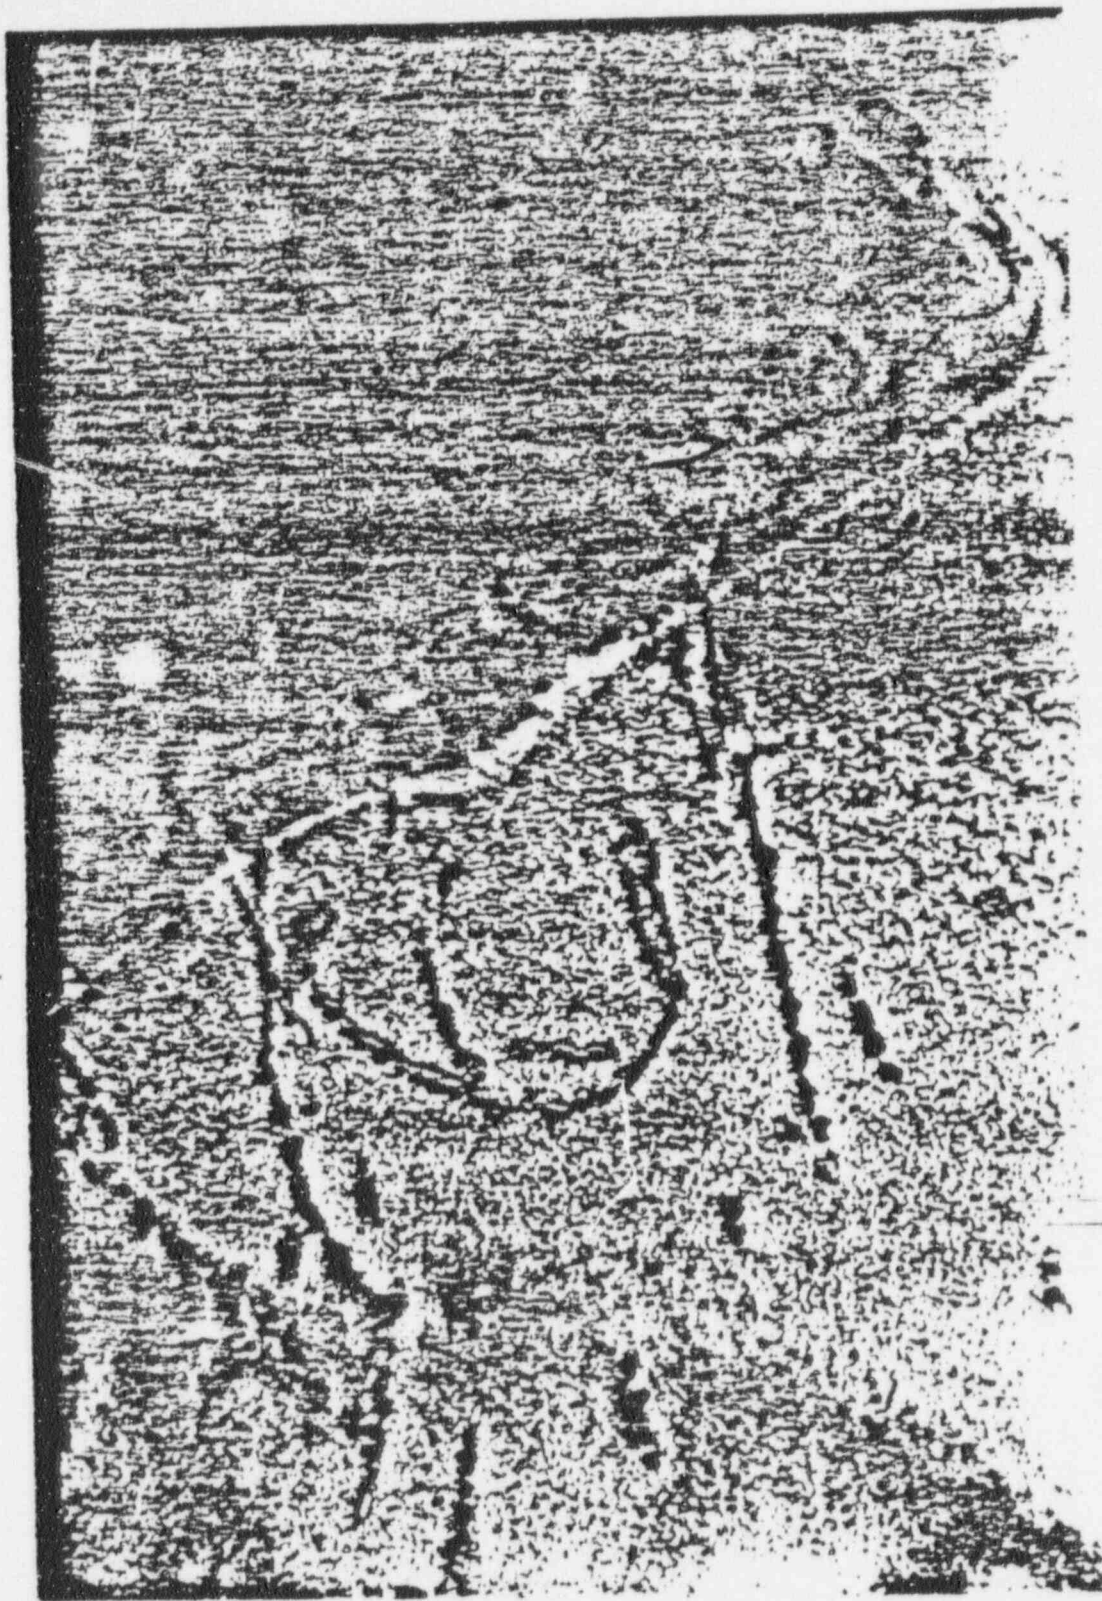
Figure 6-31. Transmission Electron Micrograph of Type-308 Stainless Steel Heat Treated at 1350°C (2462°F)/1 h, Water Quenched + 480°C (896°F)/100 h, Water Quenched 90,000X

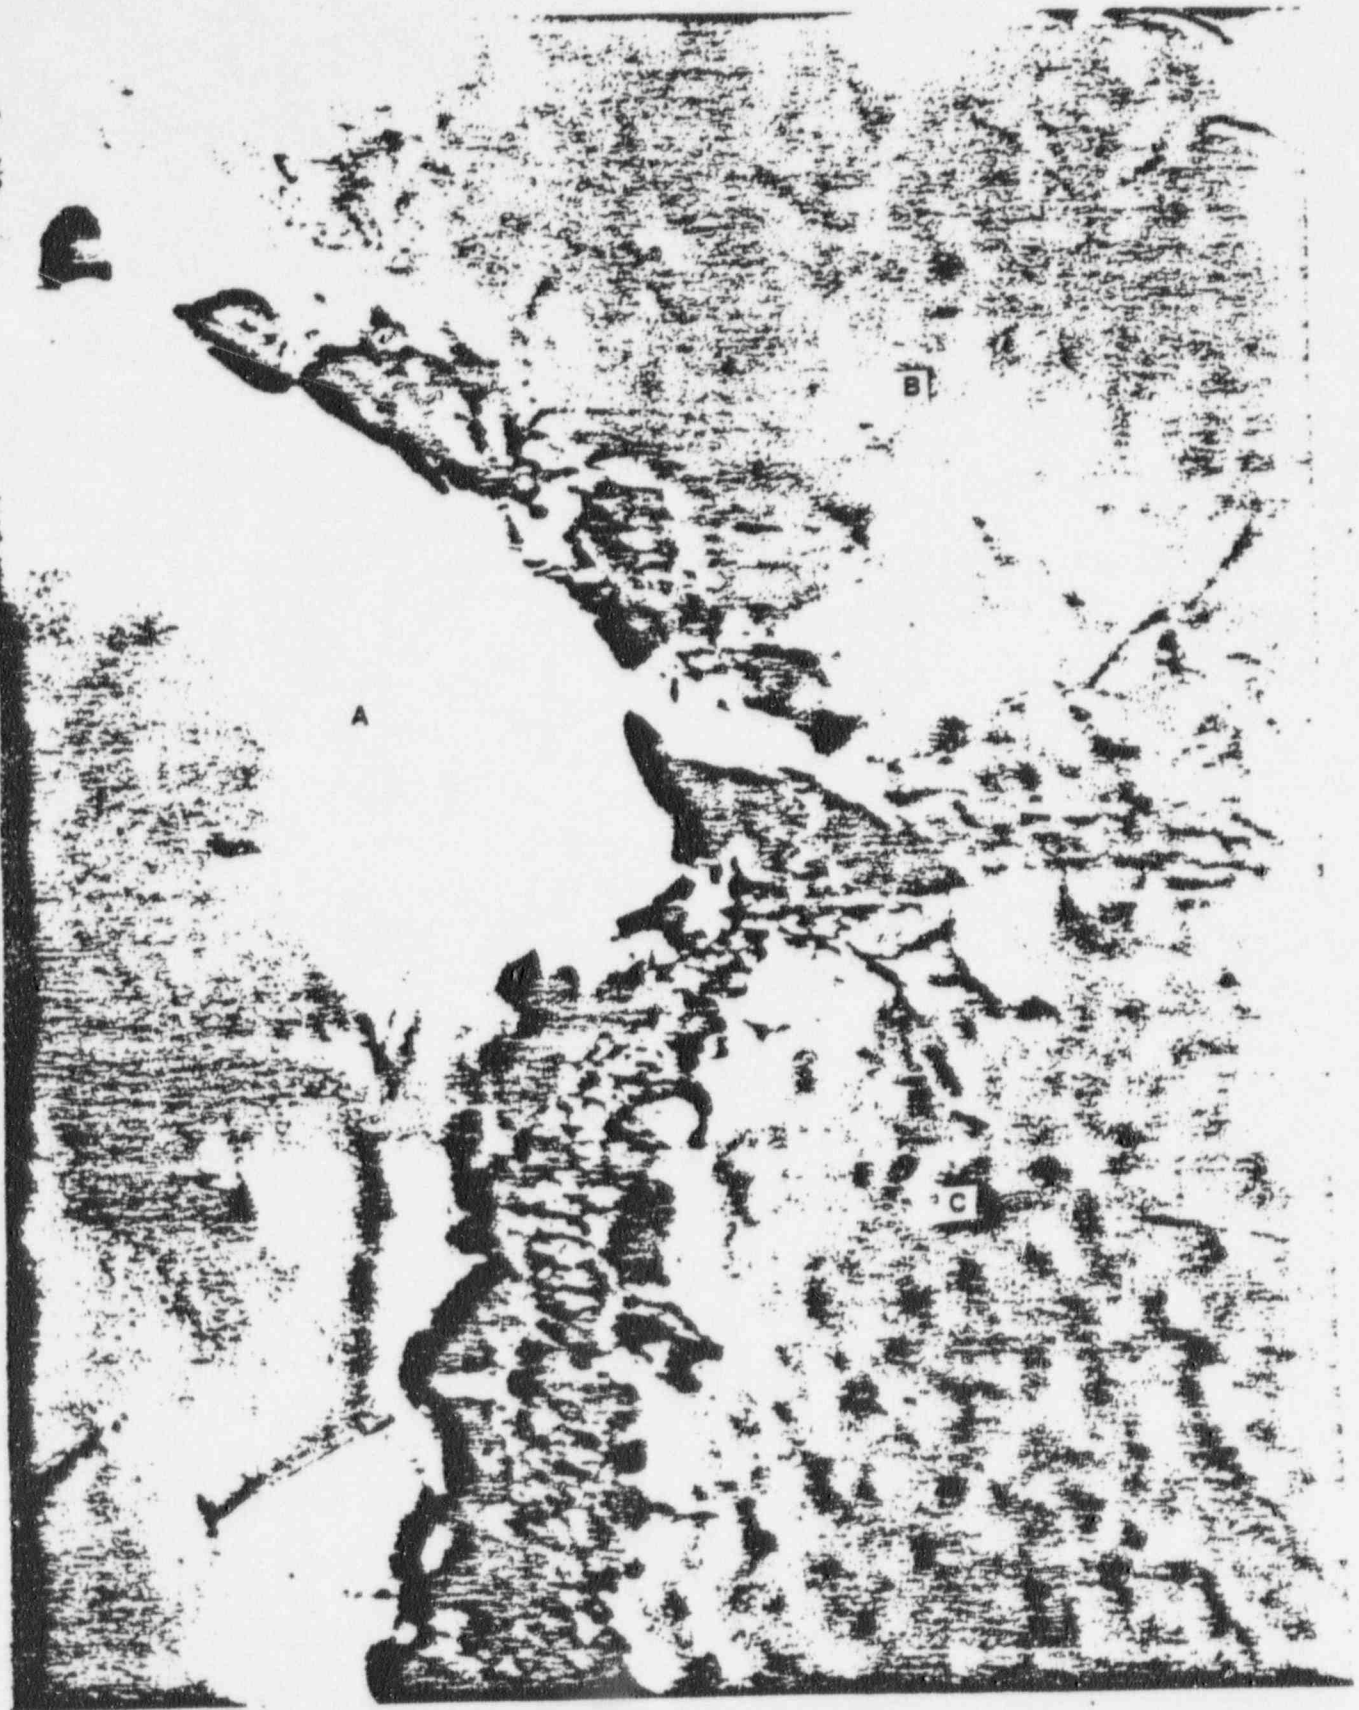
Figure 6-32. Transmission Electron Micrograph of Type-308 Stainless Steel Heat Treated at 1350°C (2462°F)/1 h, Water Quenched + 800°C (1112°F)/1 h, Water Quenched 110,000X

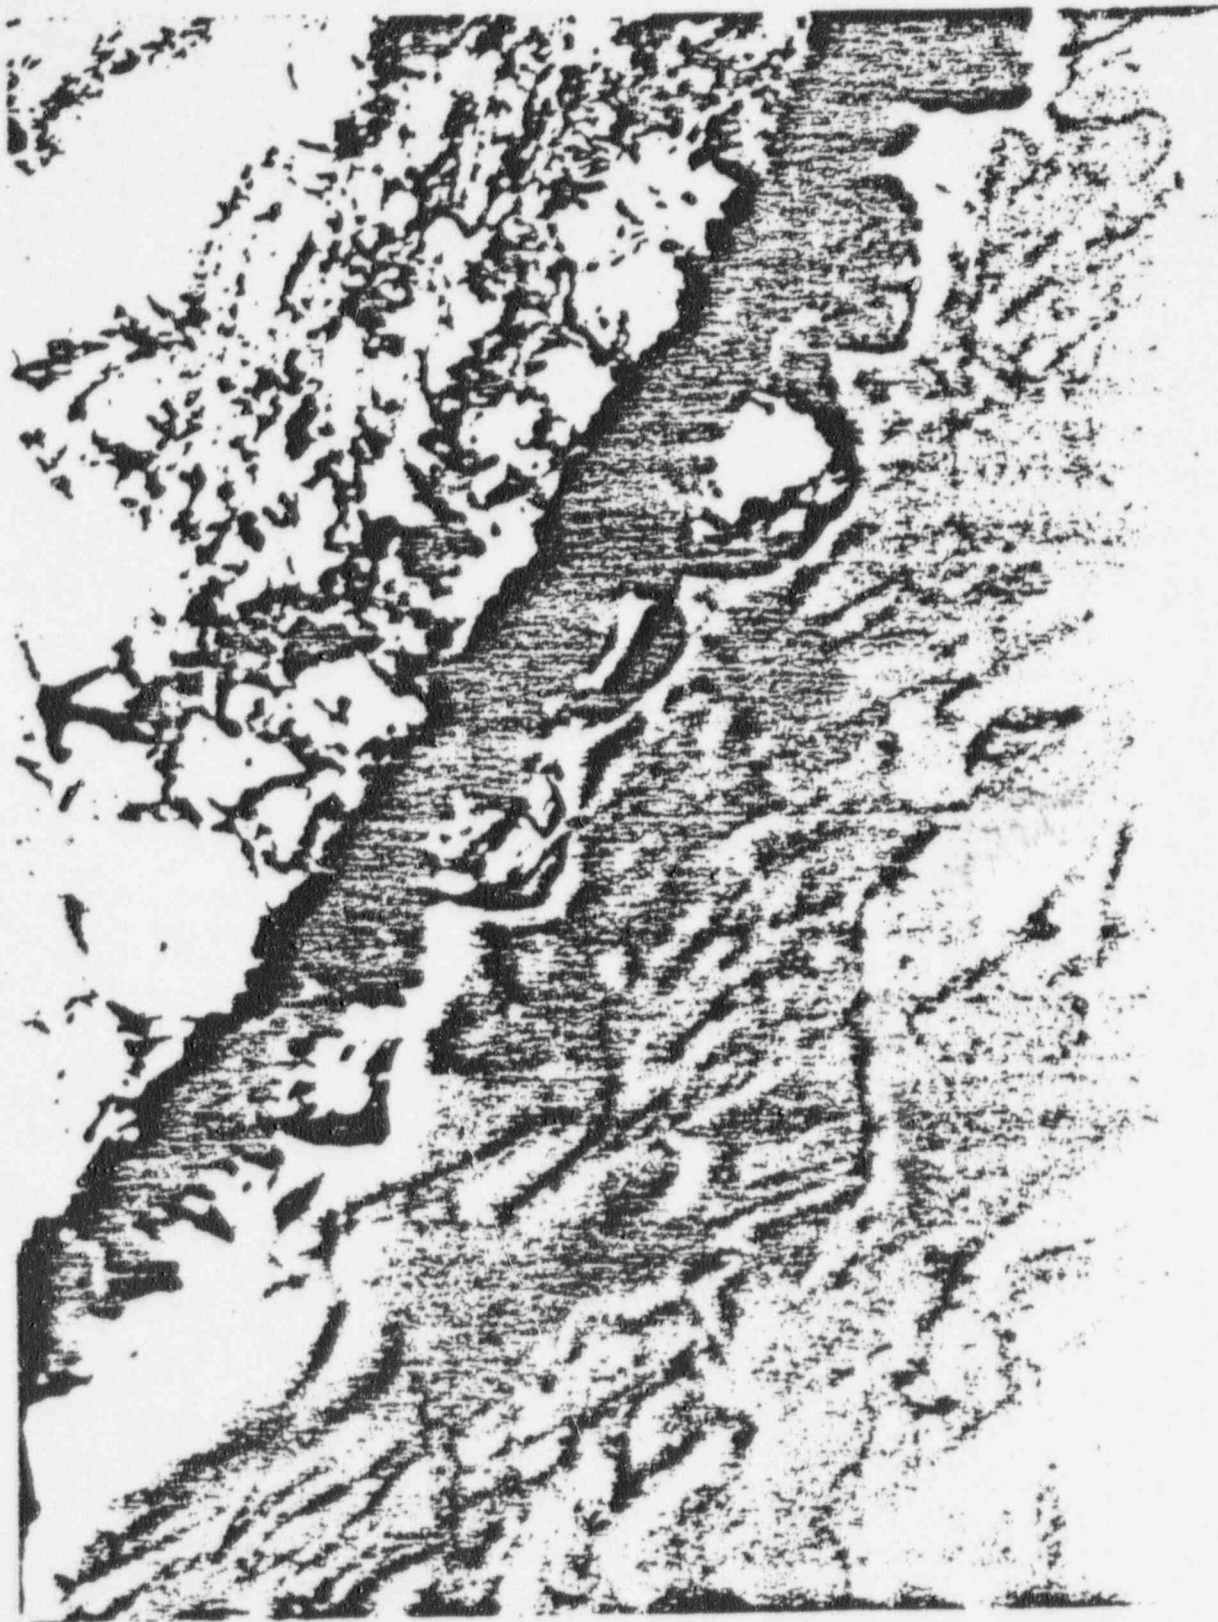
Figure 6-33a. Light Field Transmission Electron Image of Type-308 Stainless Steel Heat Treated at 1350°C (2462°F)/1 h, Water Quenched + 800°C (1112°F)/4 h, Water Quenched 80,000X

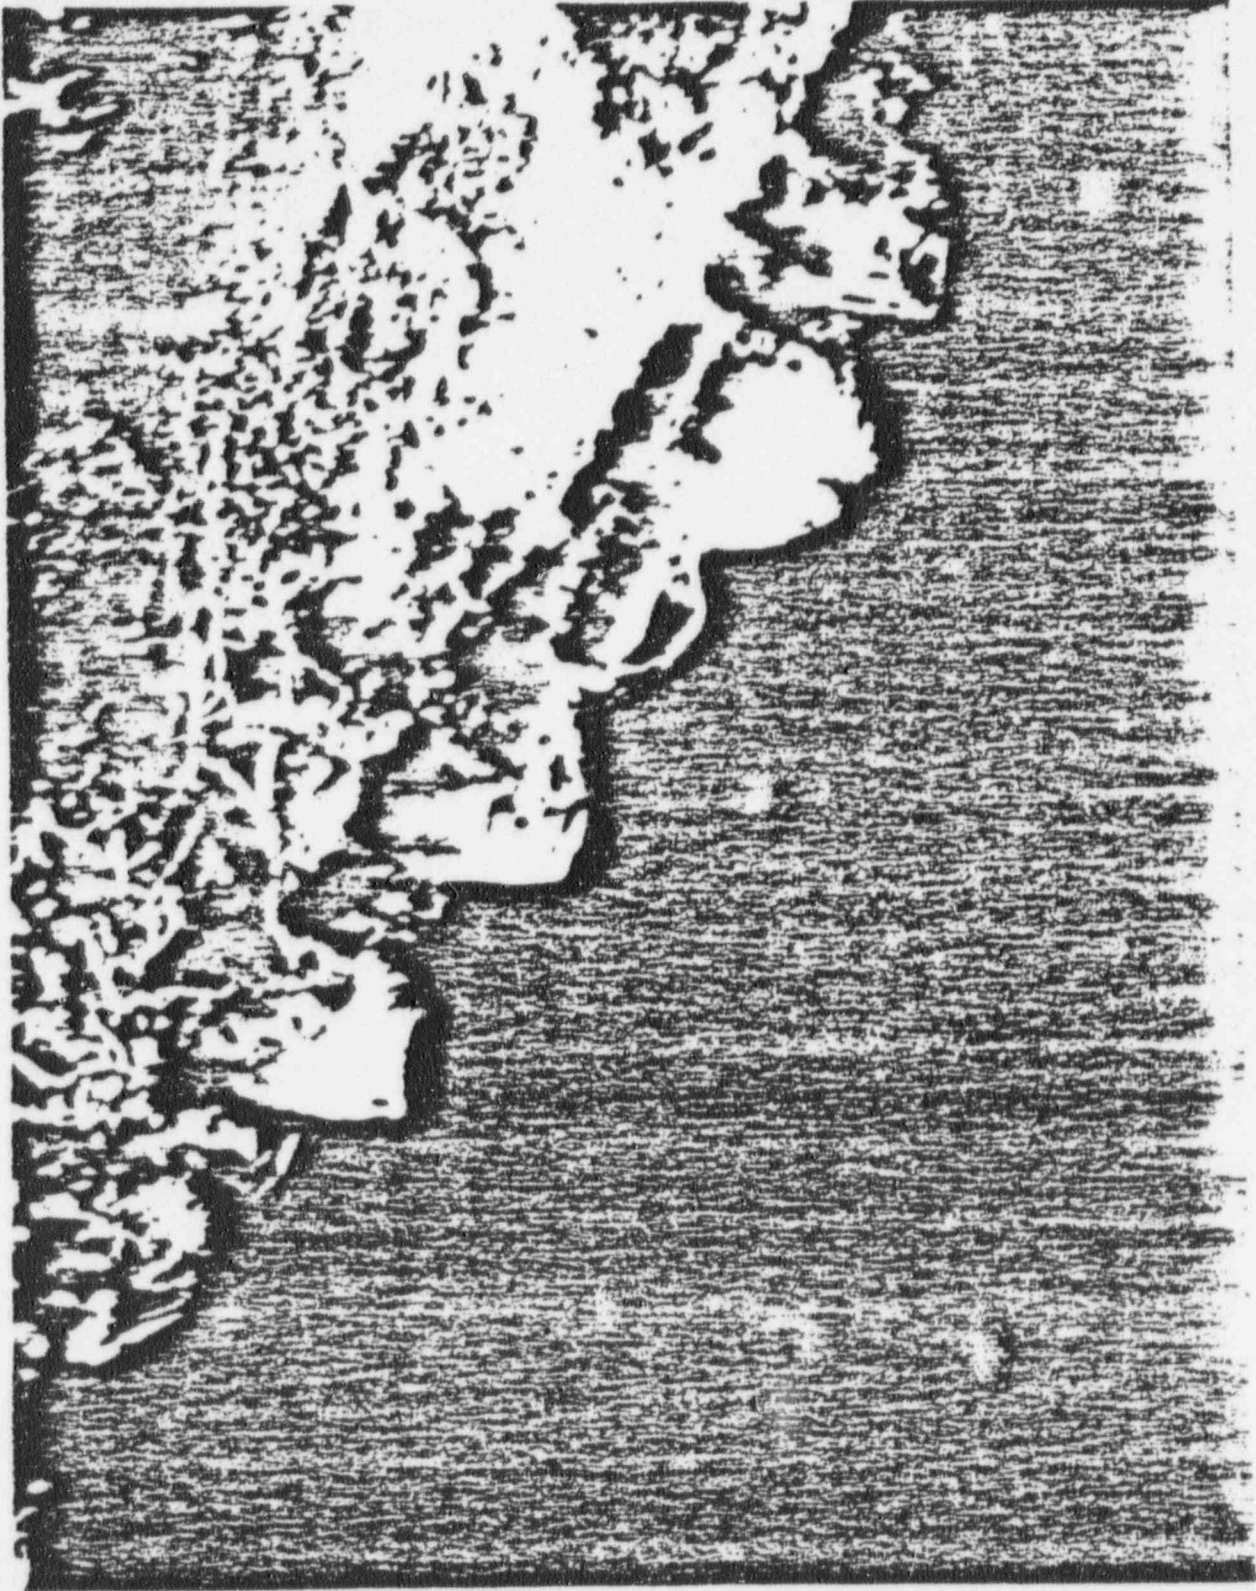
Figure 6-33b. Dark Field Transmission Electron Image of Type-308 Stainless Steel Heat Treated at 1350°C (2462°F)/1 h, Water Quenched + 600°C (1112°F)/4 h, Water Quenched 50,000X
