EVALUATION OF NEAR-TERM BWR PIPING REMEDIES

(Research Project 701-1)

Final Report

Nuclear Energy Engineering Division
General Electric Company
175 Curtner Avenue
San Jose, California 95125

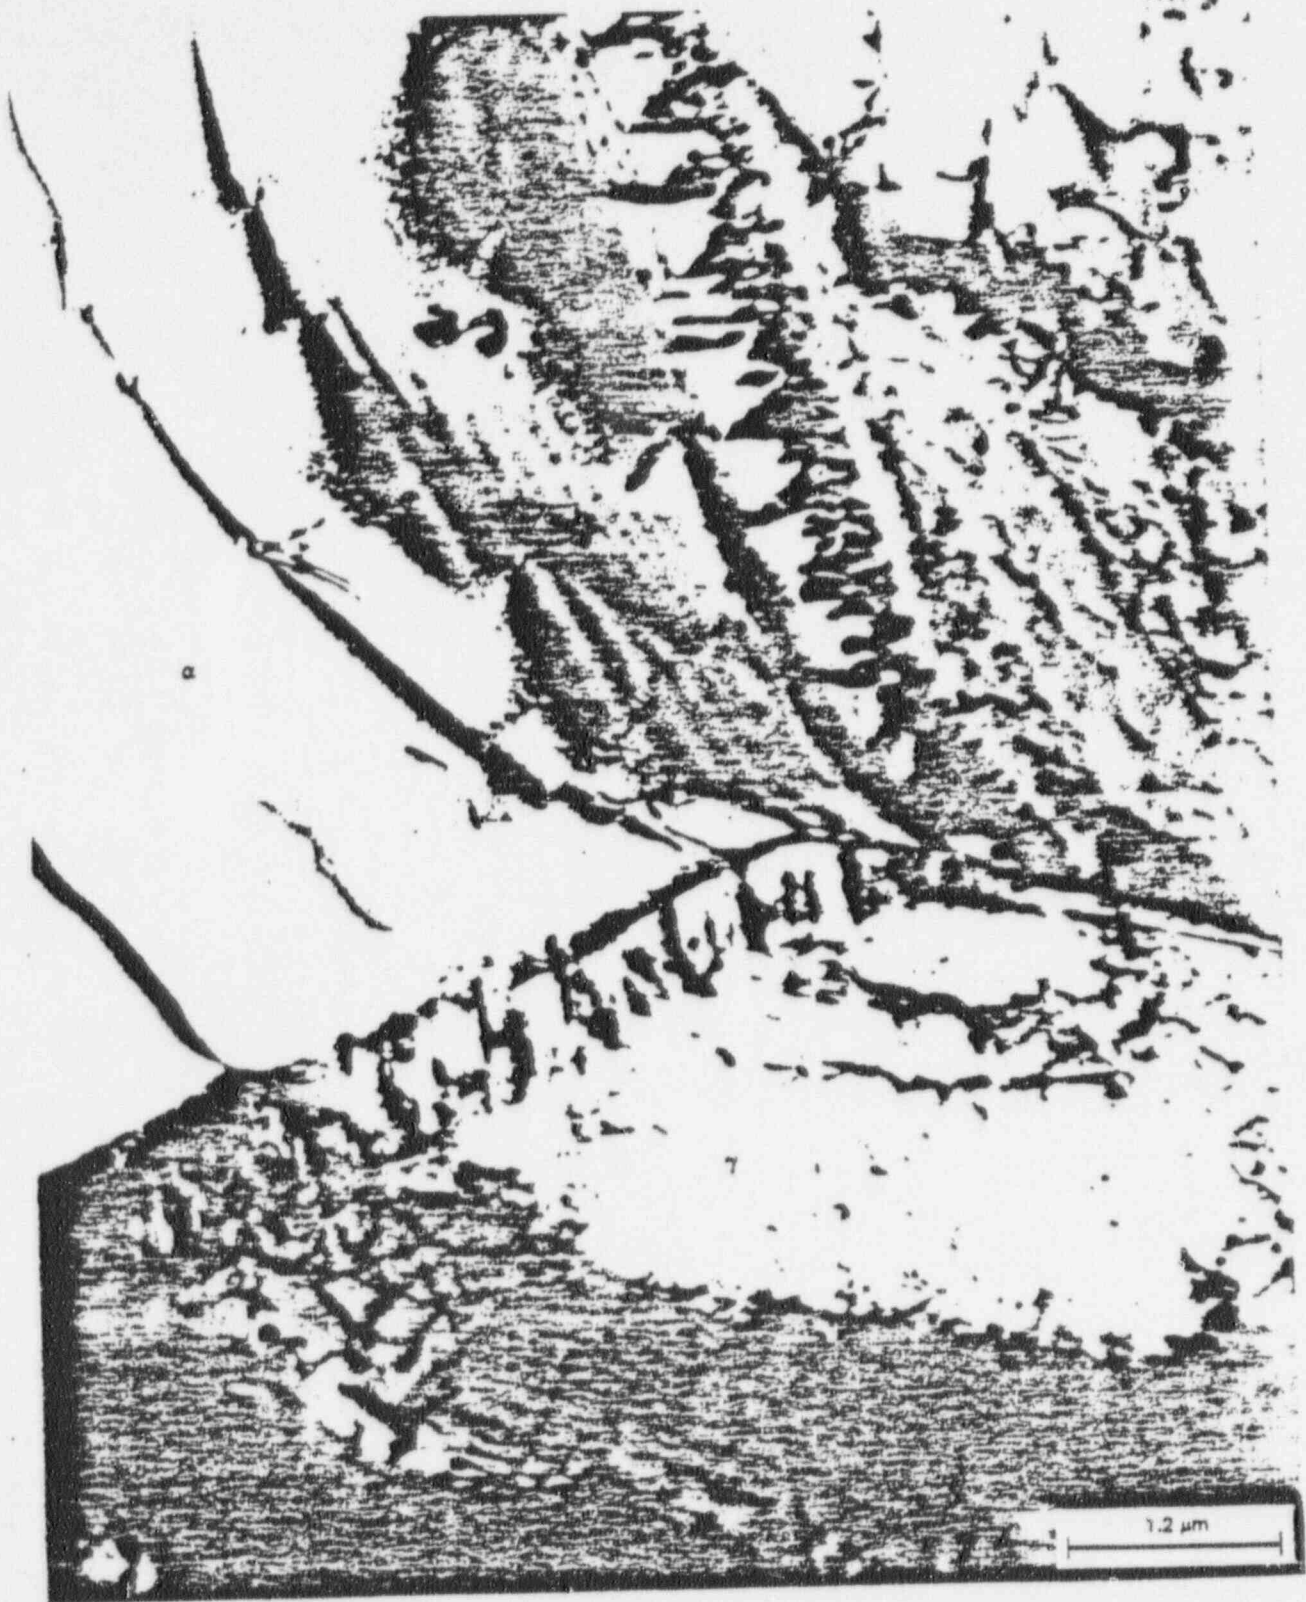
Figure 6-34e. Transmission Electron Micrograph of Type-308 Stainless Steel Heat Treated at 1350°C (2462°F)/1 h, Water Quenched + 700°C (1292°F)/1 h, Water Quenched 25,000X

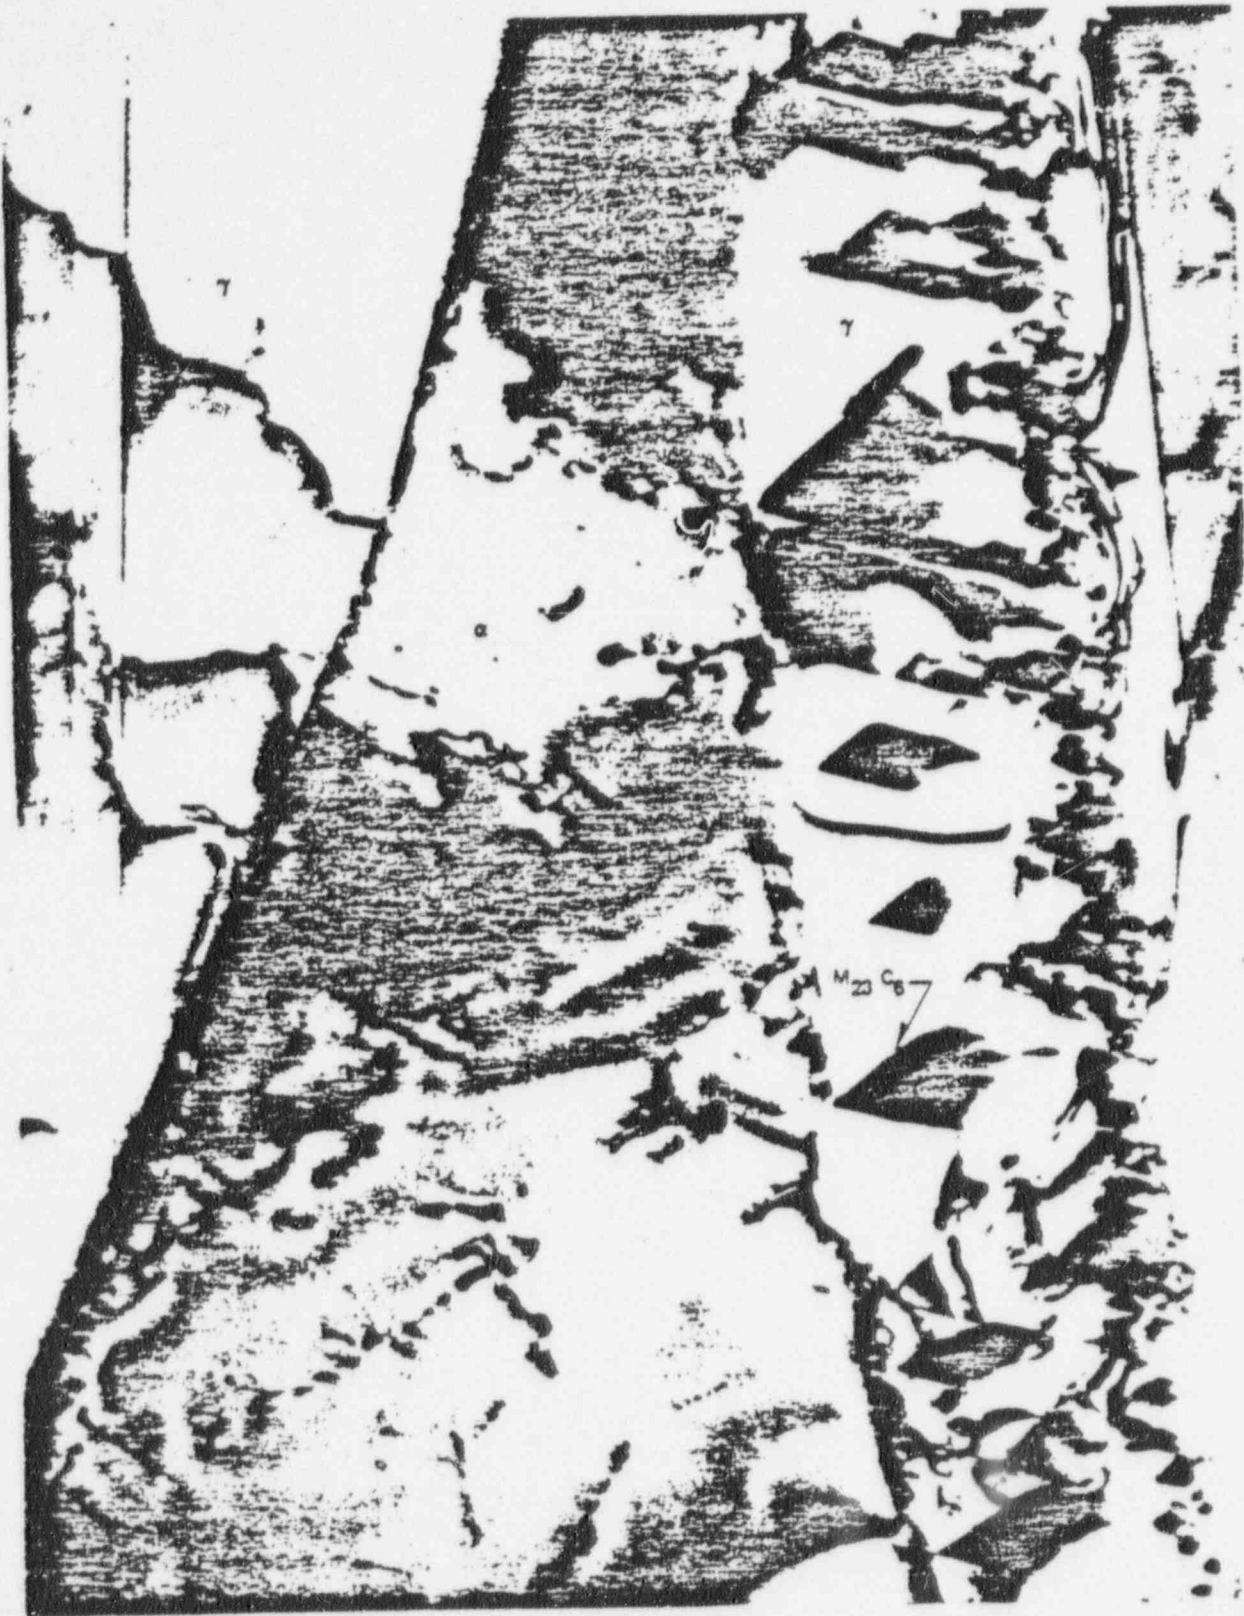
Figure 6-34b. Transmission Electron Micrograph of Type-308 Stainless Steel Heat Treated at 1350°C (2462°F)/1 h, Water Quenched + 700°C (1292°F)/1 h, Water Quenched 25,000X

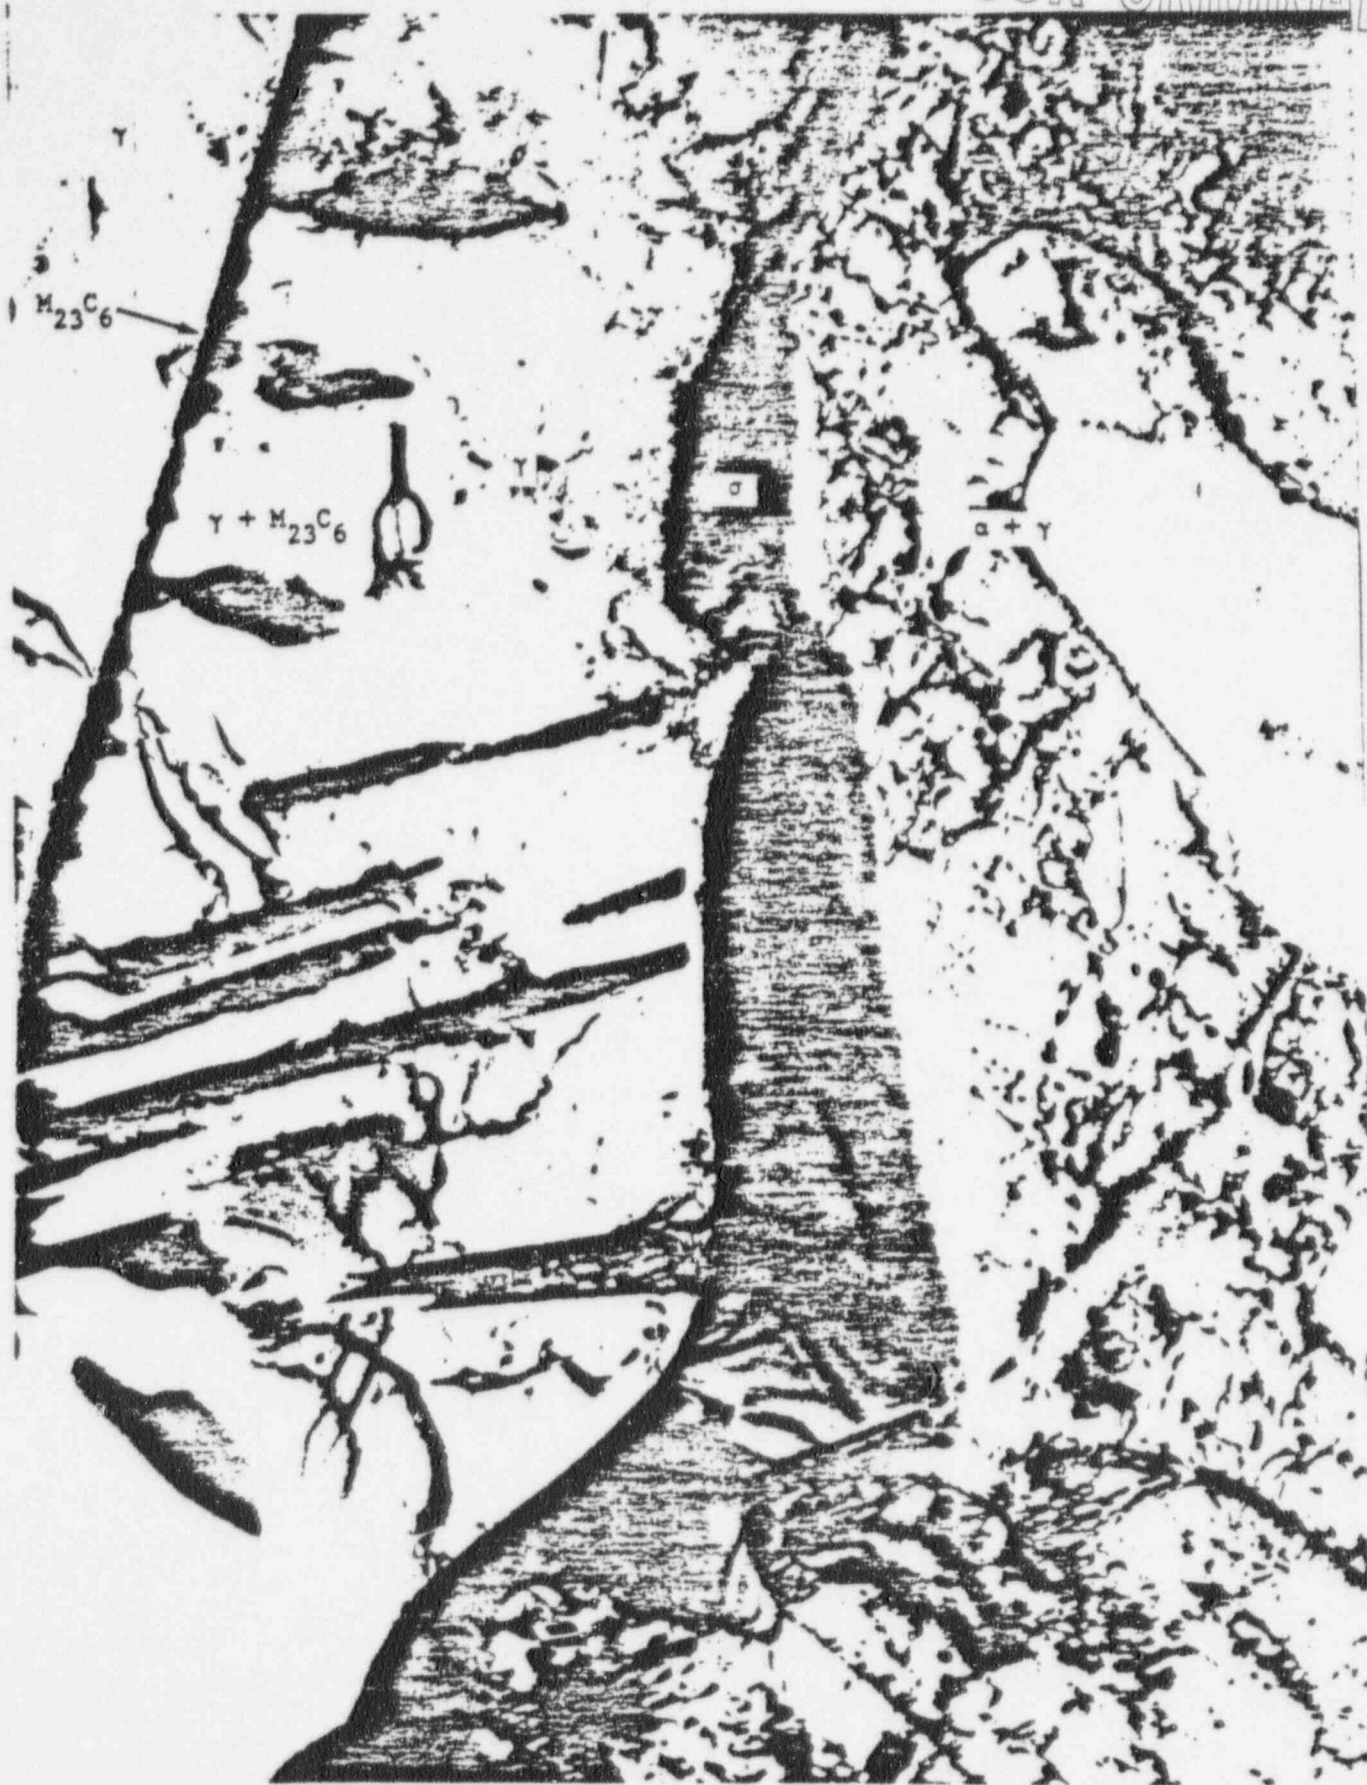
Figure 6-35. Transmission Electron Micrograph of Type-308 Stainless Steel Heat Treated at 1350°C (2462°F)/1 h, Water Quenched + 700°C (1292°F)/100 h, Water Quenched

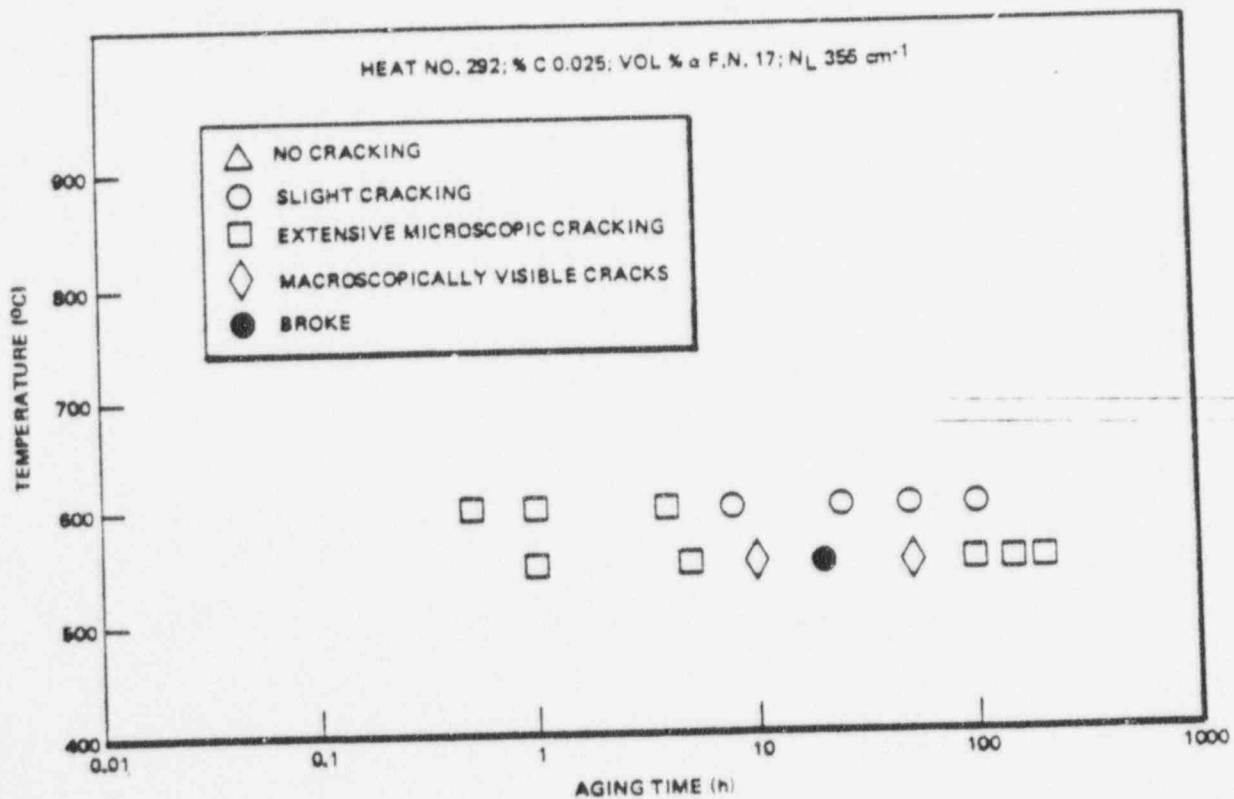
Figure 6-48. Influence of Aging Treatment on the Intergranular Corrosion Behavior of Type-308 Stainless Steel Containing 0.025% Carbon and 17 vol % Ferrite

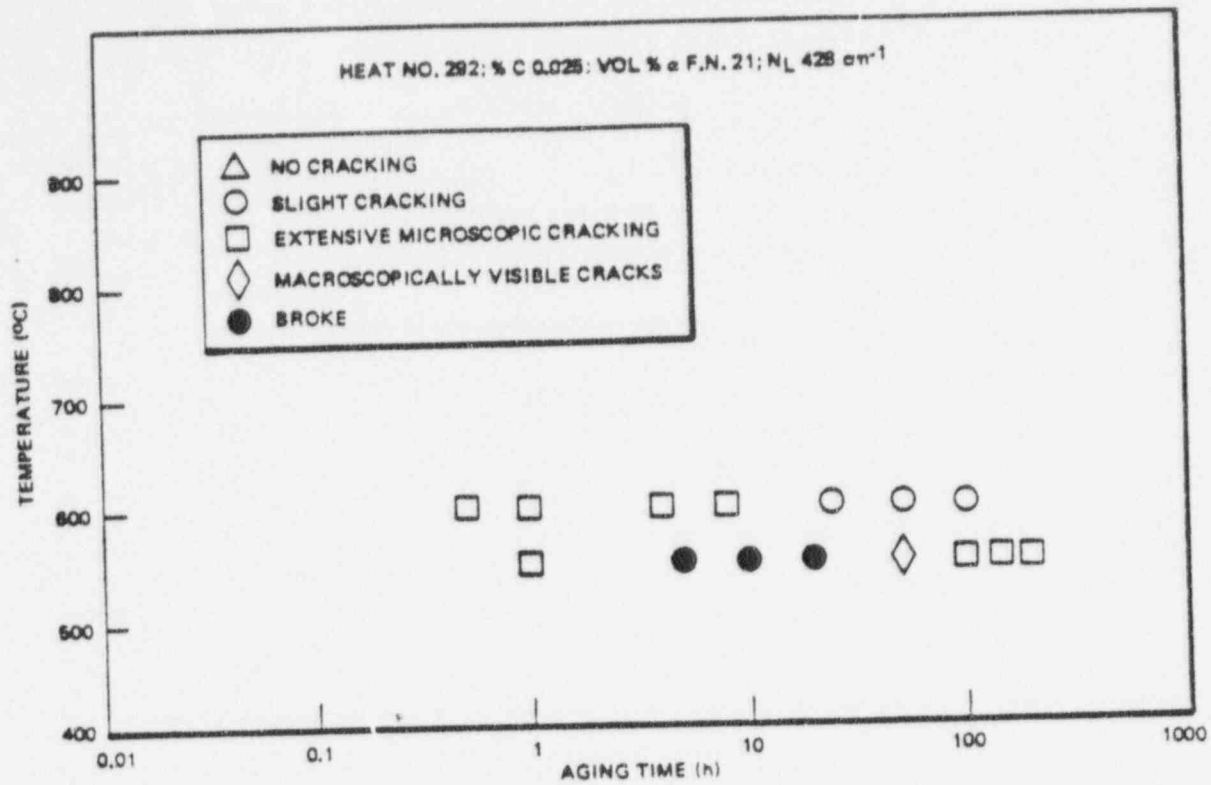
Figure 6-49. Influence of Aging Treatment on the Intergranular Corrosion Behavior of Type-308 Stainless Steel Containing 0.025% Carbon and 21 vol % Ferrite

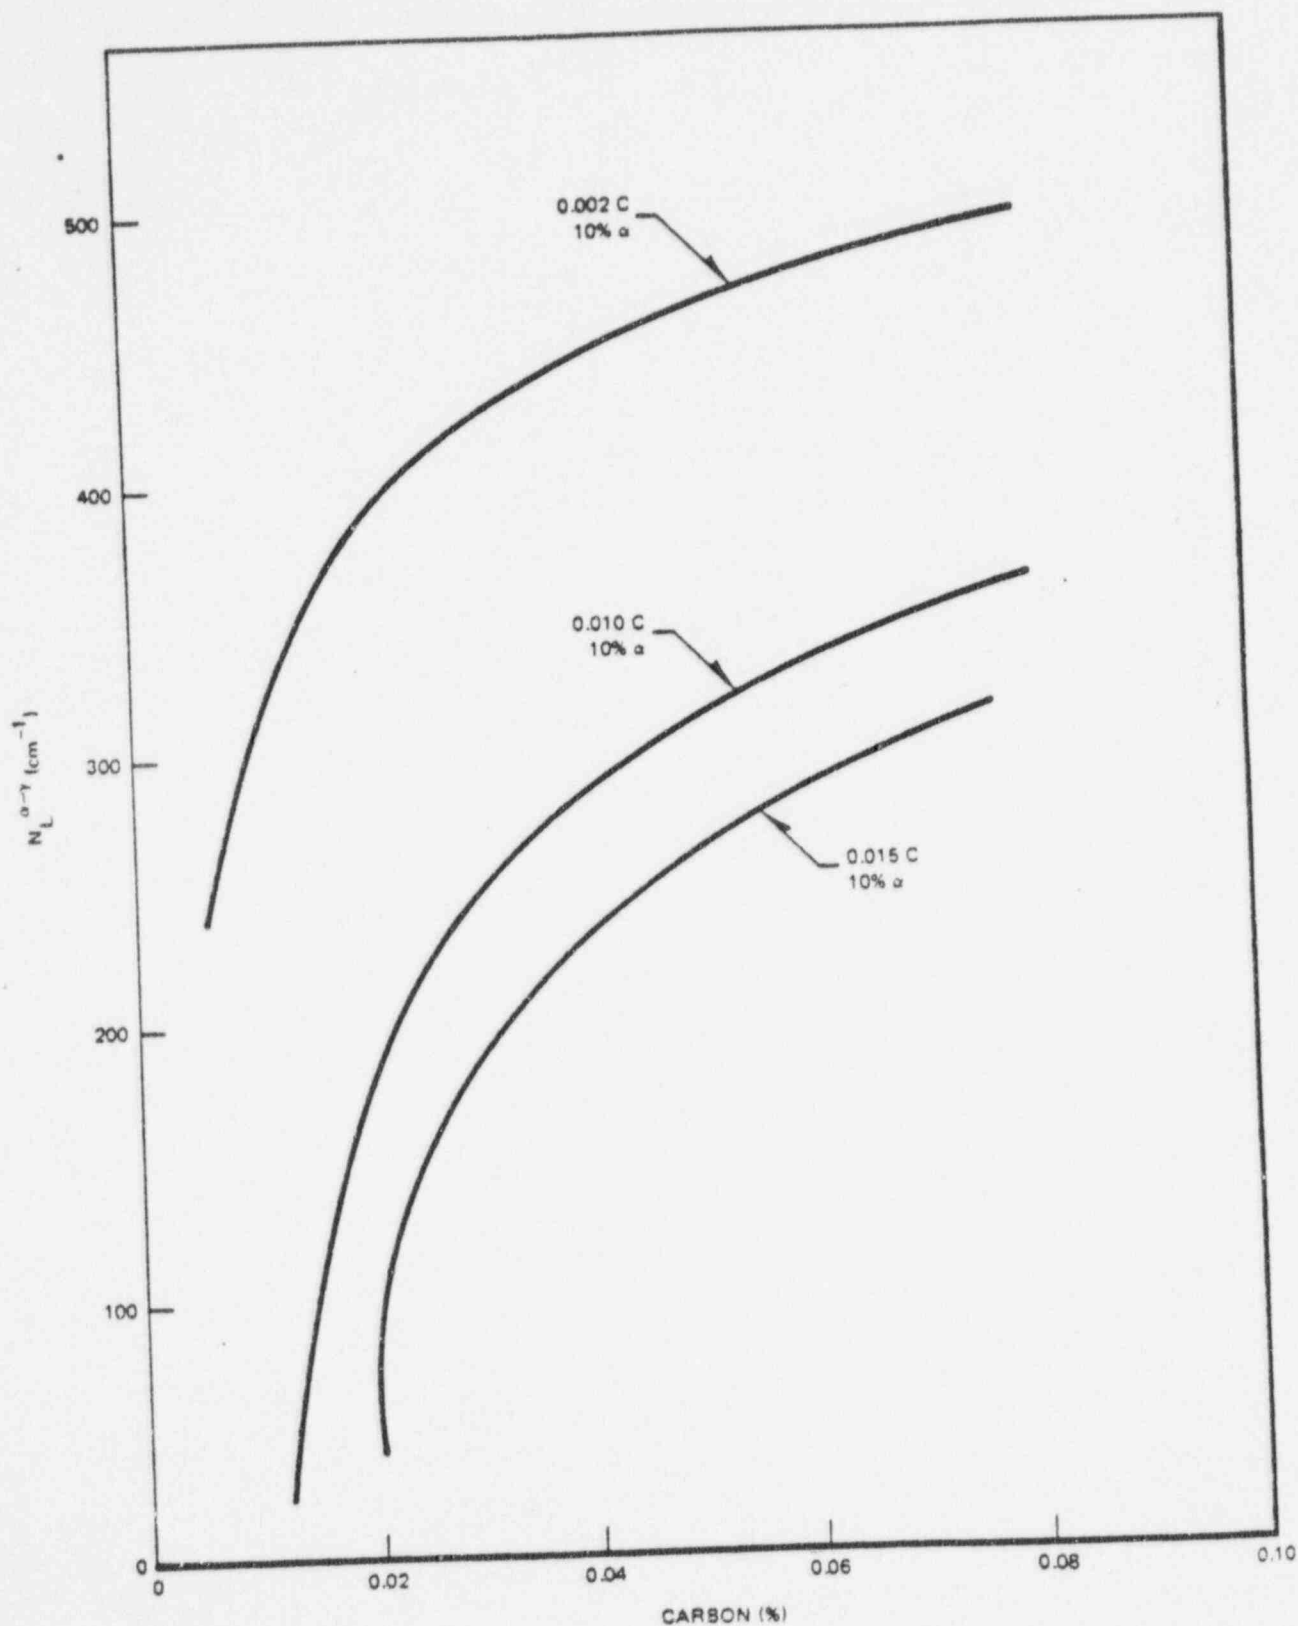
Figure 6-53. The Value of $N_L^{a-\gamma}$ Required to Reduce the Austenite Mean-Free-Path to a Level Sufficient to Inhibit Sensitization of Type-308 Stainless Steel

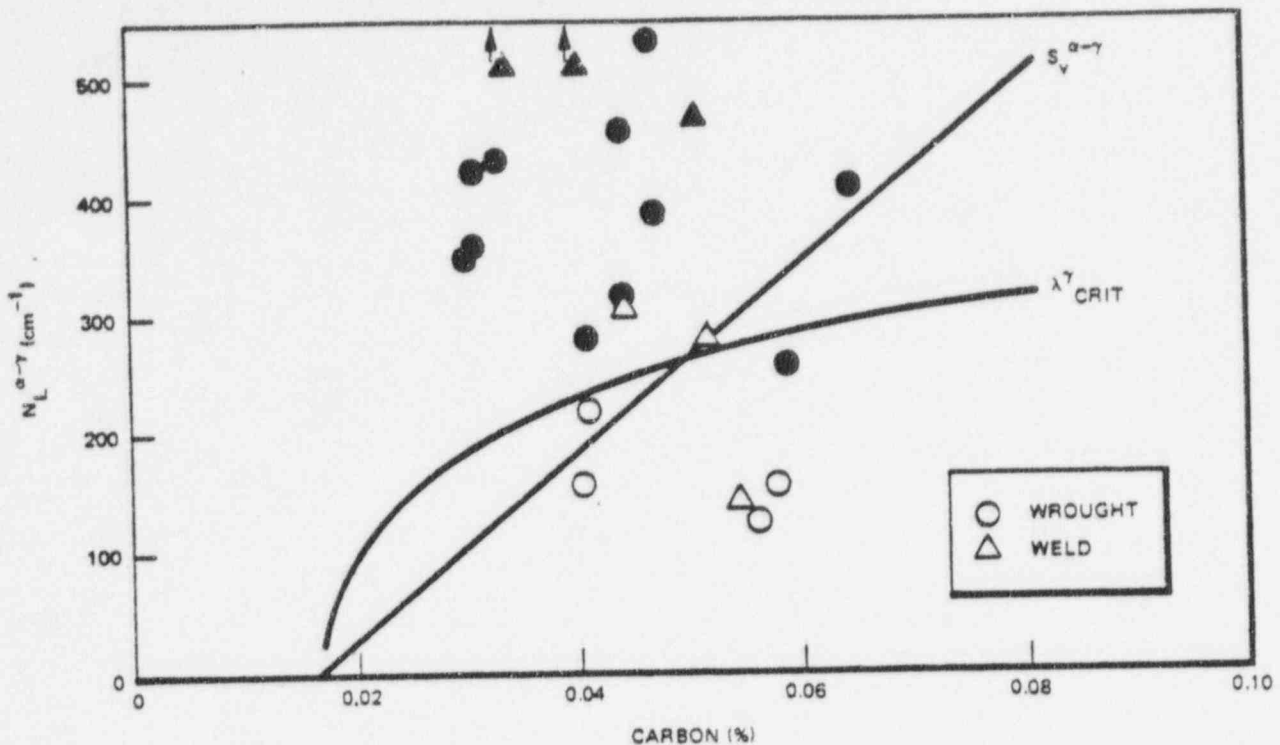
Figure 6-54. The Influence of $N_L^{\alpha-\gamma}$ on the Intergranular Corrosion Behavior of Aged Samples of Wrought and Weld-Deposited Type-308 Stainless Steel

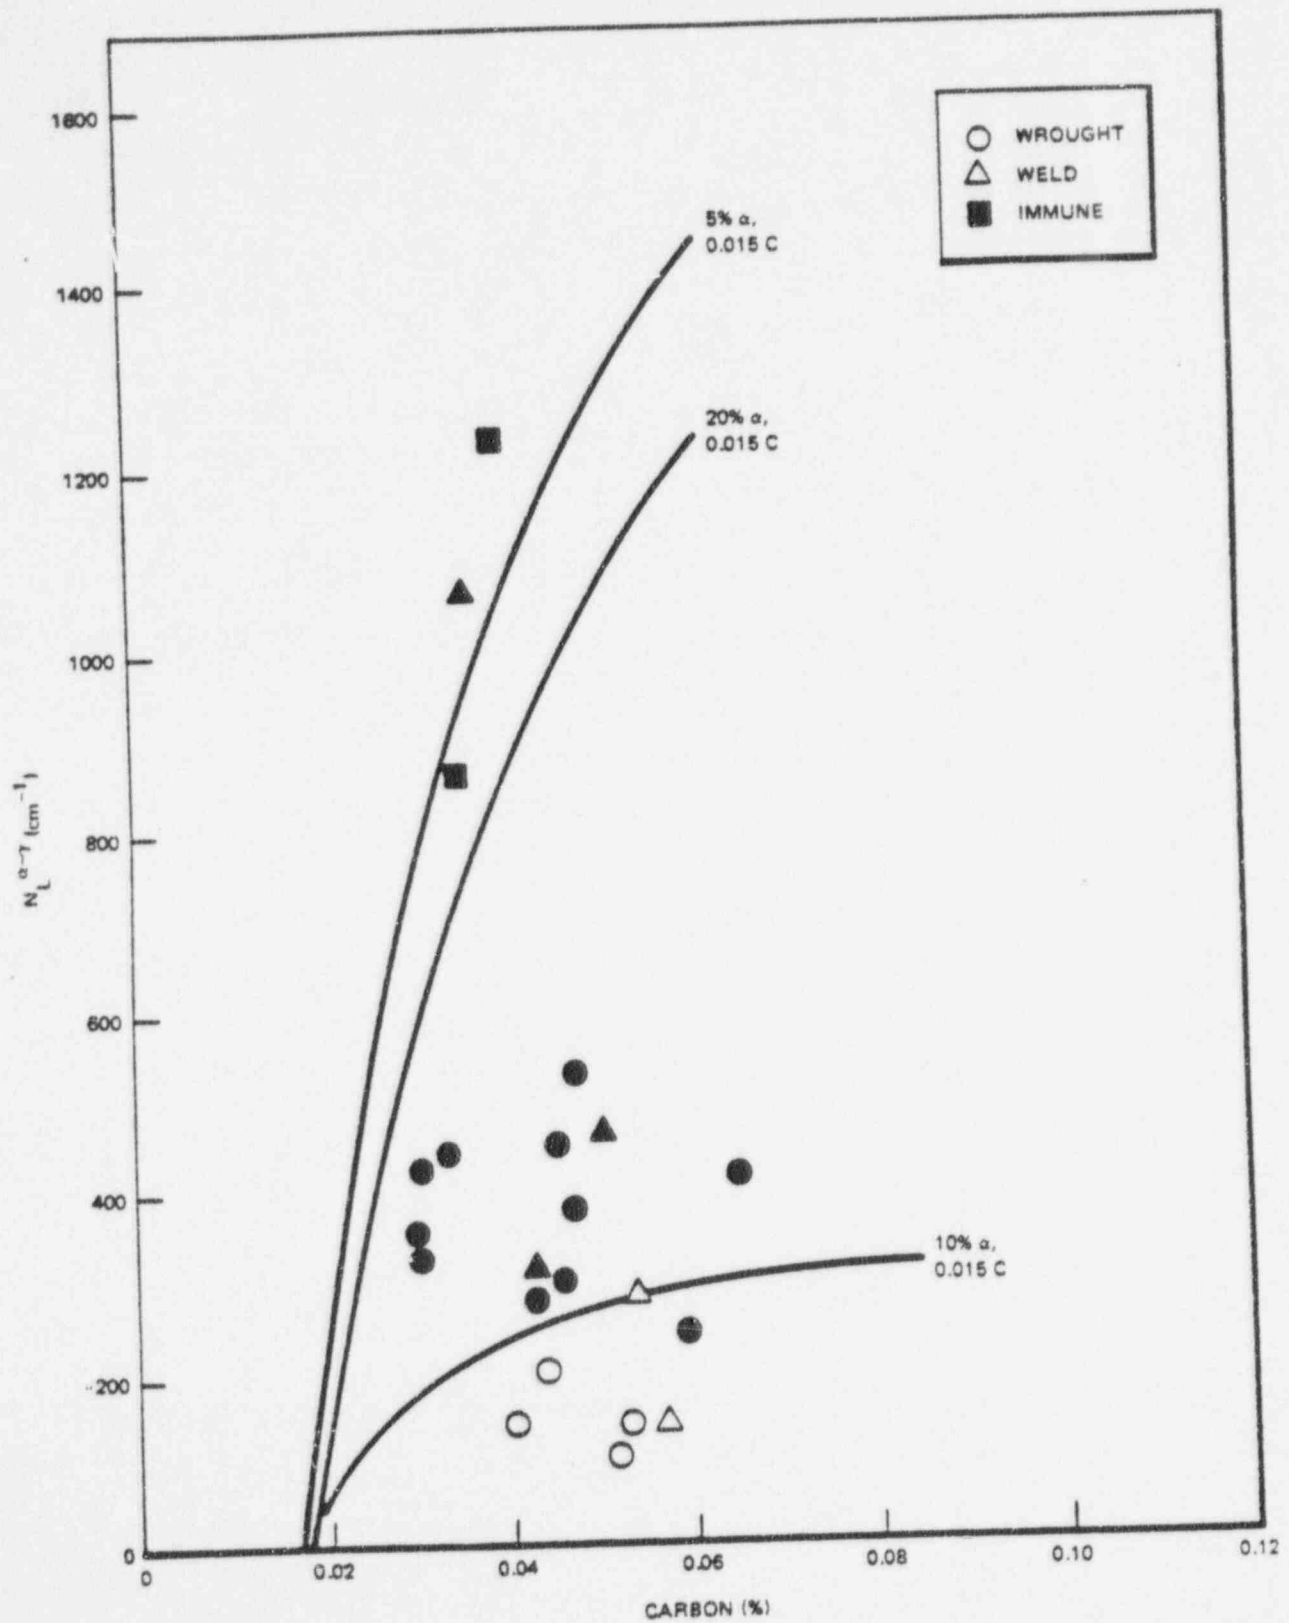
Figure 6-57. The Values of $N_L^{a-\gamma}$ Required to Reduce the Austenite Mean-Free-Path to Levels Sufficient to (a) Restrict and (b) Prevent Sensitization of Type-308 Stainless Steel

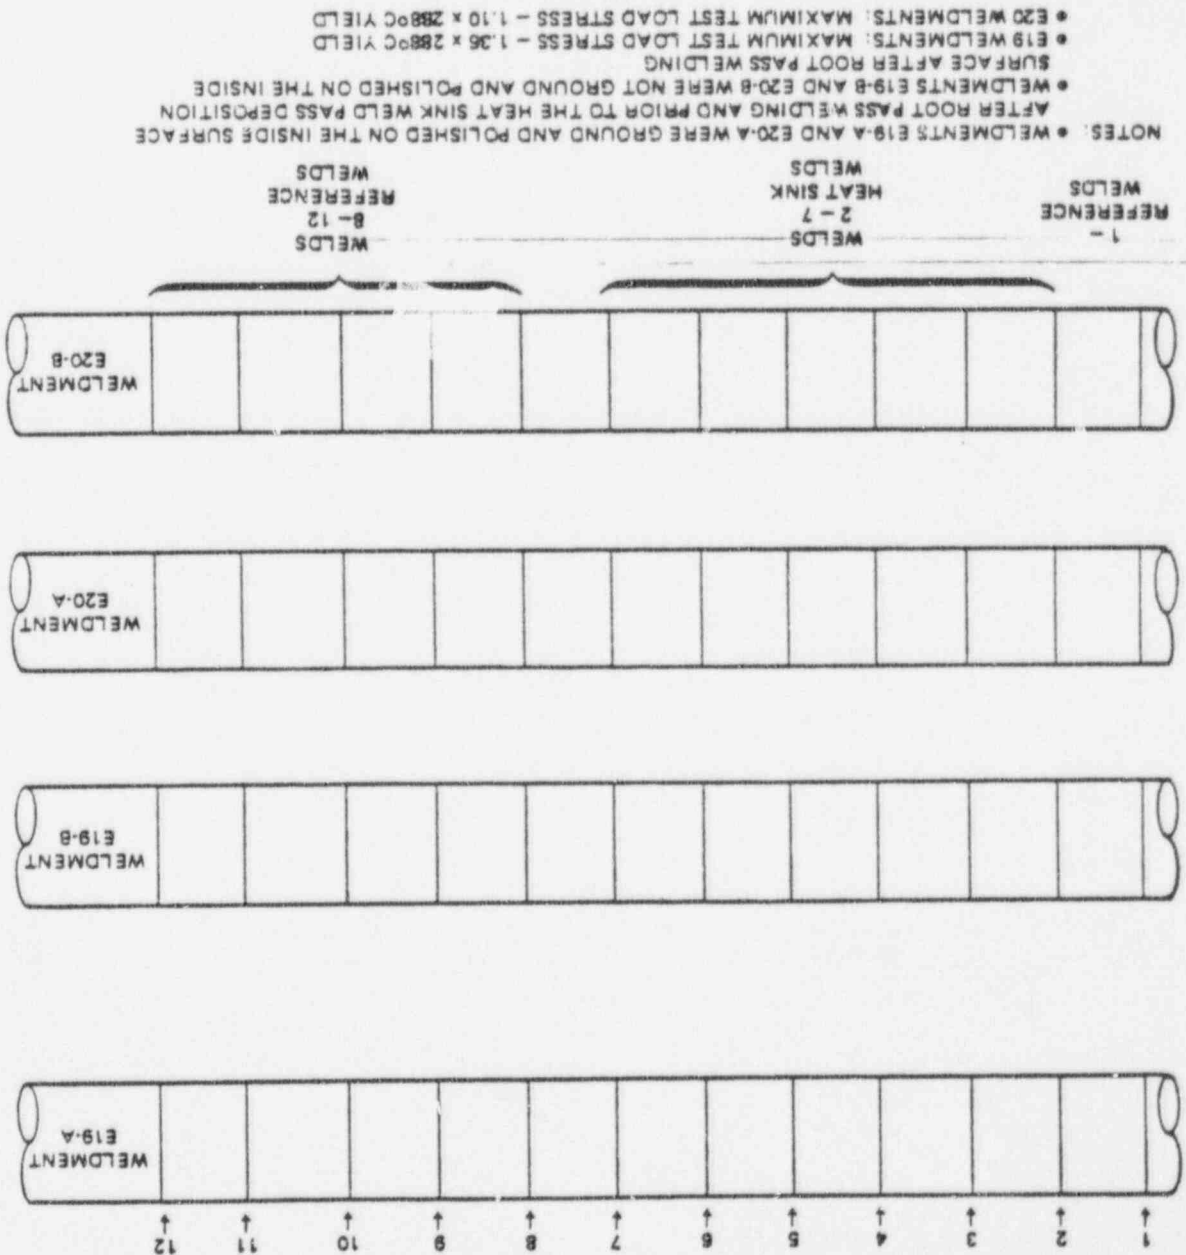
Figure G-1. Bechtel Fabricated Heat Sink Weldments (Fully Automatic-2G Position - Type-304 Stainless Steel Pipe)

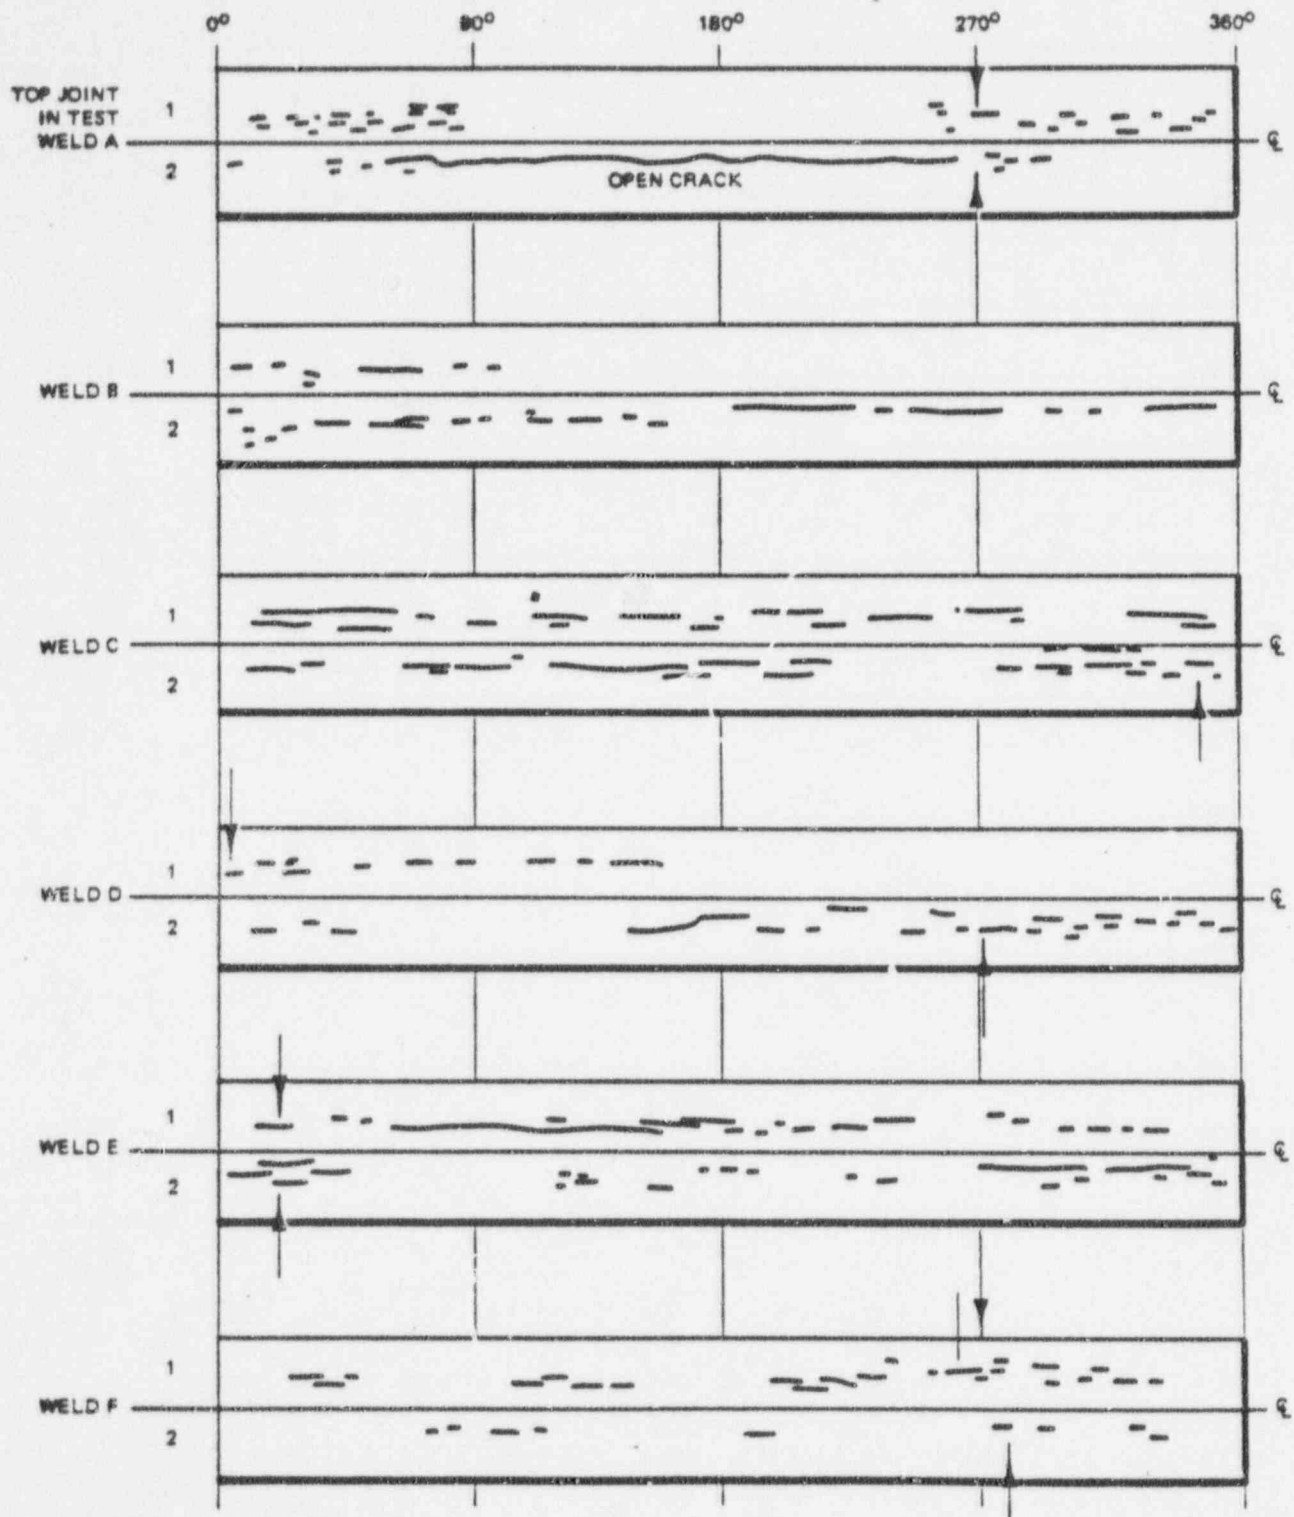
Figure I-2. Dye Penetrant Test Results (Lay-Out of Weld Joint I.D. Surfaces)

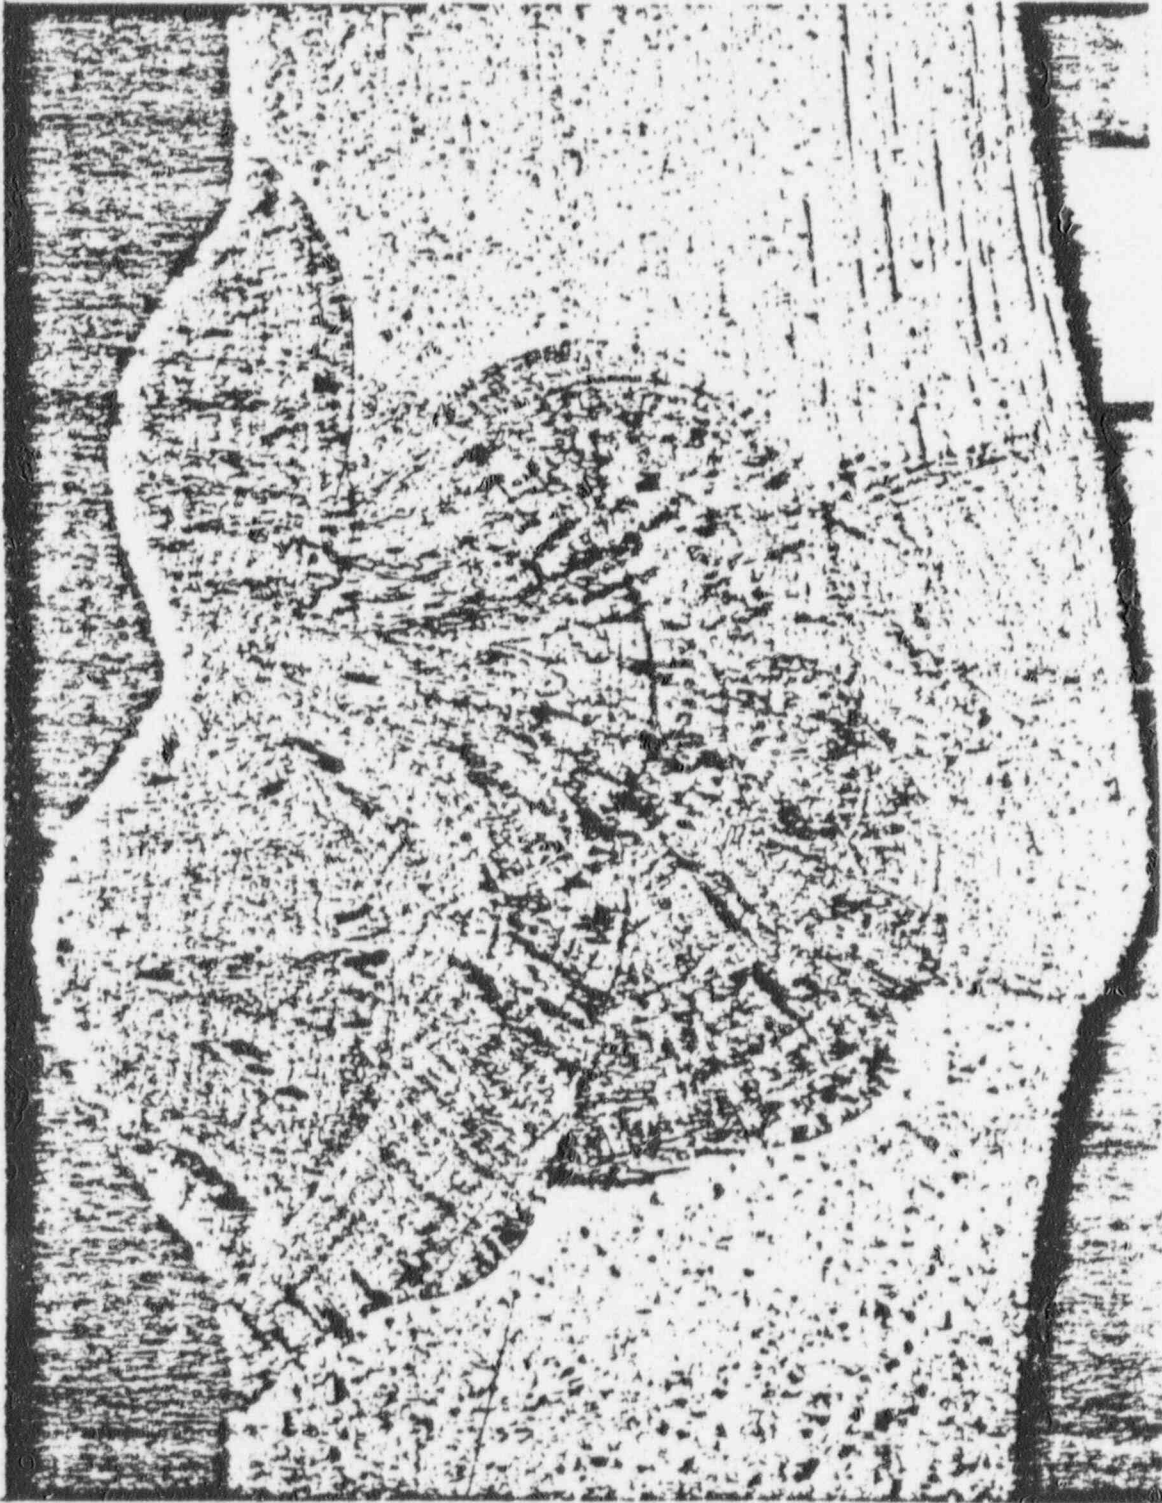
Figure J-10. 10.16-cm (4-in) Diameter Stainless Steel Butt Welded Pipe

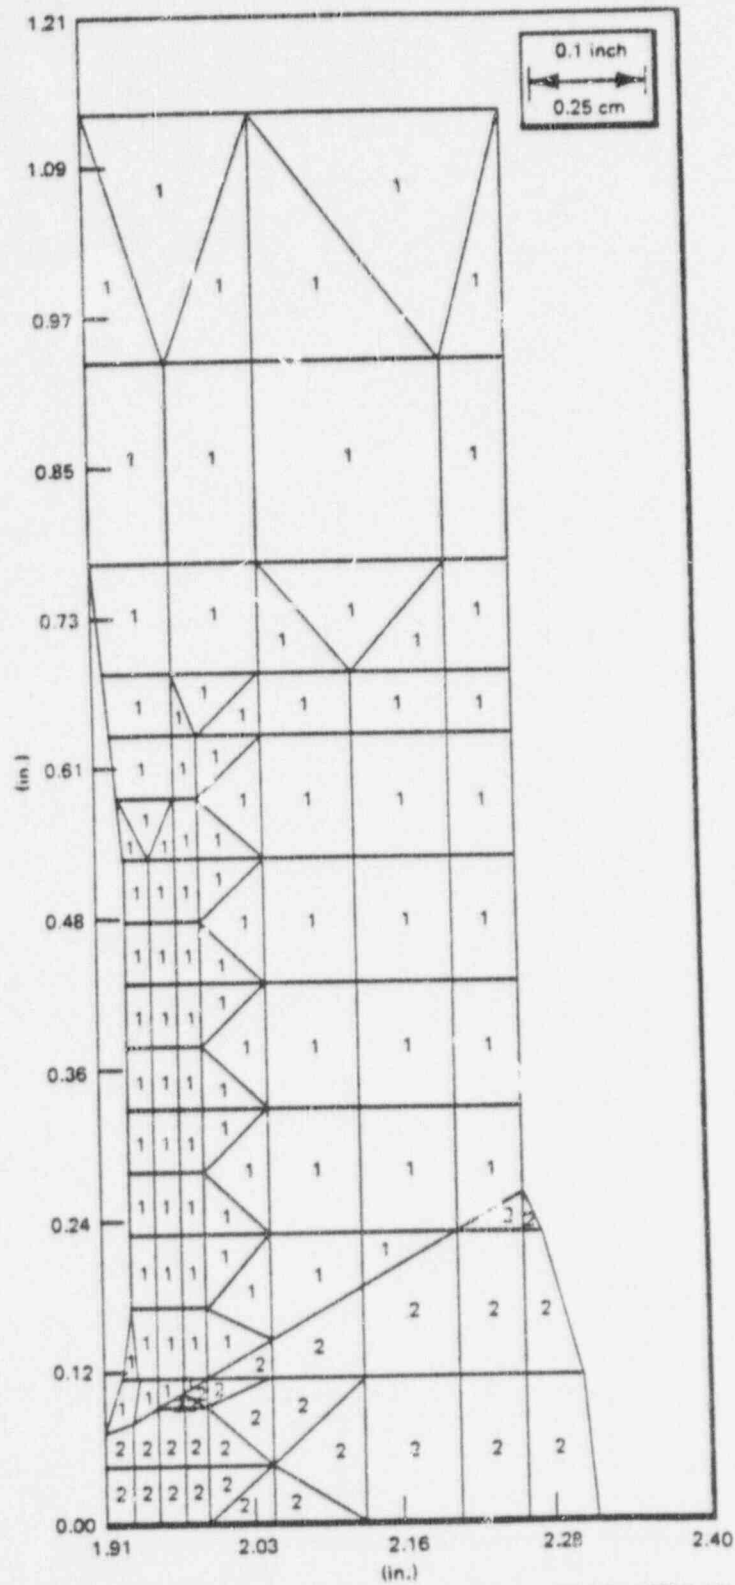
10.16 cm (4 in.) SCHEDULE 80 PIPE CONSTRAINT ELASTIC-PLASTIC ANALYSIS

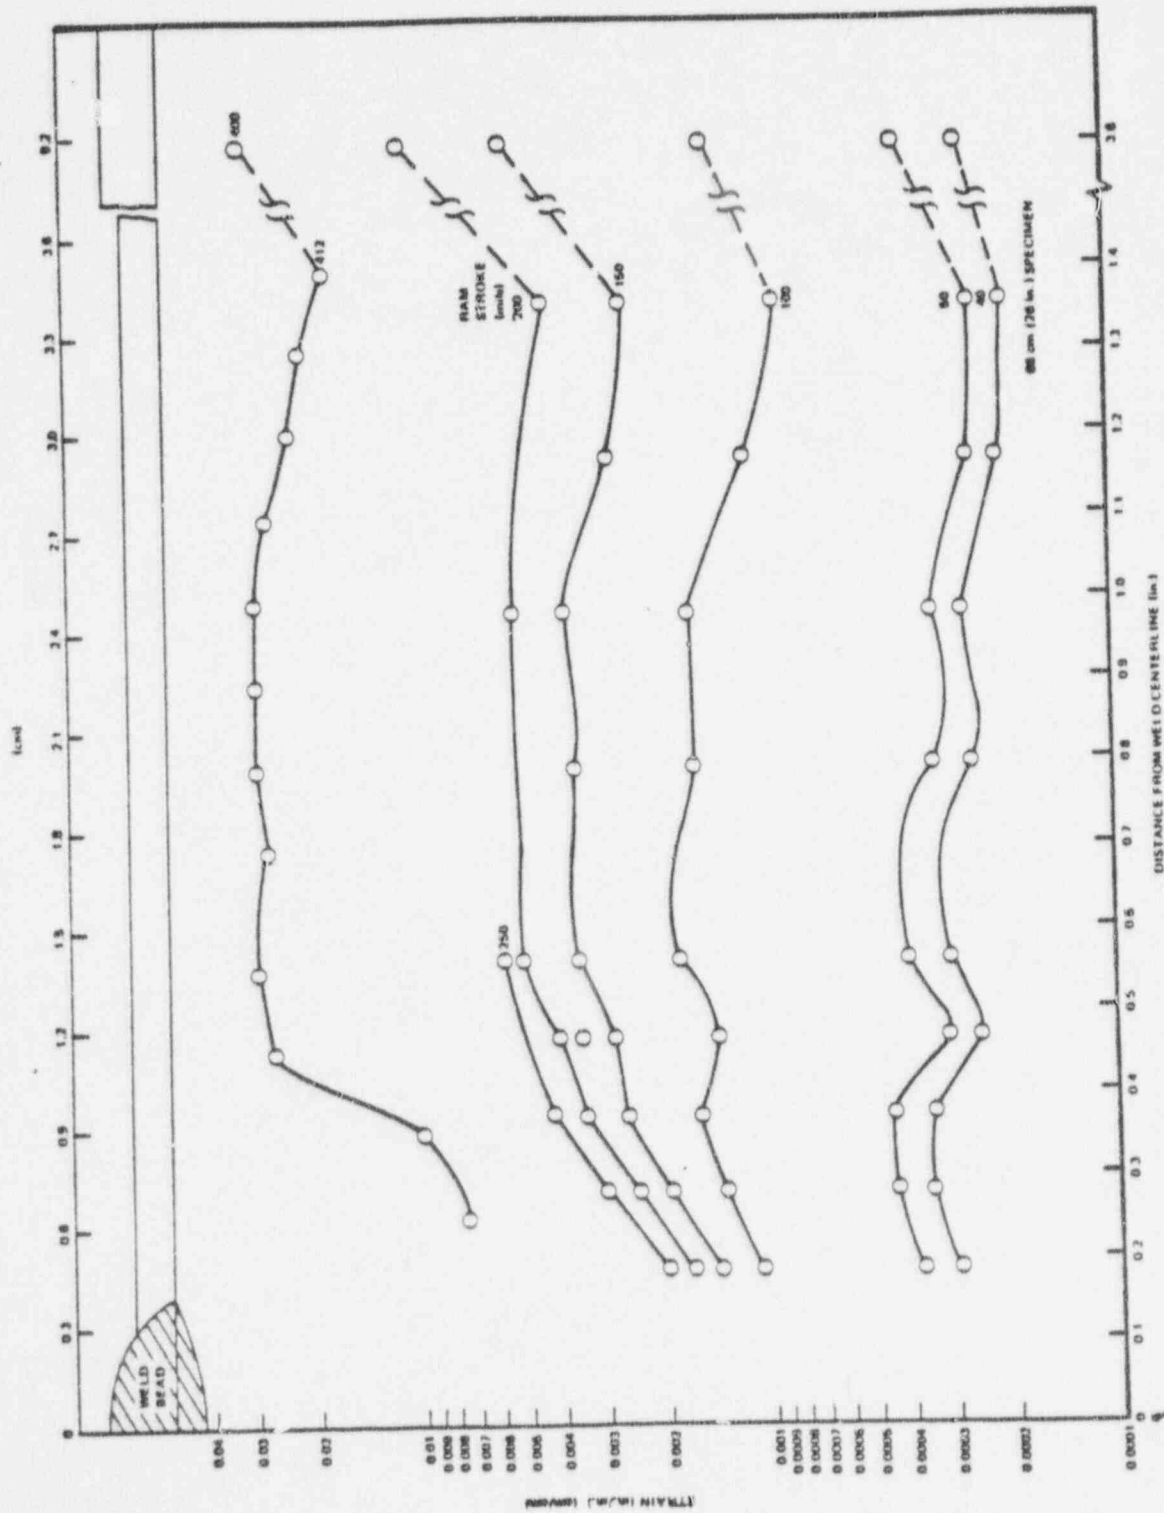
Figure K-26. Strain Versus Distance from Centerline of Weld Showing All the Strain Data from the Test for the 66-cm (26-in.) Pipe Specimen
