EVALUATION OF NEAR-TERM BWR PIPING REMEDIES

(Research Project 701-1)

Final Report

Nuclear Energy Engineering Division
General Electric Company
175 Curtner Avenue
San Jose, California 95125

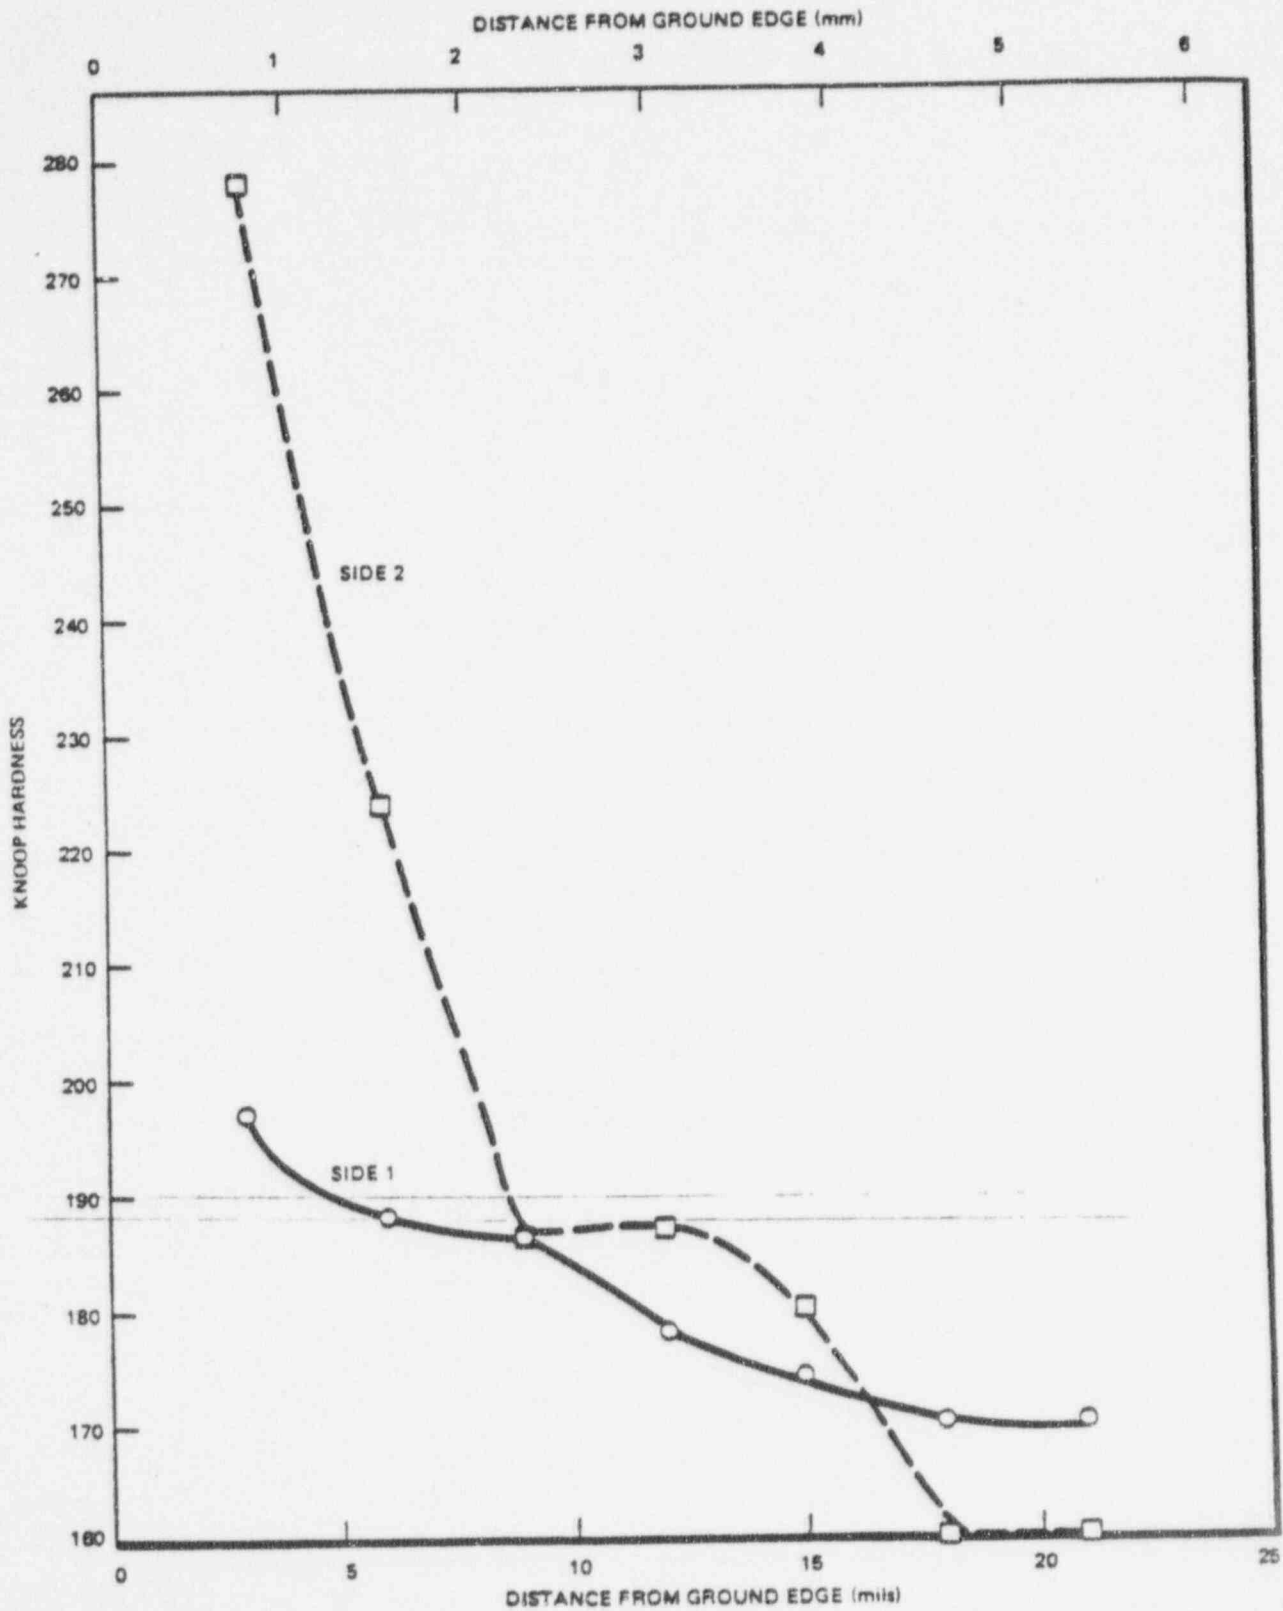
Figure L-2. Microhardness Profile for Specimen SG1, Heat Number M7616, 0% Strain

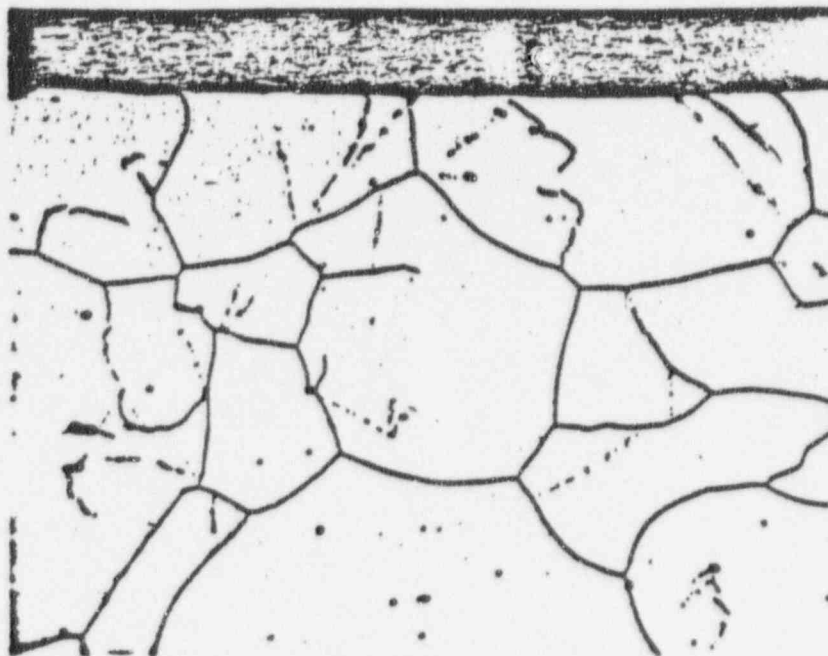
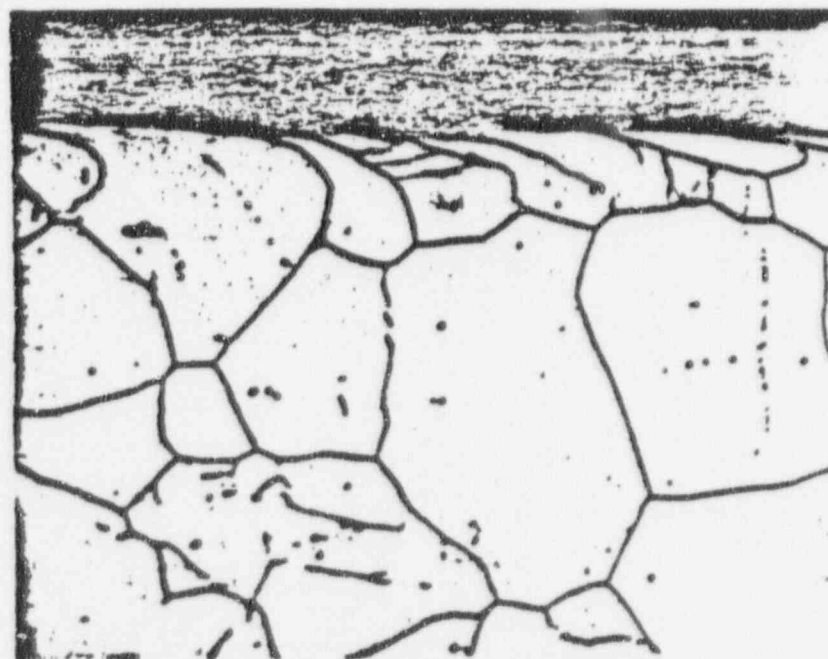
Figure L-4. SEM Micrograph of Specimen SG3 Sensitized, Ground, 5.1% Strain + 10 Cycles — Heat Number M7616

(a) TYPICAL GROUND SURFACE APPEARANCE

(b) SCATTERED AREAS WITH A HEAVIER COLD-WORKED SUBSURFACE

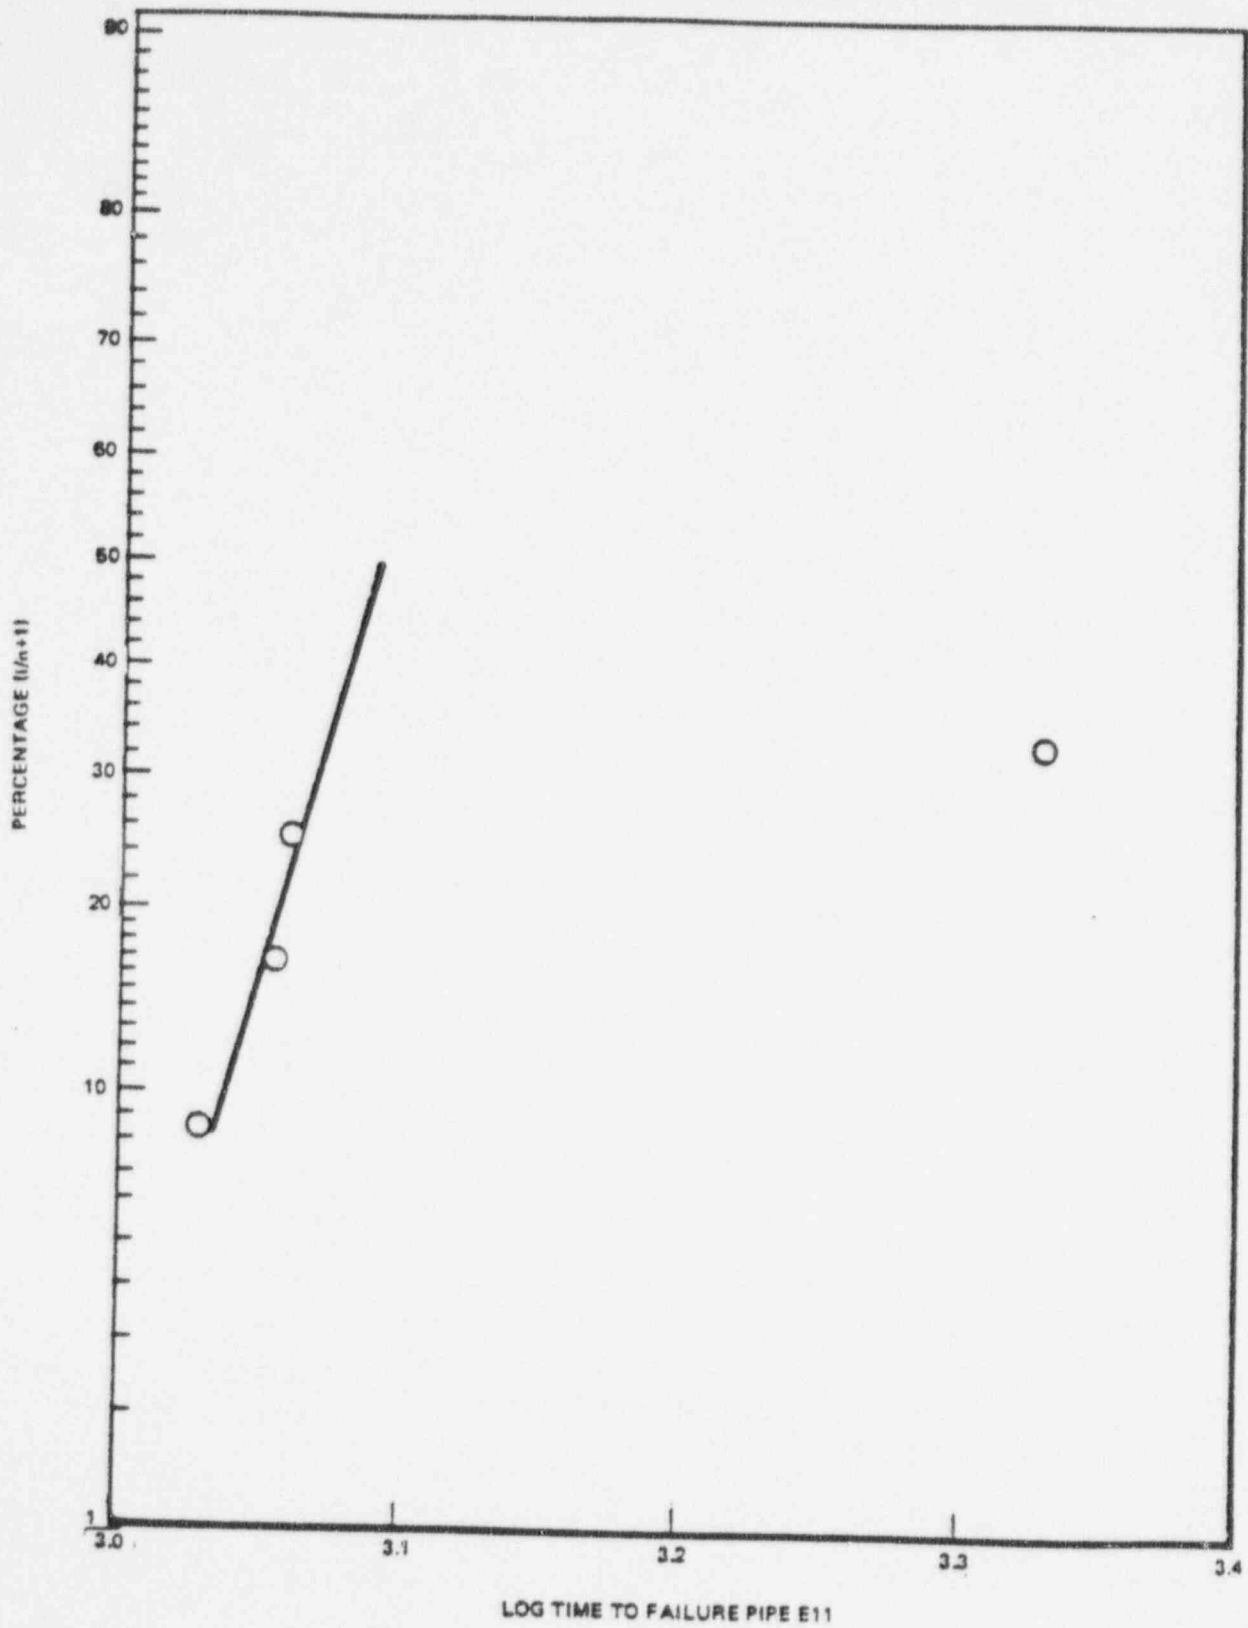
Figure M-1. Distribution of Failure Times in Pipe E11
