Draft Radiological and Engineering Assessment

Vicinity Property No. SLC 070

THE RADIOLOGICAL AND ENGINEERING ASSESSMENT

SALT LAKE CITY PROPERTY

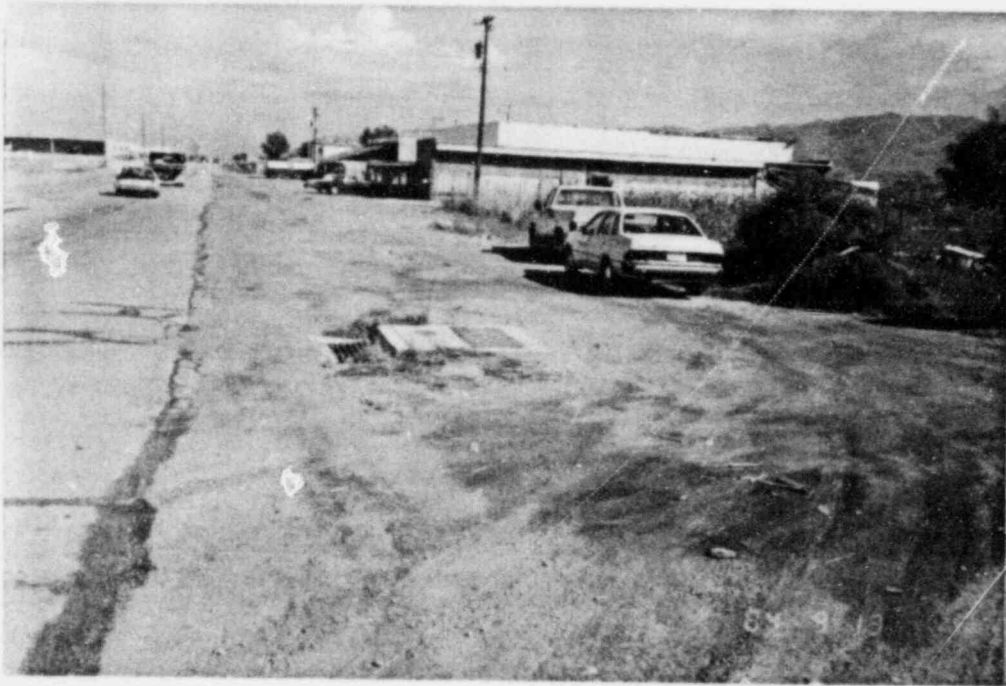
Southwest Corner of Property Looking North

The property is a vacant lot enclosed on three sides by a chain link fence and enclosed on the fourth side by a masonry building wall. The lot is surfaced with crushed stone and is used as a storage yard for construction materials and equipment.
