Draft Radiological and Engineering Assessment

Vicinity Property No. SLC 022

SALT LAKE CITY PROPERTY

March 13, 1985

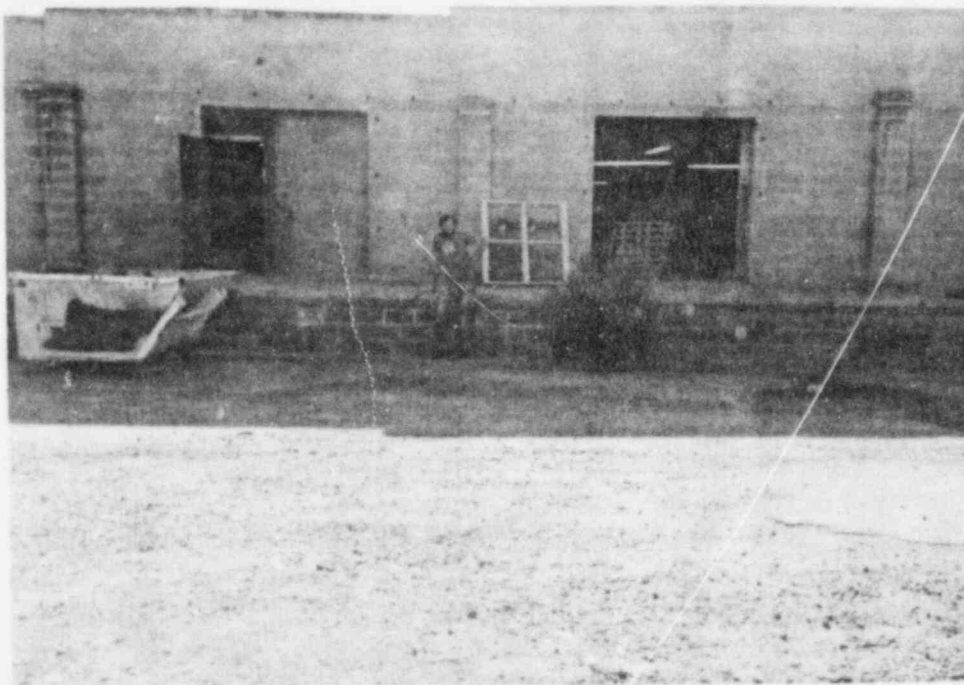
West Side of Property Looking East

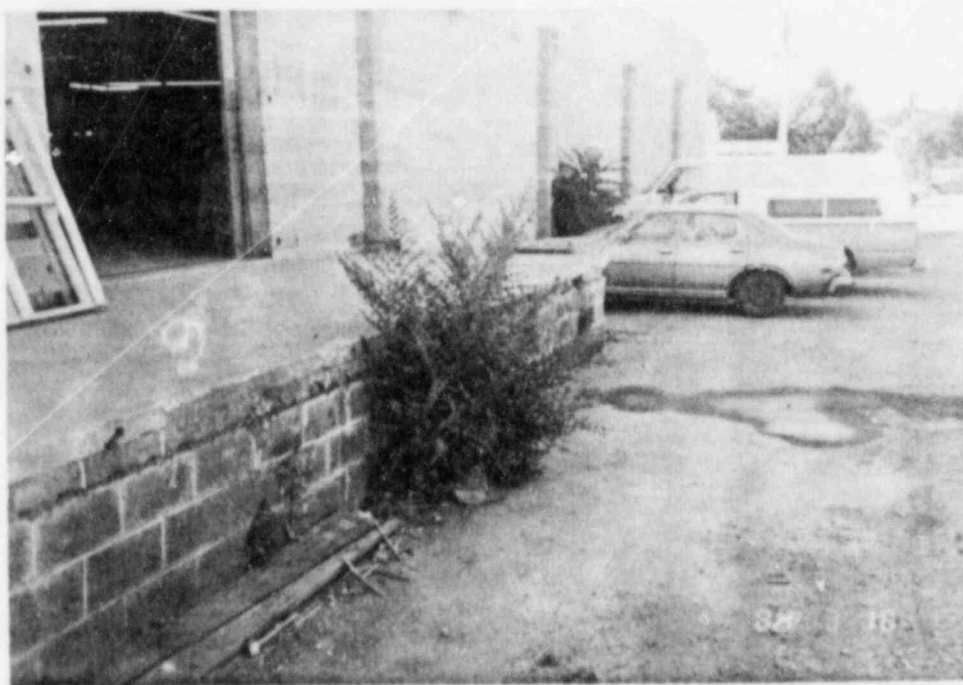
Figure 2.3 Property Photos

West Side of Property Looking South

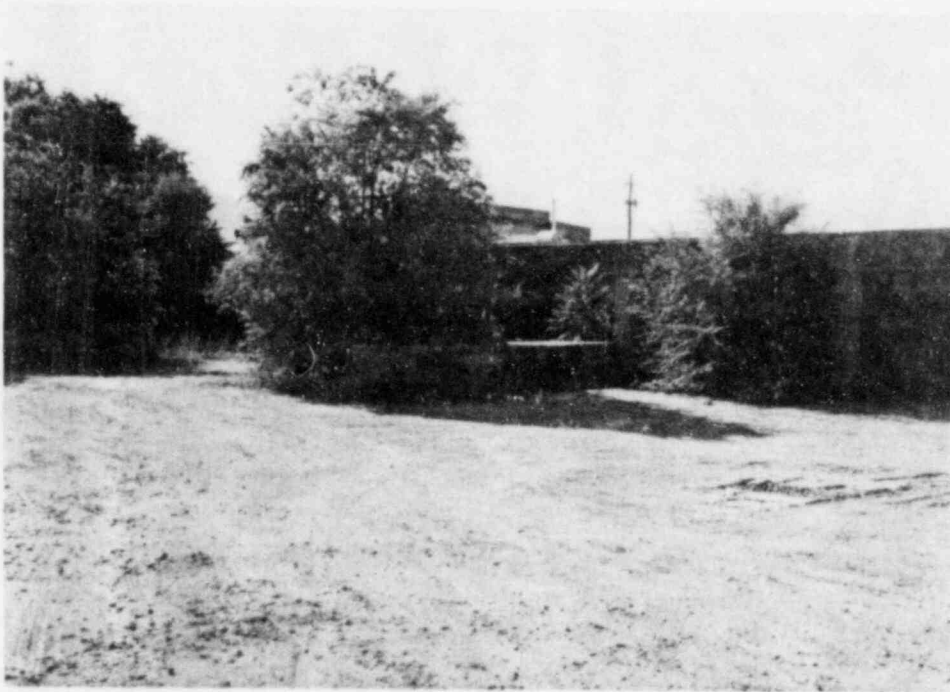
North Side of Property Looking Southeast

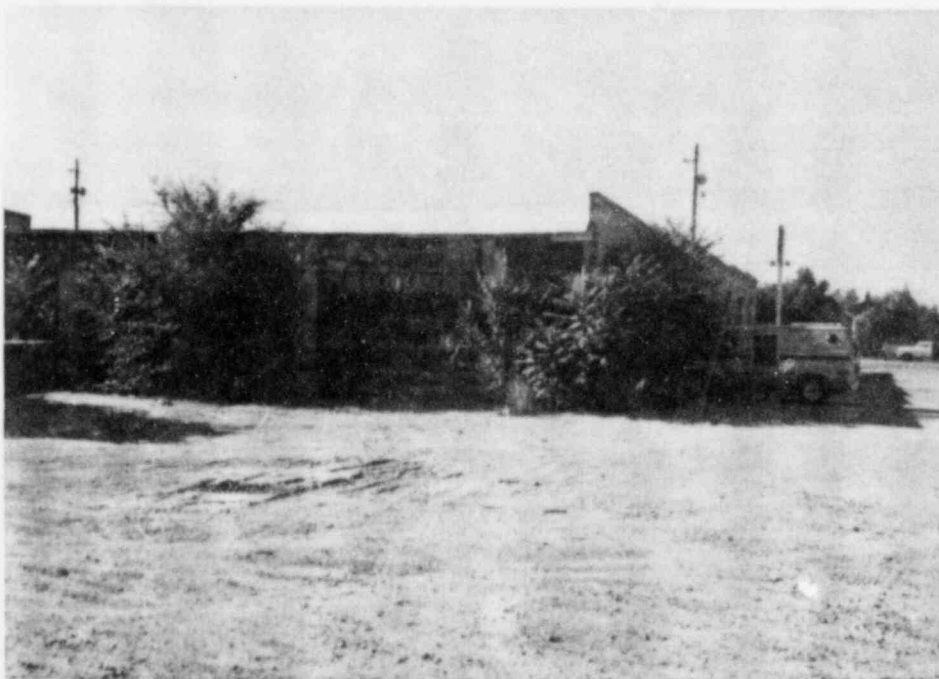
Figure 2.4 Property Photos

North Side of Property Looking South
