SUBJECT: GJPO Visit to the Recently Completed ARCO-Bluewater Title II Disposal Site

On September 24, 1996, C. S. Goodknight and M. P. Plessinger of MACTEC-ERS toured the ARCO-Bluewater Title II disposal site, at which reclamation was recently completed. After completing the site tour a close out meeting was held at the offices of AVM Environmental Services in nearby Grants, New Mexico, to discuss resolution of outstanding issues.

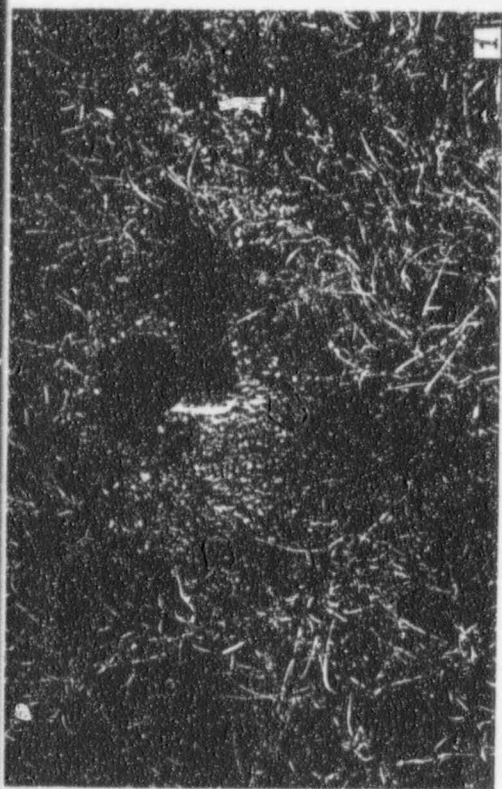
The site is in excellent condition at this time. Photographs and a photograph log are attached. Photograph number 1 shows a typical property boundary monument as installed by the land surveyor retained by ARCO to survey the final boundaries of the property to be transferred. The monument is equivalent to UMTRA-Title I boundary monument quality.

<u>Photo</u>	<u>Description</u>
1	Typical property boundary corner set at the southeast corner of the site property, RM Property Corner 22.
2	Panorama of top of main tailings pile, southwest corner, view northwest
3	Panorama of top of main tailings pile, southwest corner, view north
4	Panorama of top of main tailings pile, southwest corner, view northeast
5	Panorama of top of main tailings pile, southwest corner, view east-northeast
6	View southwest of thumb area of carbonate tailings pile from southwest corner of top of main tailings pile
7	View south of main carbonate tailings pile from southwest corner of top of main tailings pile
8	View west-southwest from survey marker ME-13 on top of hill of San Andres Limestone toward the main tailings pile (right) and the carbonate tailings pile (left)
9	View south from U.S. Coast and Geodetic Survey marker on top of hill of San Andres Limestone toward utility rights-of-ways and electric power substation

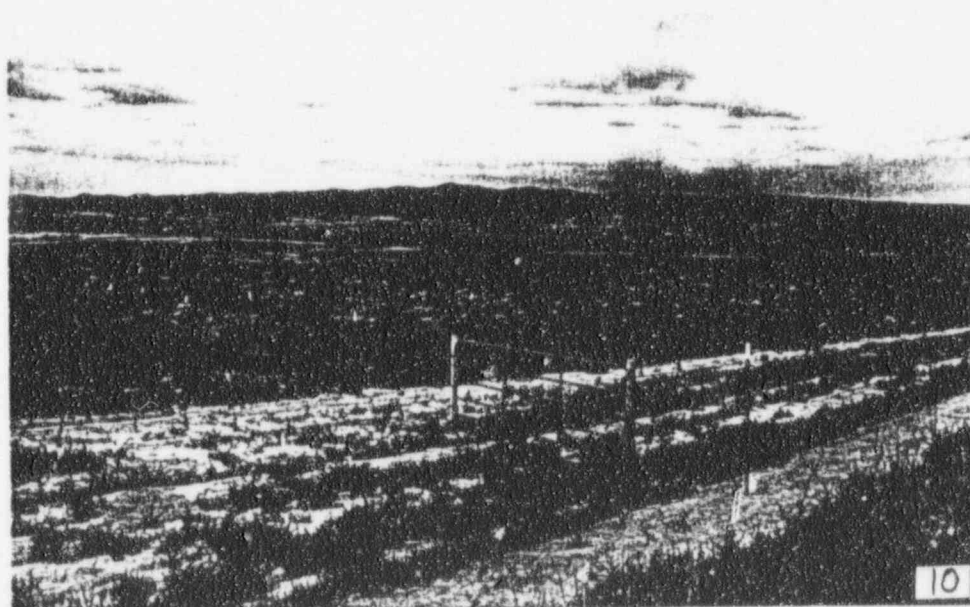
Photographs 6 and 7 show the carbonate tailings disposal area as seen from the top of the main tailings cell. Photograph 8 is a view from east of the tailings disposal cells. In photograph 9, an electric substation and some of the utility rights-of-way on the site can be seen. Photograph 10 shows a typical gate arrangement for accessing a utility right-of-way from the site perimeter road.

10	View southwest from utility right-of-way of gate along site perimeter road and main tailings pile about 1.2 miles in distance
11	View east along site boundary fence and perimeter road in east part of site of high level of ephemeral lake (highest in 15 to 20 years) caused by heavy August and September rains

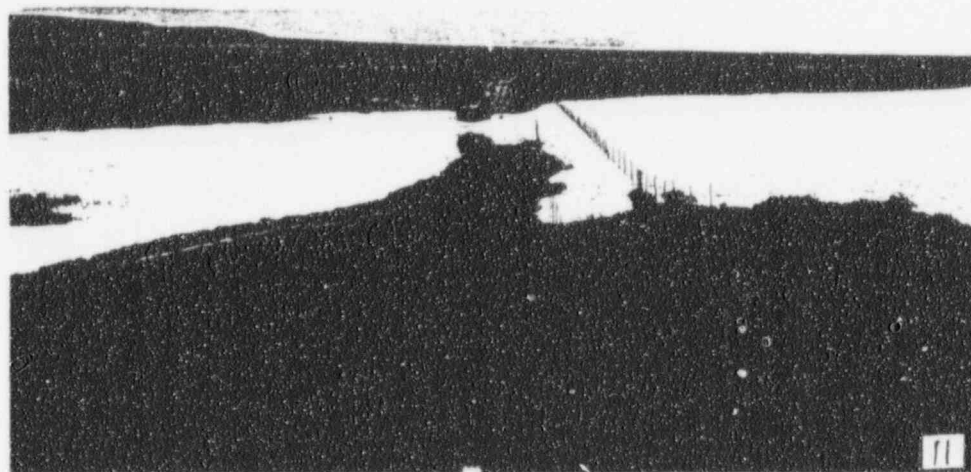
Photograph 11 shows an ephemeral lake that has overtopped the site perimeter road in the east part of the site. It had been an abnormally rainy summer and this lake was reported to be at its highest level in 15 or 20 years.
