RE: Bluewater Mill Site Reclamation Completion Report Comments
License No. SUA-1470, Docket No. 40-8902

Response to NRC's Comments

ADDENDUM 1
RESPONSE TO NRC COMMENTS

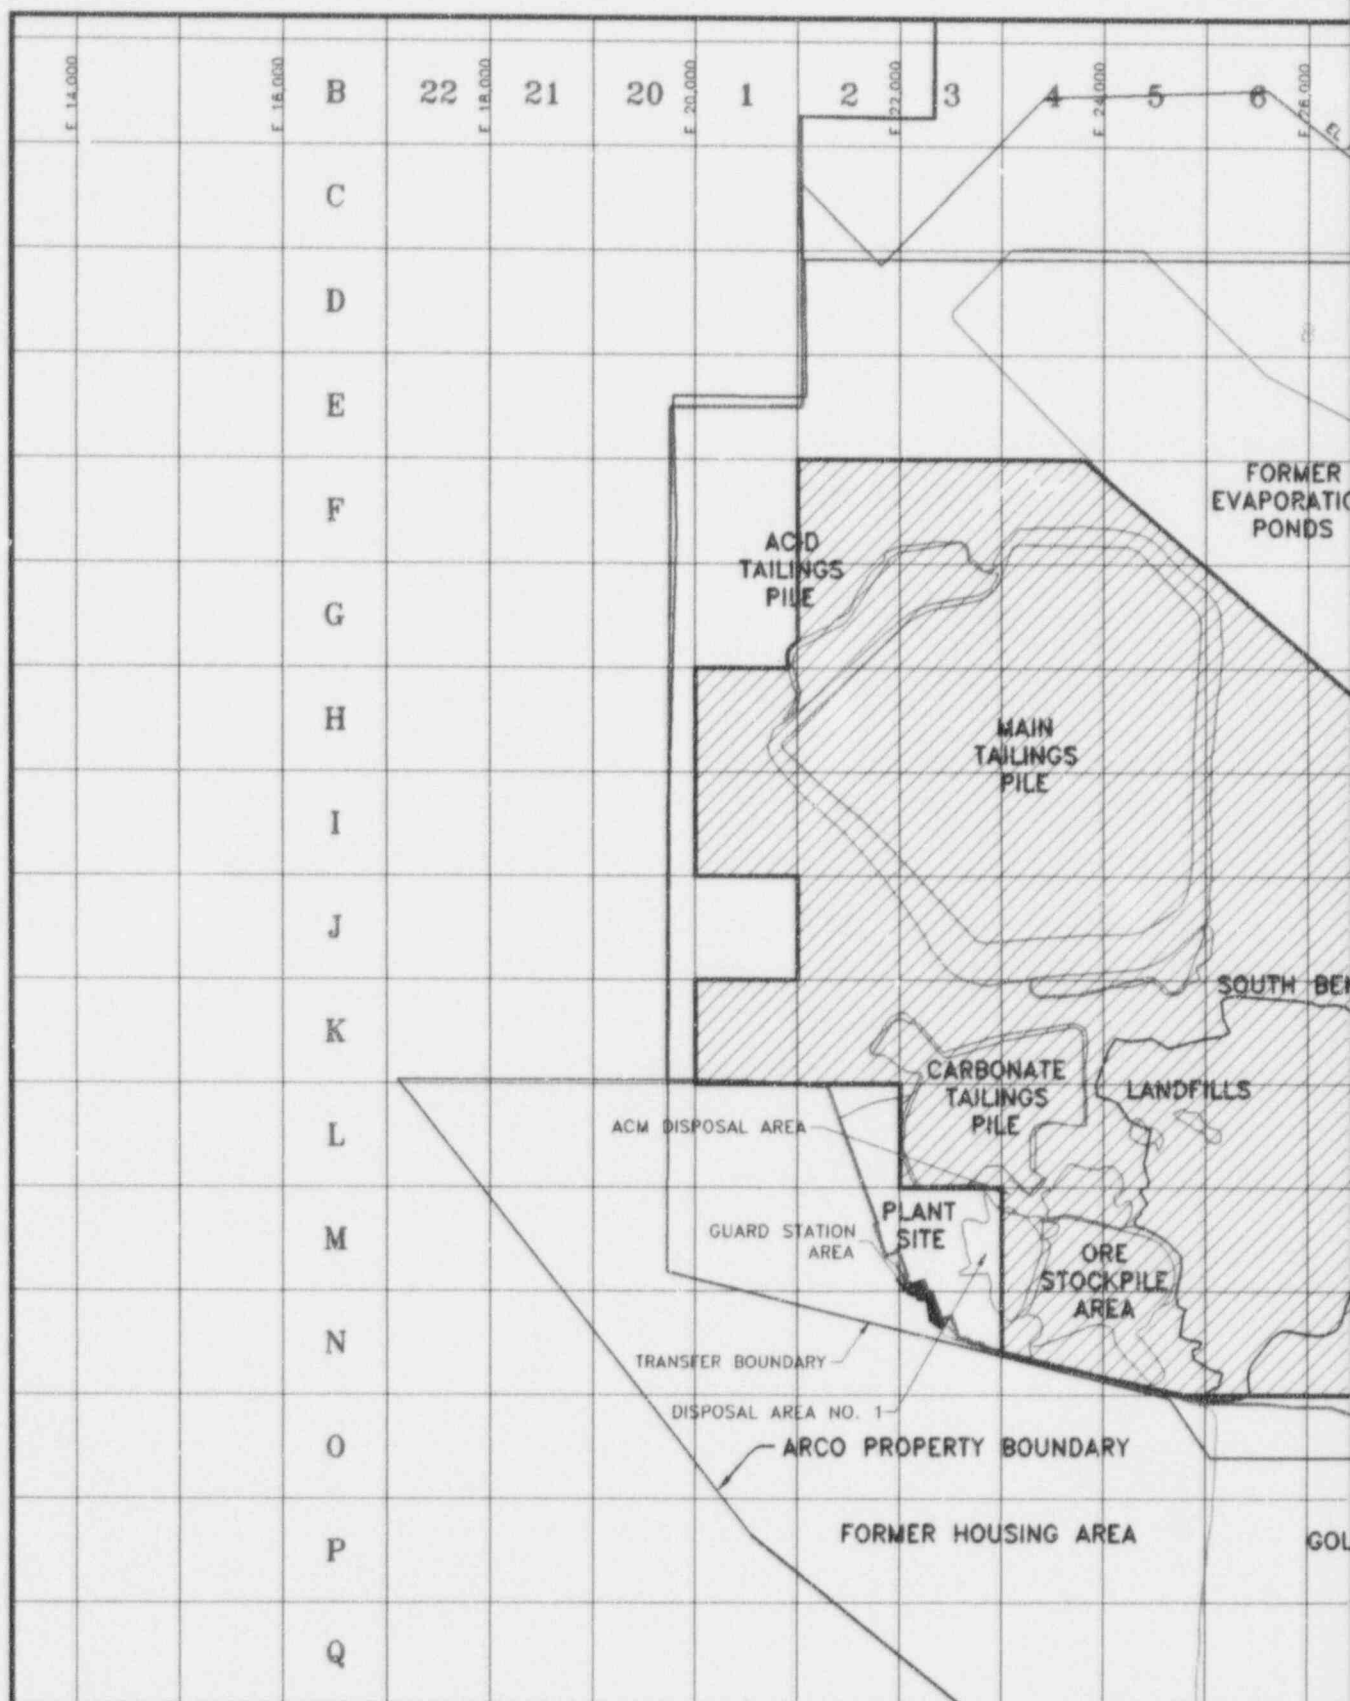
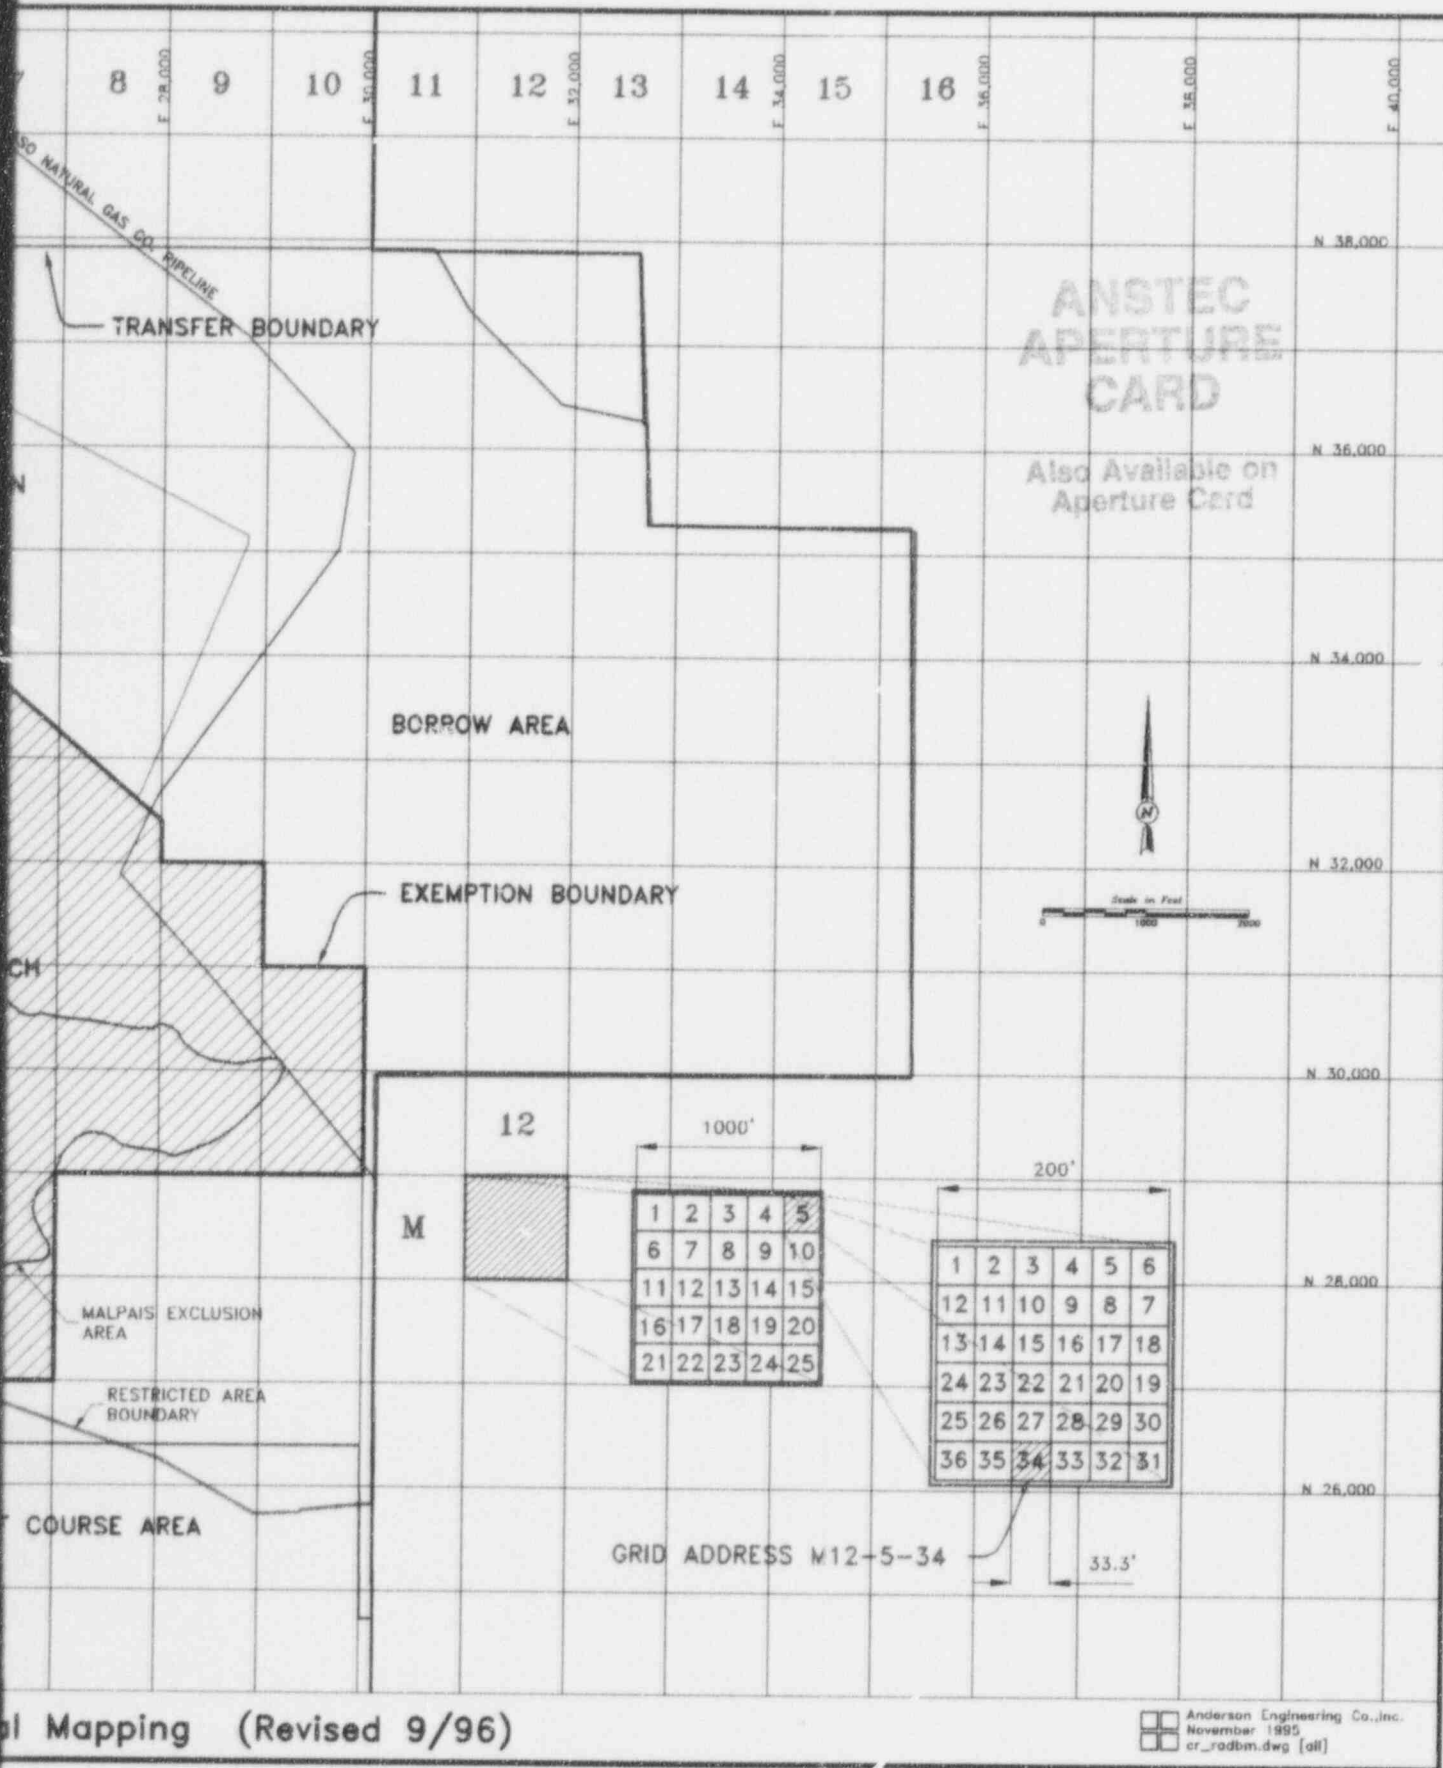
Figure 6-1 Area Features and Grid Block Nomenclature for Radiologic

Explain why there are gamma readings where part of the Plant Site Disposal Cell should be (refer to Figure 6-1).

Prior to placement of the cover on the Plant Site Disposal Cell, excavation was conducted in areas near the western edges of the Cell. The gamma survey for cleanup verification was conducted to complete the entire grids which may have overlapped the excavated area and the Plant Site Disposal Cell. Nevertheless, the survey indicates the excavated area meets the cleanup level.

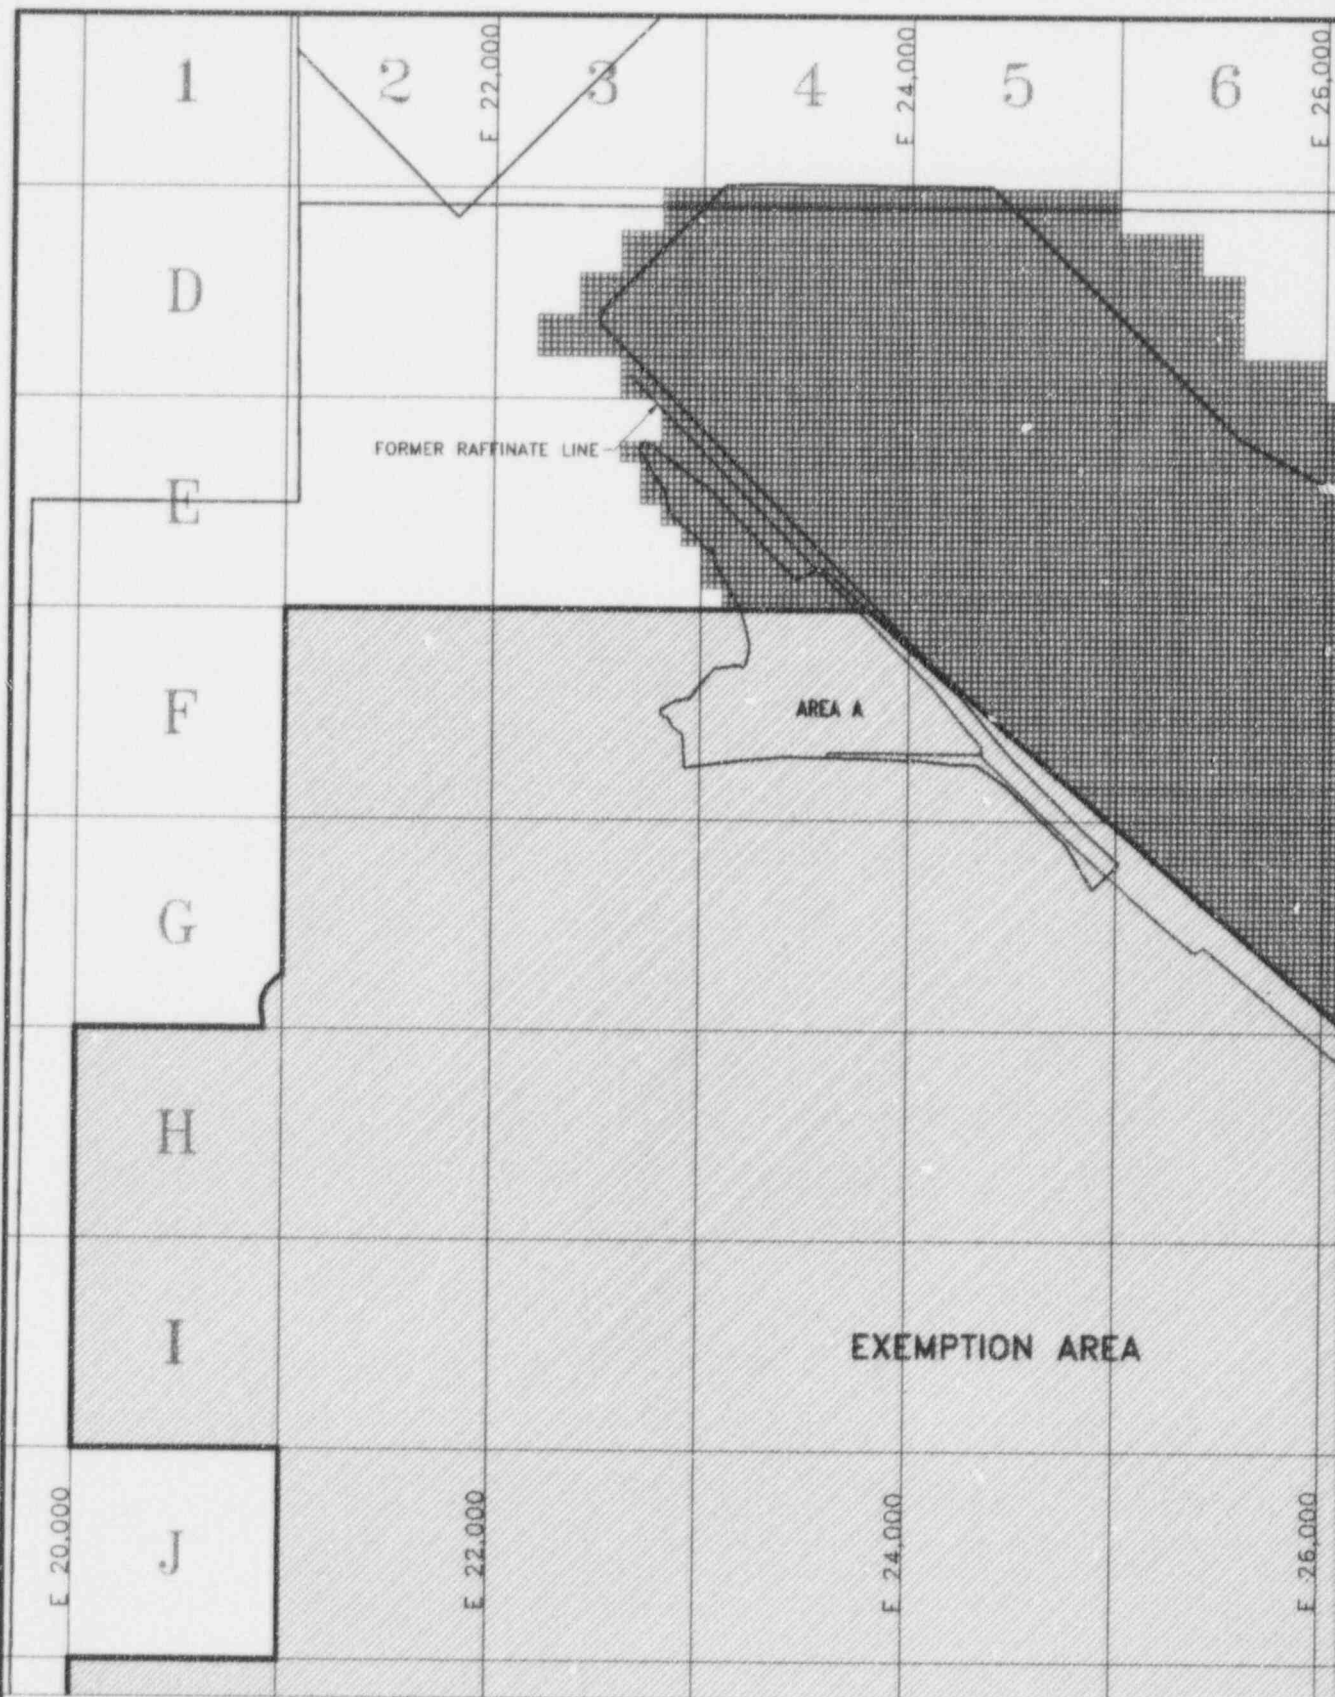
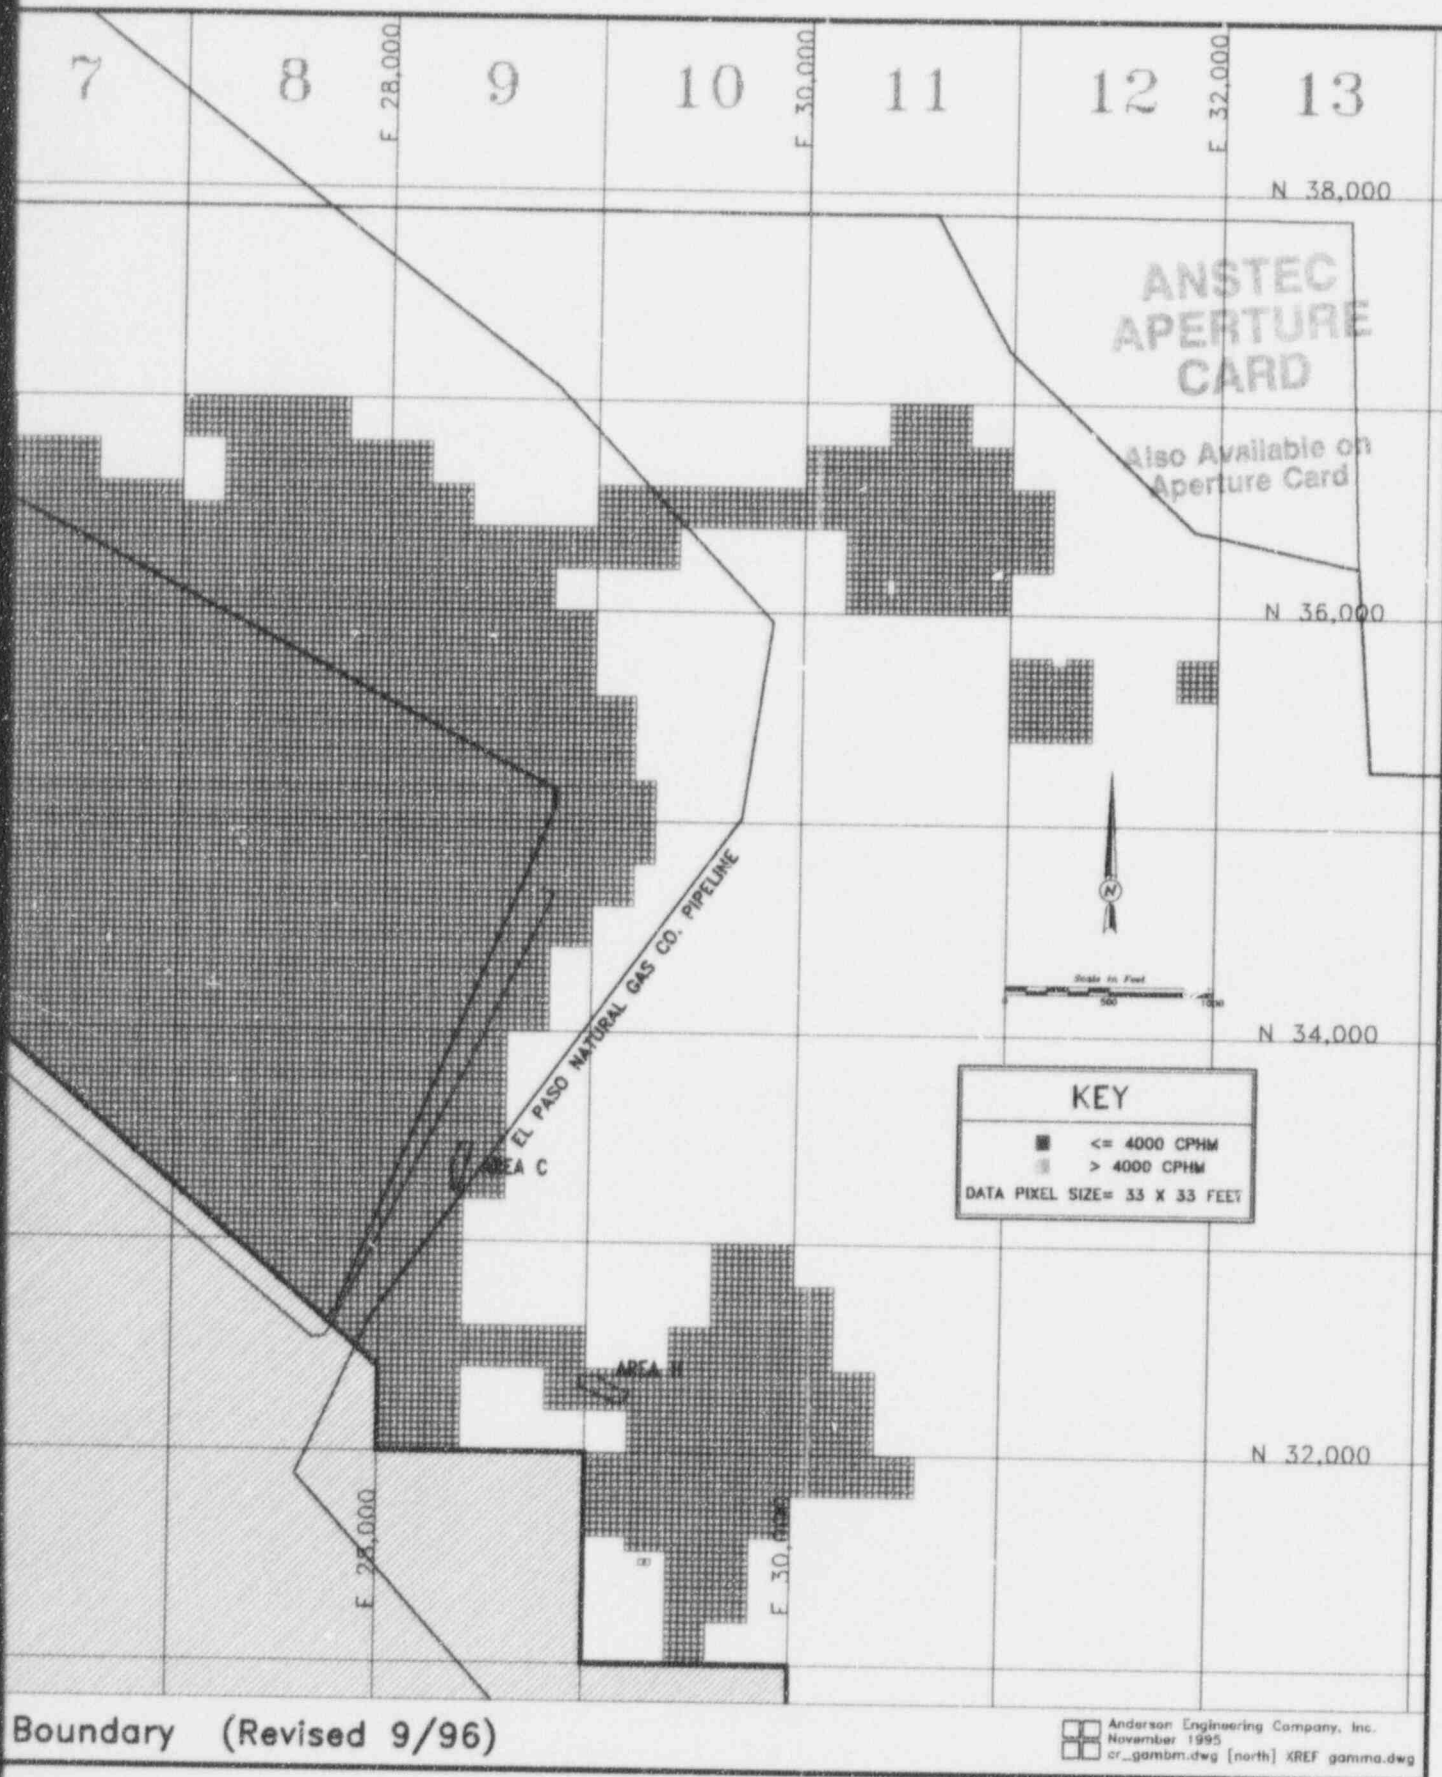
Figure 6-3 Gamma-Ray Count Rate Measurements North of Exemption

Figure 6-4 is missing Ra-226 data symbol for grids in block F12 and Ra-226 data is not in Appendix J, but gamma data is presented on Figure 6-3. ARCO should explain if this area was excavated.

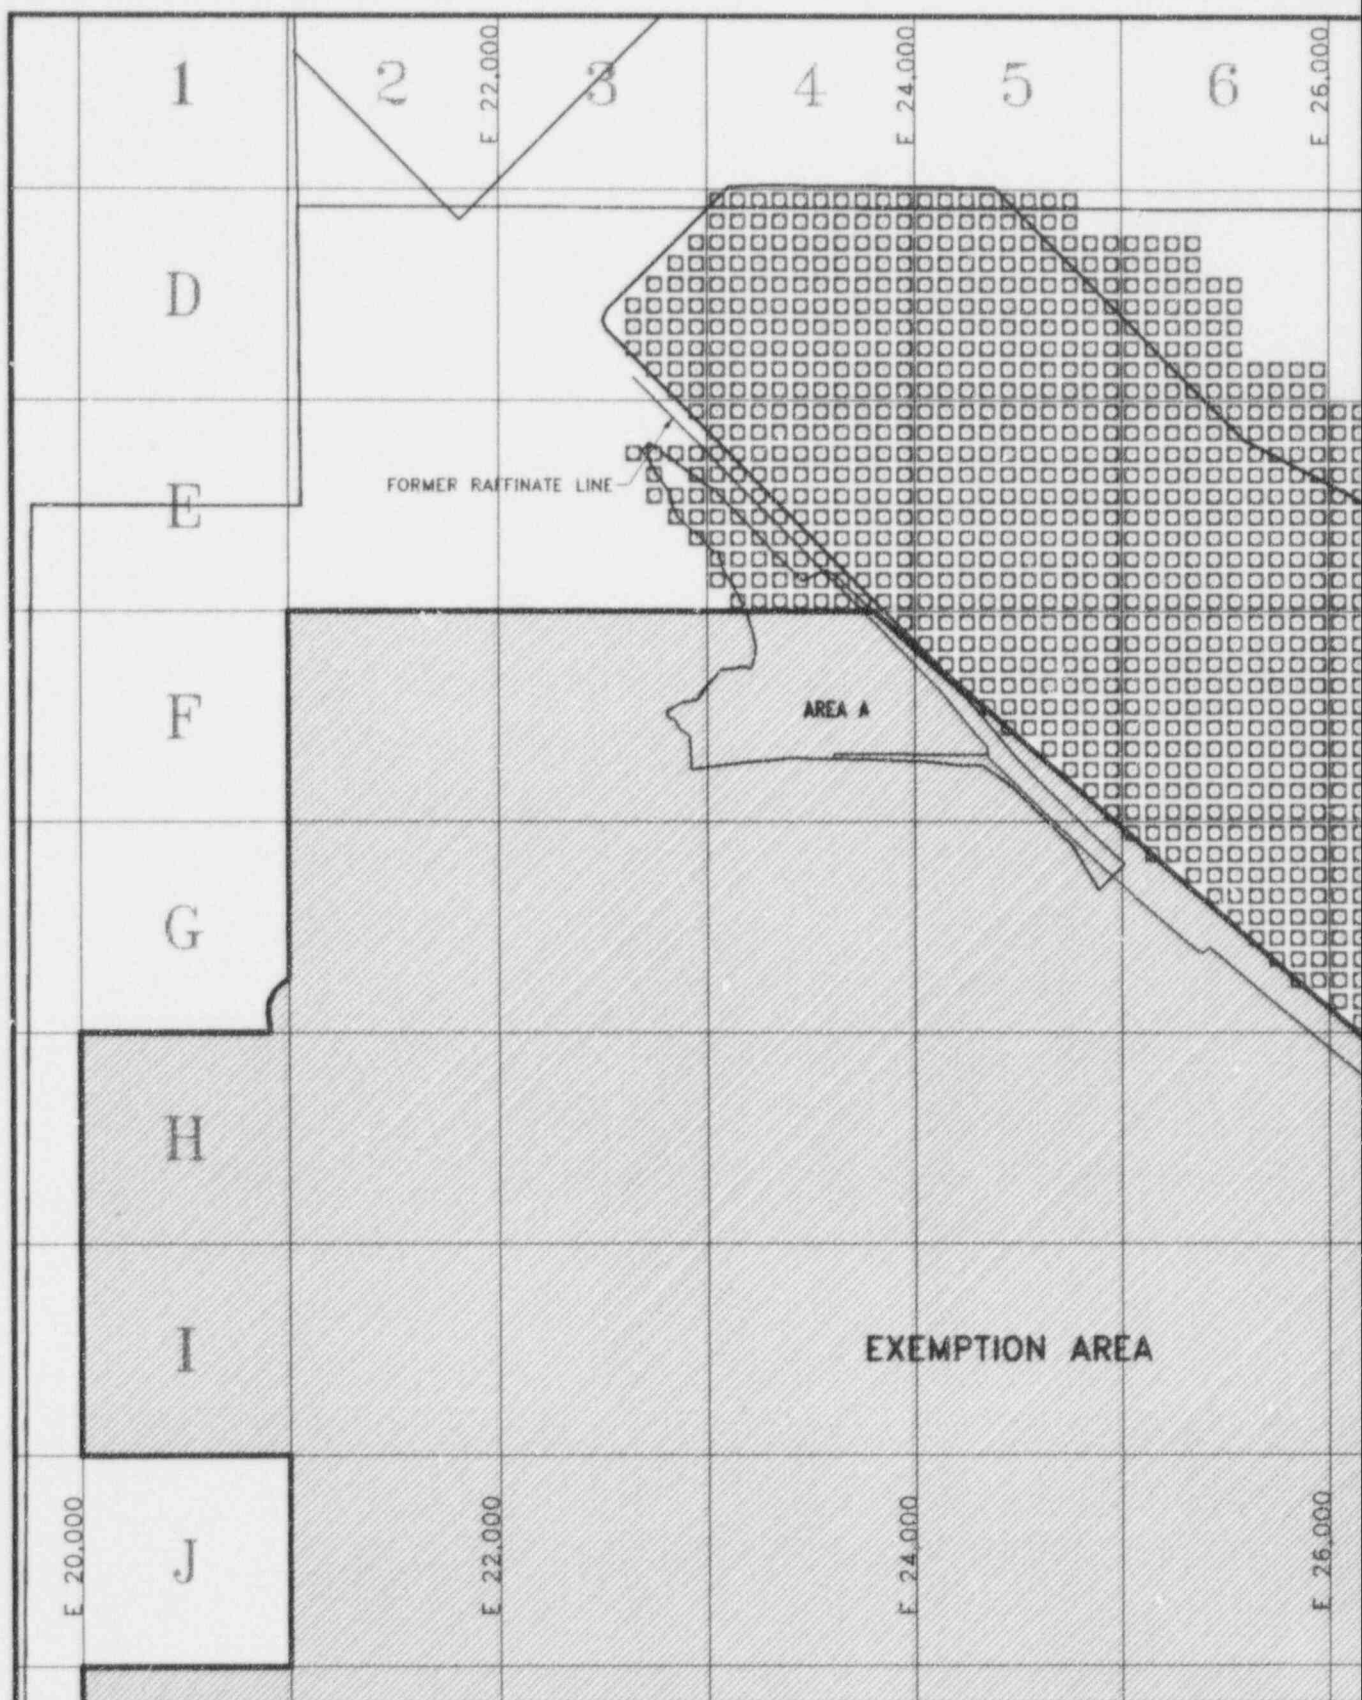
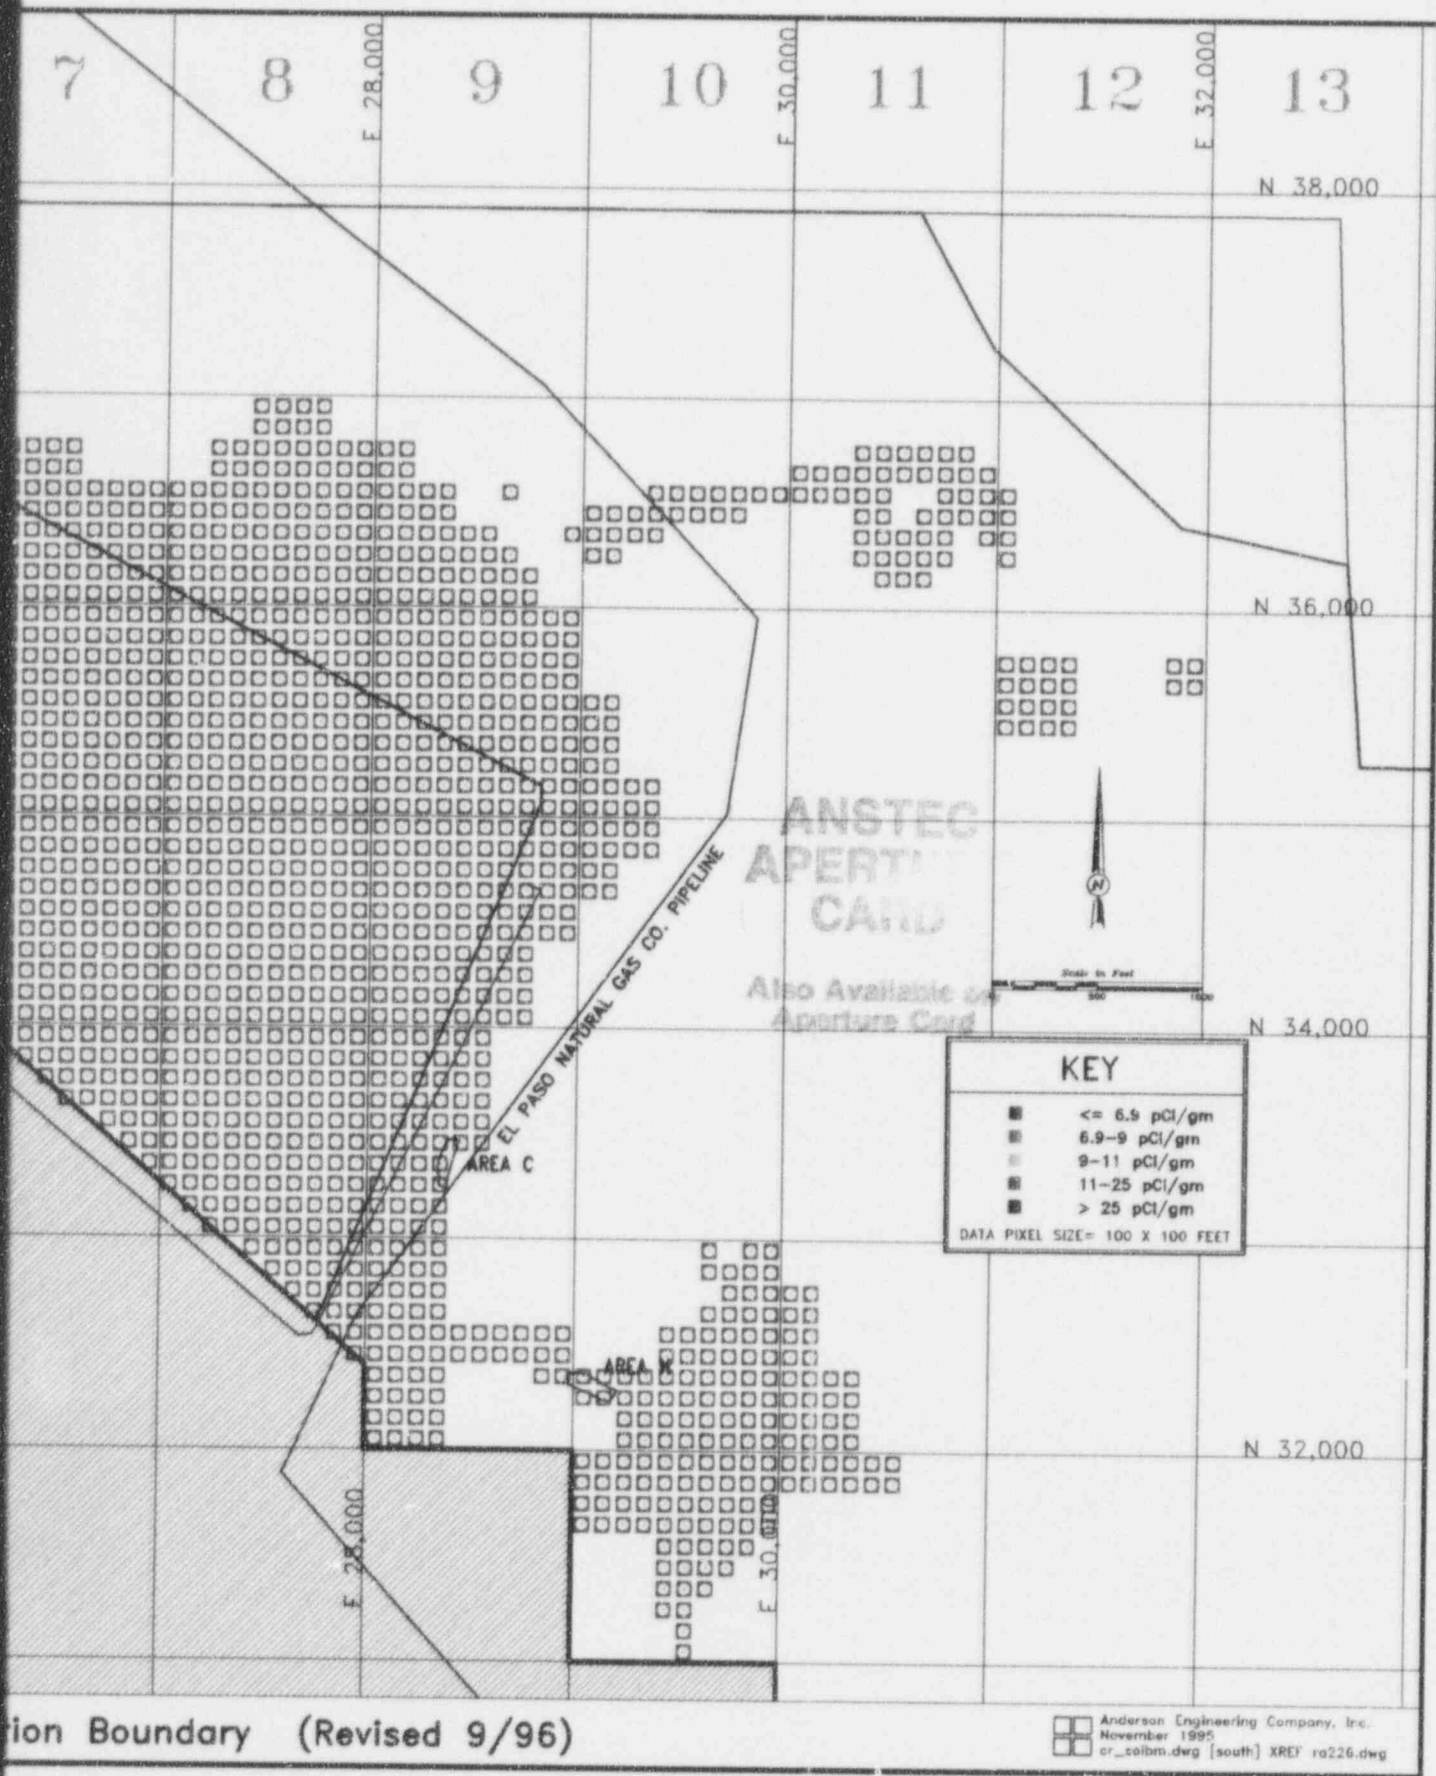
Figure 6-4 Ra226 Concentration in Soil Samples taken North of Exem

Soil samples were collected in August 1996 at locations where Ra-226 data symbols were missing but gamma data was presented in grid block F12. This was one of the excavated areas and soil sampling was inadvertently missed. Figure 6-4 has been revised to incorporate the data and is included in Attachment 1. In addition, soil sample results for Ra-226 are included in Attachment 2 for inclusion in Appendix J of the CR.

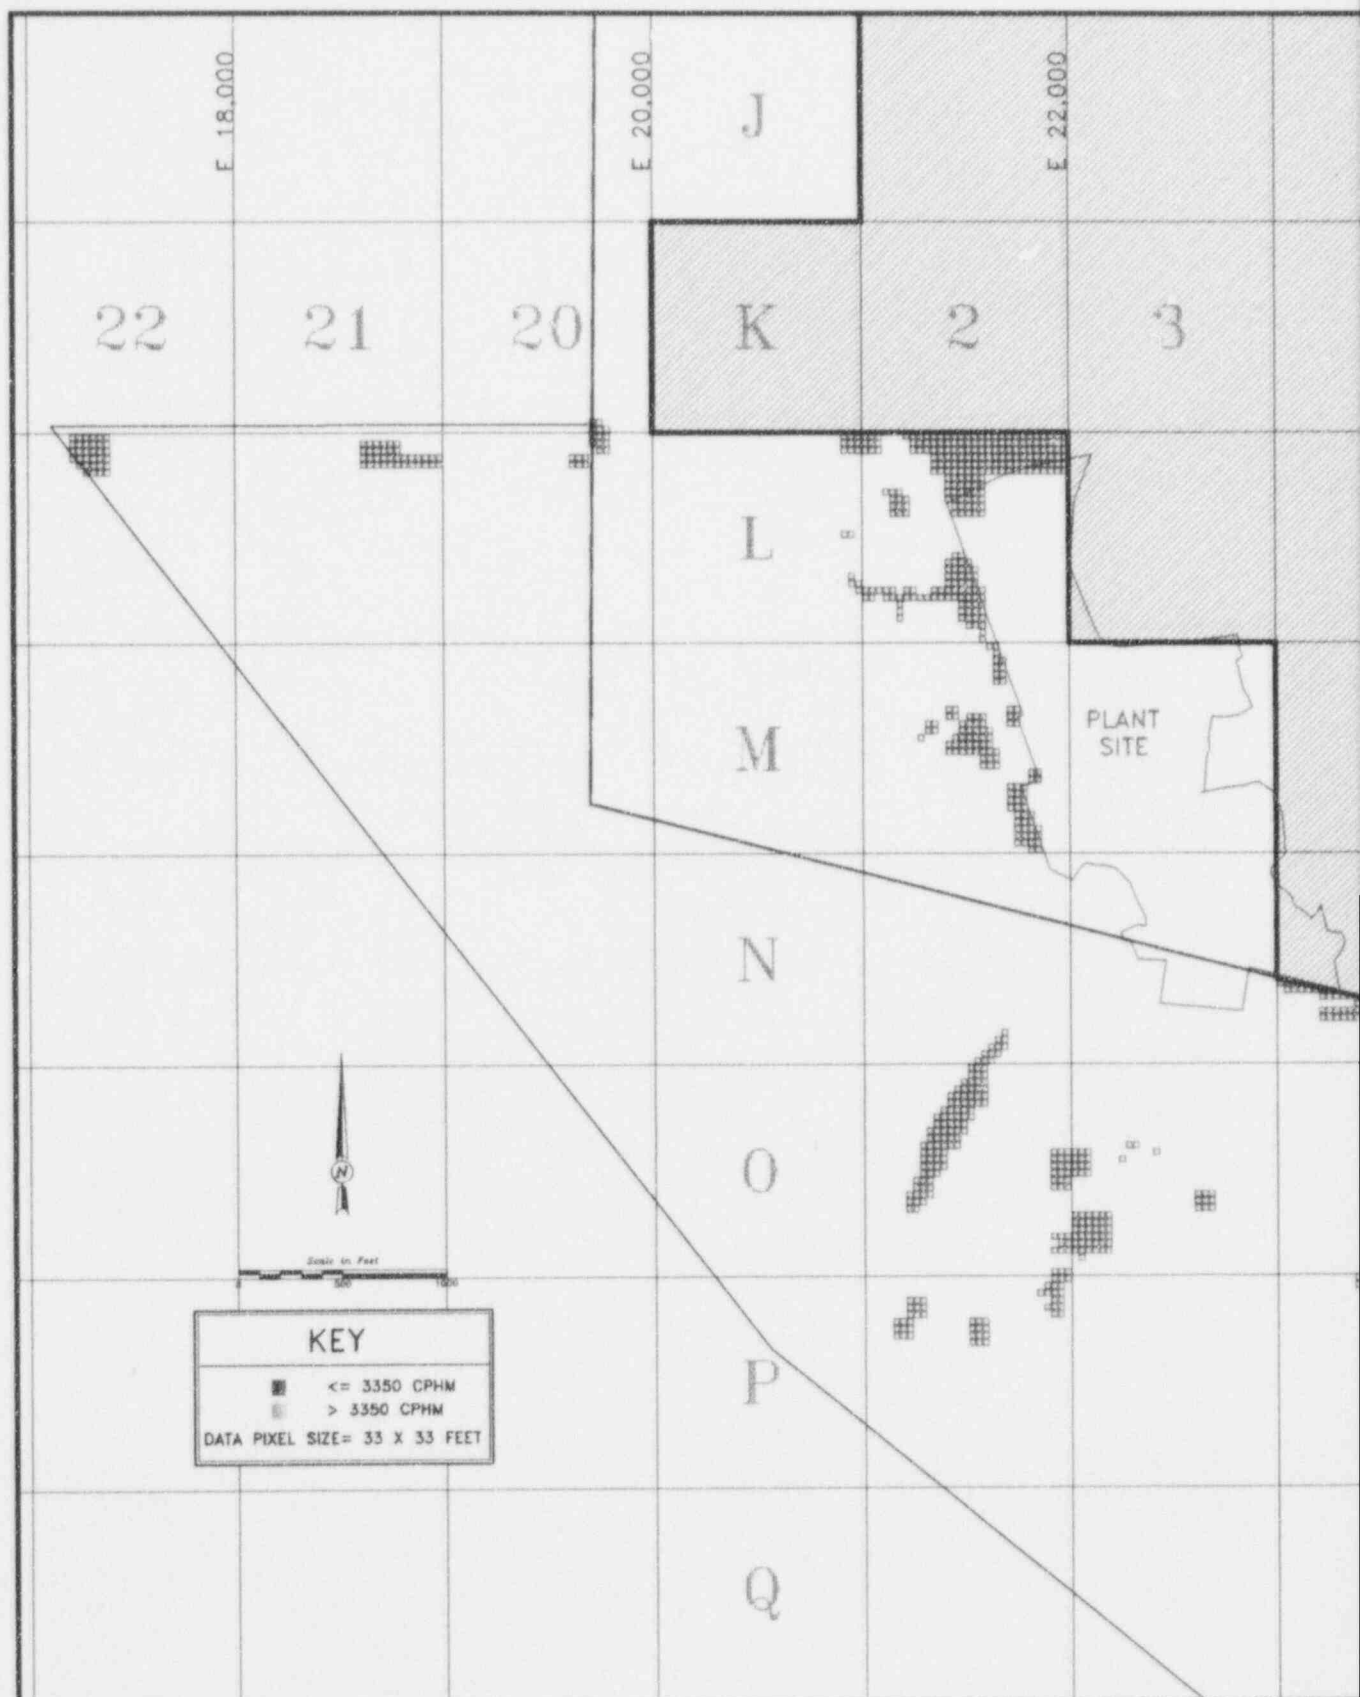
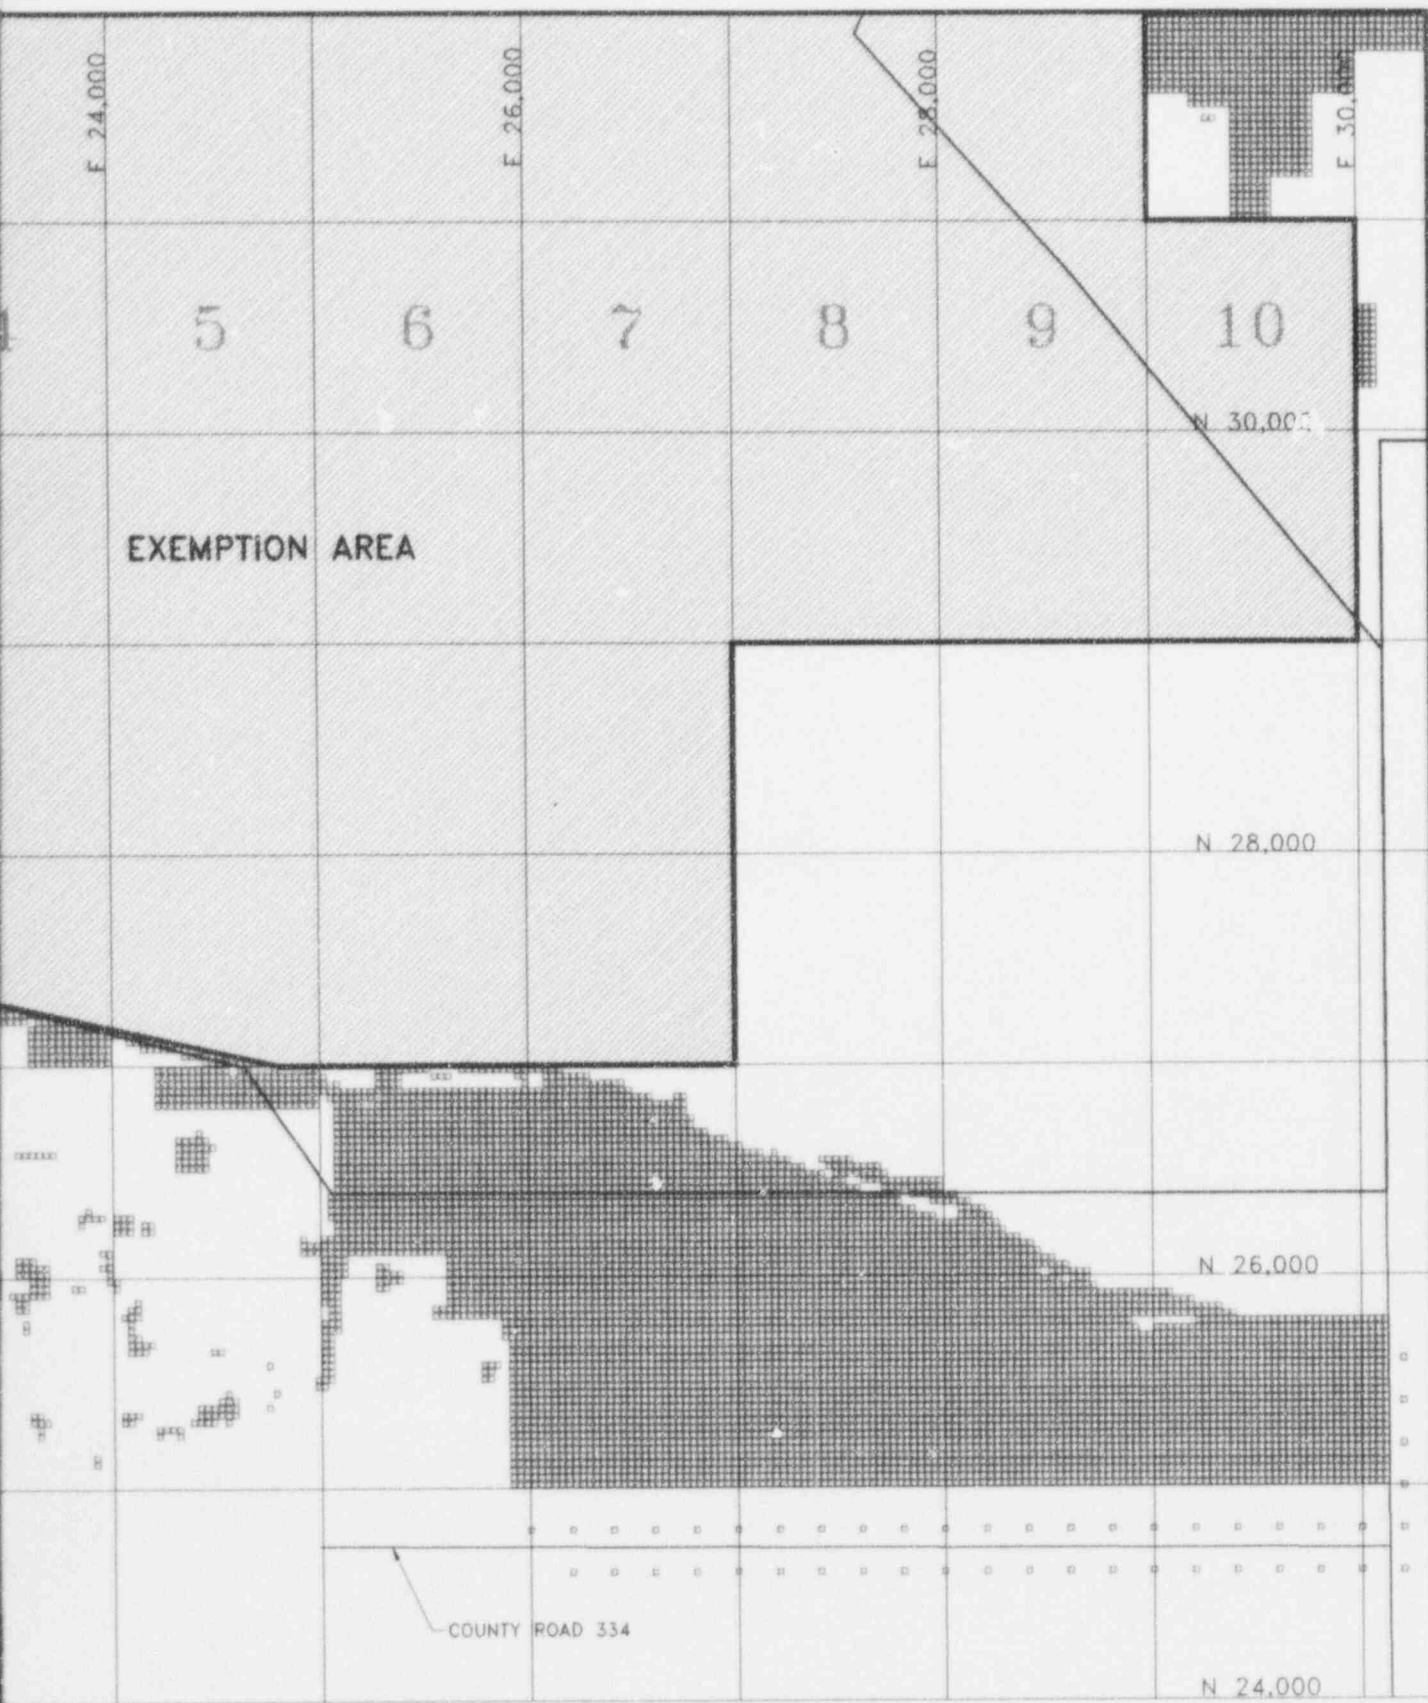
Figure 6-5 Gamma-Ray Count Rate Measurements South of Exemption

The gamma data represented by color ranges on Figure 6-5 shows 12 grid blocks that exceeded the 3350 cphm gamma-ray action level. Those areas near the intersection of Grid Blocks N5 and O5, large piles of lava flow, exhibited elevated gamma count rates while not having any soil to sample. Other areas were sampled and found to meet the Ra-226 cleanup criteria.

The grid gamma readings stop abruptly at the Q block row. Indicate why there aren't readings for every 1000-foot grid (unaffected area, Figure 6-7) to demonstrate that no removal was necessary. The restricted area boundary is not a sufficient reason for lack of data.

Where gamma readings stopped at the Q block row is the southern edge of the golf course area. Gamma radiation surveys were conducted to characterize the golf course area as it was determined affected during the later stages of the Site reclamation. Isolated pockets of tailings material were identified in the golf course area, which appeared to be the result of golf course

construction activity by man, rather than windblown tailings contamination. Therefore, it is not expected to be beyond the golf course area. In addition, gamma radiation scan was conducted during the golf course area cleanup to assure boundary of contamination. Therefore, the gamma survey for cleanup verification was stopped at the Q block row. Nevertheless, a 200' grid gamma radiation survey was conducted in September 1996 which demonstrate that area south of the Q block row is unaffected. Revised Figure 6-5, included in Attachment 1, shows result of the September 1996 gamma survey.

Explain why Figure 6-6 indicates 3 soil samples in block K11, but there are no corresponding gamma readings in Figure 6-5.

The gamma radiation readings in Figure 6-5 corresponding to the soils samples in Figure 6-6 were inadvertently missed. The gamma radiation measurements were made at this location in August 1996, and Figure 6-5 has been revised and included in Attachment 1.
