RE: Bluewater Mill Site Reclamation Completion Report Comments
License No. SUA-1470, Docket No. 40-8902

Response to NRC's Comments

ADDENDUM 1
RESPONSE TO NRC COMMENTS

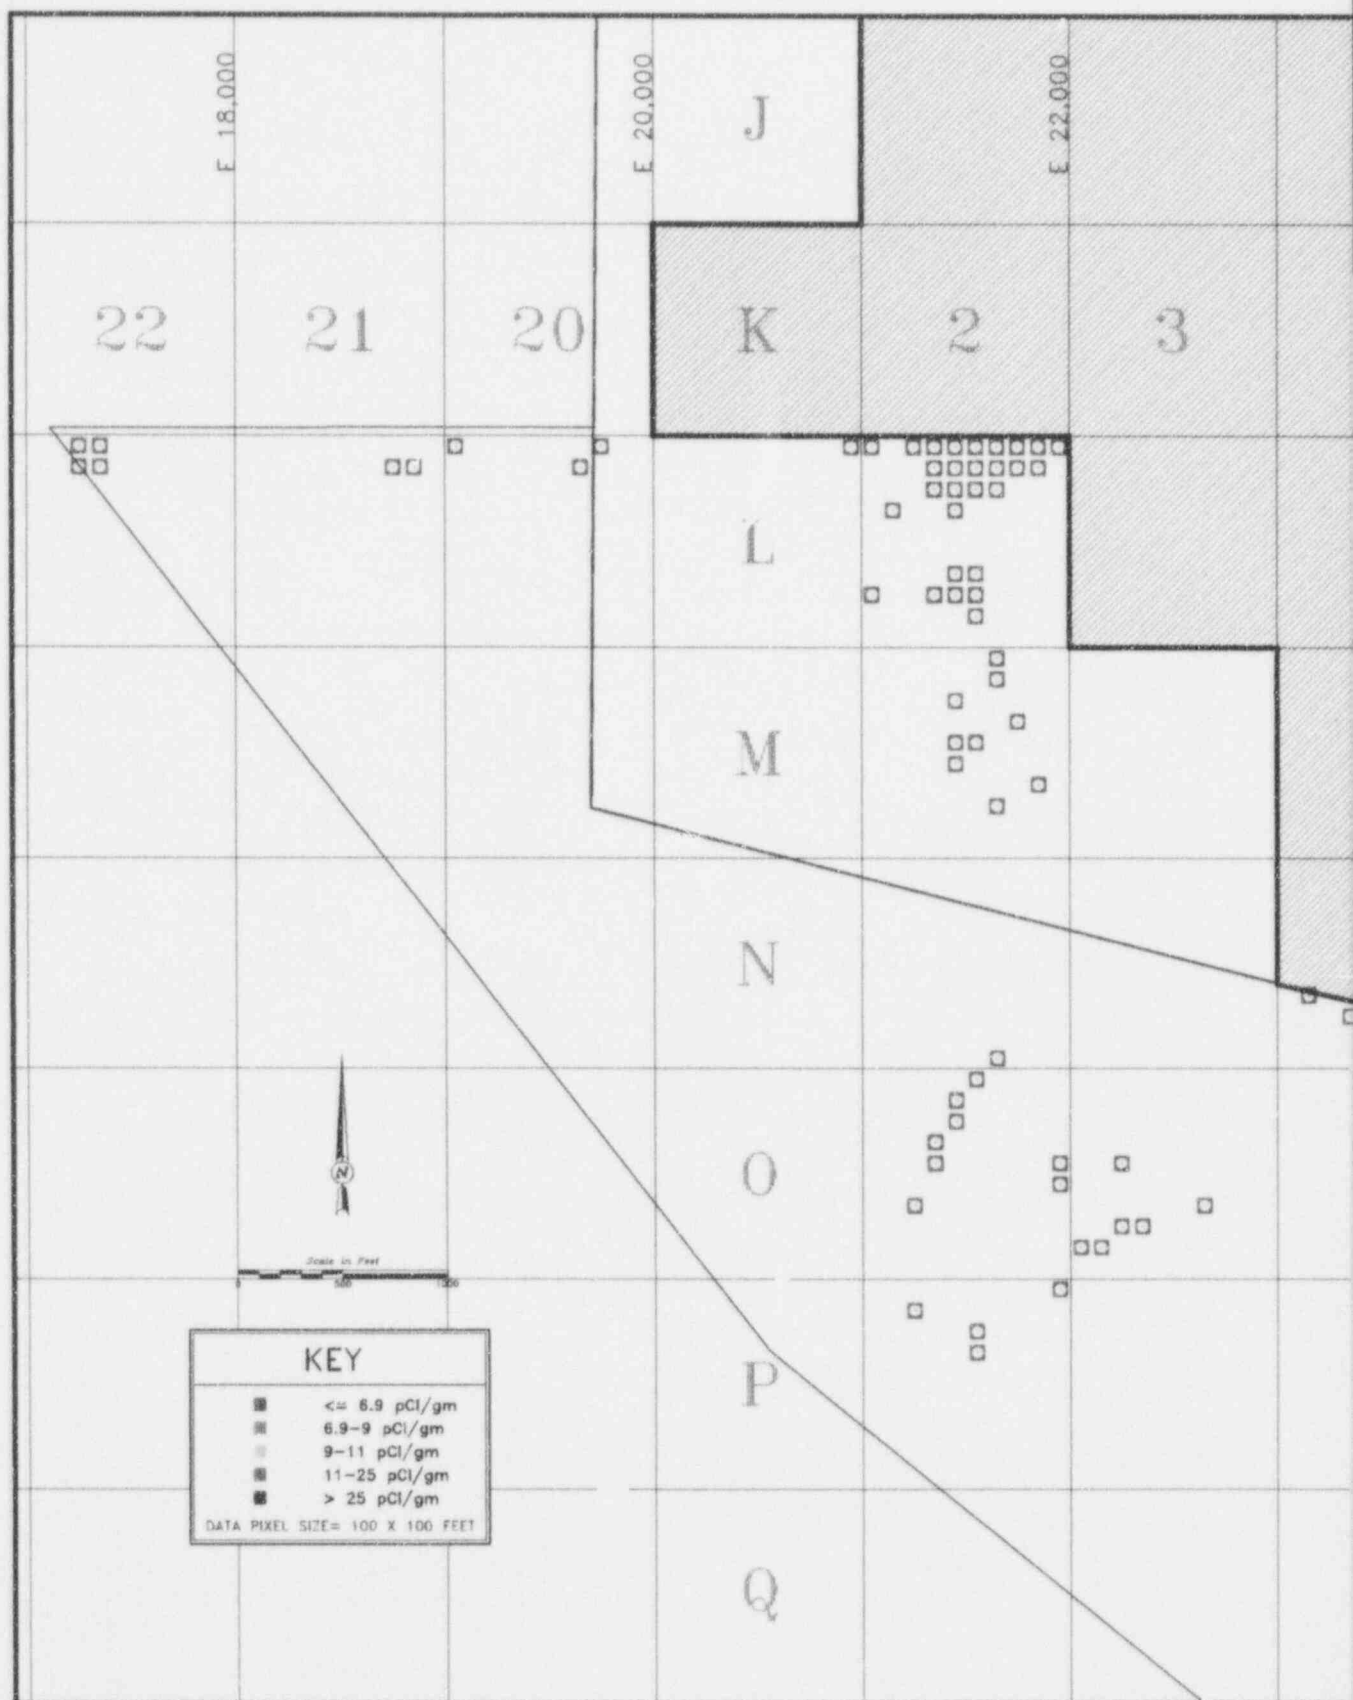
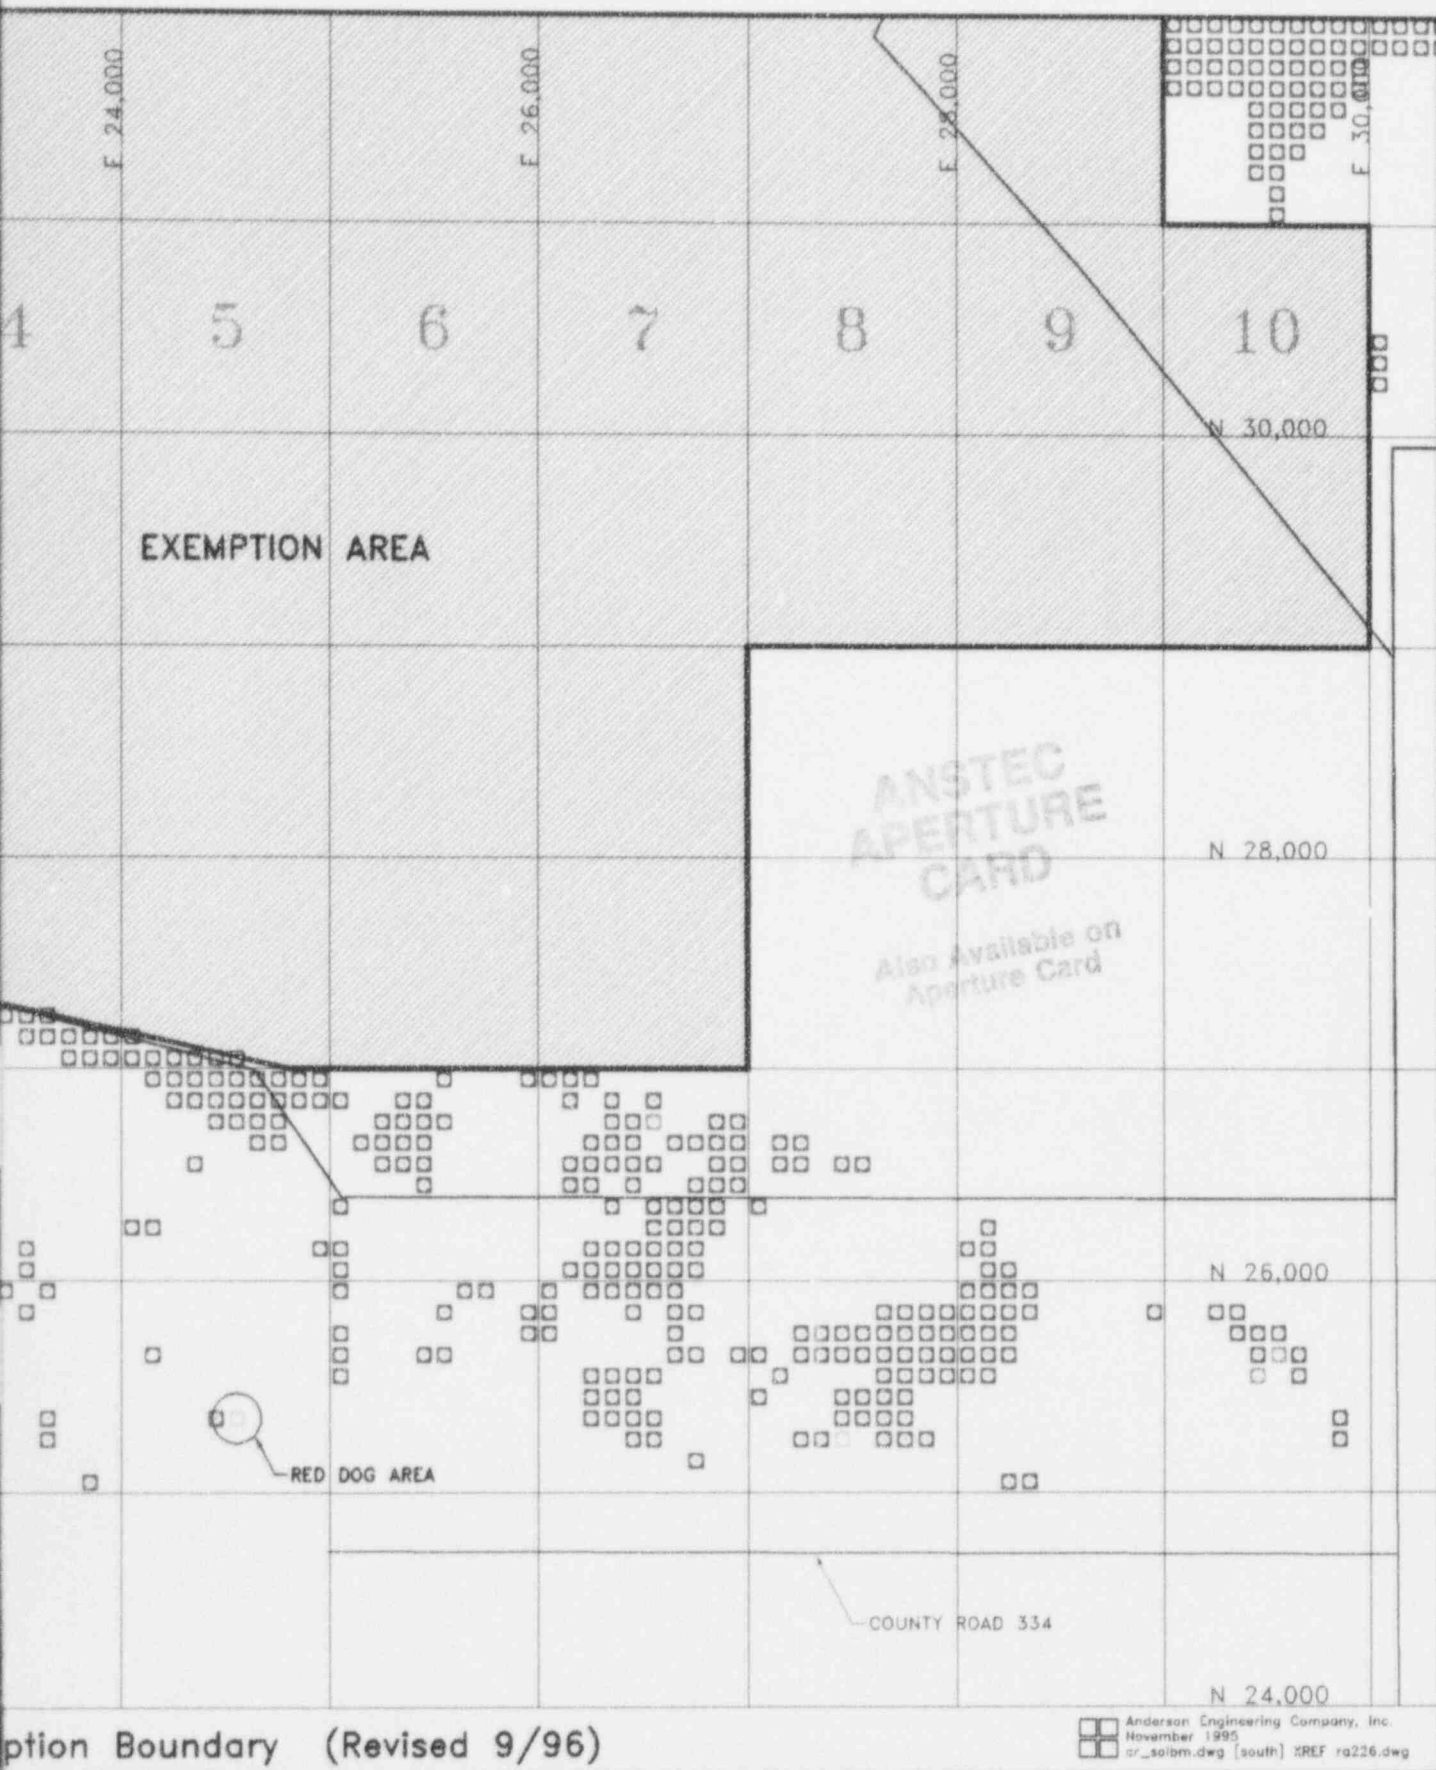
Figure 6-6 Ra226 Concentration in Soil Samples taken South of Exen

The same paragraph also indicates that Figure 6-6 shows that all Ra-226 measurements are below 6.9 pCi/g, but ARCO should explain why Figure 6-6 indicates 5 grids have Ra-226 values above 6.9 pCi/g (supported by Appendix J elevated values in grids 07-8-8, P5-18-8, P8-18-26, P10-8-29, and P10-13-11).

In all but five cases, the soil samples for the grid blocks indicated that the Ra-226 criterion was met. For the remaining five grid blocks, the soil was removed to bedrock and the small amount of residual soil sampled and analyzed. For those locations (07-8-8, P5-18-8, P8-18-26, P10-8-29, and P10-13-11), the Ra-226 concentration did not meet the cleanup criteria. However, since the area was rocked out, no additional remediation was practical.

Comparing Figure 6-6 to Appendix J Ra-226 data, it appears that grids N4-16 to 20, with values of 11.6 to 7.5 pCi/g, should be outside the exemption zone and on the figure. Similarly, grids N5-21 to 23, with values of 33.4 to 8.3 pCi/g, should be on the figure. Explain why Figure 6-6 appears incomplete, or provide a corrected figure.

Using a larger scale map, we have reviewed the locations of grid blocks N4-16 through N4-20 and find the soil sampling location designations correct as plotted on the map. This also applies to grid blocks N5-21 to N5-23. The presentation may be somewhat deceptive in that the soil sampling grid is a 33.3' by 33.3' grid block centered in each quadrant. However, the presentation on the maps indicates that this represents an area of 100' by 100'. The computer selected the samples on the basis of whether the 33.3' by 33.3' grid block that was sampled was within the boundary.

ore or the tailings, the material in Area H was black in color and had a shale type texture, which was determined to be a natural deposit of lignite in the form of a small lens. Another grab soil sample (#92-840S), the where gamma radiation level averaged at approximately 3700 cphm, was collected and sent to Acculab for analysis. The sample results indicated Ra-226 concentrations at 8 pCi/gm. Nevertheless, additional excavation was conducted after October 1992. With additional excavation, the small pocket of natural deposit was cleaned up. Revised Figure 6-3 and 6-4, included in Attachment 1, depicts Area H and show that Area H meets the cleanup criteria.

As stated in the Windblown Cleanup Report, Area C anomalous gamma readings were due to tailings material from the raffinate line near the eastern edge of the evaporation ponds. The raffinate line was remediated during Phase II reclamation, which followed the windblown cleanup. Revised Figures 6-3 and 6-4, included in Attachment 1, depict Area C and show that Area C meets the cleanup criteria.

It is difficult to determine the actual size of the remaining area of elevated gamma that is attributed to high levels of K-40 because it is in a form of a lens at a depth of over 5 feet which resulted from a fill during the housing construction activities. However, it is estimated to be less than one acre. Figure 6-6 in Attachment 1 depicts this area.

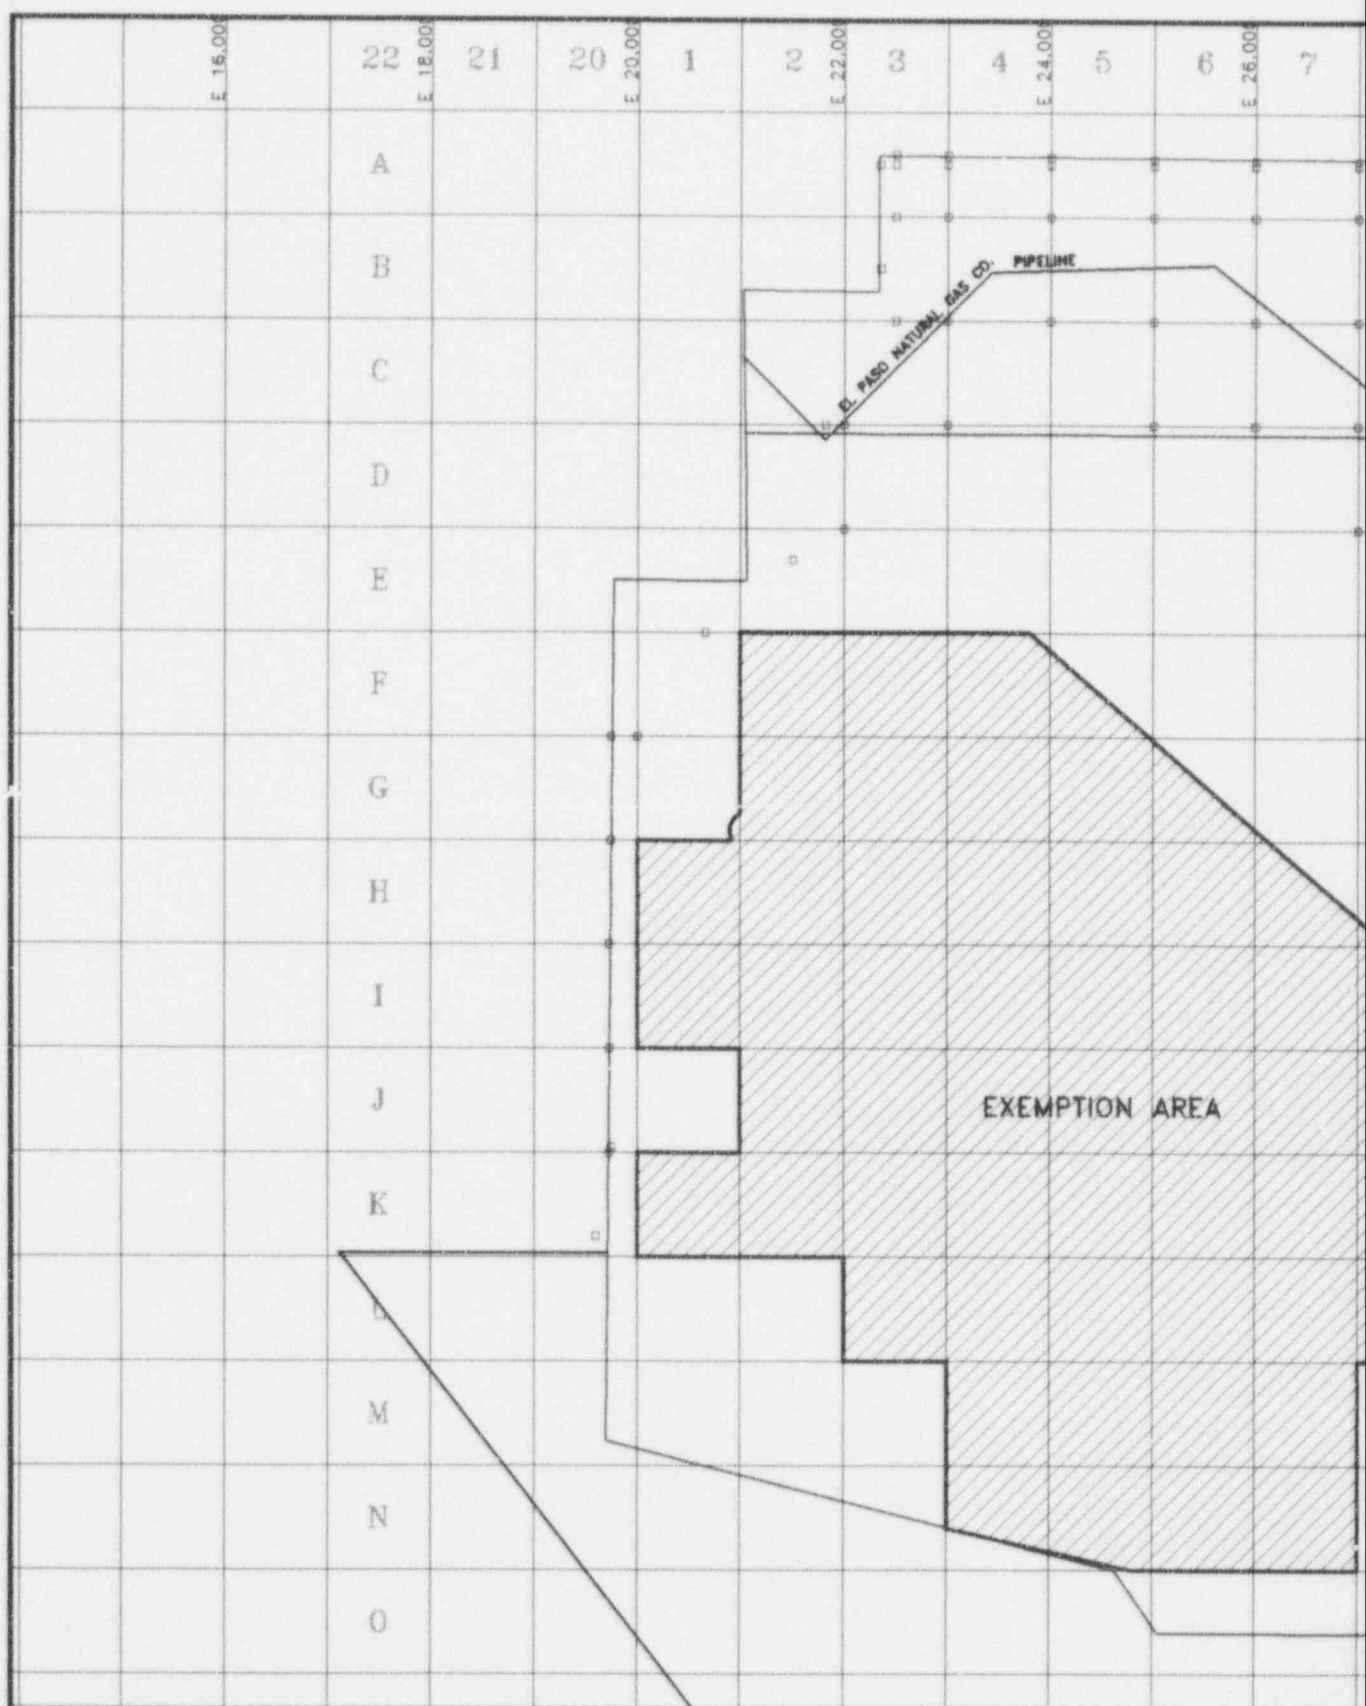
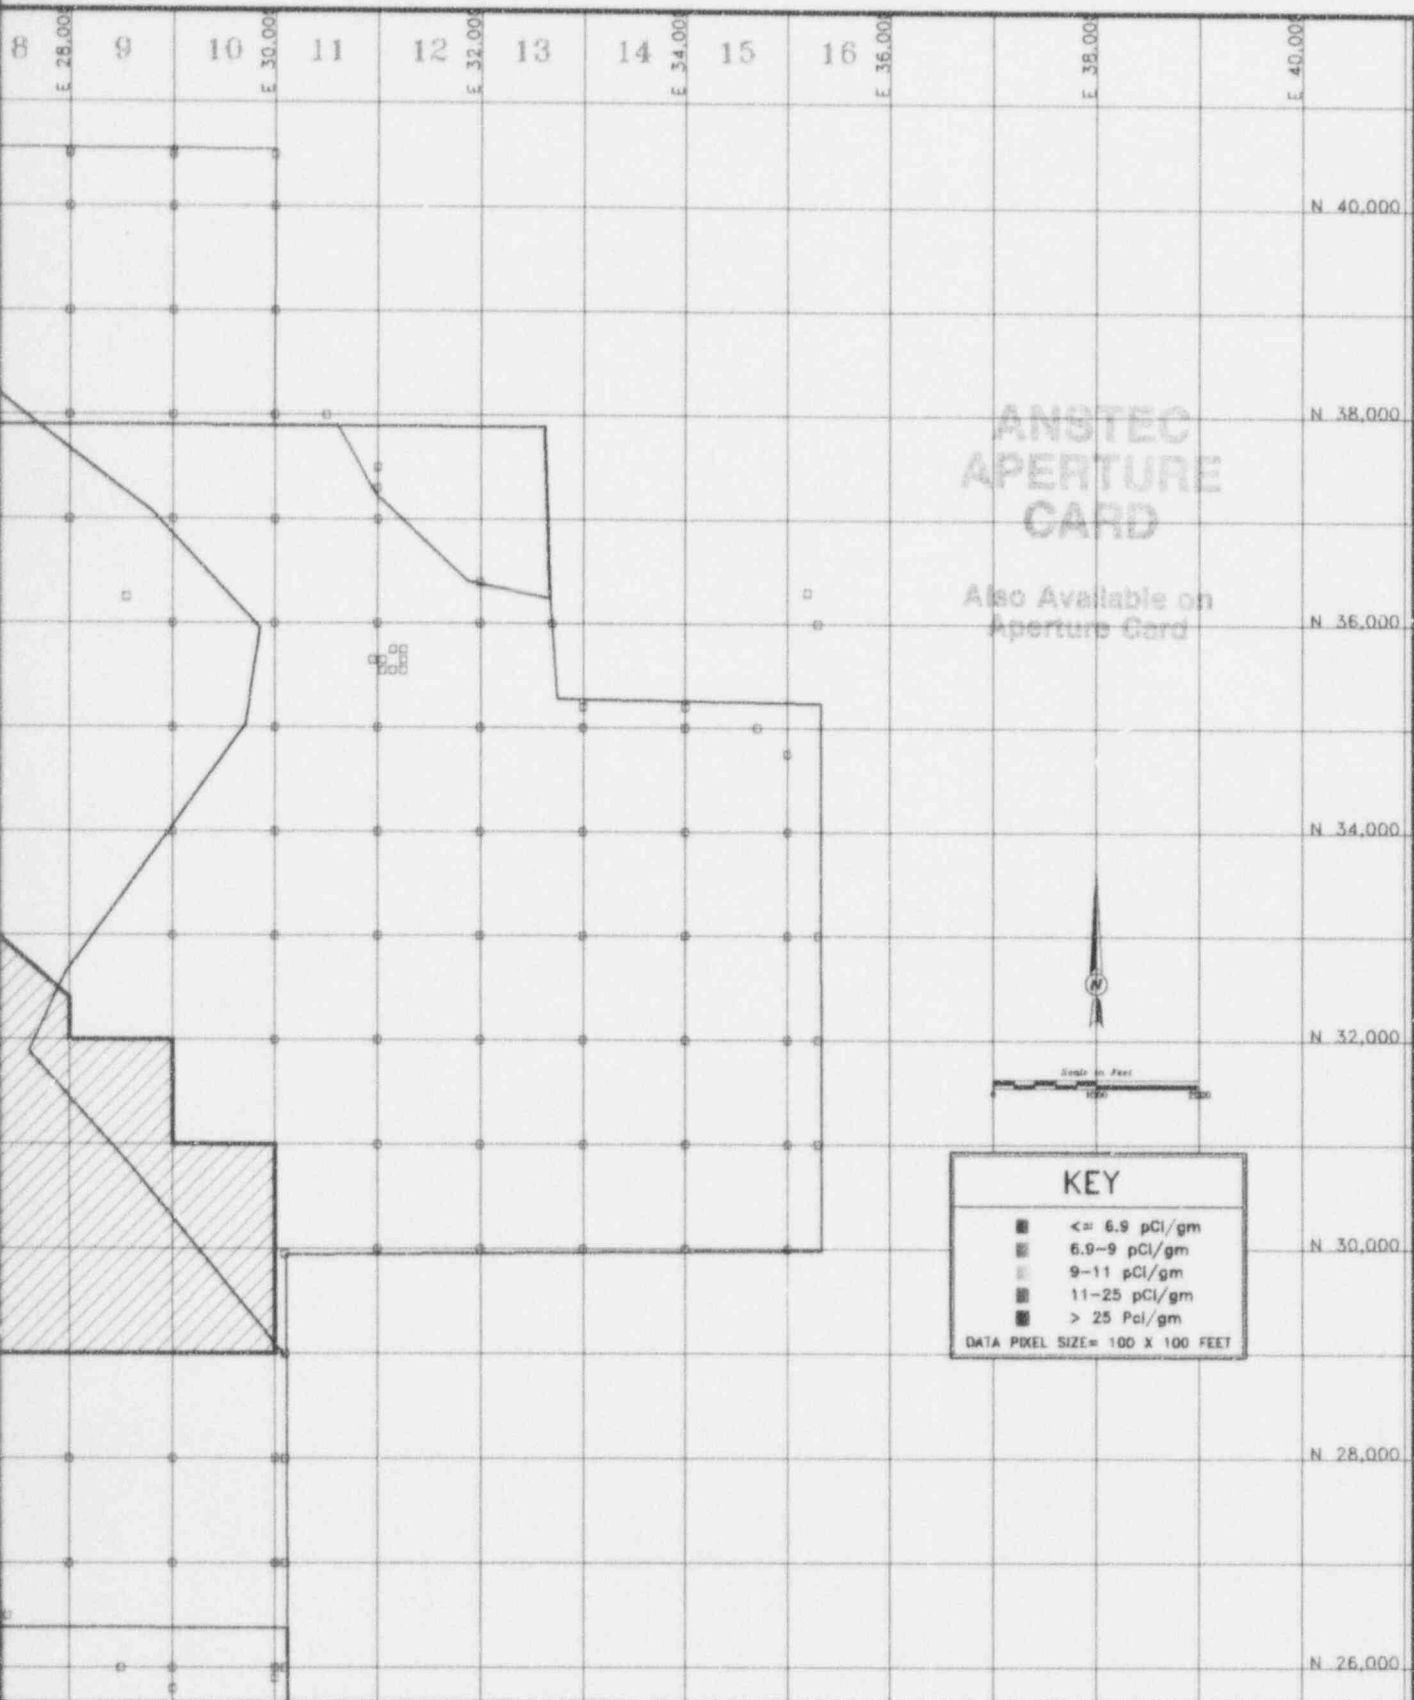
Figure 6-7 Ra-226 Concentration in Soil Samples taken in Outlying Area

The grid gamma readings stop abruptly at the Q block row. Indicate why there aren't readings for every 1000-foot grid (unaffected area, Figure 6-7) to demonstrate that no removal was necessary. The restricted area boundary is not a sufficient reason for lack of data.

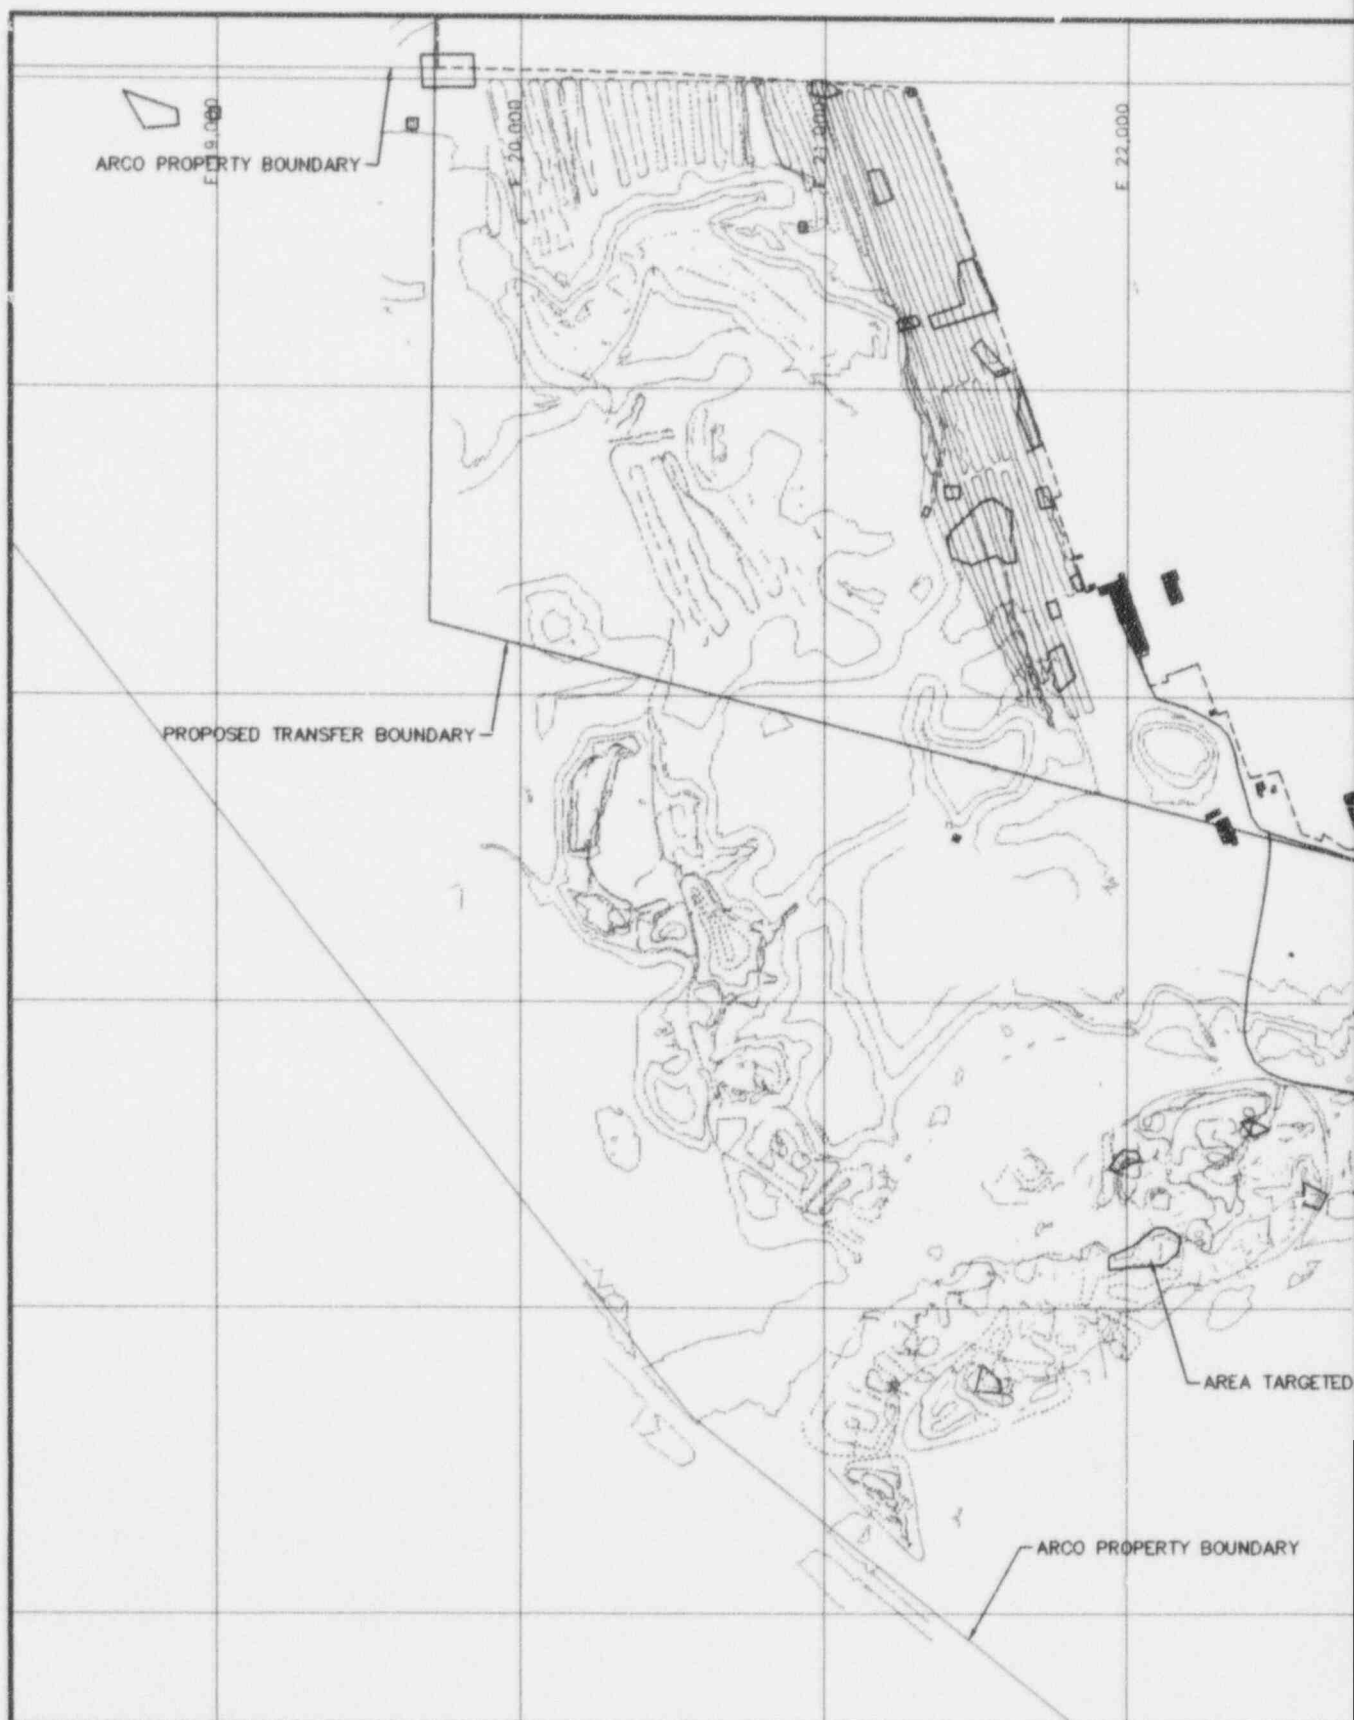
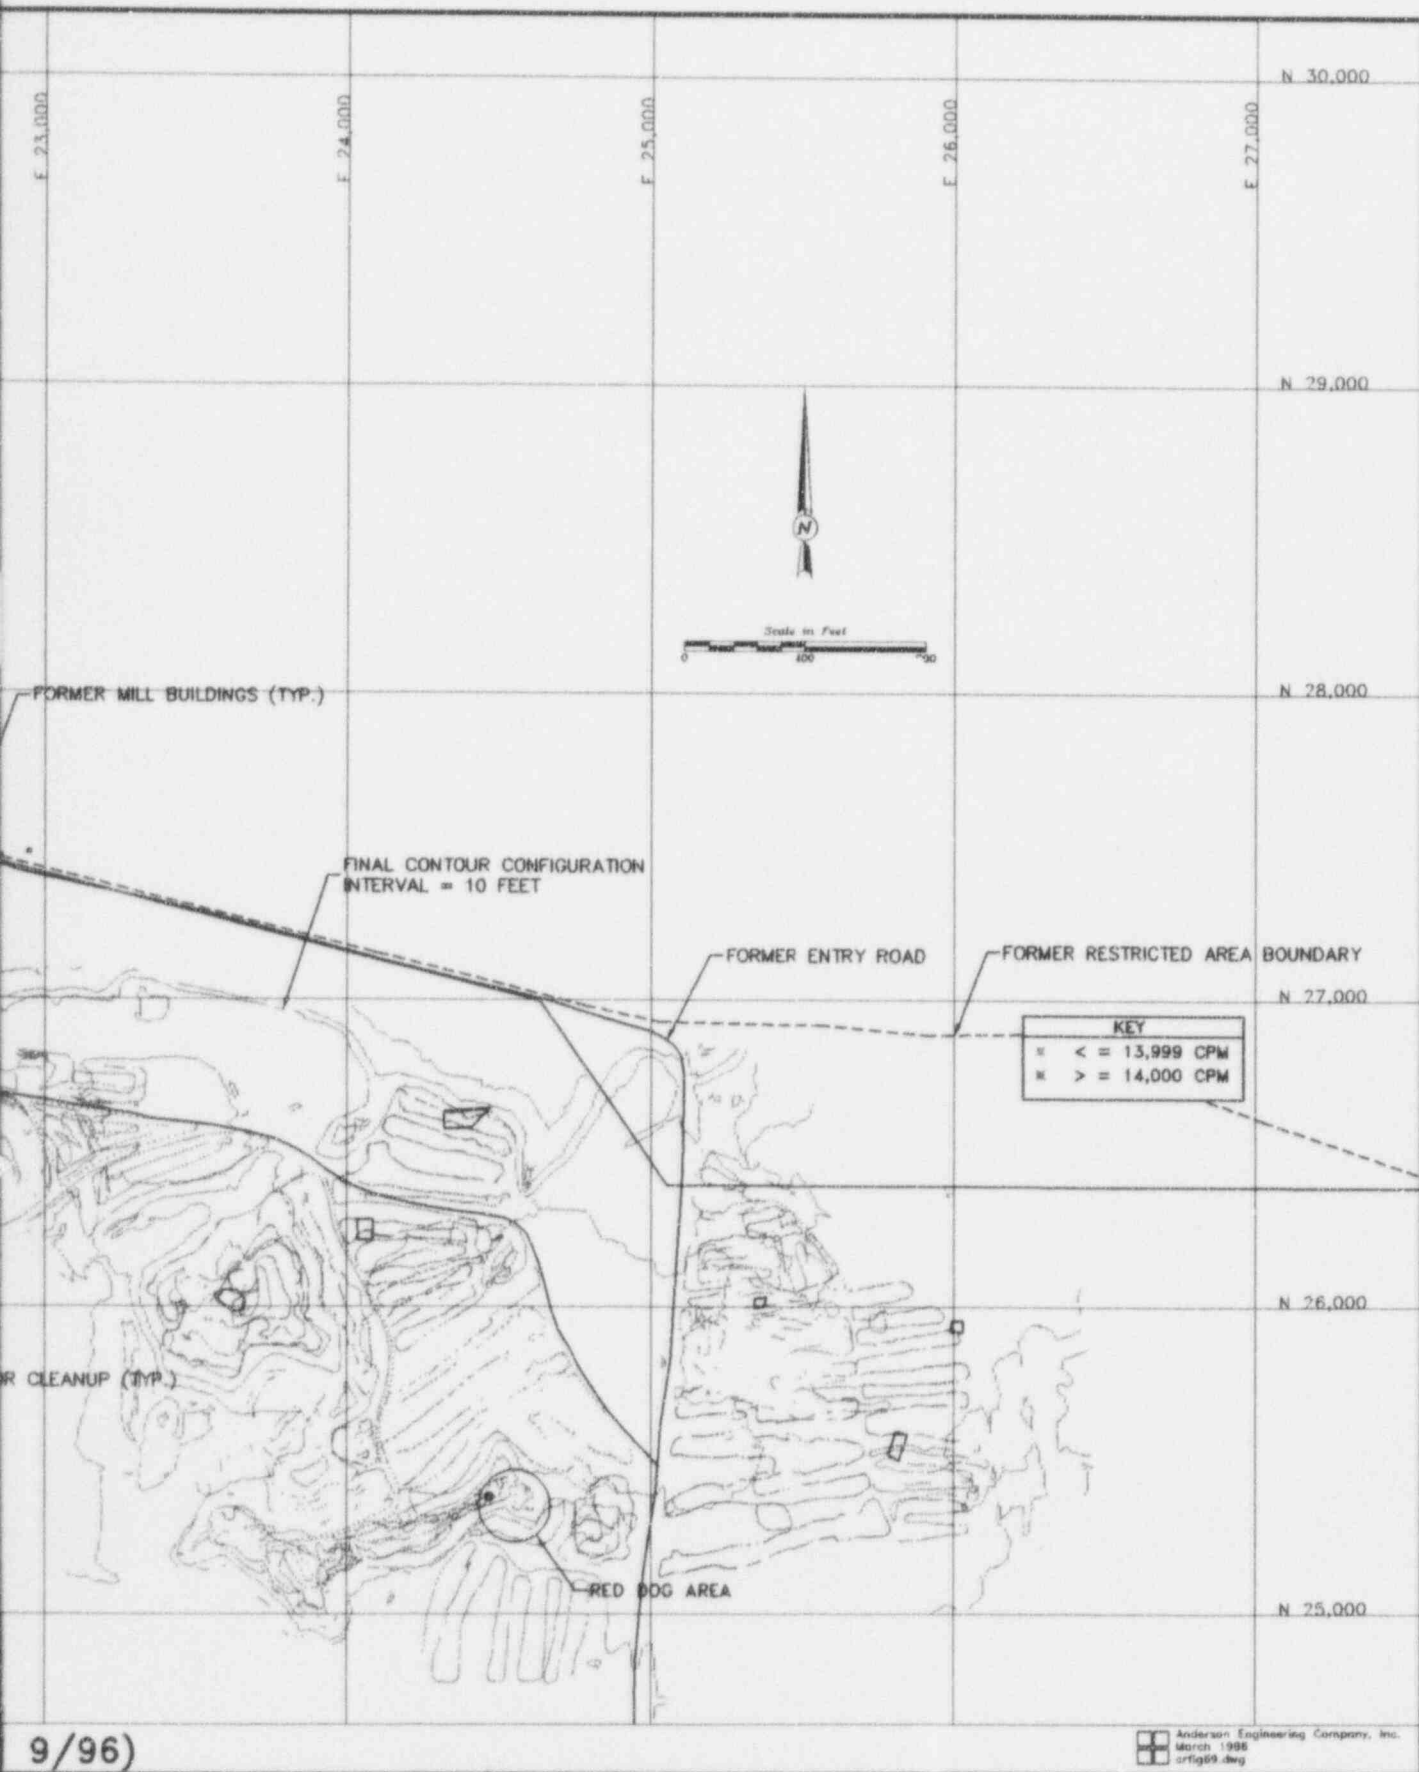
Figure 6-9 GPS Based Gamma Ray Count Rate Measurements (Revised)

On Figure 6-9, indicate the position of the former golf course, housing areas, county road, and guard station. Also, correct the north coordinate numbers and provide block numbers that correspond to those used on the other figures in Section 6.

Figure 6-9 has been revised and is included in Attachment 1.

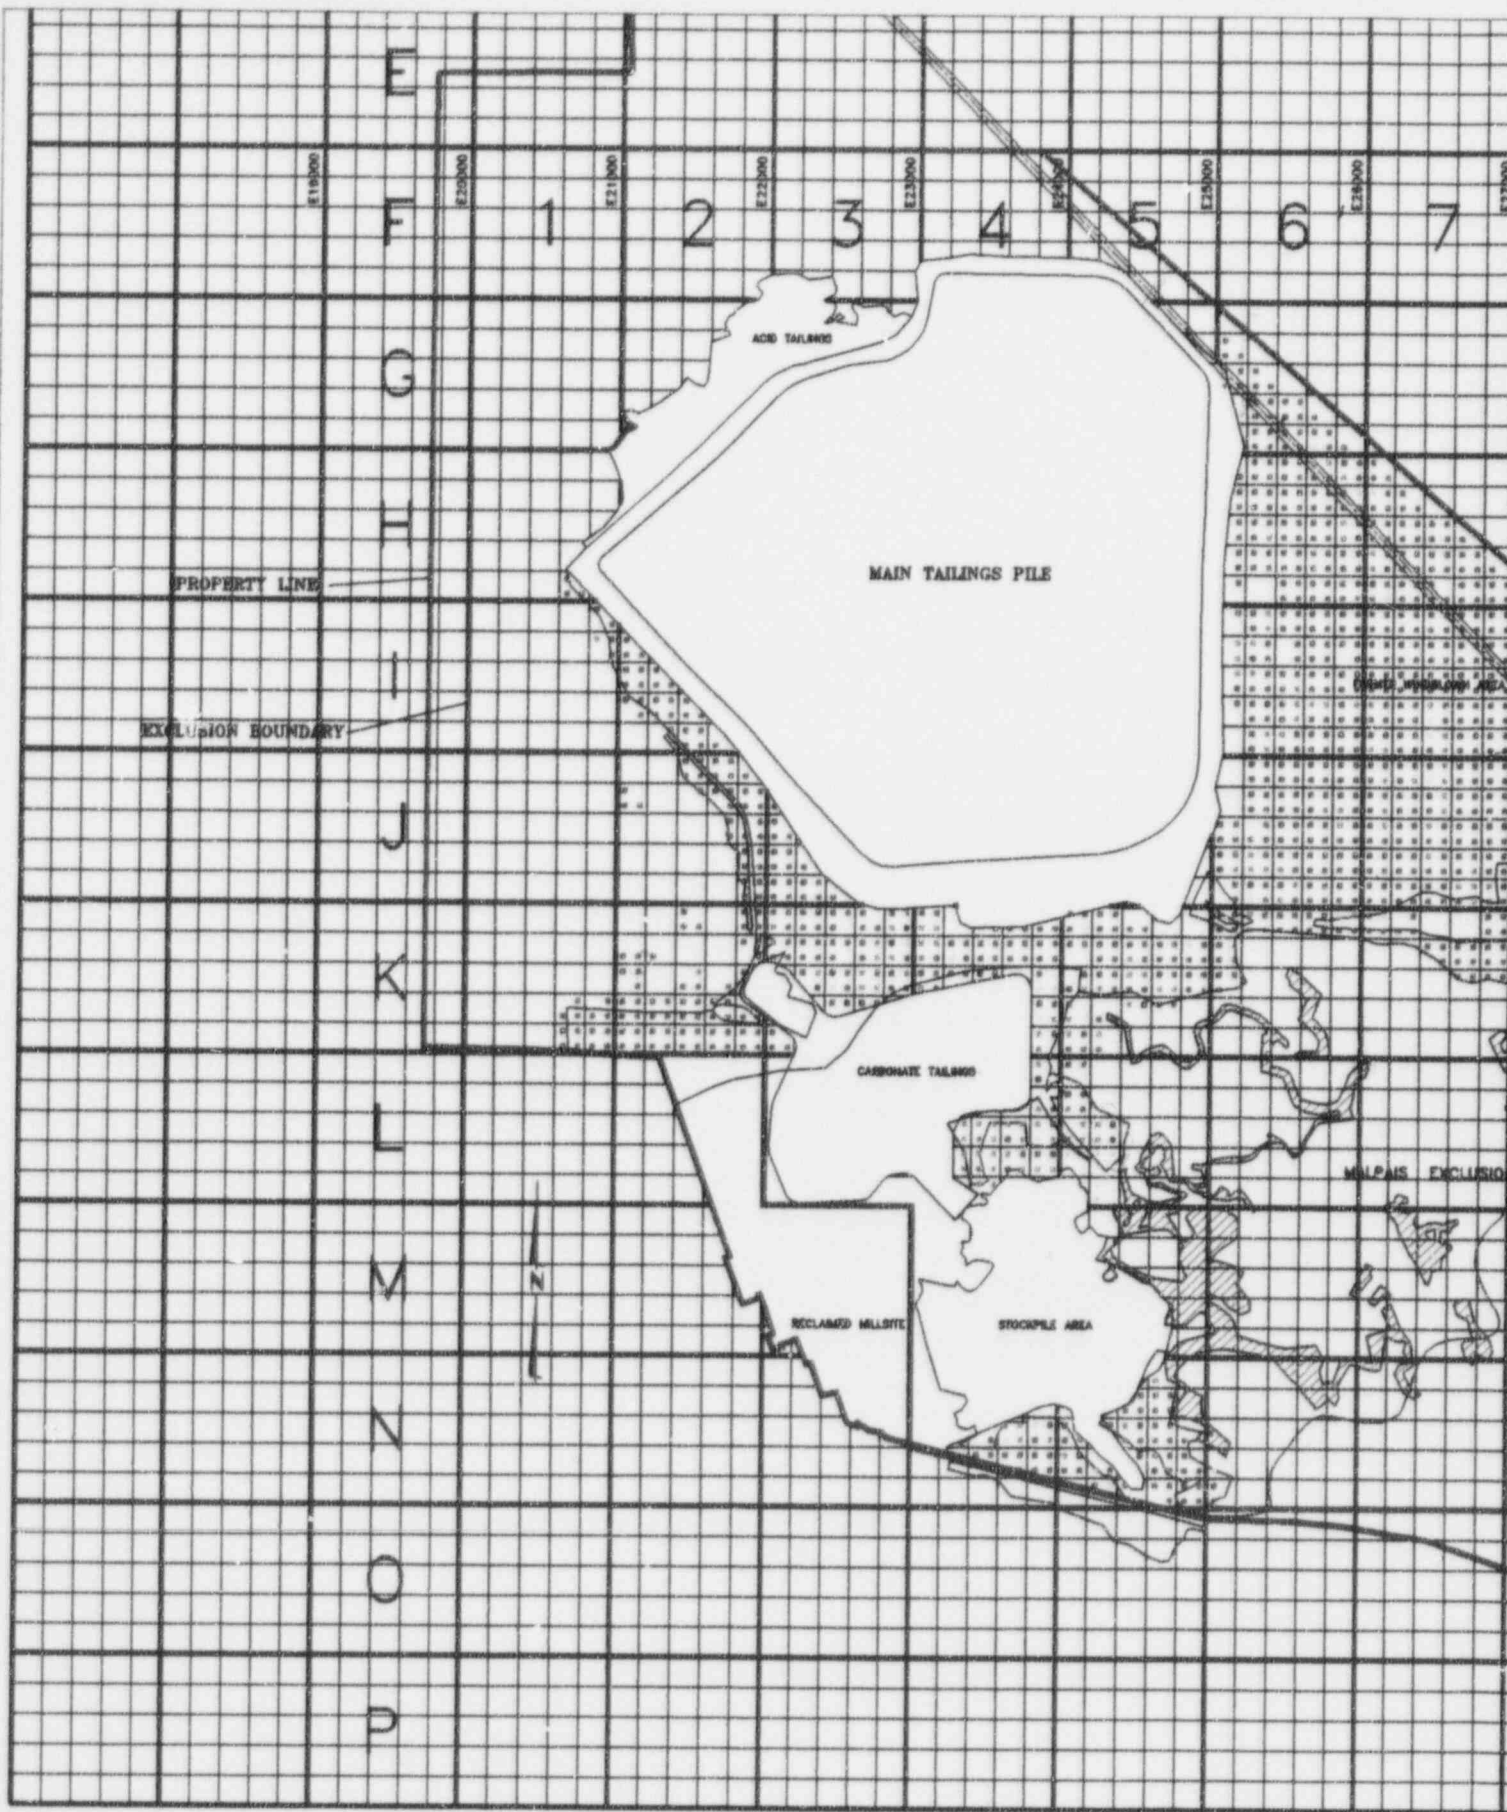
Radon flux canisters were placed at the locations shown in Figure 1 in the morning of May 9, 1996. Two trip blanks (canisters 31 and 26) were used to check the effectiveness of the charcoal bake-out, the integrity of the plastic bags, and the calibration of the spectrometer. The results of the two trip blanks were reported as 0.17 ± 0.23 and 0.03 ± 0.23 pCi/m²/sec., where the error is one standard deviation. Since the trip blanks were not removed from the plastic bags, a value overlapping zero clearly shows that the trip blanks were not effected by environmental conditions and that the spectrometer reading is not bias high or low.
