U. S. NUCLEAR REGULATORY COMMISSION

Report No.: 999-90004/96-10

Licensee: International Ranwick Limited

PHOTOGRAPHS TAKEN AT THE INTERNATIONAL RANWICK MINE SITES

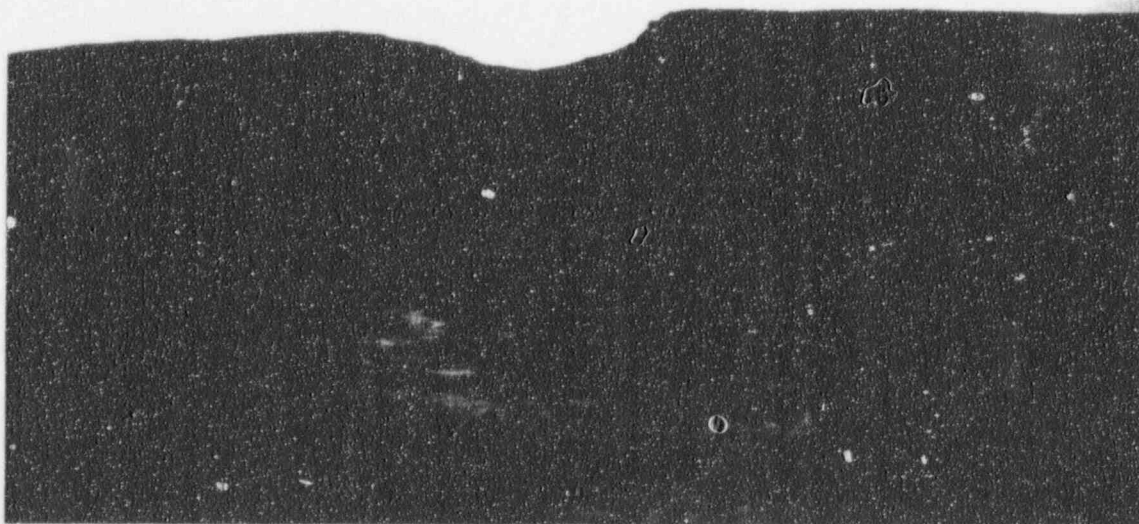
Photograph 1 - Site of Lee No. 1 mine claim, looking north from the road (no mining activities were identified in this area).

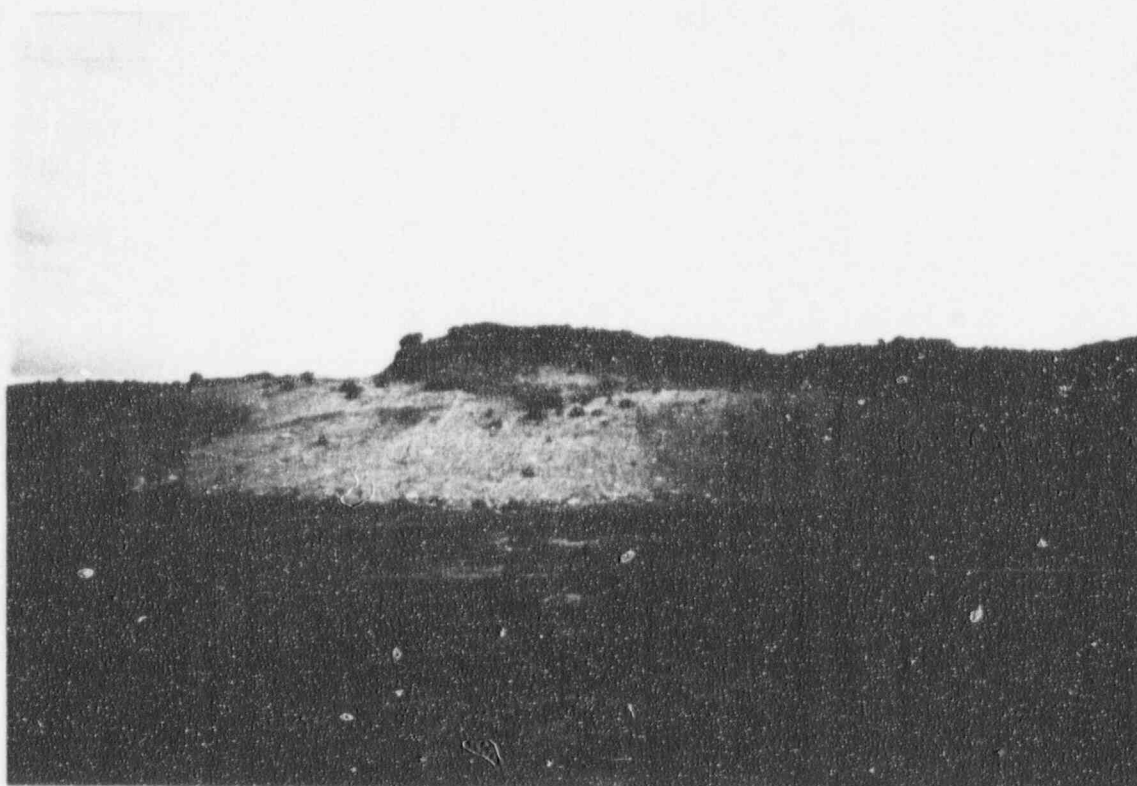
Two open surface mines were identified during the site visit. One was located several hundred yards south of the Lee No. 1 site. Using a Ludlum Model 19 microroentgen meter, calibrated to a cesium-137 source, an ambient gamma exposure rate of 150 microroentgen per hour ($\mu\text{R/hr}$) was measured on the pile. (The general area background was measured at 10-15 $\mu\text{R/hr}$.) The second open surface mine was located near the Pete No. 1 site. This site measured up to 500 $\mu\text{R/hr}$ on contact with what appeared to be mine overburden material. Blocks of concrete, cans, bottles, and other small debris were found near the second site. In summary, both sites appeared to be small-scale mining operations, no immediate health and safety issues were identified, and no houses were observed in the area of the two sites.

Photograph 2 - Surface mine south of the Lee No. 1 site.

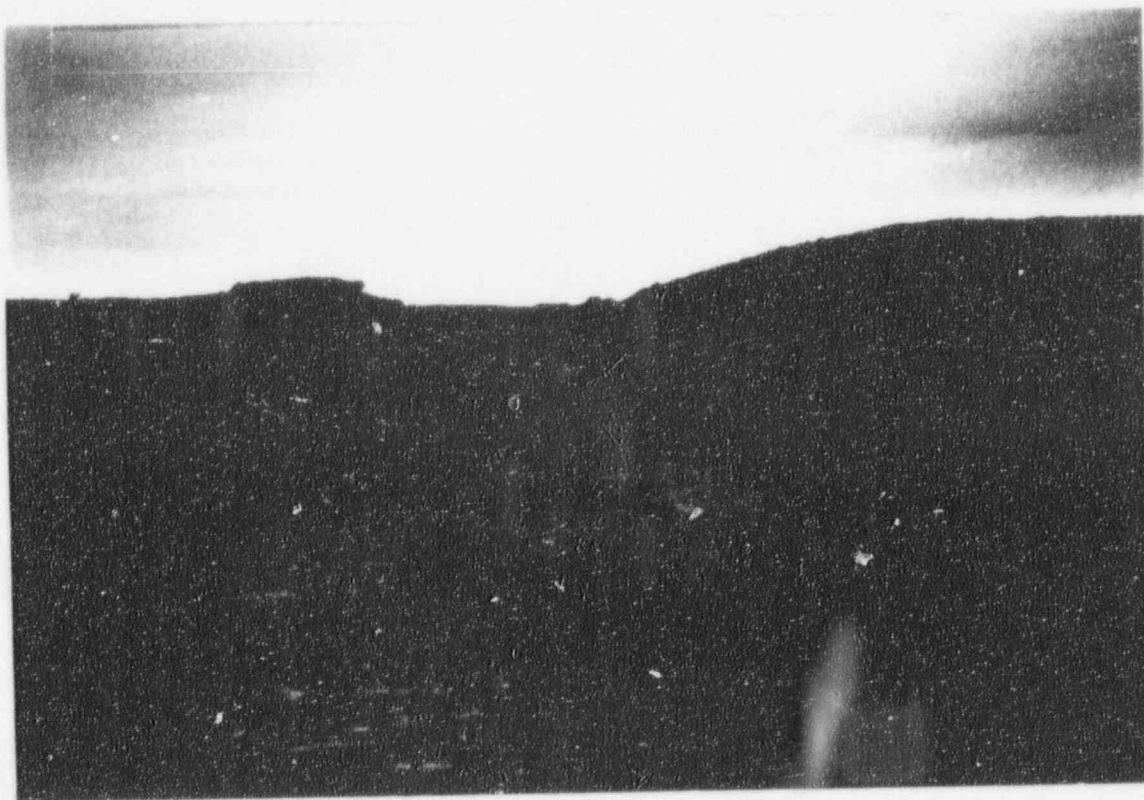
Photograph 4 - Area of the Pete No. 1 mine claim site.
