U. S. NUCLEAR REGULATORY COMMISSION
REGION IV

Report No.: 040-05593/96-01

Licensee: American Smelting and Refining Company (ASARCO)
Federated Metals Division

Inspection Date: November 6, 1996

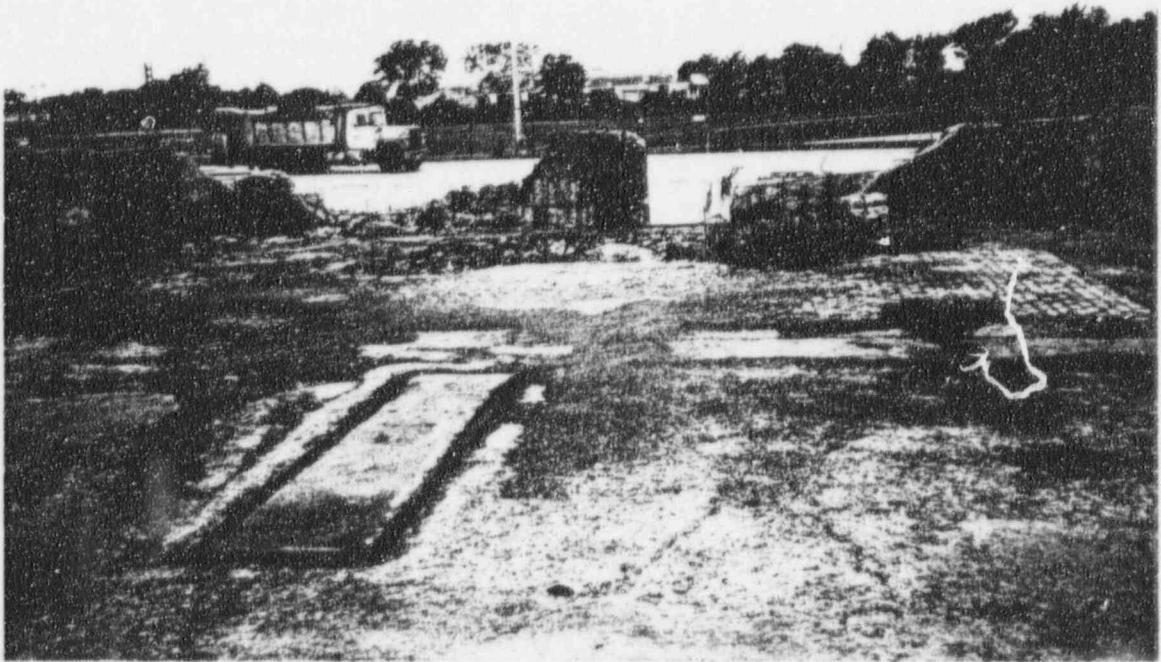
Photograph 3 - Location of former magnesium smelter.

Staff members from the Texas Department of Health, Bureau of Radiation Control, visited the ASARCO site in Houston on May 9-10, 1996. Radiological surveys and samples were obtained from portions of the site. Several areas of elevated surface gamma readings were observed during the visit, including the areas around the former smelting pots and along the west fence line.

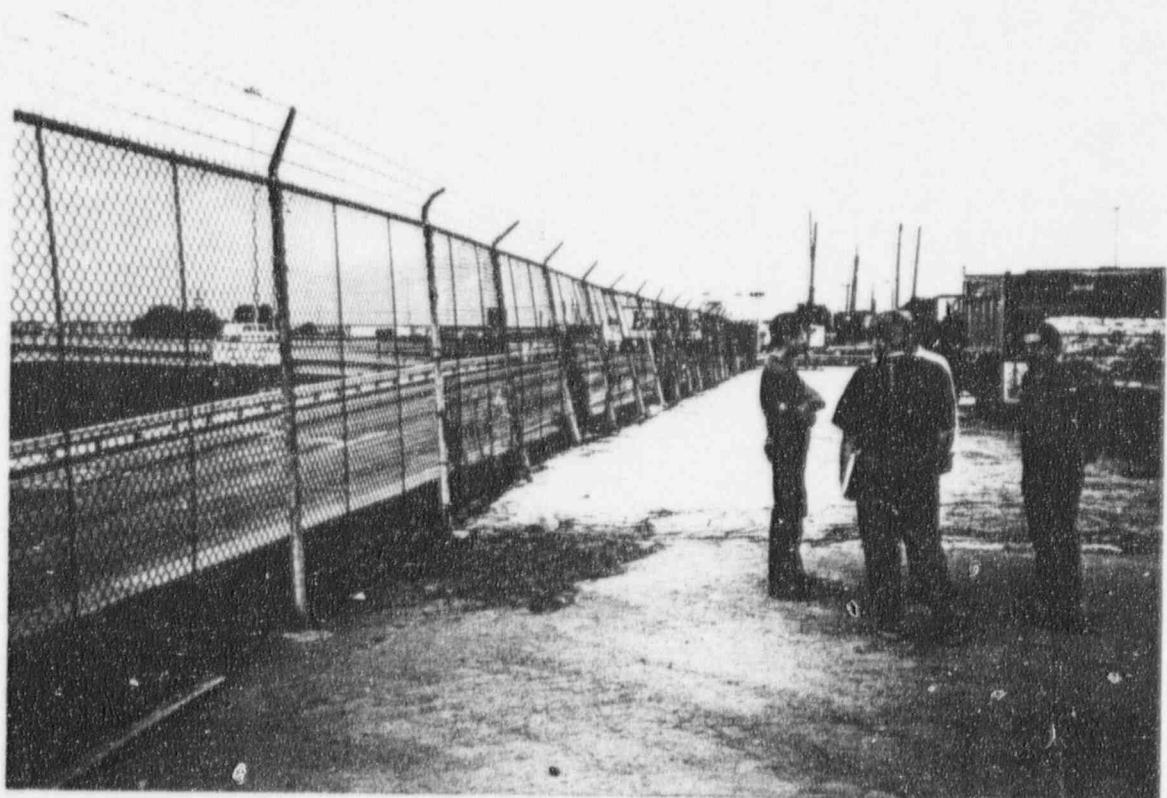
Photograph 4 - Area along the west fenceline where slightly elevated levels of radioactivity were identified.

Six soil samples were obtained by the state from five locations around the site. The highest radionuclide concentration measured was from a soil sample obtained near the west fence line. The thorium-230 concentration was measured at 321 picocuries per gram (pCi/g) in this sample, while the natural thorium concentration (thorium-228 plus 232) was 368 pCi/g.

SOIL SAMPLE ID	SAMPLE LOCATION	CONTACT GAMMA READINGS (μ R/hr)	NATURAL THORIUM CONCENTRATION (pCi/g)
S01	South 650/West 775	1100	1818 \pm 107
S02	South 450/West 400	1000	670 \pm 40
S03	South 325/West 450	800	430 \pm 25
S04	West Fenceline	200	68 \pm 4

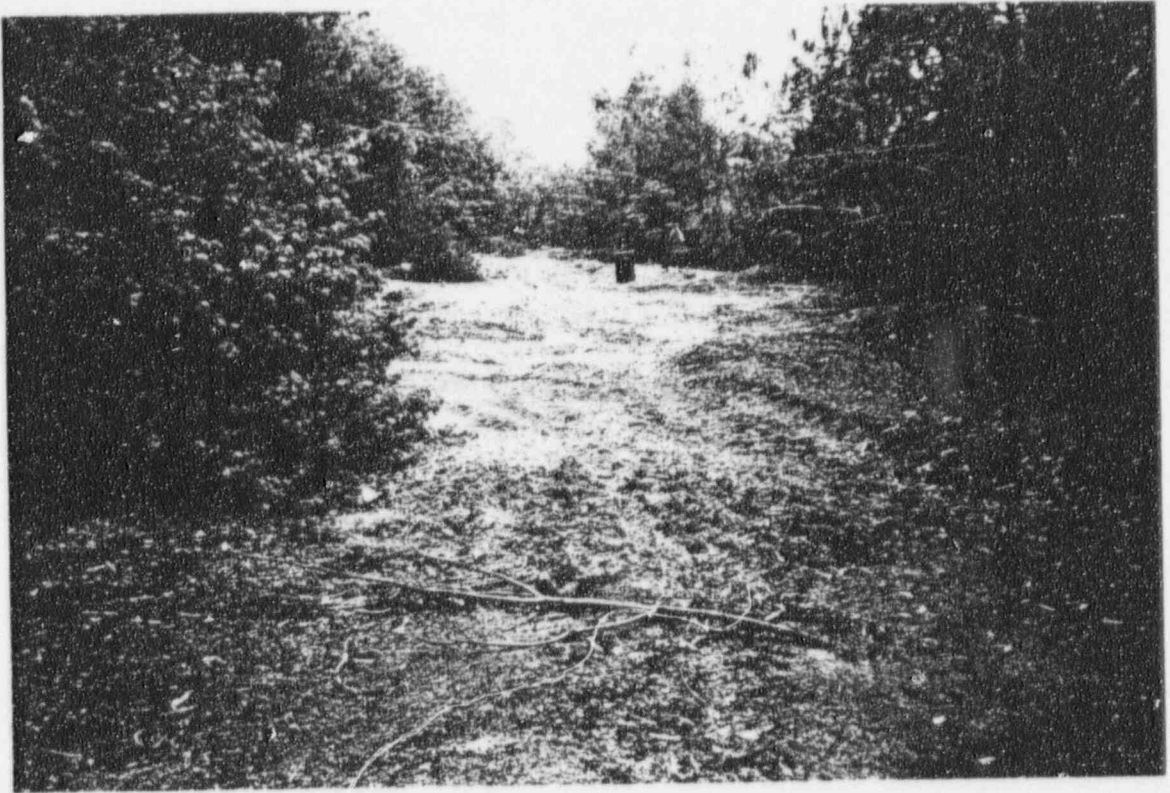
Photograph 5 - Debris resembling smelter waste products on southern end of site property; some of this material was radioactive.

During the tour of the property located south of the main site (the State did not survey the southern portion of the site during their January 1996 inspection), numerous piles of waste material were identified. The waste material included debris rejected from the smelting process (dross), bricks, and other industrial scrap material. According to a representative of ASARCO, there was one large, three medium, and five small piles of waste debris on this portion of the site.

Four or five areas of the southern property were noted to contain radioactive contamination, although not all waste material at the site was contaminated. With an ambient background gamma exposure rate of 8-10 microroentgen per hour ($\mu\text{R/hr}$), the exposure rate of the waste material varied from background levels up to 1600 $\mu\text{R/hr}$ on contact. No area was identified that met the definition of a radiation area (5000 $\mu\text{R/hr}$).

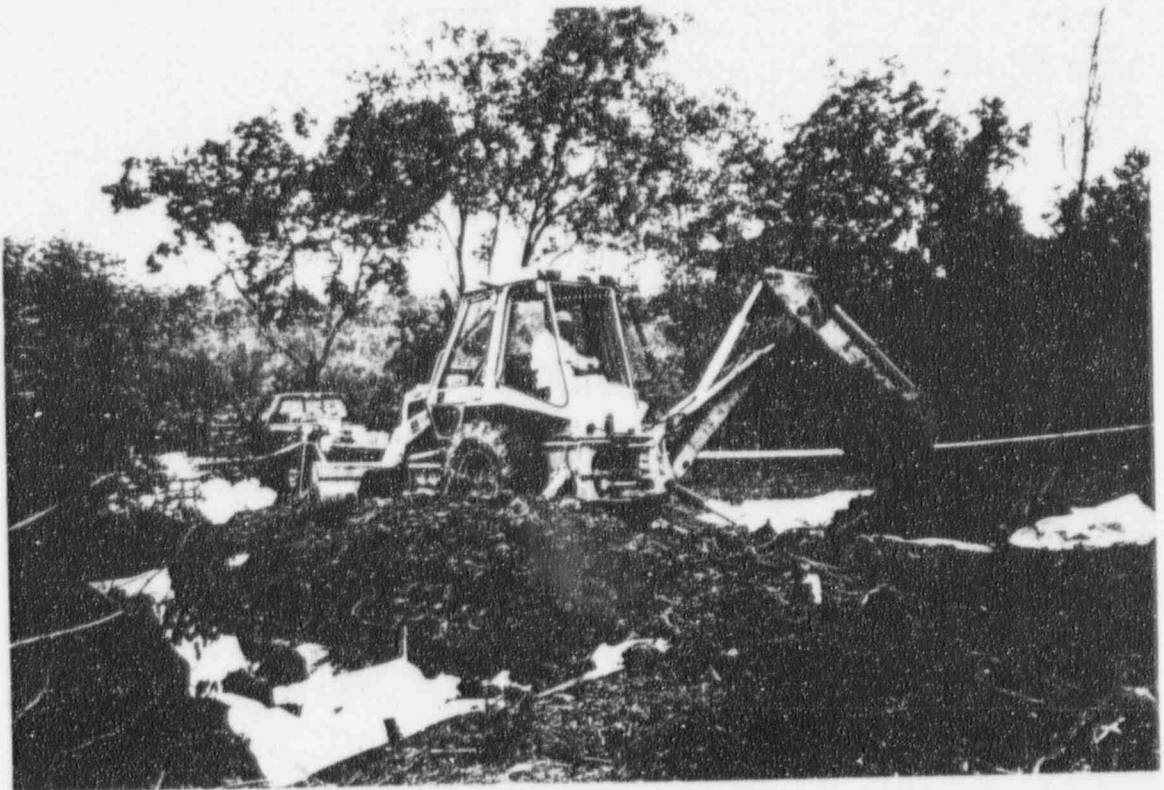
Photograph 6 - ASARCO representatives performing excavation work on the south property; non-radioactive industrial waste was identified here.

During the NRC tour, workers began exploratory excavations at the site. The first excavation uncovered buried industrial waste debris. This material was not radioactive. However, the discovery of buried waste suggested that buried materials containing radioactive contamination was possible at the site. Additional excavations were planned following the completion of the NRC site visit.

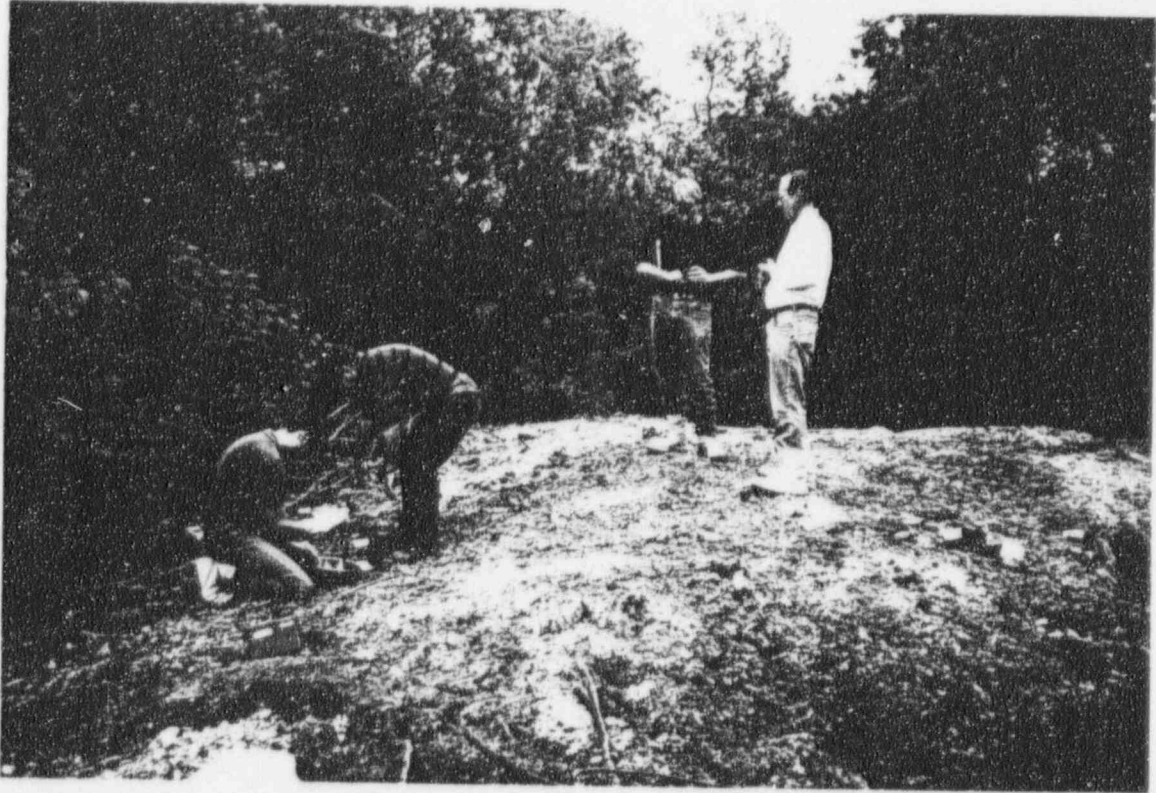
Photograph 7 - Soil sampling in progress on one of the medium-sized waste disposal piles.

In addition to the ambient gamma survey scans, four soil samples were obtained from the ASARCO site. The soil samples were analyzed by the NRC's Region III office by gamma spectroscopy. The site location, gamma exposure rate reading on contact where the sample was obtained, and the natural thorium (combination of thorium-228 and 232) concentration measured during the laboratory analysis are listed below:

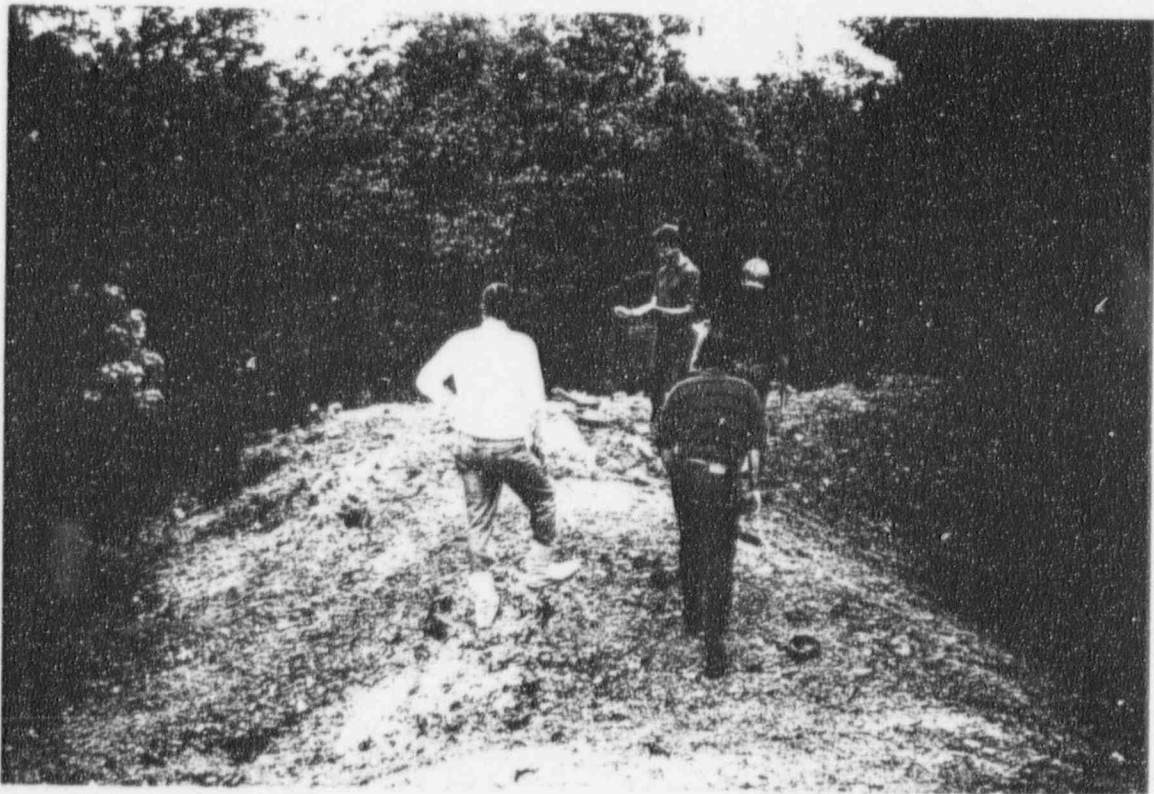
Photograph 8 - Soil sampling in progress on one of the medium-sized waste disposal piles.
