Acoustic Emission Results Obtained From Testing the ZB-1 Intermediate Scale Pressure Vessel

Prepared by P. H. Hutton, R. J. Kurtz, R. A. Pappas,
J. F. Dawson, L. S. Dake, J. R. Skorpik

Pacific Northwest Laboratory
Operated by
Battelle Memorial Institute

Prepared for
U.S. Nuclear Regulatory
Commission

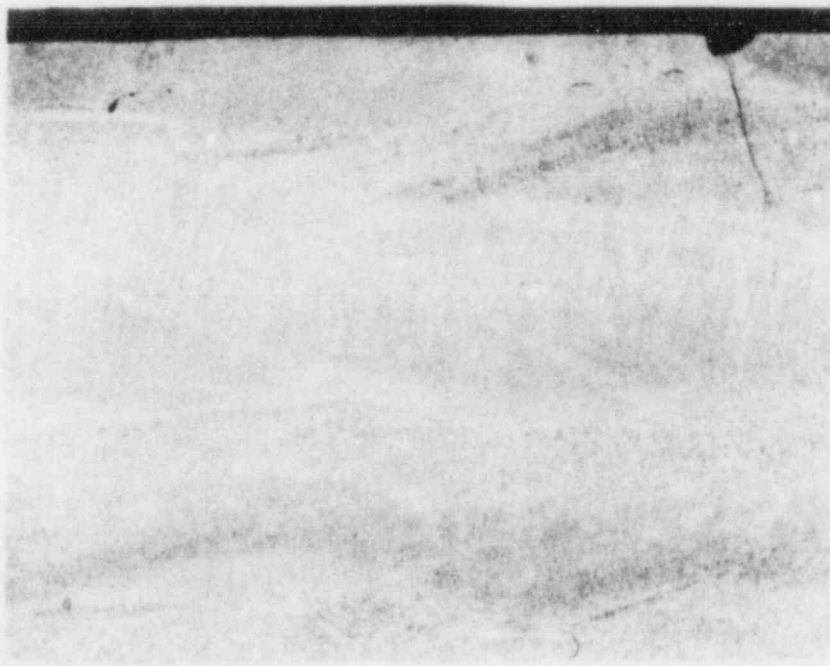
Figure 4.145. Metallographic Section from Core B2. Crack is perpendicular to longitudinal weld and is about 0.22 in. deep.
