Experimental Results of the Operational Transient (OPTRAN) Tests 1-1 and 1-2 in the Power Burst Facility

Richard K. McCardell
Scott A. Ploger

June 1985

U.S. Nuclear Regulatory Commission

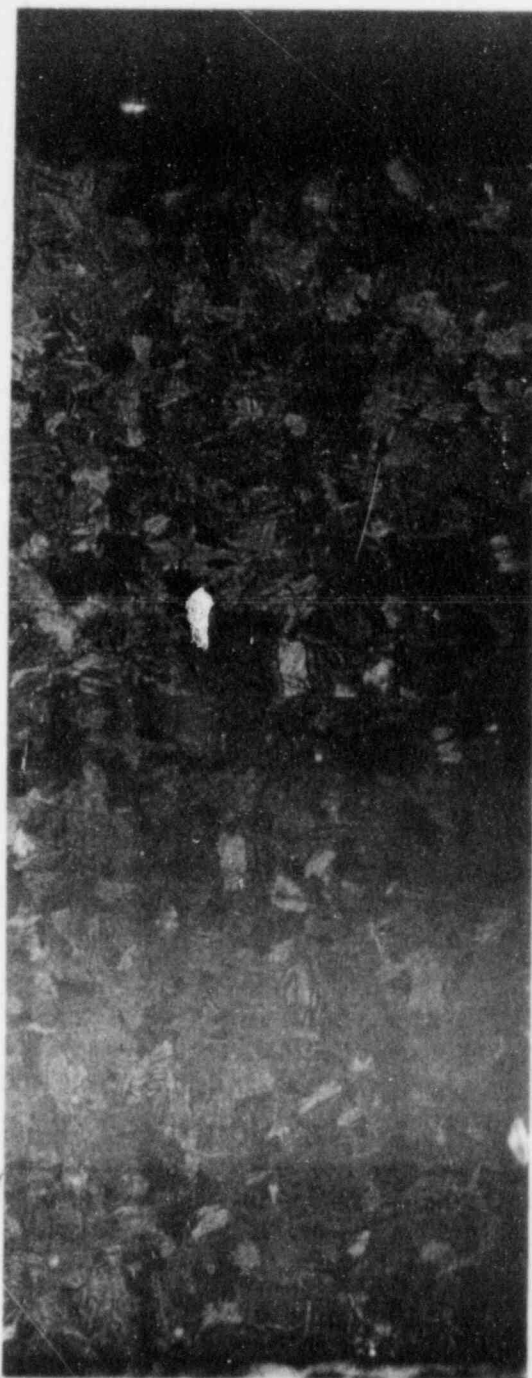
Figure 45. Cladding microstructures near the lower

Pellet
interface markings

Beta-zircaloy
grains

Etched, oblique lighting
