RADIOLOGIC AND ENGINEERING ASSESSMENT

DOE ID NO.: GJ-13970-MR  
ADDRESS: 2361 H ROAD

MAY 1985

BENDIX FIELD ENGINEERING CORPORATION  
P.O. Box 1569  
Grand Junction, Colorado 81502

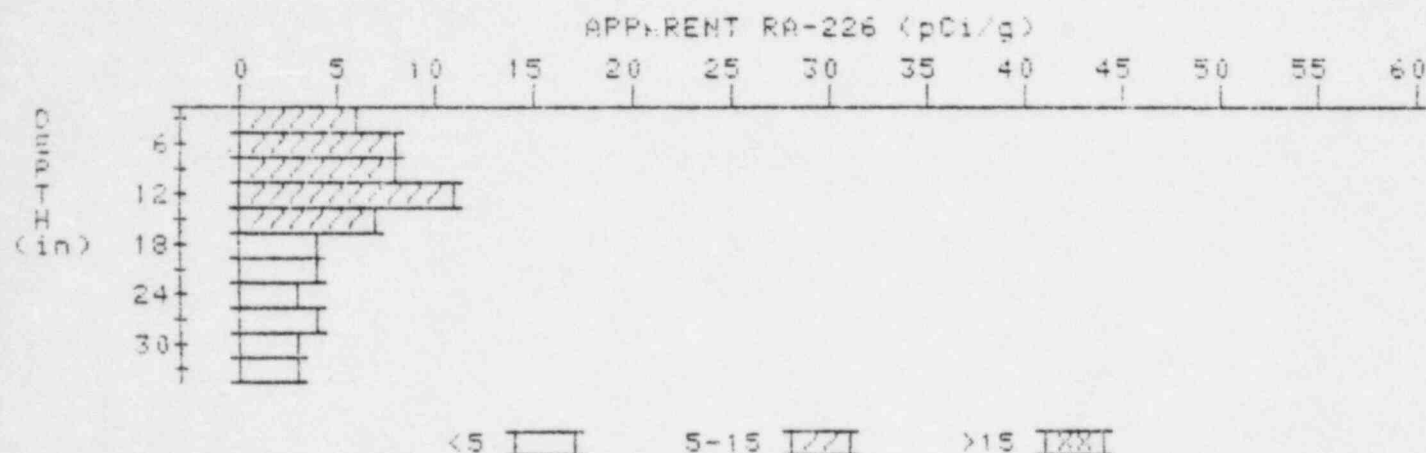
HOLE NUMBER: 5

Depth (in)	Apparent Radium-226 (pCi/g) Undeconvolved	Apparent Radium-226 (pCi/g) Deconvolved
3	5.5	5.5
6	7.0	8.4
9	7.7	8.2
12	8.1	11.1
15	6.8	7.2
18	5.3	4.1
21	4.5	4.1
24	3.9	3.2
27	3.7	3.7
30	3.5	3.3
33	3.4	3.4

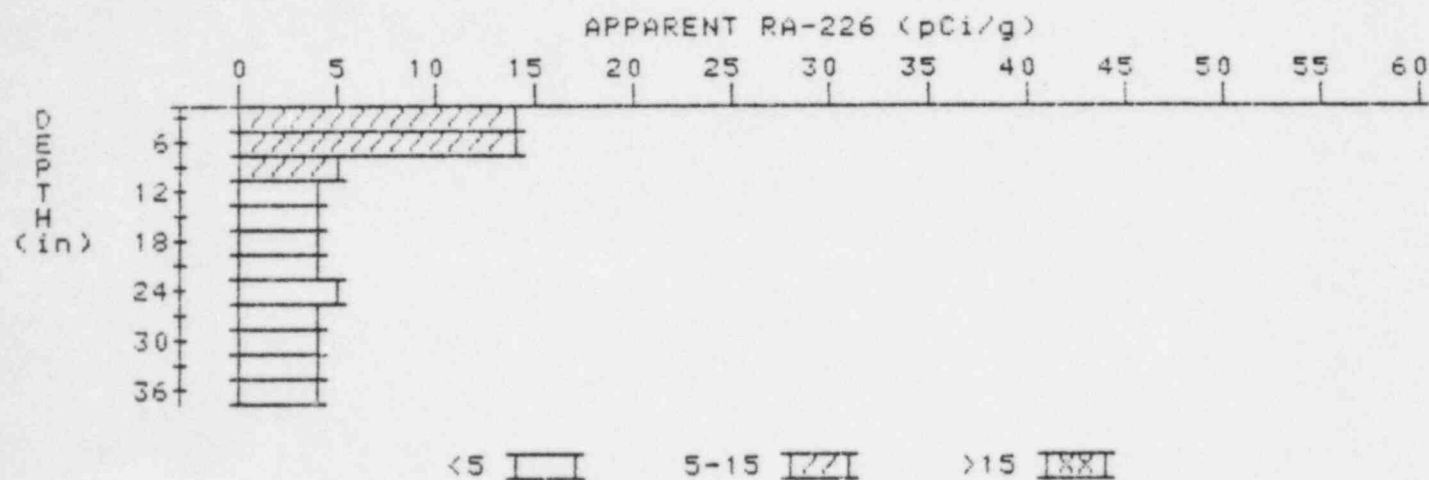
HOLE NUMBER: 7

Depth (in)	Apparent Radium-226 (pCi/g) Undeconvolved	Apparent Radium-226 (pCi/g) Deconvolved
3	13.7	13.7
6	11.5	13.8
9	8.0	5.3
12	6.0	4.2
15	5.0	4.3
18	4.4	3.7
21	4.2	3.8
24	4.2	4.6
27	4.0	3.8
30	3.9	4.1
33	3.7	3.5
36	3.6	3.6

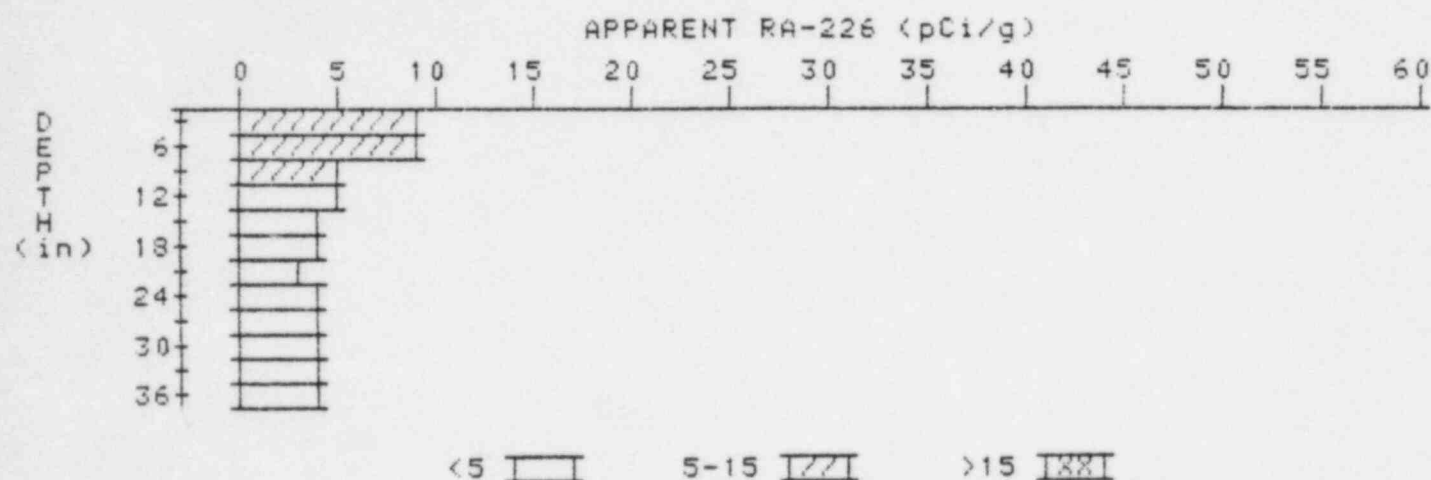
HOLE NUMBER: 9

Depth (in)	Apparent Radium-226 (pCi/g) Undeconvolved	Apparent Radium-226 (pCi/g) Deconvolved
3	8.9	8.9
6	7.9	9.0
9	6.3	5.2
12	5.3	4.8
15	4.6	3.9
18	4.3	4.3
21	4.0	3.5
24	4.0	4.2
27	3.9	3.9
30	3.8	3.8
33	3.7	3.7
36	3.6	3.6

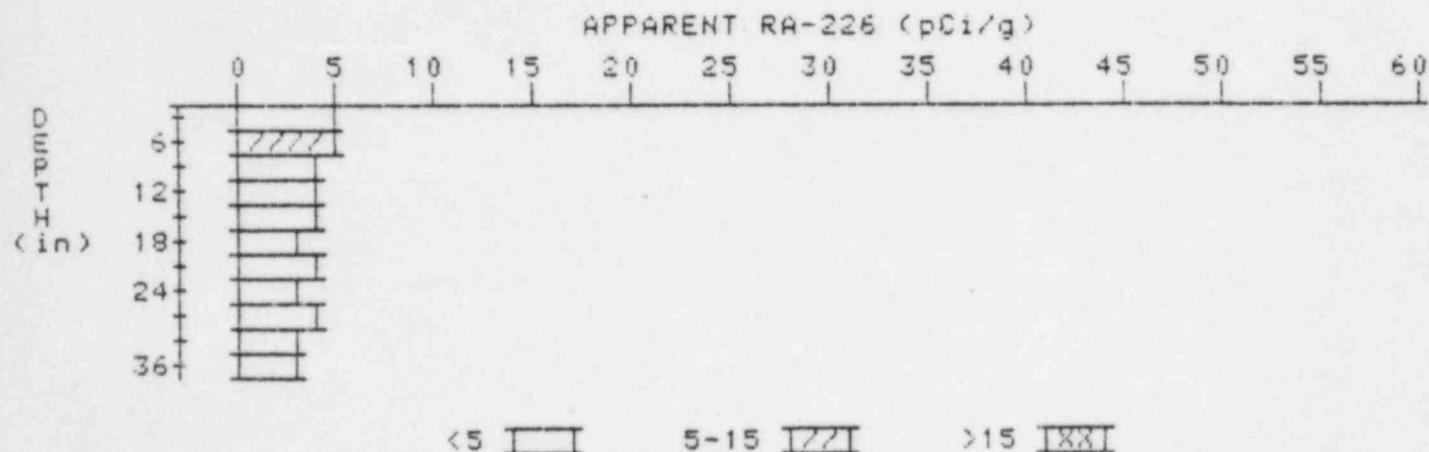
PROPERTY NUMBER: GJ-13970-MR  
HOLE NUMBER: 10  
LOCATION: 155281

Depth (in)	Apparent Radium-226 (pCi/g) Undeconvolved	Apparent Radium-226 (pCi/g) Deconvolved
3	4.9	4.9
6	4.7	5.1
9	4.3	3.9
12	4.1	3.9
15	4.0	4.2
18	3.8	3.4
21	3.8	4.2
24	3.6	3.2
27	3.6	4.1
33	3.3	2.9
36	3.2	3.2

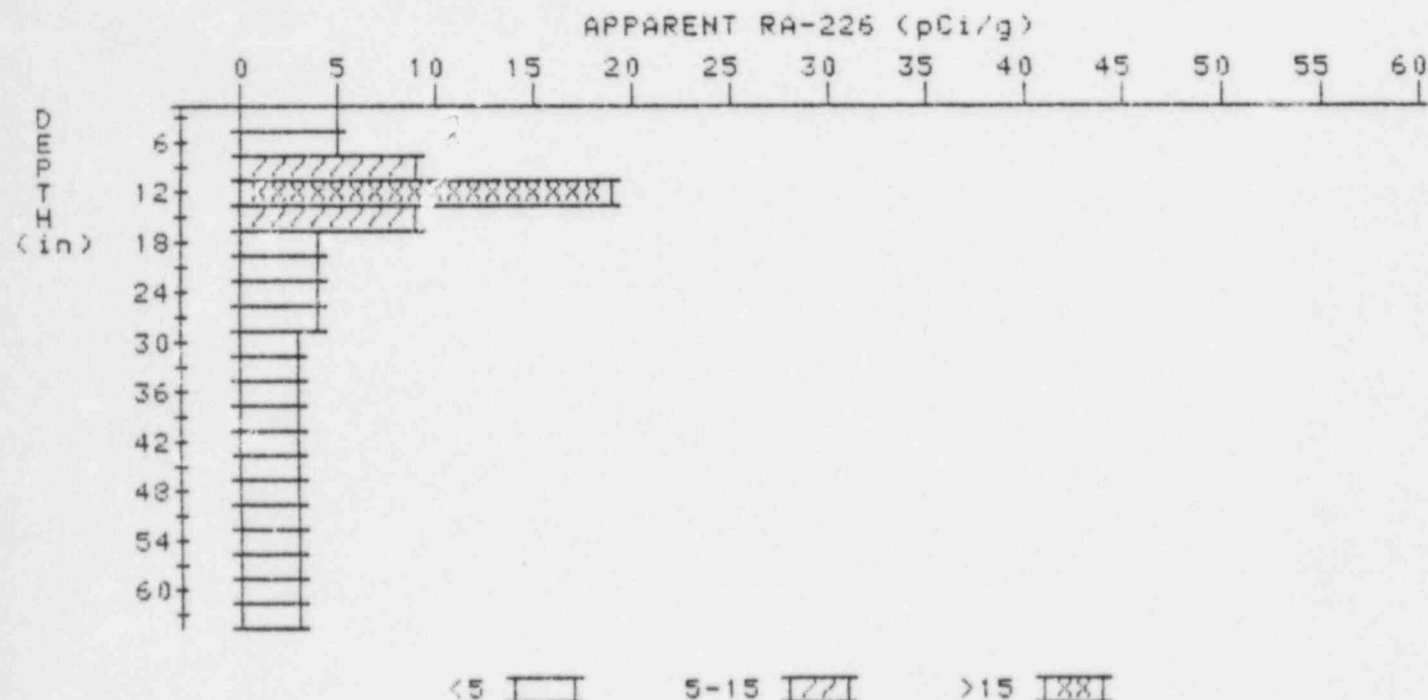
PROPERTY NUMBER: GJ-13970-MR  
HOLE NUMBER: 13  
LOCATION: 186250

Depth (in)	Apparent Radium-226 (pCi/g) Undeconvolved	Apparent Radium-226 (pCi/g) Deconvolved
3	4.9	4.9
6	6.4	4.8
9	8.8	9.3
12	10.9	18.9
15	8.5	8.7
18	6.0	3.7
21	4.8	3.7
24	4.2	3.7
27	3.9	3.9
30	3.6	3.4
33	3.4	3.2
36	3.3	3.5
39	3.2	3.2
42	3.1	2.9
45	3.1	3.1
48	3.1	2.9
51	3.2	3.2

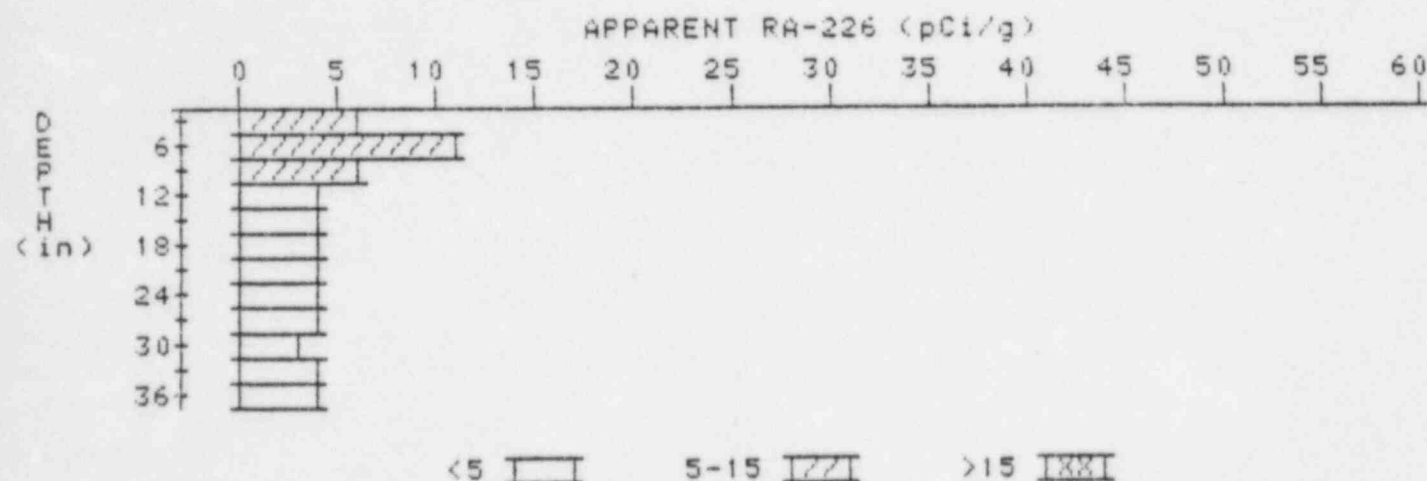
HOLE NUMBER: 14

Depth (in)	Apparent Radium-226 (pCi/g) Undeconvolved	Apparent Radium-226 (pCi/g) Deconvolved
3	6.3	6.3
6	7.3	10.9
9	6.3	6.5
12	5.2	4.3
15	4.6	4.1
18	4.3	3.9
21	4.2	4.4
24	4.0	3.8
27	3.9	4.1
30	3.7	3.3
33	3.7	3.9
36	3.6	3.6

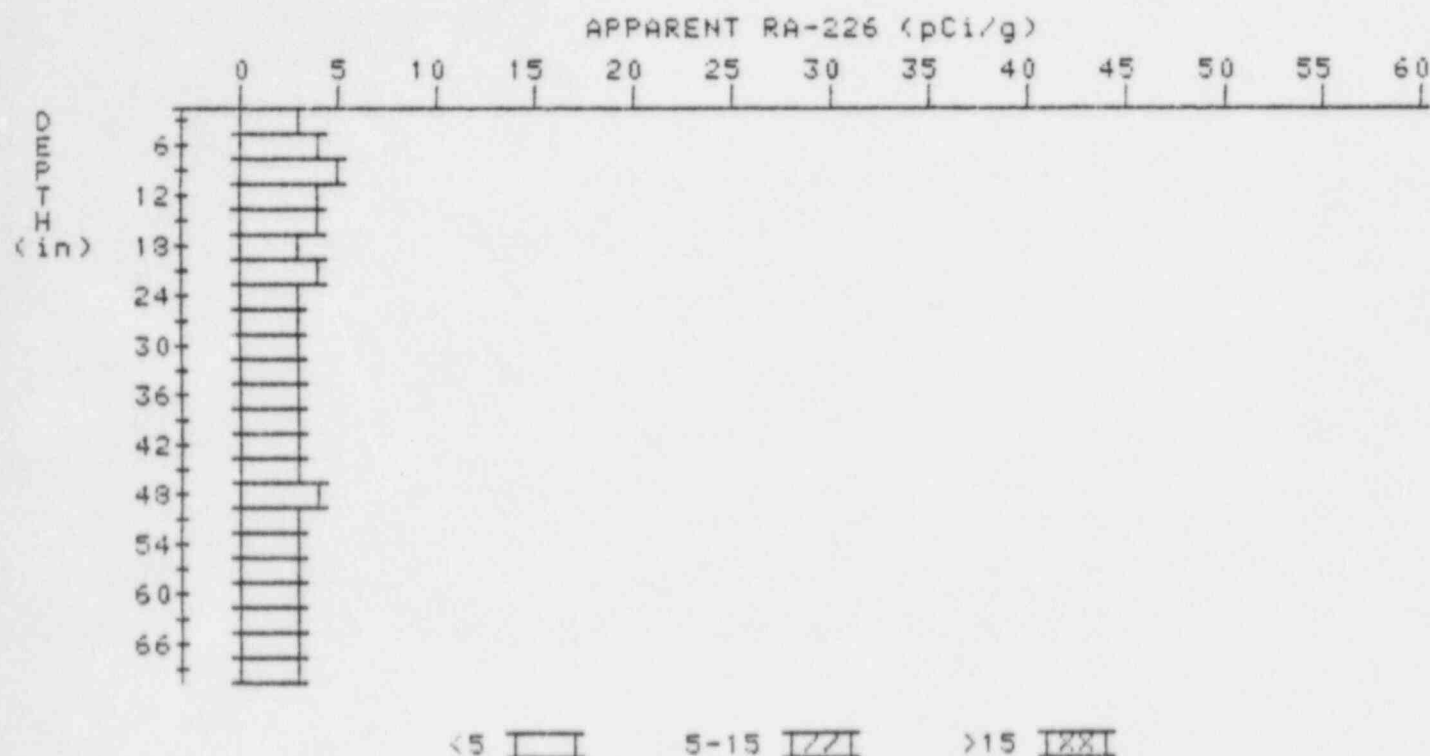
PROPERTY NUMBER: GJ-13970-MR  
HOLE NUMBER: 15  
LOCATION: 190290

Depth (in)	Apparent Radium-226 (pCi/g) Undeconvolved	Apparent Radium-226 (pCi/g) Deconvolved
3	3.3	3.3
6	3.7	3.9
9	4.0	4.7
12	3.9	3.9
15	3.8	4.0
18	3.6	3.4
21	3.5	3.5
24	3.4	3.4
27	3.3	3.5
30	3.1	2.7
33	3.1	3.3
36	3.0	2.8
39	3.0	3.2
42	2.9	3.5
45	3.0	3.0

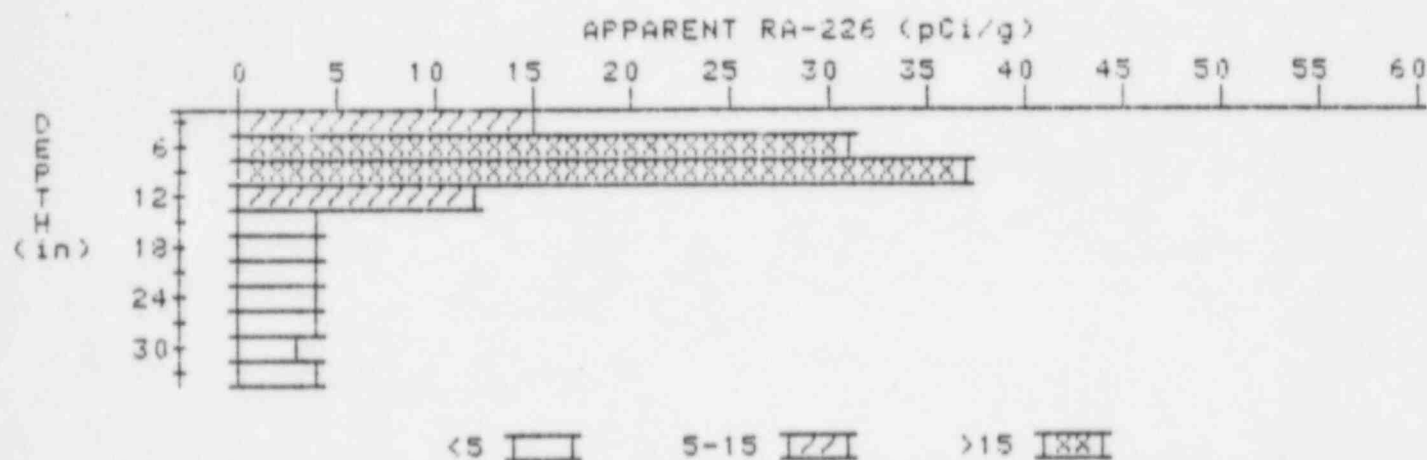
HOLE NUMBER: 16

Depth (in)	Apparent Radium-226 (pCi/g) Undeconvolved	Apparent Radium-226 (pCi/g) Deconvolved
3	14.5	14.5
6	21.1	31.1
9	22.1	37.0
12	14.7	11.5
15	9.1	3.8
18	6.5	4.4
21	5.1	3.9
24	4.4	3.7
27	4.1	4.1
30	3.8	3.4
33	3.7	3.7

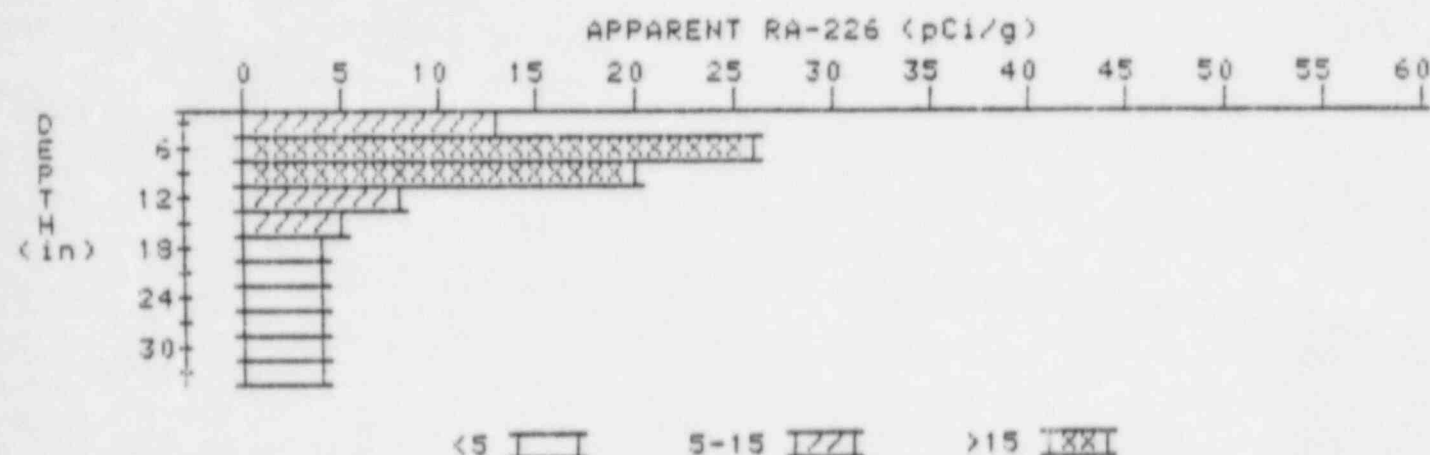
PROPERTY NUMBER: GJ-13970-ma  
HOLE NUMBER: 17  
LOCATION: 193229

Depth (in)	Apparent Radium-226 (pCi/g) Undeconvolved	Apparent Radium-226 (pCi/g) Deconvolved
3	12.7	12.7
6	16.7	26.5
9	15.2	20.4
12	10.8	8.5
15	7.7	5.4
18	5.9	4.5
21	4.9	4.2
24	4.3	3.6
27	4.1	4.1
30	3.9	3.5
33	3.9	3.9

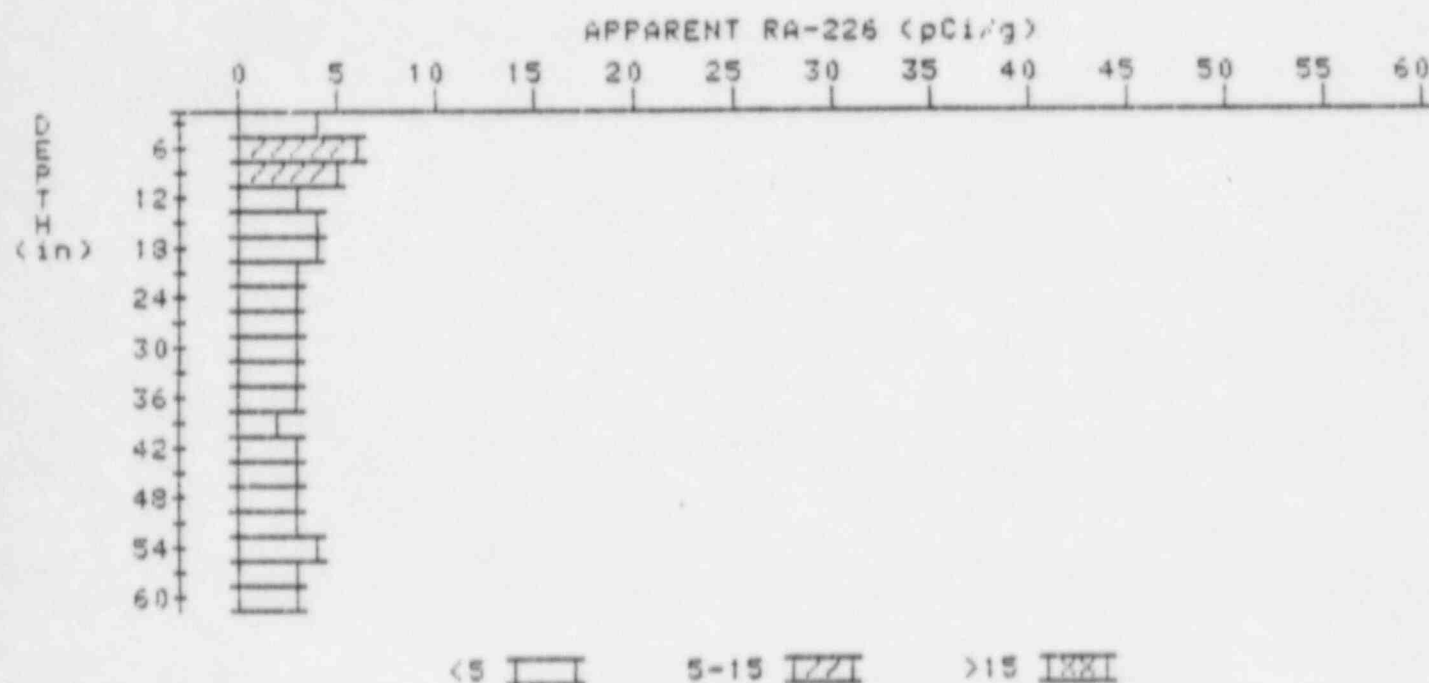
HOLE NUMBER: 18

Depth (in)	Apparent Radium-226 (pCi/g) Undeconvolved	Apparent Radium-226 (pCi/g) Deconvolved
3	3.6	3.6
6	4.3	5.5
9	4.3	5.0
12	3.9	3.4
15	3.8	4.0
18	3.6	3.6
21	3.4	3.4
24	3.2	3.0
27	3.1	3.1
30	3.0	2.8
33	3.0	3.2
36	2.9	2.9
39	2.8	2.4
42	2.9	3.1
45	2.9	2.7
48	3.0	2.8
51	3.2	3.2
54	3.4	3.9

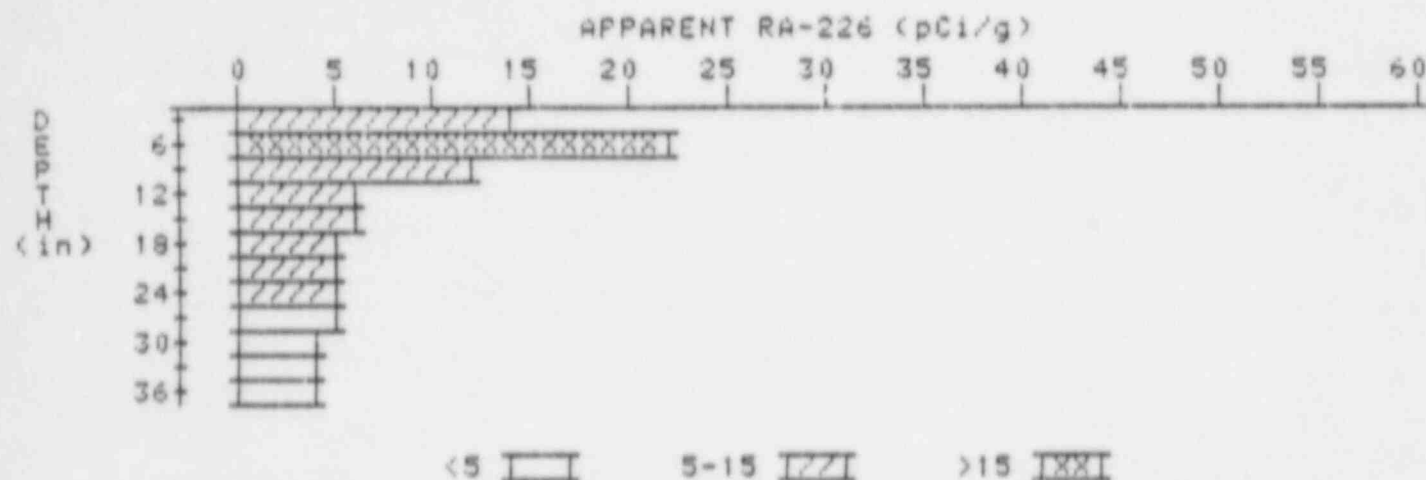
HOLE NUMBER: 19

Depth (in)	Apparent Radium-226 (pCi/g) Undeconvolved	Apparent Radium-226 (pCi/g) Deconvolved
3	14.1	14.1
6	14.9	22.0
9	11.7	11.7
12	8.5	5.7
15	6.9	5.7
18	6.0	5.3
21	5.5	5.3
24	5.1	5.1
27	4.7	4.5
30	4.4	4.0
33	4.3	4.5
36	4.1	4.1

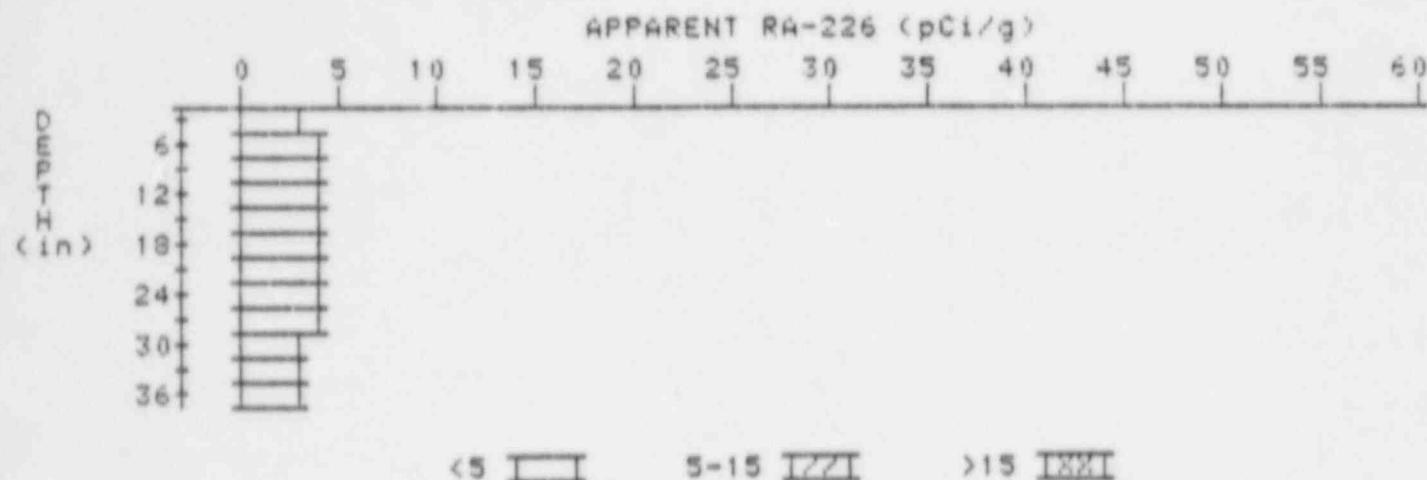
PROPERTY NUMBER: GJ-13970-mR  
HOLE NUMBER: 21  
LOCATION: 217215

Depth (in)	Apparent Radium-226 (pCi/g) Undeconvolved	Apparent Radium-226 (pCi/g) Deconvolved
3	3.0	3.0
6	3.6	4.3
9	3.8	4.0
12	3.9	4.1
15	3.9	4.1
18	3.8	3.6
21	3.8	4.0
24	3.7	3.7
27	3.6	3.8
30	3.4	3.4
33	3.2	3.0
36	3.1	3.1

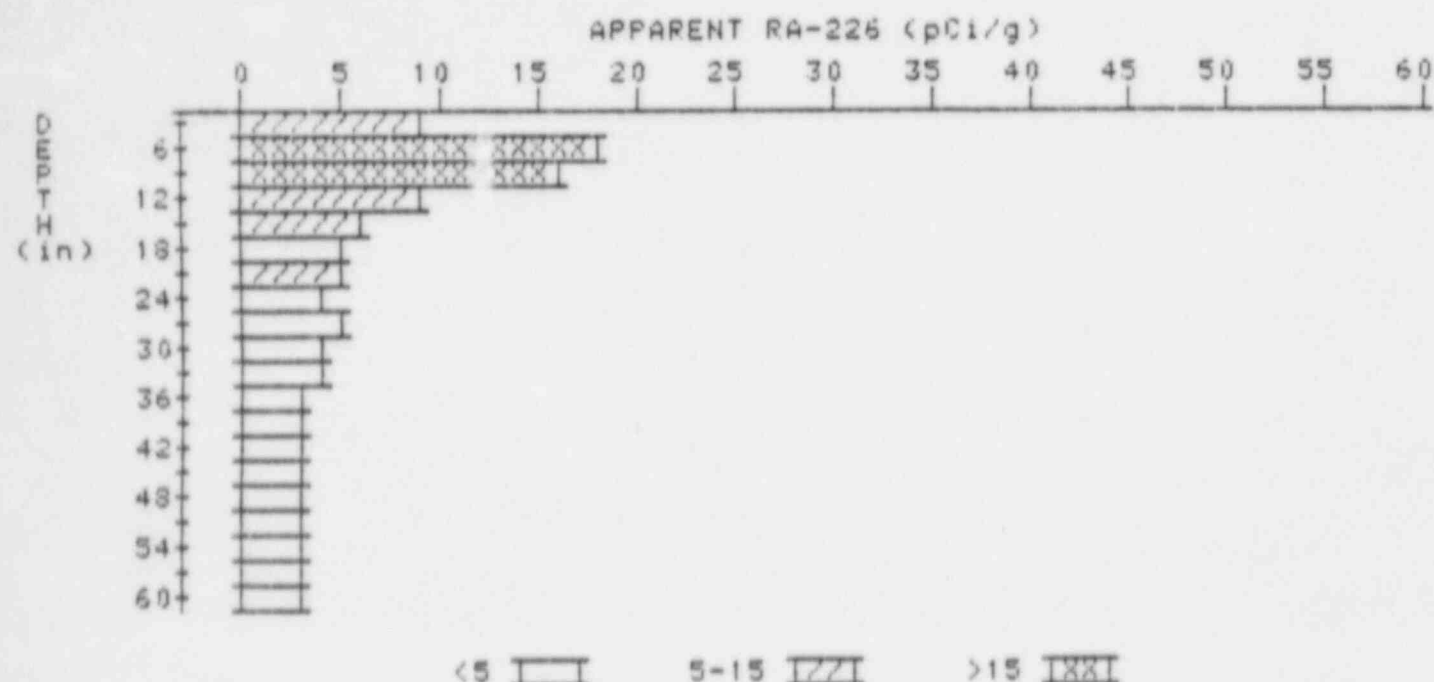
PROPERTY NUMBER: GJ-13970-Mx  
HOLE NUMBER: 22  
LOCATION: 230229

Depth (in)	Apparent Radium-226 (pCi/g)	Apparent Radium-226 (pCi/g)
	Undeconvolved	Deconvolved
3	9.1	9.1
6	12.1	17.6
9	12.0	16.3
12	9.5	9.0
15	7.3	5.7
18	6.0	4.9
21	5.3	5.3
24	4.6	3.7
27	4.4	4.0
30	4.0	3.8
33	3.7	3.7
36	3.4	3.2
39	3.2	3.0
42	3.1	3.1
45	3.0	2.8
48	3.0	2.8
51	3.1	3.5
54	3.0	2.6

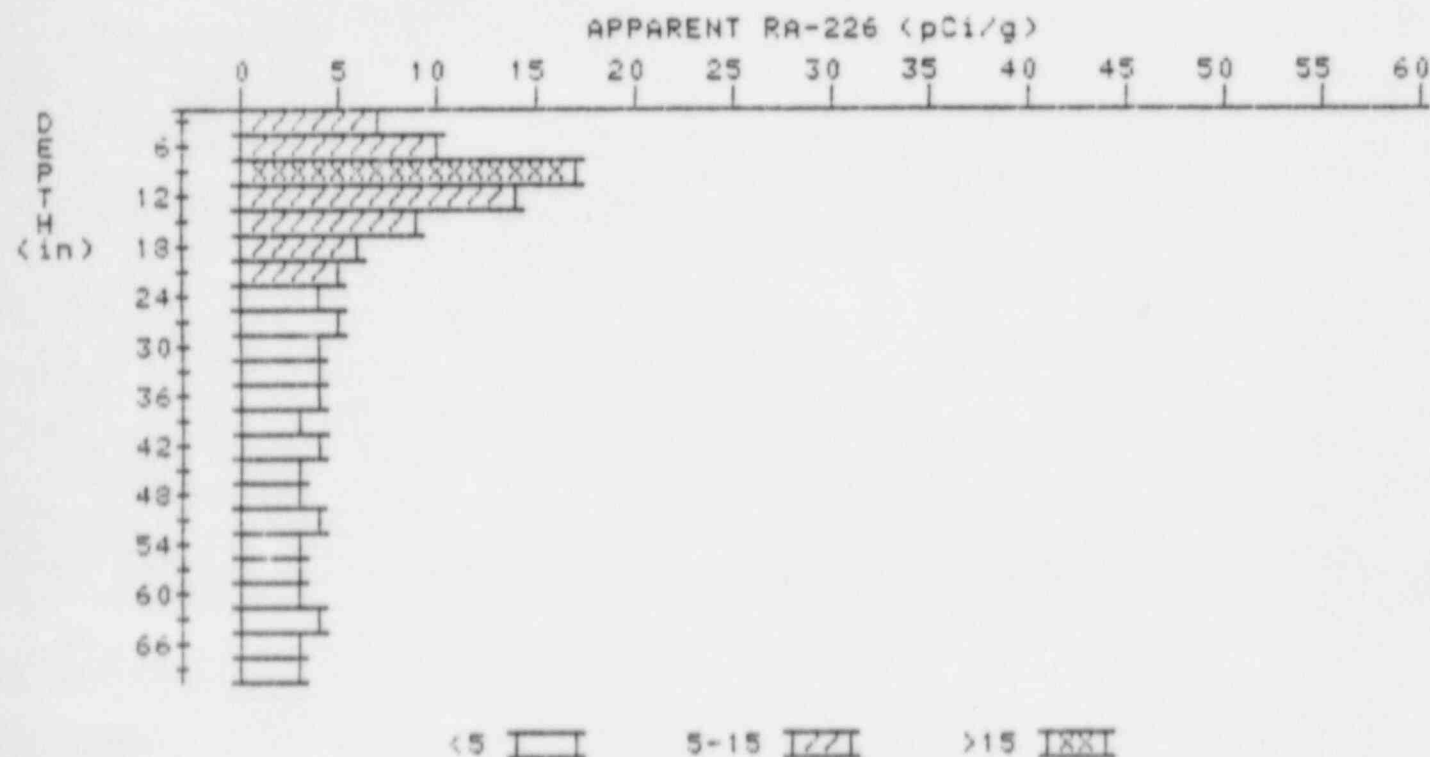
PROPERTY NUMBER: GJ-13970-MK  
HOLE NUMBER: 23  
LOCATION: 236232

Depth (in)	Apparent Radium-226 (pCi/g) Undeconvolved	Apparent Radium-226 (pCi/g) Deconvolved
3	6.8	6.8
6	9.5	10.4
9	11.7	16.5
12	11.2	13.9
15	9.2	9.0
18	7.3	6.2
21	6.0	5.1
24	5.2	4.5
27	4.8	4.6
30	4.5	4.3
33	4.3	4.3
36	4.1	4.3
39	3.8	3.4
42	3.7	3.9
45	3.5	3.3

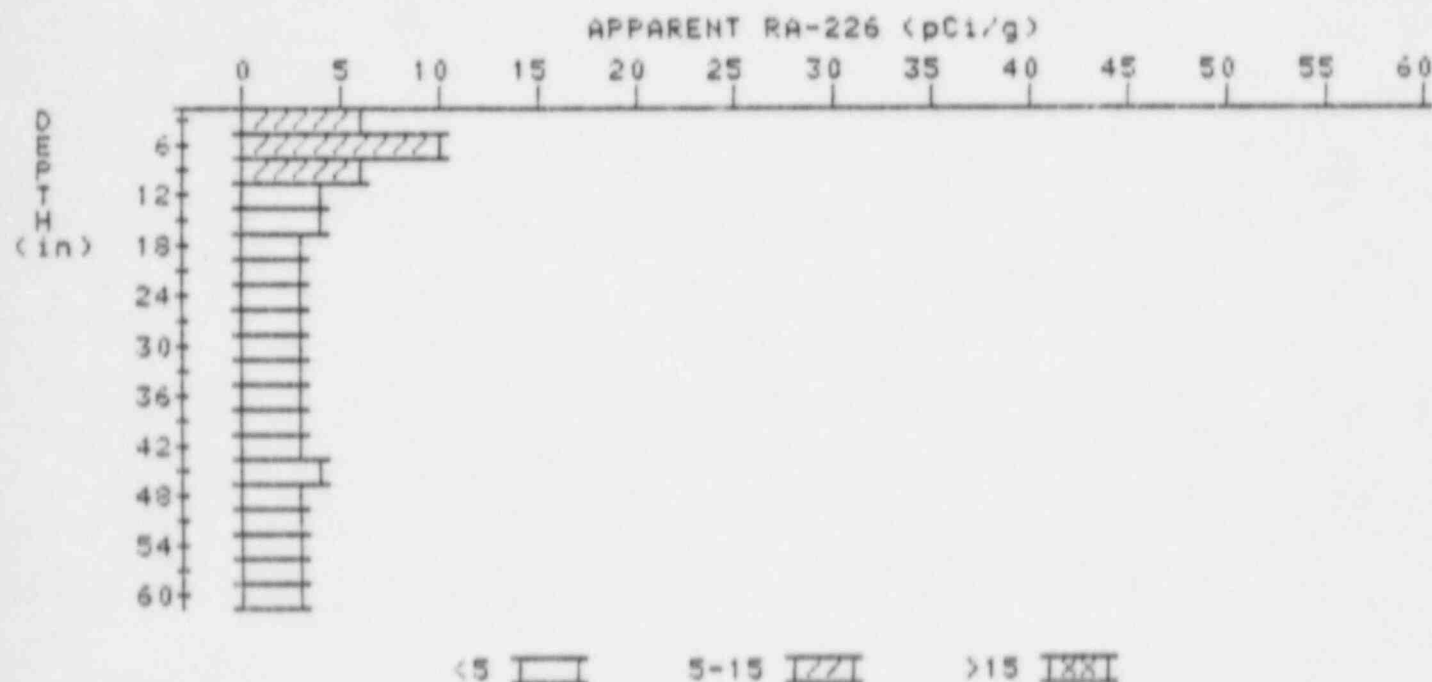
HOLE NUMBER: 24

Depth (in)	Apparent Radium-226 (pCi/g) Undeconvolved	Apparent Radium-226 (pCi/g) Deconvolved
3	5.5	5.5
6	6.5	9.9
9	5.6	5.6
12	4.7	4.2
15	4.1	3.7
18	3.7	3.3
21	3.5	3.3
24	3.4	3.4
27	3.3	3.5
30	3.1	2.9
33	3.0	2.8
36	3.0	2.8
39	3.1	3.3
42	3.1	2.7
45	3.3	3.8
48	3.2	3.0
51	3.2	3.2
54	3.2	3.0

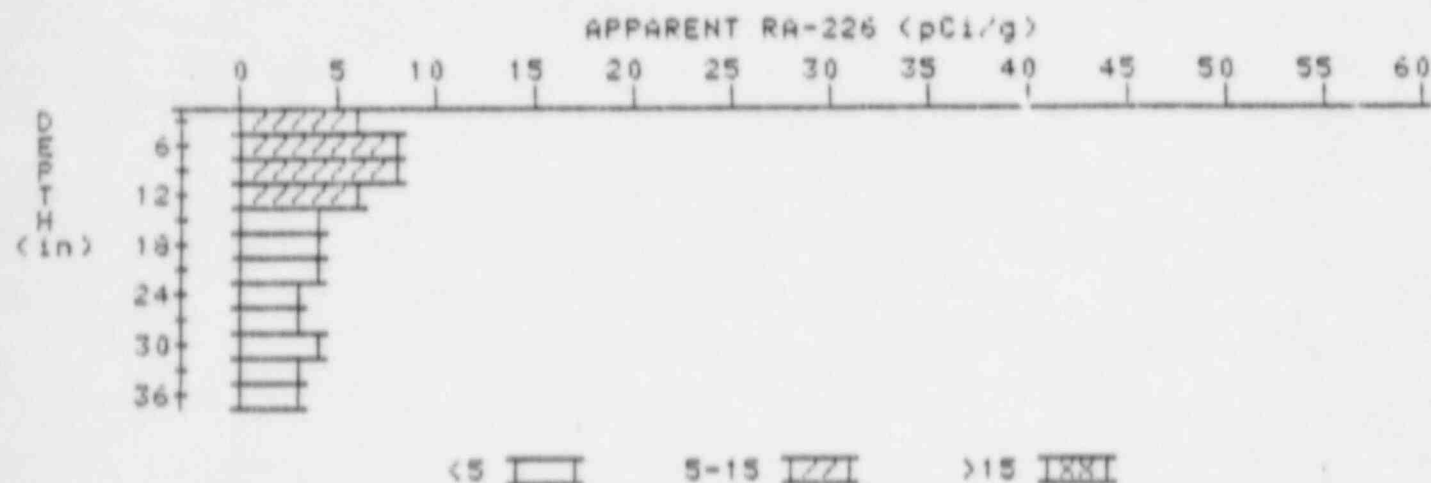
HOLE NUMBER: 25

Depth (in)	Apparent Radium-226 (pCi/g) Undeconvolved	Apparent Radium-226 (pCi/g) Deconvolved
3	6.4	6.4
6	7.0	8.2
9	6.9	8.3
12	6.0	6.2
15	5.0	4.1
18	4.5	4.1
21	4.2	4.4
24	3.8	3.4
27	3.6	3.4
30	3.5	3.7
33	3.3	2.9
36	3.2	3.3

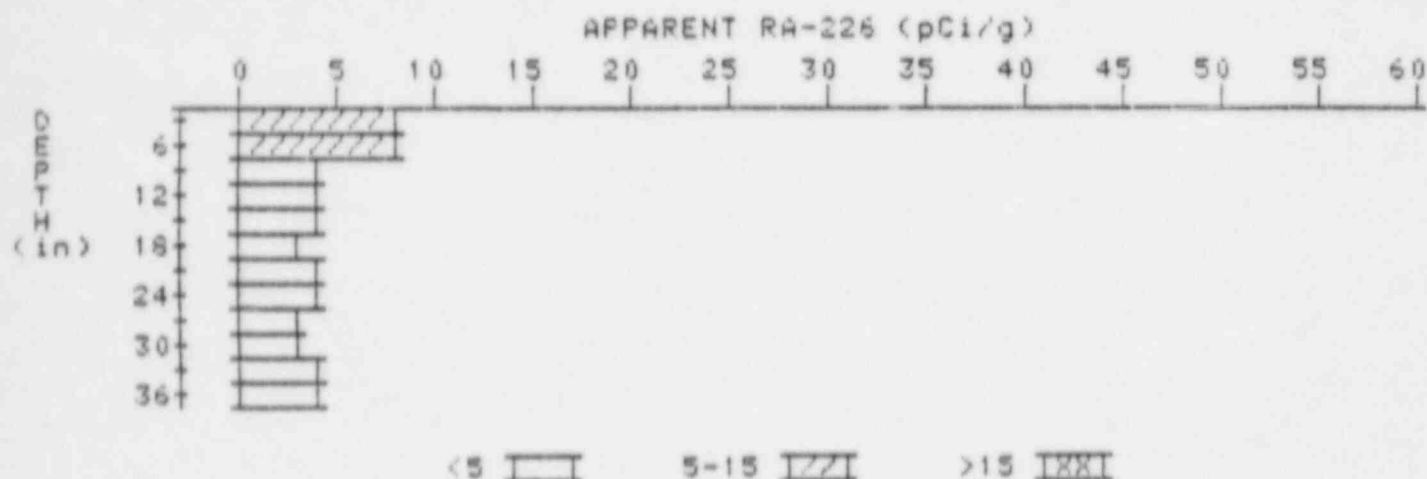
PROPERTY NUMBER: GJ-13970-MK  
HOLE NUMBER: 26  
LOCATION: 290265

Depth (in)	Apparent Radium-226 (pCi/g) Undeconvolved	Apparent Radium-226 (pCi/g) Deconvolved
3	7.9	7.9
6	7.0	6.2
9	5.5	4.4
12	4.6	3.9
15	4.1	3.9
18	3.7	3.0
21	3.7	3.9
24	3.6	3.6
27	3.5	3.3
30	3.5	3.3
33	3.6	4.0
36	3.8	3.8

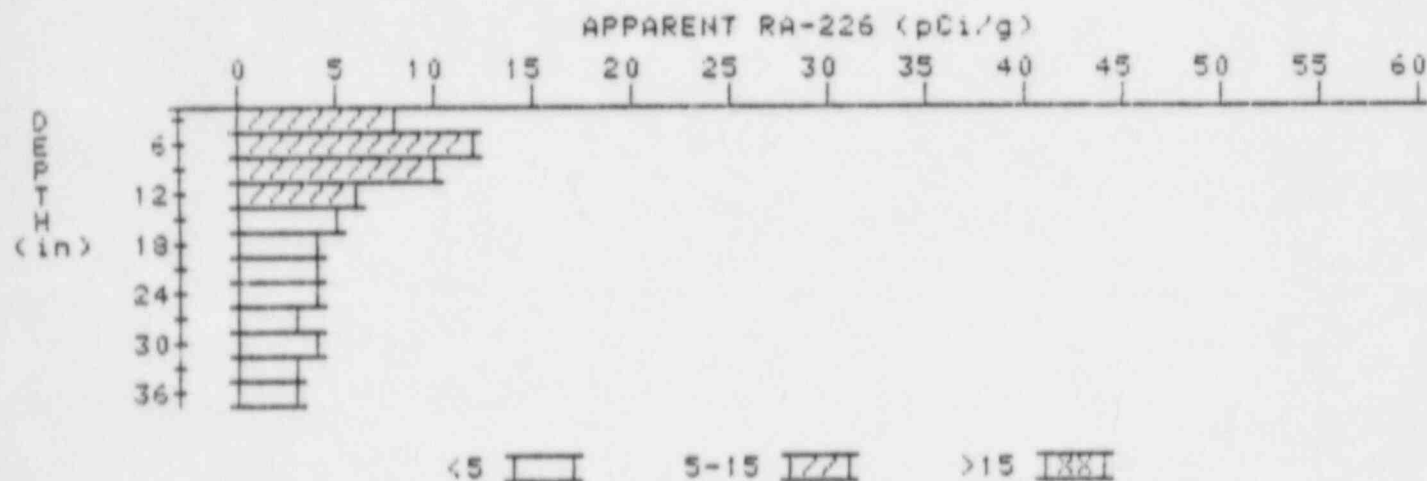
PROPERTY NUMBER: GJ-13970-MK  
HOLE NUMBER: 27  
LOCATION: 300240

Depth (in)	Apparent Radium-226 (pCi/g) Undeconvolved	Apparent Radium-226 (pCi/g) Deconvolved
3	7.6	7.6
6	8.7	11.9
9	8.0	9.6
12	6.4	5.5
15	5.3	4.6
18	4.6	4.2
21	4.1	3.7
24	3.8	3.6
27	3.6	3.4
30	3.5	3.3
33	3.4	3.2
36	3.4	3.4

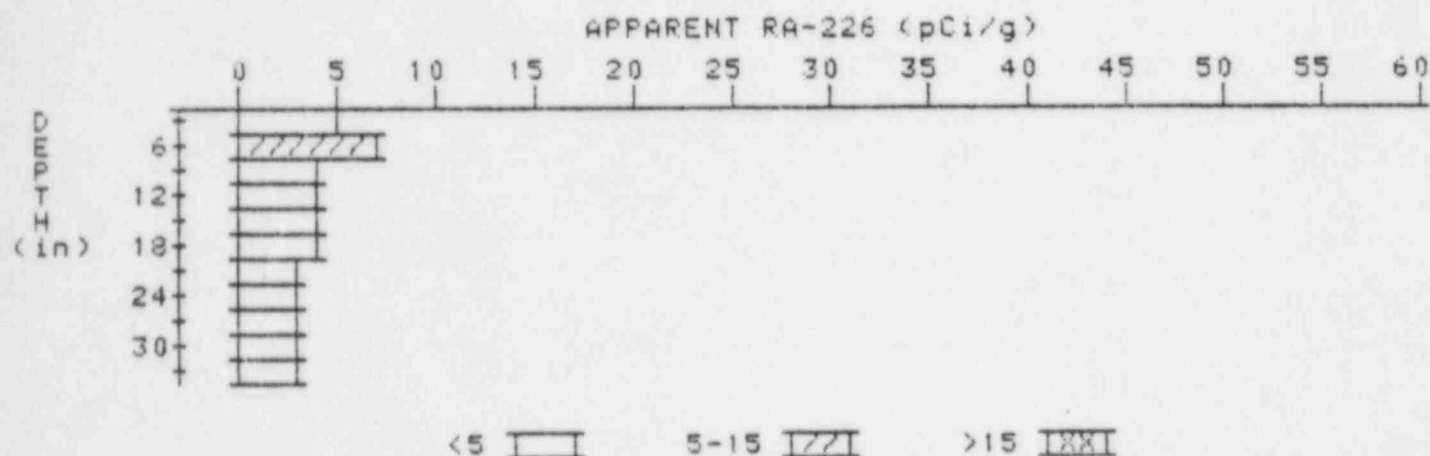
PROPERTY NUMBER: GJ-13970-MK  
HOLE NUMBER: 28  
LOCATION: 300275

Depth (in)	Apparent Radium-226 (pCi/g) Undeconvolved	Apparent Radium-226 (pCi/g) Deconvolved
3	4.9	4.9
6	5.2	7.0
9	4.5	4.0
12	4.1	3.9
15	3.8	3.6
18	3.6	3.6
21	3.4	3.2
24	3.3	3.1
27	3.3	3.3
30	3.3	3.3
33	3.3	3.3

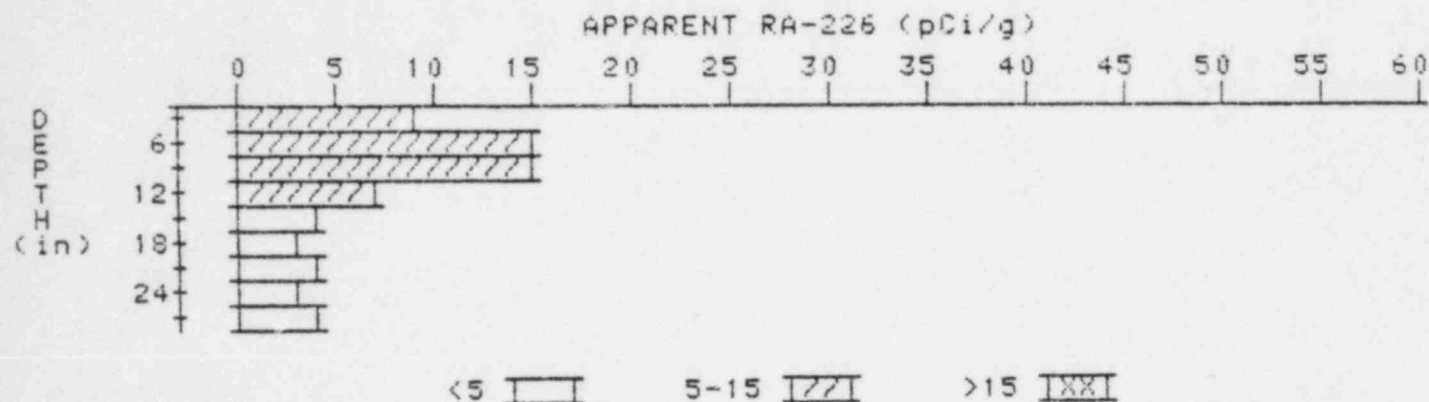
PROPERTY NUMBER: GJ-13970-MR  
HOLE NUMBER: 29  
LOCATION: 310255

Depth (in)	Apparent Radium-226 (pCi/g) Undeconvolved	Apparent Radium-226 (pCi/g) Deconvolved
3	8.8	8.8
6	10.8	14.9
9	10.5	14.6
12	7.9	7.4
15	5.6	3.6
18	4.4	3.2
21	3.9	3.5
24	3.6	3.2
27	3.5	3.5

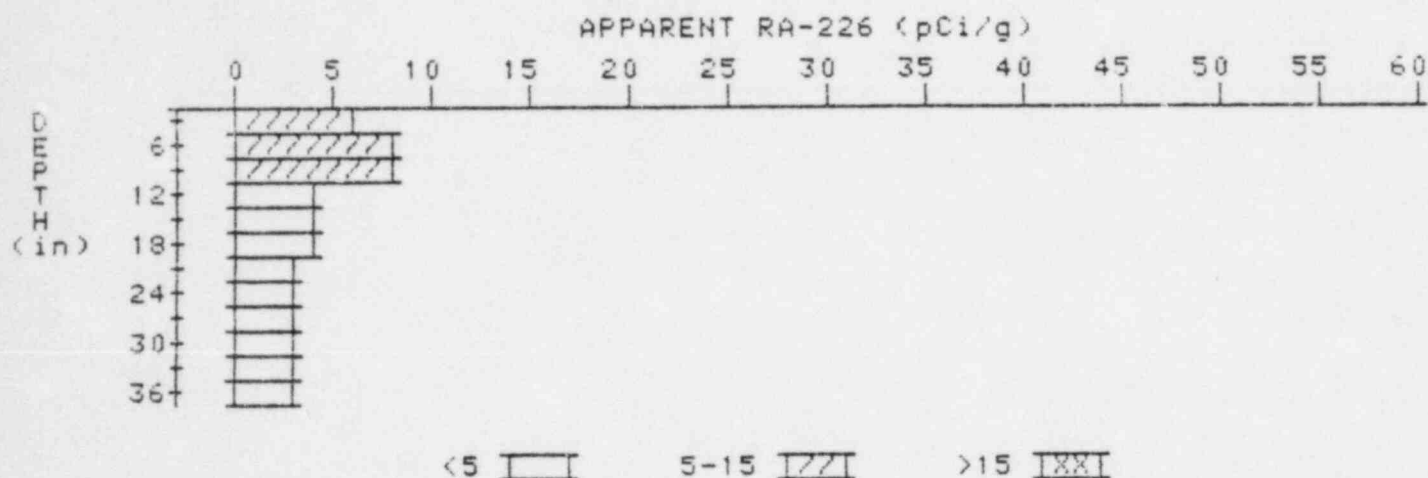
PROPERTY NUMBER: GJ-13970-MR  
HOLE NUMBER: 30  
LOCATION: 315230

Depth (in)	Apparent Radium-226 (pCi/g) Undeconvolved	Apparent Radium-226 (pCi/g) Deconvolved
3	6.1	6.1
6	6.6	8.2
9	6.2	7.6
12	5.0	4.1
15	4.3	3.8
18	3.9	3.9
21	3.5	3.1
24	3.3	3.3
27	3.1	2.7
30	3.1	3.3
33	3.0	2.8
36	3.0	3.0

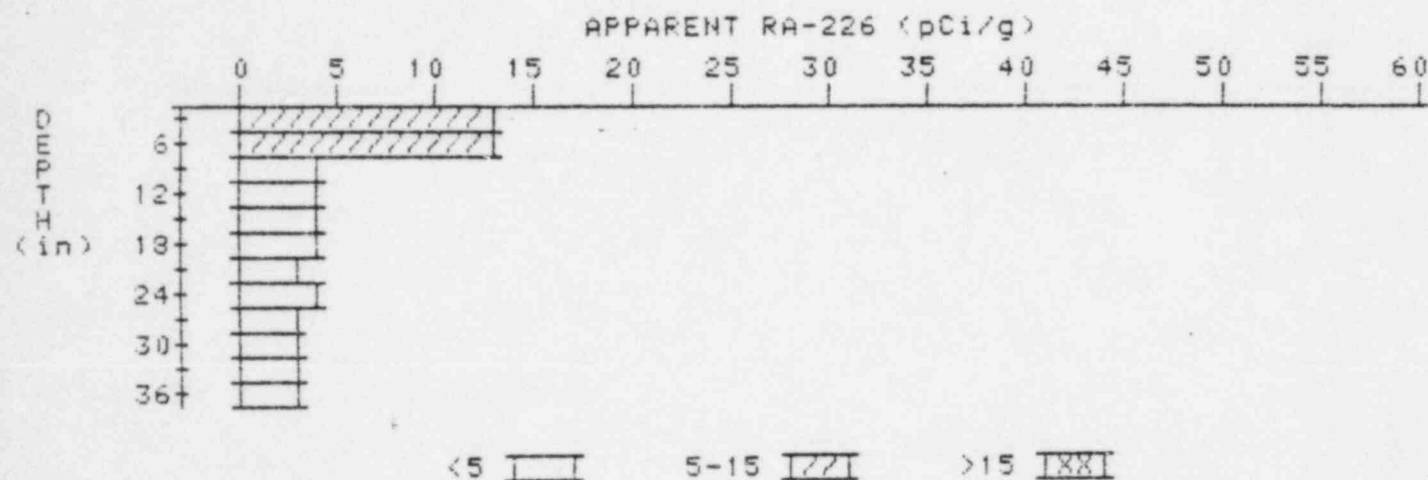
PROPERTY NUMBER: GJ-13970-MK  
HOLE NUMBER: 31  
LOCATION: 335240

Depth (in)	Apparent Radium-226 (pCi/g) Undeconvolved	Apparent Radium-226 (pCi/g) Deconvolved
3	12.8	12.8
6	10.6	12.6
9	7.3	4.5
12	5.6	4.4
15	4.6	3.7
18	4.1	3.9
21	3.7	3.3
24	3.5	3.5
27	3.3	3.1
30	3.2	3.0
33	3.2	3.2
36	3.2	3.2

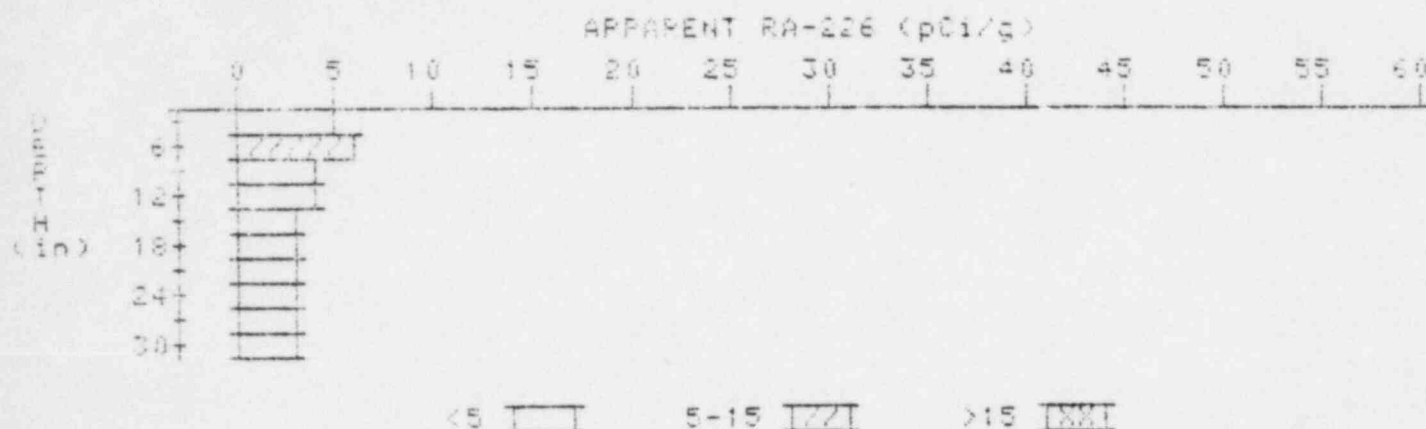
PROPERTY NUMBER: GJ-13970-MR  
HOLE NUMBER: 32  
LOCATION: 355250

Depth (in)	Apparent Radium-226 (pCi/g) Undeconvolved	Apparent Radium-226 (pCi/g) Deconvolved
0	4.6	4.6
6	4.6	6.0
12	4.6	4.1
18	3.9	3.7
24	3.6	3.4
30	3.4	3.4
36	3.2	3.0
42	3.1	3.1
48	3.0	2.6
54	3.1	3.1

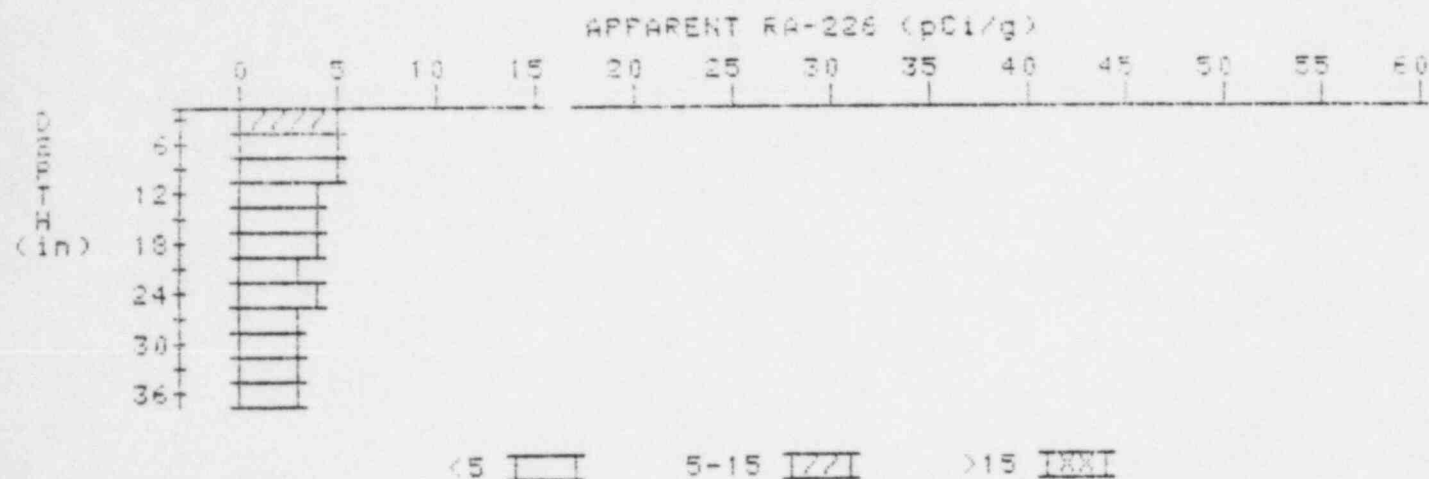
PROPERTY NUMBER: GJ-13970-MK  
HOLE NUMBER: 33  
LOCATION: 251235

Depth (in)	Apparent Radium-226 (pCi/g) Undeconvolved	Apparent Radium-226 (pCi/g) Deconvolved
3	5.0	5.0
6	4.8	5.0
9	4.5	4.7
12	4.1	3.7
15	3.9	3.7
18	3.8	4.0
21	3.6	3.4
24	3.5	3.5
27	3.4	3.4
30	3.3	3.1
33	3.3	3.1
36	3.4	3.4

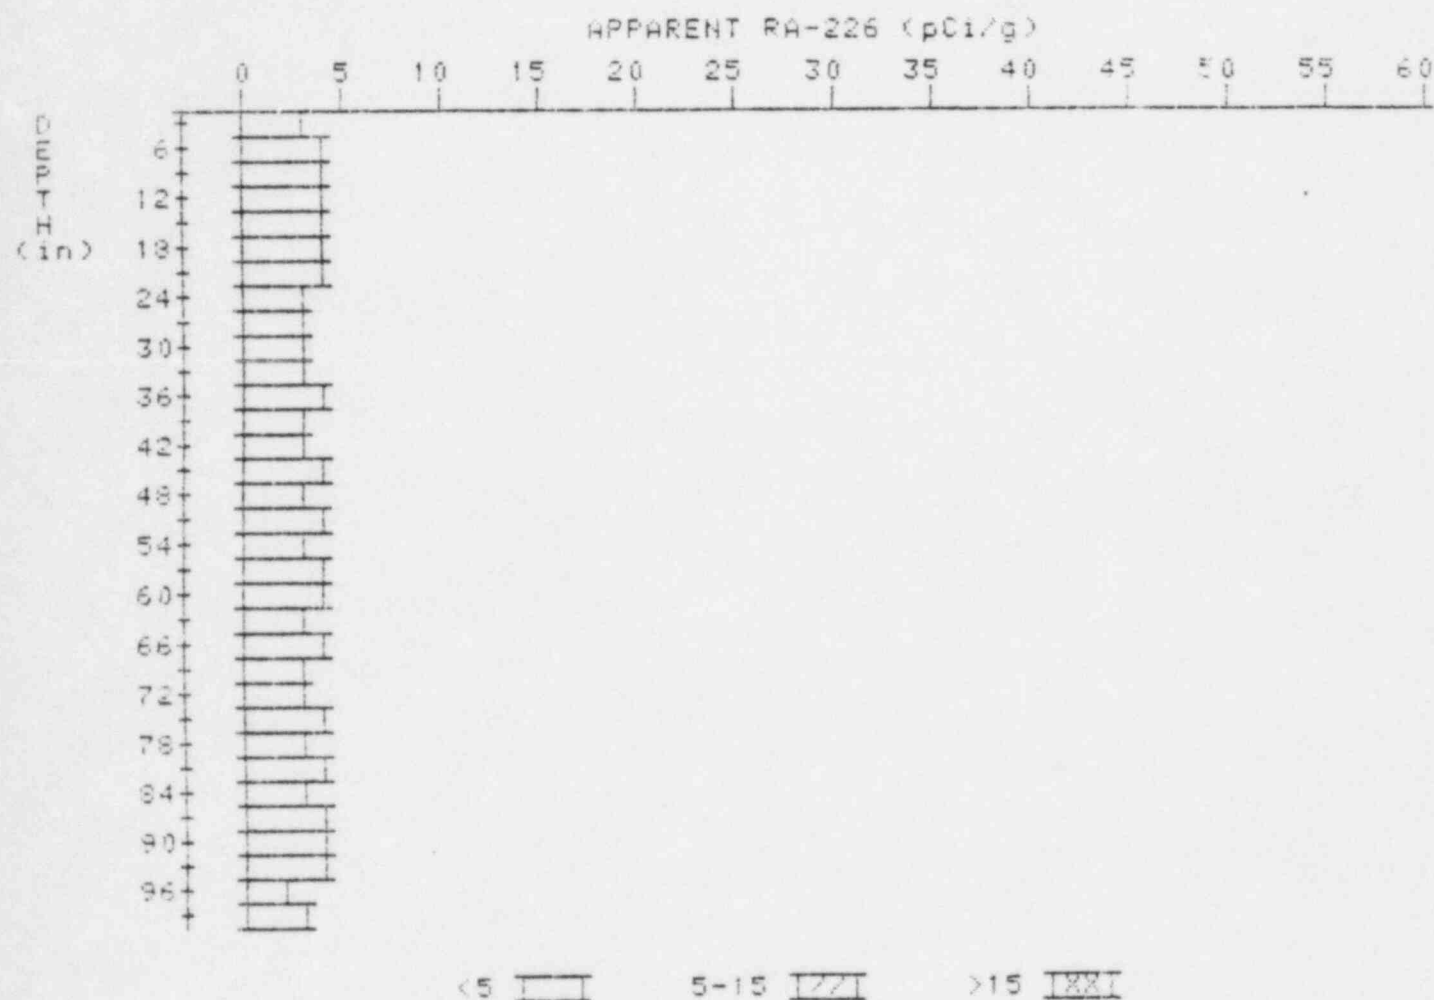
PROPERTY NUMBER: GJ-13970-MR  
HOLE NUMBER: 34  
LOCATION: 300240

Depth (in)	Apparent Radium-226 (pCi/g) Undeconvolved	Apparent Radium-226 (pCi/g) Deconvolved
3	3.1	3.1
6	3.5	3.9
9	3.7	4.1
12	3.7	3.7
15	3.7	3.9
18	3.6	3.6
21	3.5	3.5
24	3.4	3.2
