MUDFLOW HAZARDS ALONG THE TOUTLE AND COWLITZ RIVERS FROM
A HYPOTHETICAL FAILURE OF SPIRIT LAKE BLOCKAGE

Water-Resources Investigations Report 82-4125

MOUNT ST. HELENS RECOVERY OPERATIONS

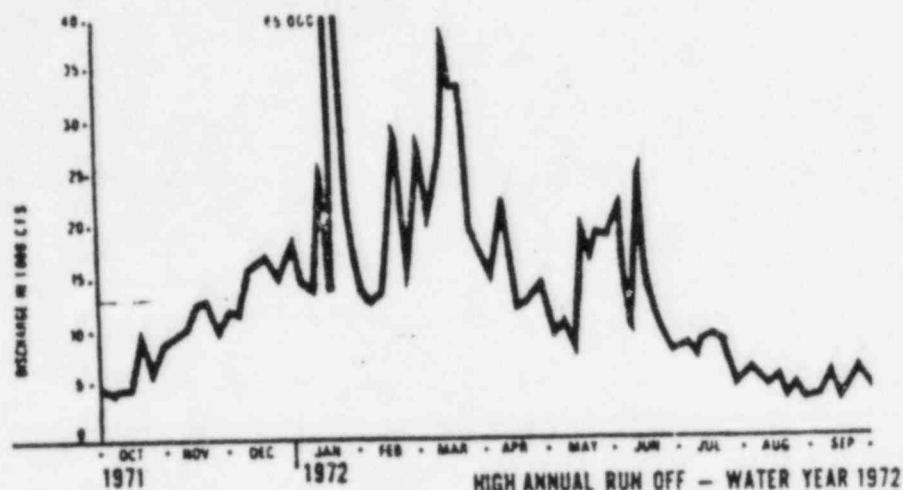
Figure 5 Potential for Flooding on the Cowlitz River

COWLITZ RIVER RUN OFF — COWLITZ RIVER AT CASTLE ROCK
