AN ASSESSMENT OF THE TMI-2 AXIAL POWER

SHAPING ROD DYNAMIC TEST RESULTS

Published April 1983

EG&G Idaho, Inc.
Idaho Falls, Idaho 83415

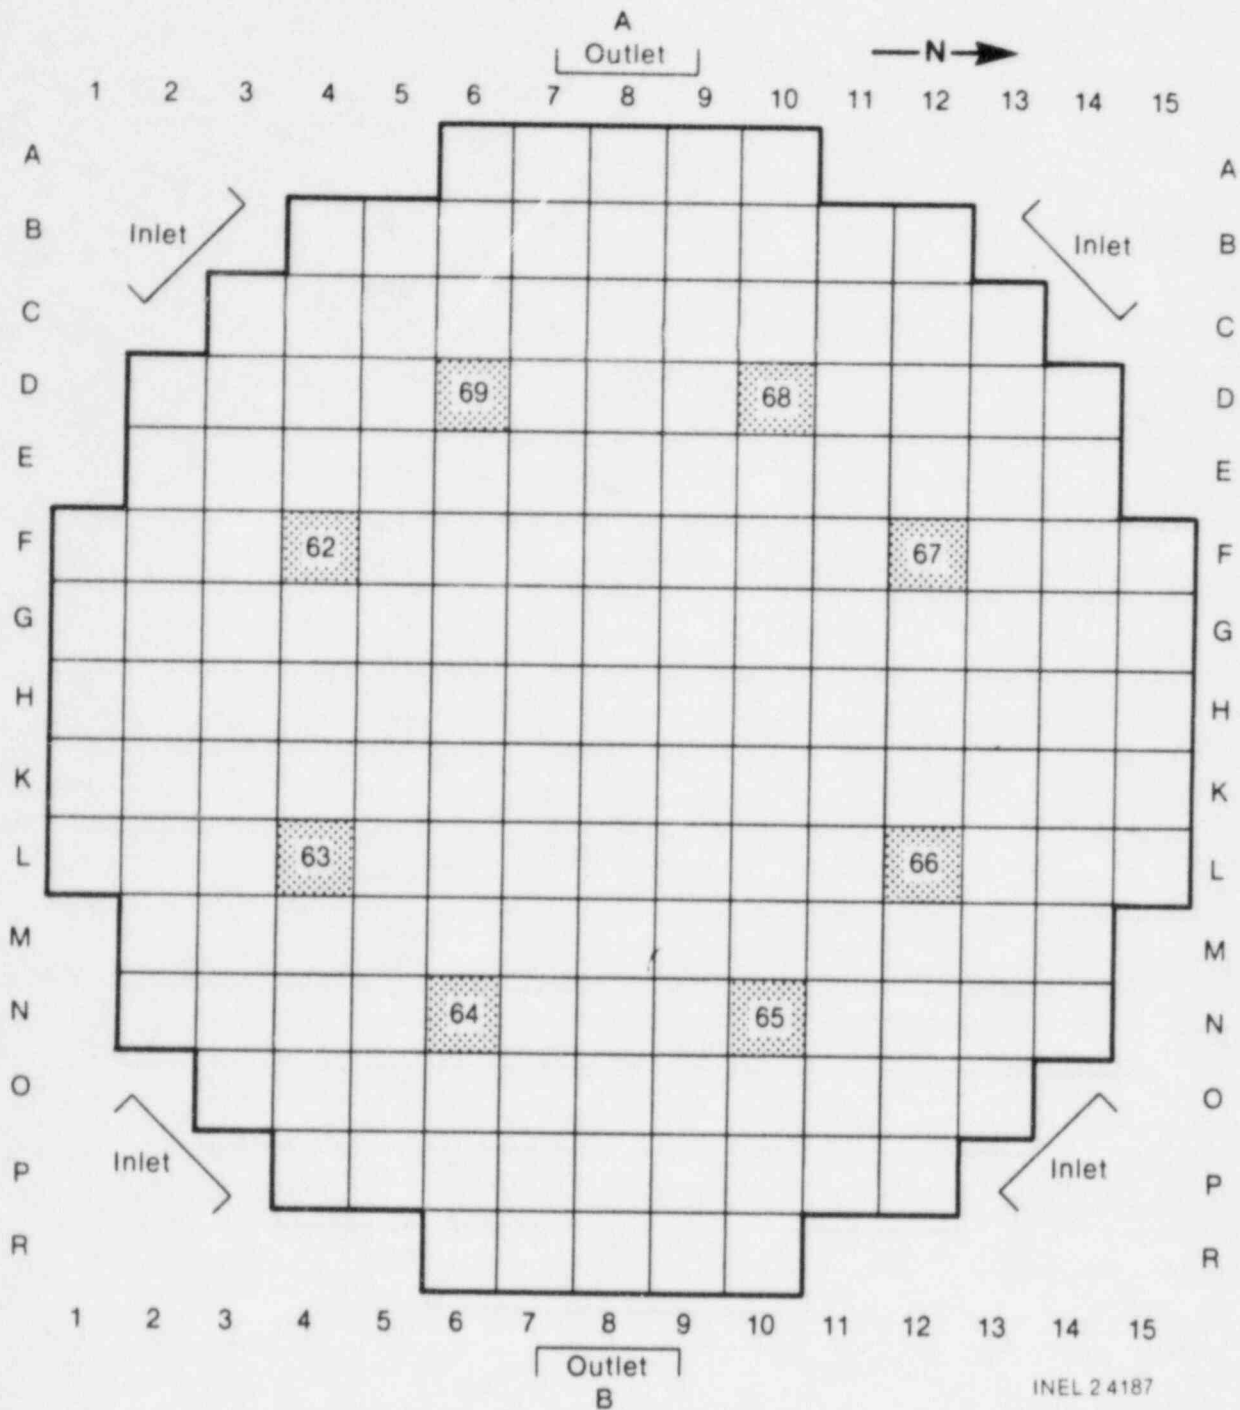
Figure 1. Diagram of TMI-2 core cross section, showing grid locations of the eight axial power shaping rod assemblies.

In addition to 61 control rods assemblies, the TMI-2 reactor contains eight axial power shaping rod assemblies (APSRs) that are used to adjust the axial power shape for efficient fuel utilization throughout core lifetime. The APSRs are distributed symmetrically around the reactor core in the positions numbered 62 through 69, and are located as shown in Figure 1. Each APSR assembly contains 16 stainless steel clad silver, indium, cadmium shaping rods attached to a common spider, as shown in Figure 2. Each APSR is inserted into a fuel assembly through guide tubes located within the assembly.

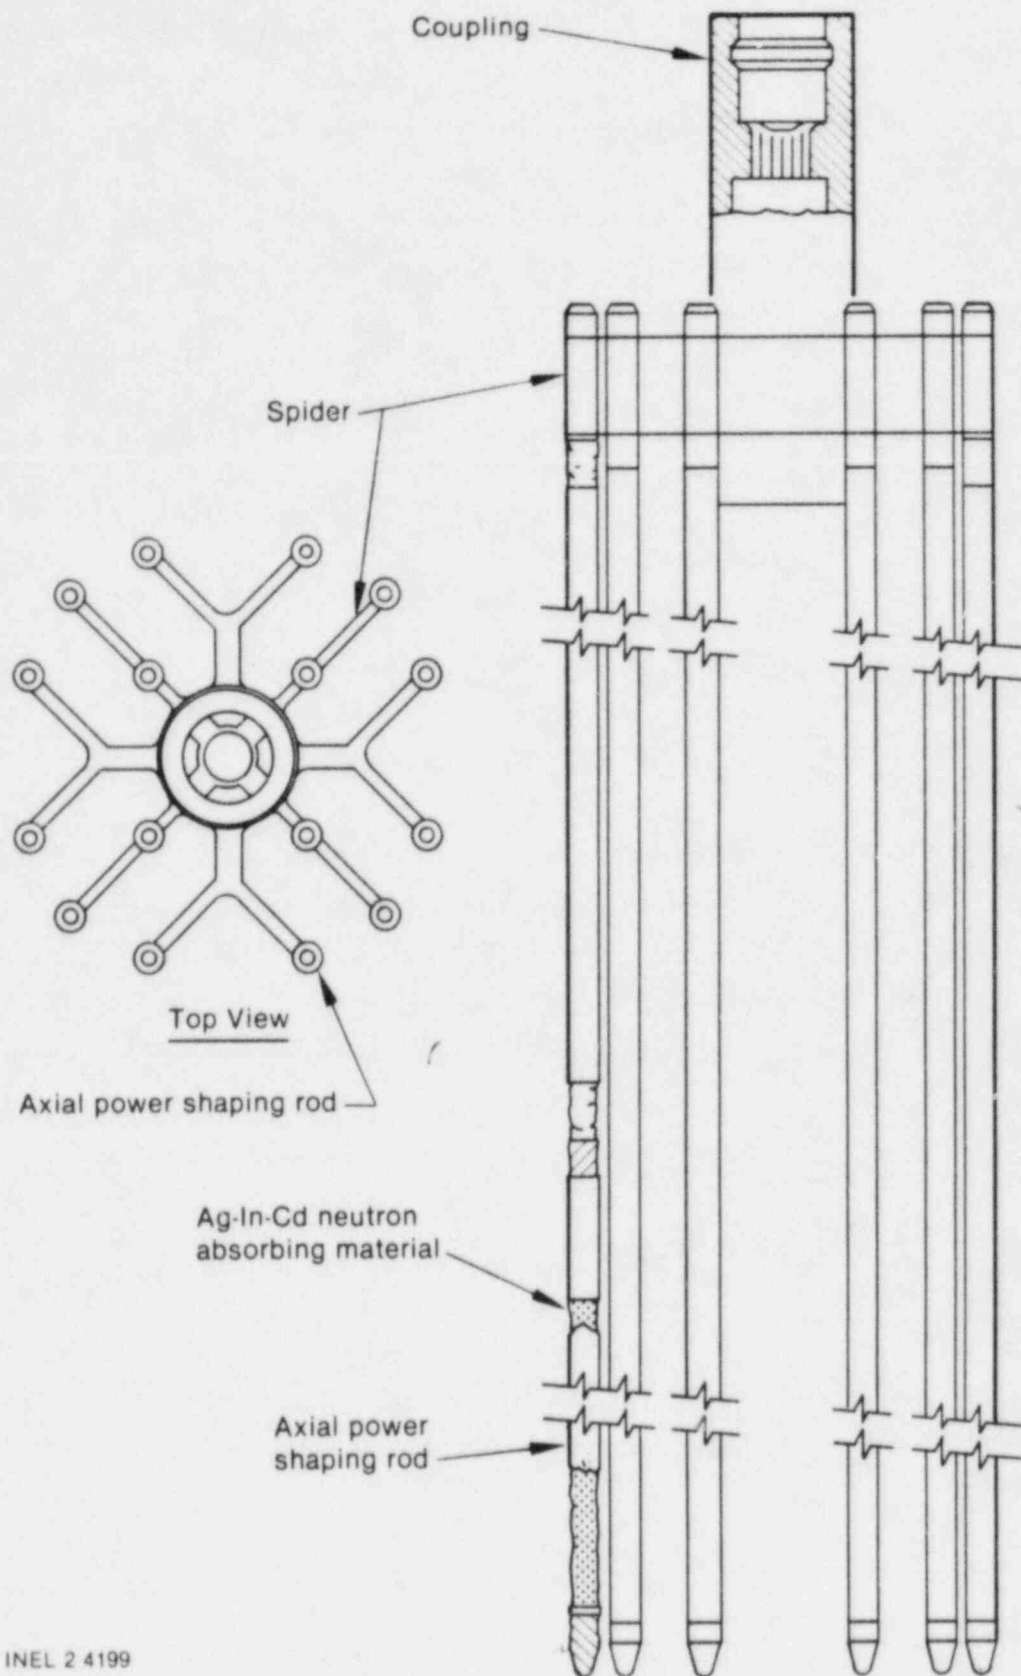
INEL 2 4199

Figure 2. TMI-2 axial power shaping rod assembly.

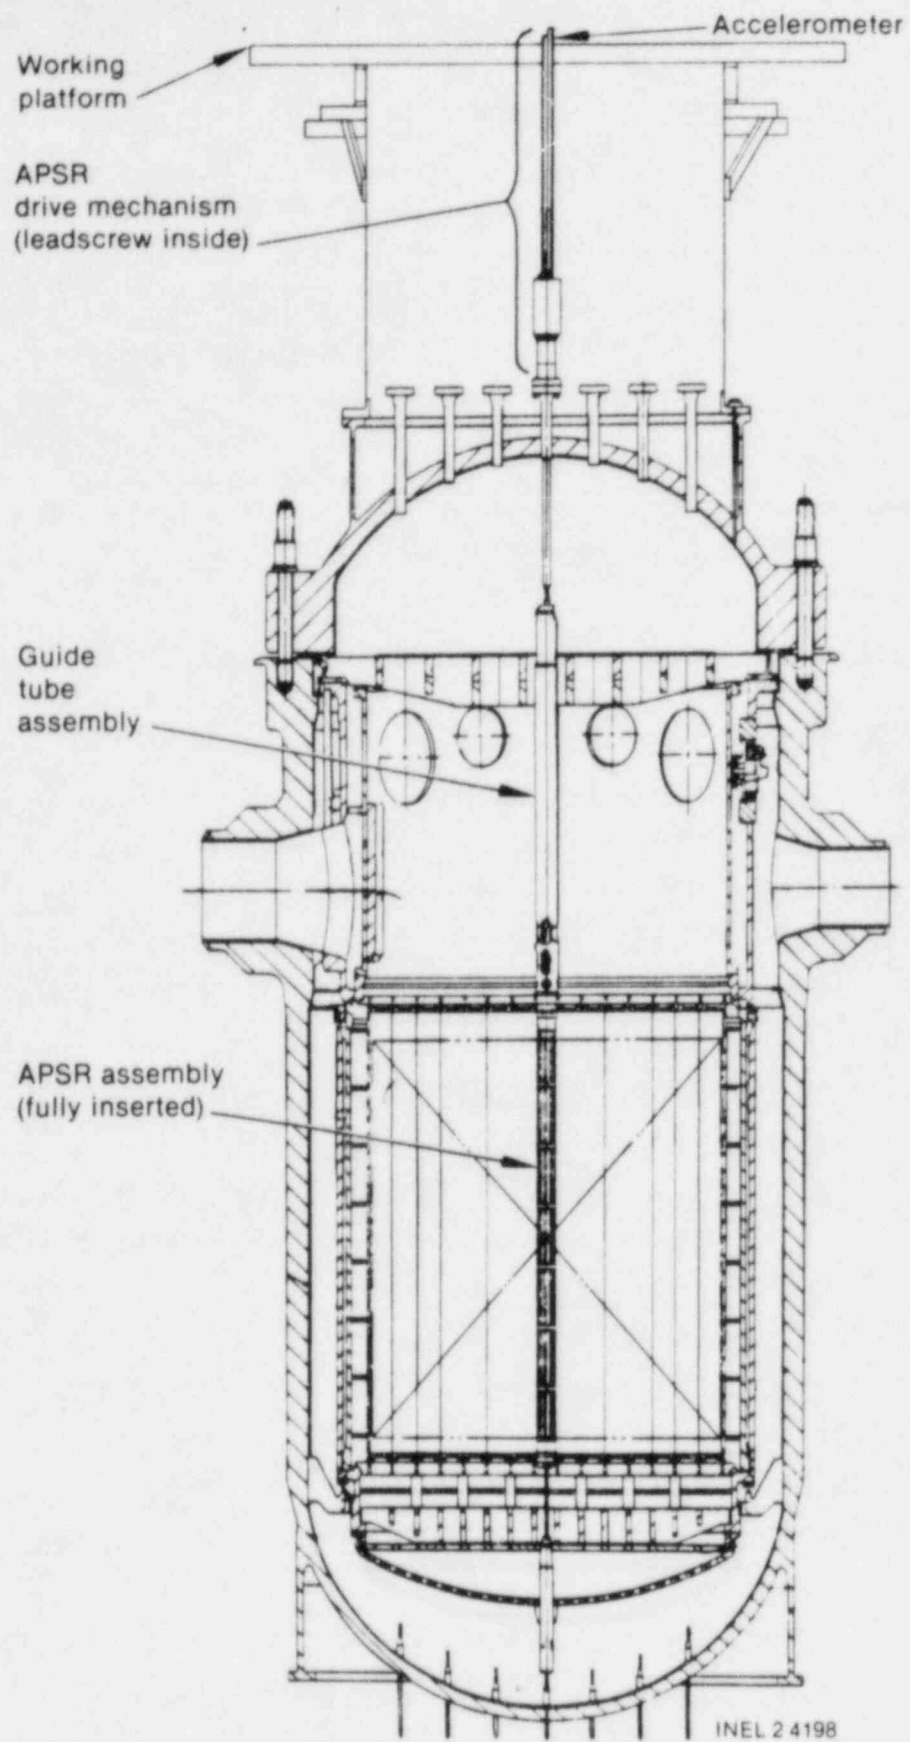
Figure 3. Cross section of TMI-2 reactor vessel, showing typical axial power shaping rod assembly.

Acoustical data were obtained from accelerometers that were attached to the top of the drive mechanism motor tubes of each of the eight APSRs as shown in Figure 3. To identify the APSR mechanical functions that can be detected acoustically, tests were performed on APSR mockups at the Diamond Power Speciality Company (Lancaster, Ohio). Details of these tests are described in Reference 1. The Diamond Power tests demonstrated that the following mechanical functions could be detected acoustically:

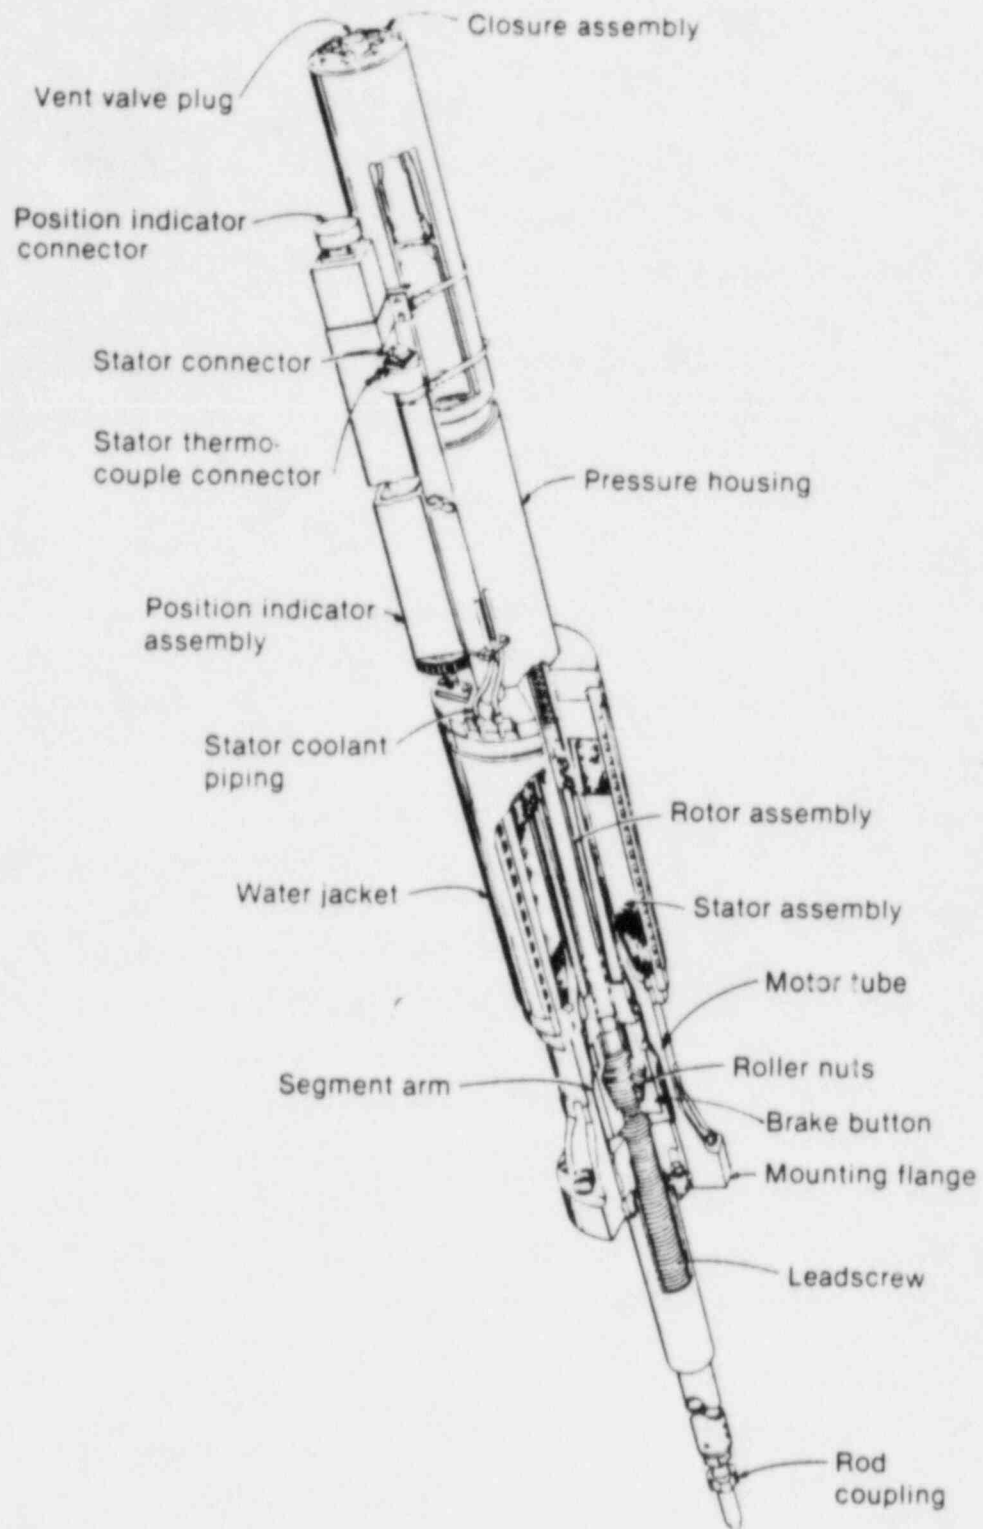
INEL 2 4202

Interpretation of the APSR Insertion Test acoustic data requires an understanding of the APSR drive mechanism, shown in Figure 4. The axial power shaping rod drive mechanism is an electromechanical device consisting of an electrically driven, rotating nut assembly (rotor) within a pressure vessel; a four pole, six-phase stator; a translating leadscrew that converts rotary motion of the nut to linear travel of the leadscrew and APSR cluster; and a brake that prevents motion of the APSR assembly when power is interrupted to the stator. When power is off (or interrupted), the rotor assembly segment arms pivot until contact between buttons on the lower end of the segment arms contact a rotationally fixed cylinder (motor tube). Contact of the buttons with the tube prevents complete disengagement of the roller nuts from the leadscrew while imparting a friction force that prevents rotor movement and thus leadscrew translation.

The drive mechanism control system inputs a sequentially programmed direct current to the four-pole, reluctance-type drive motor that incorporates a six-coil, star-connected winding. The stator coils are sequentially energized in a unique 3-2-3-2 progression, producing a rotating magnetic field around the rotor assembly. When power is applied to the stator, the magnetic field established by energizing the stator assembly acts as a magnetic coupling through the motor tube wall to pull the upper portions of the rotor segment arms outward. Due to the pivoting action, the lower portions of the segment arms move inward, causing the brake buttons to lose contact with the motor tube and the roller nuts to complete engagement with the leadscrew. As the stator coils are progressively energized, the rotor rotates (steps) to orient itself to the new positions. Basic functions of the drive mechanism are described by the following terminology, which is used throughout this report and supporting documents:

Figure 4. TMI-2 axial power shaping rod drive mechanism.

- Latch The action by which the rotor is aligned with the stator magnetic field, releasing a mechanical brake and locking the rotor into synchronization with the active magnetic poles of the stator windings. This is accompanied by a radially outward motion of the two rotor arms and inward travel of the roller nut elements, thus providing tight engagement of the four nut rollers with the leadscrew.

- Single step A single incremental advance (or retreat) of the stator field. This represents 15 degrees of mechanical rotation, which translates to 0.079 cm (1/32 in.) of axial linear movement of the leadscrew.

- Jog Continuous sequential step advance (or retreat) of the stator field. This represents 96 steps per minute or four full revolutions per minute and translates to 7.62 cm (3 in.) of linear movement per minute.

- Pole slip The action wherein the rotor fails to advance in response to the advance of the stator field. On the fourth such zero movement step, the rotor will reverse direction and move backwards the equivalent of two steps and again lock into synchronization, representing a 90-degree phase slip with respect to the field advance. This produces an audible noise. One must then step forward twice in order to get to the starting point. Thus, pole slip represents a loss in actual movement of six steps, when considered in terms of "applied" steps.

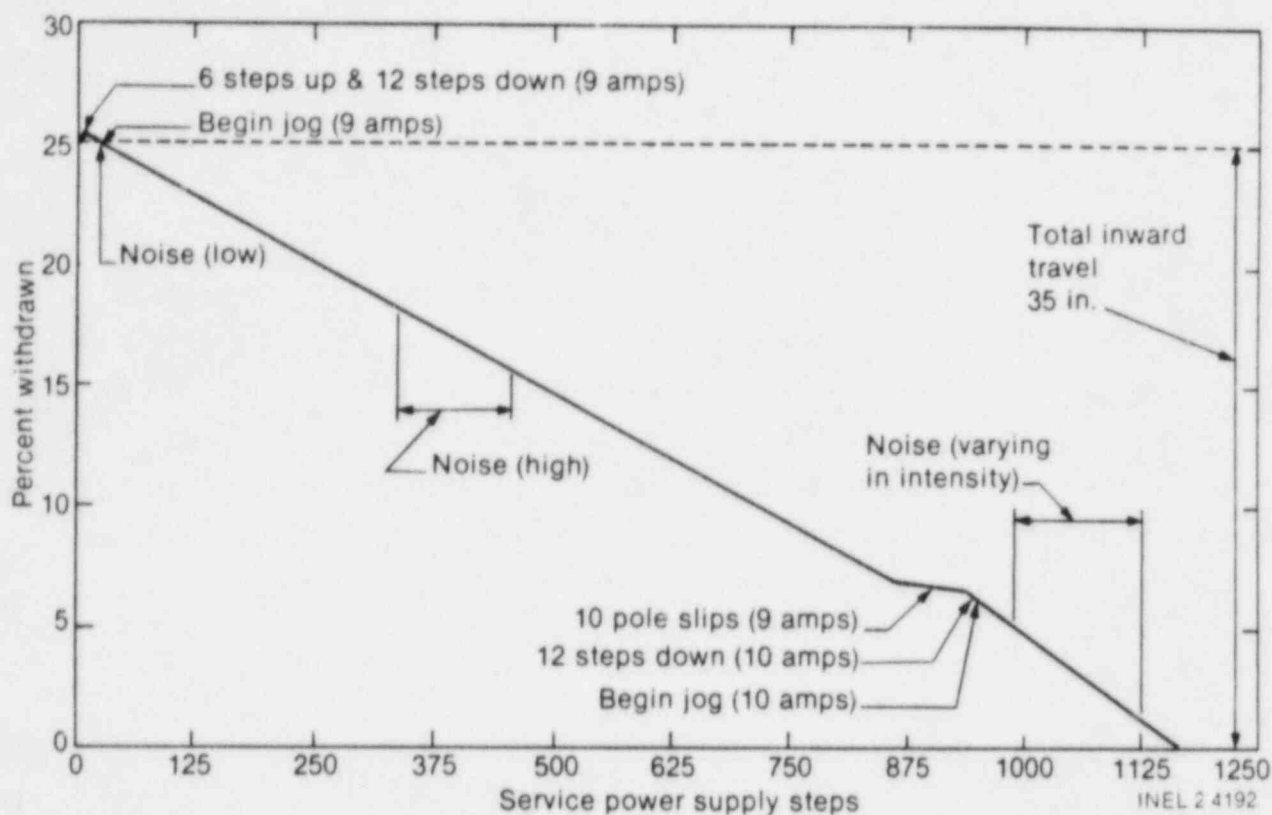
Figure 5. Movement summary diagram for APSR 65, during the TMI-2 APSR Insertion Test.

A detailed event log for each of the eight APSRs is provided in Appendix A. In addition to the event log, a movement summary plot was developed for each APSR. The movement summary plots relate APSR position (in terms of percent withdrawn) to the number of service power supply steps, and identify the locations at which pole slips occurred, which may be indicative of increased resistance to APSR rod movement or even total blockage of movement. A sample movement summary plot for APSR 65, which was inserted to the full-in position, is shown in Figure 5. Movement summary plots for all eight APSRs are also provided in Appendix A. Table 1 describes the initial position, final position, and inches of absolute movement of all eight APSR assemblies during the test.

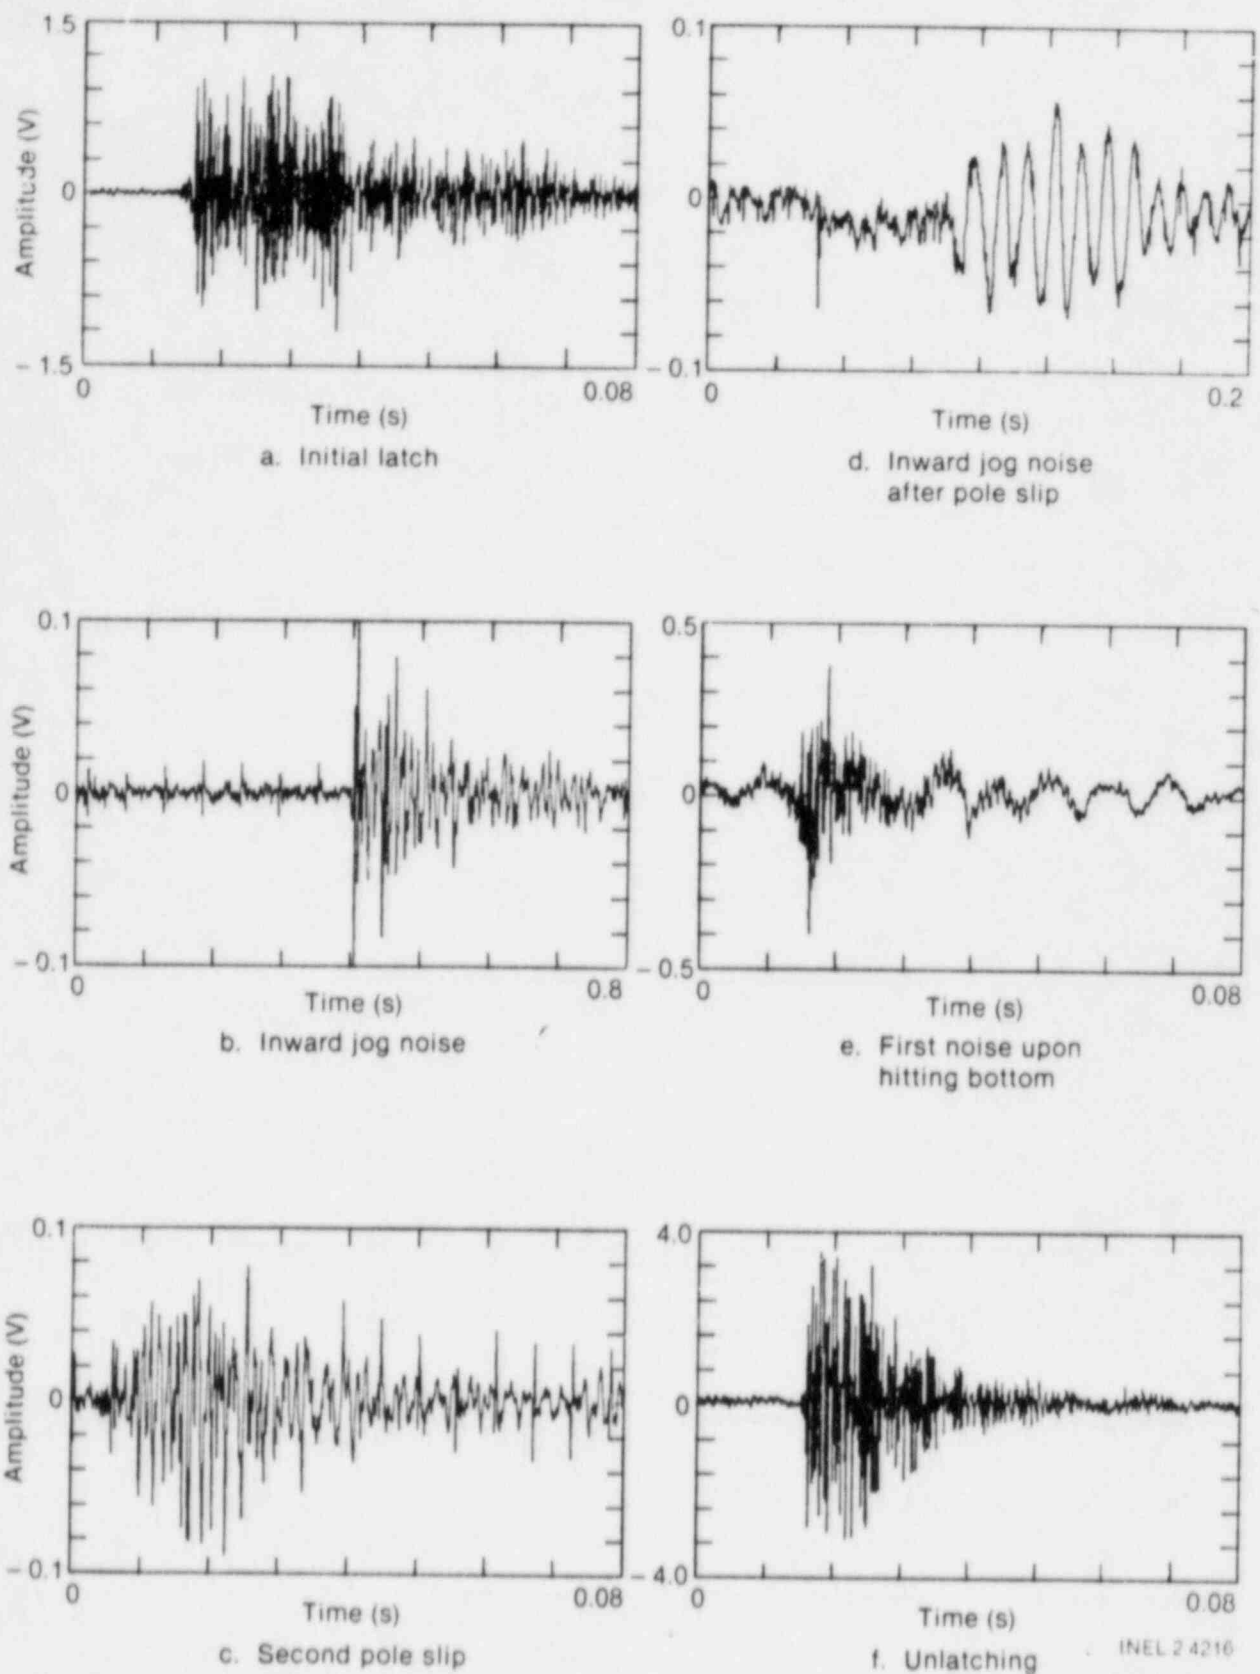
Figure 6. Acoustic signature of selected significant APSR rod movement events, as recorded on APSR 65 during the TMI-2 Insertion Test.

Individual APSR insertion event diagrams were developed, based on the acoustic signals (see Appendix B), which relate observed rod motion noise to rod position (percent withdrawn) during the insertion test. Based on the insertion event diagram, the diagram shown in Figure 7 was developed to compare rod motion noise levels (pole slip, running noise, quiet motion, and end of motion) at different rod positions for all the APSRs. Figure 7 clearly illustrates how each APSR assembly moved and identifies the major acoustic features associated with that movement.

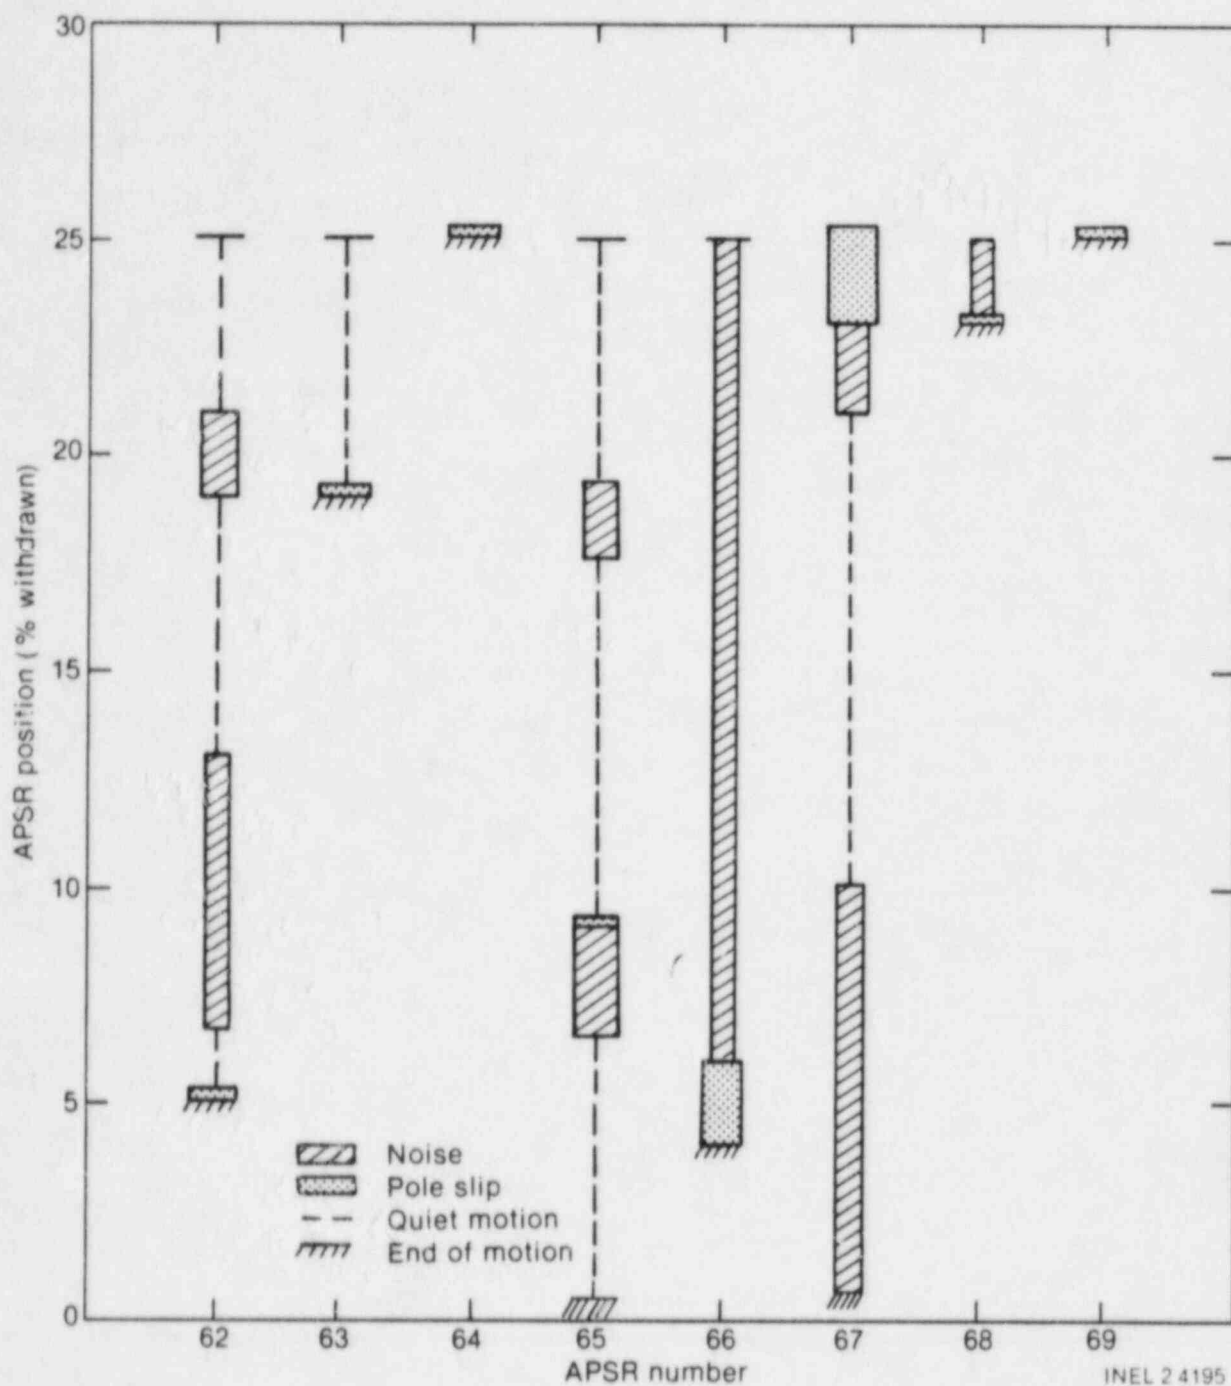
Figure 7 reveals that although none of the insertion acoustic profiles are exactly alike (with the exception of the rods that did not move at all), there are similarities between several of the rods at specific locations. For example, Rods 62, 63, 65, and 66 all exhibit a high noise level (Rod 63 actually stopped) at about the 19 to 20% withdrawn level. Also, Rods 62, 65, 66, and 67 all exhibit a high noise level over the region from the 10 to 7% levels, Rods 62 and 66 stopping completely at the 5 and 4% withdrawn levels, respectively. It appears, then, that at specific elevations the resistance to rod movement increases. In some cases the increase is sufficient to stop rod motion, whereas in other cases the resistance decreases after movement past these locations.

Figure 7. Comparison of rod motion noise levels at different rod positions for all APSRs during the TMI-2 APSR Insertion Test.

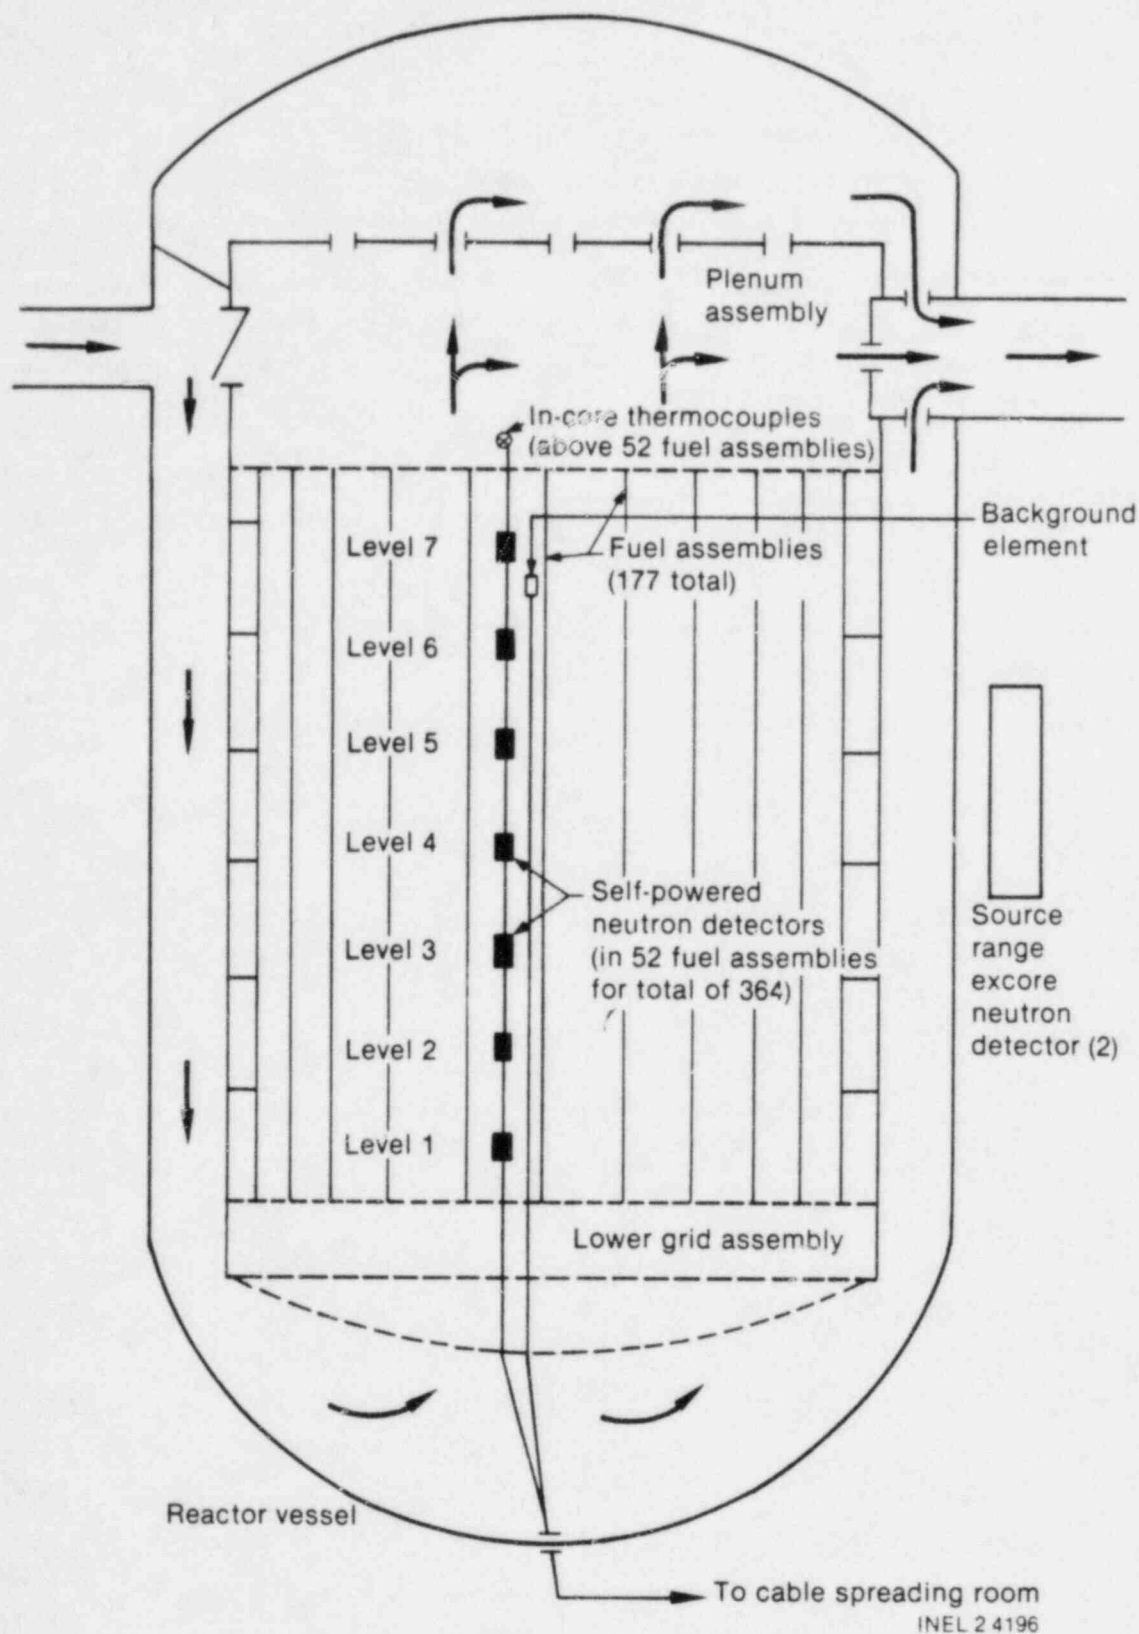
Of the 177 fuel assemblies in the TMI-2 core, 52 are instrumented with a string of 7 self-powered neutron detectors (SPNDs), one background element (BE), and one thermocouple, located vertically along the length of the core, as shown in Figure 8. When the core was initially instrumented, resistance measurements were made on all in-core thermocouples, BEs, and SPNDs. Following the TMI-2 accident, resistance measurements were again made on all thermocouples, and the results were compared with the original measurements to obtain estimates of changes in the lengths of the thermocouple wires as a result of damage during the accident. Measurement of the postaccident thermocouple resistances revealed three distinct groups: Group 1 averaged a reduction corresponding to an apparent average reduction in length of 19 ft; Group 2 averaged a reduction in resistance corresponding to an apparent average reduction in length of 9 ft; and Group 3 consists of thermocouples for which the data, and consequently the thermal damage estimates, were inconsistent. These three statistical groups of thermocouple damage are located on the core map shown in Figure 9, "1" for Group 1, "2" for Group 2, and "3" for Group 3. As would be expected, the thermocouples that experienced the highest degree of apparent damage are generally located in the central core region.

Figure 8. Cross section of TMI-2 core, showing relative vertical locations of in-core self-powered neutron and background element detectors and thermocouples in the 52 instrumented fuel assemblies.

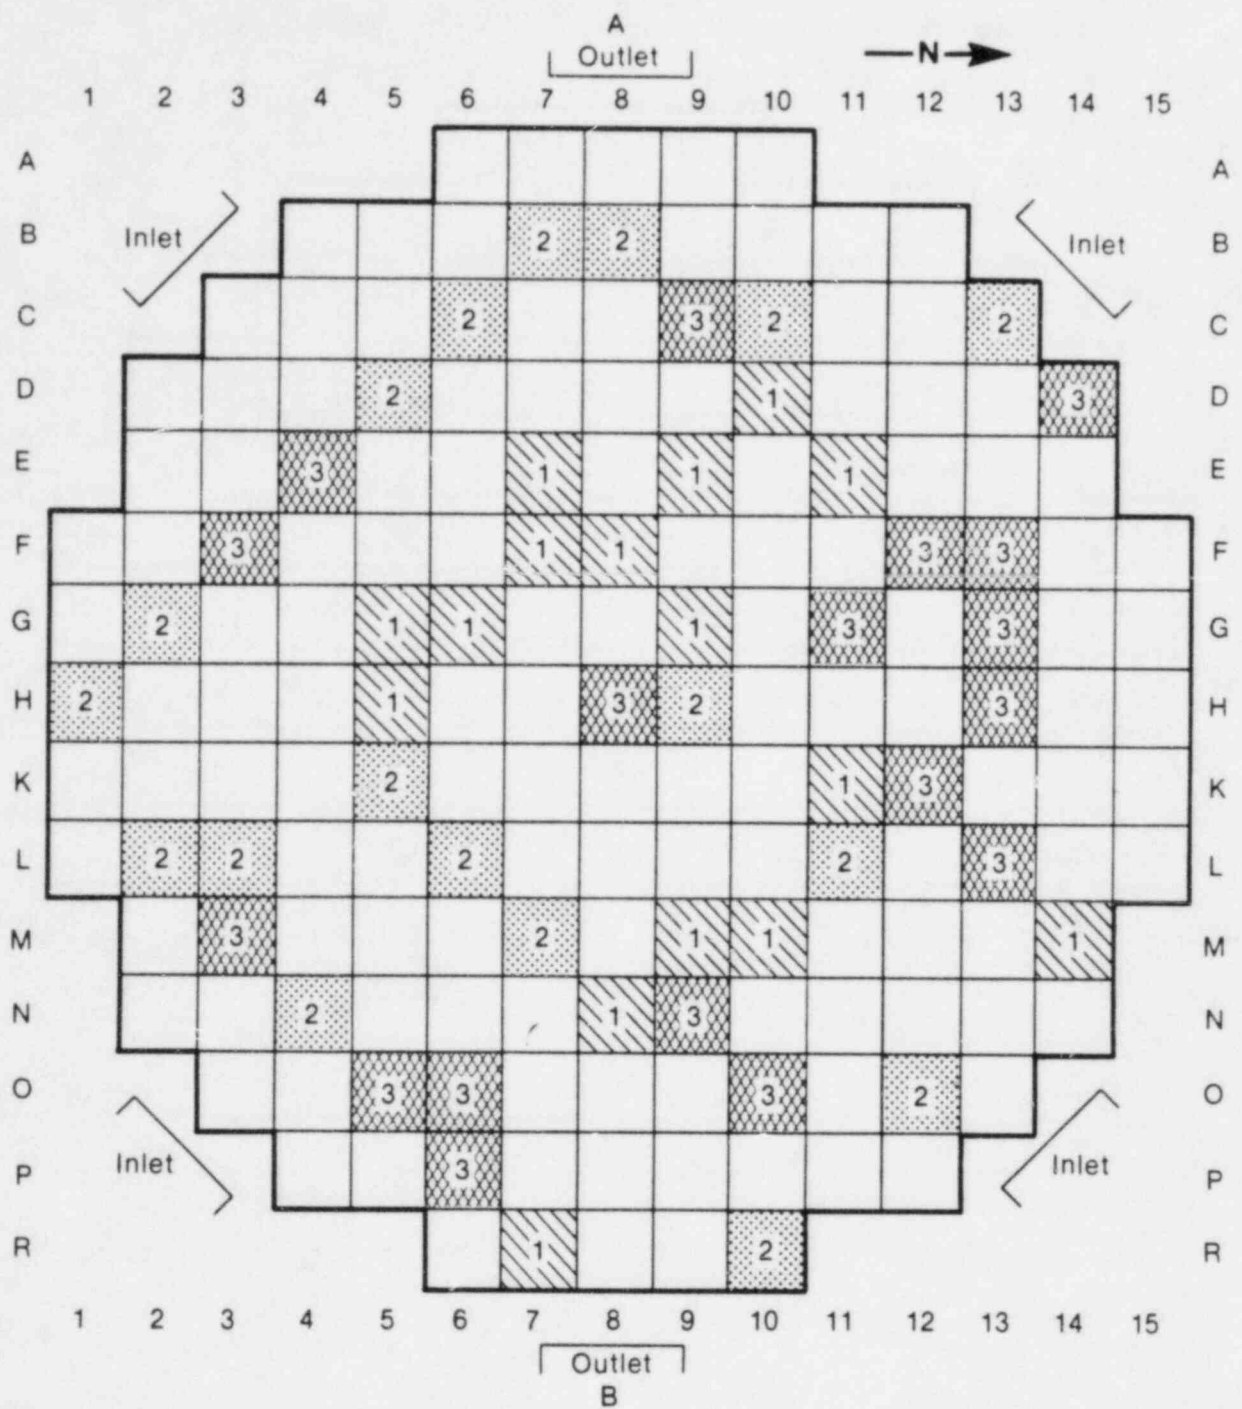
INEL 2 4190

Figure 9. Thermal damage estimates for TMI-2 in-core thermocouples.

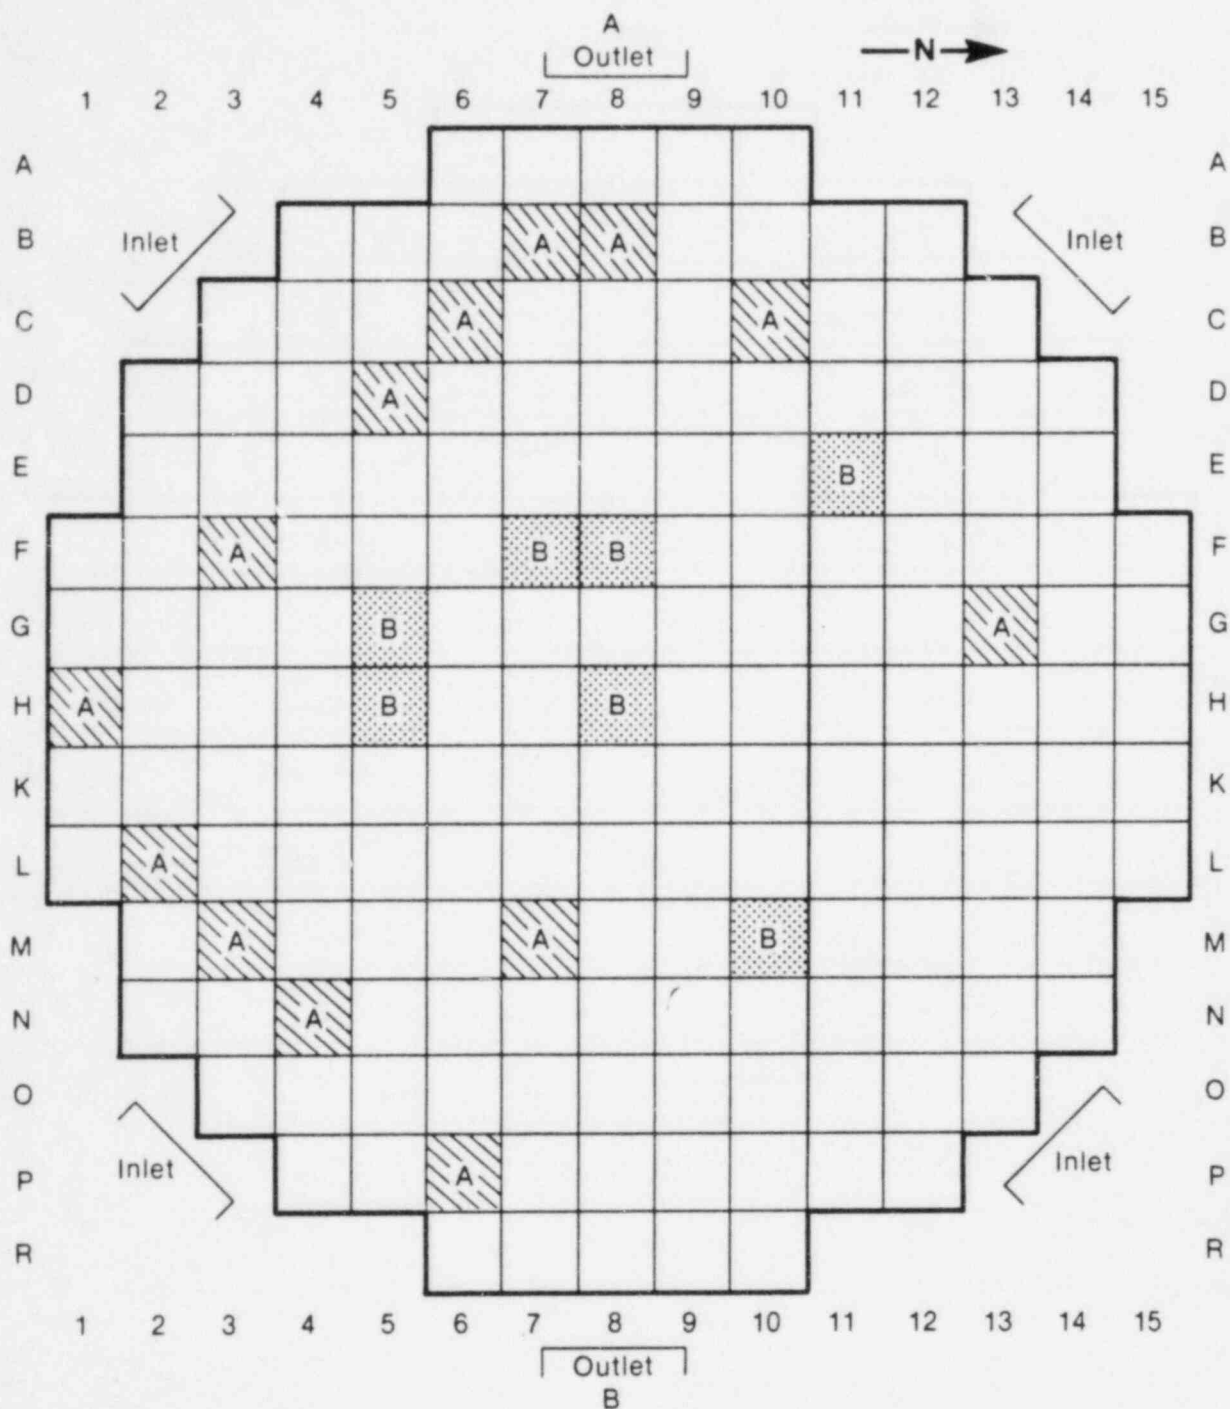
Figure 10. Thermal damage estimates for TMI-2 in-core SPNDs.

Statistical analyses of the insulation resistance measurements on each of the 364 SPNDs and 52 BEs were also performed. Under normal conditions, the SPNDs and BEs exhibit an insulation resistance of $\geq 10^{10}$ ohms, representing essentially an open circuit. Lower resistance would indicate some type of cable failure or damage. The data indicate that some of the SPNDs and BEs are badly damaged, as evidenced by an electrical short between the center conductor and sheath. These damaged elements can be further categorized by fuel assembly location and SPND vertical position. Category A includes locations at which only SPNDs above the second level (see Figure 8) were considered failed. Category B includes locations at which essentially all SPNDs at all levels had failed. Locations of the Category A and Category B SPNDs are identified on the Figure 10 core map. Again, the area of apparently more severe damage is the central core region.

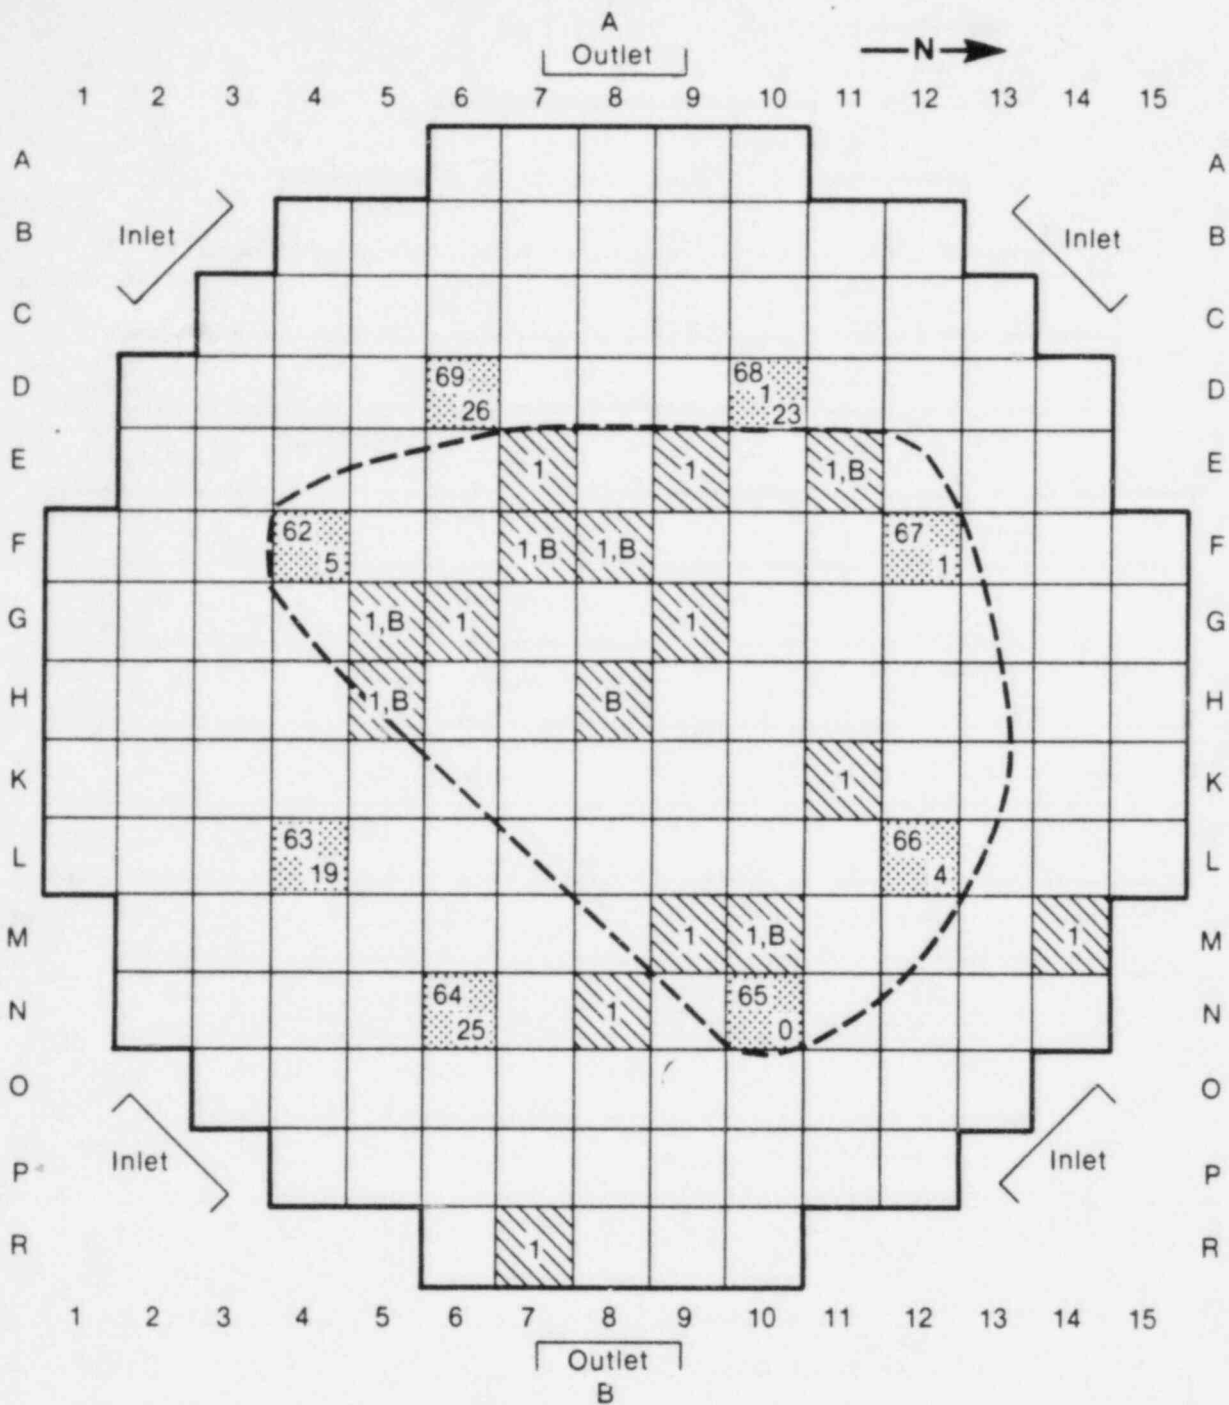
INEL 2 4188

For comparison, Figure 11 shows the distribution of the final positions of all eight APSR assemblies, as determined from the APSR Insertion Test. The data shown in Figure 11 can be interpreted in two ways. The ability to drive APSRs numbered 62, 65, 66, and 67 to essentially the fully inserted position means that either, (a) core damage at these locations was severe enough that the control rods of these APSRs are virtually missing, and, therefore, there was no resistance to movement of the leadscrews to their fully inserted positions, or (b) that core damage at these locations was minor and that the APSR control elements can move freely in the fuel assembly guide tubes.

Assuming that complete or nearly complete APSR insertion means that these locations experienced severe core damage, one can outline this area of the core. A comparison of the areas of probable severe damage to the in-core instrumentation (the Group 1 locations in Figure 9 and the Category B locations in Figure 10) with the outline of essentially complete APSR insertion is also provided in Figure 11, and shows a high degree of correlation. From these data one would conclude that it is likely that the APSRs (with the exception of Numbers 63 and 64) are severely damaged and probably no longer attached to their leadscrews. It is, therefore, highly unlikely that resistance to APSR movement results from interference with in-core features such as fuel assembly guide tubes and spacer grids.

| Fuel assembly at which in-core instrumentation (TCs and SPNDs) appear to be severely damaged | Thermocouple with average reduction in length of 19 ft |

Figure 11. Areas of TMI-2 core damage based on APSR movement and in-core instrument analyses.
