AN ASSESSMENT OF THE TMI-2 AXIAL POWER

SHAPING ROD DYNAMIC TEST RESULTS

Published April 1983

EG&G Idaho, Inc.
Idaho Falls, Idaho 83415

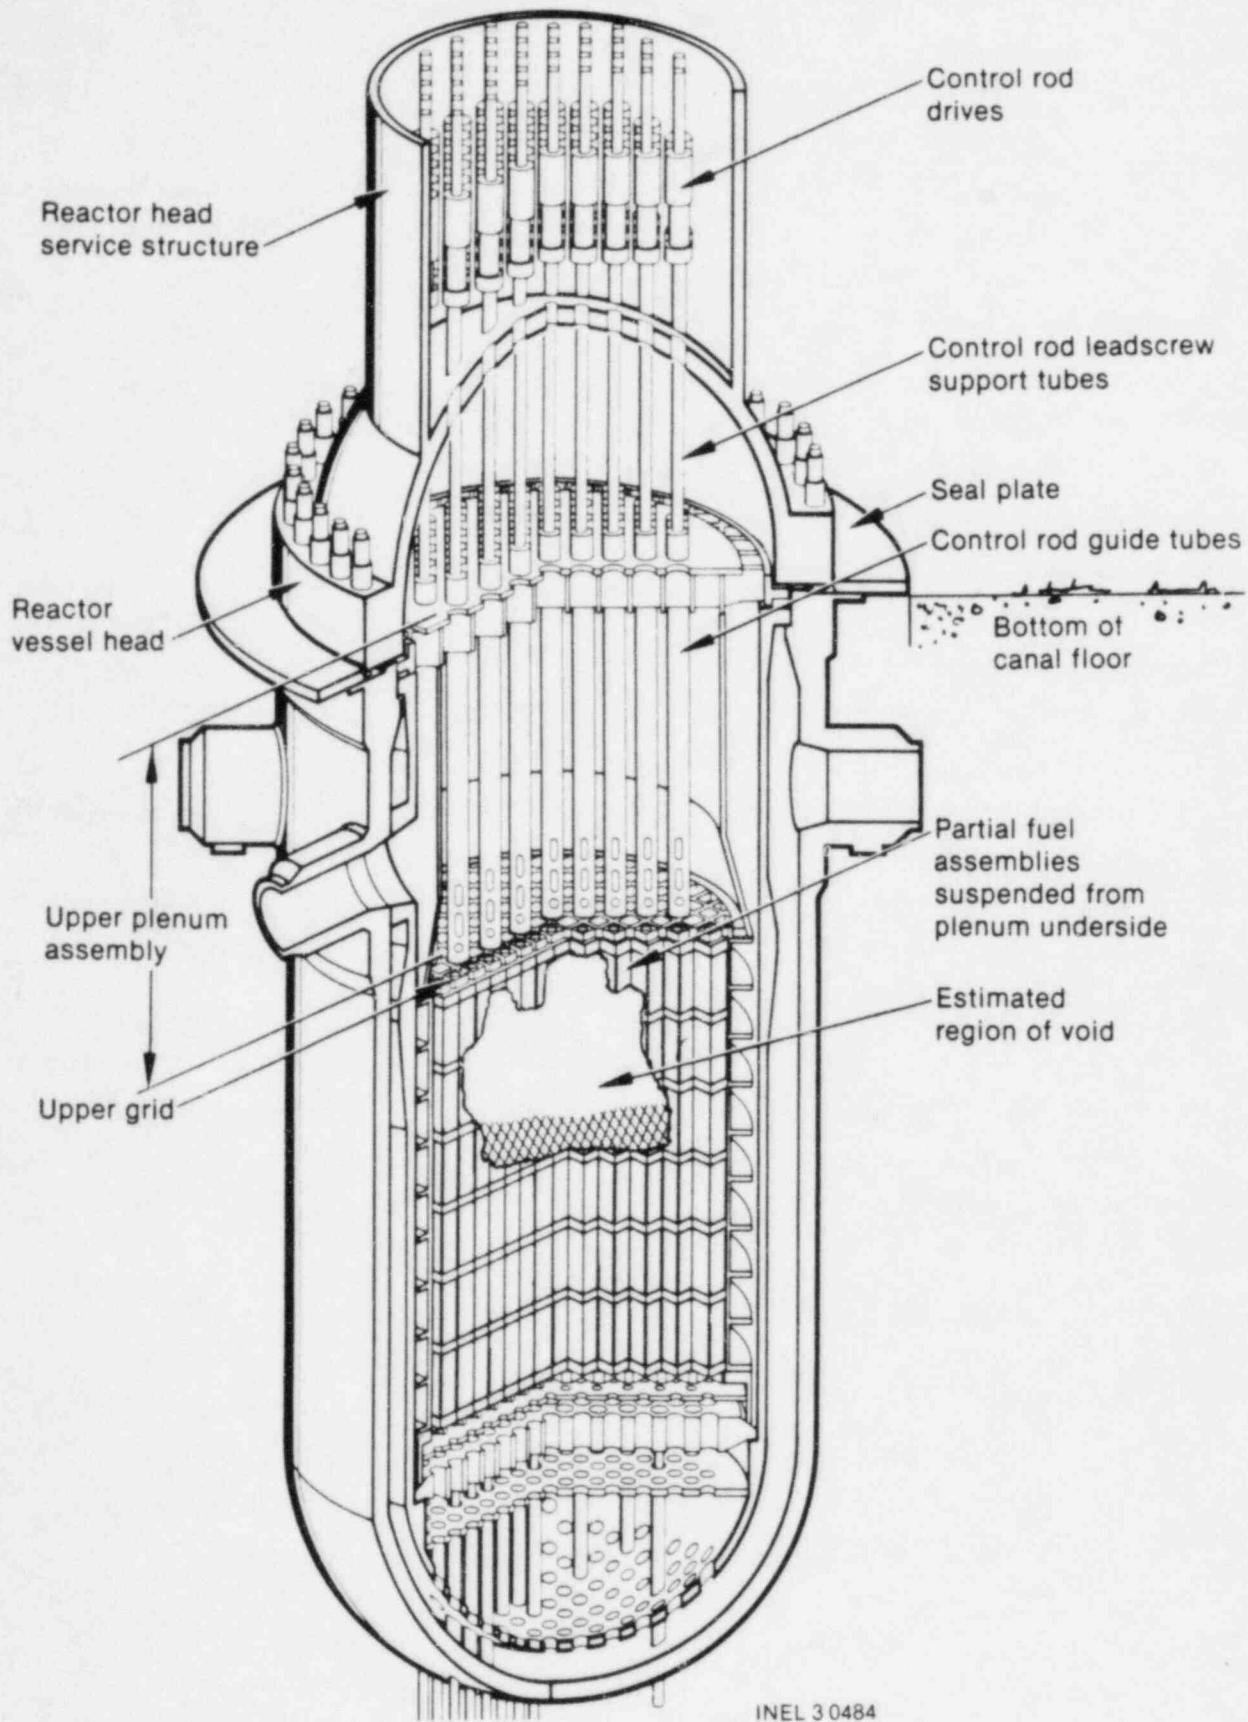
There is a void in the upper central portion of the core, as shown schematically in Figure 12. At the core center, the H-8 location, the void

Figure 12. Void in the upper central portion of the TMI-2 reactor core.

extends downward from the bottom of the plenum to a debris bed whose top surface is about 150 cm (5 ft) below the plenum lower surface. The void also extends down to about 150 cm (5 ft) below the top of the core at the E-9 location. In addition, several fuel rod stubs extend vertically upward from the debris bed at E-9. Adjacent to the E-9 location, the remains of the upper ends of some severely damaged fuel assemblies are suspended from the bottom of the plenum.

- The TMI-2 fuel was severely damaged over a significant portion of the core, with the result that a portion of the fuel is in rubble.
- A large void exists in the upper center of the core, due to settling of the damaged core or removal and redistribution of material from the reactor vessel.

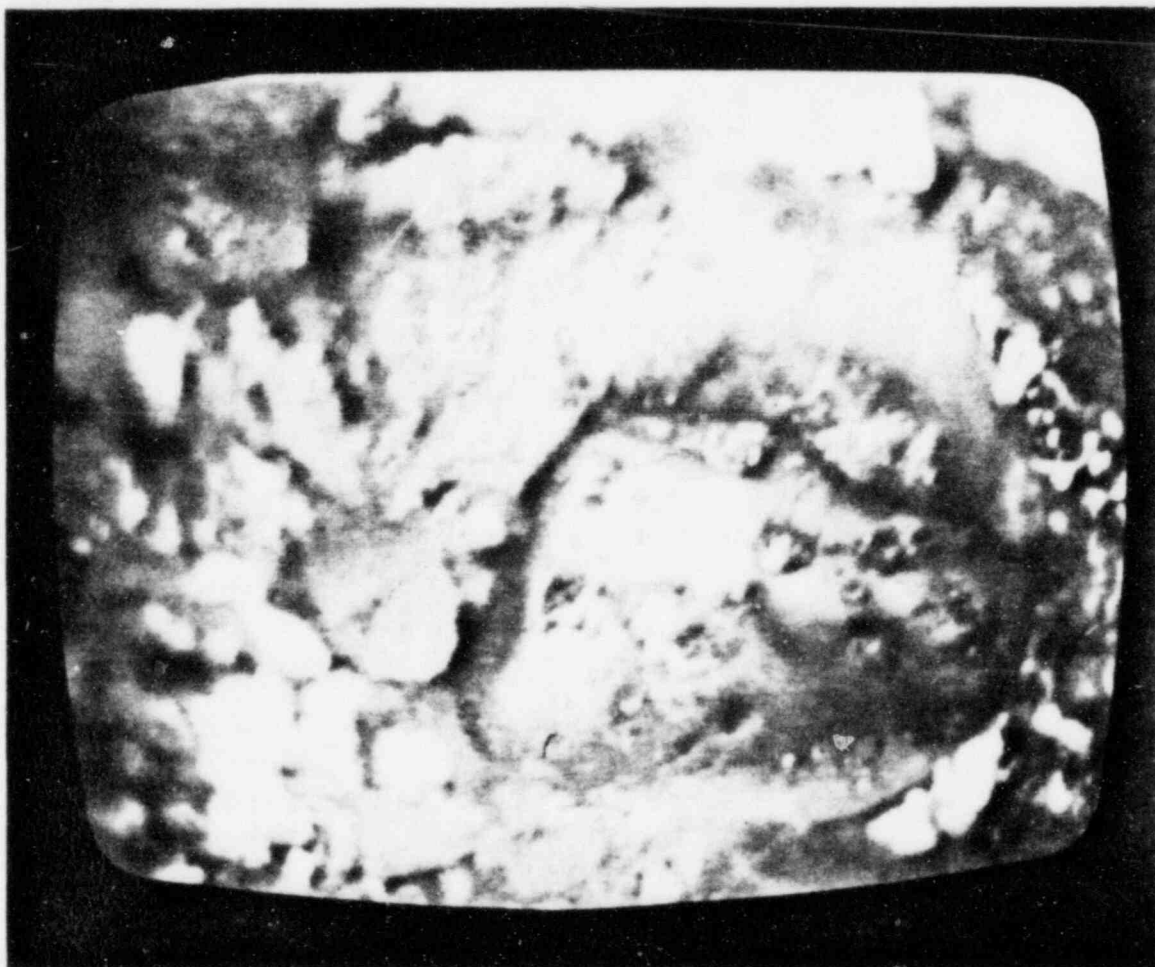
size is ~0.32 cm (1/8 in.) or less. A few very small particles that appear to have once been molten were also observed. A photograph taken of this material appears as Figure 13. The debris bed is more irregular at location E-9; the pieces are larger and many identifiable components, such as fuel rod cladding pieces, broken cladding shards, and $\text{Al}_2\text{O}_3\text{-B}_4\text{C}$ burnable poison rod pellets, are present (Figure 14).

Figure 13. Photograph of debris bed at location H-8, showing a small particle that appears to have been molten and resolidified.

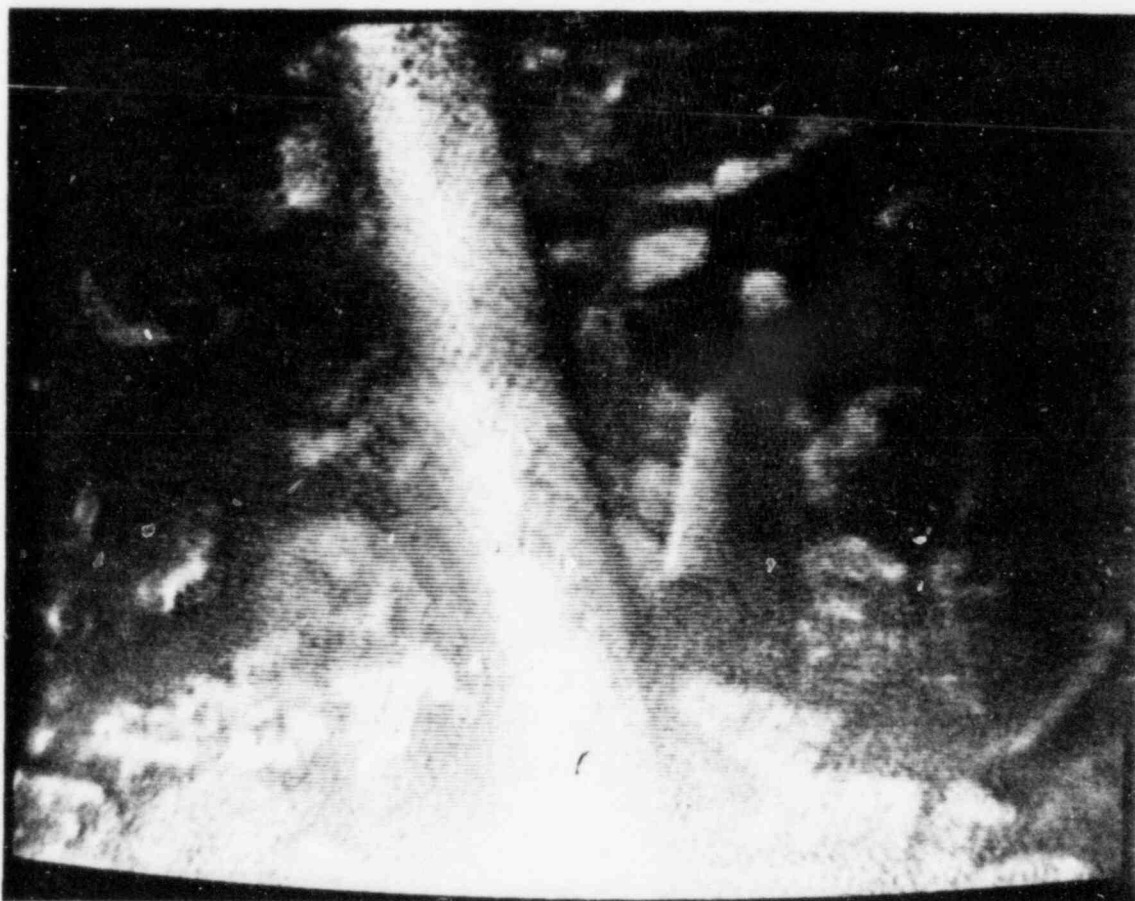
Figure 14. Photograph of debris bed at location E-9, showing larger recognizable pieces.

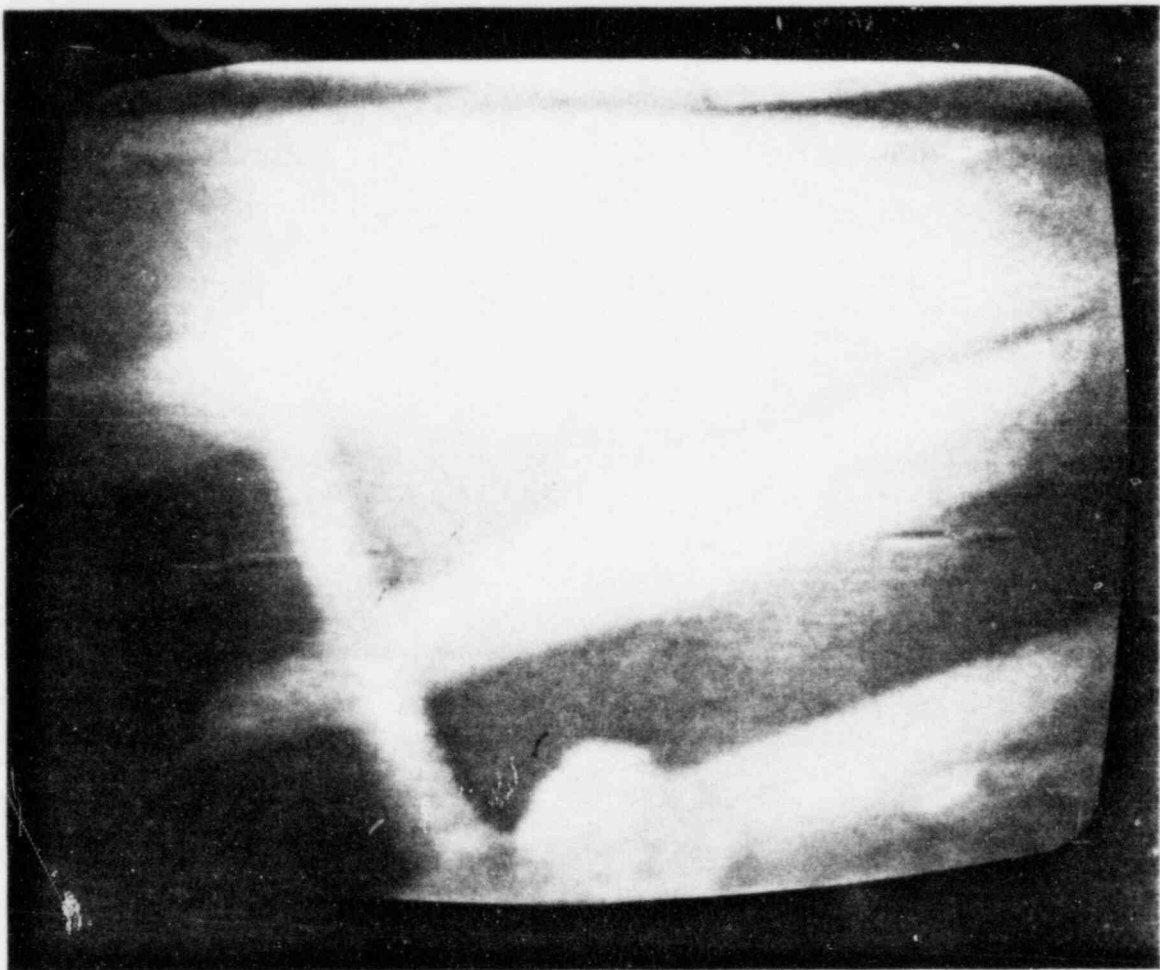
Four adjacent fuel assembly upper end-fittings could be seen suspended from the underside of the plenum at location E-9. The four end-fittings suspended from the grid plate have been identified as belonging to the fuel elements located at grid points D-9, D-8, and E-8. Protruding downward from these fuel assembly upper end-fittings were, at various locations, damaged control rod stubs, fractured fuel rods, and portions of a damaged top-most fuel assembly spacer grid. Also, the grillage on the bottom of the stainless steel upper end-fittings was eroded or melted in several locations (see Figure 15).

Figure 15. Photograph of grillage on bottom of a stainless steel upper end-fitting, showing partial melting and resolidification.

It is considered highly likely that the high temperatures that caused severe damage to the fuel assemblies and control rods could also have melted and fused the stainless steel cladding of the APSRs to the associated fuel assembly upper-end fittings. If the upper end-fittings in turn were distorted or fused to the upper plenum support plate, APSR motion would have been prevented.

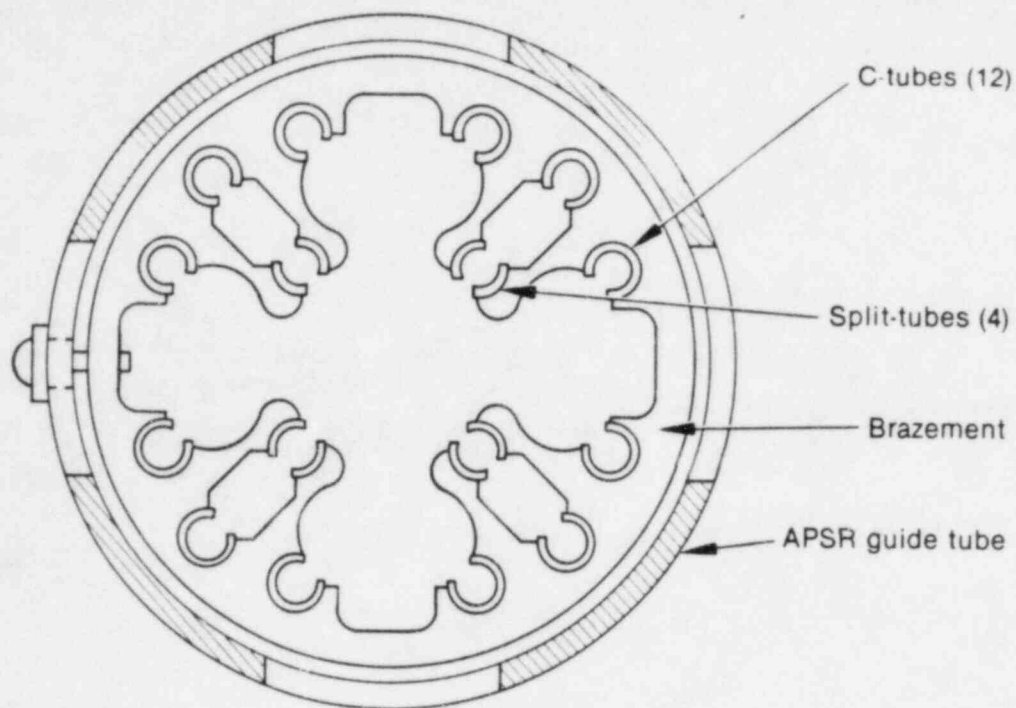
16 a

The C- and split-tubes, which guide the control rods and APSRs when they are withdrawn into their guide tubes (shown in Figure 16), are intact

Figure 16a. Cross-sectional diagram showing relative orientations and radial location of C- and split-tubes in an APSR guide tube.

and in good condition. The brazement support plates, which support the C- and split-tubes, appear normal and show no sign of distortion, damage, or braze material melting.

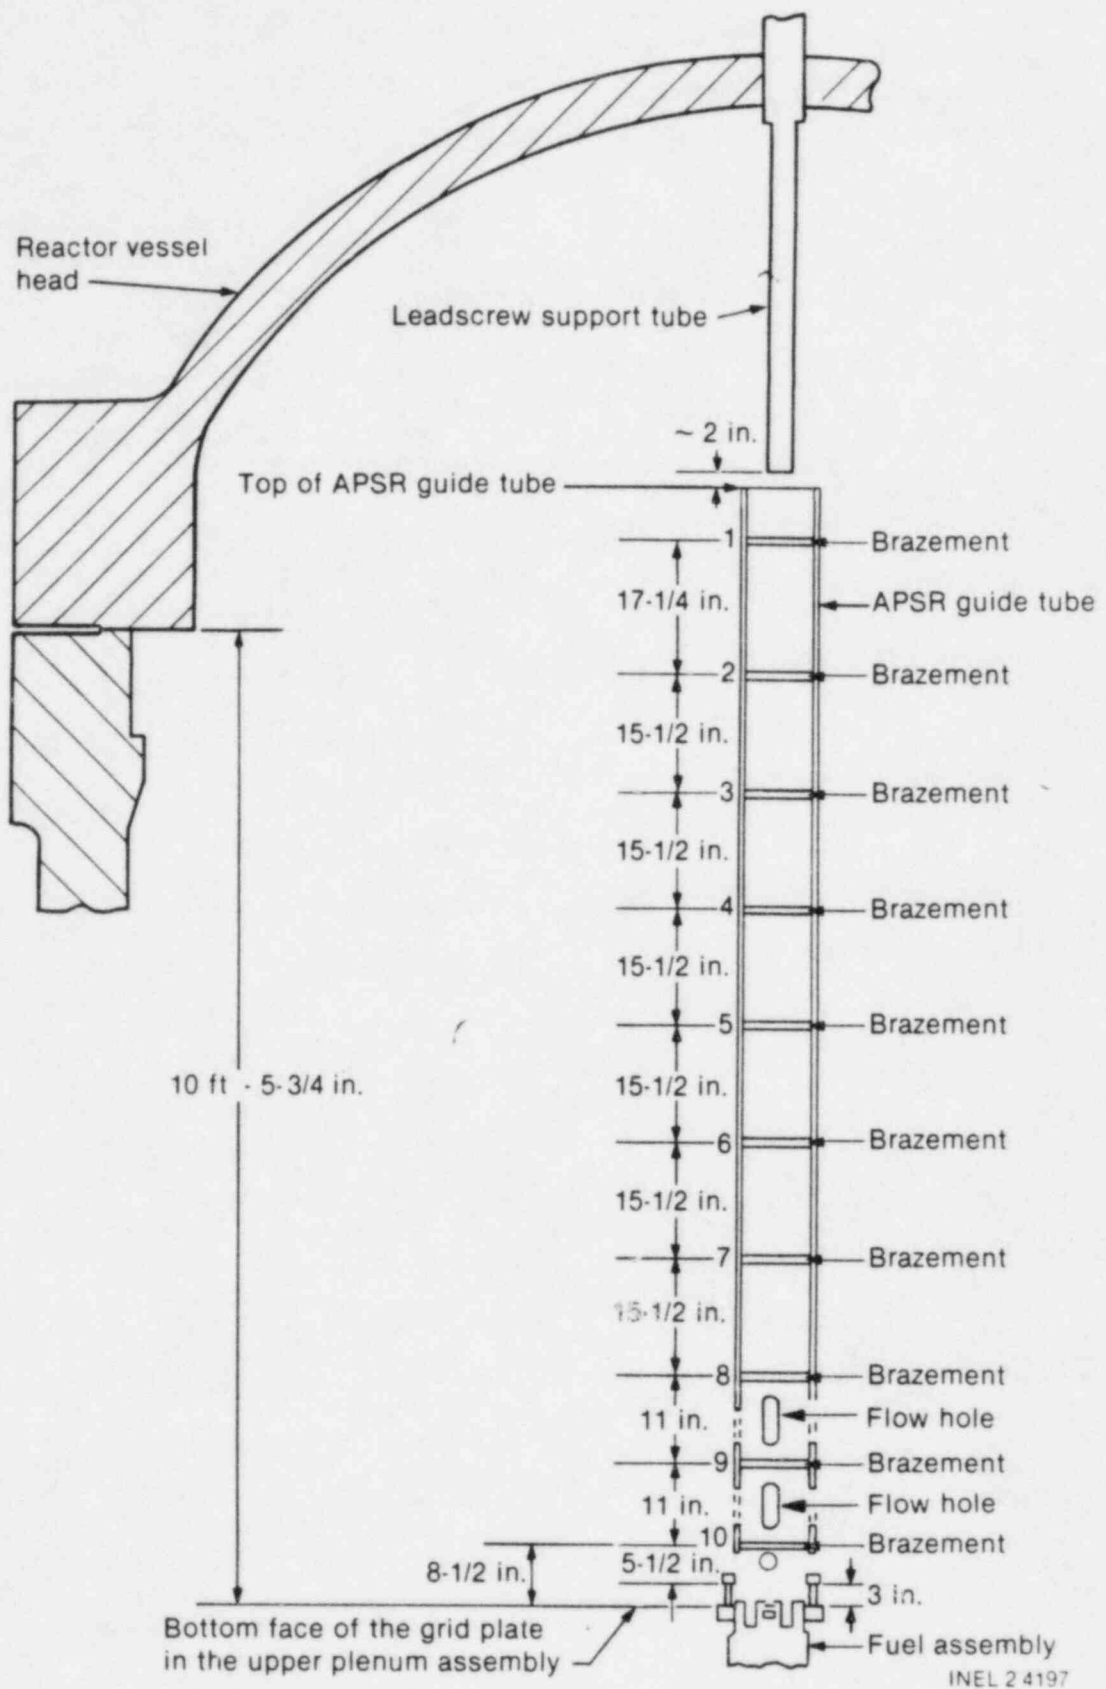
Figure 17. Reactor vessel head and APSR guide tube assembly, showing attachment of C- and split-tubes to 10 axially positioned brazements.

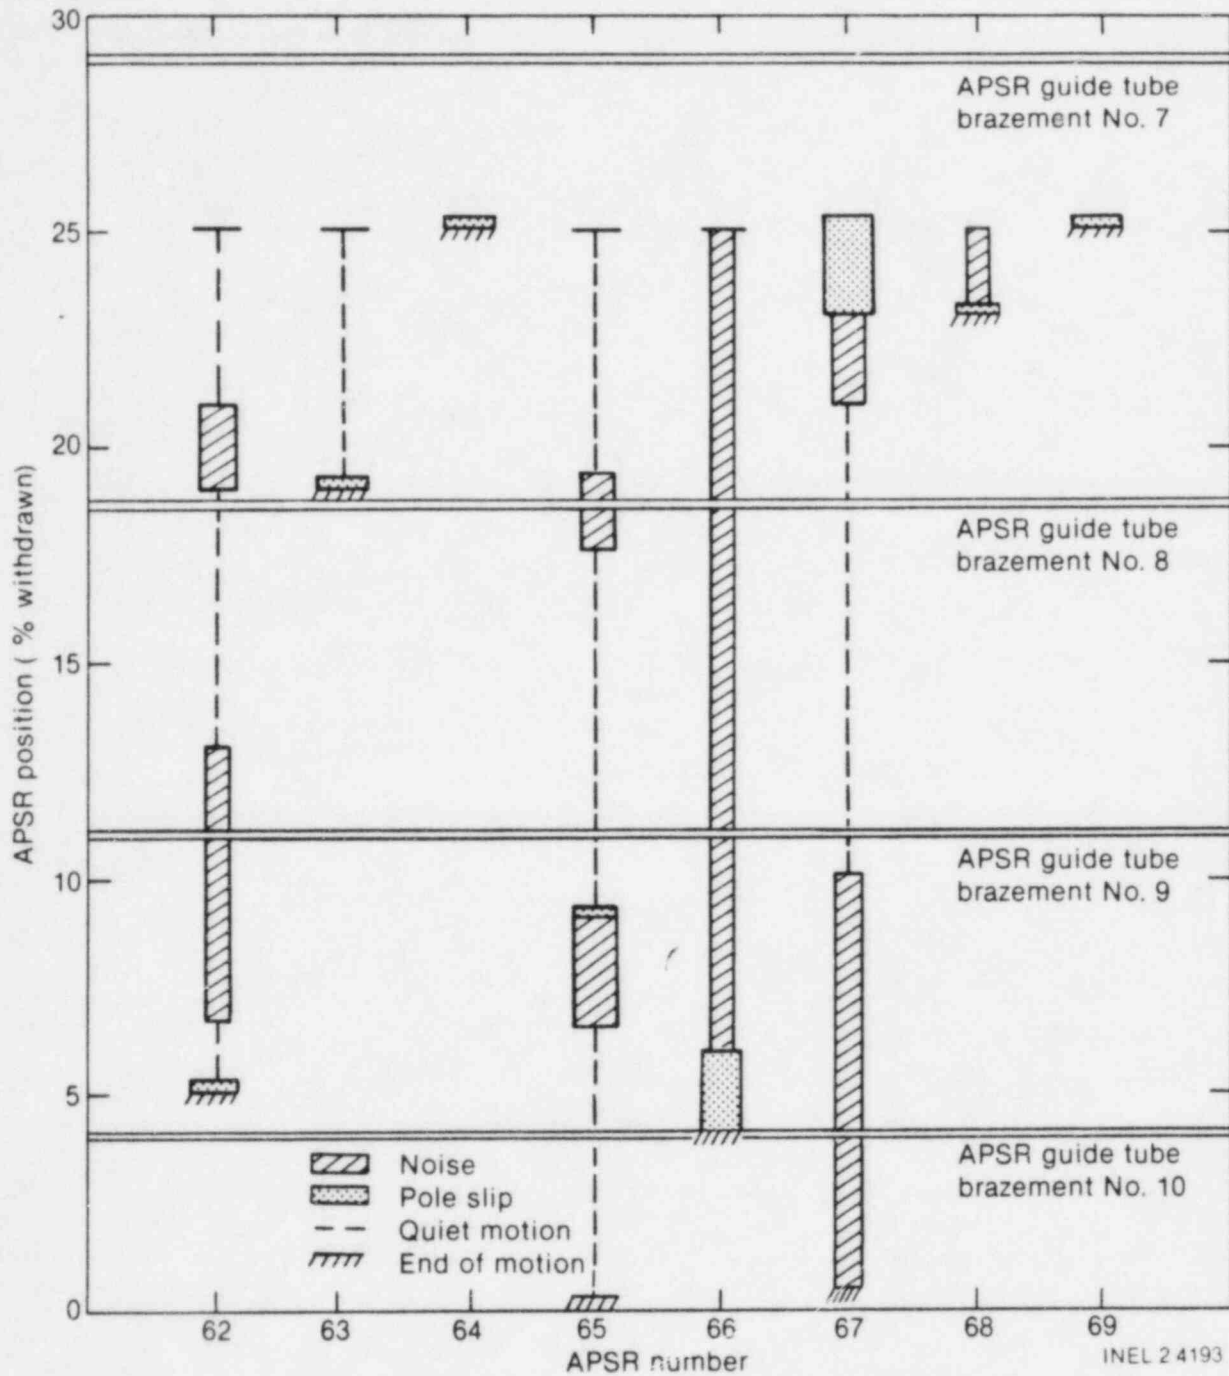
The relative axial positions of the bottom four APSR guide tube brazements have been superimposed over the APSR rod movement results (Figure 7) in Figure 18. From the data in Figure 18, it is postulated that the resistance to movement of some of the APSRs, as indicated by increased noise levels or, as in the cases of Rods 62, 63, and 66, complete stoppage of movement, may be due to interference caused by distortion or bowing of the C- or split-tubes. It is possible that the severity of the postulated distortions may be greater at the locations of the brazements, thereby resulting in complete stoppage of movement for Rods 62, 63, and 66 at these locations. Severe distortion of the C- and or split-tubes could also account for the fact that Rods 64 and 69 could not be inserted at all, and that Rod 68 could only be inserted a short distance before it reached a hard-stop position. The analysis by B&W of the APSR Insertion Test acoustic data (see Appendix B) concentrated on the role of the C-tubes, split-tubes, and brazement upon APSR insertion. The B&W analysis noted that the interference to rod motion observed for some APSRs coincided with the brazement locations, and concluded that such interference might be explained by core debris on the brazement plates or by local distortion of the C- and split-tubes caused by braze alloy melting.

Figure 18. Comparison of guide tube brazement locations and relative APSR rod motion noise levels at different axial positions of the APSR spiders during the TMI-2 APSR Insertion Test.

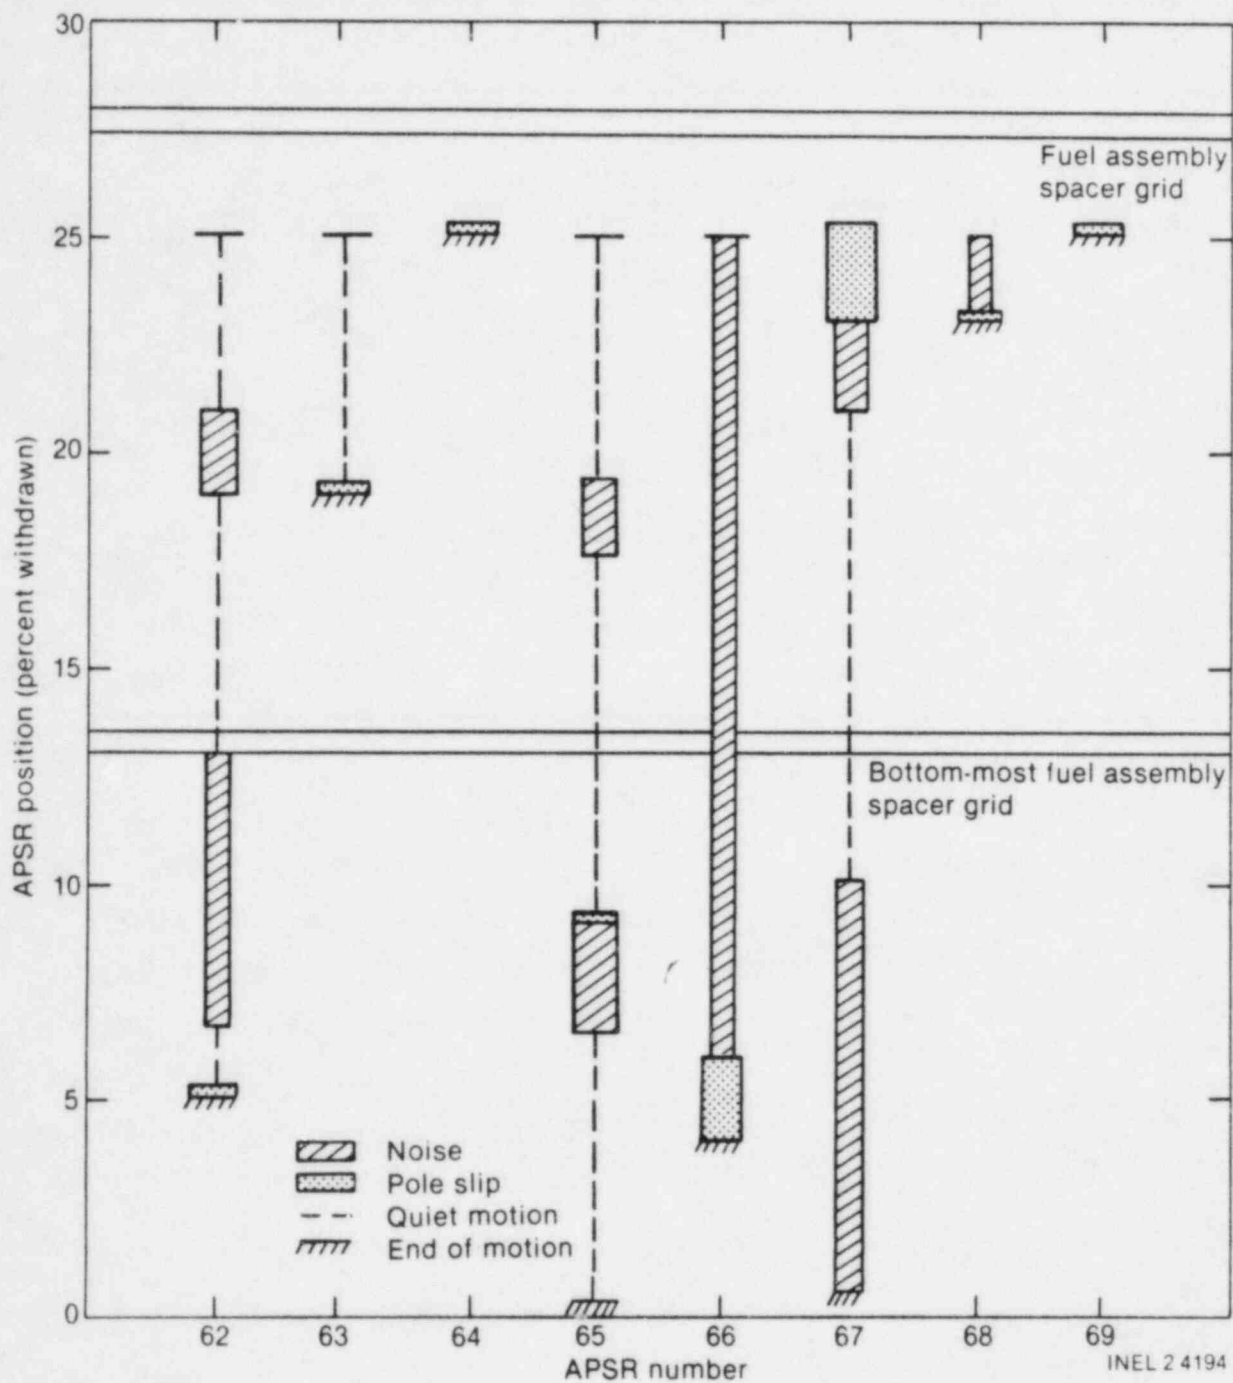
It is also possible to make a similar comparison between the relative axial positions of the APSR control elements and the locations of possible

obstructions in the core region. In the core, each of the APSR control rods must pass through a fuel assembly guide tube that is held in place by spacer grids. The guide tubes span the entire length of the fuel assemblies. Therefore, distortion of the guide tubes in the core region could easily increase resistance to movement of the APSRs, or even prevent movement. If the APSR assemblies are still intact, obstructions to their movement could be due to damage to the guide tubes in the core region. Figure 19 provides a comparison of the relative axial positions of the bottom tips of the APSRs and the axial positions of the lower two spacer grids in the TMI-2 fuel assemblies. From Figure 19, it is seen that of the four APSR control elements that were inserted to positions below the lower spacer grid, two of them exhibited high noise levels in the region of the bottom-most grid, and two of them exhibited reduced noise levels at this location. It is likely that distortion, or possibly extensive damage, to the APSR control rod guide tubes could have occurred over a large portion of the fuel assembly length in the core region, and that this distortion could contribute to APSR movement resistance. This possible explanation for APSR motion interference was noted by Service Application Incorporated (SAI) (Appendix C). However, SAI also concluded that the data obtained during the APSR Insertion Test were insufficient to confirm that the APSR assemblies were intact and connected to the APSR drives. Therefore, it would be highly speculative to attribute APSR movement resistance to specific in-core features such as guide tube distortion or spacer grid locations. It is possible, as shown below, that core damage was extensive enough that some, if not all, of the APSR control elements are themselves missing or severely damaged.

Figure 19. Comparison of fuel assembly lower spacer grid locations and relative APSR rod motion noise levels at different axial positions of the APSR tips during the TMI-2 APSR Insertion Test.

It is likely that the high temperatures that caused severe damage to the fuel assemblies, control rods, and fuel assembly upper end fittings also fused the cladding of the APSRs to the upper end fittings. Such interference might account for the lack of movement of Rods 64 and 69.
